JL Fashions Limited (relocated)

Baniarchala, Mahna, Vhabanipur, Gazipur Sadar

12th & 18th August 2021

Buildings Information

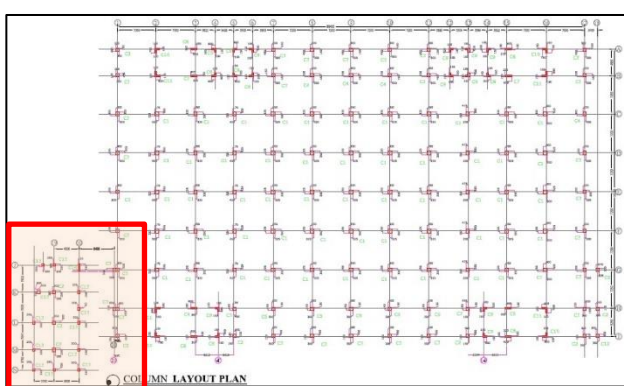
Column Layout Plan- marked portion toilet block

The toilet block is connected at foundation with the Main Building. And there is an expansion gap between the structures. The assessment of the toilet block has not been included in design report. Factory engineer is required to assess the toilet block including the foundation adequacy.

As per BNBC, every building or structure designed shall have its design documents prepared in accordance with the provision of Section 1.9.1. The design document shall include a design report, and a set of structural drawings, which shall be prepared in compliance with section 1.9.1.1 and section 1.9.1.2 as per BNBC. Revise the software-based analysis model, design report & documents following BNBC requirements.

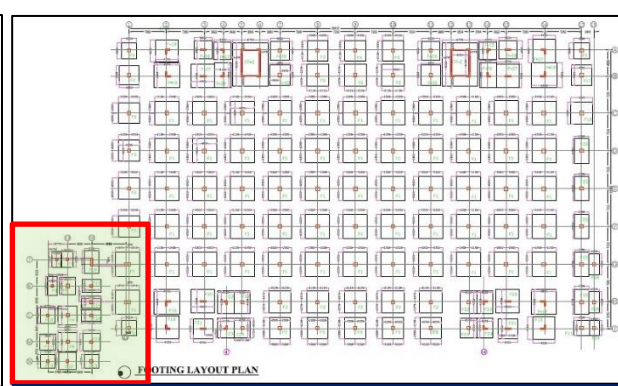
Foundation layout plan- marked portion toilet block

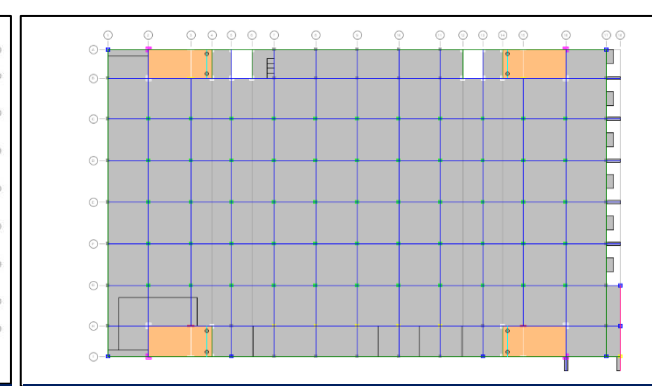
Toilet block has not been assigned in FEA model

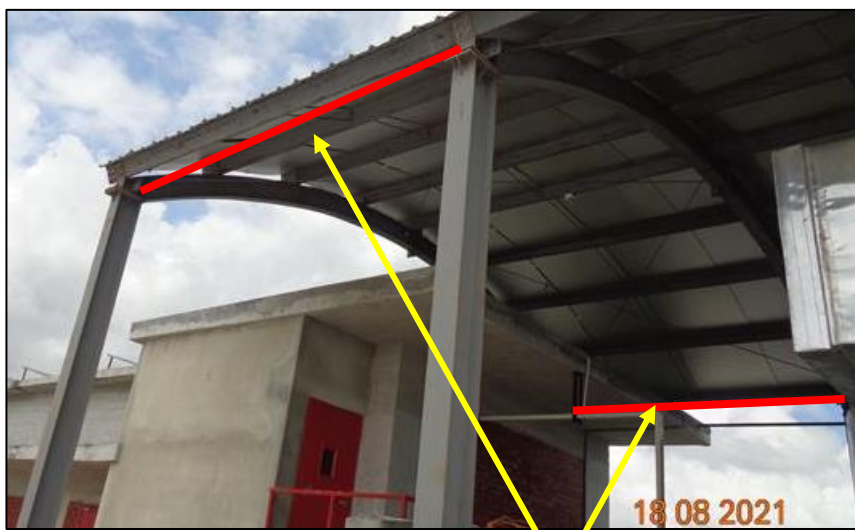
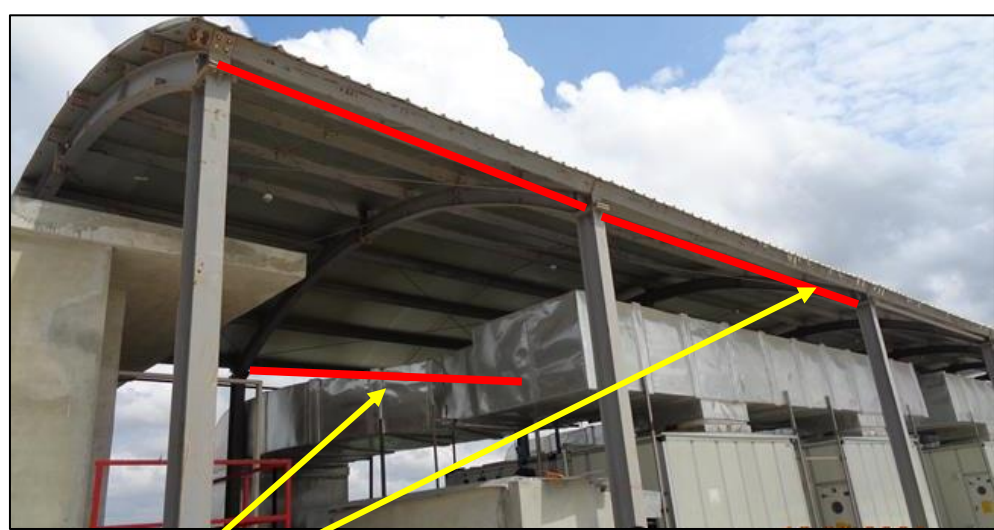
Compression strut was found missing at site condition

Compression strut was not found at site condition as per as built drawing. Factory engineer is required to revise the Engineering Assessment (EA) for the shed which compliance with section 1.9.1 (part-6, BNBC-2006).

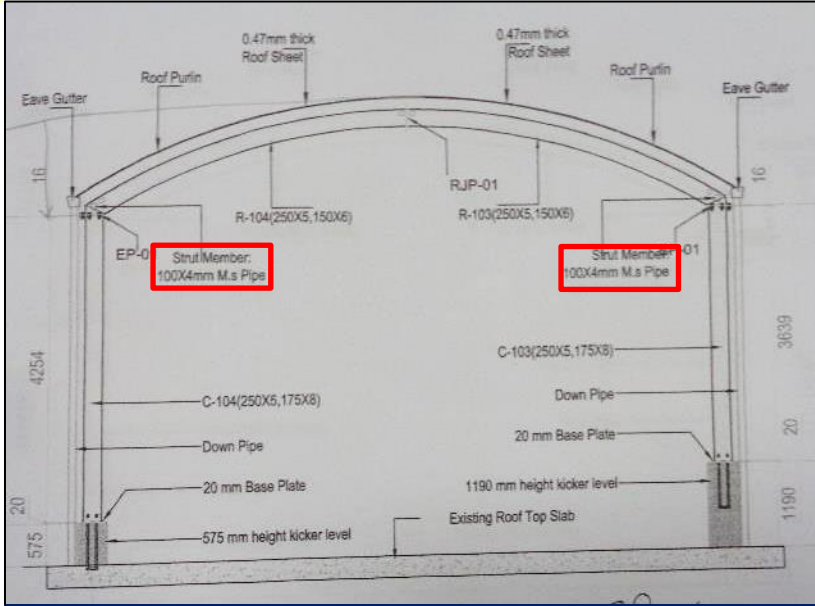
Compression strut has been shown in as-built drawing at all the panel.

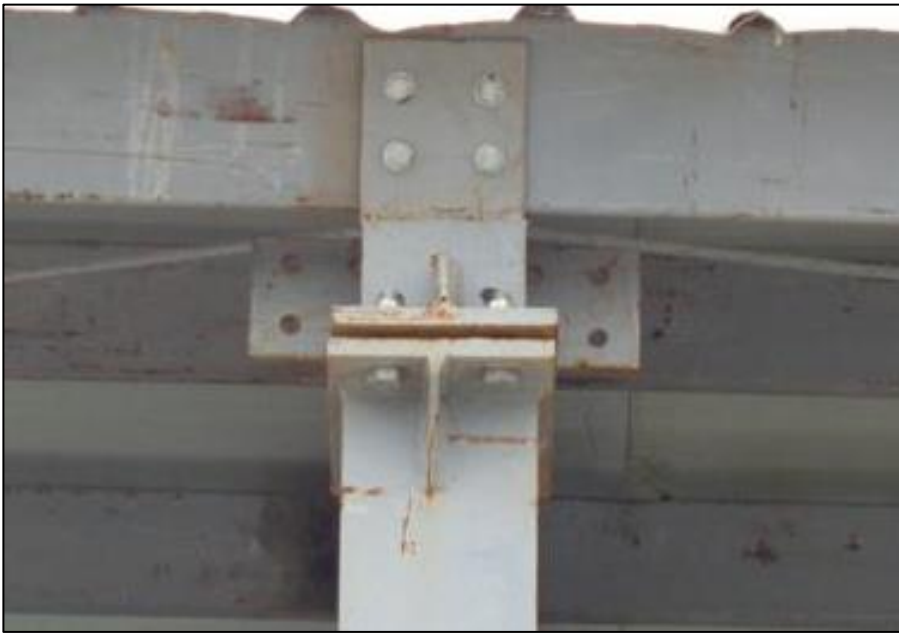
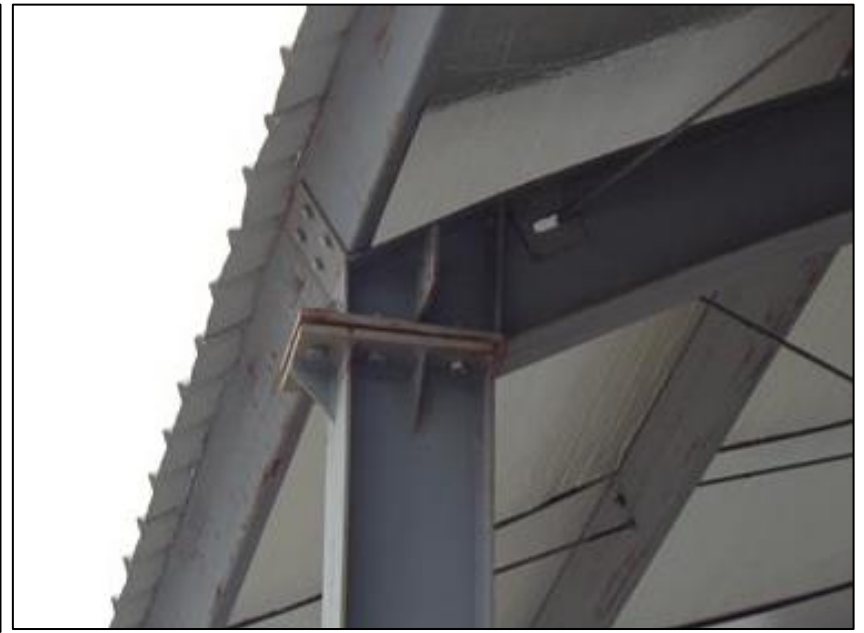
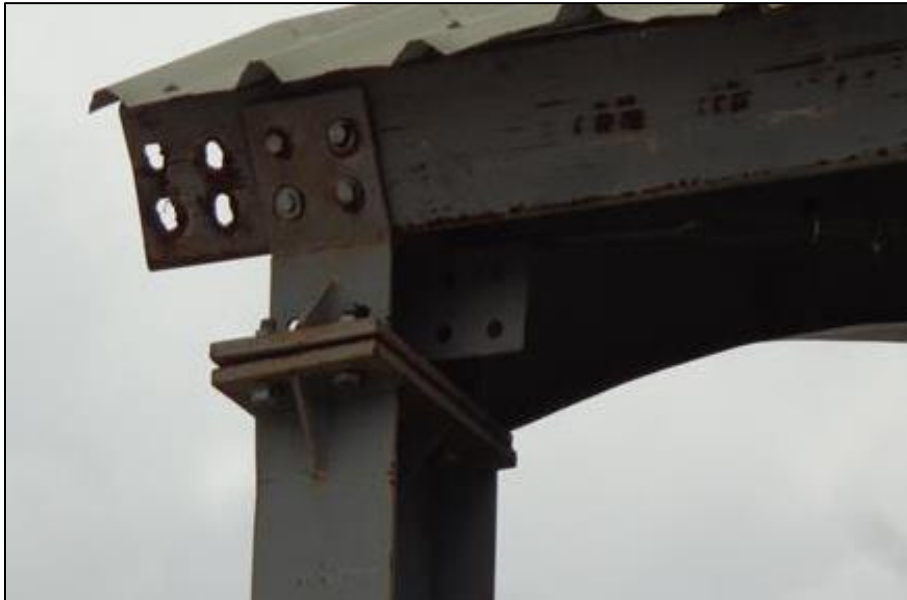
Significant gap in connection of rafter & column was found at roof shed (AHU). Factory engineer is required to survey the whole structure & identify the locations of the connection gaps. Factory engineer is also required to assess the reason of connection gap & provide proper remediation. Factory is required to follow recommendation of remediation suggested by the engineer.

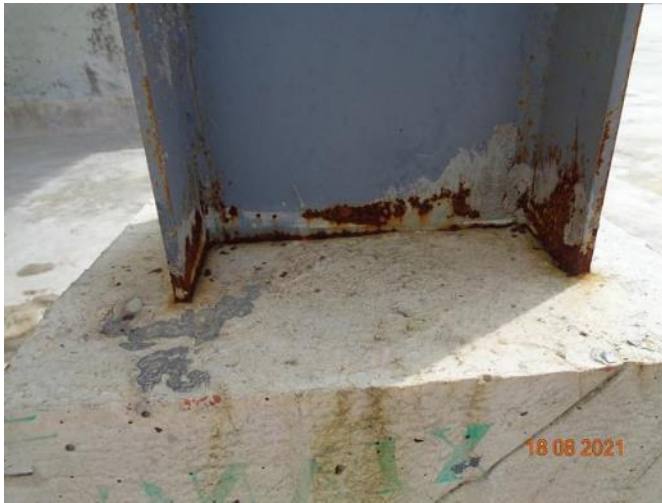
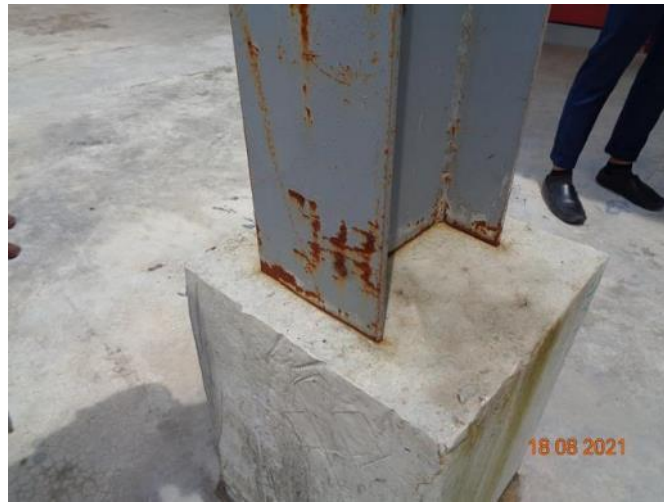
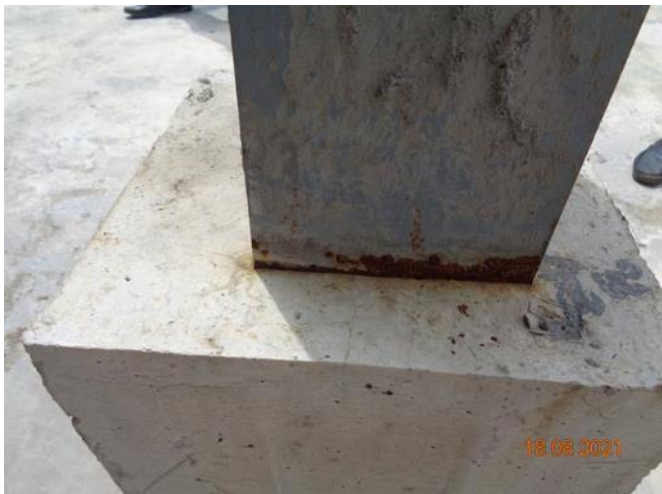
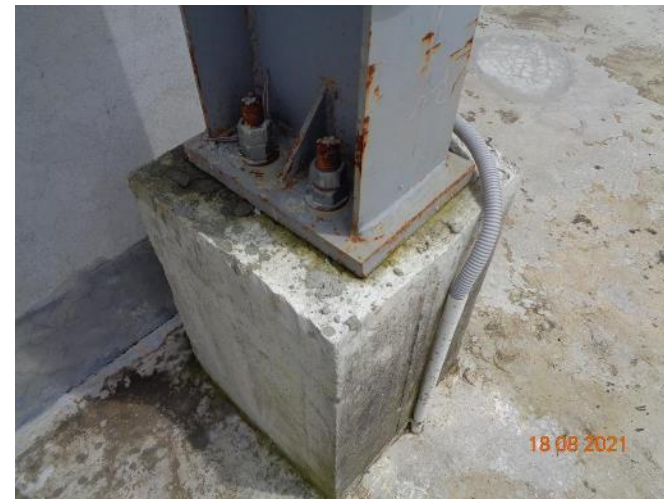
Corrosion in steel column

Corrosion was found in the steel members. Factory is required to apply rust proofing on the corroded areas to protect the steel members from corrosion.

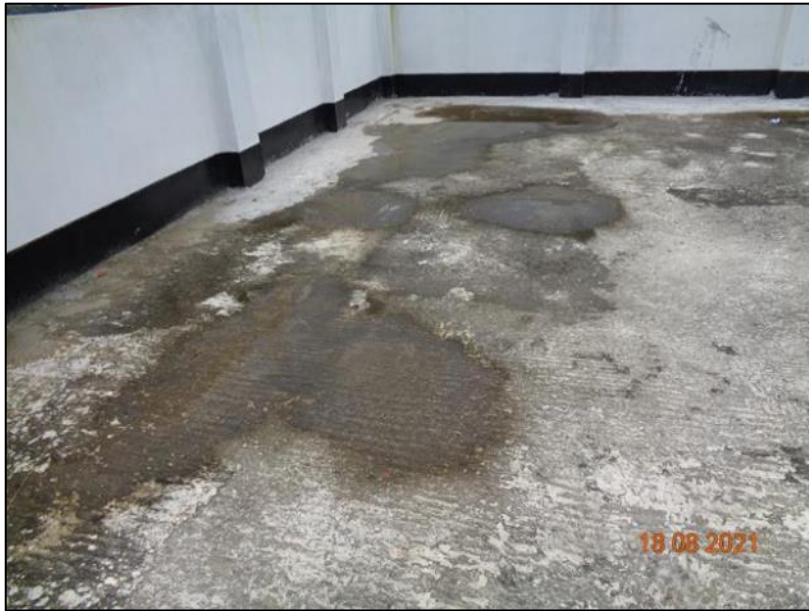
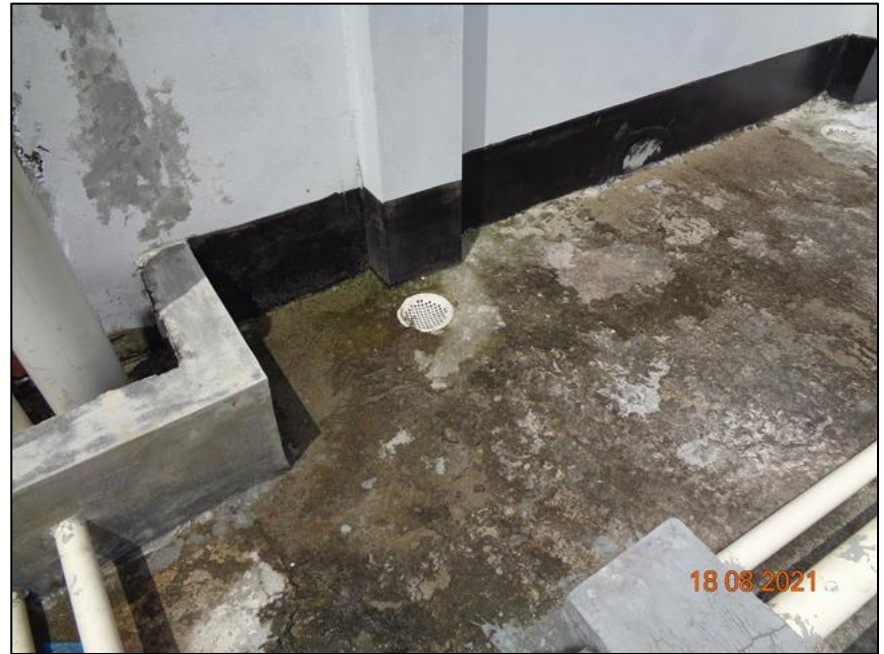
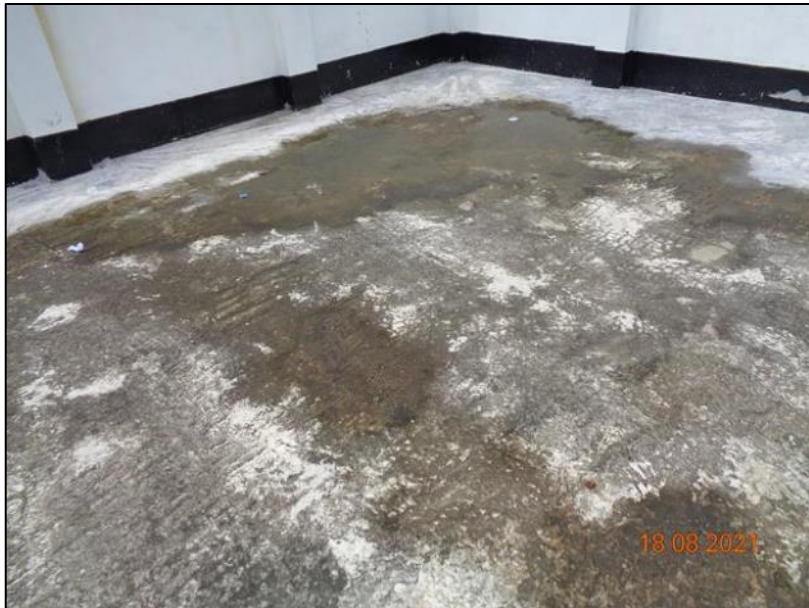
Water ponding was found at roof at toilet zone area. The water drainage system was found but adequate sloping was not found. And there is no water proofing layer on this area. The factory engineer is required to develop proper drainage system with adequate sloping on the mentioned area.

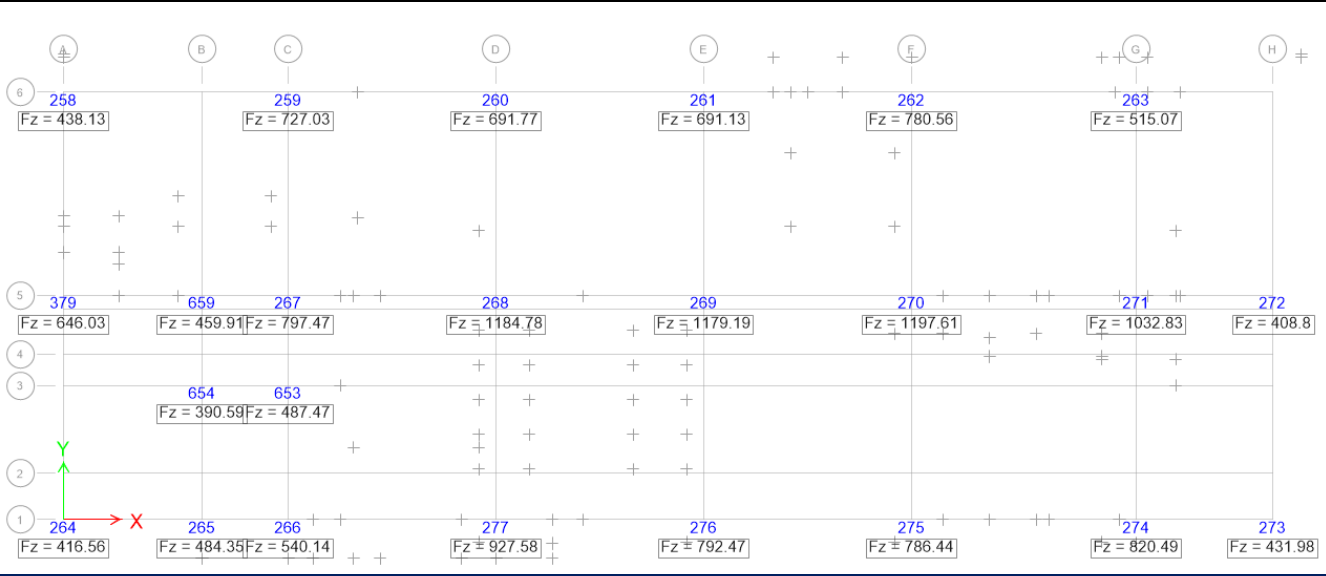
Base reaction from FEA model (E-tabs)

In foundation adequacy table the size of the footing has been considered larger size than the size provided in footing schedule of the as built drawing. Also, the base reaction from FEA model does not match with the load in foundation adequacy table.

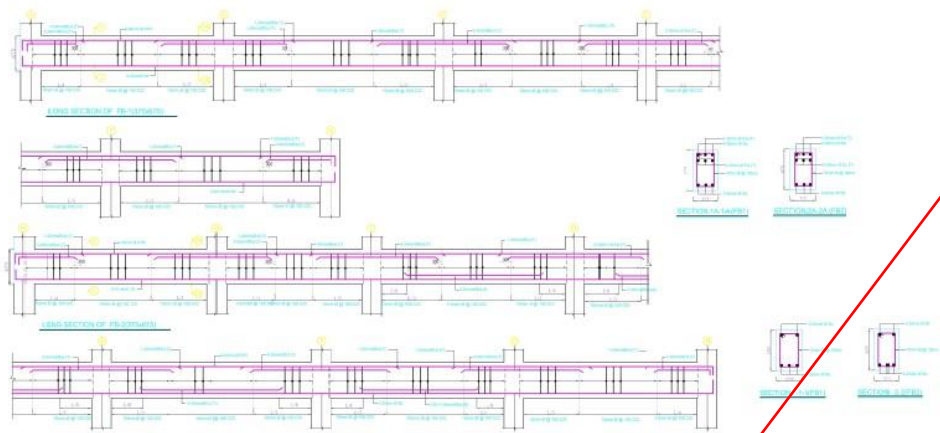
In drawing the concrete design strength for beam has been shown 3500 psi but in the FEA model, 4000 psi has been assigned.

$f'_c = 4000$ psi has been assigned in FEA model for beam

As per BNBC, every building or structure designed shall have its design documents prepared in accordance with the provision of Section 1.9.1. The design document shall include a design report, and a set of structural drawings, which shall be prepared in compliance with section 1.9.1.1 and section 1.9.1.2 as per BNBC. Revise the software-based analysis model, design document following BNBC requirements.

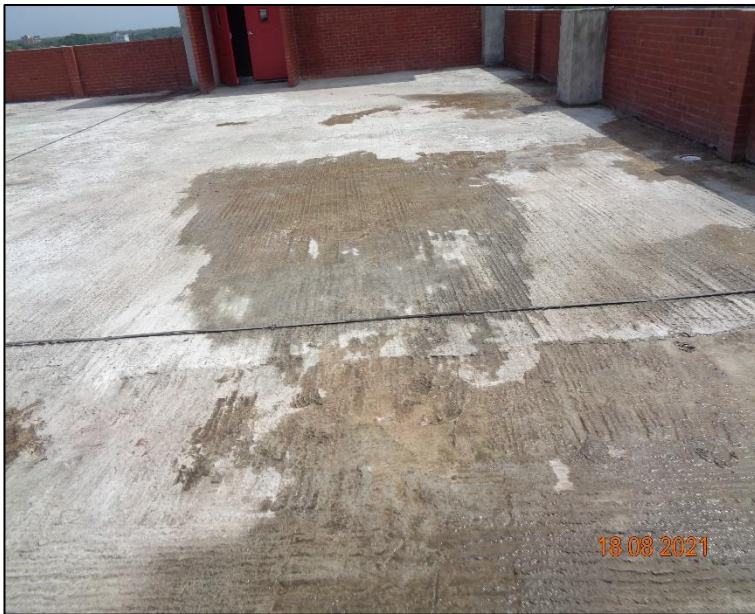
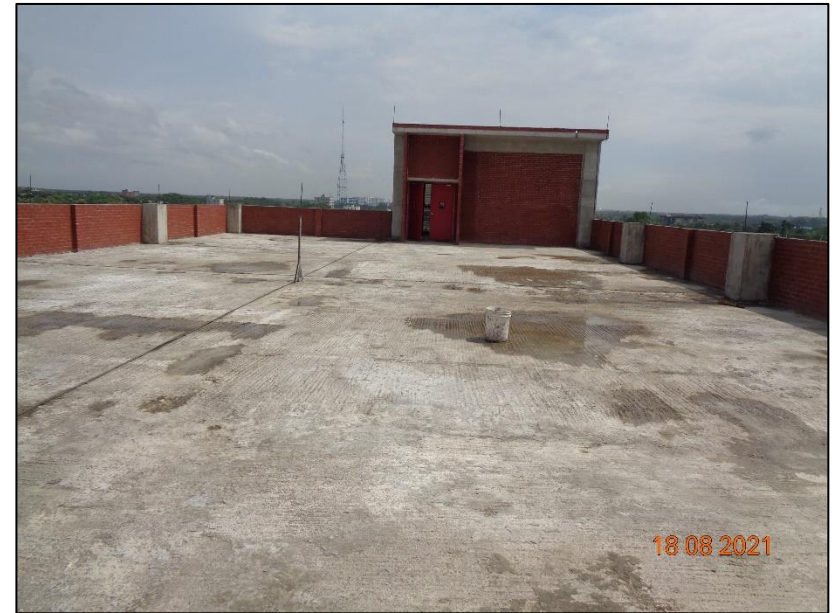
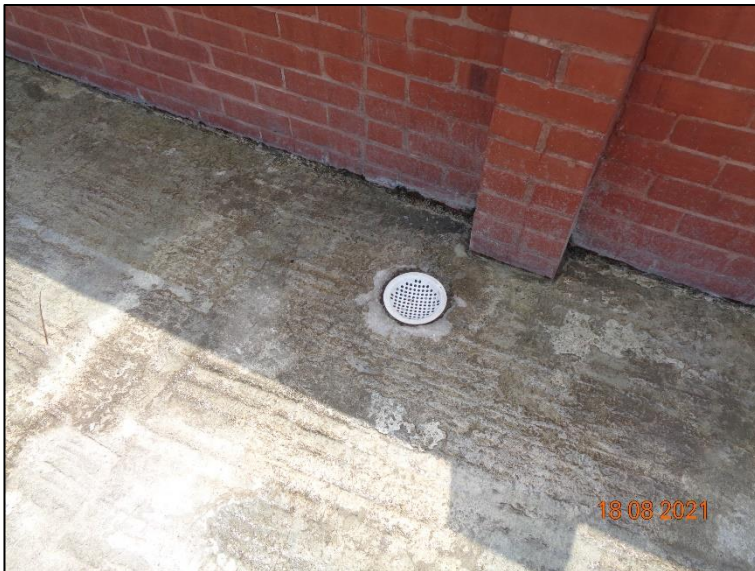
Water ponding was found at roof. The water drainage system was found but adequate sloping was not found. The factory engineer is required to develop proper drainage system with adequate sloping on the mentioned area. `

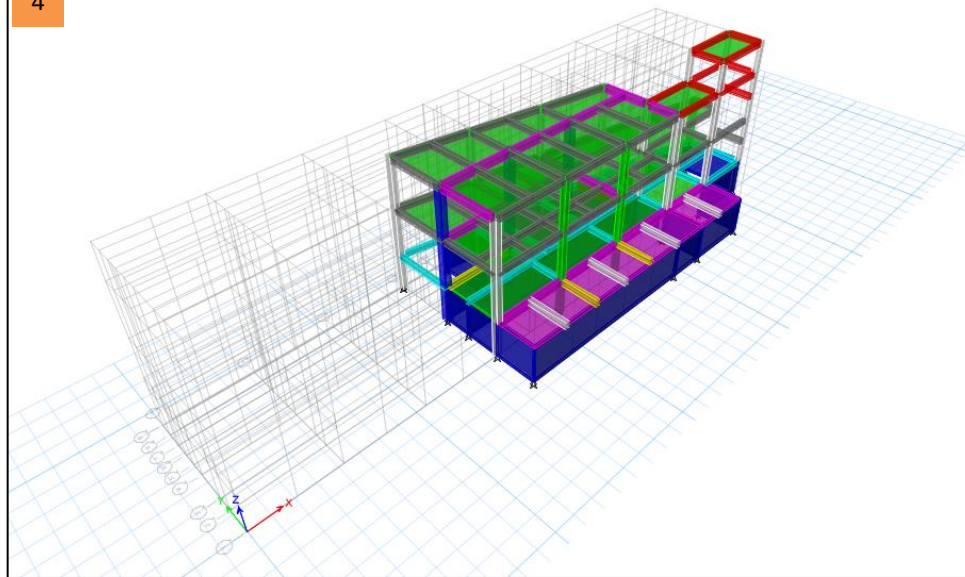
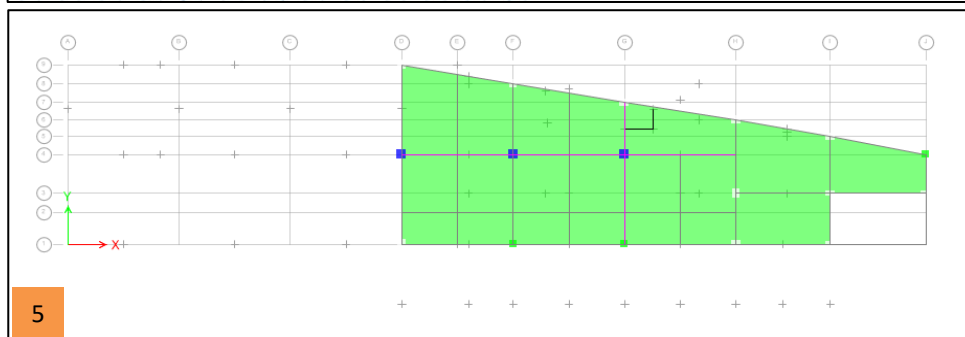
4. 3D view, 5. Plan view of the structure in FEA model. In FEA model whole structure has not been assigned as per drawing & site condition.

As per BNBC, every building or structure designed shall have its design documents prepared in accordance with the provision of Section 1.9.1. The design document shall include a design report, and a set of structural drawings, which shall be prepared in compliance with section 1.9.1.1 and section 1.9.1.2 as per BNBC. Revise the software-based analysis model & design document following BNBC requirements.

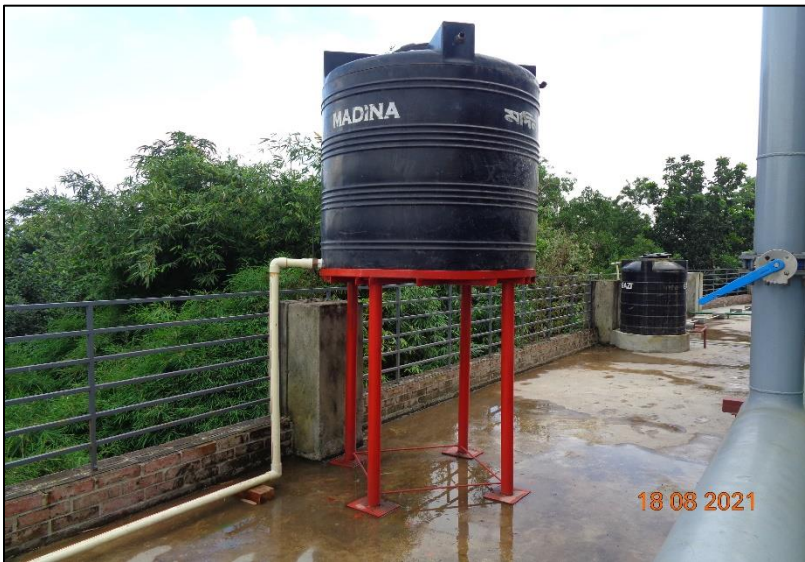
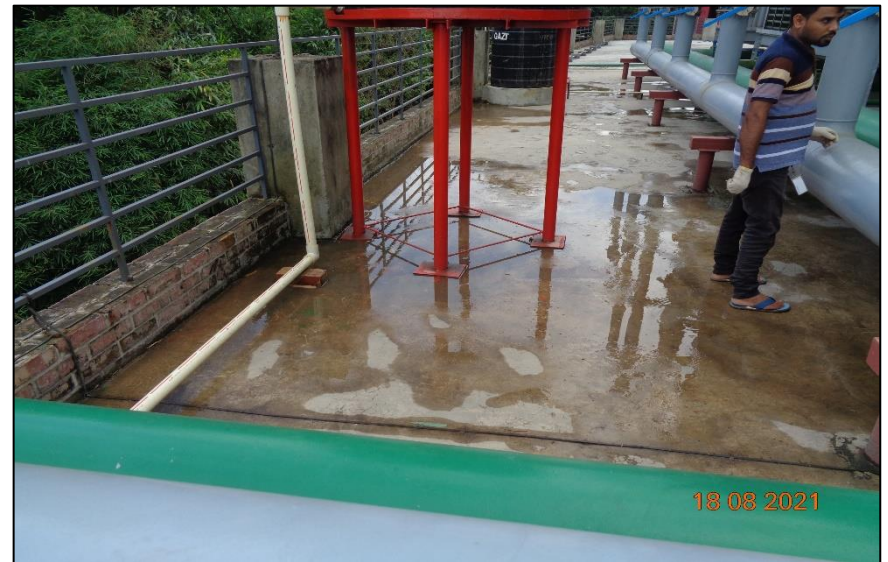
Water ponding on roof top slab

Water ponding was found on roof top and 1st floor open to sky area. The water drainage system was found but adequate sloping was not found. The factory engineer is required to develop proper drainage system with adequate sloping on the mentioned area.

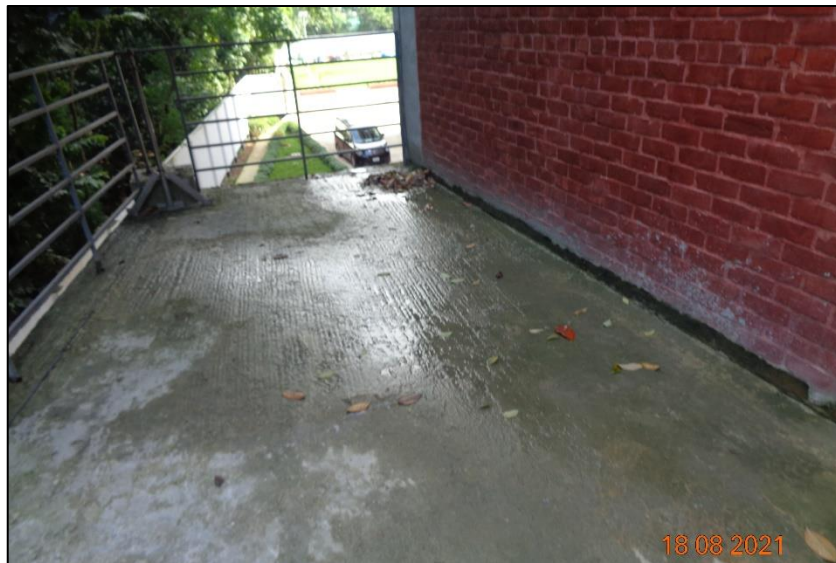
Water ponding on 1st Floor Open to Sky Area

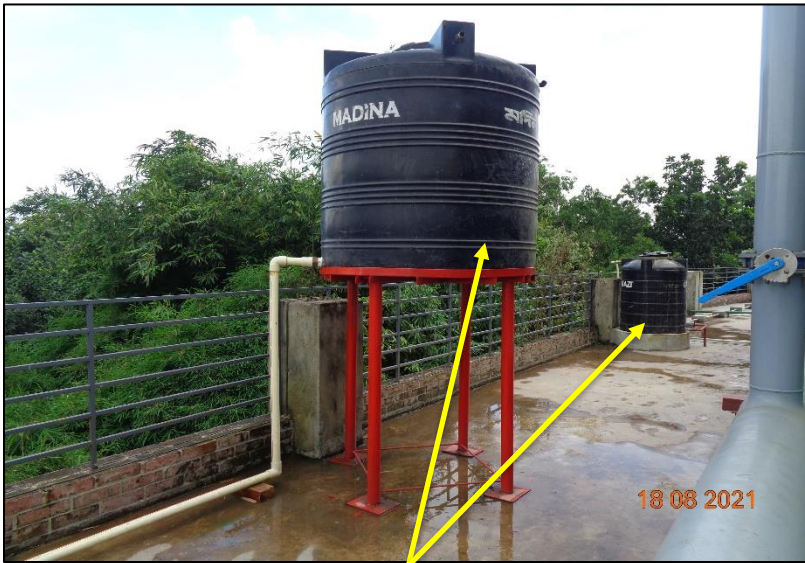
2 nos. Plastic Water Tank on roof top slab
(Capacity- 2000 & 1000 Liter)

3 nos. undocumented plastic water tank found on roof top where 1 nos. 2000 liters plastic water tank rest on 57 inch build up. The factory engineer is required to check the adequacy of slab considering these undocumented water tanks whether it is satisfactory or not. Also, update the as-built drawing and load plan.

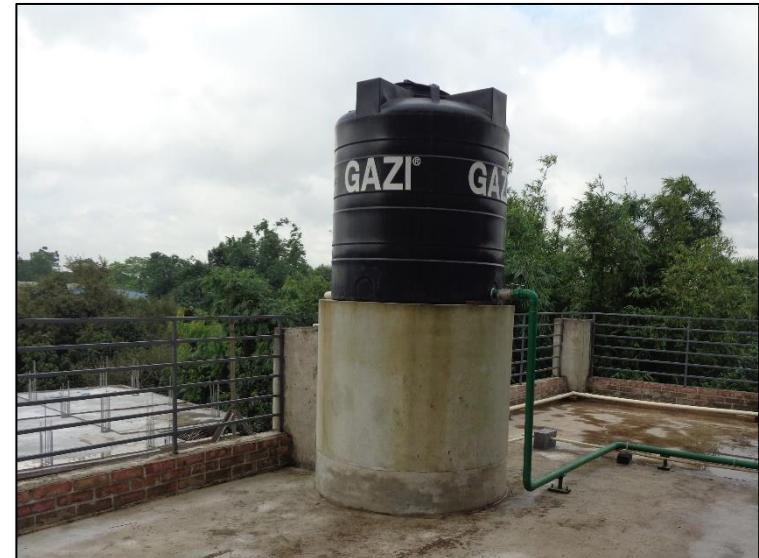
Plastic Water Tank with 57" Build Up
(Capacity- 2000 Liter)

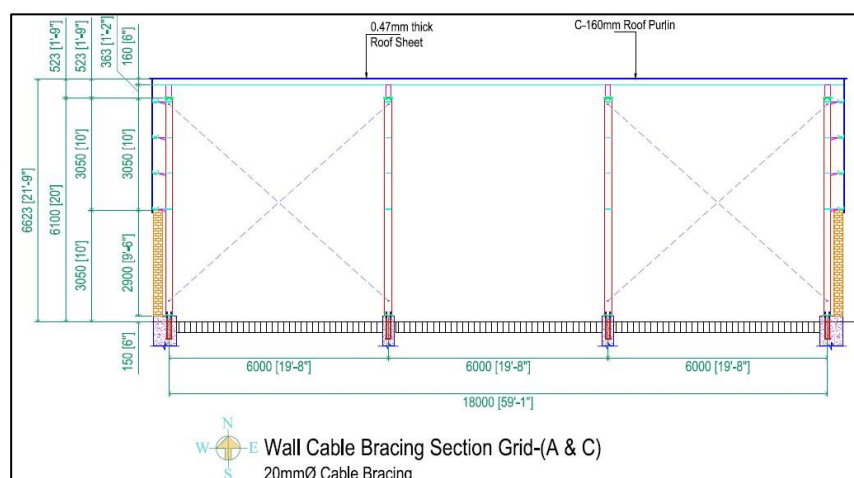
Wall Bracing Layout plan

The assessment of the structure has been conducted considering wall bracing, but during inspection wall bracing was not found at factory site. Factory engineer is required to revise the design documents as per actual site condition

As per BNBC, every building or structure designed shall have its design documents prepared in accordance with the provision of Section 1.9.1. The design document shall include a design report, and a set of structural drawings, which shall be prepared in compliance with section 1.9.1.1 and section 1.9.1.2 as per BNBC. Prepare the software-based analysis model based on actual site condition and revise design documents following BNBC requirements.

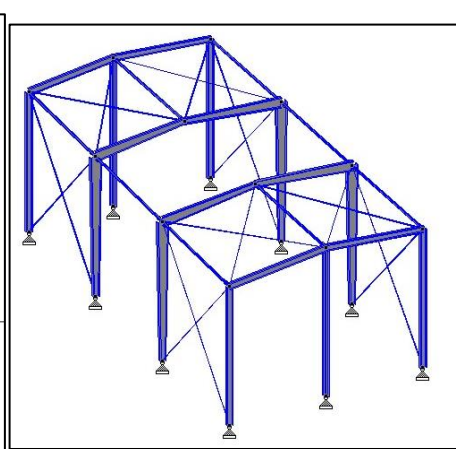
Design report has been provided that prepared based on a software-based analysis, but the analysis model was not provided by the factory. The factory engineer is required to submit the Design report along with the software analysis model

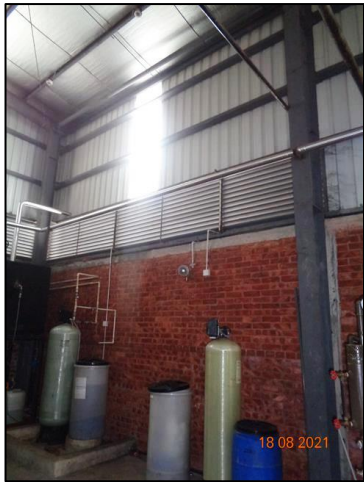
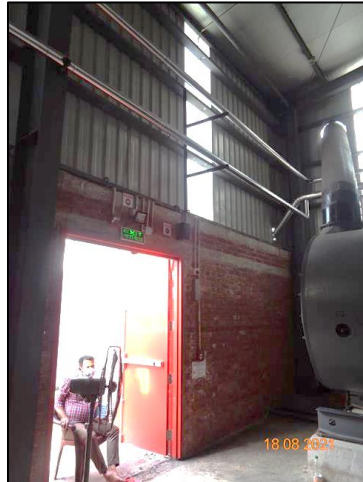
Wall bracing was not found at site condition
