# Mosharaf Apparels Studio Limited

12th & 18th August 2021

# Building Information

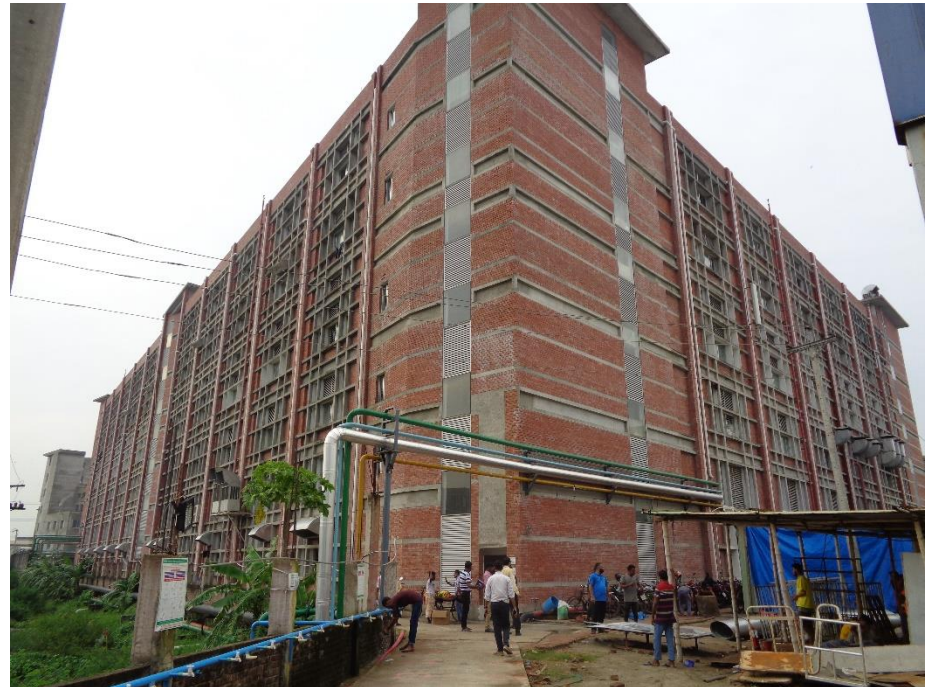
Building-1 is constructed up to 5 storied

Provided Geotechnical investigation was carried out for 3 storied Building by "Engineering Survey & Design".

Cast in situ pile suggested in provided Geotechnical investigation report. But as per drawing, pre-cast pile has been constructed for Building-1. The capacity of pre-cast pile are not mentioned in the geotechnical report.

Capacity Calculation of pre-cast pile included in DEA report in reference to another soil investigation report (AB Soil & Foundation Engineering) which was not available during inspection.

Factory is required to verify the foundation adequacy as per the actual foundation type & capacity. Also, justify the geotechnical investigation report.

| Item No. | Observation | Recommended Action Plan | Recommended Timeline |
|---|---|---|---|
| 01 | Foundation adequacy to be verified (Building-1) | Factory is required to verify the foundation adequacy as per the actual foundation type & capacity. Also, justify the geotechnical investigation report. | 6-weeks |

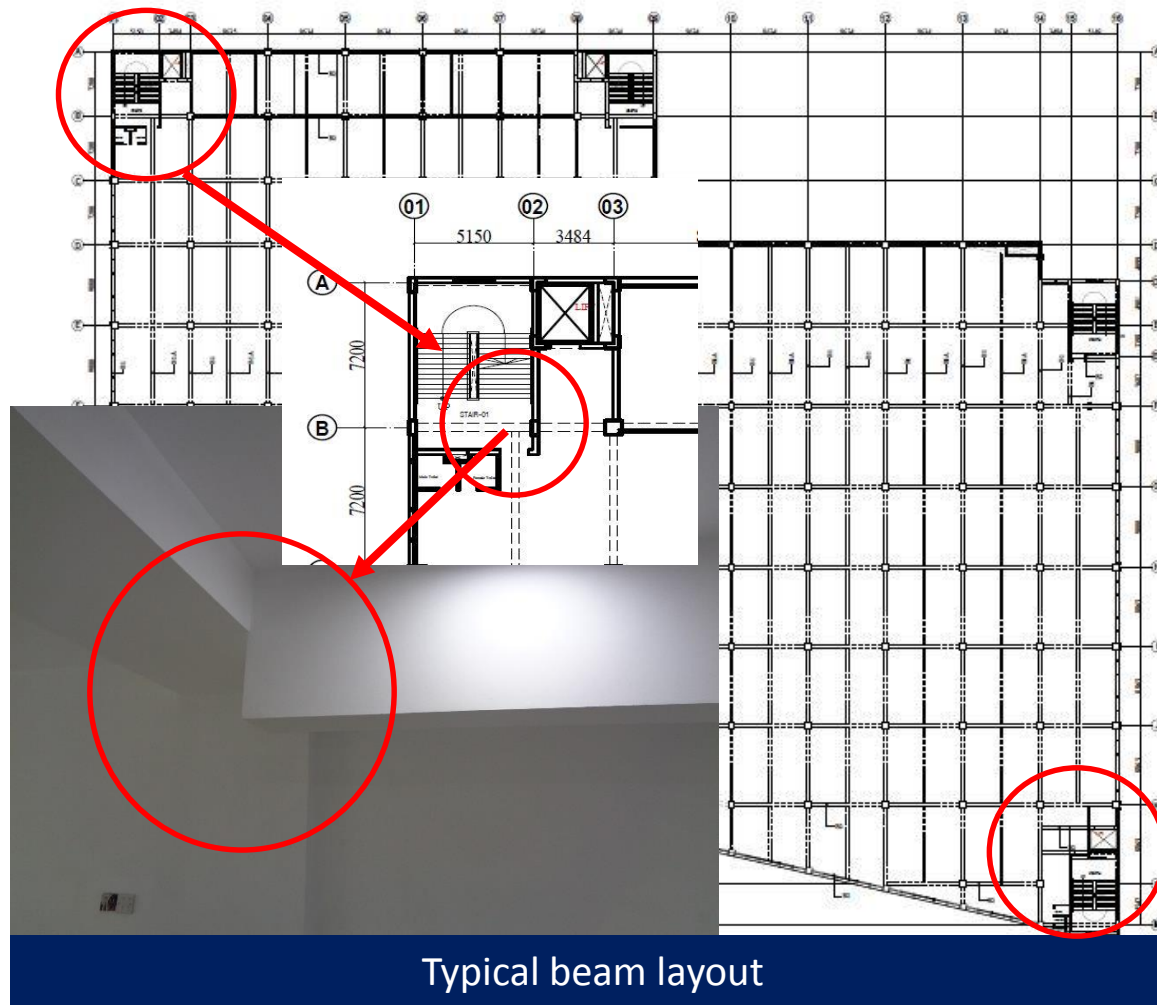
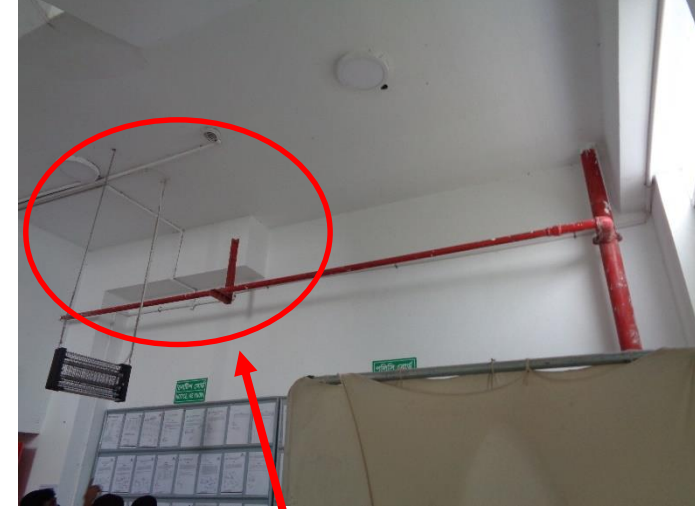
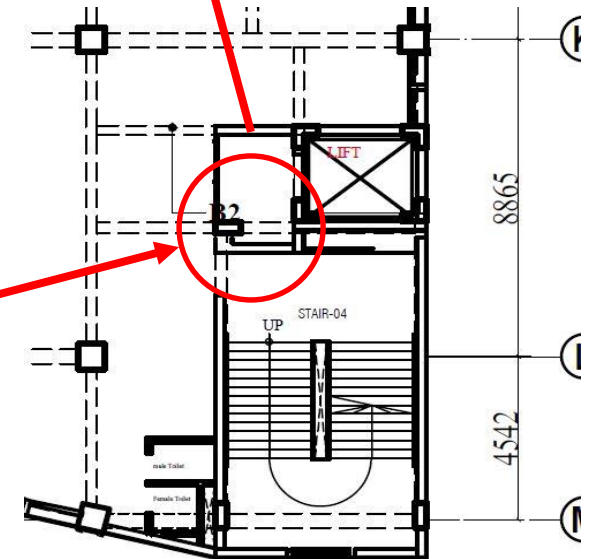
At those highlighted areas, beams are resting neither as per beam layout nor in usual way. Therefore, load transfer system is apparently irregular. Factory engineer is required to check the load transfer system of those highlighted beams.

| Item No. | Observation | Recommended Action Plan | Recommended Timeline |
|---|---|---|---|
| 03 | Irregularities in load transfer system (Building-1) | Factory engineer is required to check the load transfer system of the building. | 6-weeks |

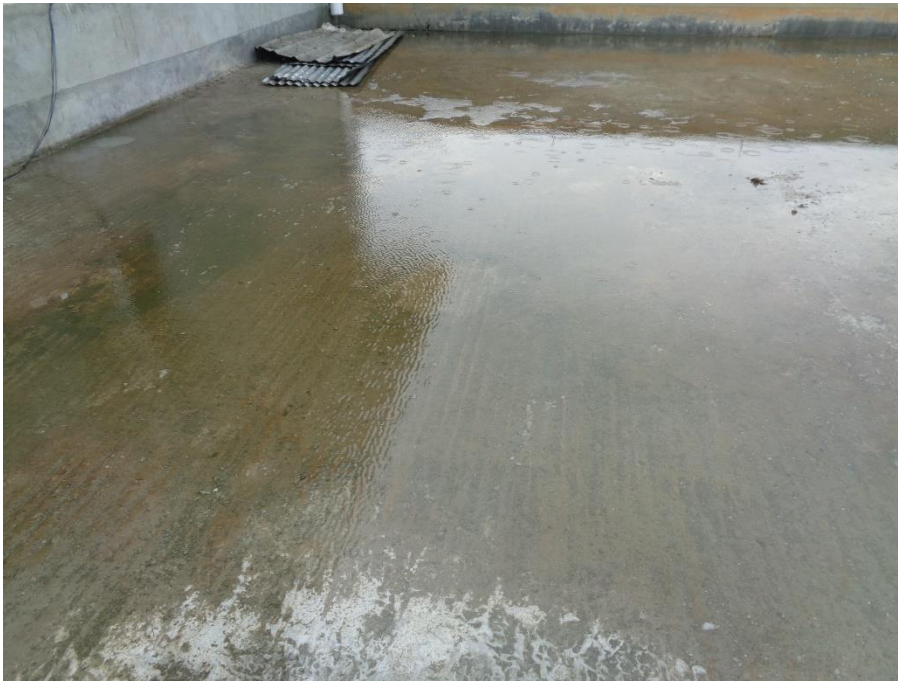
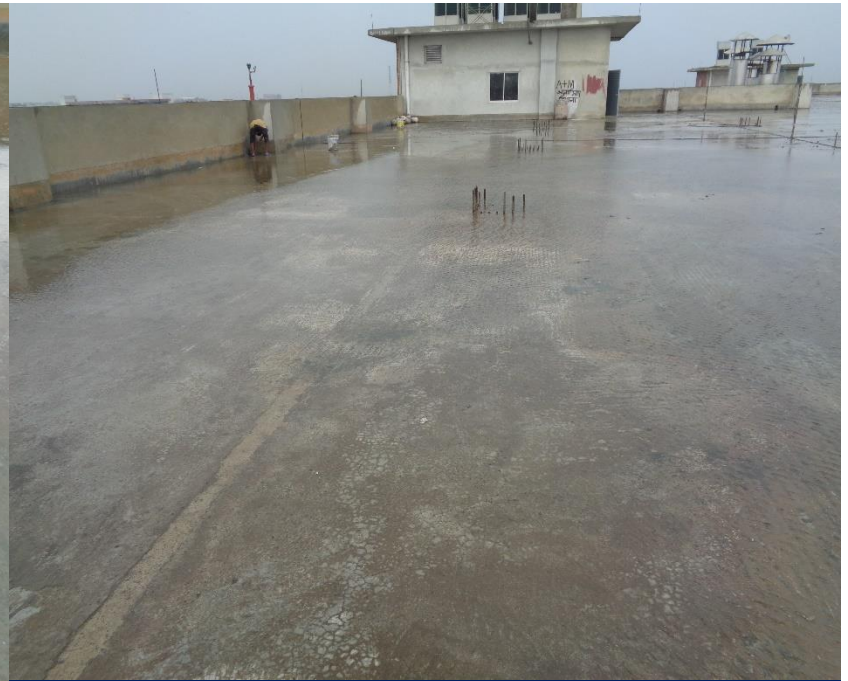
Water ponding was found on roof slab. Factory is required to provide necessary slope and improve drainage system to prevent water ponding.

| Item No. | Observation | Recommended Action Plan | Recommended Timeline |
|---|---|---|---|
| 05 | Water ponding on roof slab (Building-1) | Factory is required to provide necessary slope and improve drainage system to prevent water ponding. | 6-months |

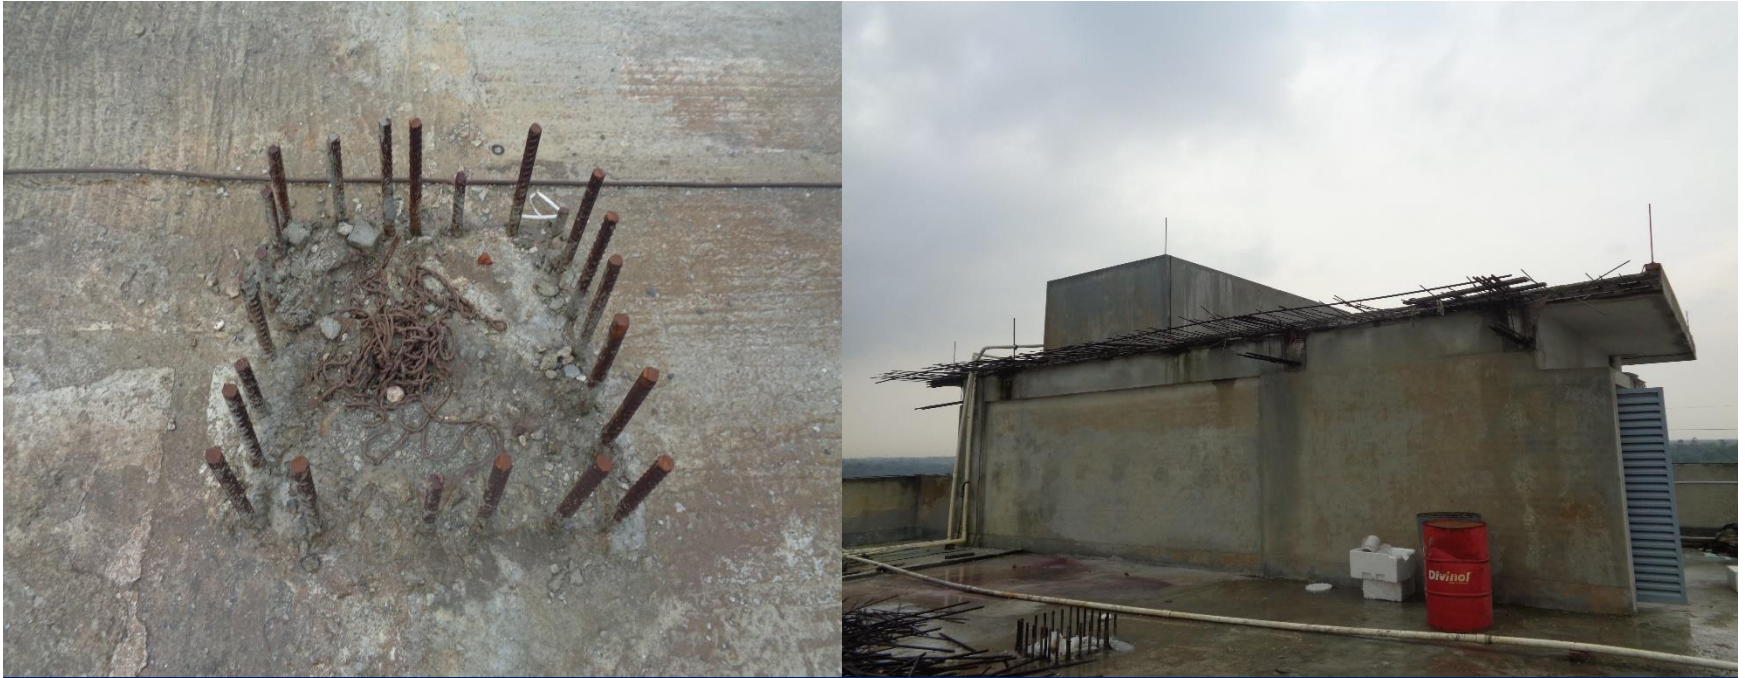
Exposed reinforcement is left at roof level & staircase which was prone to corrosion. Factory is required to provide rust proof paint on exposed reinforcement to protect from corrosion.

| Item No. | Observation | Recommended Action Plan | Recommended Timeline |
|---|---|---|---|
| 06 | Exposed reinforcement left at roof level (Building-1) | Factory is required to provide rust proof paint on exposed reinforcement to protect from corrosion. | 6-months |

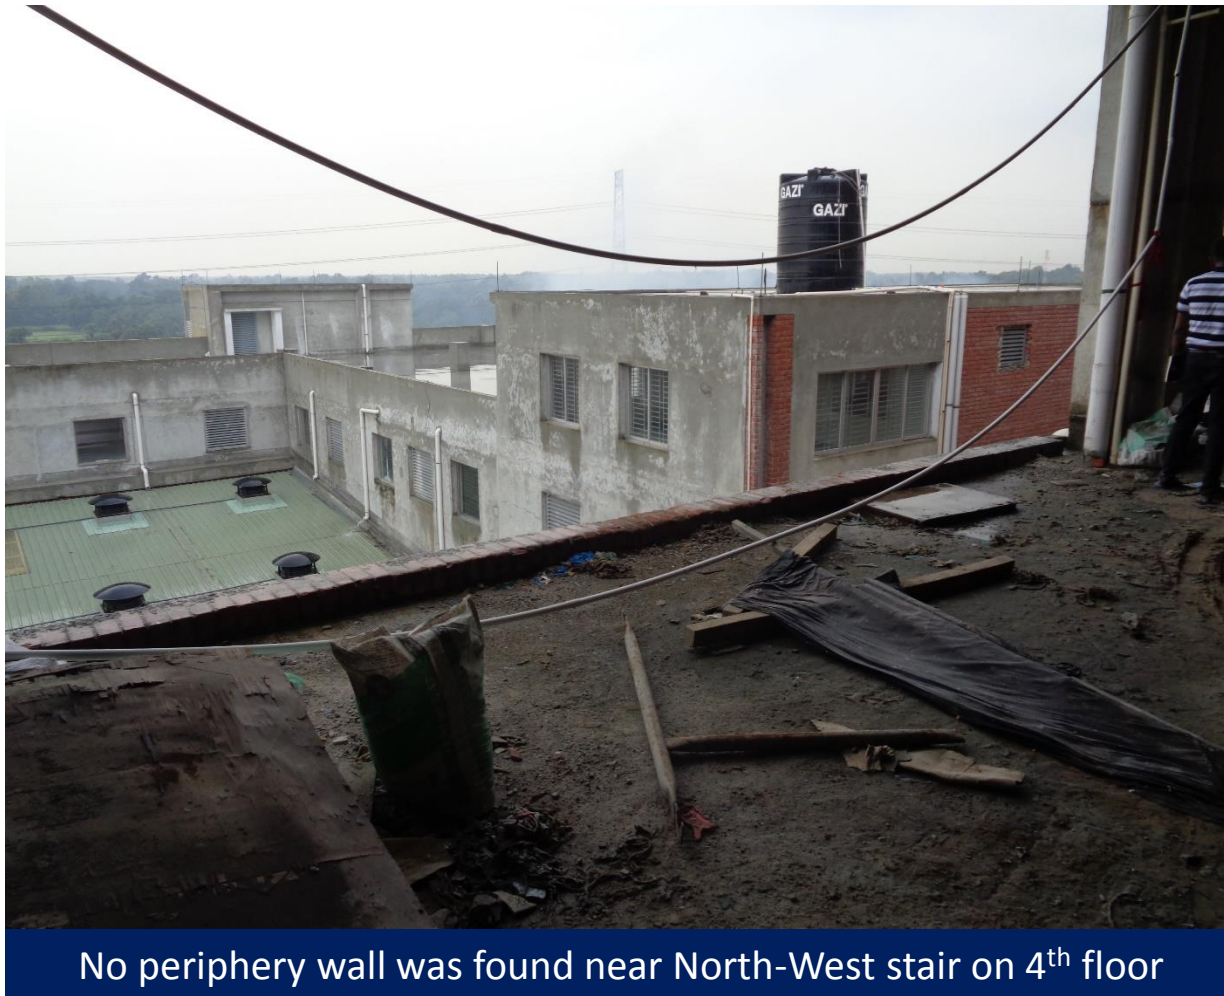
No periphery wall was found near North-West stair on 4<sup>th</sup> floor. Factory is required to provide adequate protection to avoid possible falling hazard.

| Item No. | Observation | Recommended Action Plan | Recommended Timeline |
|---|---|---|---|
| 07 | Falling hazard On 4th floor (Building-1) | Factory is required to provide adequate protection to avoid possible falling hazard. | 6-weeks |

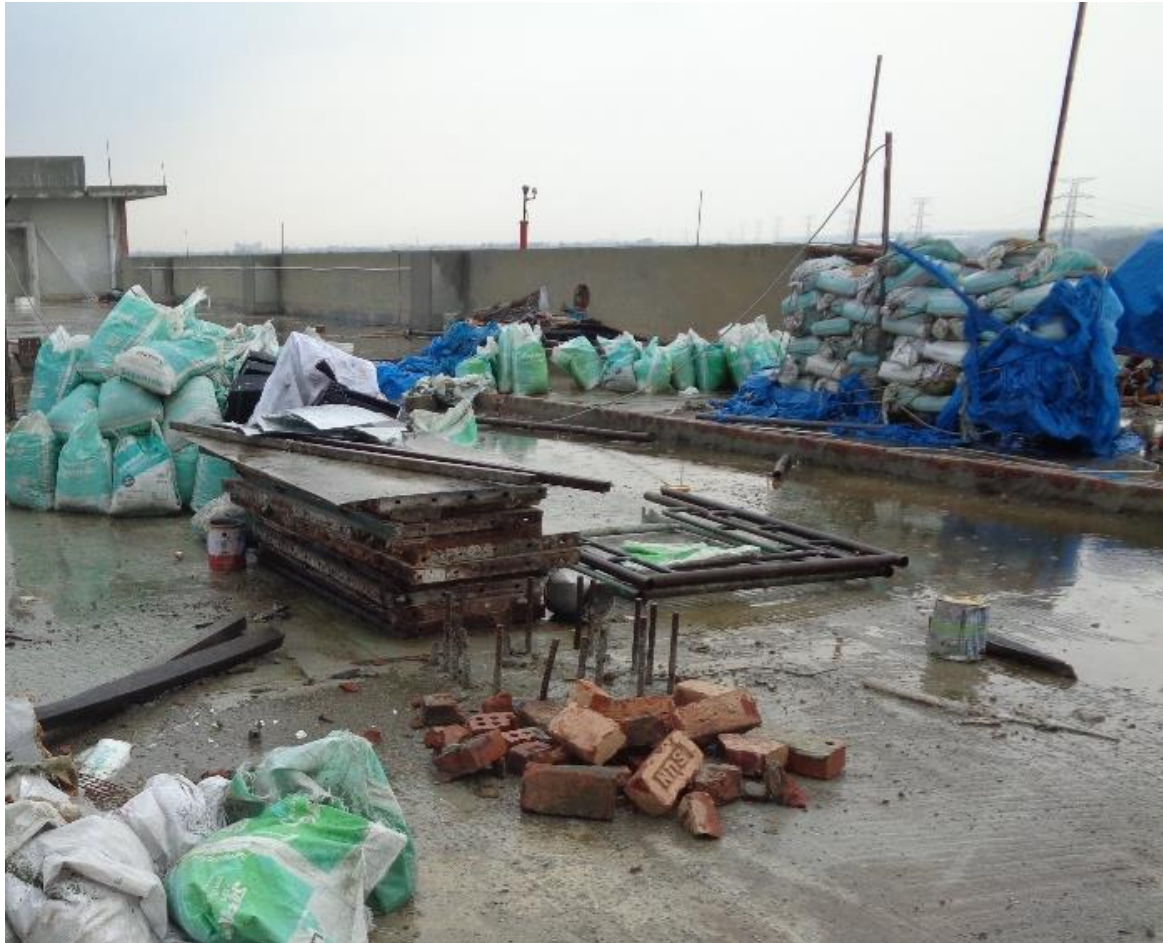
Construction material on roof slab

Stack of construction material was found on both roof slab. Factory is required to remove all construction materials from those areas.

| Item No. | Observation | Recommended Action Plan | Recommended Timeline |
|---|---|---|---|
| 08 | Stack of construction material on roof slab (Building-1) | Factory is required to remove all construction materials from the roof. | 6-weeks |

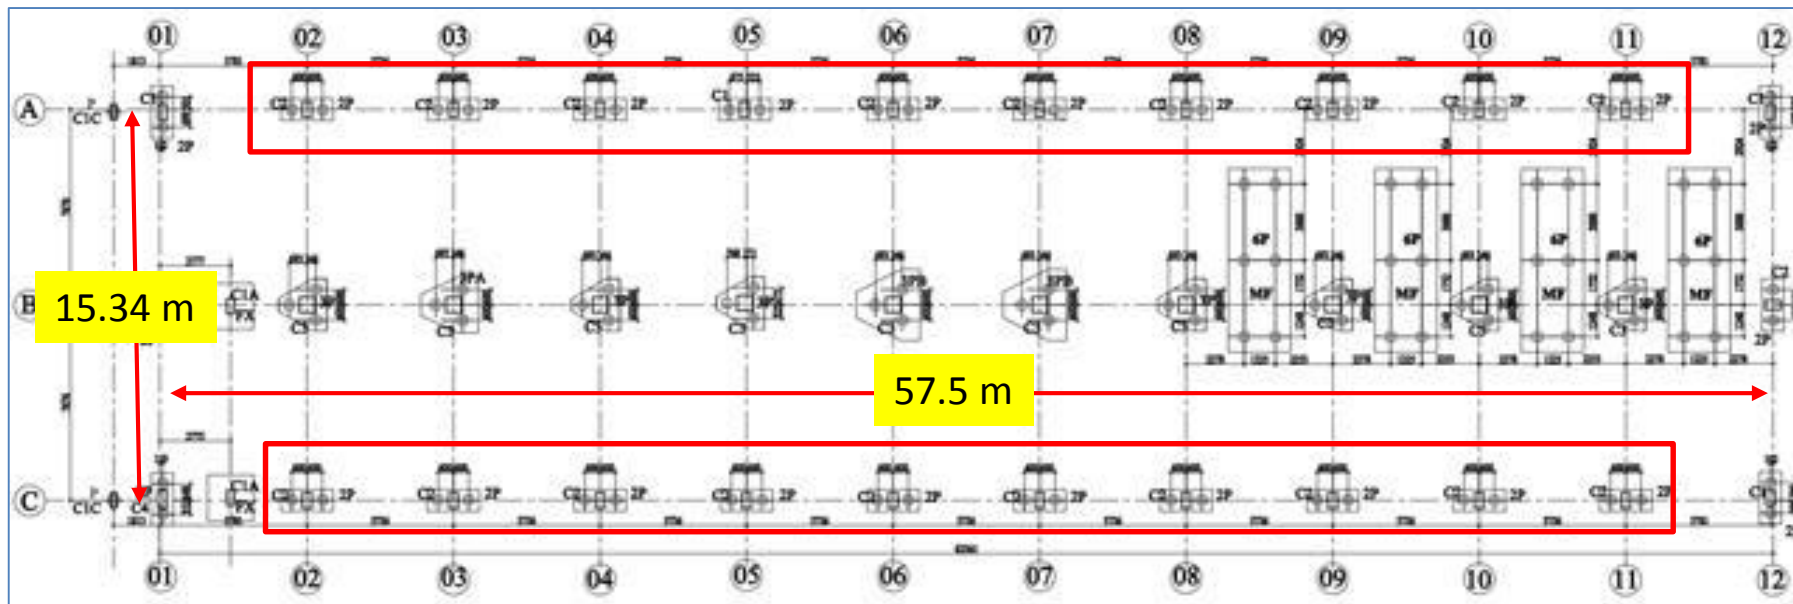
The length of the building is very long compared to its width. The building has only two spans along short direction and the height of the 3 storied building is 17.78 m. The piles of the 2-pile group foundation are placed along the long direction. So, the building seems to be laterally unstable. In the provided design report, lateral stability has not been verified. However, the factory engineer is required to check the lateral stability of the structure and update the design/assessment report accordingly.

| Item No. | Observation | Recommended Action Plan | Recommended Timeline |
|---|---|---|---|
| 09 | Lateral Stability (Utility Building) | Factory engineer is required to check the lateral stability of the structure and update the assessment report accordingly. | 6-weeks |

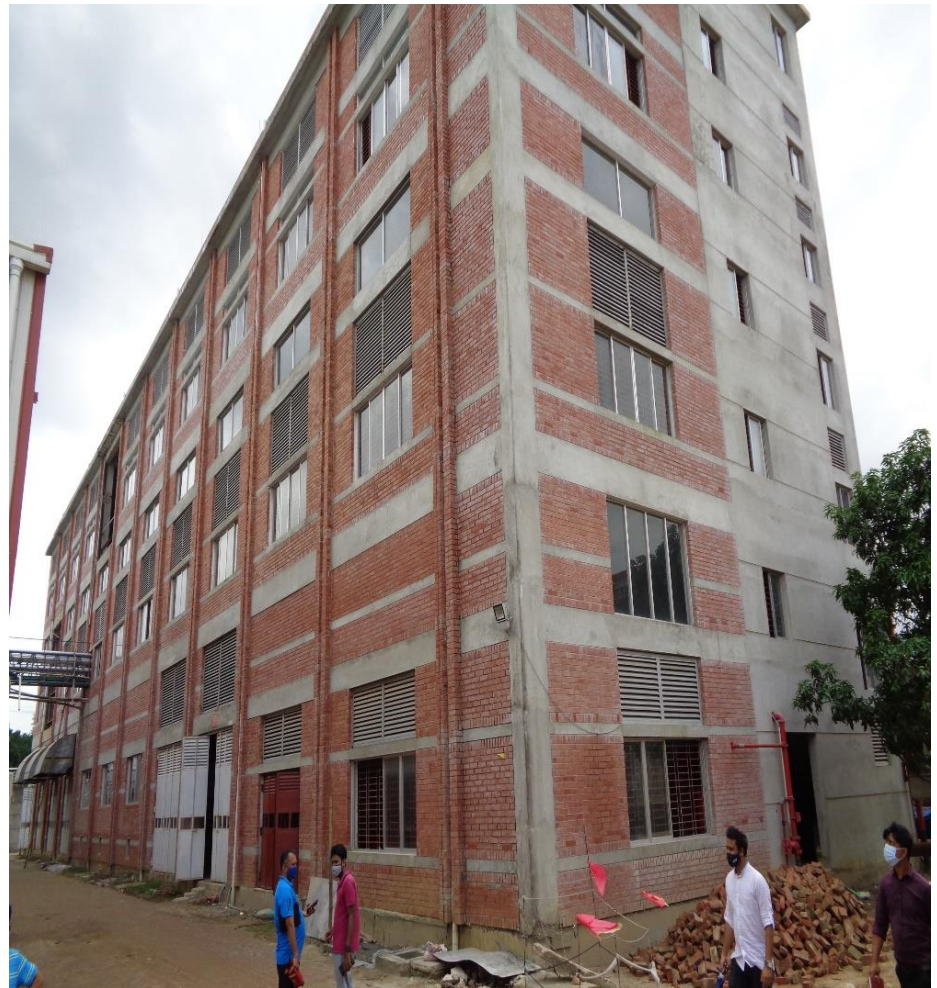
**Geotechnical investigation was carried out  
for 2 storied Building**

**Building is constructed up to 3 storied**

Cast in situ pile suggested in provided Geotechnical investigation report. But as per drawing, pre-cast pile has been constructed for Utility Building. The capacity of pre-cast pile are not mentioned in the geotechnical report.

Capacity Calculation of pre-cast pile included in DEA report in reference to another soil investigation report (AB Soil & Foundation Engineering) which was not available during inspection.

Factory is required to verify the foundation adequacy as per the actual foundation type & capacity. Also, justify the geotechnical investigation report.

| Item No. | Observation | Recommended Action Plan | Recommended Timeline |
|---|---|---|---|
| 11 | Foundation adequacy to be verified (Utility Building) | Factory is required to verify the foundation adequacy as per the actual foundation type & capacity. Also, justify the geotechnical investigation report. | 6-weeks |

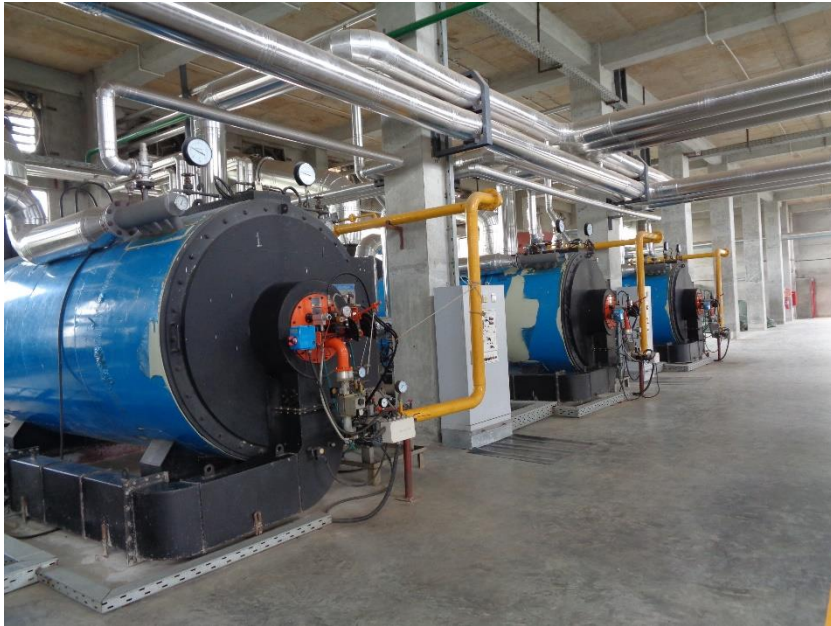
Heavy Machin on 1<sup>st</sup> floor

Live load for 1<sup>st</sup> floor is considered as 5 KPa but live load was found more than 5 kPa on that locations due to heavy machineries. Factory engineer is required to verify and update the live load plan as per site condition.

| Item No. | Observation | Recommended Action Plan | Recommended Timeline |
|---|---|---|---|
| 13 | Prepared load plan to be verified and updated (Utility Building) | Factory engineer is required to verify and update the live load plan as per site condition. | 6-weeks |

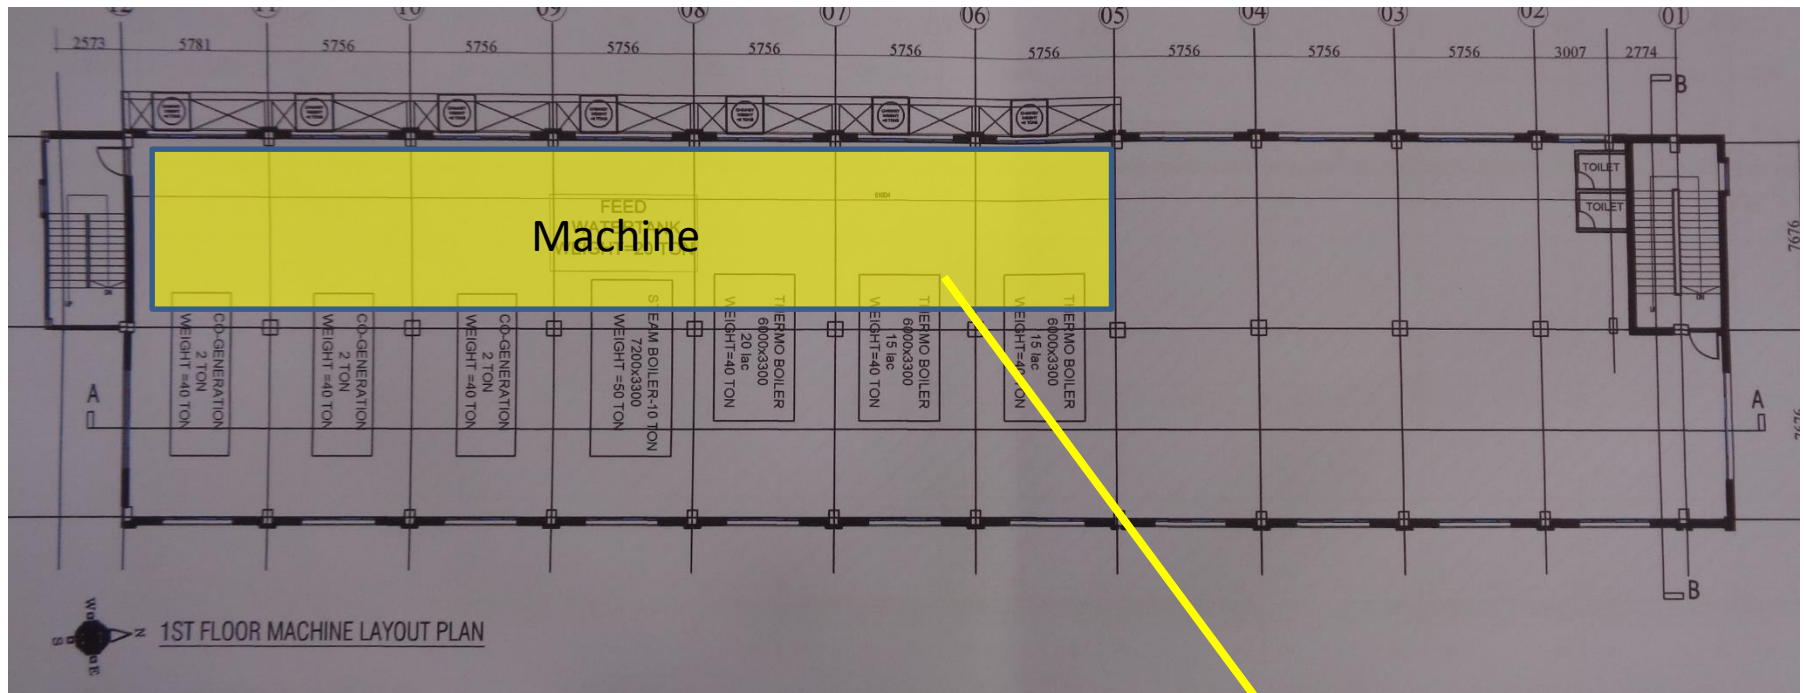
Heavy Machine on 1<sup>st</sup> floor shown at east side

Heavy machineries on 1<sup>st</sup> floor was shown at east side in floor layout but found at west side of the floor. Factory engineer is required to update the as-built drawing as well as load plan.

| Item No. | Observation | Recommended Action Plan | Recommended Timeline |
|---|---|---|---|
| 15 | Discrepancy in as-built drawing (Utility Building) | Factory engineer is required to update the as-built drawing. | 6-weeks |

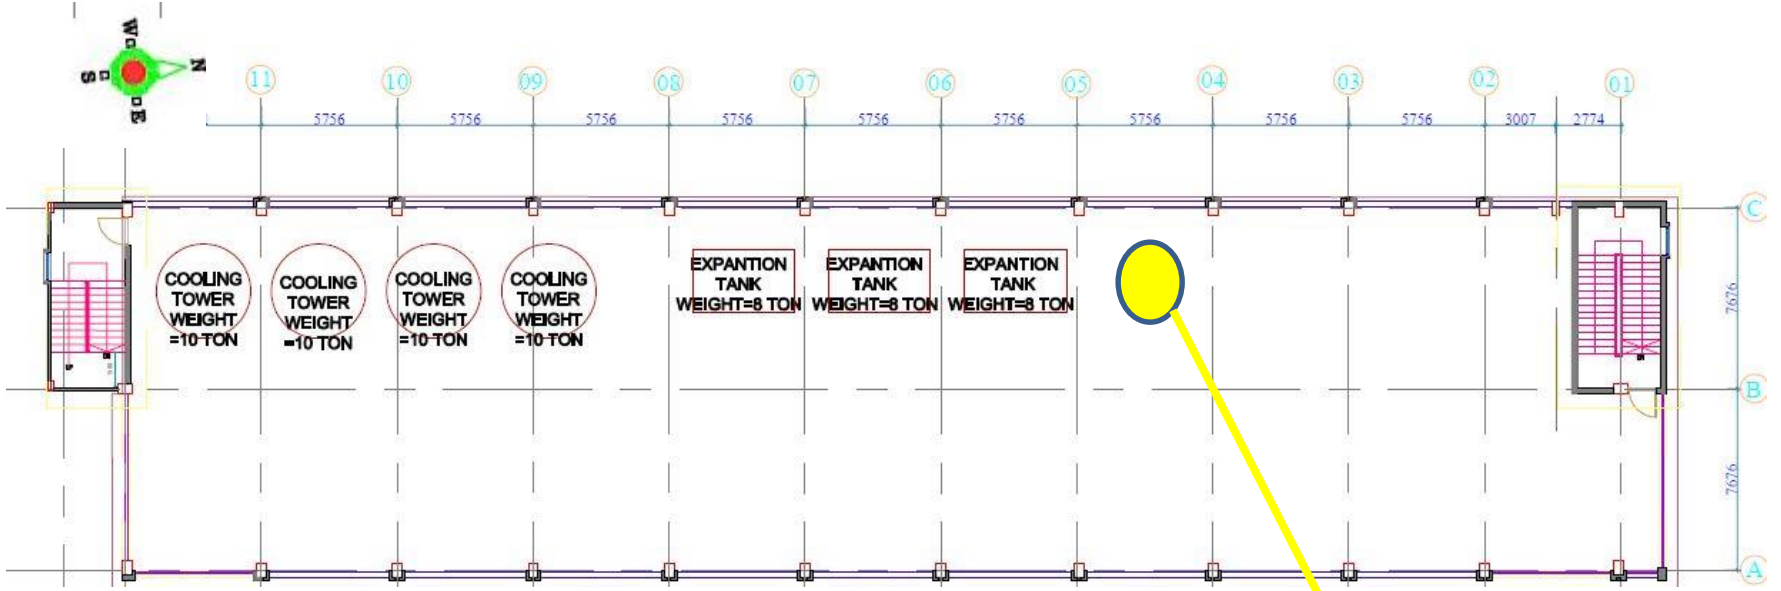
Roof plan

A plastic water tank having capacity of 3000 liter was found on roof slab which was not shown in as-built drawing. Factory engineer is required to update the as-built drawing as well as load plan.

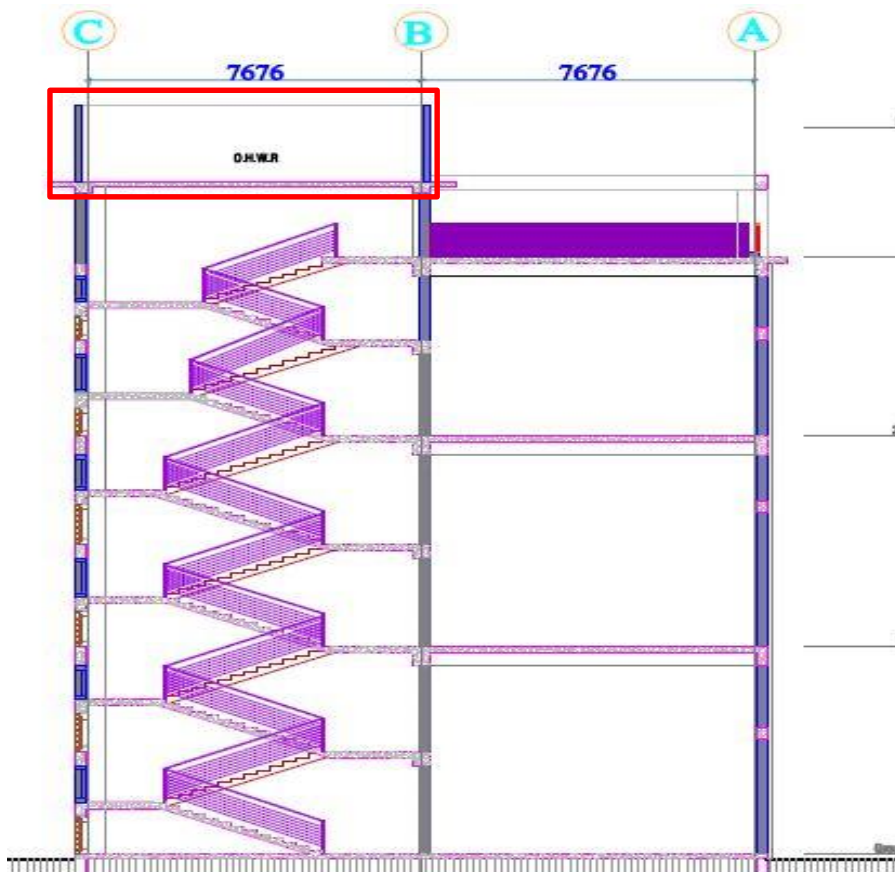
Overhead RC water tank shown in architectural drawing

Overhead water tank section shown in as-built drawing, but no overhead RC water tank found on staircase roof. Factory engineer is required to update both as-built architectural and structural drawing.

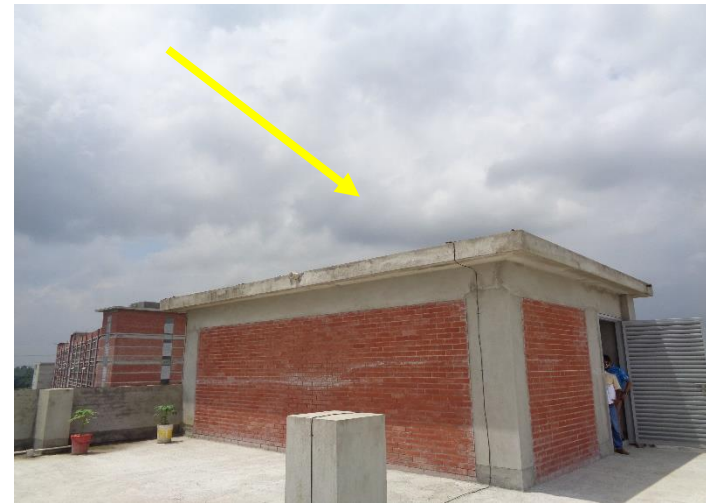
No overhead RC water tank on staircase roof.

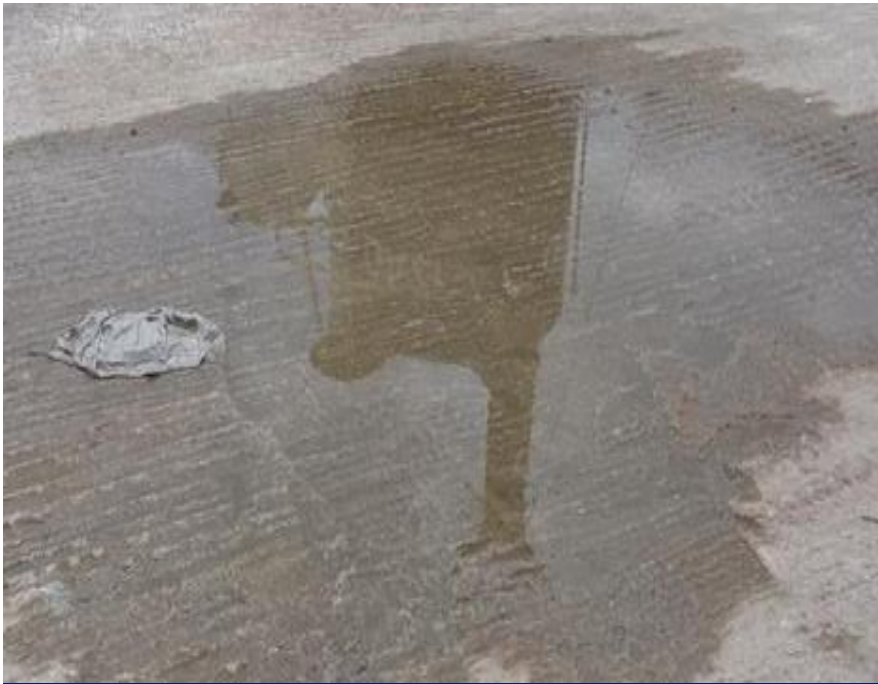
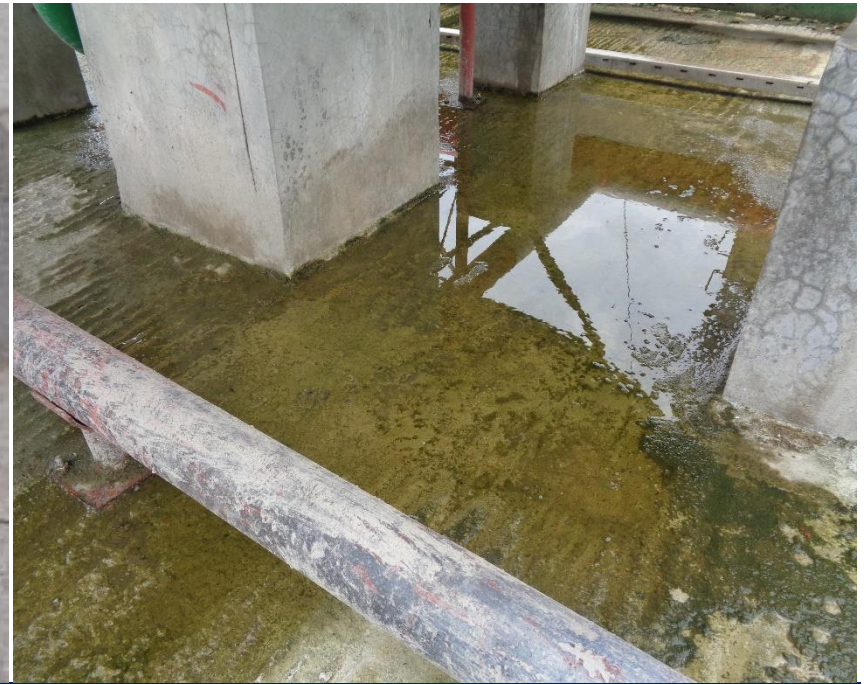
Water stagnant on roof slab

Water stagnant was found on roof slab due to improper drainage system. Factory is required to provide necessary slope and improve drainage system to prevent water ponding.

| Item No. | Observation | Recommended Action Plan | Recommended Timeline |
|---|---|---|---|
| 16 | Improper drainage system on roof slab (Utility Building) | Factory is required to provide necessary slope and improve drainage system to prevent water ponding. | 6-months |

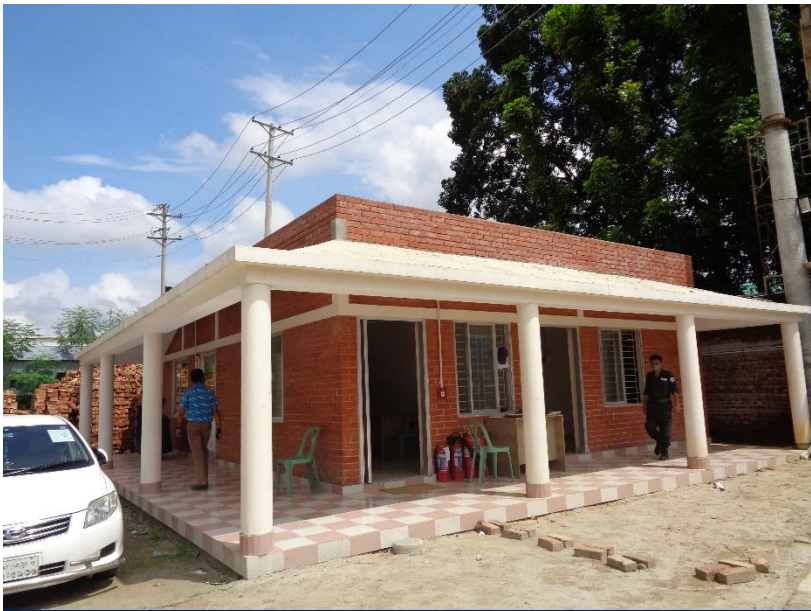
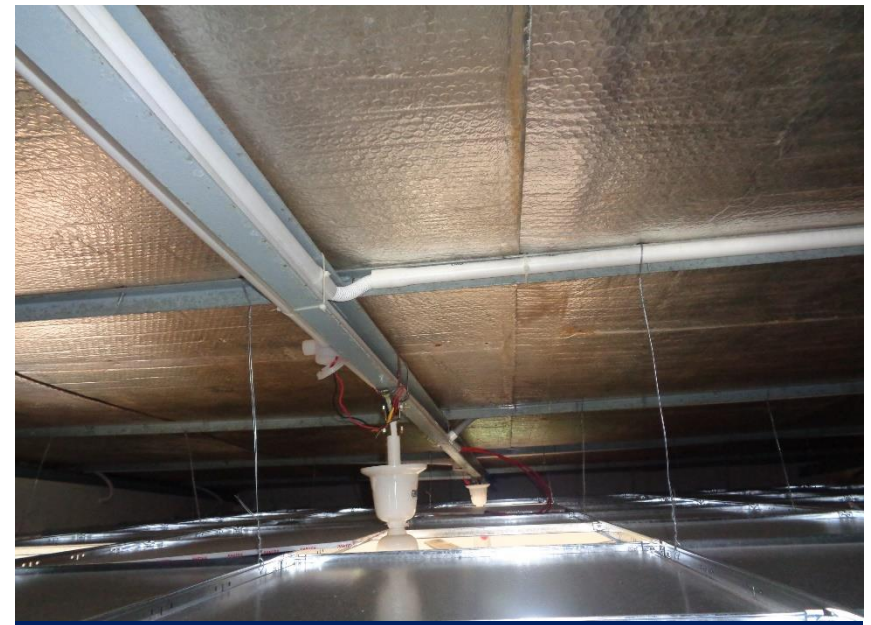
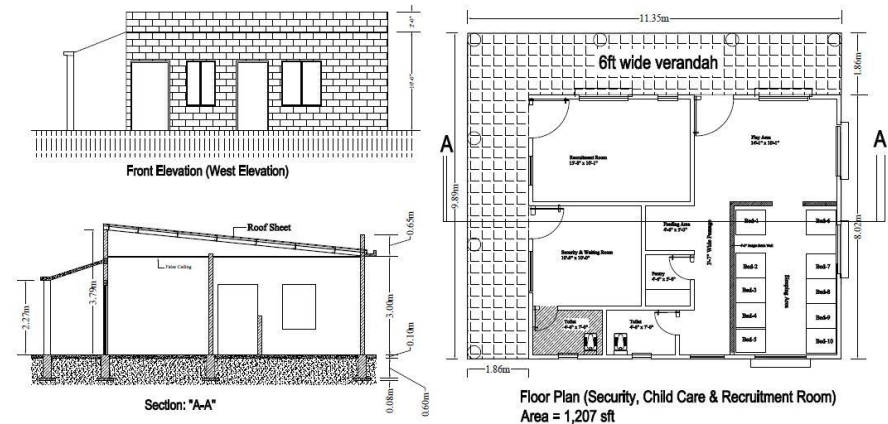
Steel shed rest on masonry wall

Only an architectural plan was provided by the factory, but no structural drawing were available. Factory engineer is required to produce full set of as-built structural drawing.

| Item No. | Observation | Recommended Action Plan | Recommended Timeline |
|---|---|---|---|
| 17 | Lack of documentation (Childcare and Security Room) | Factory engineer is required to produce full set of as-built structural drawing. | 6-weeks |

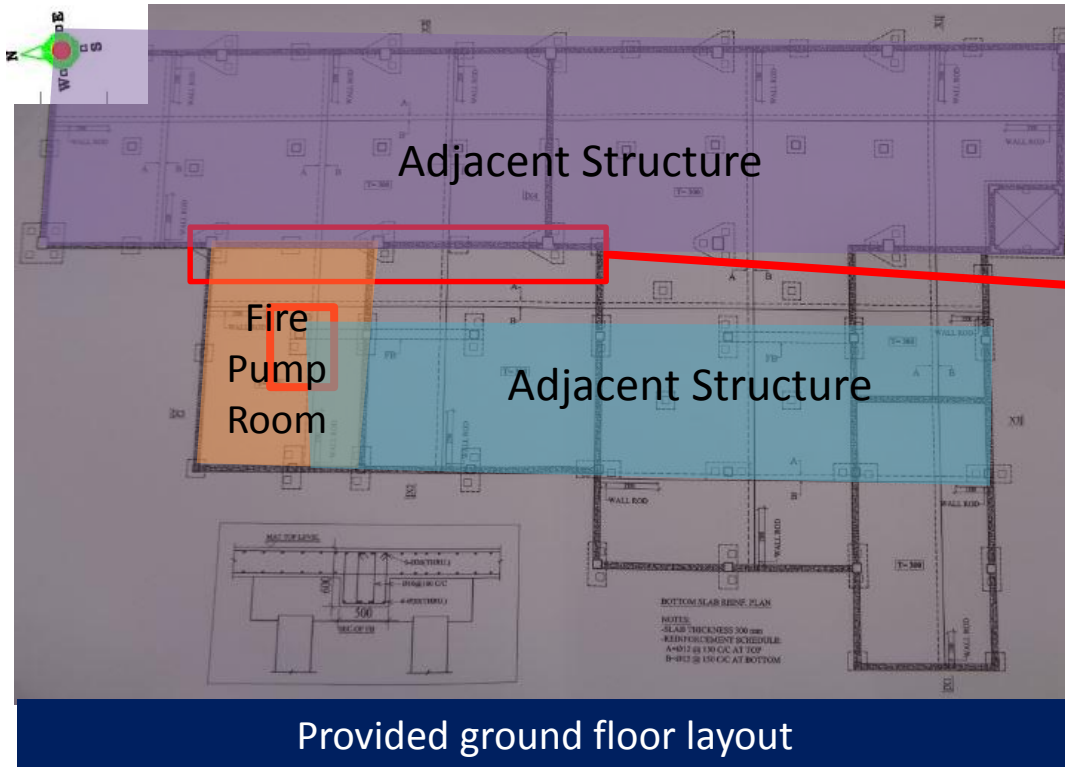
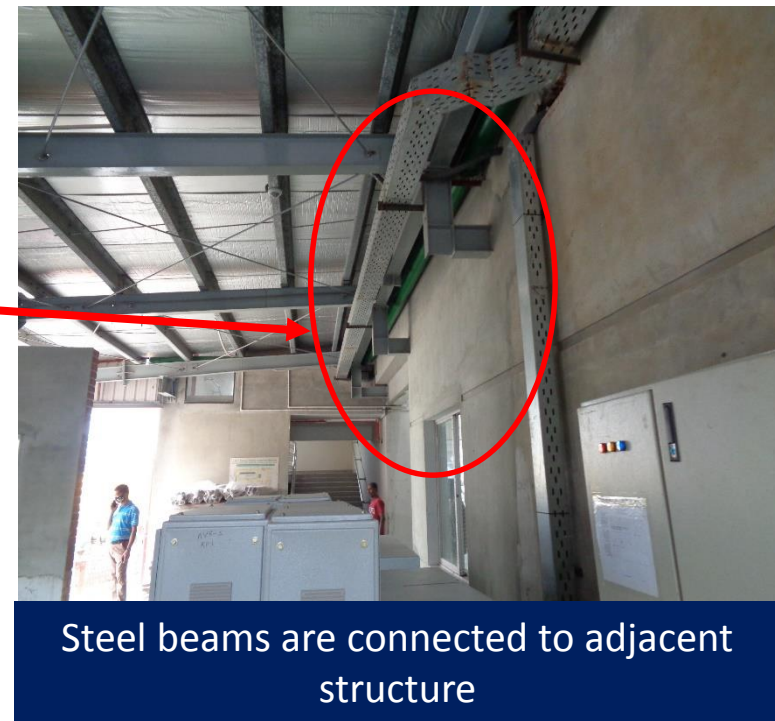
Grade beams of Fire Pump Room structurally connected with the grade beams of the adjacent buildings. Also, rafter of shed is resting on corbels of adjacent building

Fire pump room is located under the north-east corner of adjacent structure (2). The main column of fire pump room is the corner column of that building. Provided ground floor slab indicates that Fire Pump Room is structurally connected with adjacent buildings at grade beam level. No geotechnical investigation report was available for this area. Therefore, foundation adequacy could not be verified. Factory engineer is required to verify the structural integrity and the foundation system for the Fire Pump Room.

| Item No. | Observation | Recommended Action Plan | Recommended Timeline |
|---|---|---|---|
| 18 | Structural system to be verified (Fire Pump Room) | Factory engineer is required to verify the structural integrity and the foundation system. | 6-weeks |

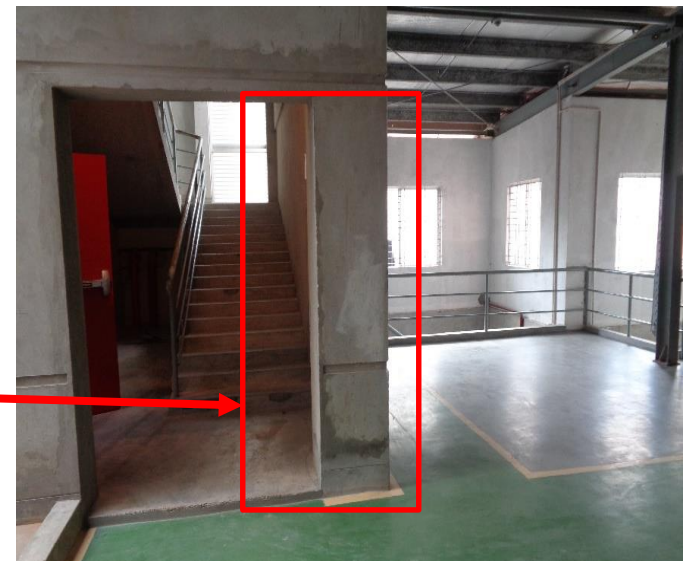
Main Column of pump room (Corner column of adjacent structure) at ground floor

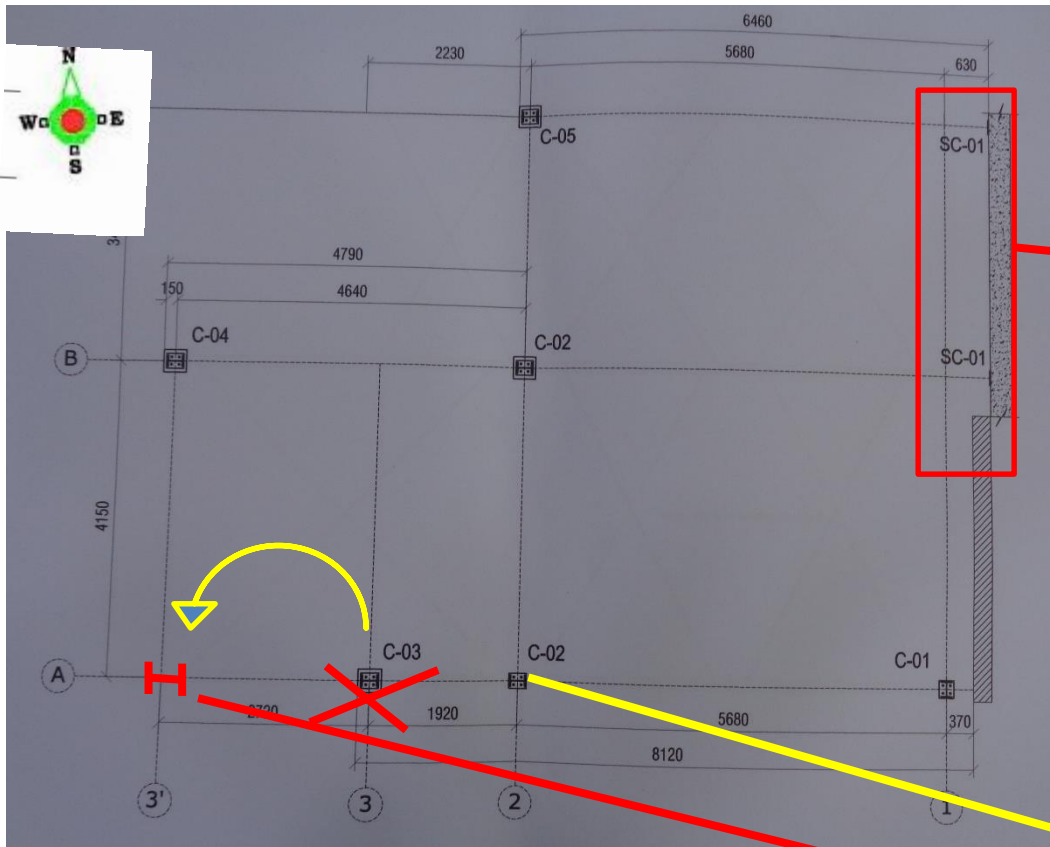
Provided Ground floor slab detail

No structural detail was available for the column and beam, RC wall and foundation. One steel column found at different position and two steel columns were found missing. Also, no rafter layout was shown in drawing. Factory engineer is required to produce full set of as-built structural drawing.

| Item No. | Observation | Recommended Action Plan | Recommended Timeline |
|---|---|---|---|
| 20 | Incomplete as-built drawing (Fire Pump Room) | Factory engineer is required to produce full set of as-built drawing. | 6-weeks |

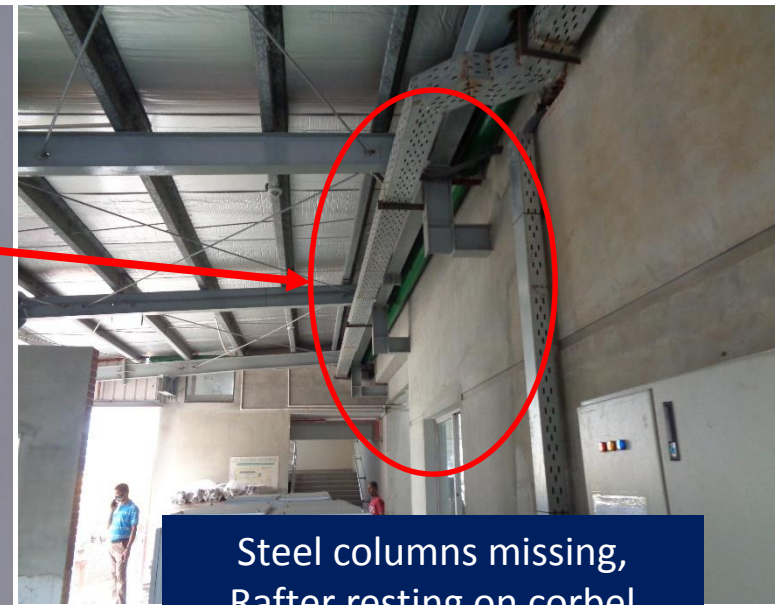
Steel columns missing, Rafter resting on corbel

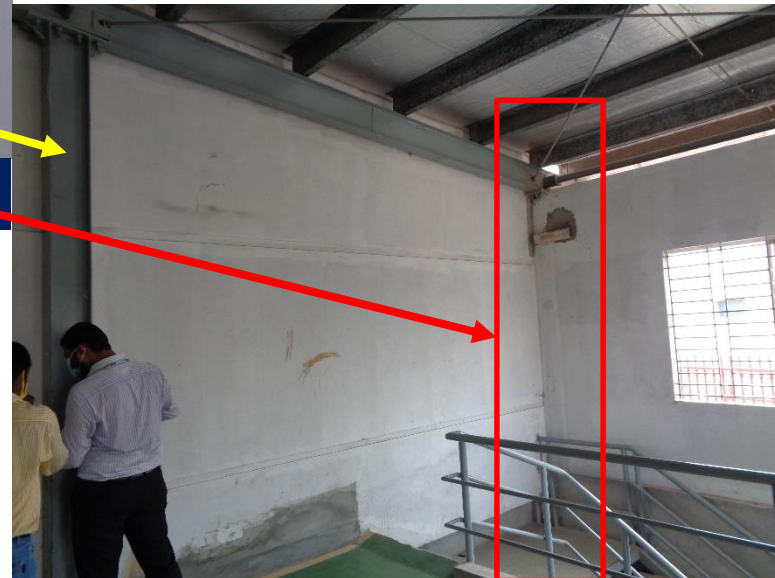
Column found at different position
