# Oxford Knit Composite Ltd.

19 August 2021

# Buildings Information

# Observations

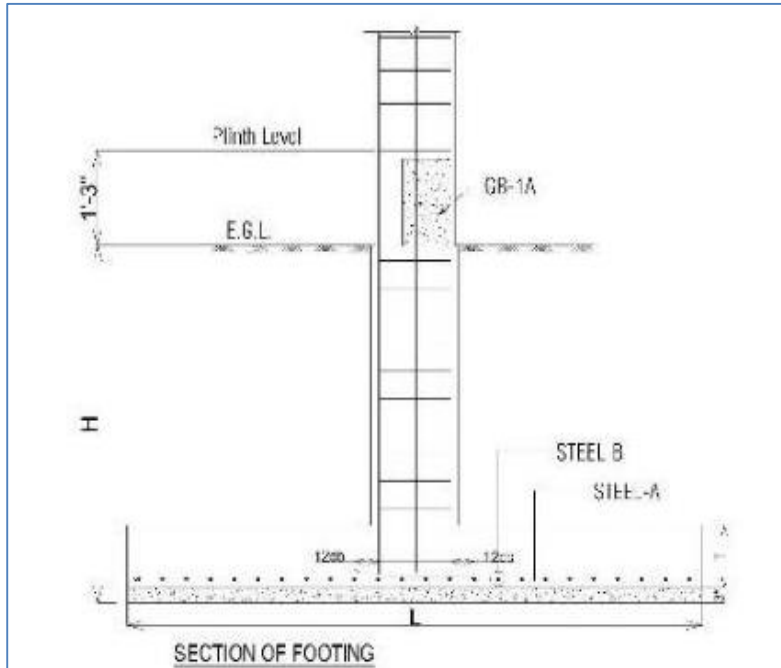
Typical Section of Footing

As per geotechnical investigation report, the allowable bearing capacity is 0.46 tsf (49.33 KN/m<sup>2</sup>) at depth 5 ft (1.5 m) considering F.S 2.5.

Cursory calculation indicates that footing appears to be stressed above normal design limits considering the recommended soil bearing capacity in geotechnical report and footing sizes in drawing. Factory engineer is required to review the adequacy of footings and comply with BNBC.

| Item No. | Observation | Recommended Action Plan | Recommended Timeline |
|---|---|---|---|
| 01 | Footings are stressed above normal design limit (Building 1) | Building engineer is required to review the adequacy of footings and comply with BNBC. | 6-weeks |

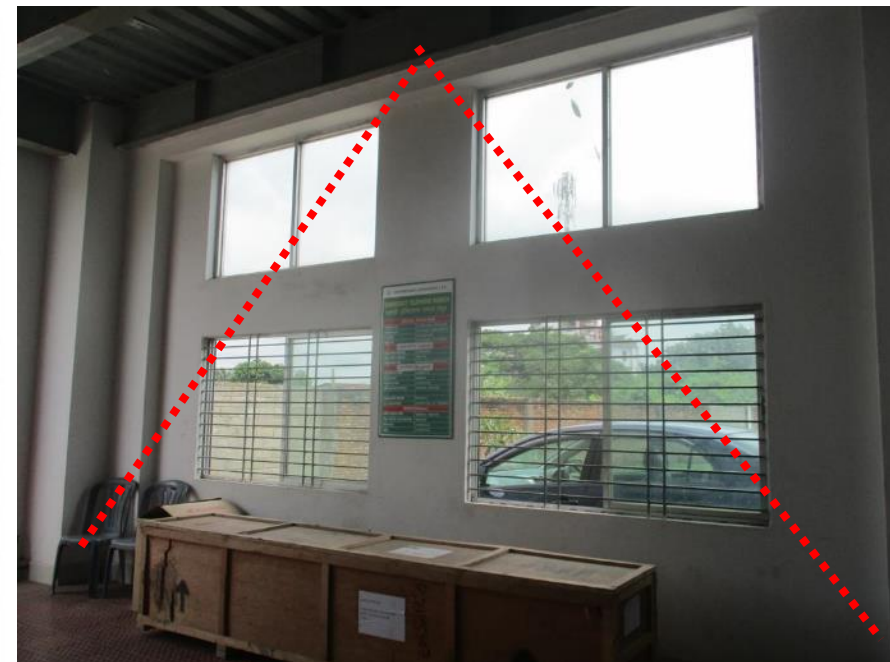
Missing bracing

Vertical bracing found missing in long direction.  
Building engineer is required to re-install all the missing bracing as per the design specifications.

| Item No. | Observation | Recommended Action Plan | Recommended Timeline |
|---|---|---|---|
| 11 | Vertical bracing missing. (Building 1) | Building engineer is required to re-install all the missing bracing as per the design specifications. Or check whether the existing bracing system are adequate for lateral stability. | 6-weeks |
| 12 | Vertical bracing missing. (Building 1) | Complete implementation of any remedial works deemed necessary by the Design Report. | 6-months |

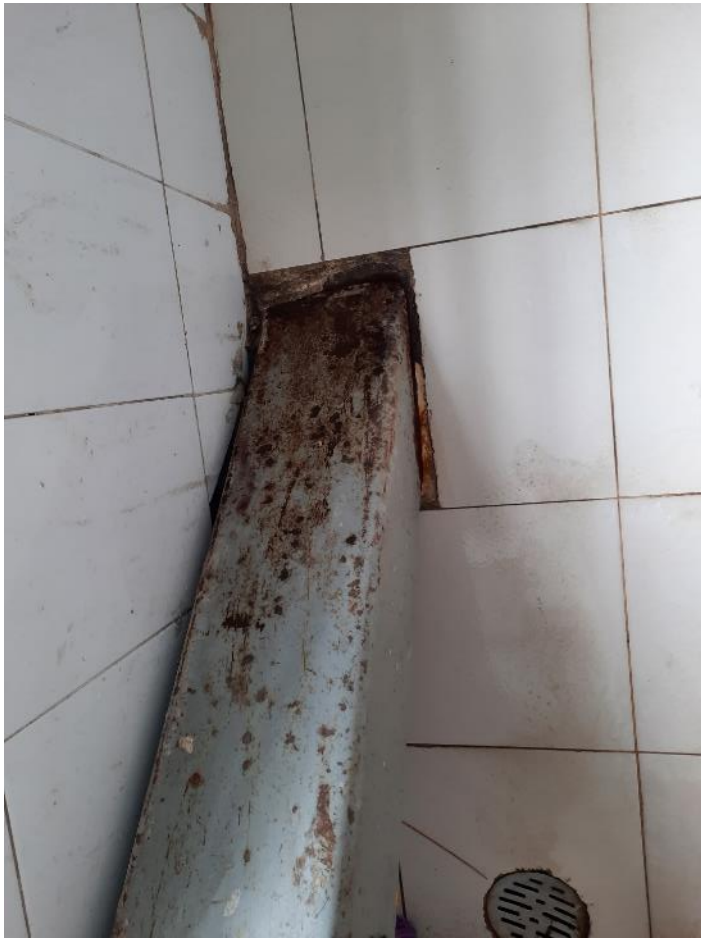
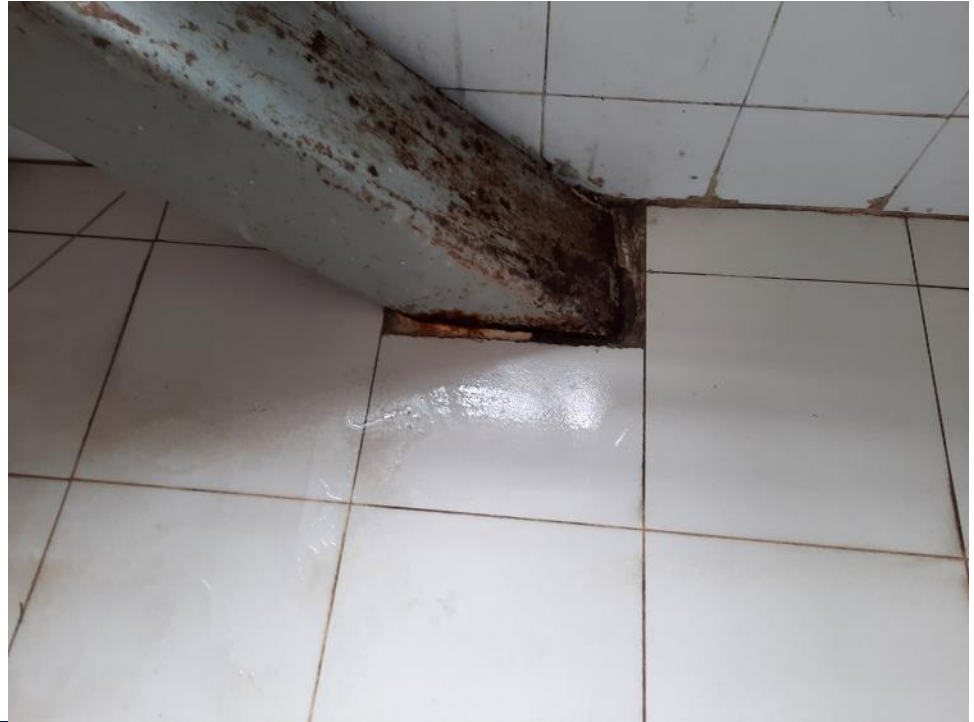
Corrosion in steel members was observed at toilet area. The extent of corrosion to be investigated by a qualified structural engineer.

| Item No. | Observation | Recommended Action Plan | Recommended Timeline |
|---|---|---|---|
| 14 | Corrosion on steel member (Building 1) | Building engineer is required to take necessary action to prevent further corrosion and repair the corroded steel members with suitable method. | 6-weeks |
