Axis Knitwears Ltd (relocated)

Mawna, Sreepur, Gazipur
(24.253515N, 90.399563E)
17th June & 11th August 2021

Buildings Information

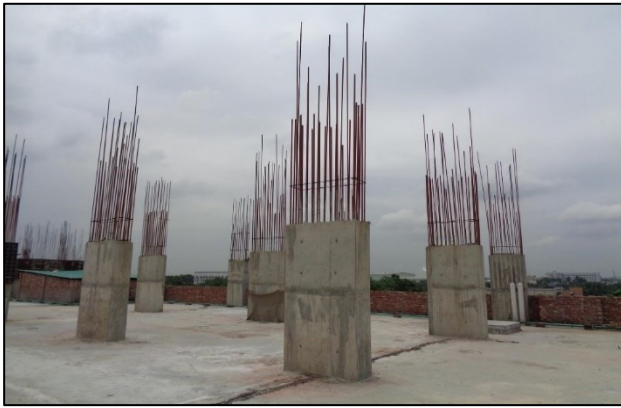
Poorly anchored tin shed and extended column on roof

On roof, full height columns have been constructed which has not been incorporated in FEA model and as-built drawing. Moreover, in FEA model all staircase top has been assigned with RC Slab which does not match with existing condition. Factory engineer is required to revise the FEA model for roof top RC columns as per onsite condition and replace the tin shed with RC slab/engineered structure as per the FEA model and update the design documents accordingly.

Item No.	Observation	Recommended Action Plan	Recommended Timeline
01	Poorly anchored tin shed and extended column on roof (Main Building)	Factory engineer is required to revise the FEA model for roof top RC columns as per onsite condition and update the design documents in compliance with section 1.9.1 (Part-6, BNBC-2006).	6-weeks
02	Poorly anchored tin shed and extended column on roof (Main Building)	Factory engineer is required to replace the tin shed with RC slab/engineered structure as per the outcome of FEA analysis and update the design documents accordingly.	6-months
03	Design report needs to be revised. Building-2 & 3 (Generator and Sub-station Room)	Building engineer to update the design document including a design report, and a set of structural drawings in compliance with section 1.9.1 (Part-6, BNBC-2006).	6-weeks
04	Design report needs to be revised. Building-2 & 3 (Generator and Sub-station Room)	Complete implementation of any remedial works deemed necessary by the assessment report.	6-months

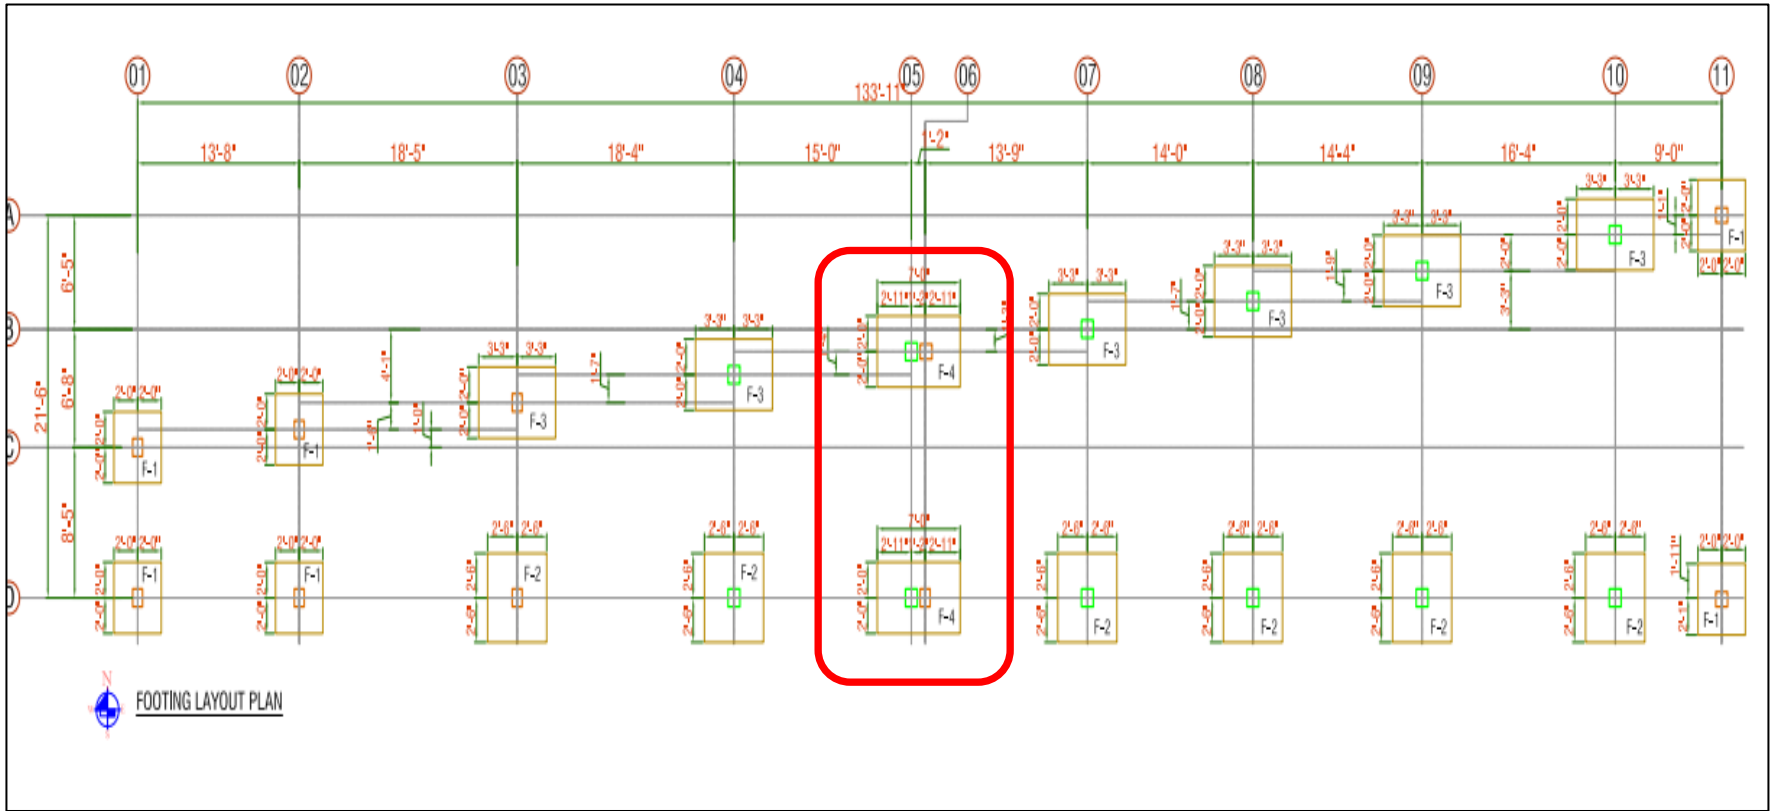
Combined footing F4 between Building-2 & 3 (Generator & Sub-station)

In expansion joint between Building-2 & 3 (Generator & Sub-station), footing type F4 is being share between them according to drawing. But in foundation adequacy check axial load from single column has been considered. Factory engineer is required to check the adequacy of footing F4 considering loads from both columns and incorporate them in design report.

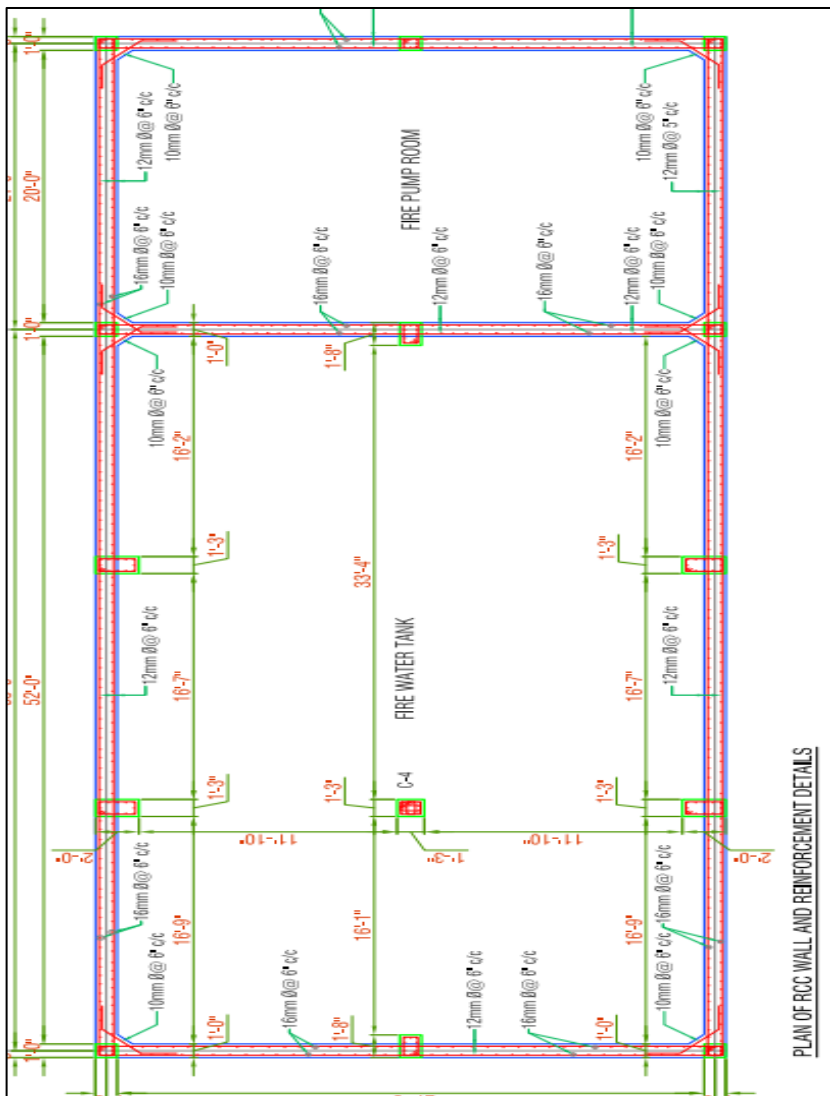
Structural wall reinforcement details :Building-4 (Fire Reservoir & Compressor Room)

These structures are combination of moment resisting frame and structural wall. These walls have been incorporated in FEA model and reinforcement details are also provided in drawing. However in design report no information has been provided regarding the adequacy of these structural walls. Factory Engineer is required to incorporate the adequacy check in design report.

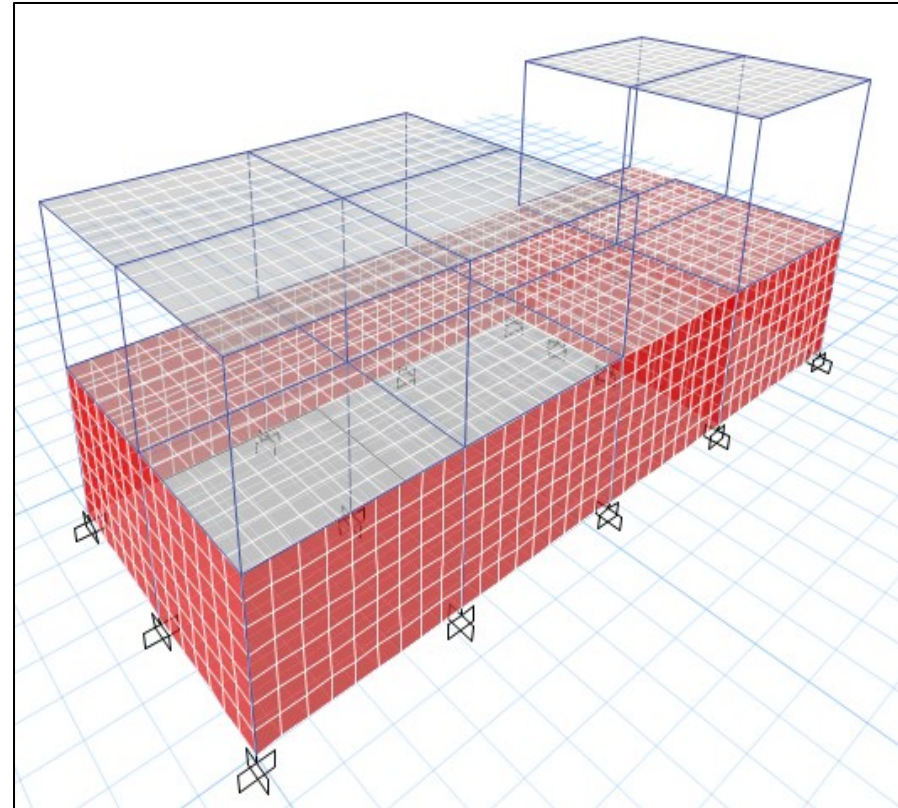
Structural wall assigned in FEA :Building-4 (Fire Reservoir & Compressor Room)

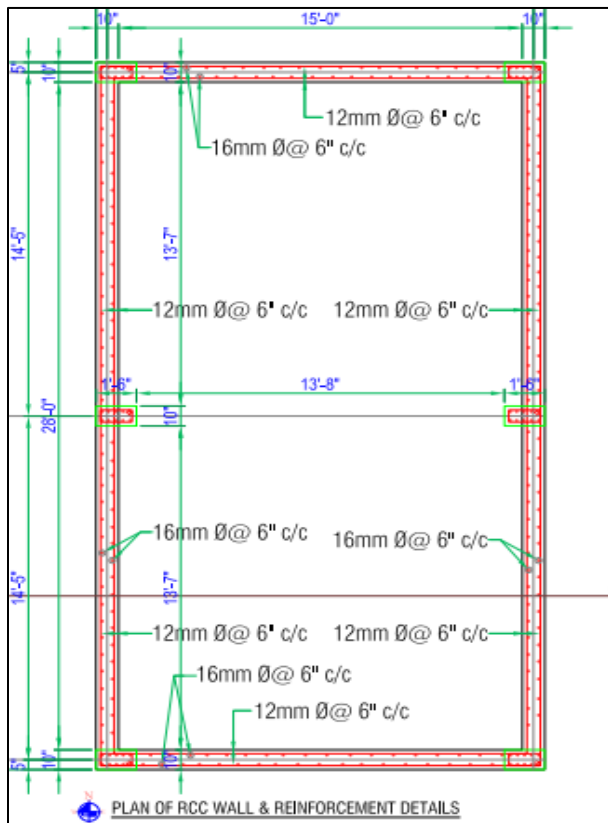
Structural wall reinforcement details :Building-5 (Domestic Reservoir & Boiler Room)

Item No.	Observation	Recommended Action Plan	Recommended Timeline
05	Design report needs to be revised. Building 4&5: (Fire Reservoir & Compressor Room) & (Domestic Reservoir & Boiler Room)	Building engineer is required to incorporate the adequacy check of structural walls in design report update the design document including a design report, and a set of structural drawings in compliance with section 1.9.1 (Part-6, BNBC-2006).	6-weeks
06	Design report needs to be revised. Building 4&5: (Fire Reservoir & Compressor Room) & (Domestic Reservoir & Boiler Room)	Complete implementation of any remedial works deemed necessary by the assessment report.	6-months
07	Lack of stability. (Shed-1)	Building engineer is required to check the adequacy of the roof shed for uplift and lateral forces or replace with the engineered sheds.	6-weeks
08	Lack of stability. (Shed-1)	Carry out remedial works where necessary.	6-months

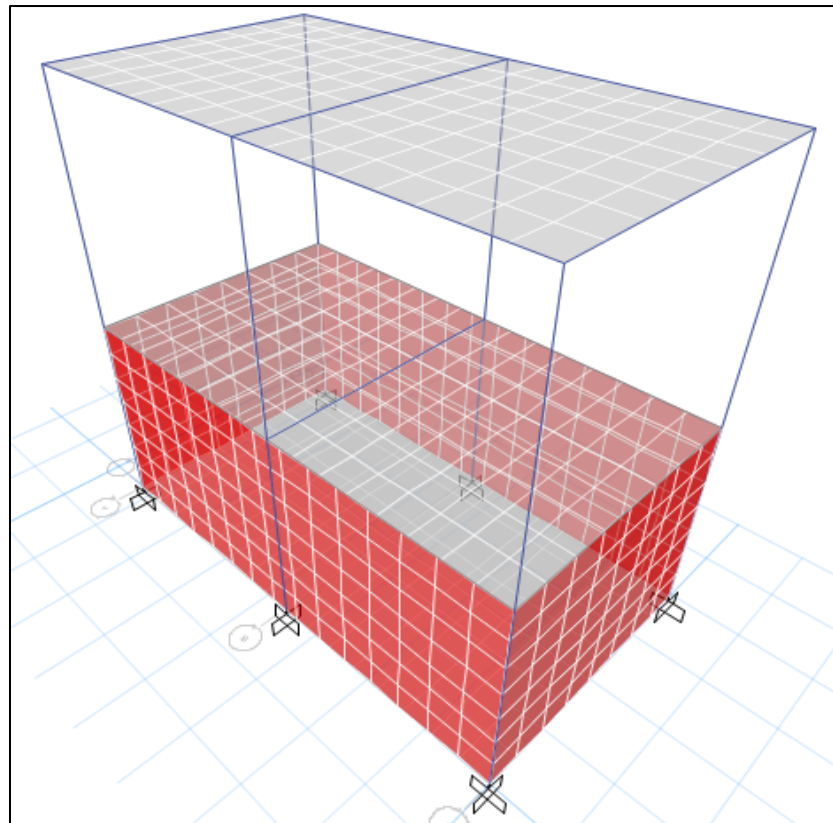
Structural wall assigned in FEA :Building-5 (Domestic Reservoir & Boiler Room)

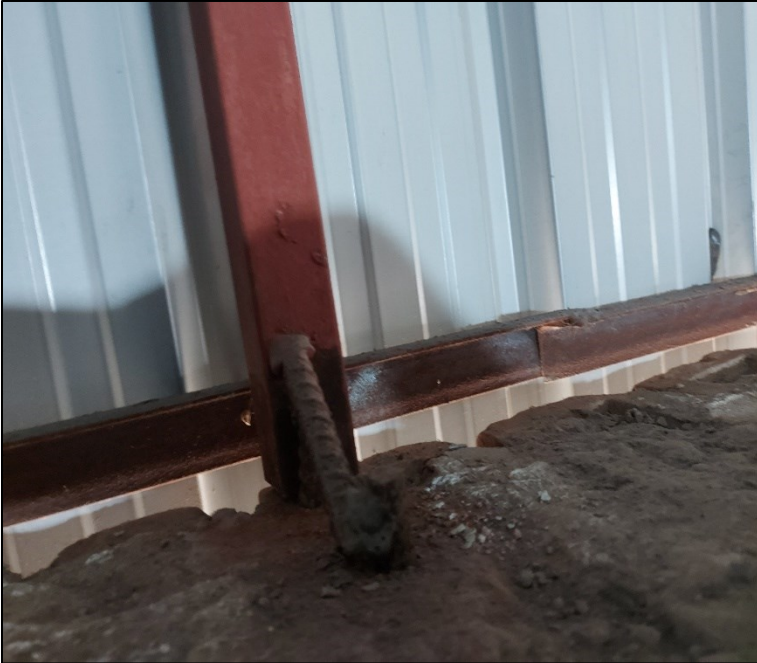
Lack of stability

The steel roof shed made of angle section which is supported by brick wall in transverse direction. No horizontal bracing members are available for lateral stability. Apparently Inadequate structural member, poor connection details found. Building engineer is required to check the adequacy of the steel members & connection for uplift and lateral forces otherwise replace with engineered structure.

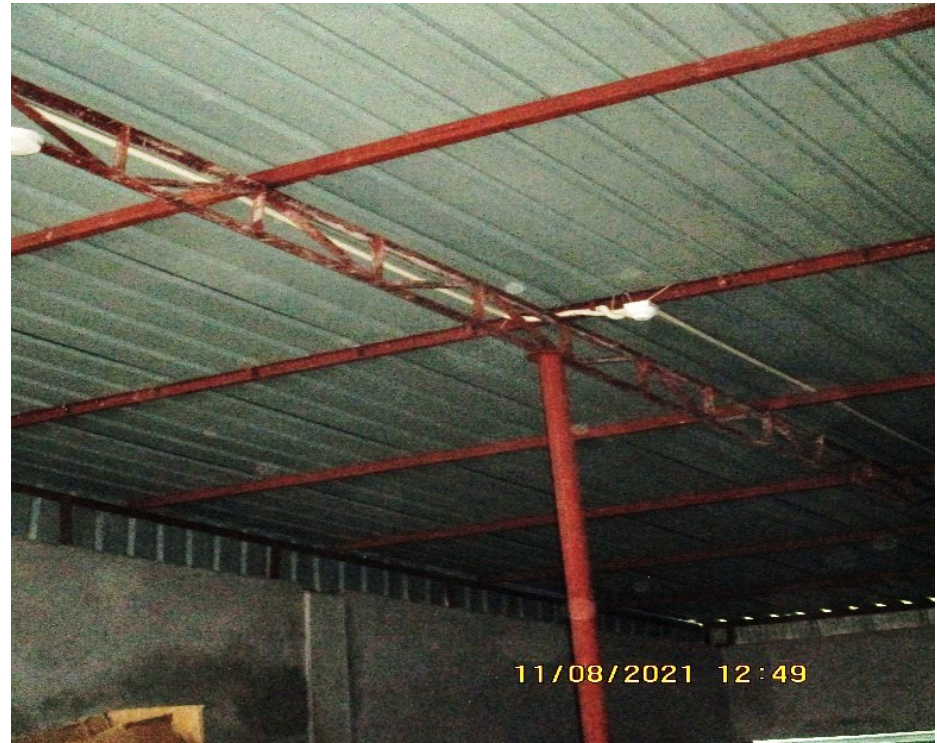
Poor connection details

Apparently inadequate structural members
