J K Knit Composite Ltd. (Extension)

10/1, South Dariapur, Savar, Dhaka-1340,
(23.8348N, 90.2547E)
9th June & 26th August 2021

Buildings Information

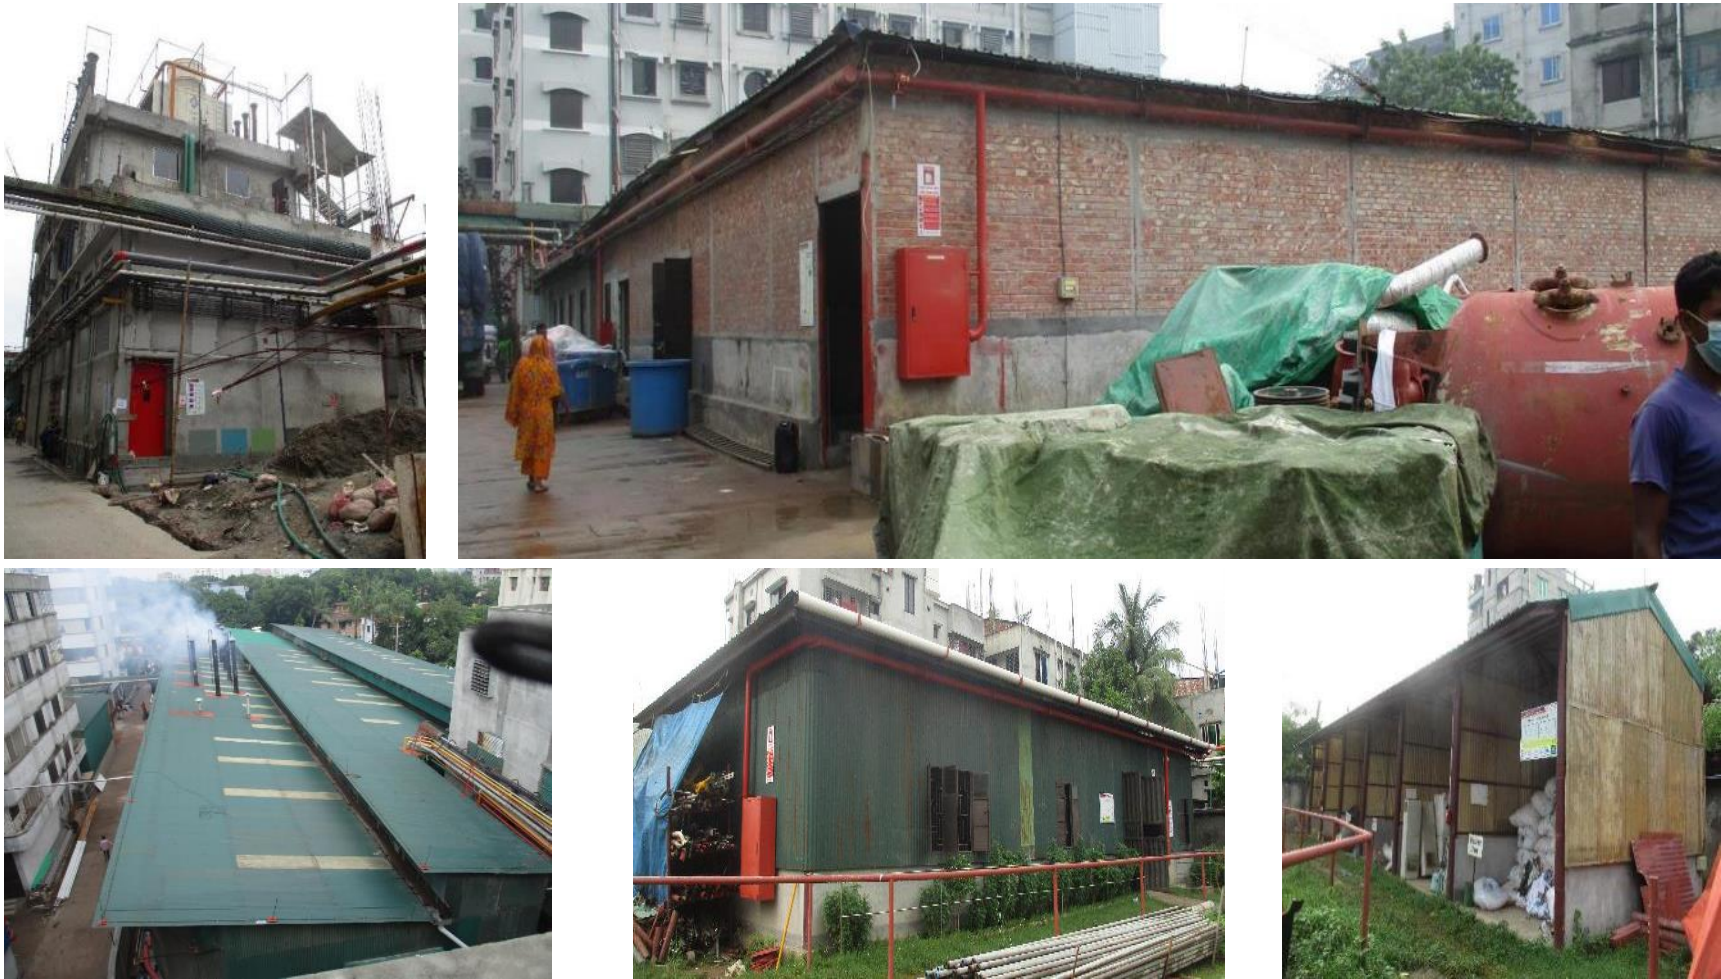
Lack of design documents

As per BNBC Section 1.9.1, every structure should have design documents.

There is no design documents for above mentioned structures. So, the factory engineer is required to prepare a set of design documents for all structures as per BNBC part-6, section 1.9.1.

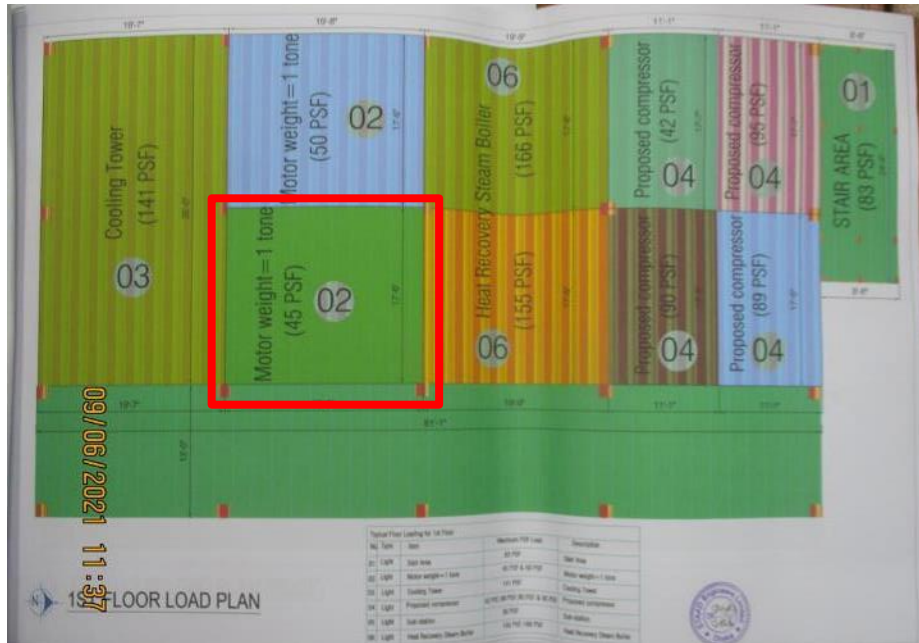
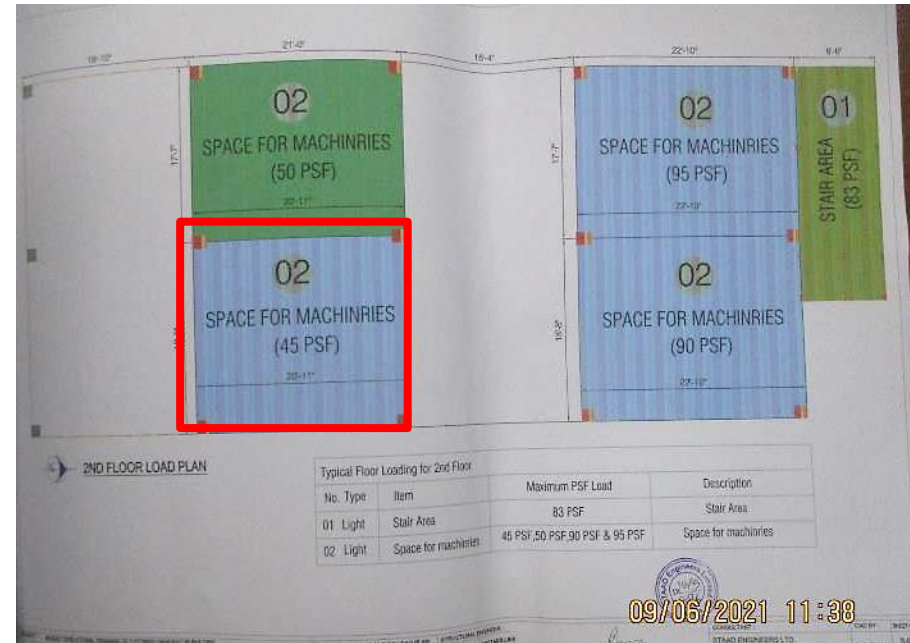
Prepared live load plan for 1st and 2nd floor

The factory engineer prepared a live load plan for 1st and 2nd floor considering 45 psf (2 kPa). As per BNBC requirement, the minimum floor live load for factory building is 3 kPa. So, the factory engineer is required to revise the floor load plan based on minimum live loading requirements of BNBC and column, floor & foundation capacity.

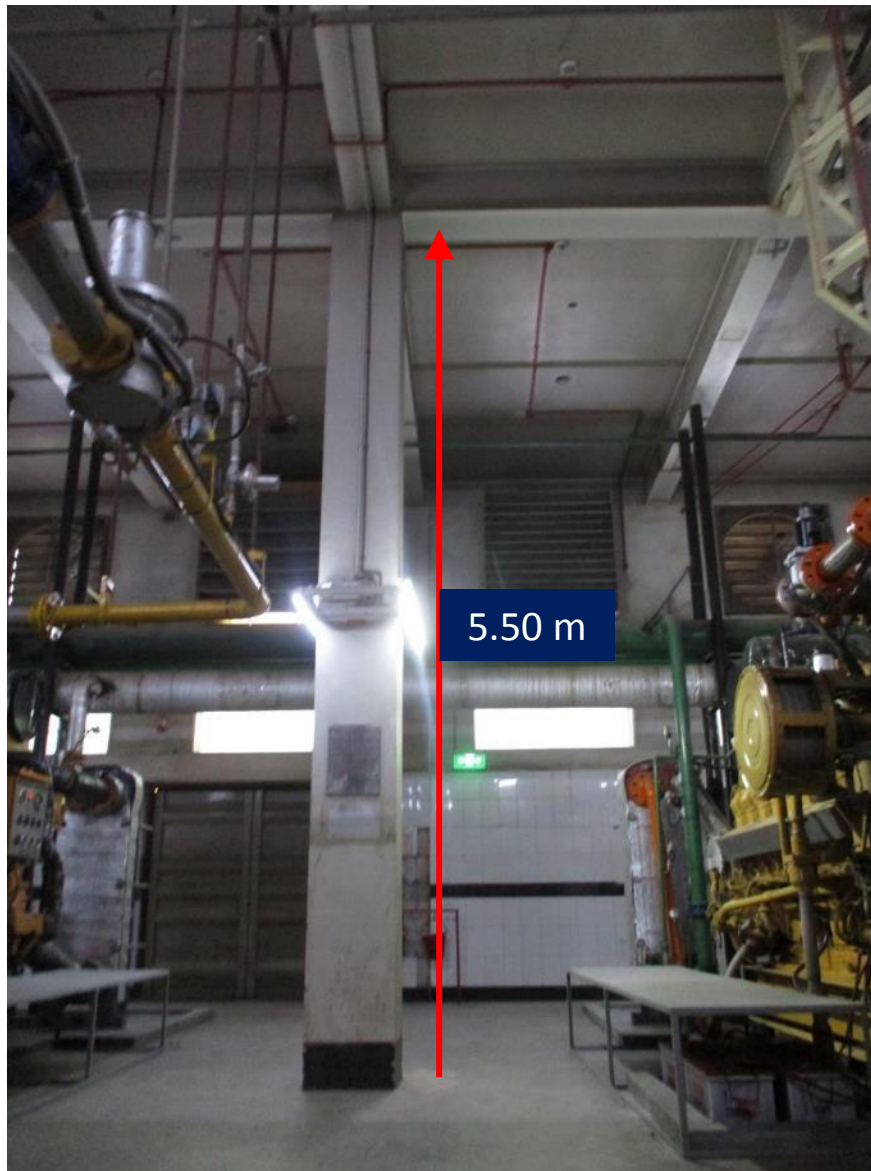
Central column Size: 375 mm x 450 mm

The ground floor height is 6 m and clear height of column is 5.5 m. The least dimension is 375 mm. There is no intermediate tie beam. The factory engineer is required to check the slenderness effect of the column.

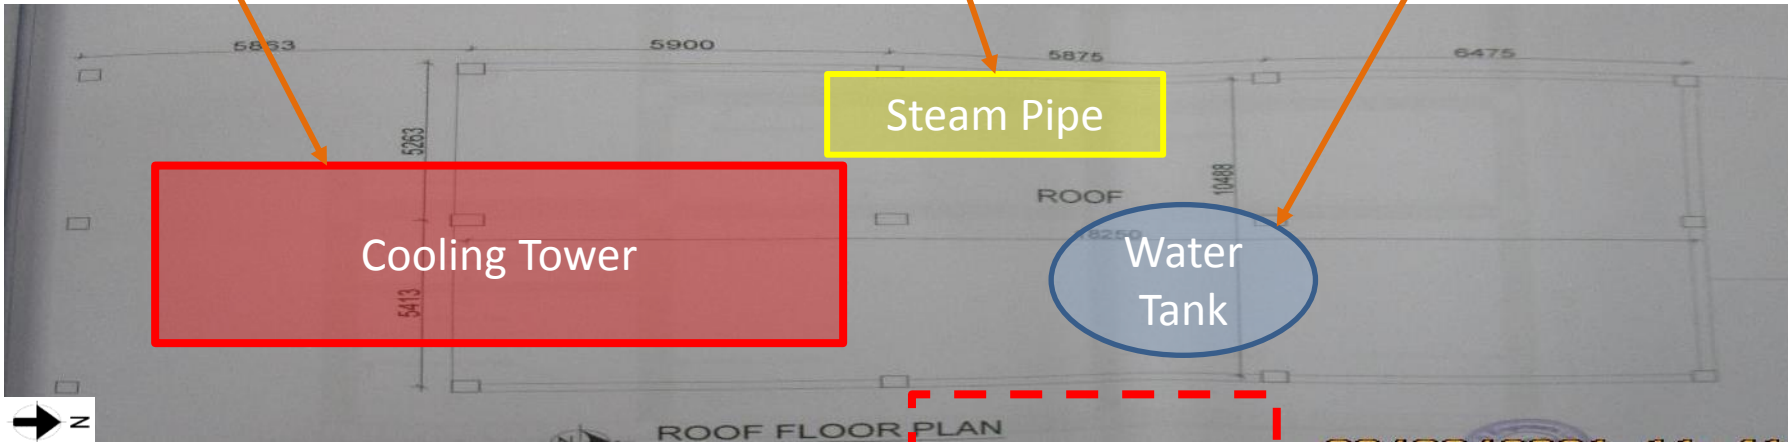
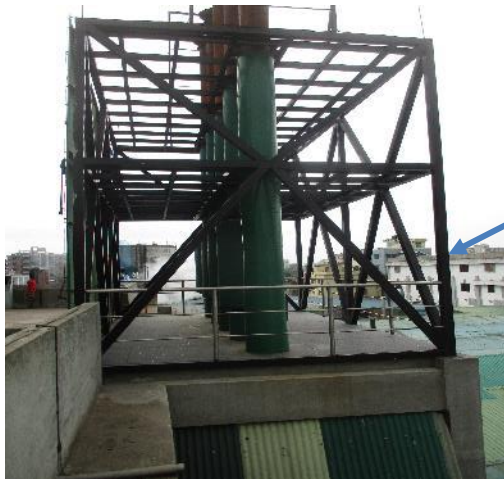
Cooling tower, steam pipe and water tank were not mentioned in the roof layout plan. Undocumented horizontal expansion at east side of the building with steel framing was observed.

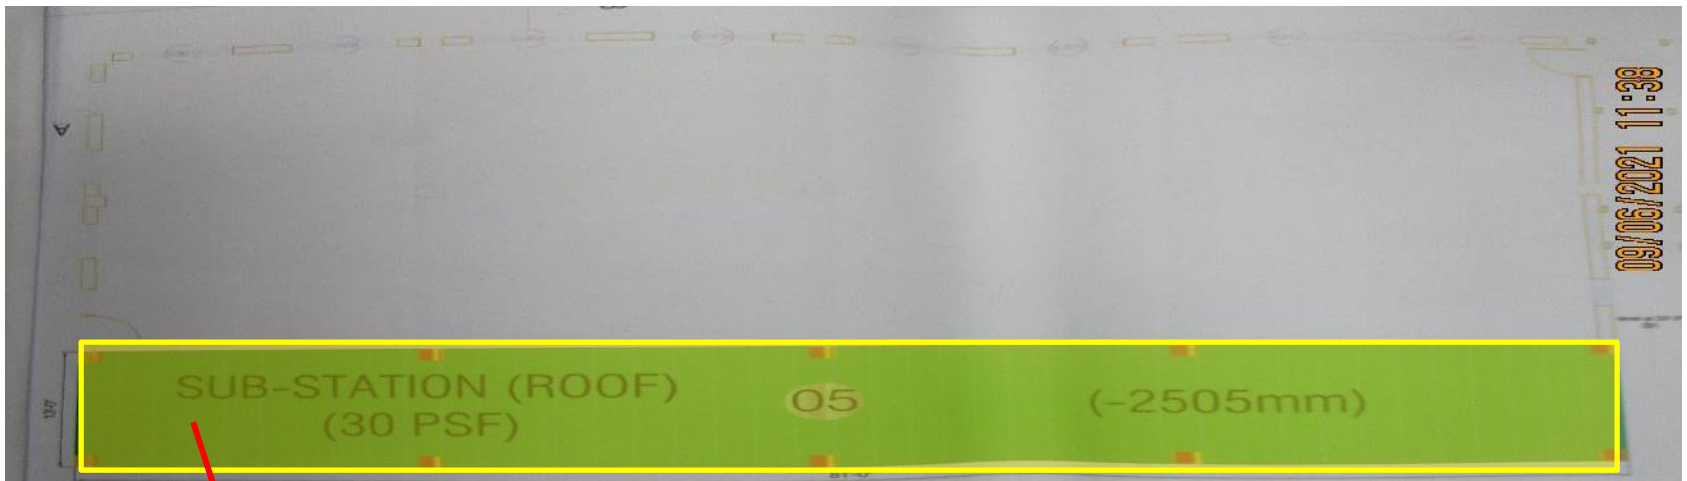
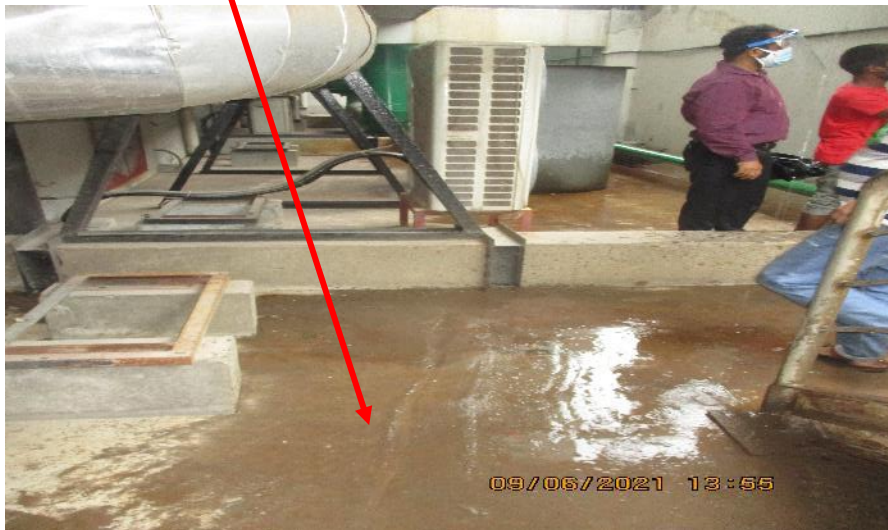
Mezzanine level not mentioned in as-built drawing. Only load plan was found.

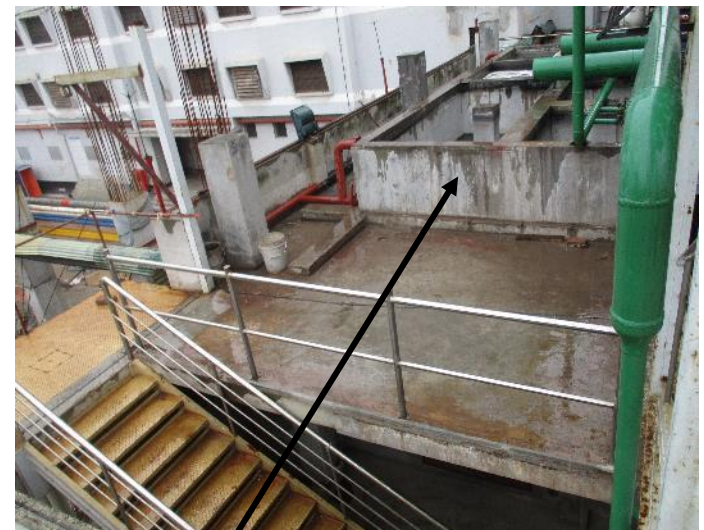
Undocumented water reservoir was found on the 1st Floor.

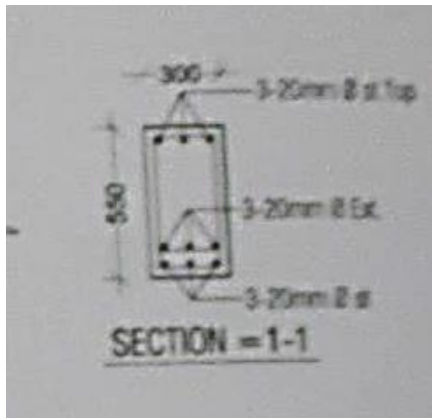
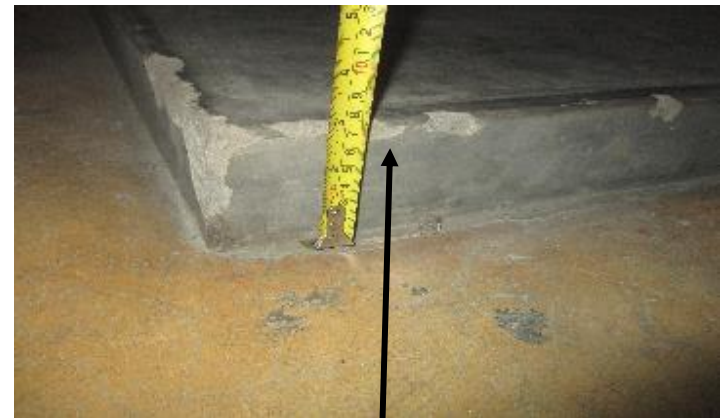
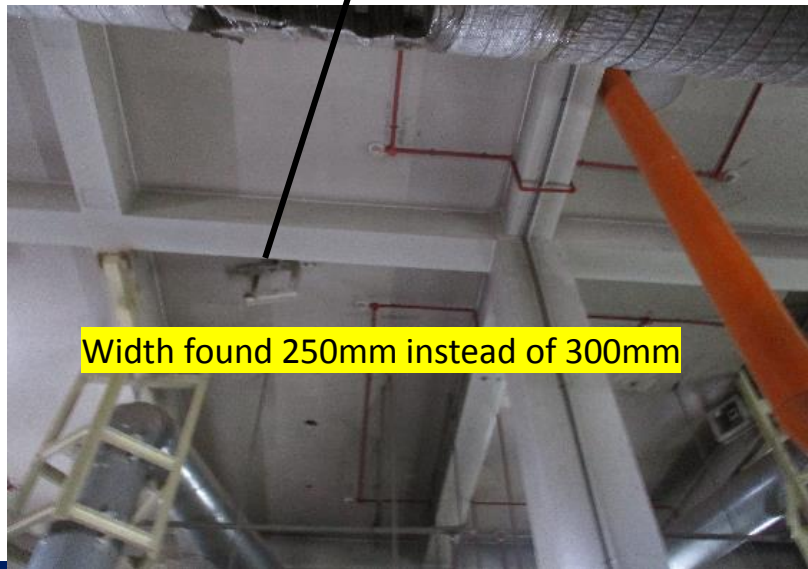
Width found 250mm instead of 300mm

Beam width for ground floor, second floor and staircase does not match with provided drawing.

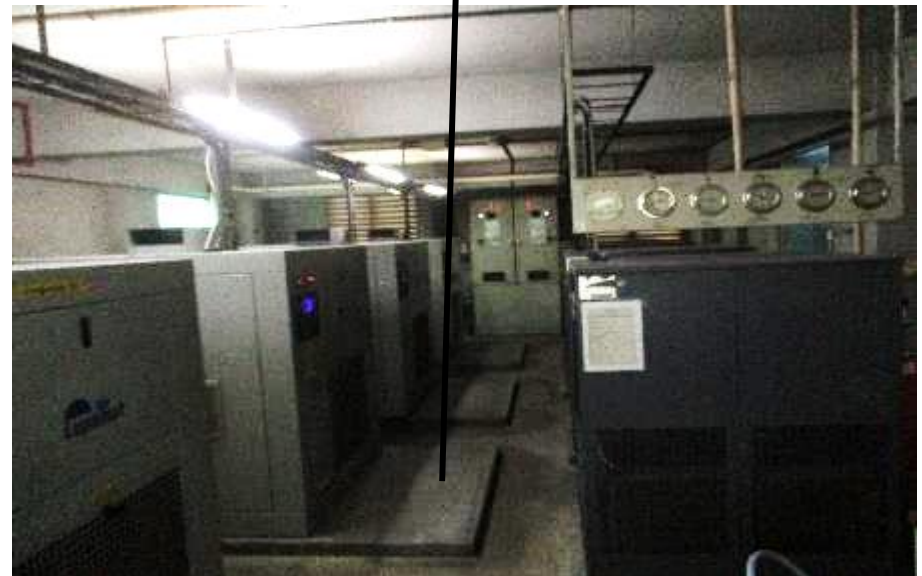
75mm build up at 1st floor not mentioned.

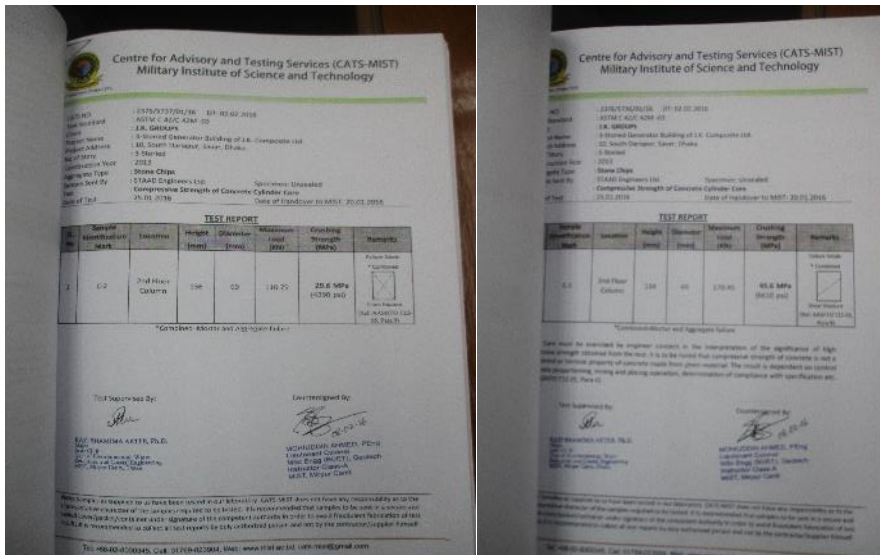
Concrete core test reports

13 number of concrete cores were taken from different locations of beam and column. But we identified only 5 core locations. Core layout plan was not available. Factory engineer to prepare core layout plan properly.

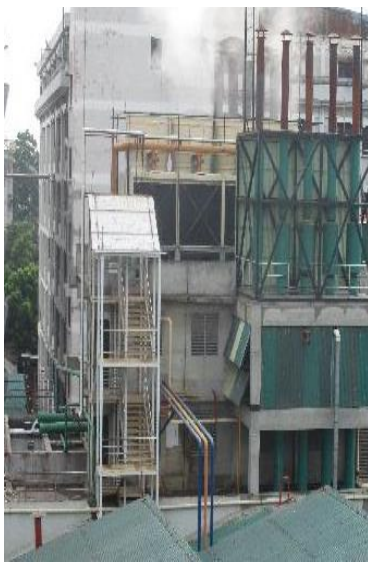
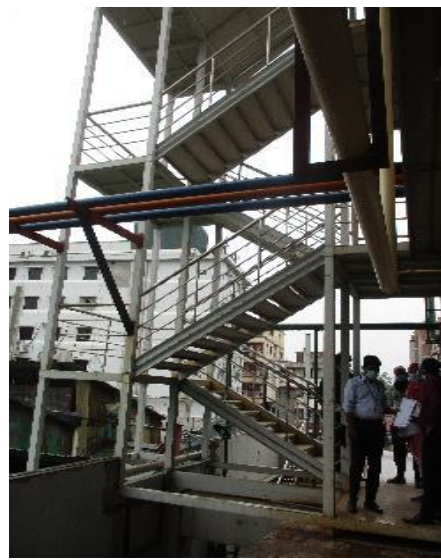
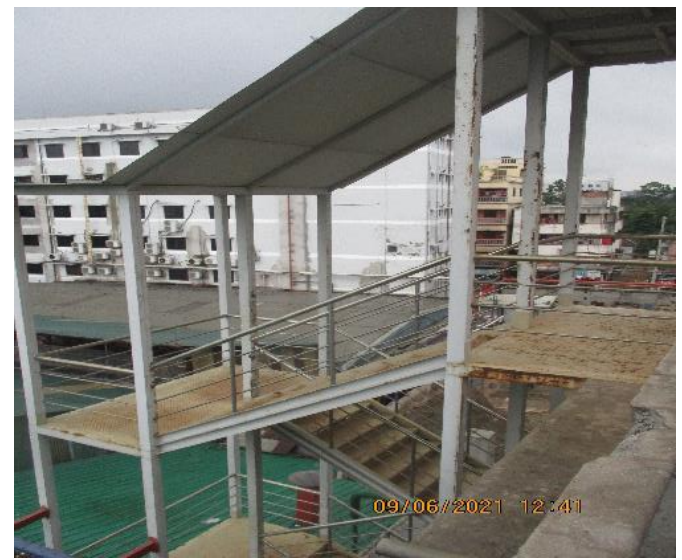
South side

Undocumented and apparently non-engineered Steel Stair found at South-East and North-West corner of the building. No as-built drawing was found. These stairs are structurally attached to the Building-6. The factory engineer is required to prepare as-built drawing and check the structural integrity for the steel stairs.

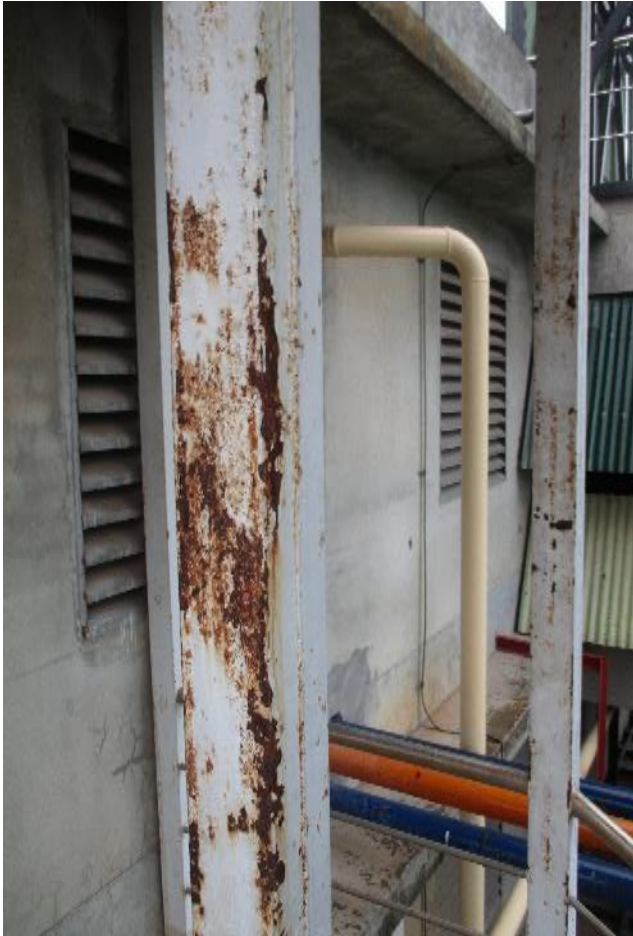
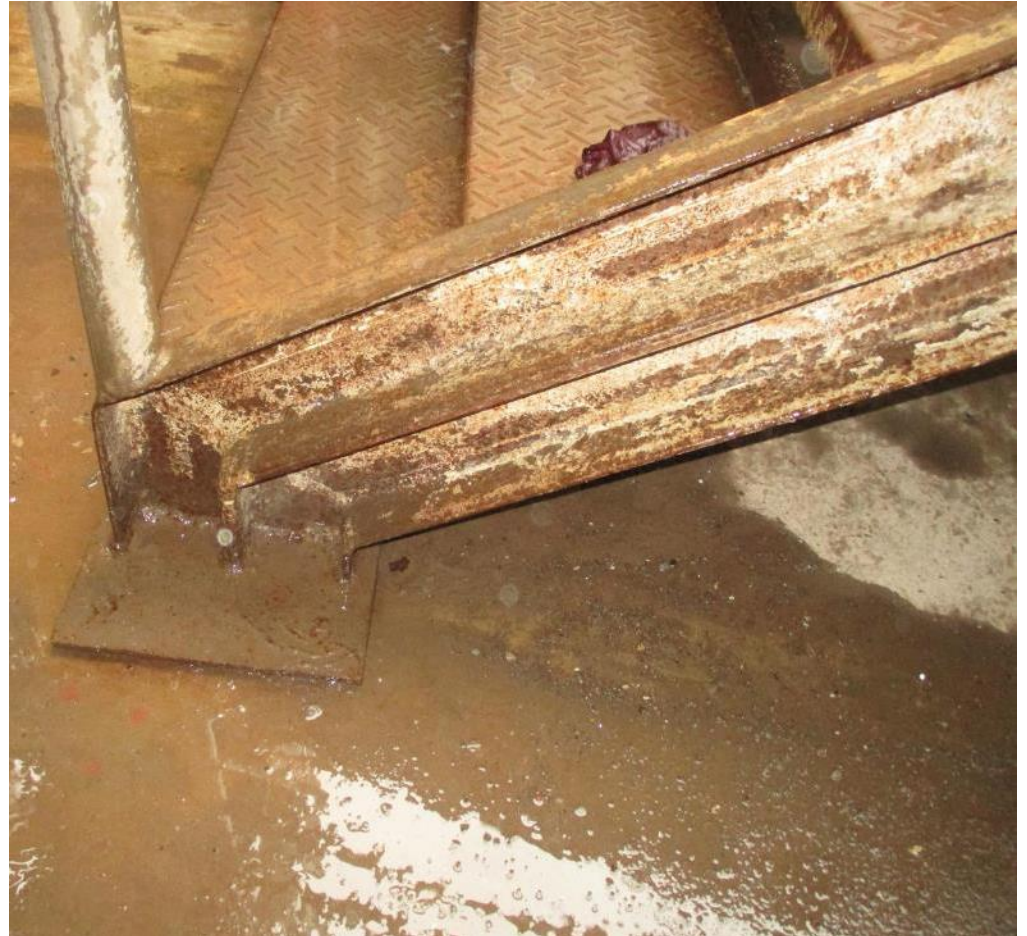
Corrosion found in steel stair

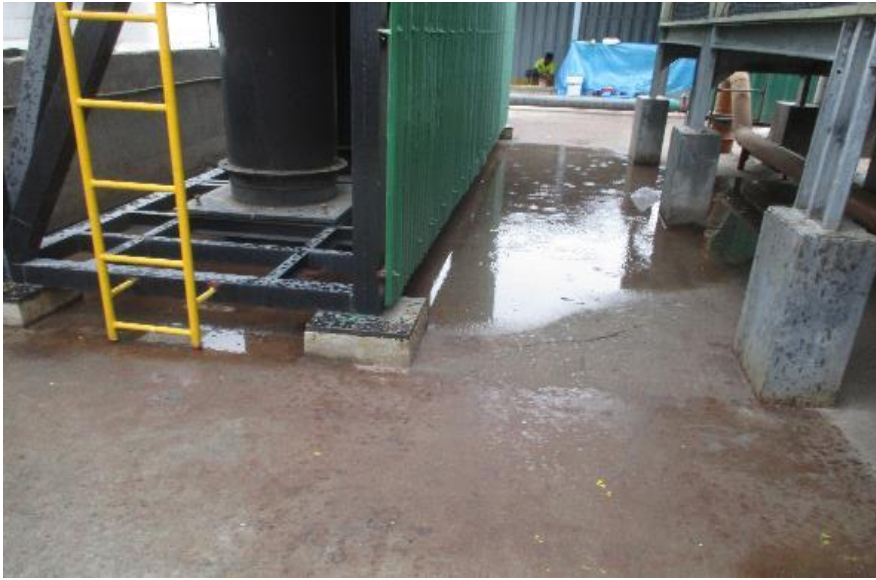
Stagnant water found at roof.

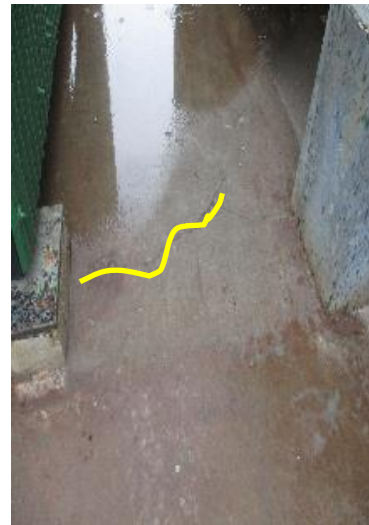
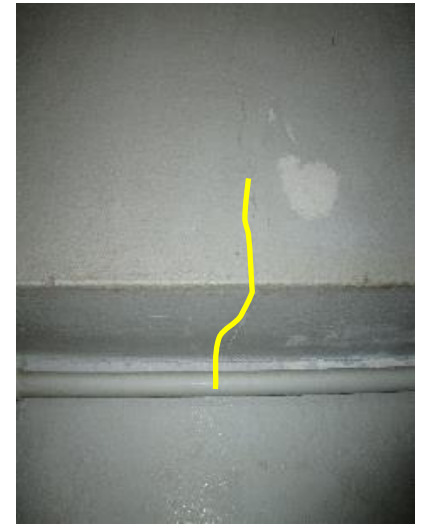
Crack at roof slab and stair beam

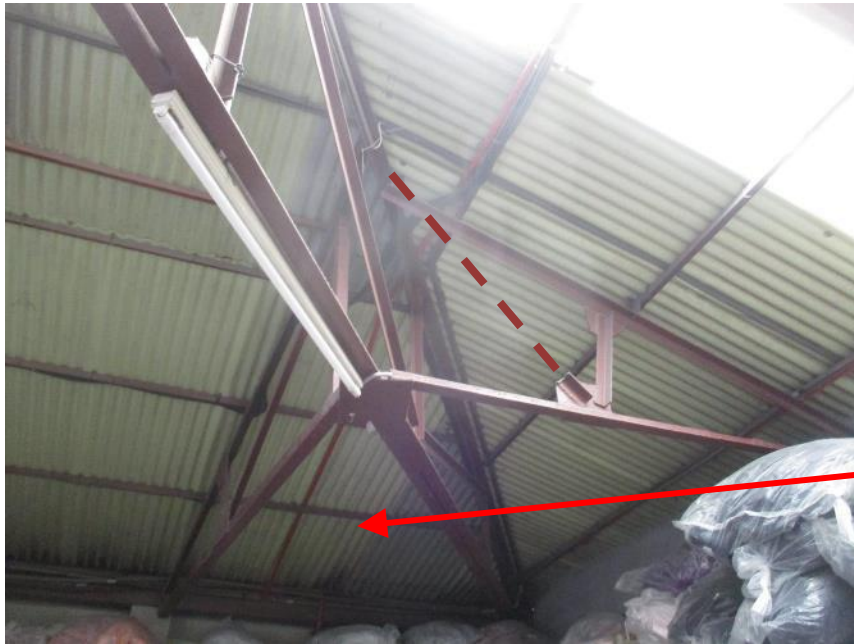
Diagonal truss chord was cut off and roof bracing between grid 11 & 13 was missing.

The factory is required to reinstall the diagonal truss chord. Also, the factory is required to analyze the structure to confirm the bracing requirements.

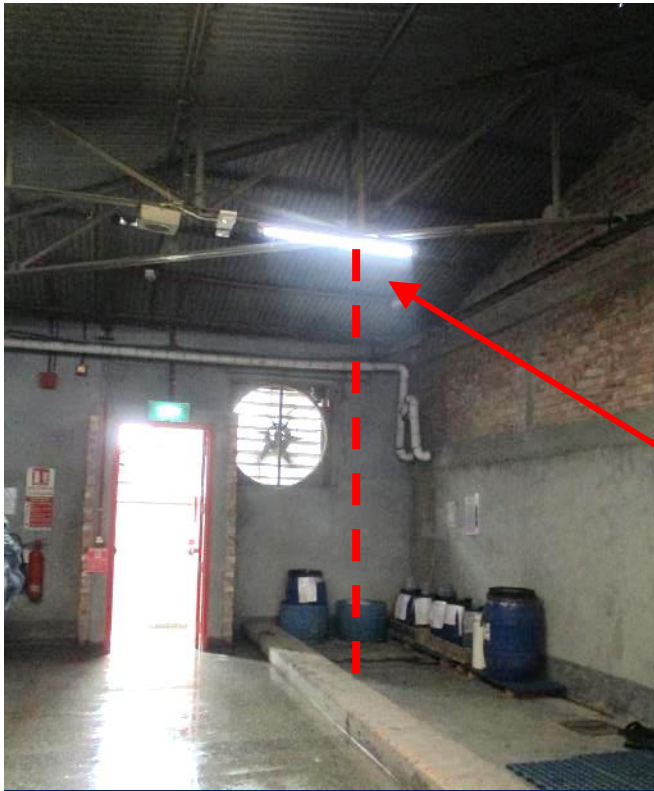
Steel column missing in marked location.

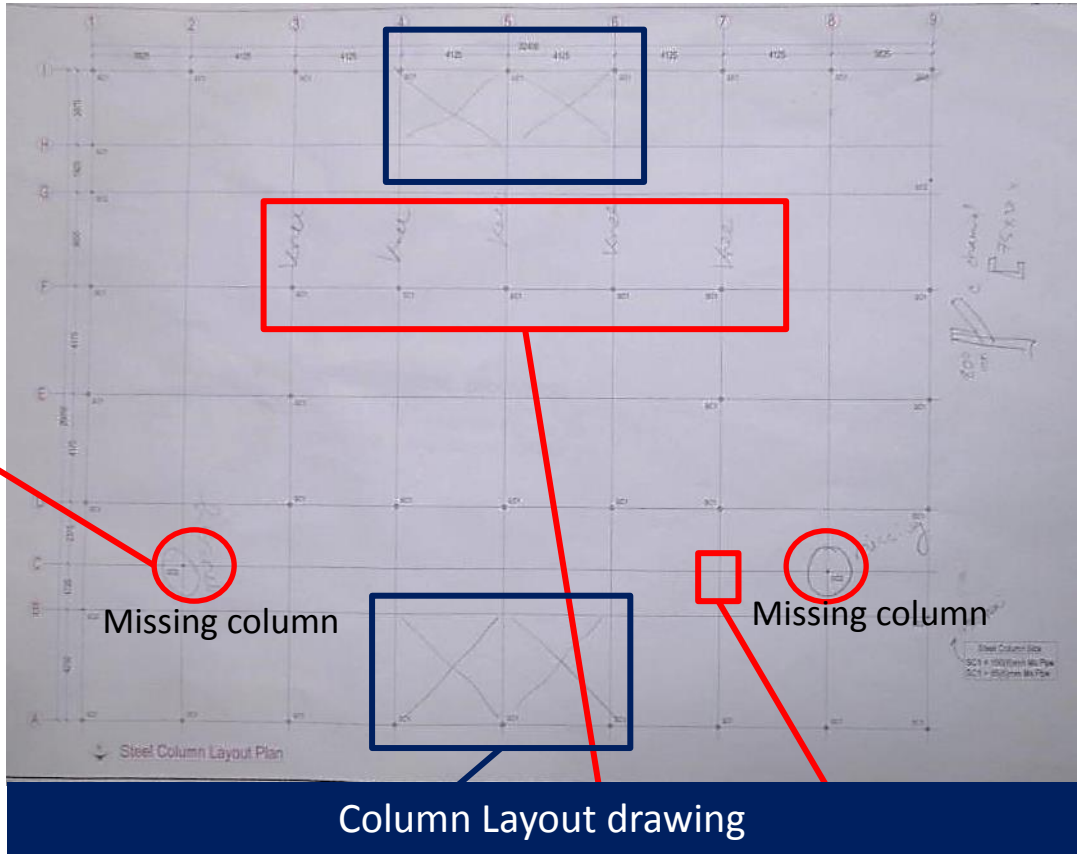
Column Layout drawing

Missing column

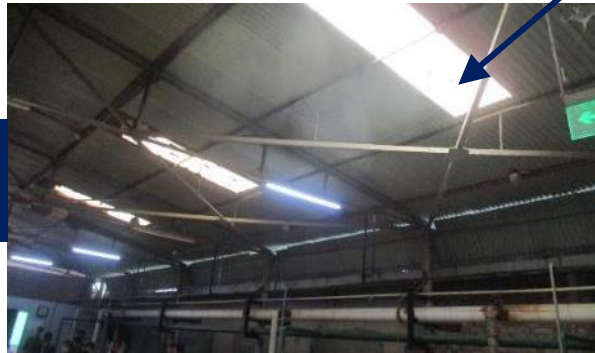
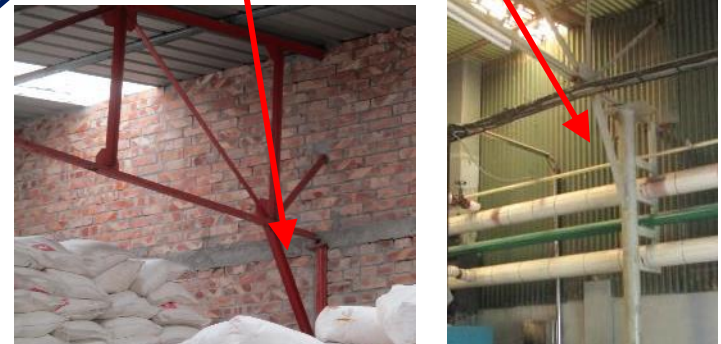
Discontinuous roof bracing.

Undocumented knee bracing.

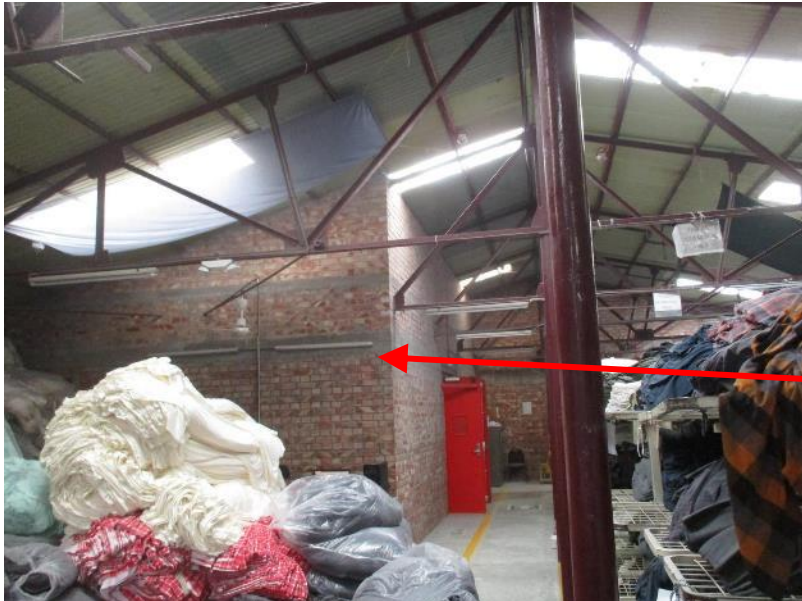
This portion was not shown in the drawing.

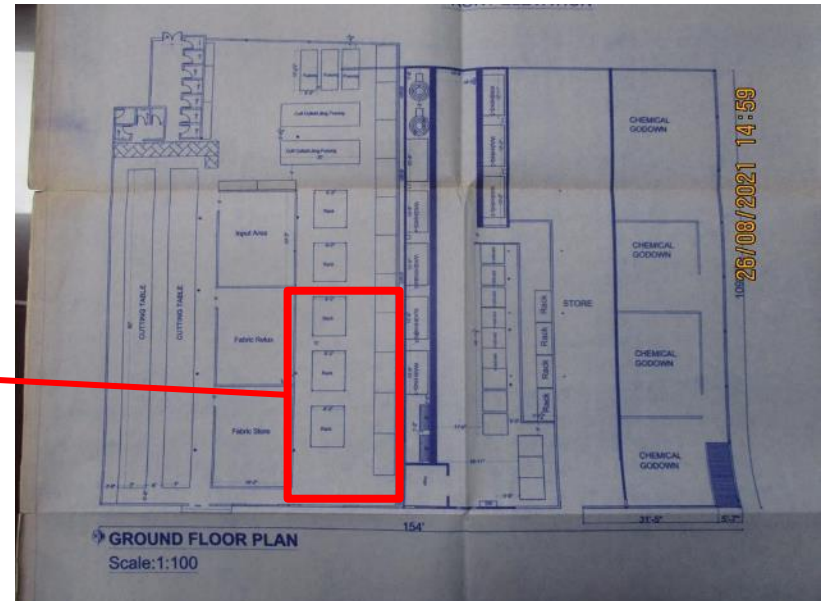
Architectural drawing.

Floor layout shown in the architectural drawings does not match with the as-built conditions. Factory engineer to survey the structure and update the as-built drawings and review the design accordingly.

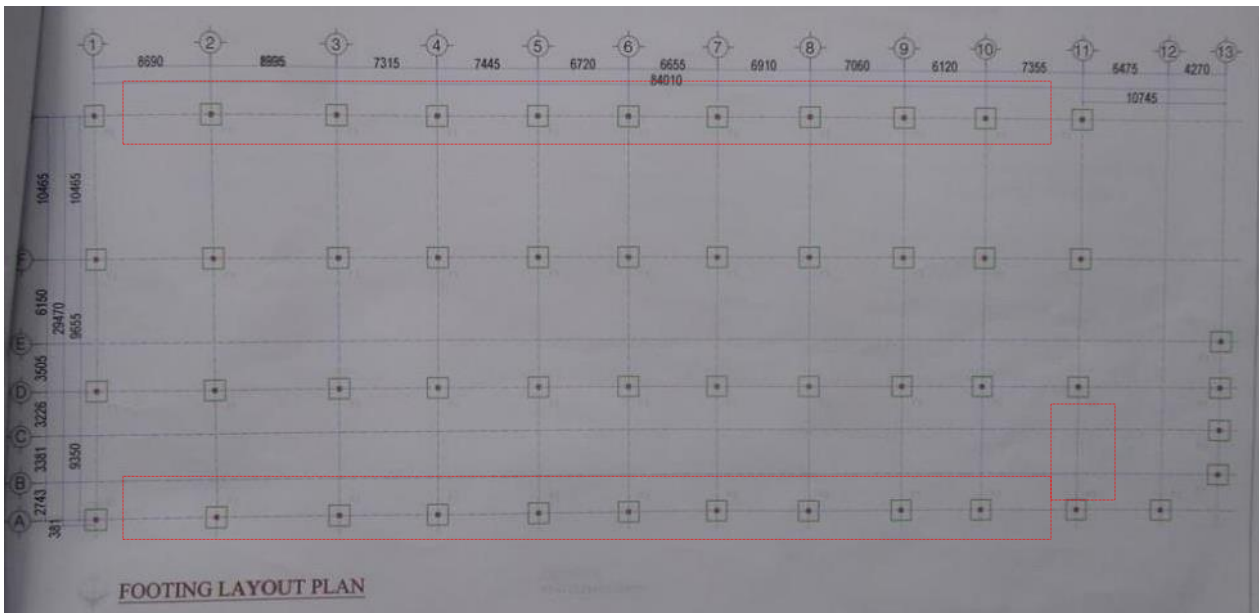
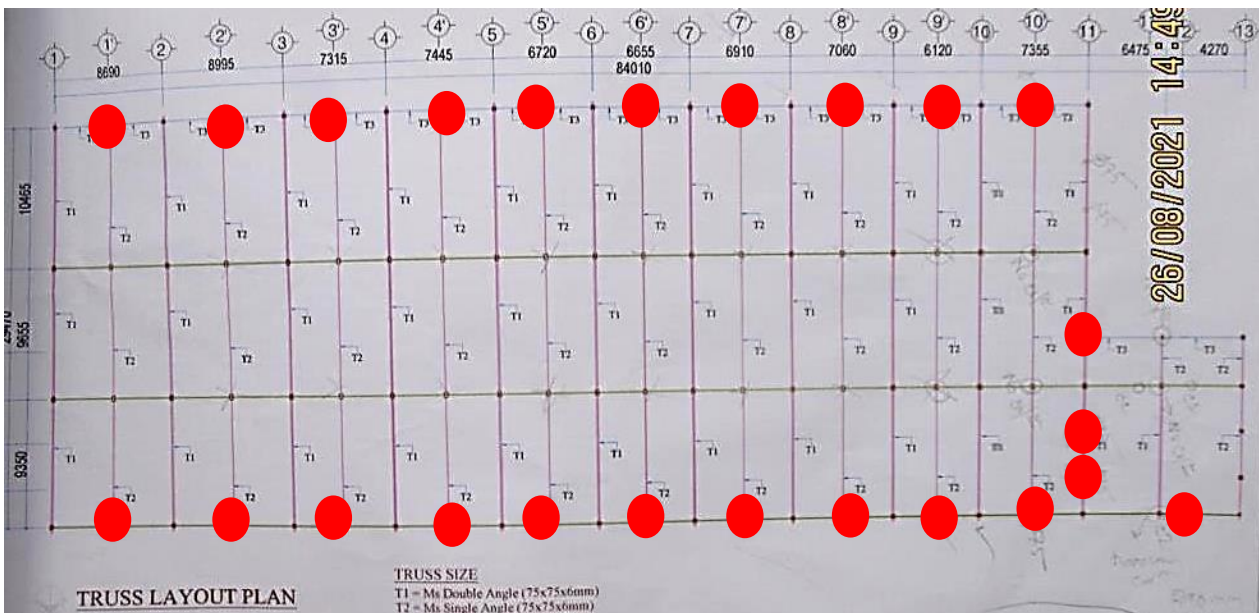
Truss and Footing Layout Plan.

● Pipe column

There are some steel pipe columns marked in the layout. The steel pipe columns along periphery and below the secondary trusses have no foundation details.

The factory engineer to update the as-built drawings and check the adequacy of the pipe columns for gravity and lateral loads, also provide necessary alternatives for the foundation of columns.

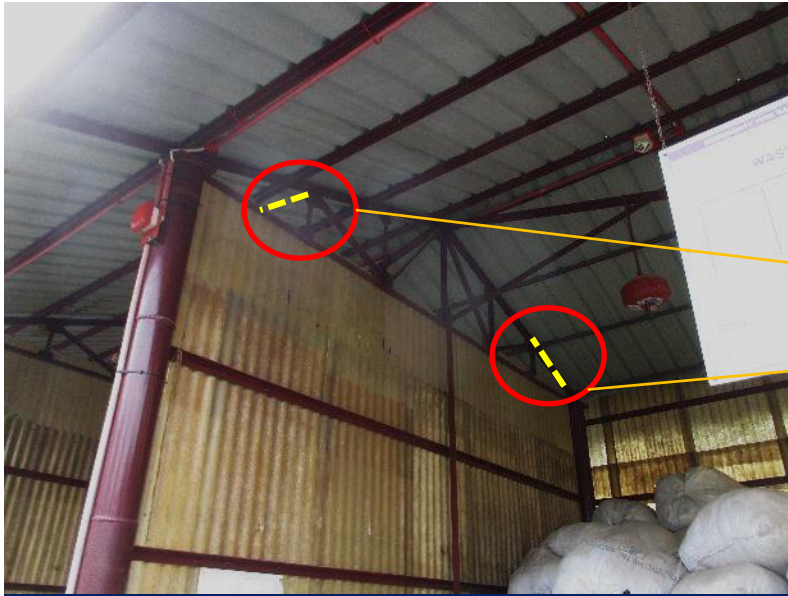
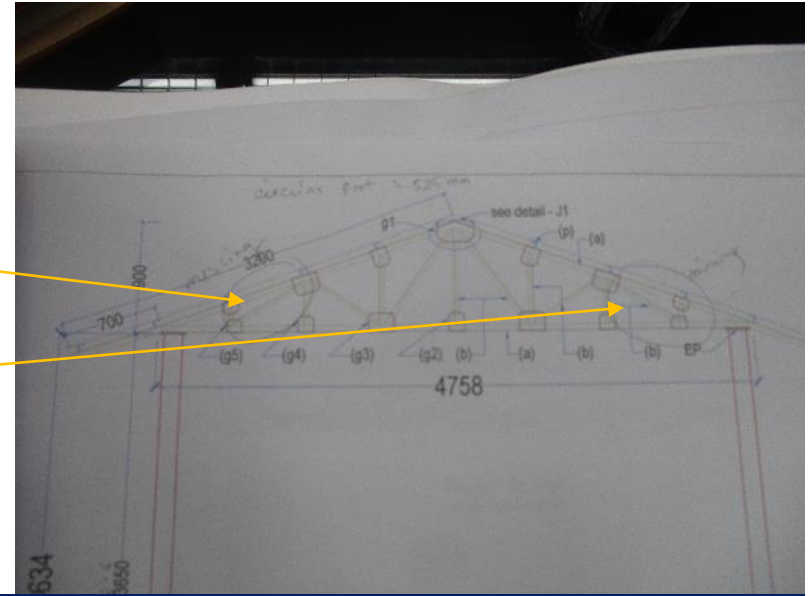
Missing vertical member

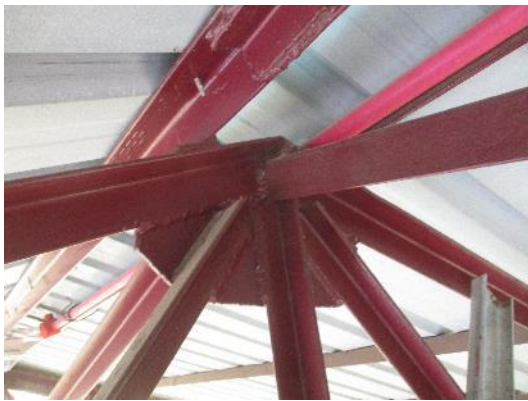
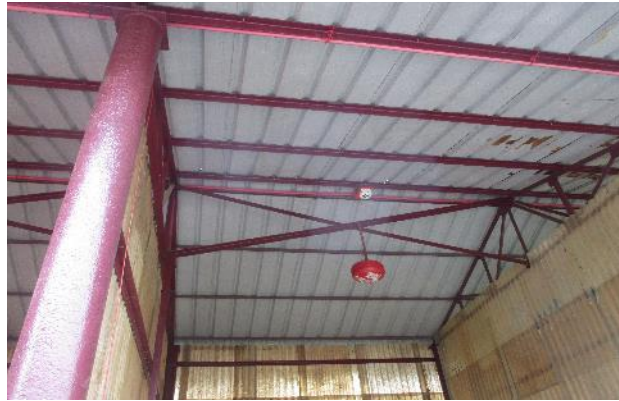
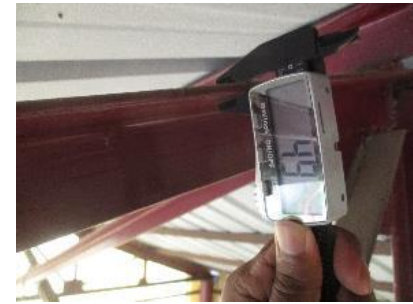
Top & Bottom Chord and bracing thickness 5mm instead 6mm

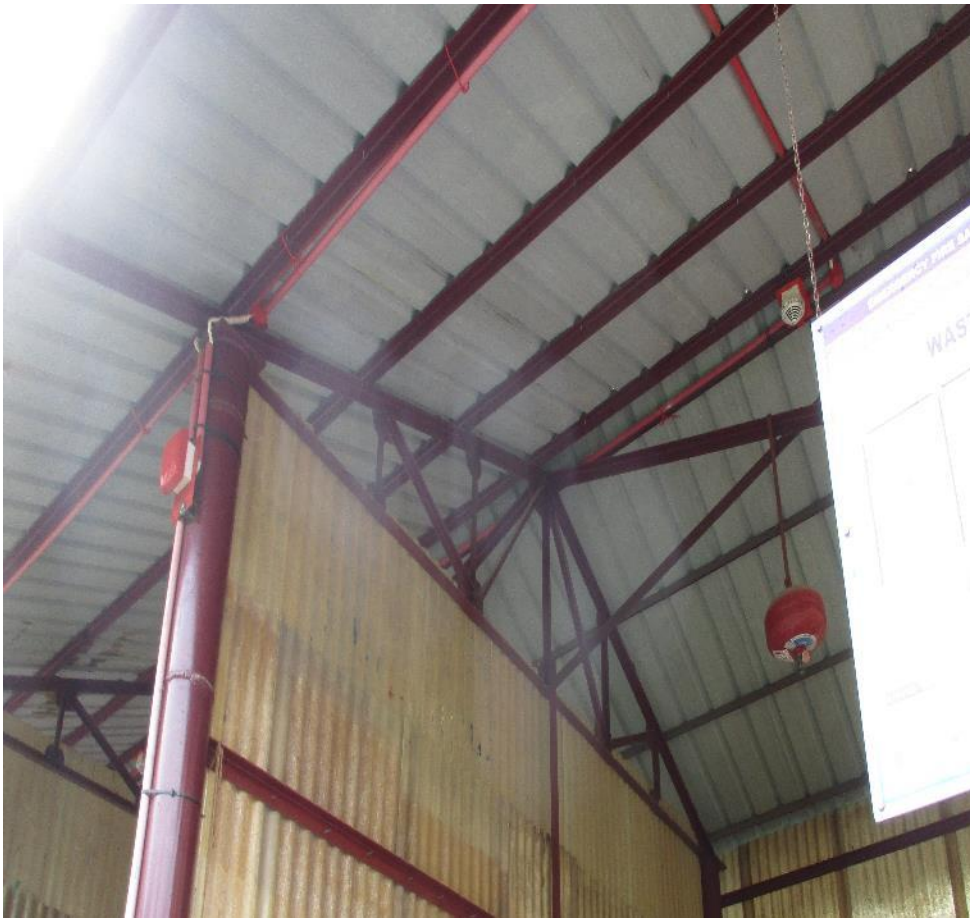
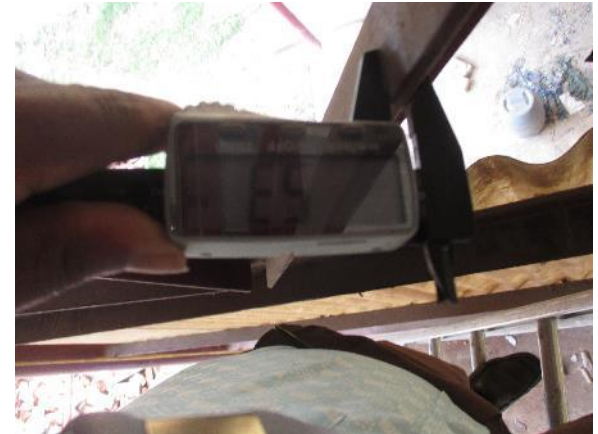
Purlin number found 10 instead 12 and section 38X38X5 instead 50x50x6

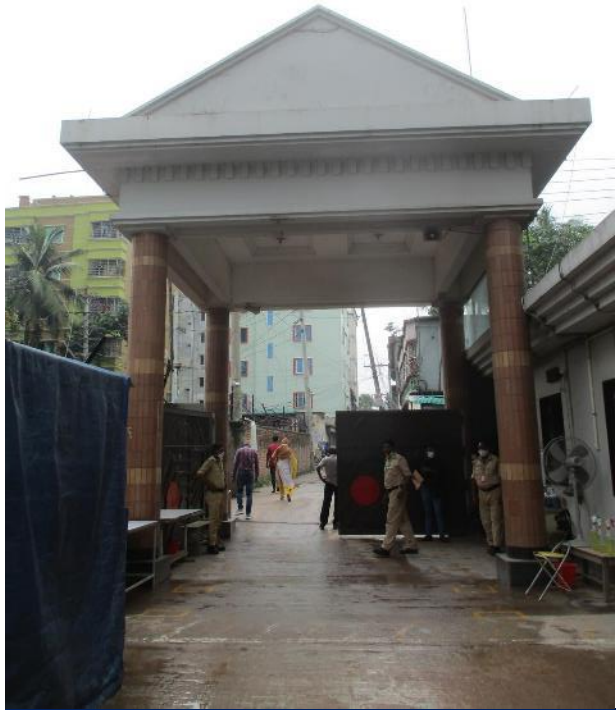
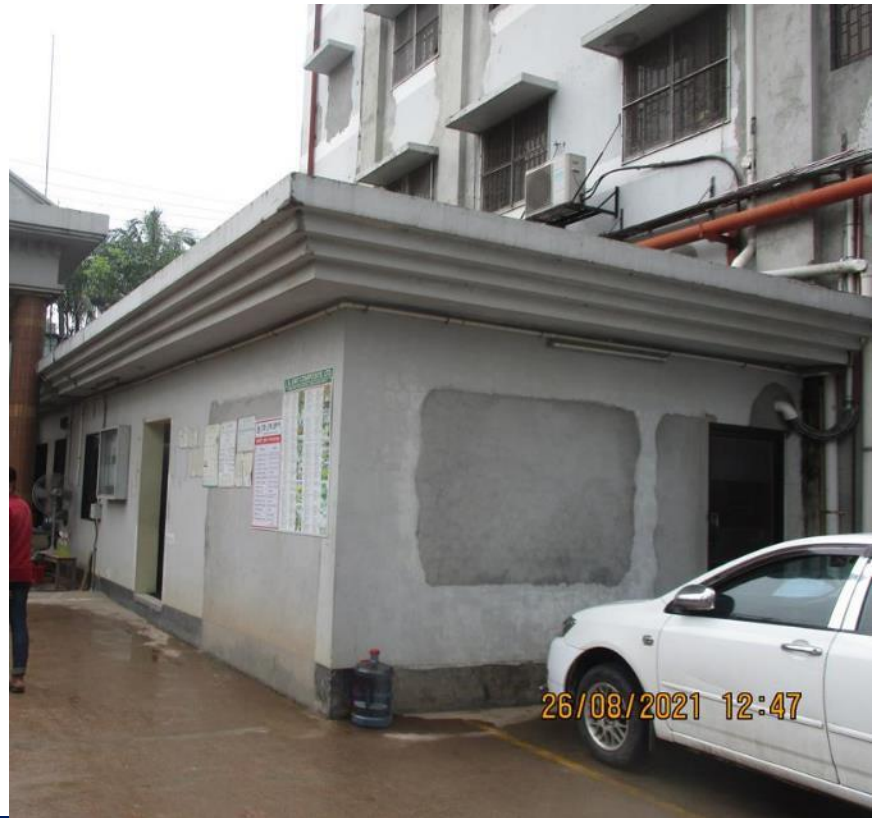
No drawing was available for Security Post and Gate .

Factory engineer to survey the structure and develop a set of as-built drawings for those structure.
