# Fatullah Apparels

B-68/1 Wapda Road (Samad Member Dyeing Road), Jalkuri, Narayanganj.

31<sup>st</sup> May & 25<sup>th</sup> August 2021

# Building Information

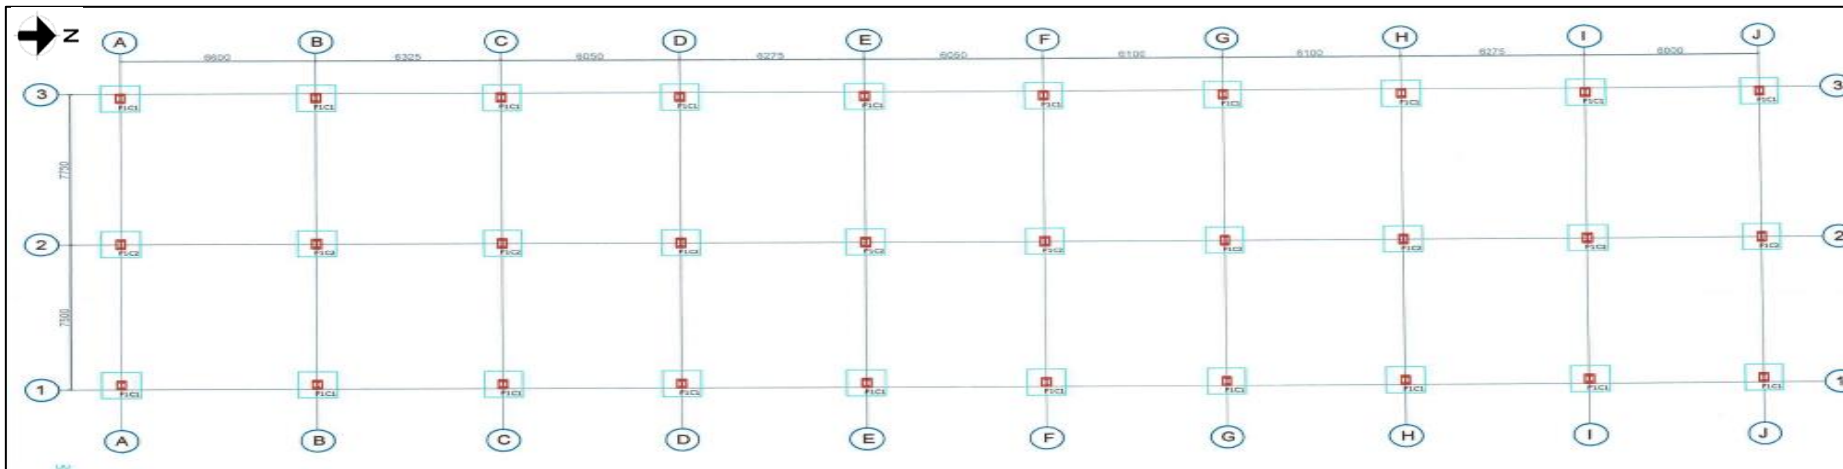
Foundation layout

**Stress in foundation exceeds normal design limit**

Cursory calculation indicates that the stress in some foundations exceeds normal design limit. Considering 2 kPa live load on typical floor & 1 kPa live load on roof top. The footings were found stressed in excess of normal design limit against the soil bearing capacity available from Geotechnical investigation report. Building engineer is required to carryout foundation adequacy check to justify the load carrying capacity.

| Item No. | Observation | Recommended Action Plan | Recommended Timeline |
|---|---|---|---|
| 01 | Stress in foundation exceeds normal design limit (Building-1) | Factory Engineer to review design, loads and foundation stresses. | 6-weeks |
| 02 | Stress in foundation exceeds normal design limit (Building-1) | Produce and actively manage a loading plan for all floor plates within the factory giving consideration to floor capacity and column capacity. | 6-weeks |
| 03 | Stress in foundation exceeds normal design limit (Building-1) | Implement any remediation work if required. | 6-months |

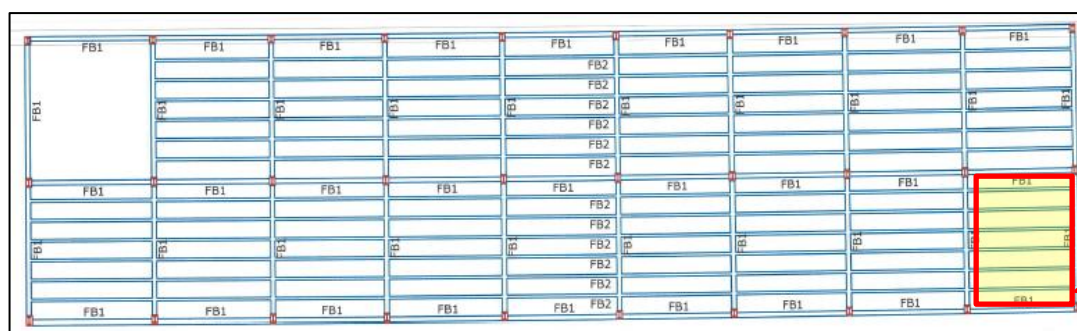
At site, no sub-beam & deck slab was found

At the marked location

The factory engineer is required to survey the structures and prepare as-built drawings complying with section 1.9.1.2 of BNBC.

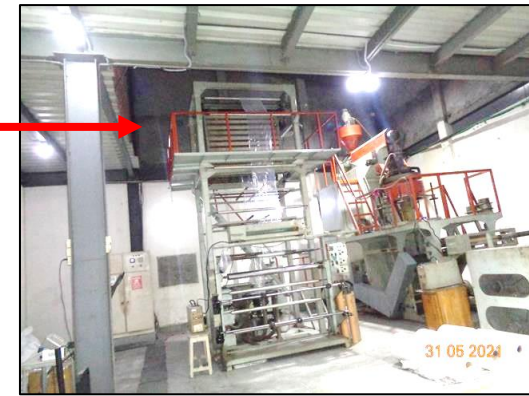
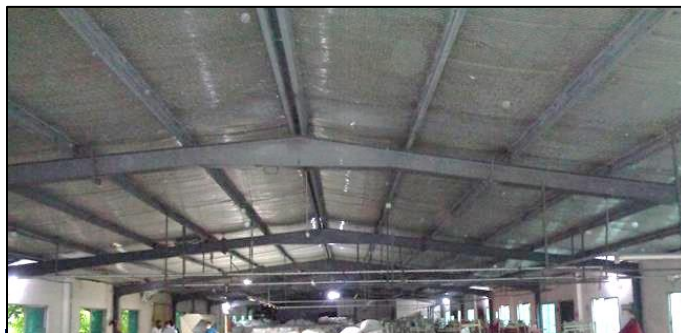
Details of the Rafter & purlin has not been provided

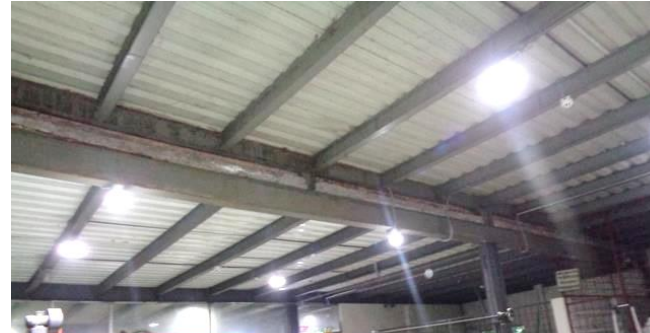
Thickness of the deck slab has not been provided.

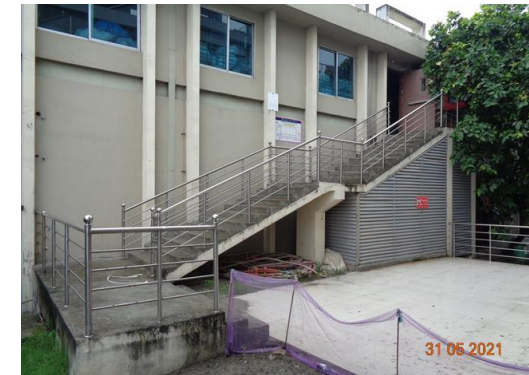
Drawing of RC stair was not available

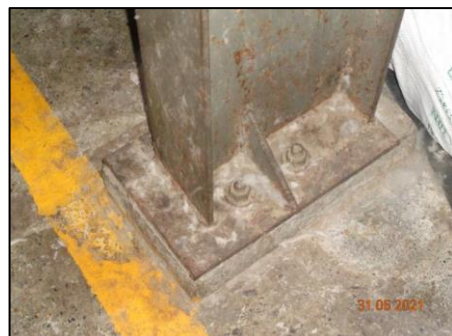
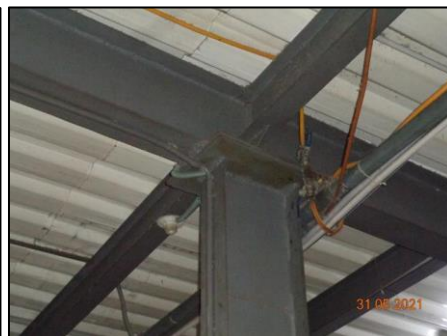
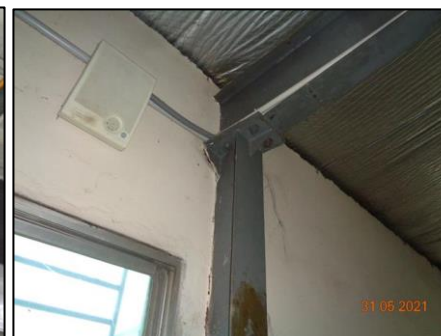
Connection Details are not available in as-built drawing

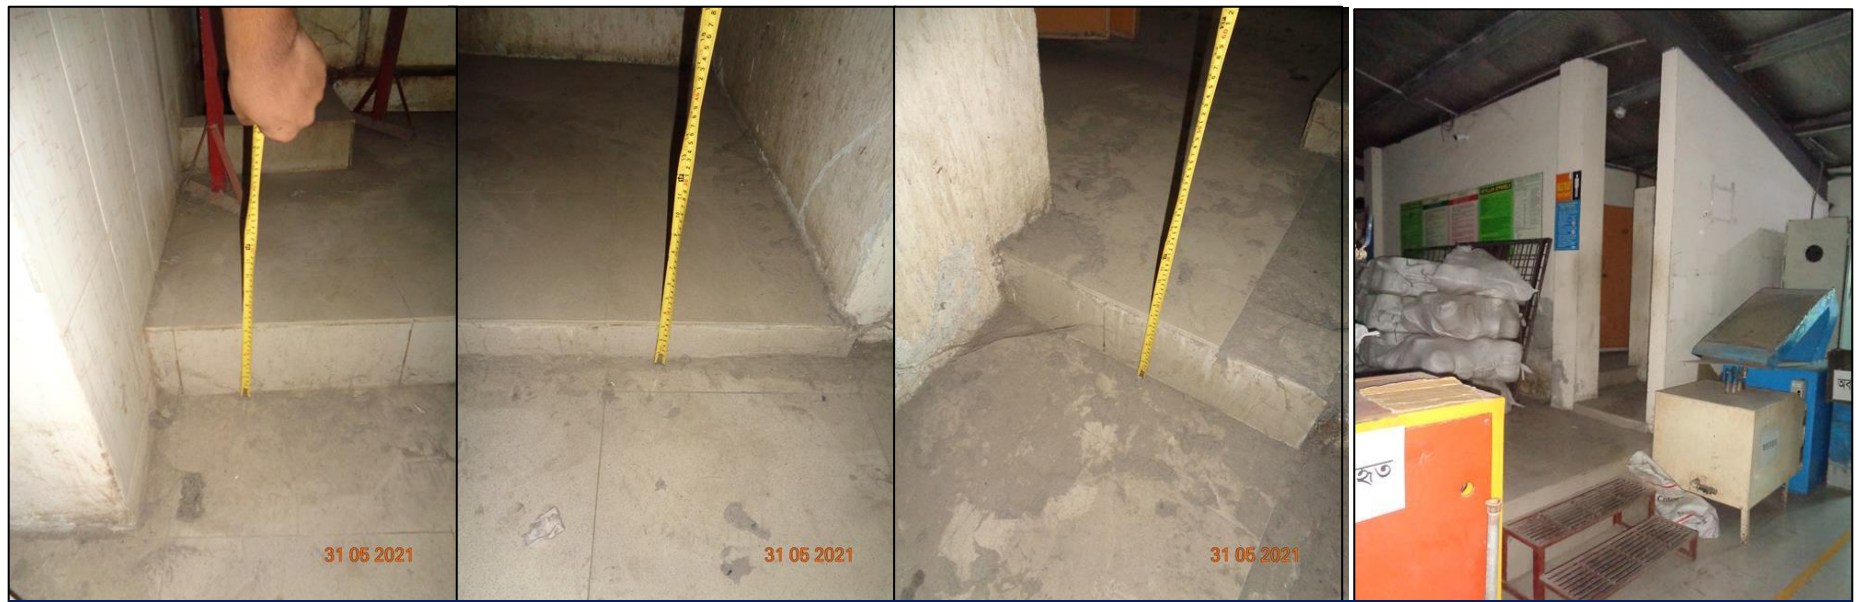
Build-up found at toile block area.

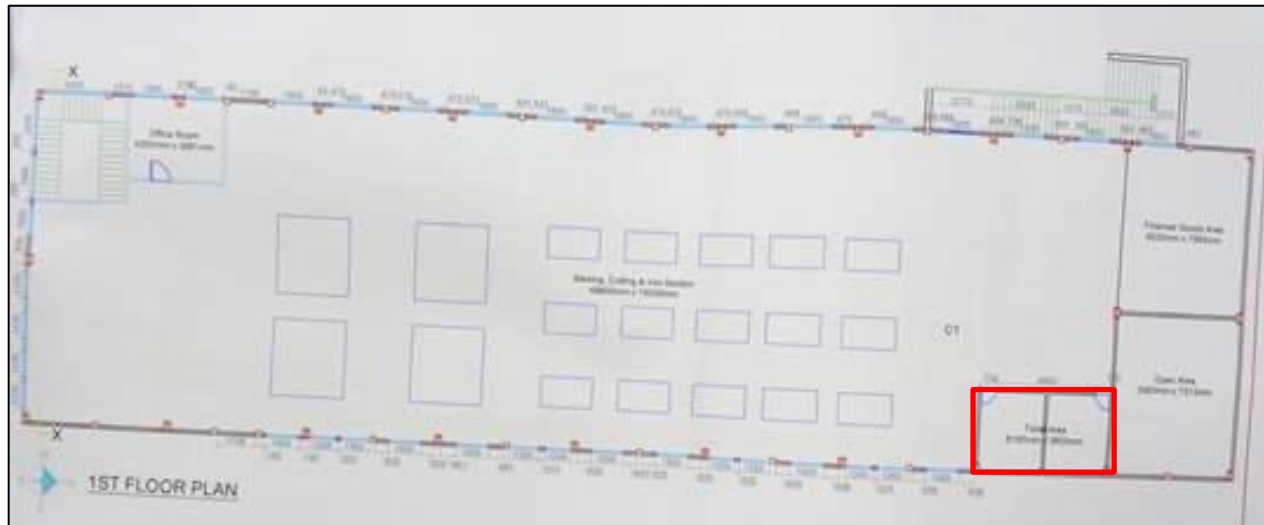
Toilet build-up information has not been provided

Toilet build-up was found at 1<sup>st</sup> floor which has not been shown in drawing. The build-up was found 100mm to 250mm. Also, the arrangement of toilet zone wall & number of toilet do not match with as-built drawing.

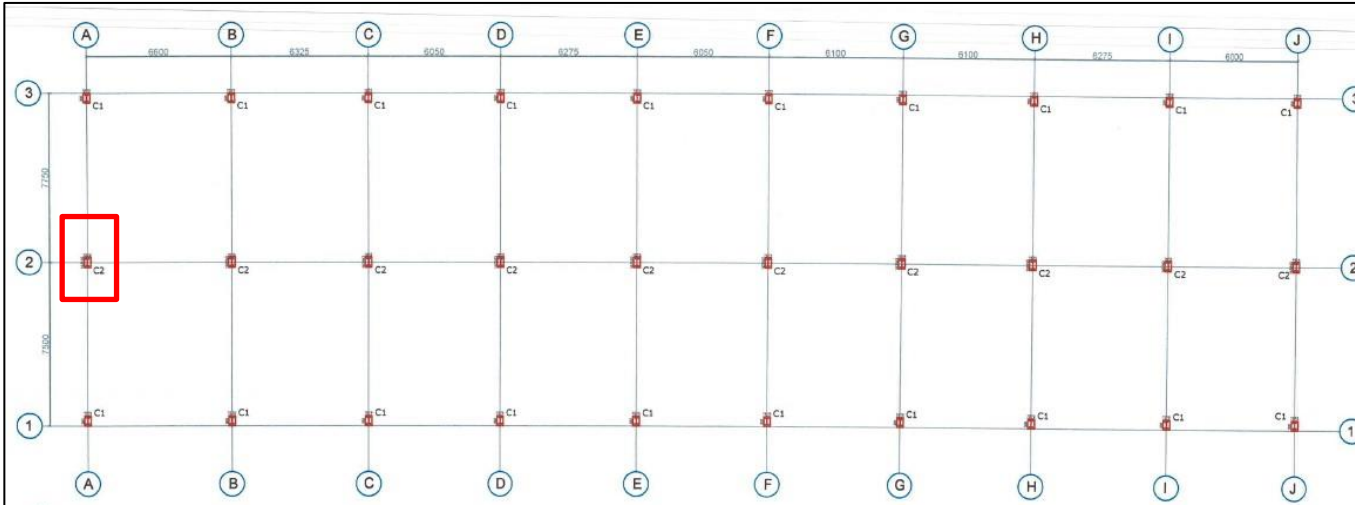
The steel column (C2) at marked grid at 1<sup>st</sup> floor was found W:300XF:150(6) instead of W:325XF:150(10)

In Steel column schedule;  
C2 column has been  
shown  
W:325(8)XF:150(10)

The factory engineer is required to survey the structures and prepare as-built drawings complying with section 1.9.1.2 of BNBC.

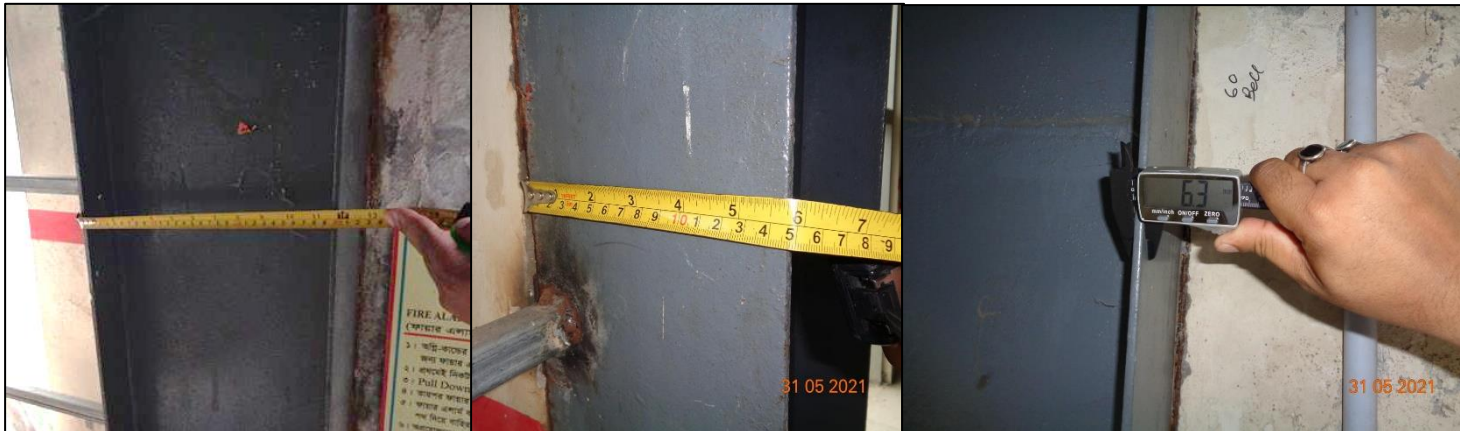
At site the web was measured 300mm, Flange 150mm & flange thickness 6mm

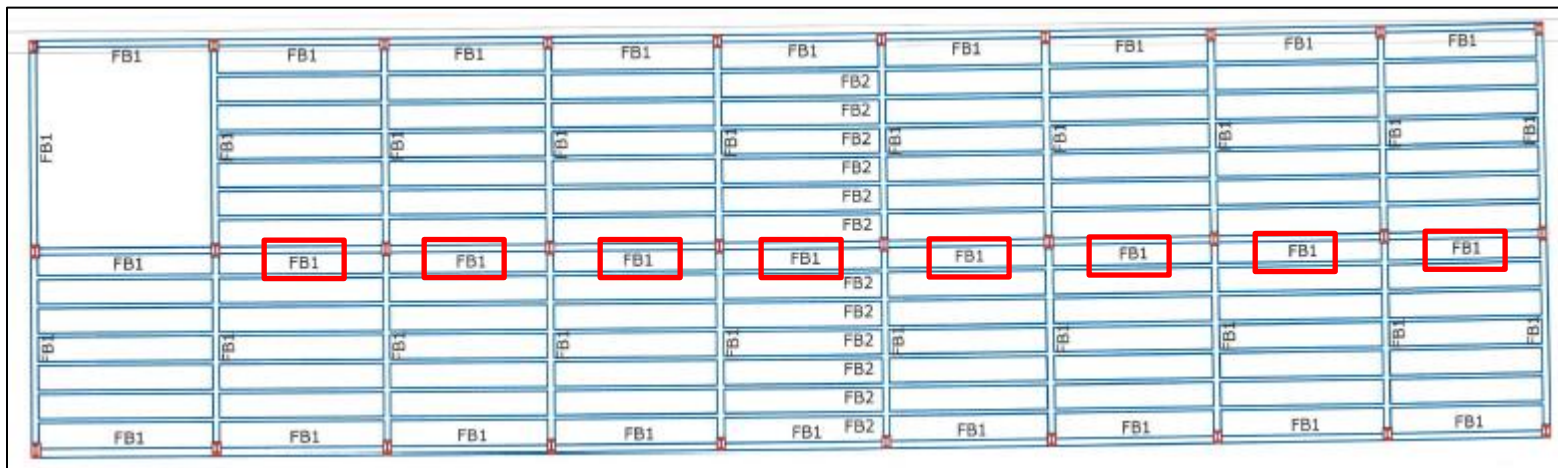
The size of steel beam FB1 at marked locations was found W:180XF:100(6) instead of W:325XF:150(10)

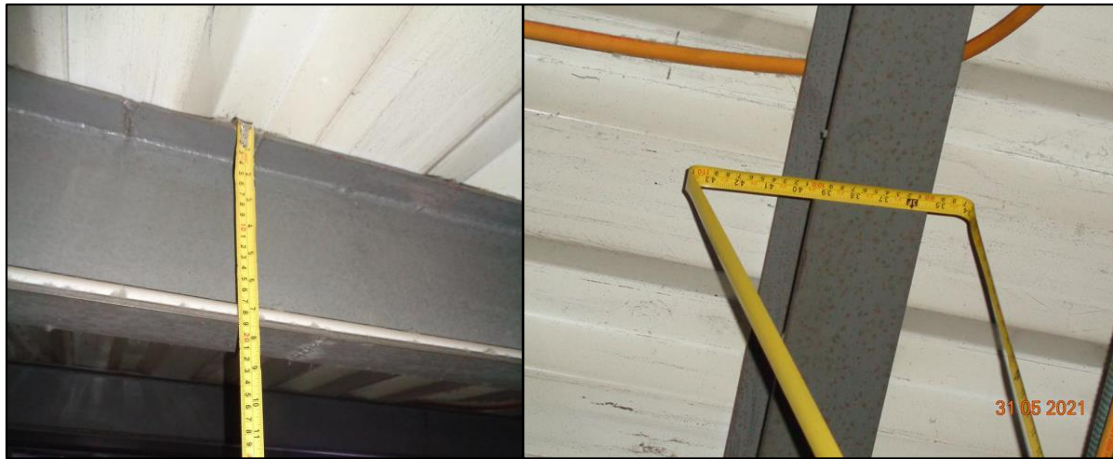
At site the web was measured 180 mm and Flange 100mm

In Steel Beam schedule; FB1 beam has been shown W:325(8)XF:150(10)

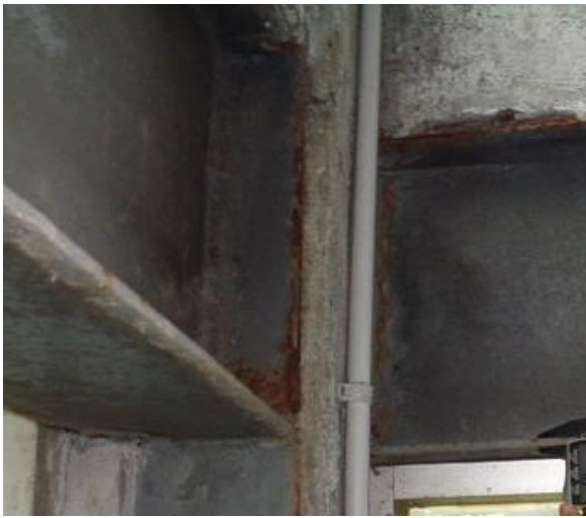
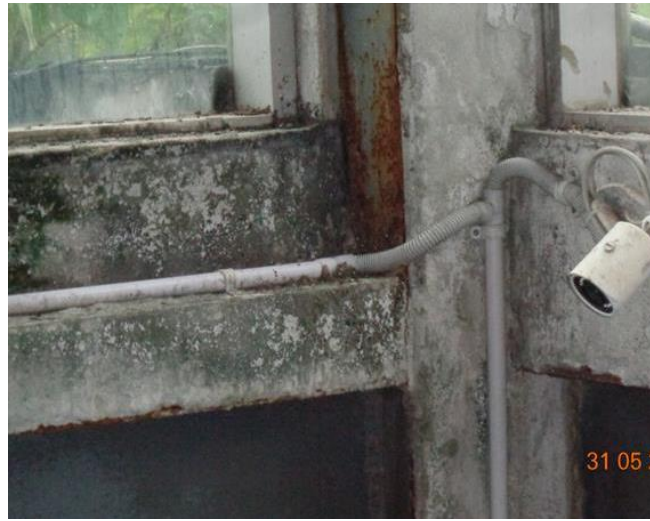
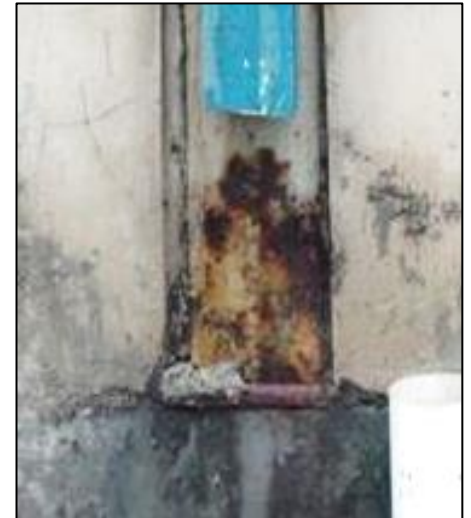
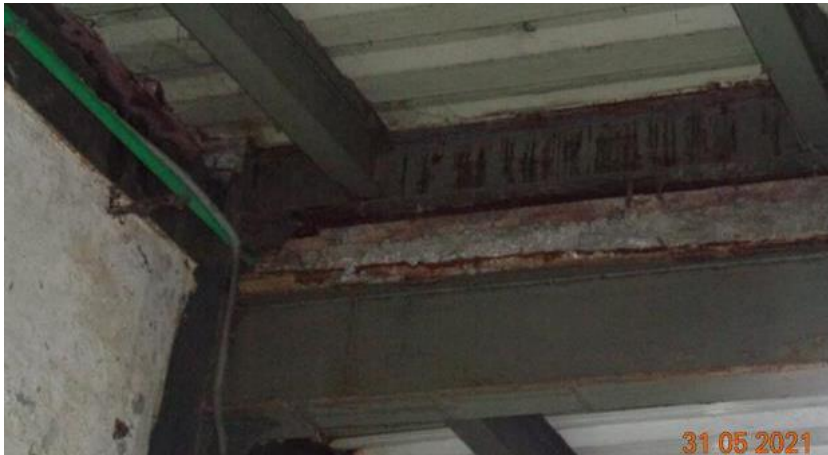
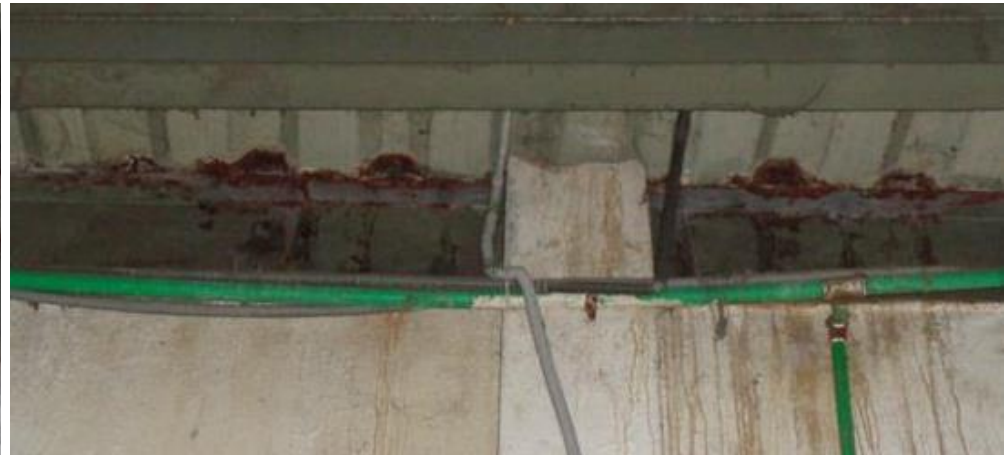
Corrosion in steel column

Corrosion in steel member was observed in various locations. The building engineer to investigate the reason of corrosion and suggest proper remedial measure accordingly.

| Item No. | Observation | Recommended Action Plan | Recommended Timeline |
|---|---|---|---|
| 05 | Corrosion in steel member (Building-1) | The building engineer to investigate the reason & extent of corrosion and suggest proper remedial measure accordingly. | 6-weeks |
| 06 | Corrosion in steel member (Building-1) | Take necessary measures to prevent further corrosion and repair the corroded steel members as per engineer's suggestion. | 6-months |

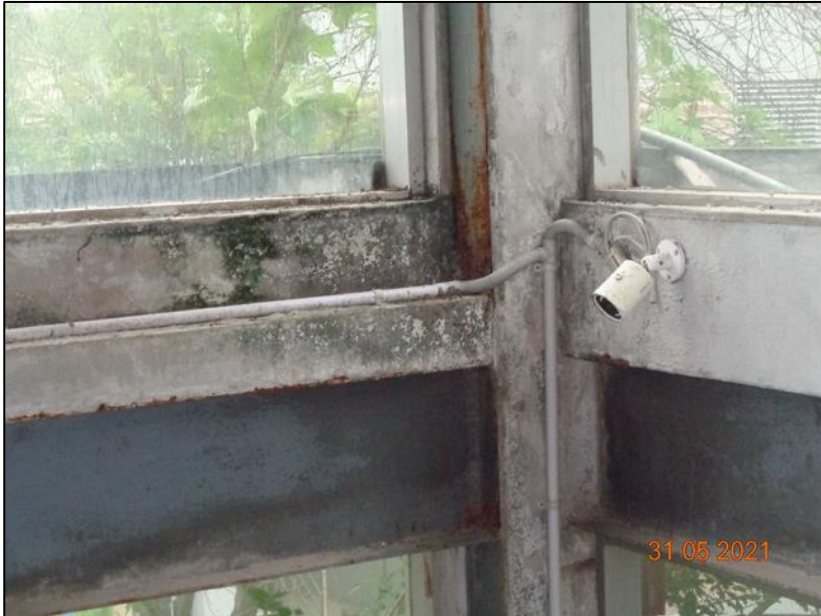
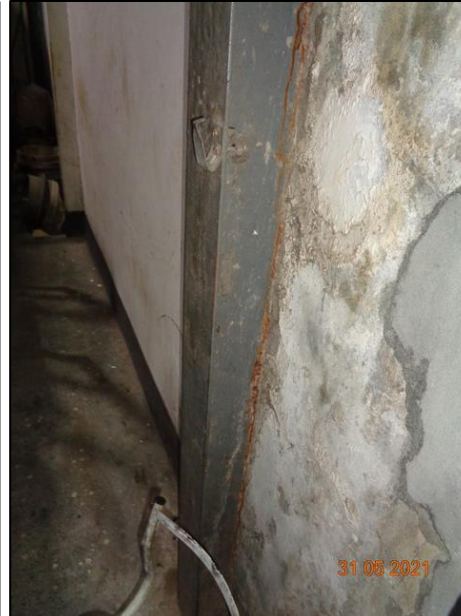
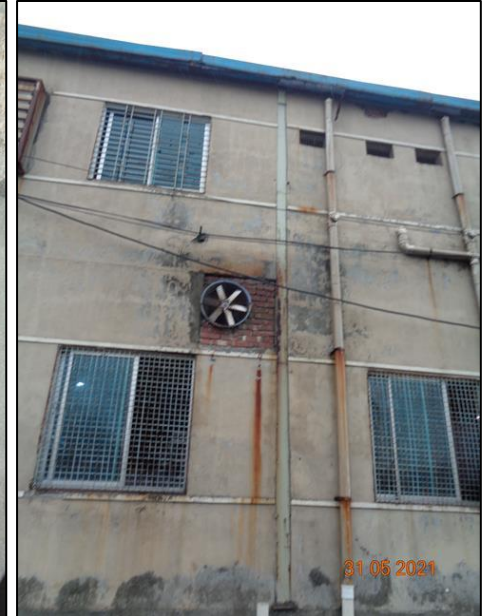
Dampness found in brick wall.

Dampness found in several locations of the structure. Building engineer is required to take necessary measures to prevent source of dampness.

| Item No. | Observation | Recommended Action Plan | Recommended Timeline |
|---|---|---|---|
| 07 | Water dampness in brick wall (Building-1) | Factory management is required to take necessary measures to proof the leakage in water supply line. | 6-weeks |
| 08 | Water dampness in brick wall (Building-1) | Factory engineer is required to investigate the damp beam & column to verify if any damaged occurred due to the presence of the moisture. | 6-weeks |
| 09 | Water dampness in brick wall (Building-1) | Improve the roof drainage system. | 6-months |

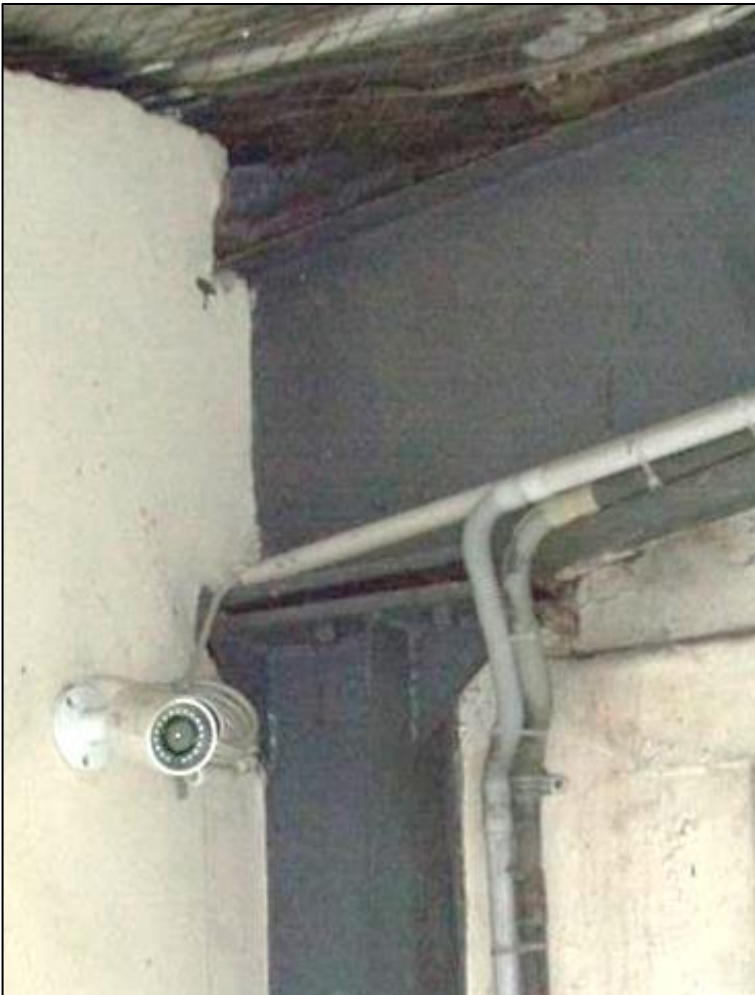
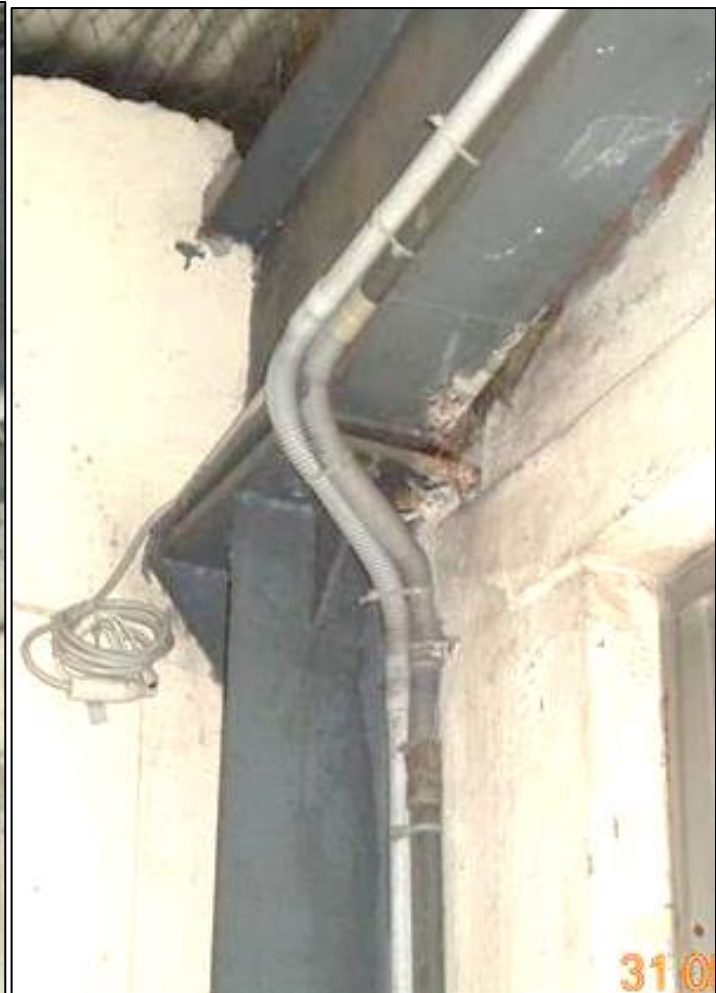
Gap observed in Rafter- Column connection

Significant gaps observed at column-rafter joint at several location. Factory engineer is required to carry out suitable remedial works.

| Item No. | Observation | Recommended Action Plan | Recommended Timeline |
|---|---|---|---|
| 10 | Connection gap at several location (Building-1). | Identify the locations and carryout suitable repair works where necessary. | 6-weeks |

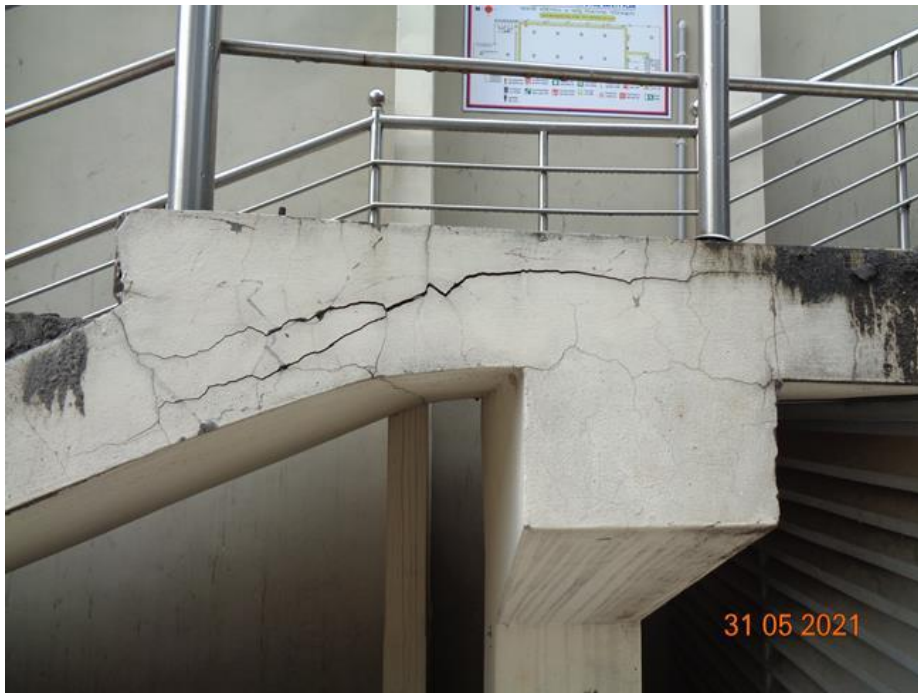
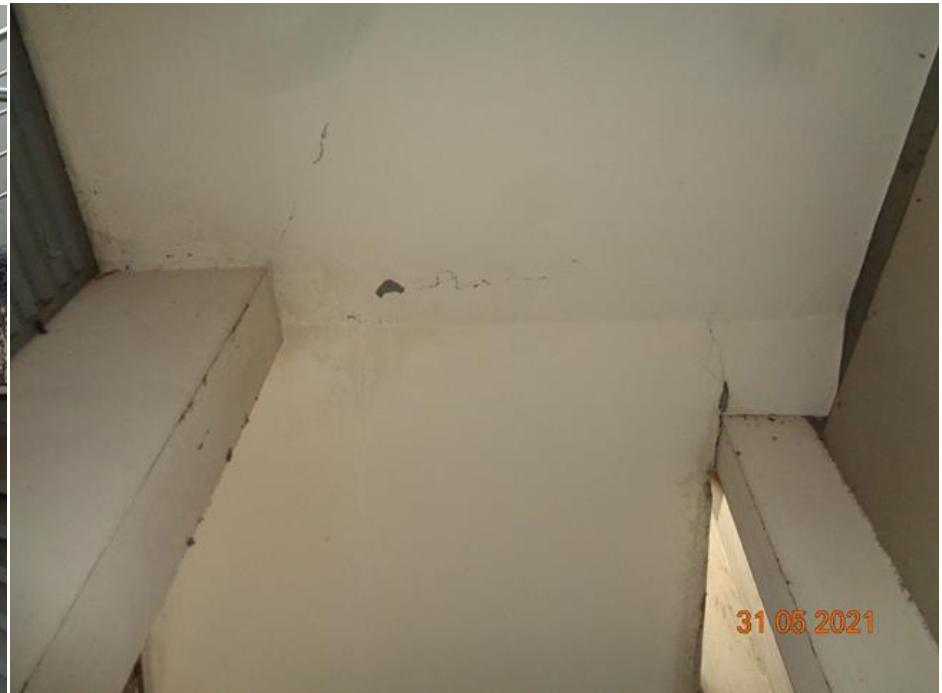
Crack found in external RC stair

Crack was found in several locations of RC stair. Factory engineer is required to investigate the cause of crack and repair the crack as per recommendation from investigation report.

| Item No. | Observation | Recommended Action Plan | Recommended Timeline |
|---|---|---|---|
| 11 | Cracks found in external RC stair (Building-1) | Factory engineer is required to investigate the cause of crack and repair the crack as per recommendation from investigation report. | 6-weeks |

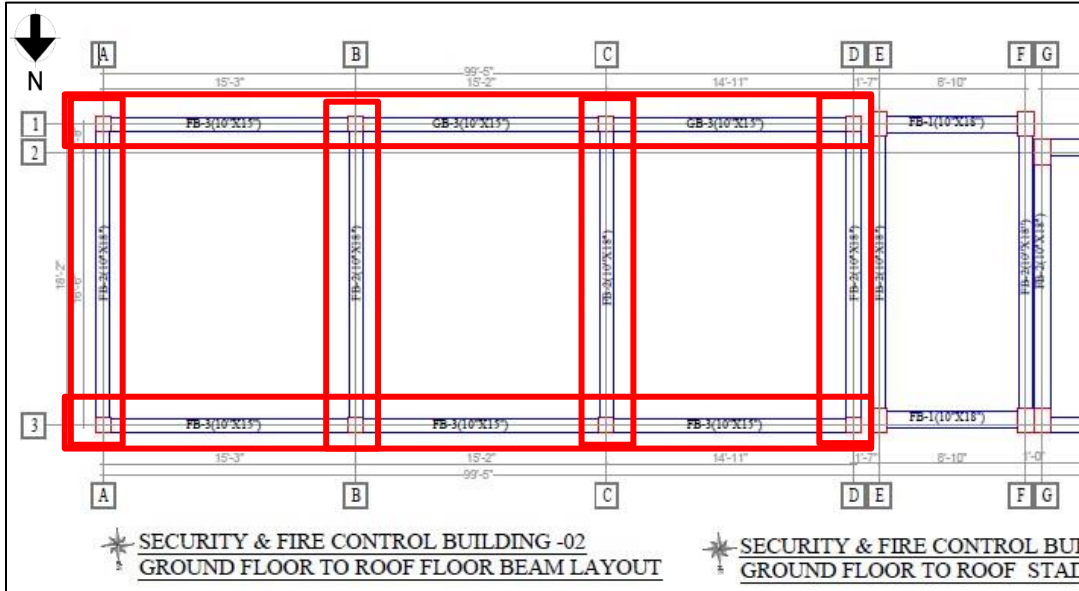
Beam Layout has been shown in drawing

In as built drawing floor beam has been shown. But actual site condition, the building was found flat slab. Factory engineer is required to survey the whole structure and update the as-built drawing.

As per BNBC, every building or structure designed shall have its design documents prepared in accordance with the provision of Section 1.9.1. The design document shall include a design report, and a set of structural drawings, which shall be prepared in compliance with section 1.9.1.1 and section 1.9.1.2 as per BNBC. Factory engineer is required to update the drawing and prepare a design report following BNBC requirements.

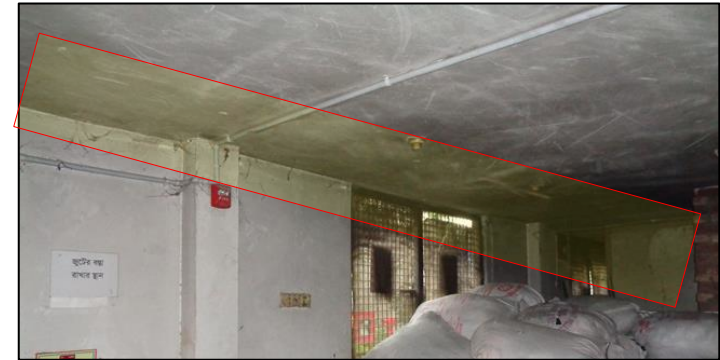
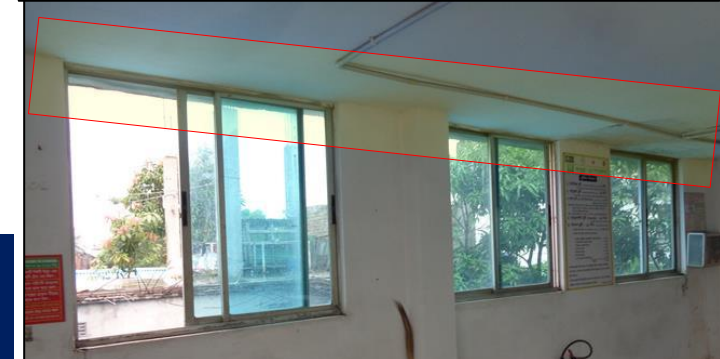
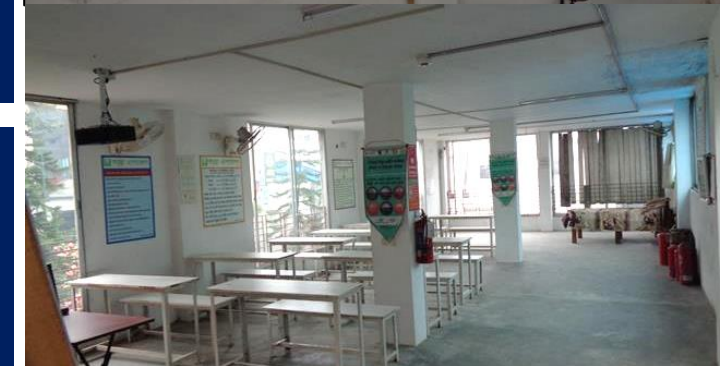
At site, no beam was found

| Item No. | Observation | Recommended Action Plan | Recommended Timeline |
|---|---|---|---|
| 12 | Discrepancy in as-built drawing. (Building -2 ) | Building Engineer to survey the structure and prepare accurate as-built (architectural and structural) drawings. | 6-weeks |

| Item No. | Observation | Recommended Action Plan | Recommended Timeline |
|---|---|---|---|
| 13 | Discrepancy in as-built drawing. (Building -2 ) | Building engineer to update the design document including a design report, and a set of structural drawings in compliance with section 1.9.1.1 and section 1.9.1.2 as per BNBC. | 6-weeks |

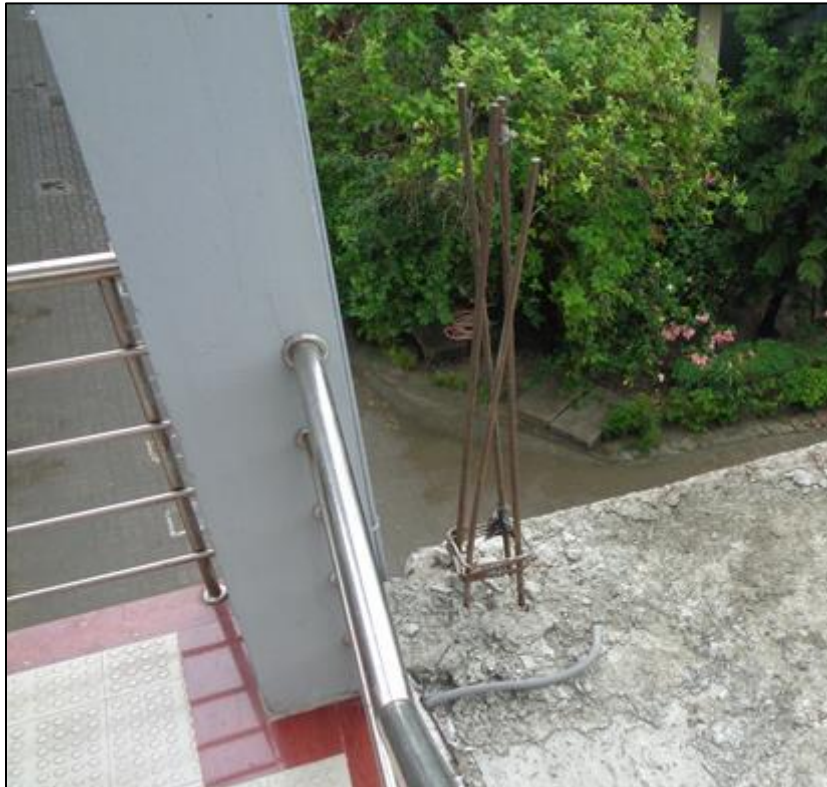
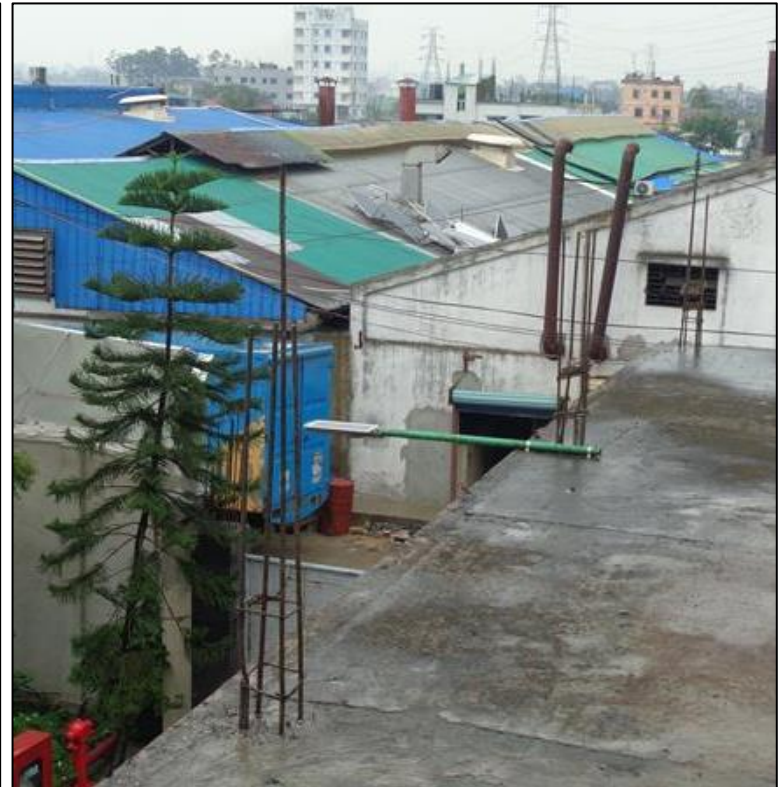
Exposed rebar of Column

Exposed reinforcement was found on roof top columns. Factory engineer is required to take necessary measures to prevent the corrosion in exposed rebar.

| Item No. | Observation | Recommended Action Plan | Recommended Timeline |
|---|---|---|---|
| 14 | Exposed re-bar at roof (Building-2) | All exposed reinforcement is to be protected from corrosion which may cause degradation of the concrete. | 6-weeks |

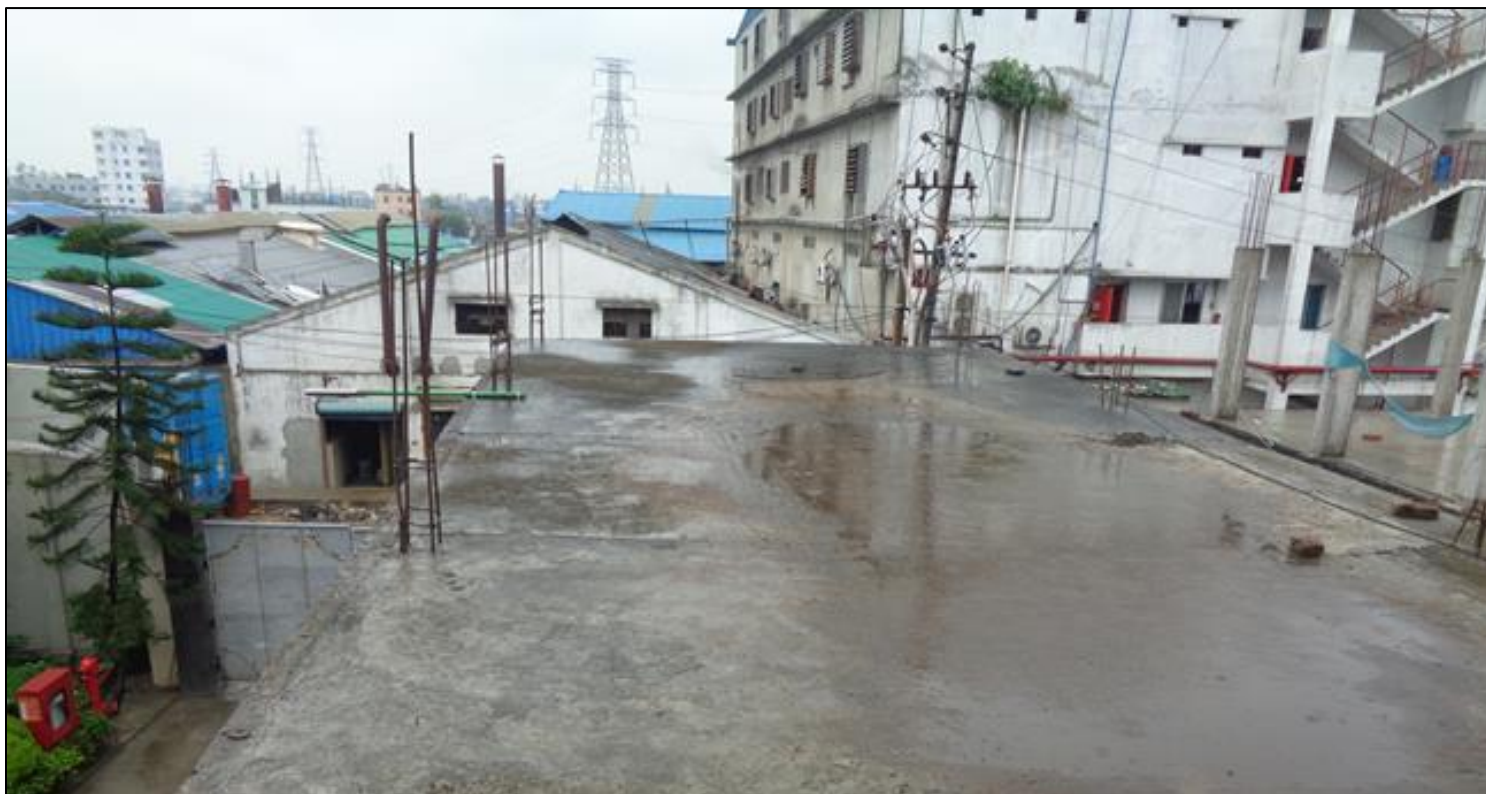
Water ponding at roof

Water ponding was found at roof area. The water drainage system and adequate sloping was not found. The factory engineer is required to develop proper drainage system with adequate sloping on the mentioned area.

| Item No. | Observation | Recommended Action Plan | Recommended Timeline |
|---|---|---|---|
| 15 | Water ponding at roof (Building-2) | The factory engineer to develop proper drainage system with adequate sloping to resist water ponding on roof. | 6-months |

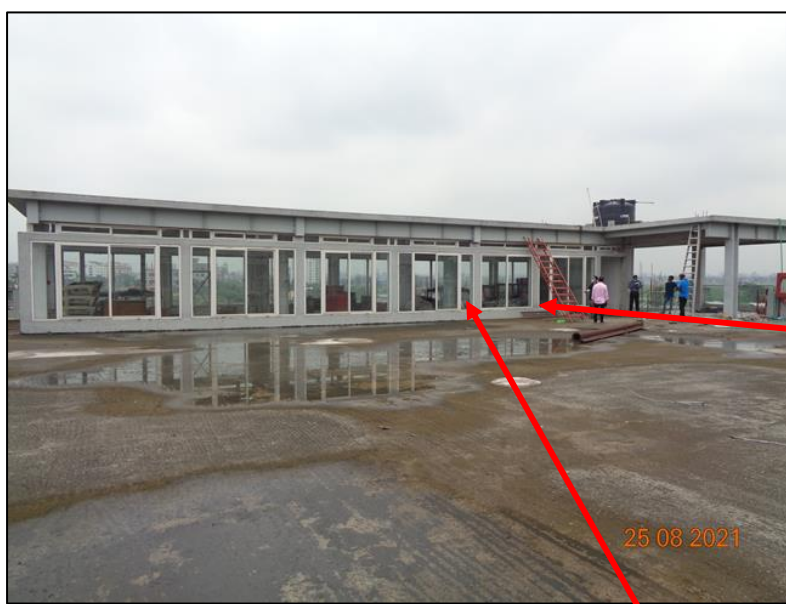
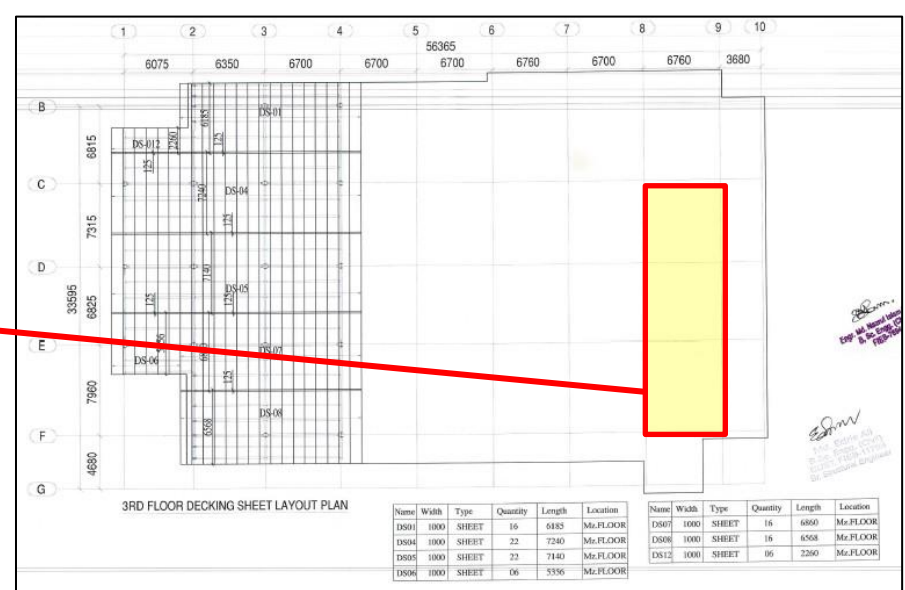
Undocumented partial storey at roof

At roof a partial storey having 3X1 panel (marked location) has been constructed. But in as-built drawing & design report which has not been considered.

As per BNBC, every building or structure designed shall have its design documents prepared in accordance with the provision of Section 1.9.1. The design document shall include a design report, and a set of structural drawings, which shall be prepared in compliance with section 1.9.1.1 and section 1.9.1.2 as per BNBC. Revise the provided design report and load plan based on the observation.

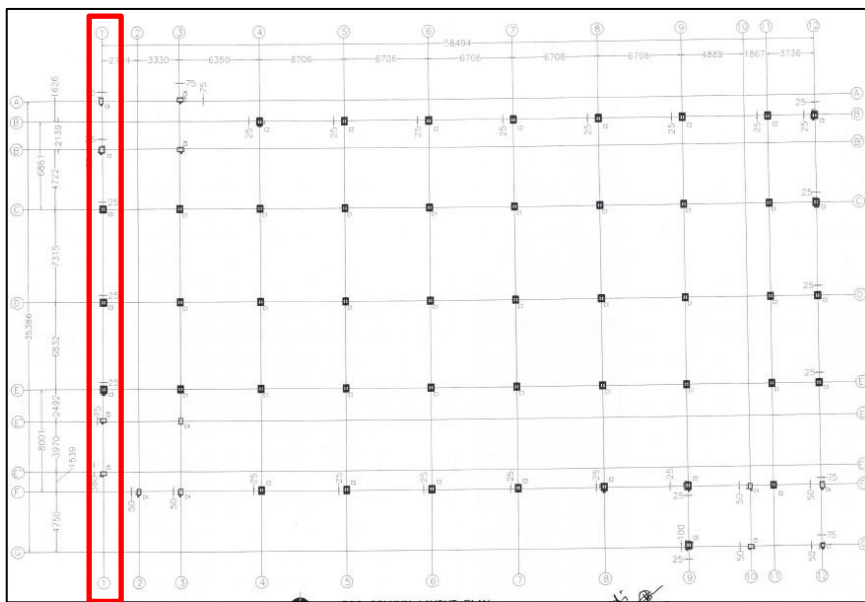
Column Layout Plan. The details of the structural members along the grid-1 has not been provided in as-built drawing.

Factory engineer is required to survey the whole structure and update the as-built drawings.

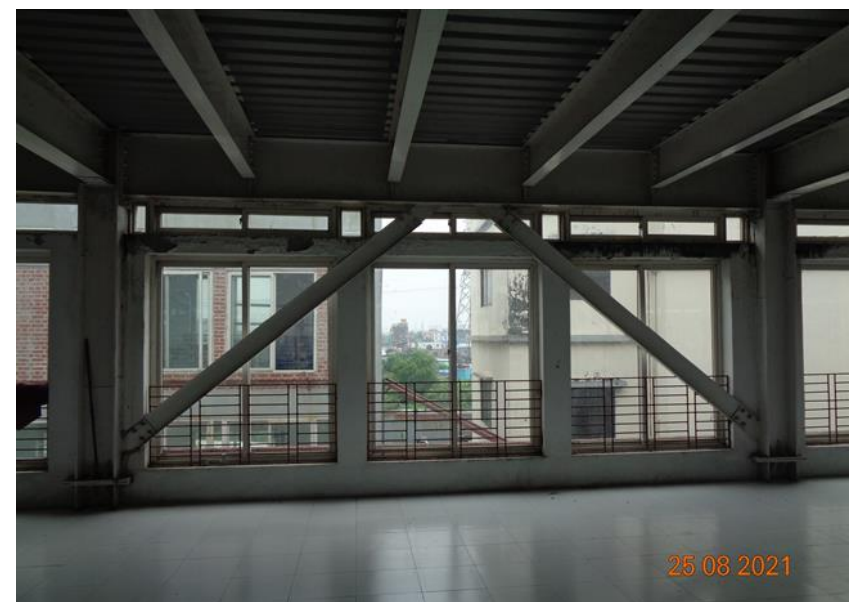
The details of the bracing was not found in as-built structural drawing.

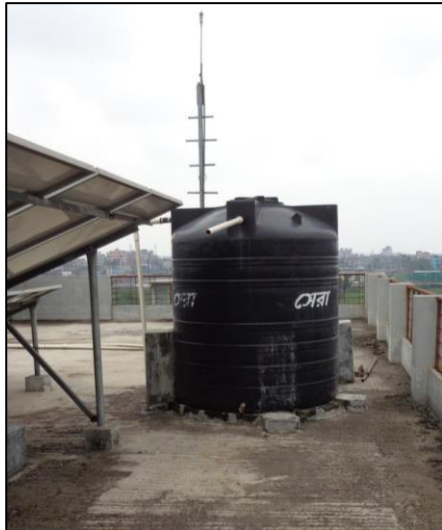
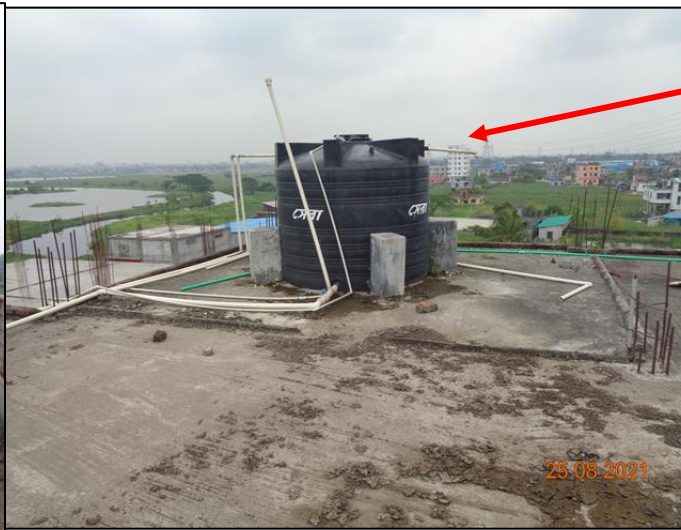
Undocumented water tank was found at roof top.

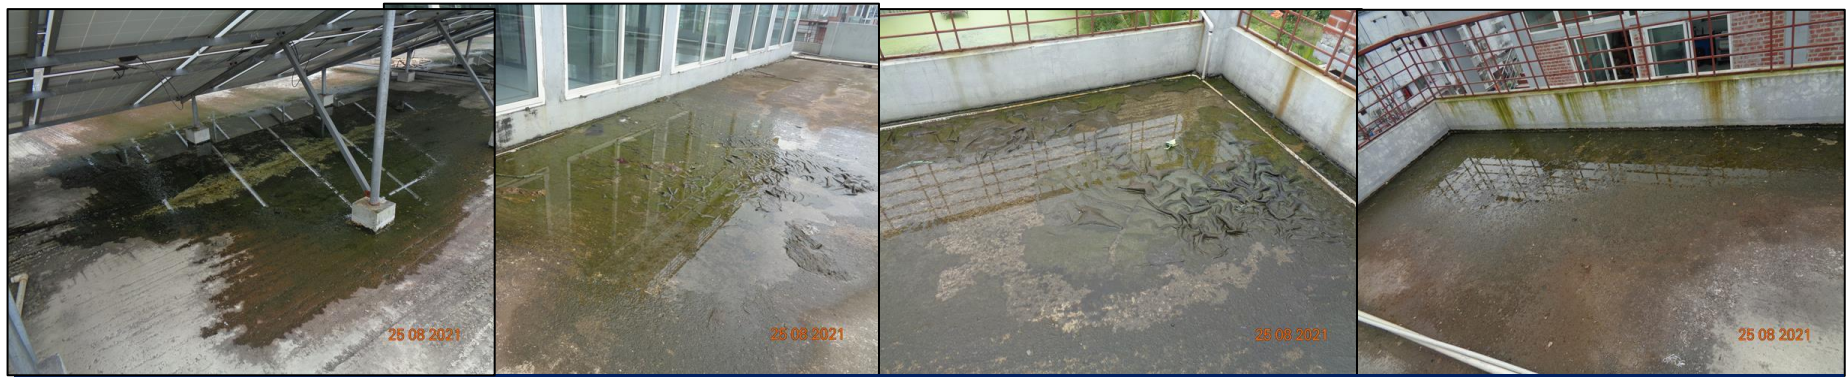
Water ponding at roof due to lack of proper drainage system & inadequate slope

Due to water ponding at rooftop, dampness was found at beam, column and roof top slab. Building engineer is required to take necessary measures to prevent water ponding by providing proper drainage system Also, investigate the extent of corrosion in beams & columns due to the presence of moisture.

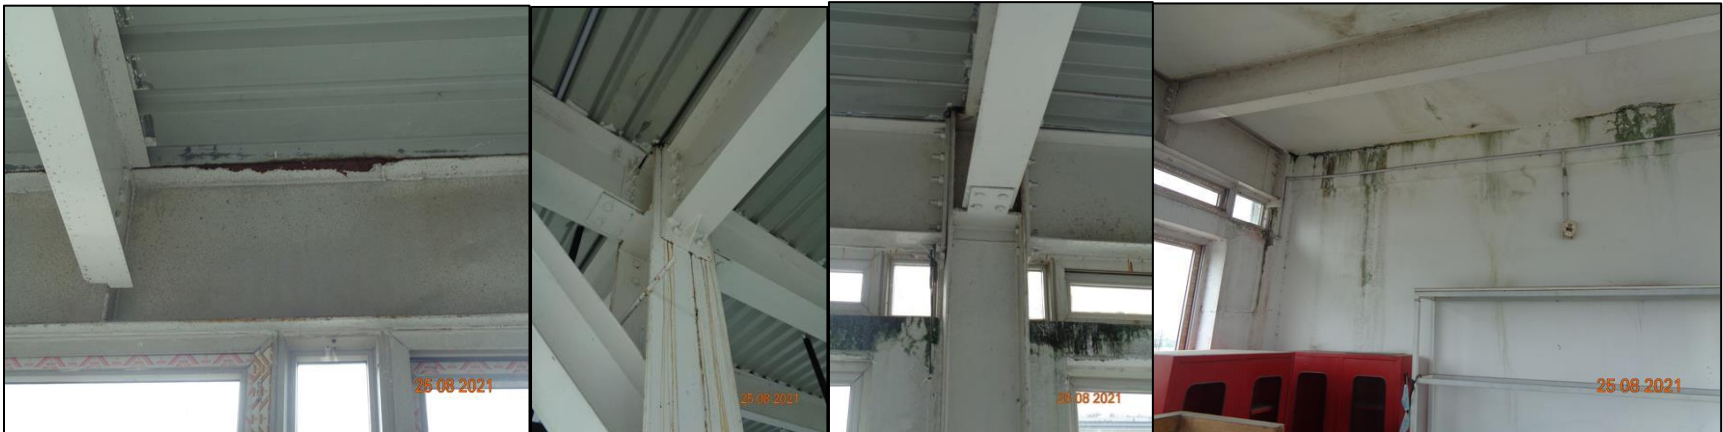
Due to the water ponding at roof, dampness and corrosion found in deck slab & steel sections
