# Fatullah Apparels

B-68/1 Wapda Road (Samad Member Dyeing Road), Jalkuri, Narayanganj.

31<sup>st</sup> May & 25<sup>th</sup> August 2021

# Building Information

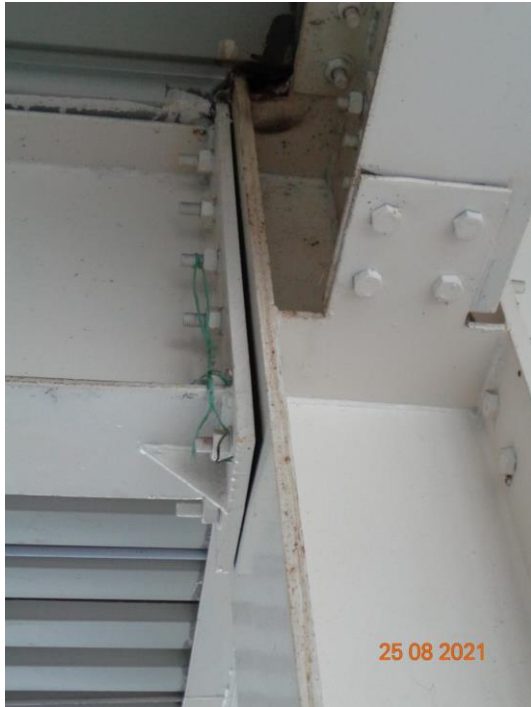
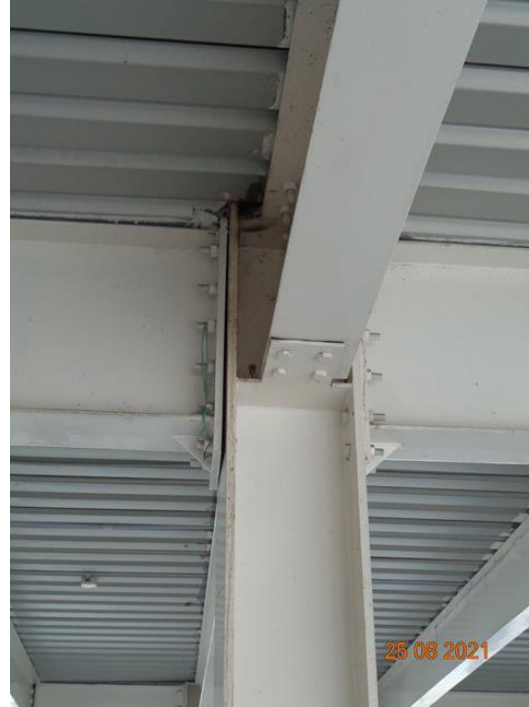
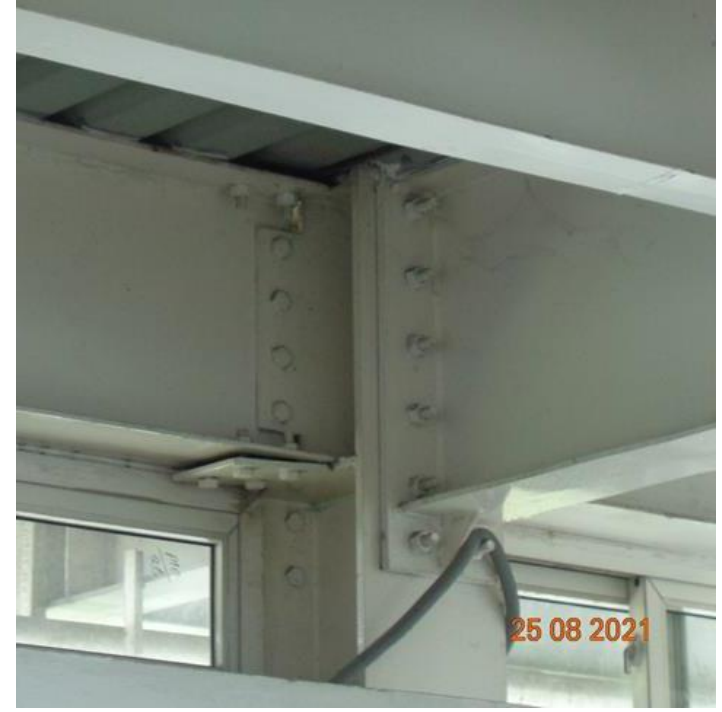
Gap observed in Beam- Column connection

Significant gaps observed at column-rafter & beam joint at several location. Factory engineer is required to carry out suitable remedial works.

| Item No. | Observation | Recommended Action Plan | Recommended Timeline |
|---|---|---|---|
| 23 | Connection gap at several location (Building-3). | Identify the locations and carryout suitable repair works where necessary. | 6-weeks |

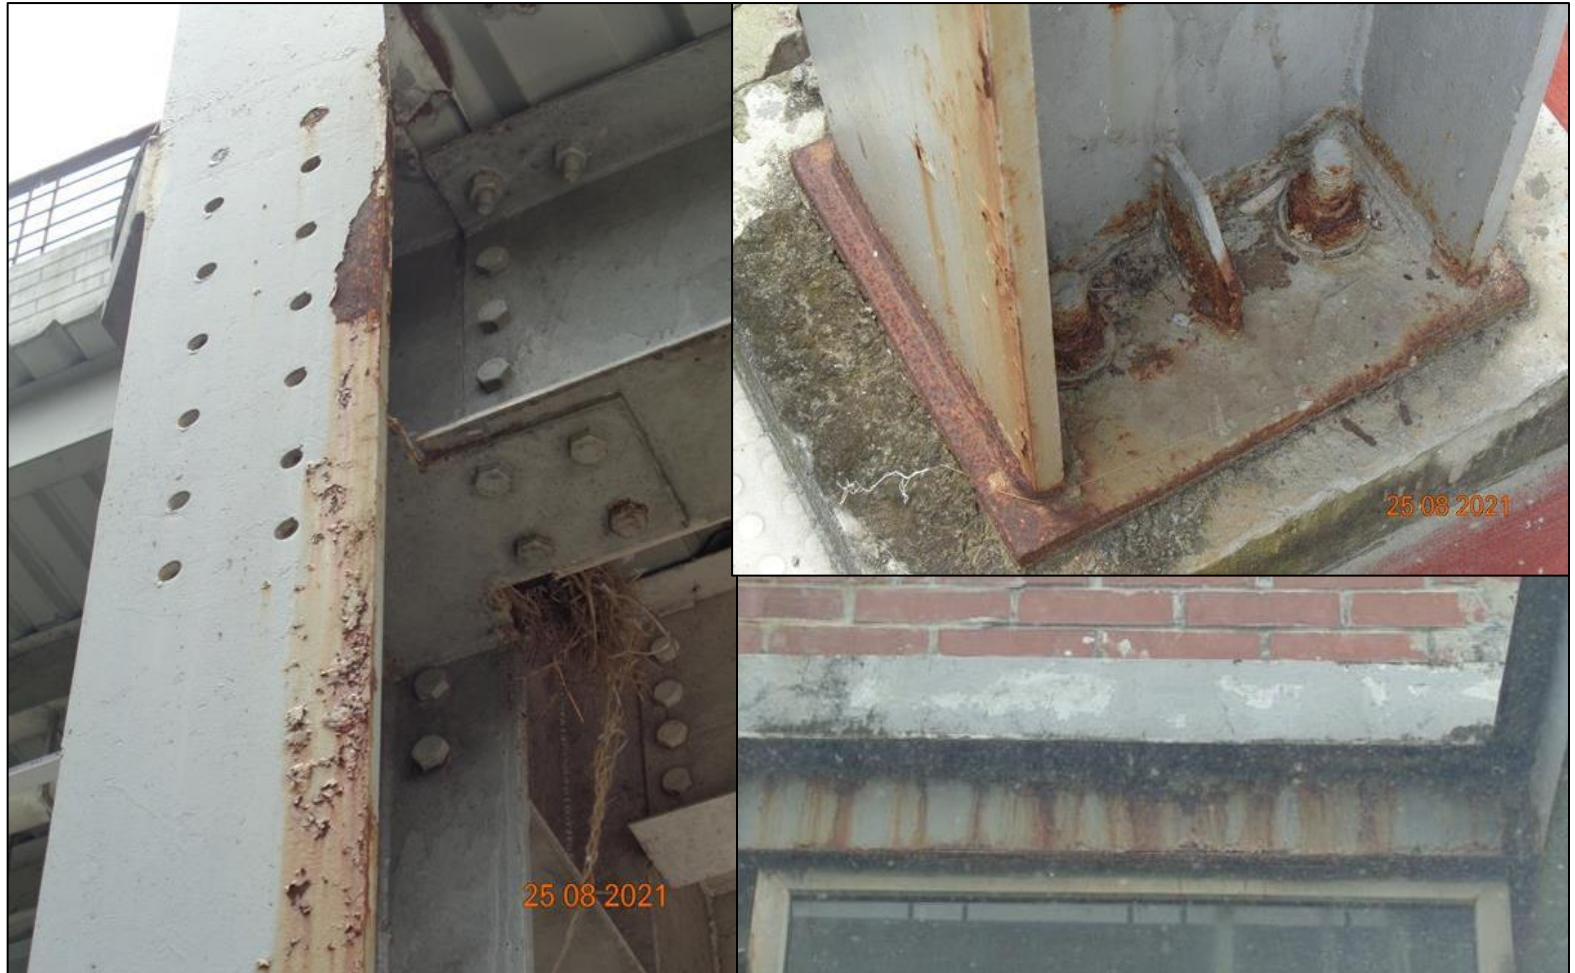
Corrosion in steel column

Corrosion in steel member was observed in various locations. The building engineer to investigate the reason of corrosion and suggest proper remedial measure accordingly.

| Item No. | Observation | Recommended Action Plan | Recommended Timeline |
|---|---|---|---|
| 24 | Corrosion in steel member (Building-3) | The building engineer to investigate the reason & extent of corrosion and suggest proper remedial measure accordingly. | 6-weeks |

| Item No. | Observation | Recommended Action Plan | Recommended Timeline |
|---|---|---|---|
| 25 | Corrosion in steel member (Building-3) | Take necessary measures to prevent further corrosion and repair the corroded steel members as per engineer's suggestion. | 6-months |

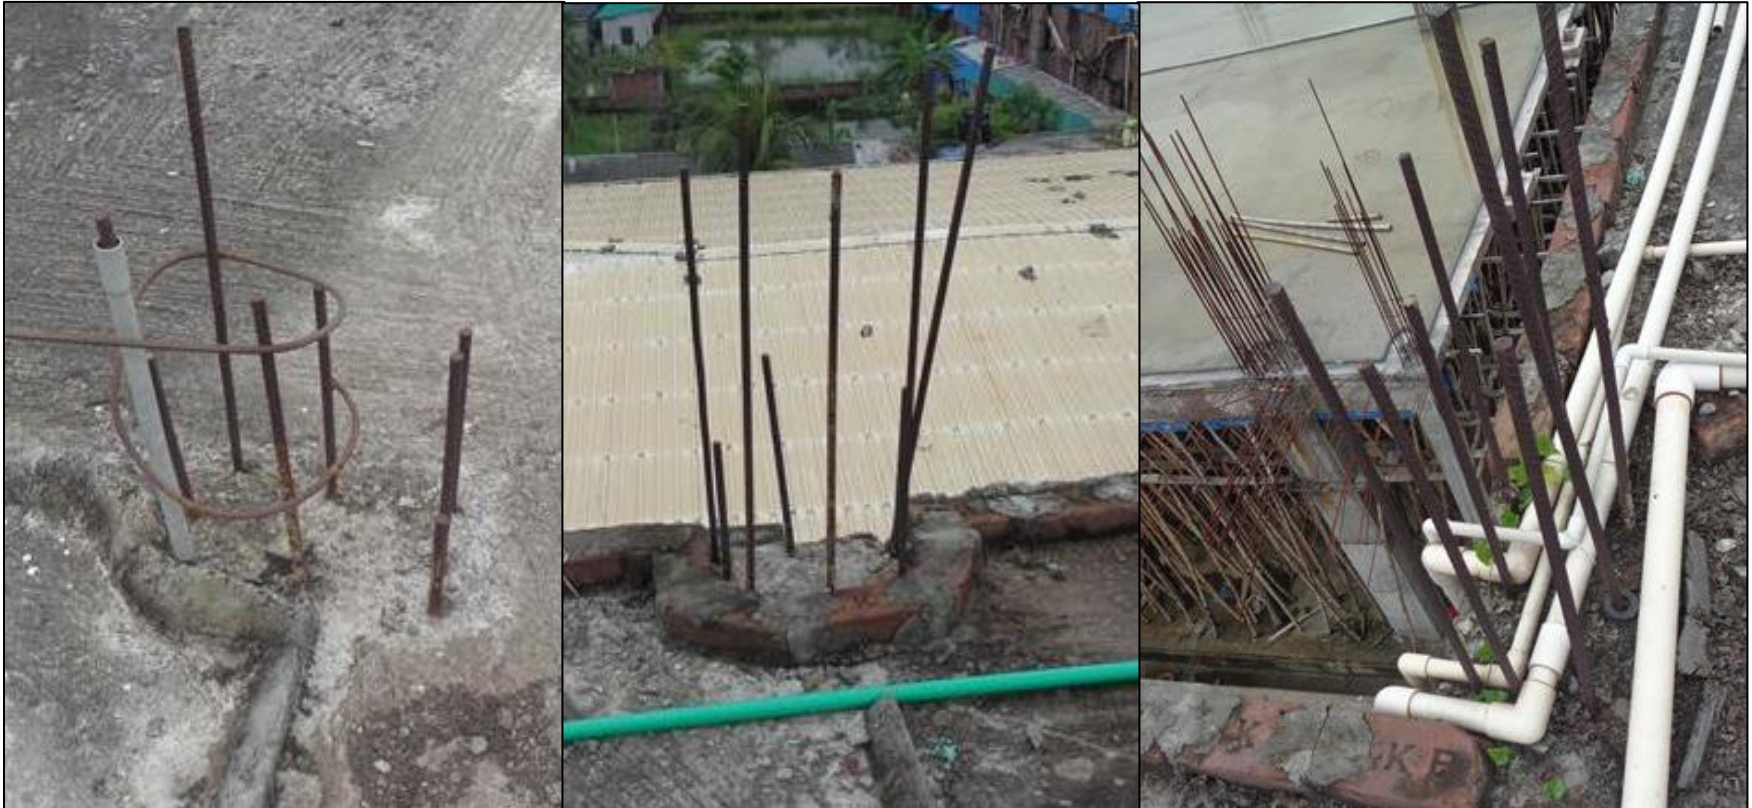
Exposed rebar of Column

Exposed reinforcement was found on roof top columns. Factory engineer is required to take necessary measures to prevent the corrosion in exposed rebar.

| Item No. | Observation | Recommended Action Plan | Recommended Timeline |
|---|---|---|---|
| 26 | Exposed re-bar at roof. (Building-3) | All exposed reinforcement is to be protected from corrosion which may cause degradation of the concrete. | 6-weeks |

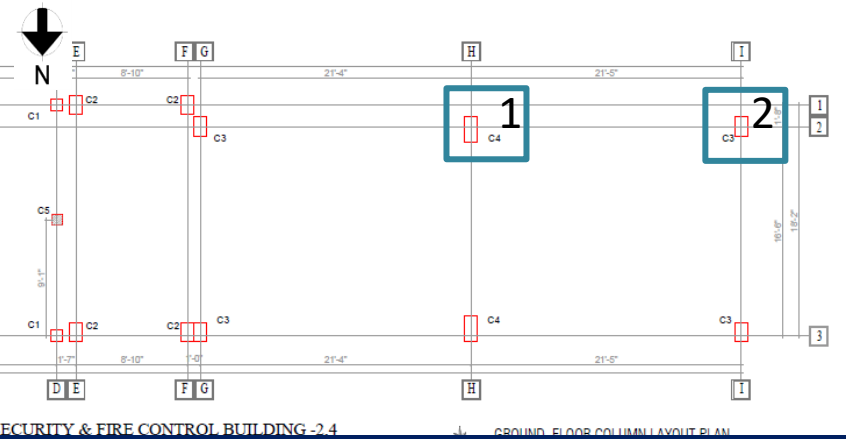
SECURITY & FIRE CONTROL BUILDING -2.4 GROUND FLOOR COLUMN LAYOUT PLAN

**Ferro-scan location of Column:- 1. C4 & 2. C3**

Column schedule shows total 14 numbers of re-bar for C4 column and 10 numbers of re-bar for C3 column.

Factory engineer is required to survey the whole structure and update the as-built drawing.

As per BNBC, every building or structure designed shall have its design documents prepared in accordance with the provision of Section 1.9.1. The design document shall include a design report, and a set of structural drawings, which shall be prepared in compliance with section 1.9.1.1 and section 1.9.1.2 as per BNBC. Factory engineer is required to update the drawing and prepare a design report following BNBC requirements.

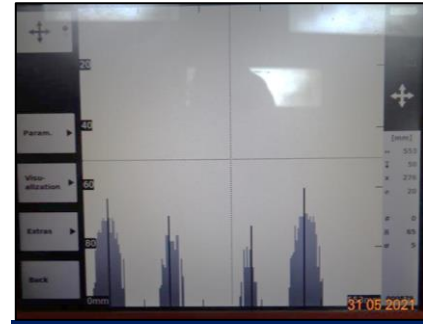
From the ferro scan 10 nos re-bar was found for C4 column instead of 14 nos

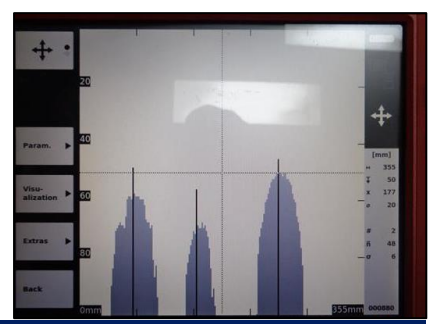
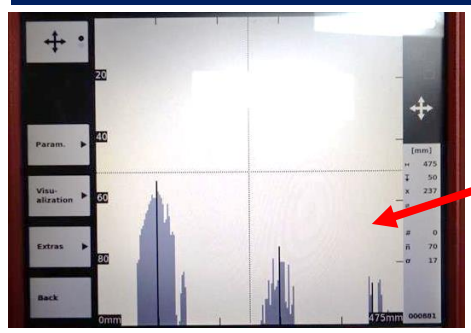
From the ferro-scan only 3 number of re-bar at long face of C3 column found was found instead of 4 numbers re-bar.

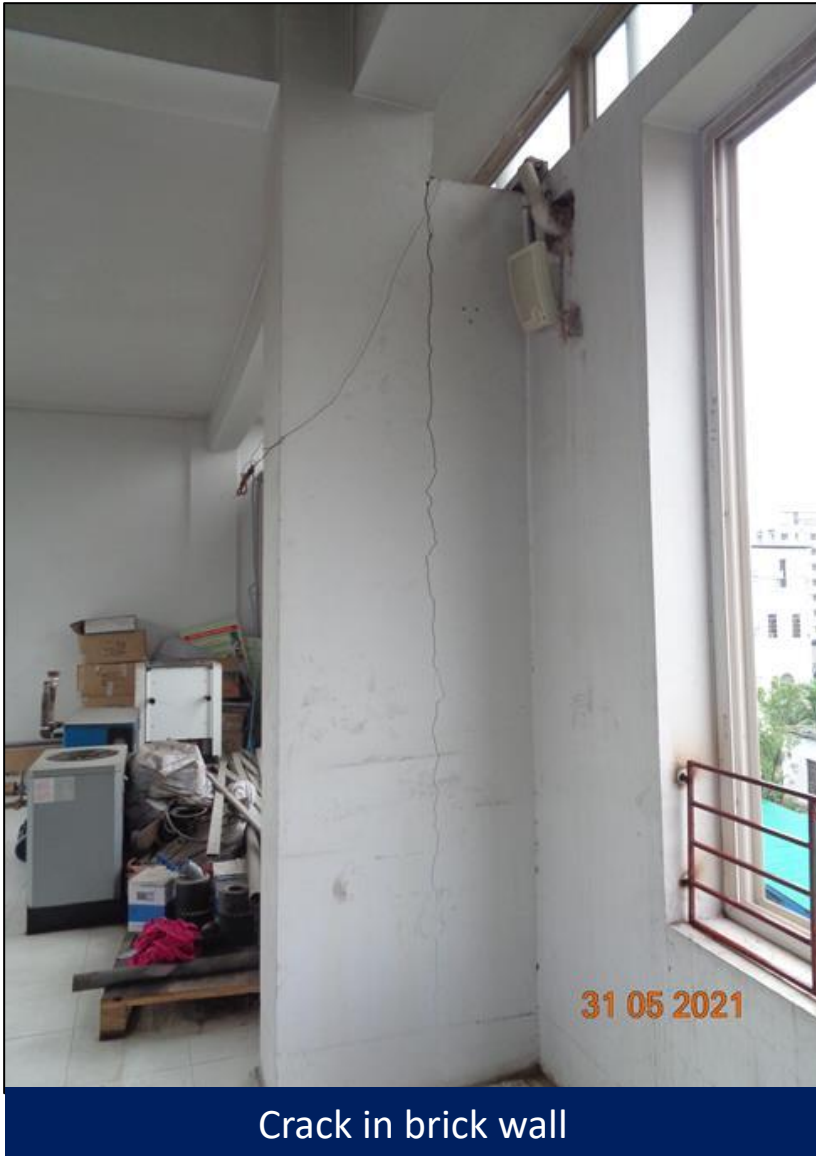
Crack in brick wall

Crack was found in brick wall at 2<sup>nd</sup> floor in joint of column & brick wall.  
Factory engineer is required to investigate the cause of crack and repair the crack as per recommendation from investigation report.

| Item No. | Observation | Recommended Action Plan | Recommended Timeline |
|---|---|---|---|
| 29 | Cracks in brick wall (Building-4) | Factory engineer is required to investigate the cause of crack and repair the crack as per recommendation from investigation report. | 6-weeks |

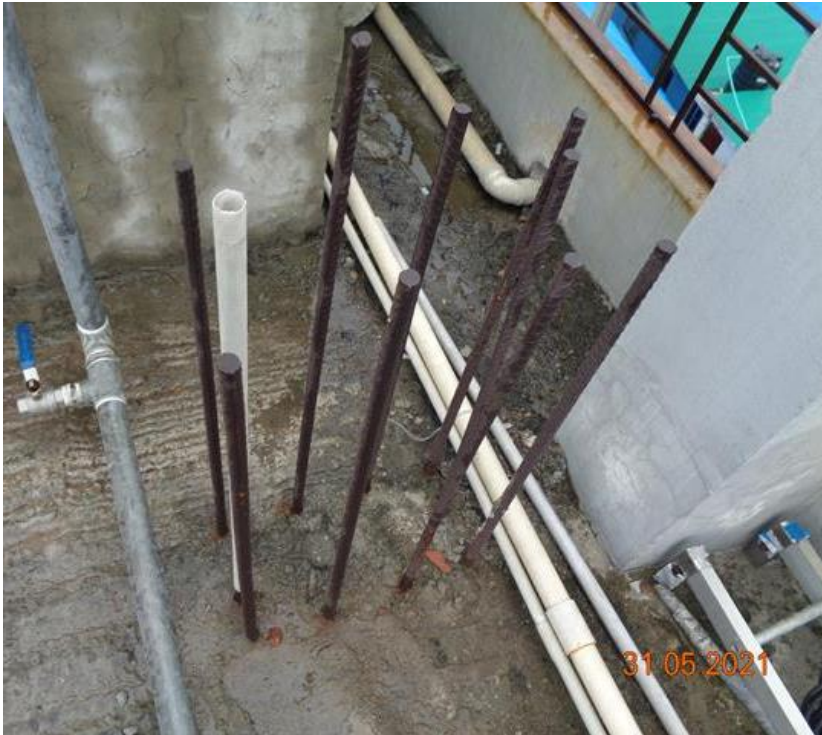
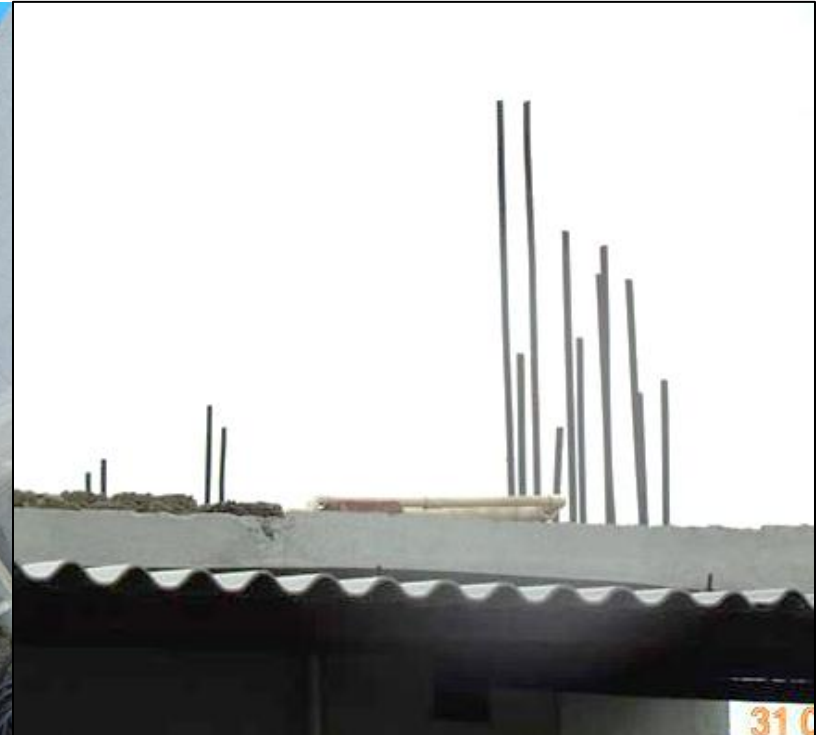
Exposed rebar of Column

Exposed reinforcement was found on roof top columns. Factory engineer is required to take necessary measures to prevent the corrosion in exposed rebar.

| Item No. | Observation | Recommended Action Plan | Recommended Timeline |
|---|---|---|---|
| 30 | Exposed re-bar at roof (Building-4) | All exposed reinforcement is to be protected from corrosion which may cause degradation of the concrete. | 6-weeks |

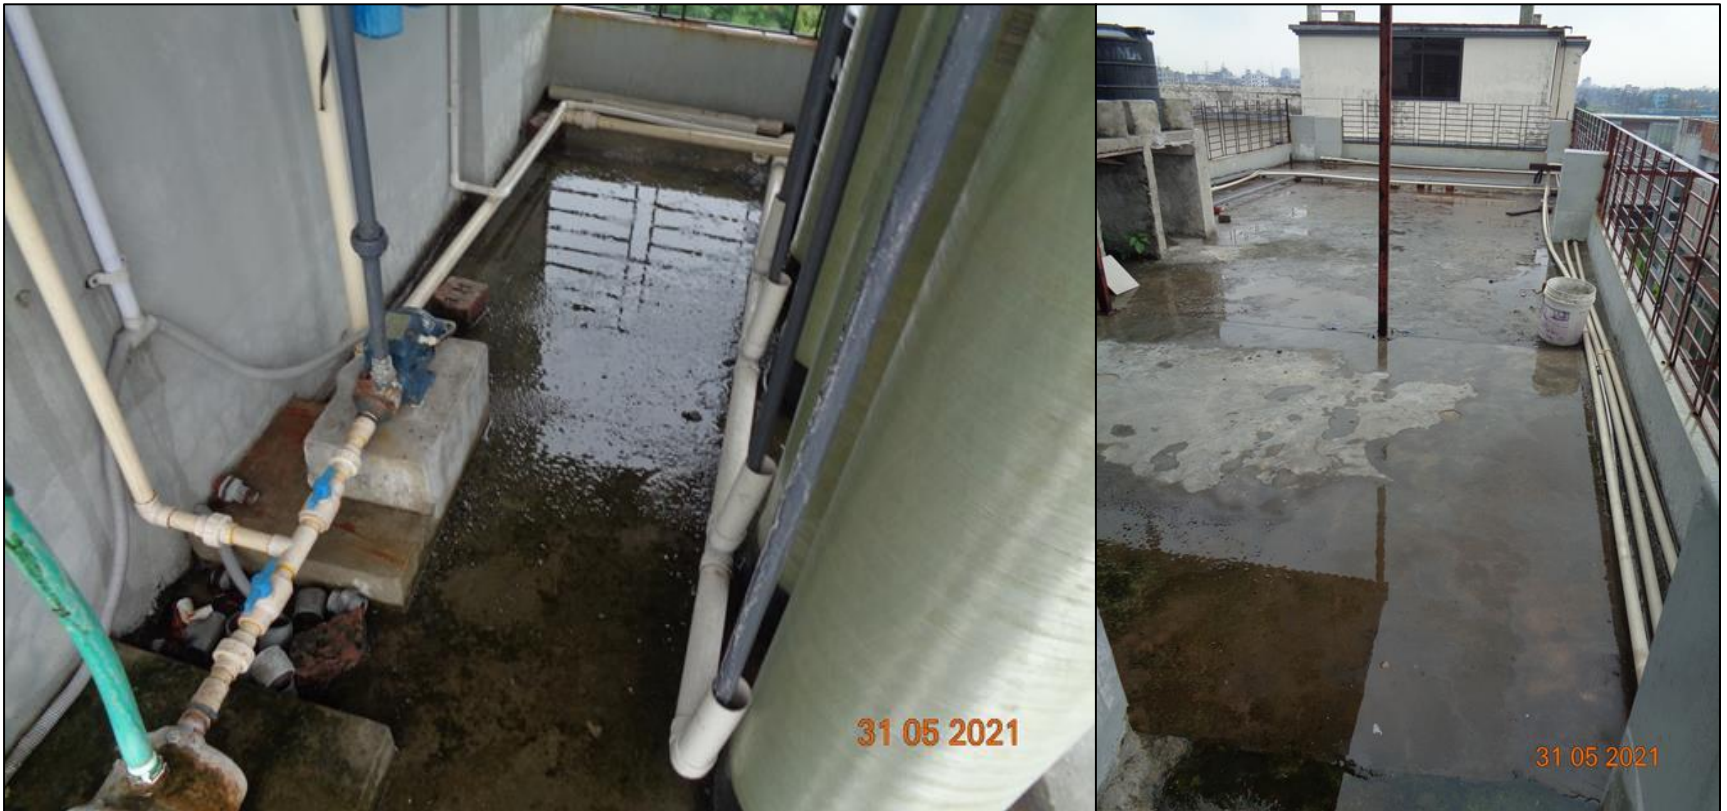
Water ponding at roof

Water ponding was found at roof area. The water drainage system and adequate sloping was not found. The factory engineer is required to develop proper drainage system with adequate sloping on the mentioned area.

| Item No. | Observation | Recommended Action Plan | Recommended Timeline |
|---|---|---|---|
| 31 | Water ponding at roof (Building-4) | The factory engineer to develop proper drainage system with adequate sloping to resist water ponding on roof. | 6-months |

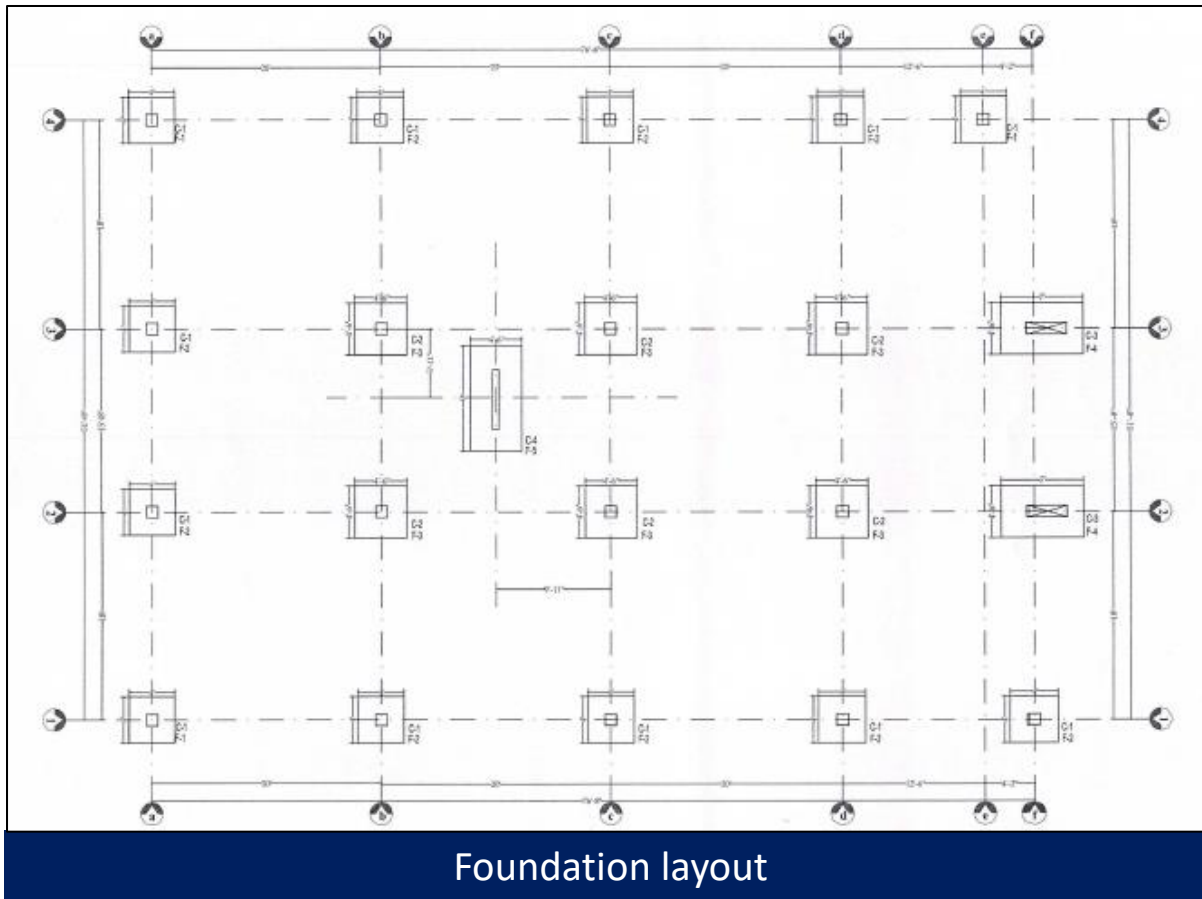
Cursory calculation indicates that the stress in some foundations exceeds normal design limit. Considering 2 kPa live load on typical floor & 1.5 kPa live load on roof top. The footings were found stressed in excess of normal design limit against the soil bearing capacity available from Geotechnical investigation report. Building engineer is required to carryout foundation adequacy check to justify the load carrying capacity.

| Item No. | Observation | Recommended Action Plan | Recommended Timeline |
|---|---|---|---|
| 32 | Stress in foundation exceeds normal design limit ( Building-5) | Factory Engineer to review design, loads and foundation stresses. | 6-weeks |
| 33 | Stress in foundation exceeds normal design limit ( Building-5) | Produce and actively manage a loading plan for all floor plates within the factory giving consideration to floor capacity and foundation capacity. | 6-weeks |
| 34 | Stress in foundation exceeds normal design limit ( Building-5) | Implement any remediation work if required. | 6-months |

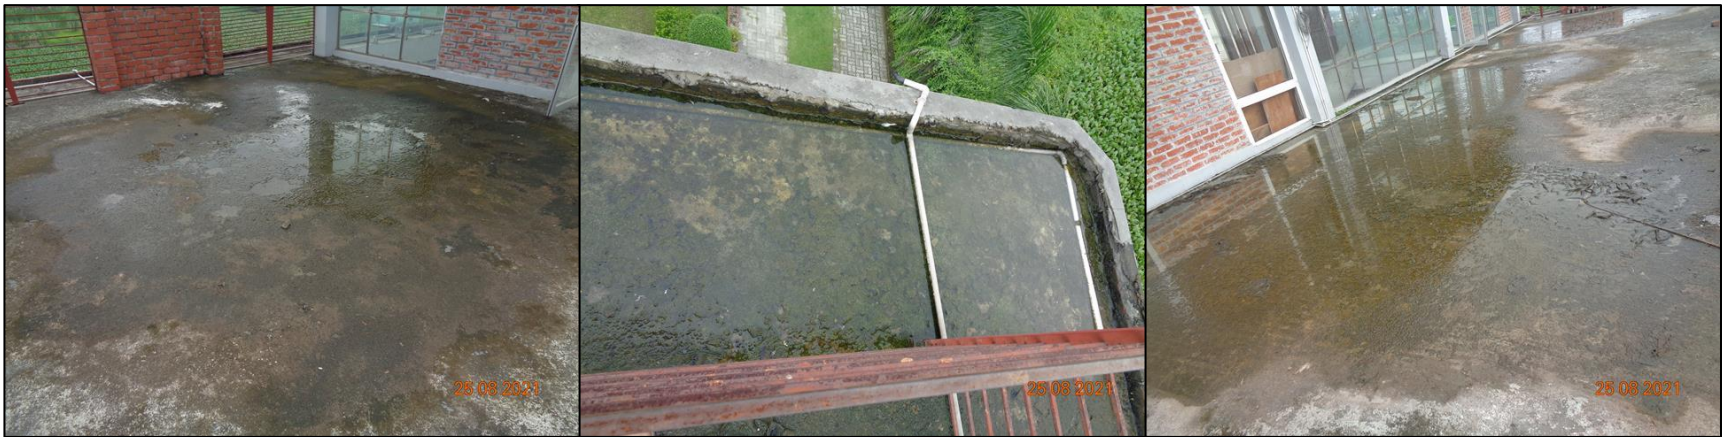
Water ponding at roof

Water ponding was found at roof area. The water drainage system and adequate sloping was not found. And there is no water proofing layer on this area. The factory engineer is required to develop proper drainage system with adequate sloping on the mentioned area.

| Item No. | Observation | Recommended Action Plan | Recommended Timeline |
|---|---|---|---|
| 35 | Water ponding at roof (Building-5) | The factory engineer to develop proper drainage system with adequate sloping to resist water ponding on roof. | 6-months |

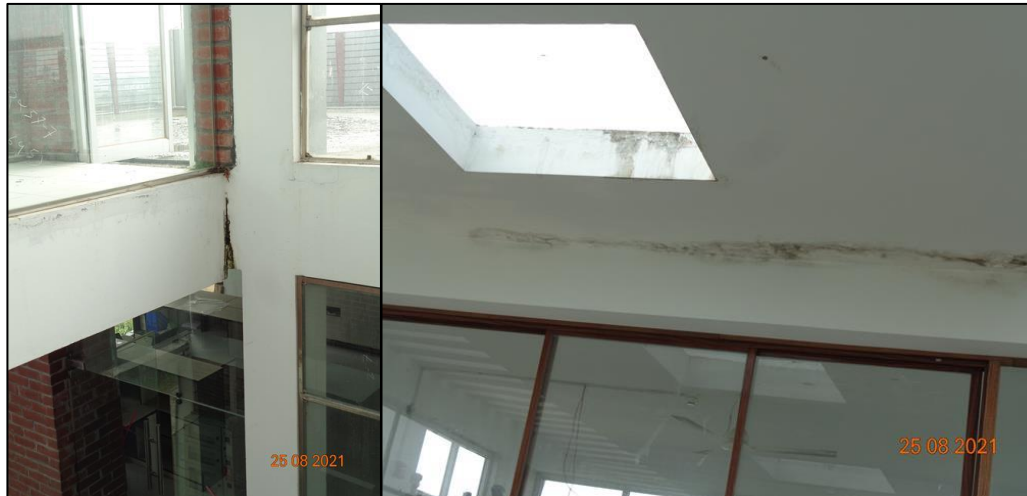
Dampness in Beam-Column & slab due to water ponding
