JL SWEATER LIMITED-EXTENDED BUILDING

Zirabo Post, Ashulia Thana, Savar
(23.911748, 90.310916)

5th September 2021

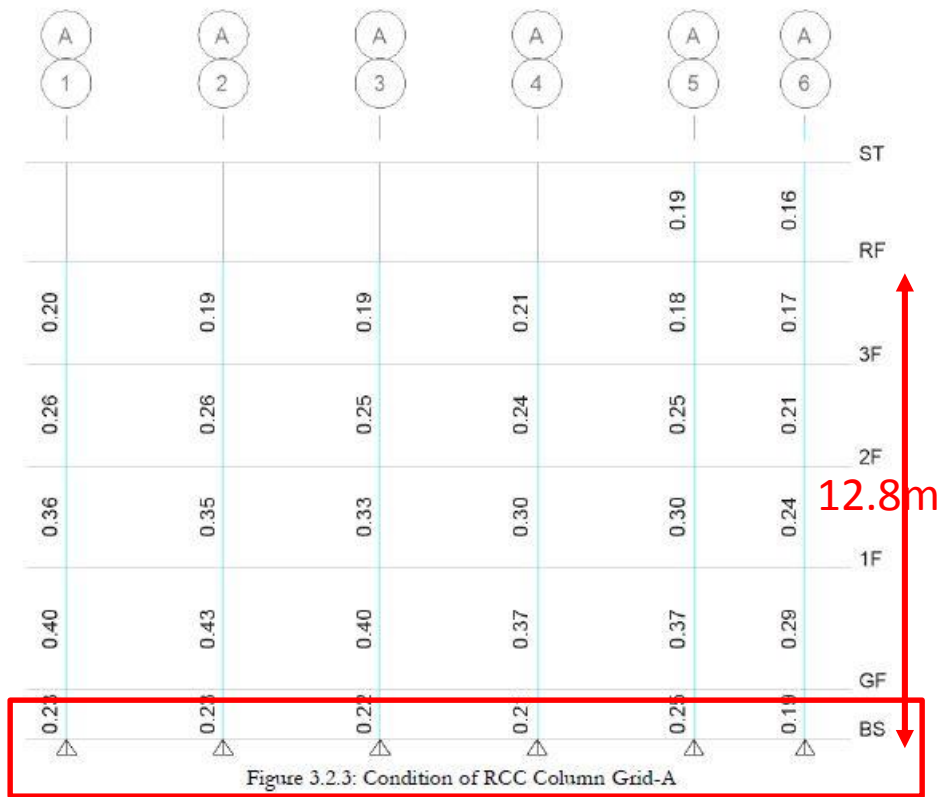
Overturning capacity of building to be checked

The length and width of structure are 22.8m and 6.1 m respectively. The height of the building is 12.8 m. The building has cantilever along the length. Hinge support for foundation to column joint is considered for analysis. As the building is single bay structure, height is more and have cantilever in critical direction, the factory engineer should check the sway & over-turning capacity of the building against the lateral loadings and revise the foundation adequacy accordingly.

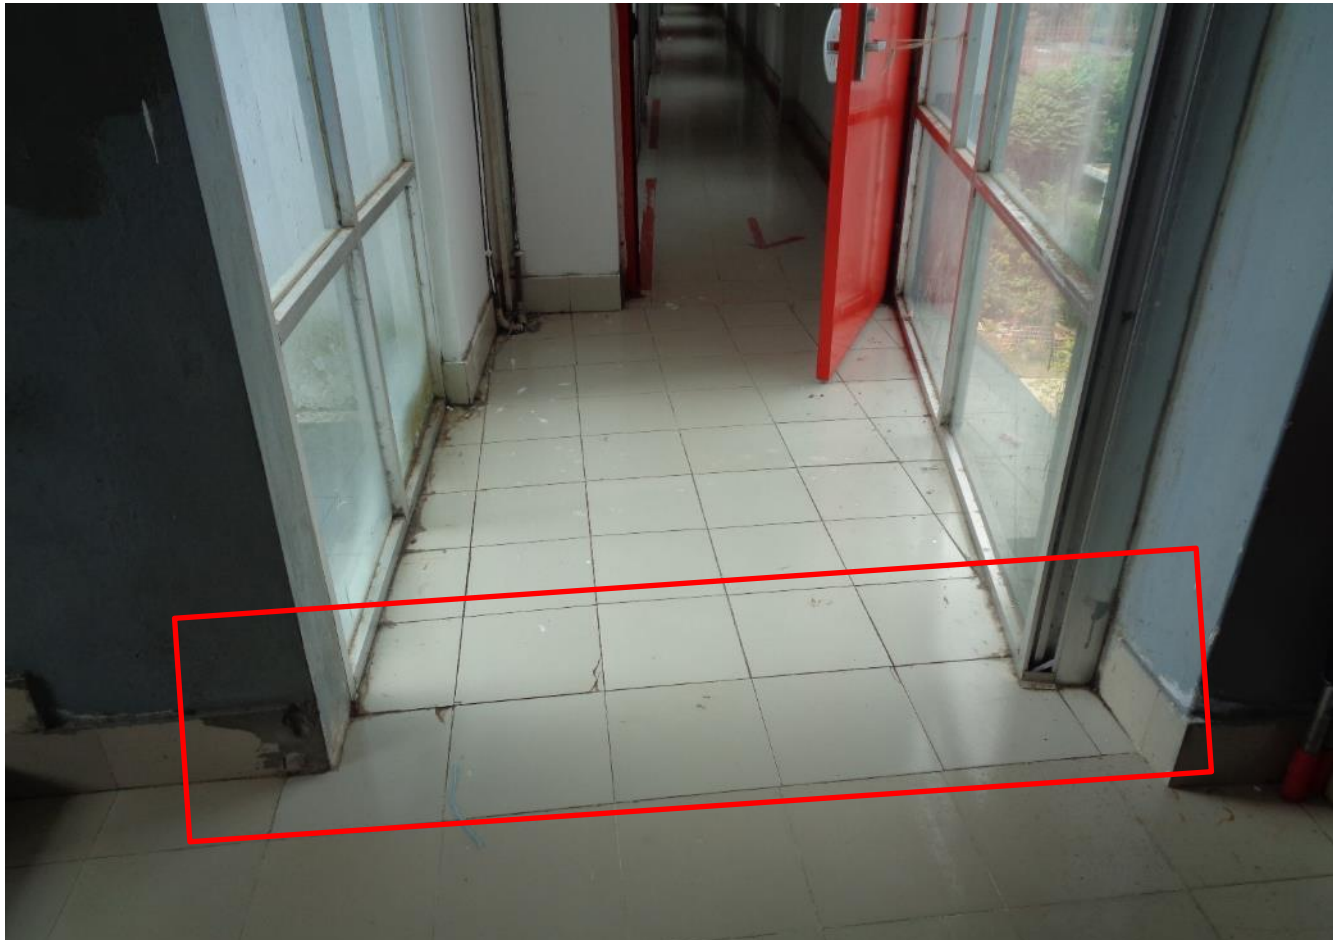
Expansion joint filled with rigid material

Expansion joint filled with rigid material at every floor

Expansion joint with adjacent building was found filled with rigid material which may result in development of crack and falling hazard during an earthquake or lateral movement of the buildings. Factory is required to fill the gap with any flexible material suggested by the structural/fire engineer.

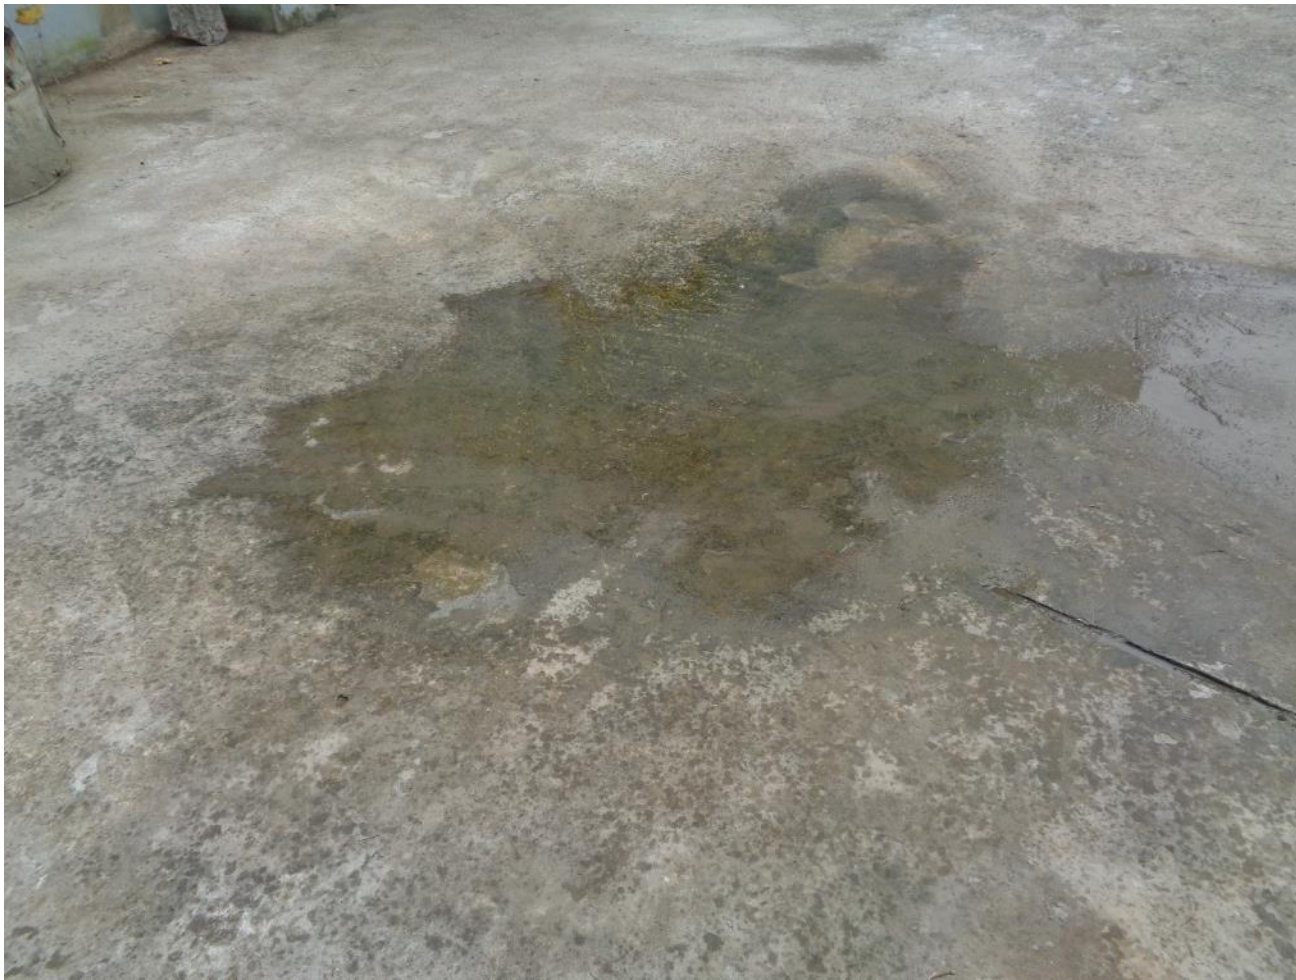
Water stagnant on roof slab

Water stagnant was found on roof slab. Factory is required to provide necessary slope and improve drainage system to prevent water stagnant.

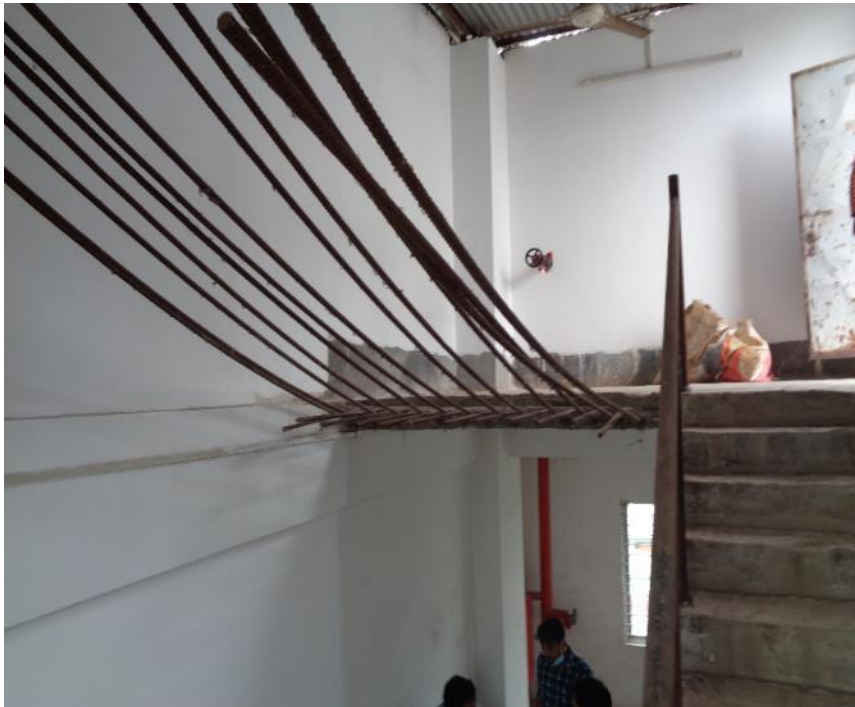
Exposed reinforcement left at roof level

Exposed reinforcement left at Staircase

Exposed reinforcement is left at roof level & staircase which was prone to corrosion. Factory is required to provide rust proof paint on exposed reinforcement to protect from corrosion.

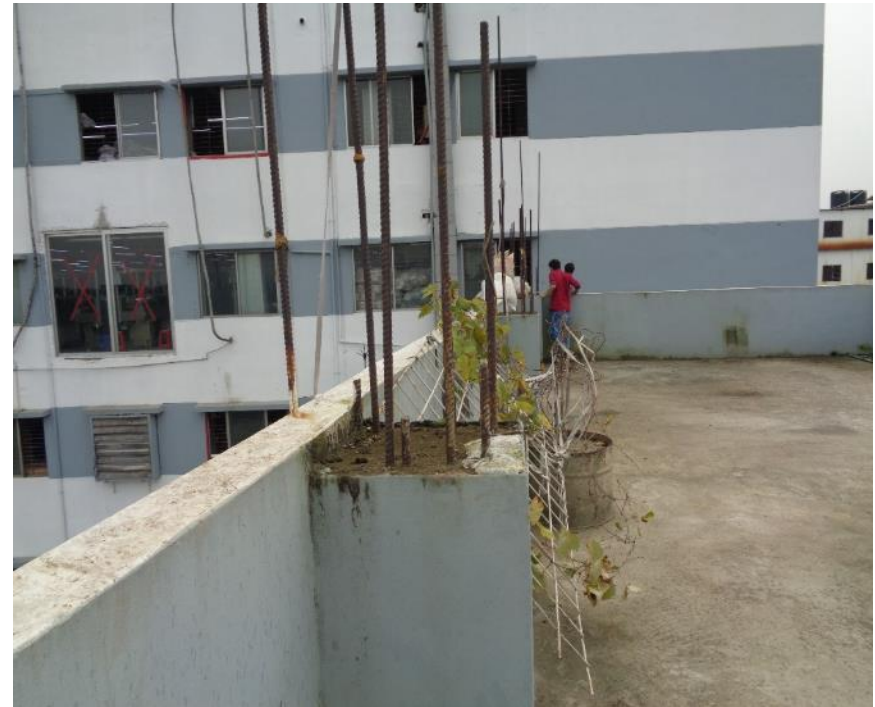
Exposed reinforcement left at roof

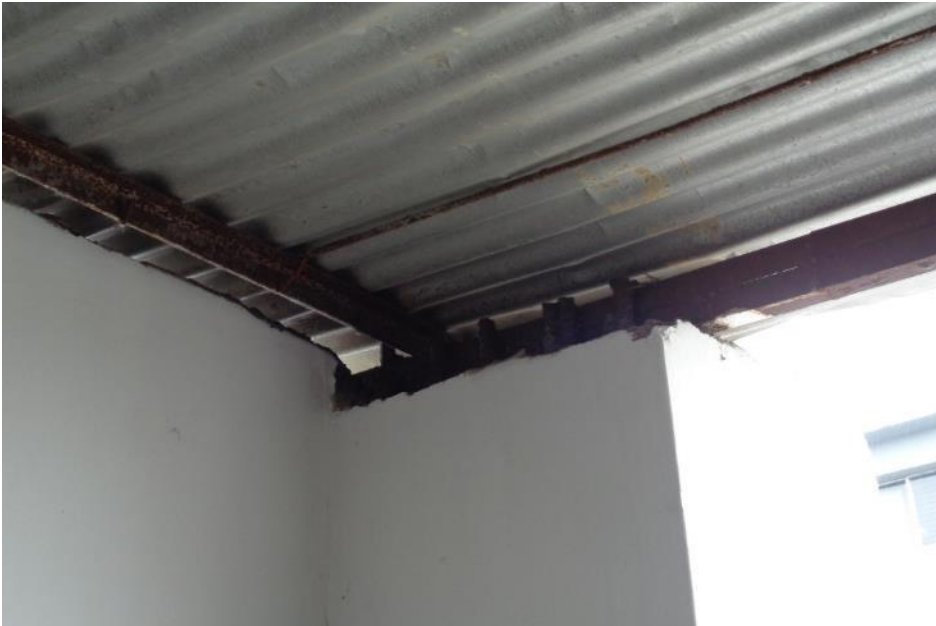
Lack of as-built drawing

Rafter connected with column rebar

No as-built drawing was provided for the stair roof shed. This shed is made of steel rafter and purlin . The rafters are connected with reinforcement of the stair columns by welding. Factory engineer is required to produce as-built drawing of this shed.

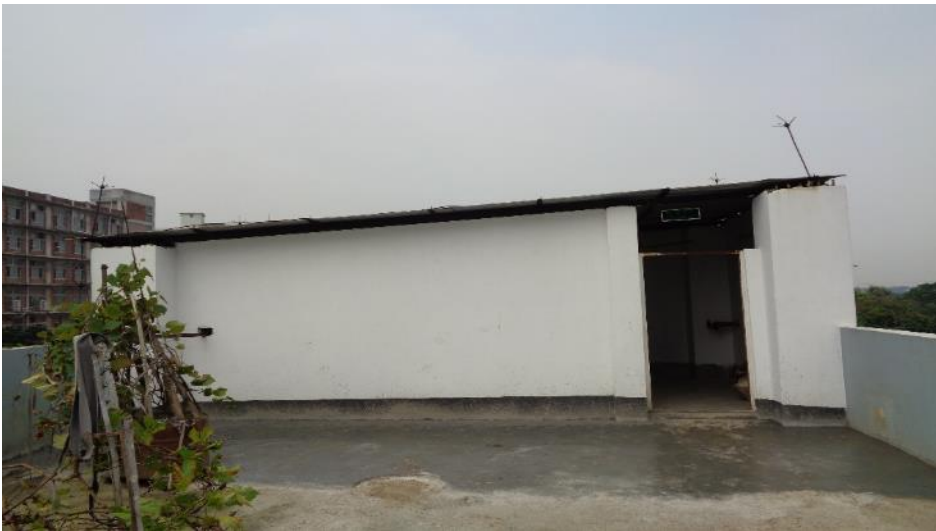
Stair roof shed at north side

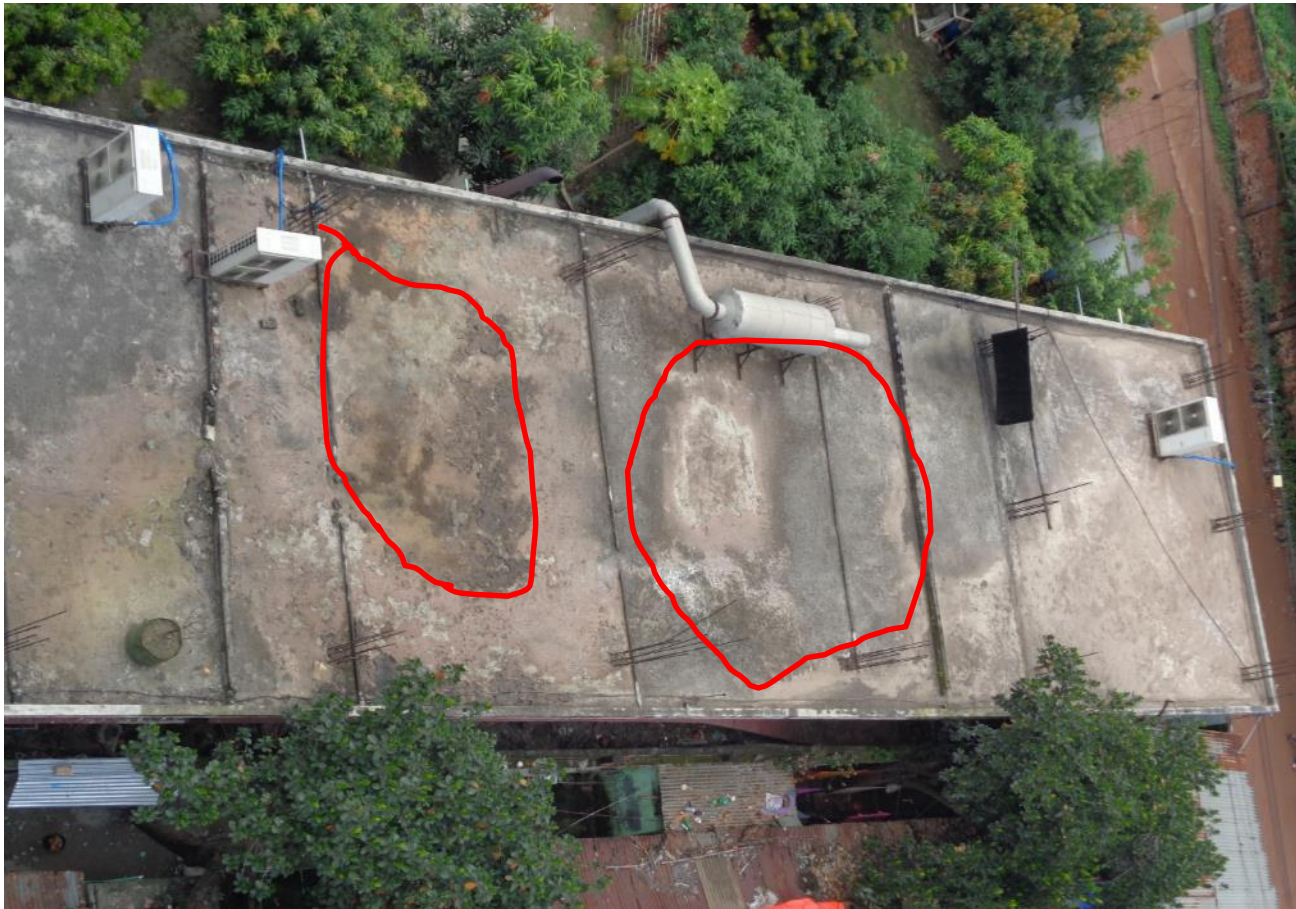
Sign of water stagnant on roof slab

Water stagnant on roof slab

Sign of water stagnant was found on roof slab. Factory is required to provide necessary slope and improve drainage system to prevent water stagnant.

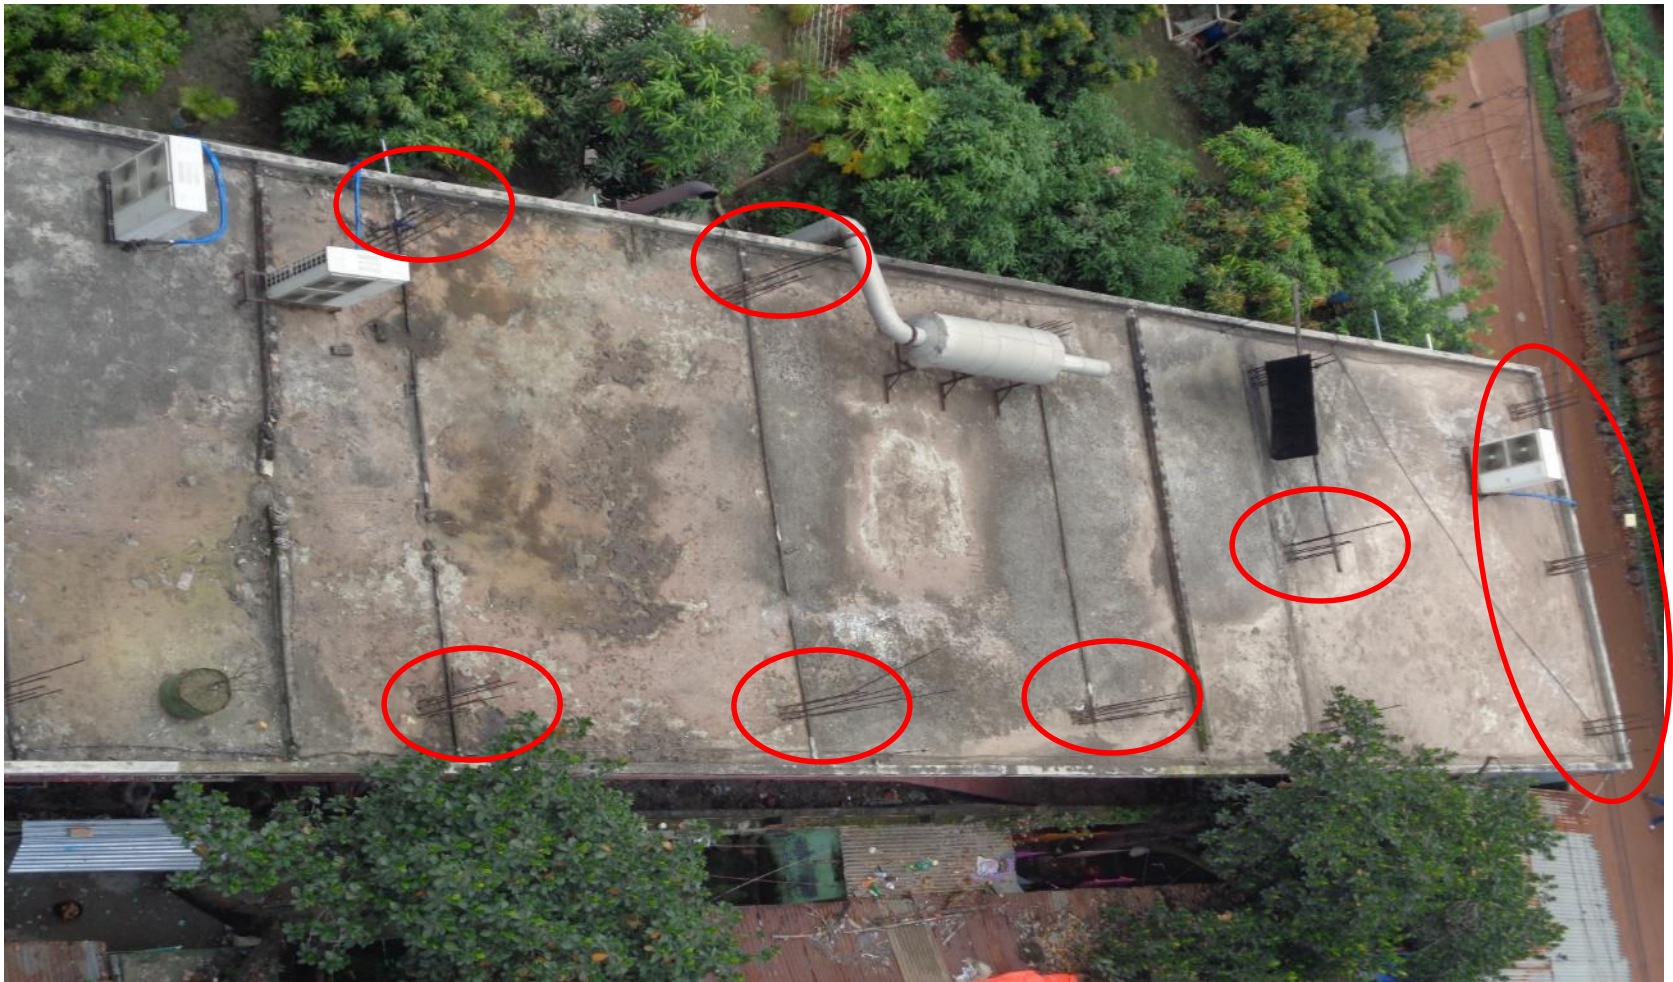
Exposed reinforcement left at roof level

Exposed reinforcement left at Staircase

Exposed reinforcement is left at roof level & staircase which was prone to corrosion. Factory is required to provide rust proof paint on exposed reinforcement to protect from corrosion.

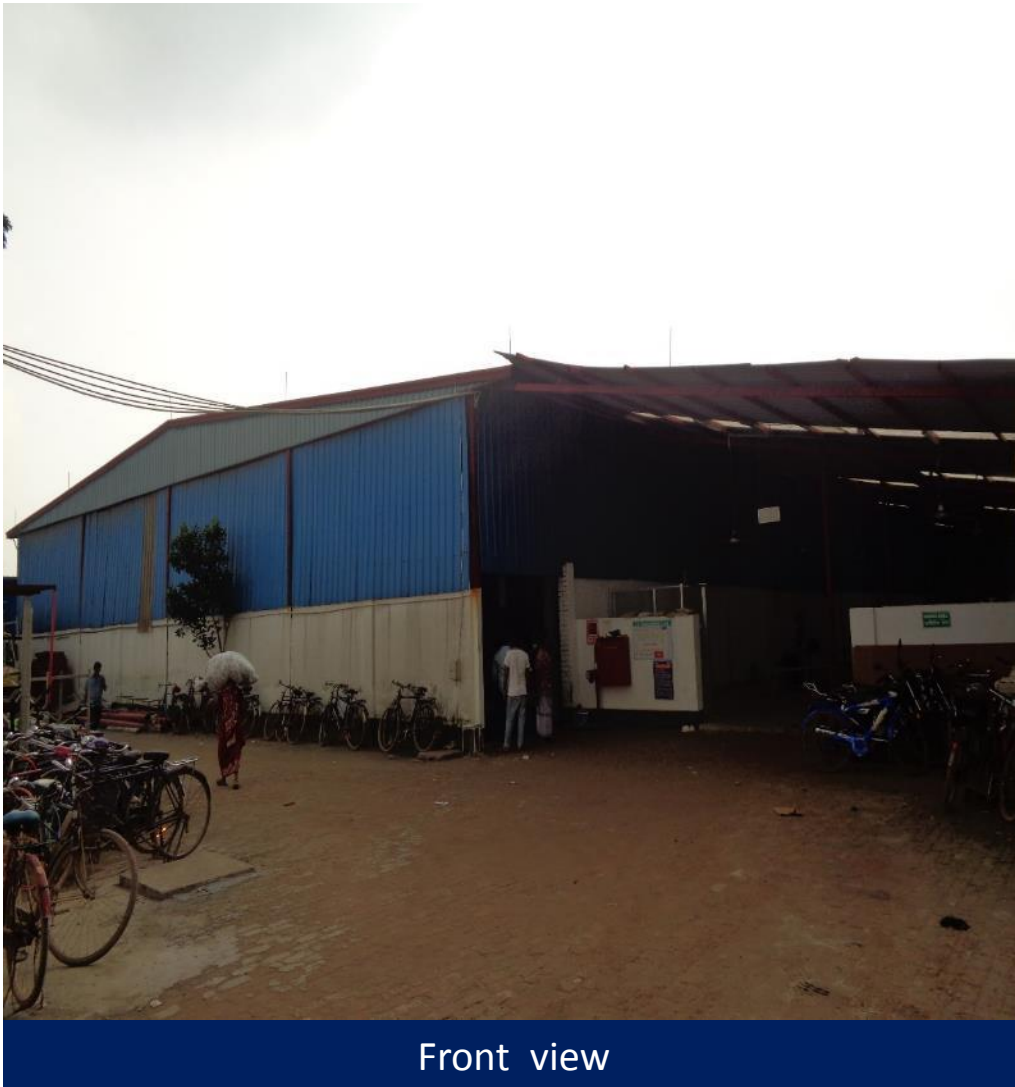
Design Report needs to be prepared

As per BNBC, every building or structure designed shall have its design documents prepared in accordance with the provision of Section 1.9.1. The design document shall include a design report, and a set of structural drawings, which shall be prepared in compliance with section 1.9.1.1 and section 1.9.1.2 as per BNBC. At the time of inspection, only as-built drawing was available, but no design report was available which is required to be prepared in compliance with section 1.9.1.1 (part-6, BNBC).

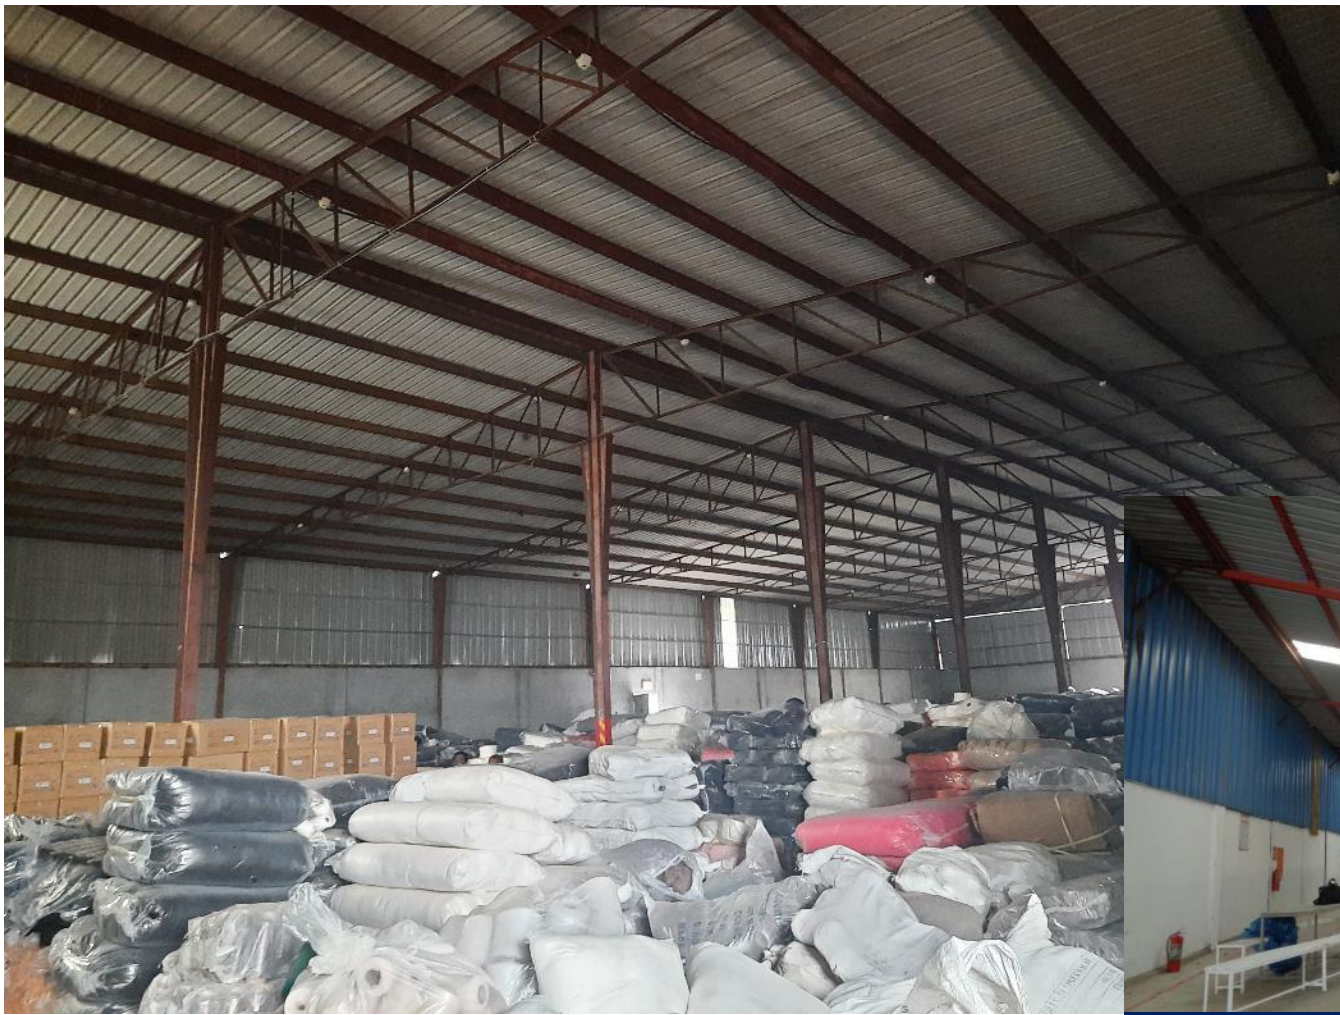
Lack of lateral stability

No roof bracing/compression member

No roof bracing or compression member provided along long direction. There are some non engineered connections between column & rafter. Therefore, there is no obvious lateral stability along the long direction. Factory engineer is required to carry out the lateral stability check for this steel shed.

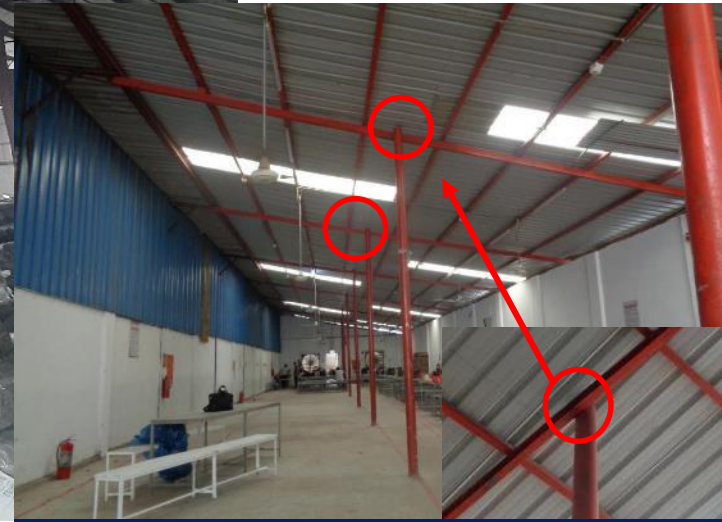
Non-engineered connections
