# Motex Fashion

802/1, Jajor, National University, Gazipur-1704

5 September 2021

# Observations

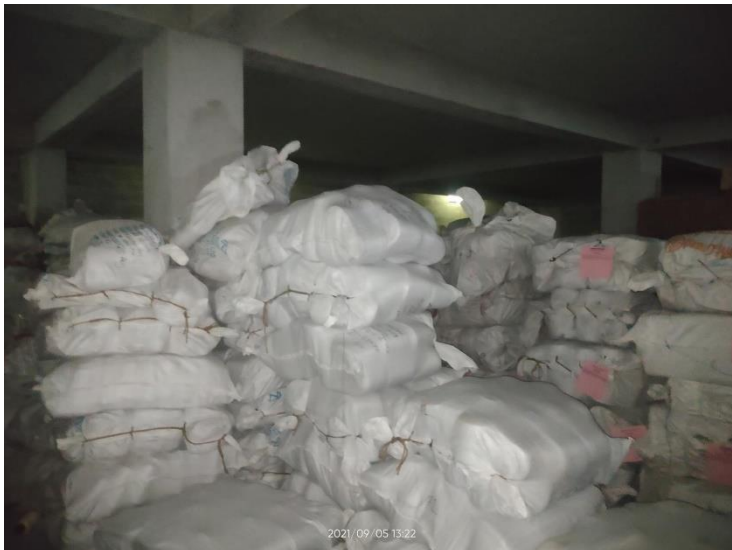
Storage at 3rd floor

Storage live load 84 psf (4 kN/m<sup>2</sup>) in design report

As per BNBC, the minimum floor live load for light storage is 6 kN/m<sup>2</sup> (125 psf). The storage in this building is designed for 4 kN/m<sup>2</sup> live loads. The building engineer is required to revise the storage live load limit based on BNBC requirement and update the load plan and design report accordingly.

| Item No. | Observation | Recommended Action Plan | Recommended Timeline |
|---|---|---|---|
| 01 | Prepared design report to be revised. (Building-1: Main Building) | Review the design, loads, columns stresses and prepare a set of design documents including floor live load plan in accordance with BNBC, Section 1.9.1. | 6-weeks |

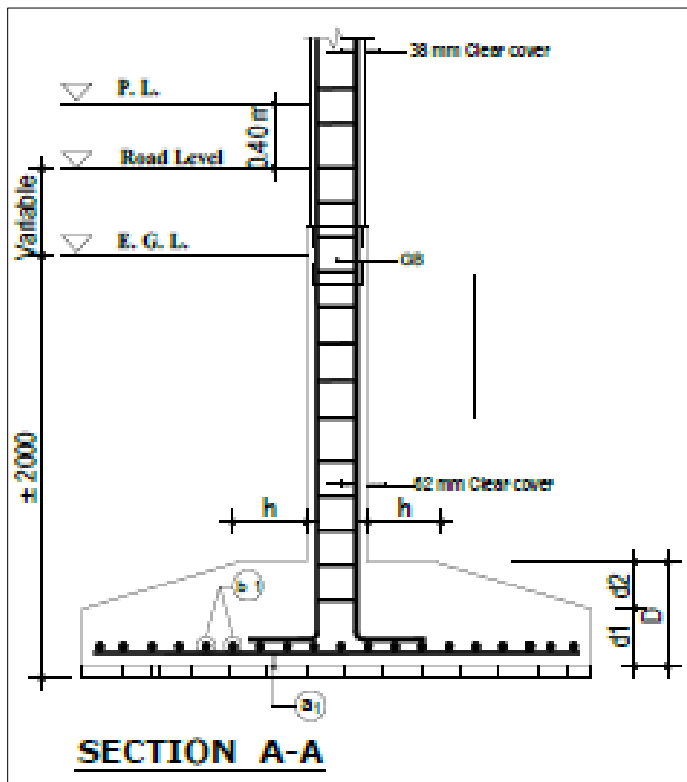
Footing depth considered in design report 10 feet (3m).

Report: Soil bearing capacity 1.80 tsf at 8 feet (2.4m) depth

Footing depth about 2m (6.56 feet)

As per drawing, isolated footing is provided in 6.56 feet depth. Geotechnical report recommend bearing capacity for 8 feet depth. In the design report, SPT calculated for 10 feet depth and calculated soil bearing stress accordingly. Revise the footing bearing stress calculation as per actual foundation depth.

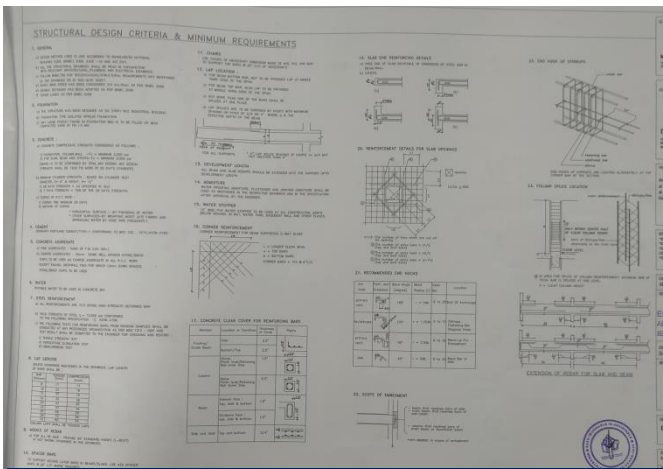
Structural drawings

Concrete design strength in Design report

No cylinder test report was available for column. 2 set concrete cylinder sample were taken from two different floor slab. As per test report for one slab, concrete strength (2180 psi) is well below the design strength (3000 psi) mentioned in the design report and structural drawings. Also, rebar strength considered 72,500 psi without any test report.

The building engineer is required to verify in-site concrete strength for column and floor slab by taking minimum 4 number of concrete cores from lower tier of existing column and slabs. Based on in-site concrete strength revise the design, loads and capacity of each structural members.

| Item No. | Observation | Recommended Action Plan | Recommended Timeline |
|---|---|---|---|
| 04 | Insufficient material test reports. (Main Building) | Building engineer to take minimum 4 number concrete core of 100 mm diameter from lower tier of the columns. | 6-weeks |

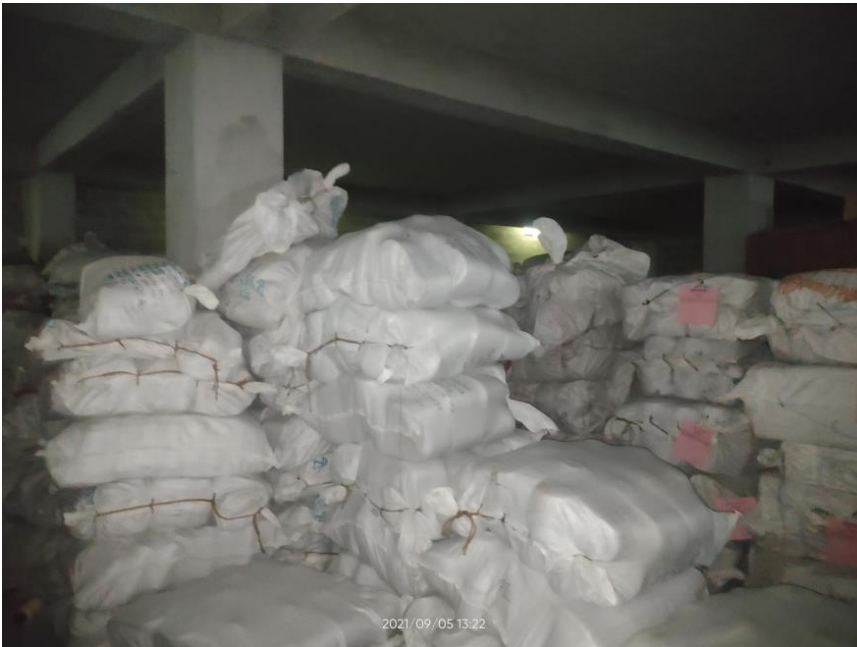
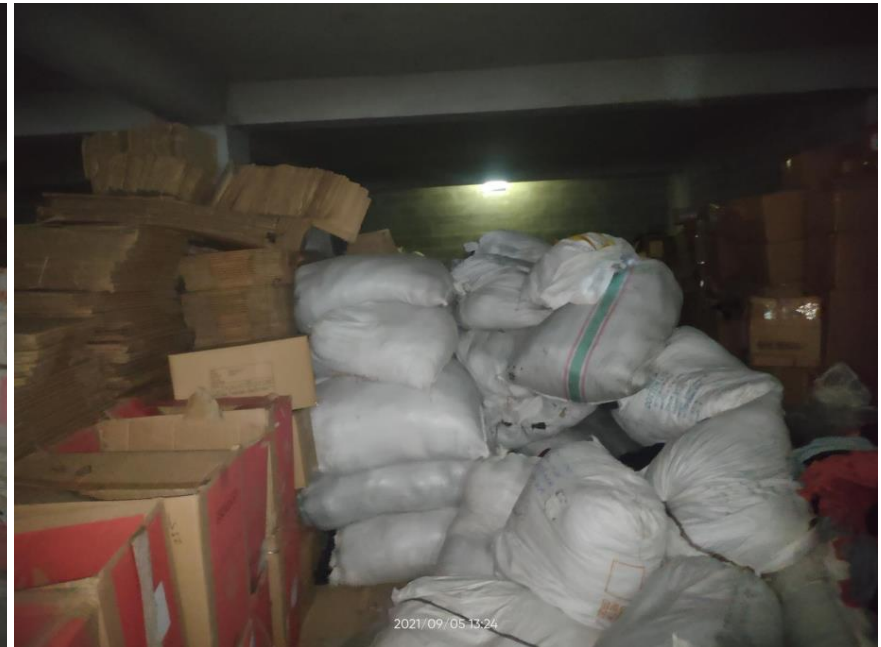
Loading in storage area of 3rd floor.

4 to 5 kPa loading was found in storage area (3rd floor). Also, load management program was not observed. Produce and actively manage a loading plan for all floor plates considering the foundation and column capacity.

| Item No. | Observation | Recommended Action Plan | Recommended Timeline |
|---|---|---|---|
| 07 | Uncontrolled loading on 3rd floor (Building-1, Main Building) | Maintain floor live loading within 3 kPa in storage area. | 6-weeks |
| 08 | Uncontrolled loading on 3rd floor (Building-1, Main Building) | Produce and actively manage a floor loading plan for each floor considering foundation & column capacity. | 6-weeks |

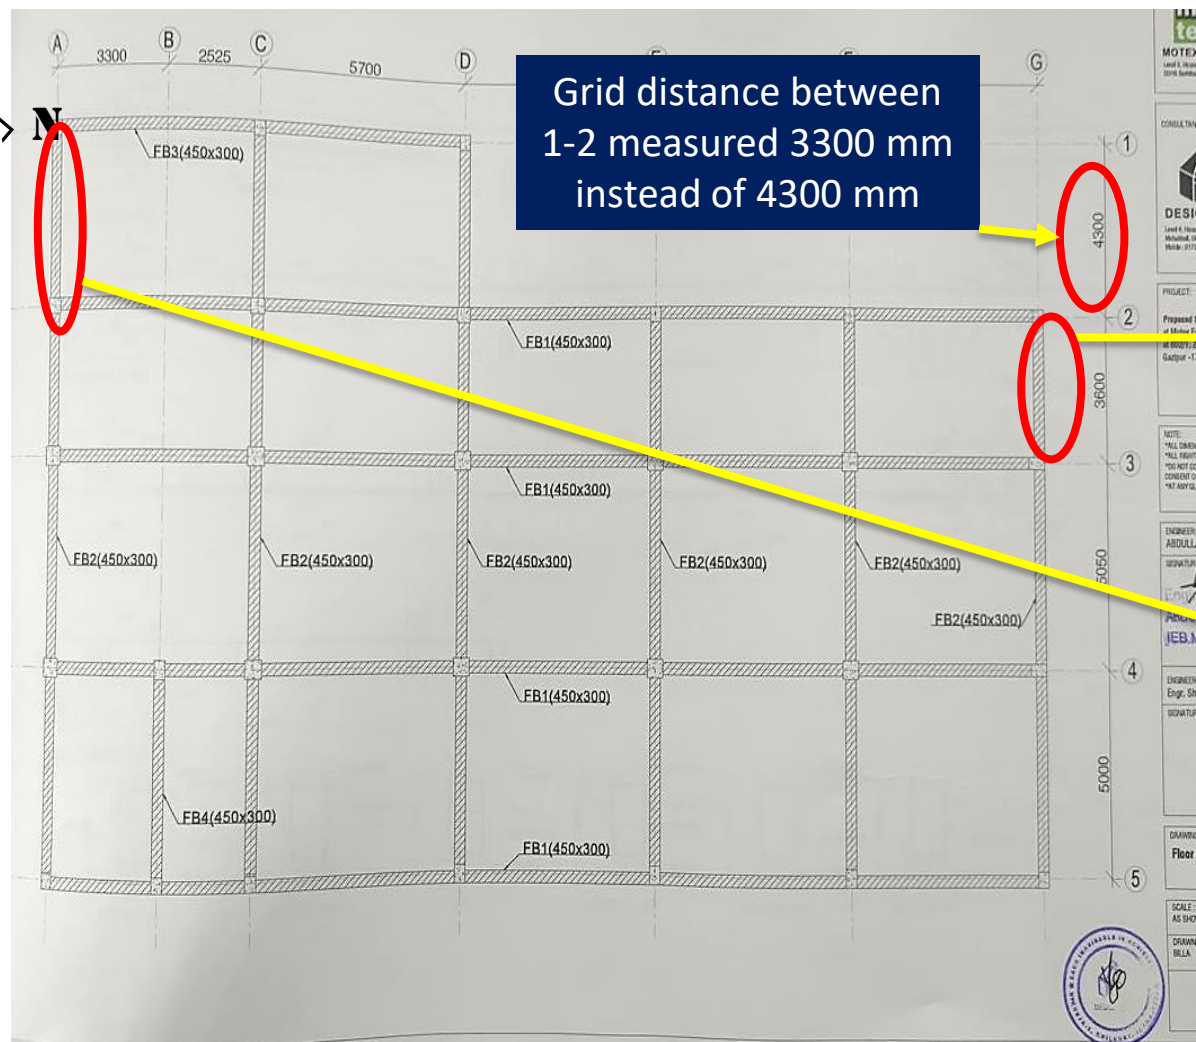
Floor Roof Beam Layout Plan(marked beams are missing)

Some stair beams were missing on-site but shown in the provided drawings. Grid distance between 1 and 2 was measured 3300mm instead of 4300mm. Update as-built drawings as per actual as-built condition.

| Item No. | Observation | Recommended Action Plan | Recommended Timeline |
|---|---|---|---|
| 10 | Discrepancies in as-built drawings. (Main Building) | Survey the structure and prepare accurate as-built (architectural and structural) drawings in compliance with section 1.9.1.2 as per BNBC. | 6-weeks |

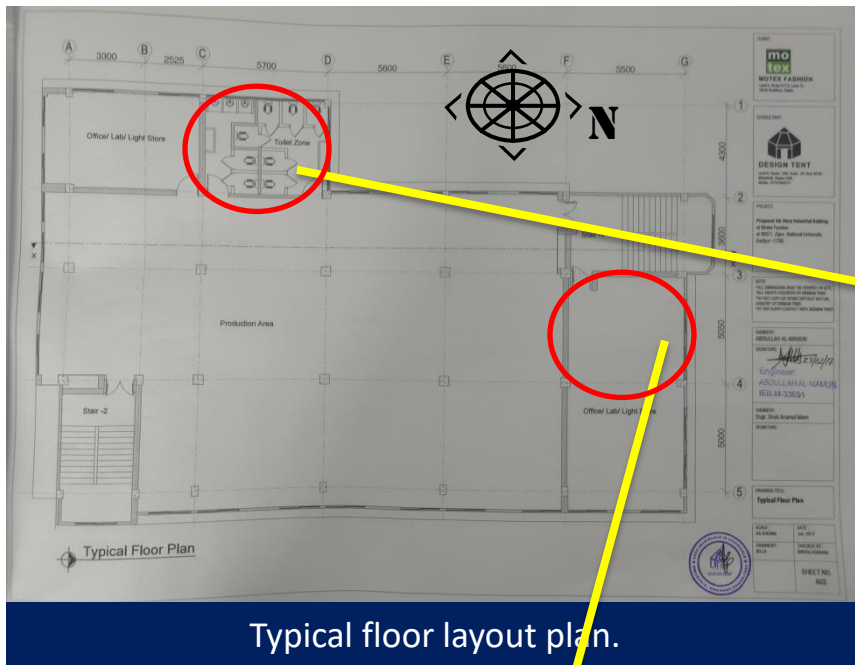
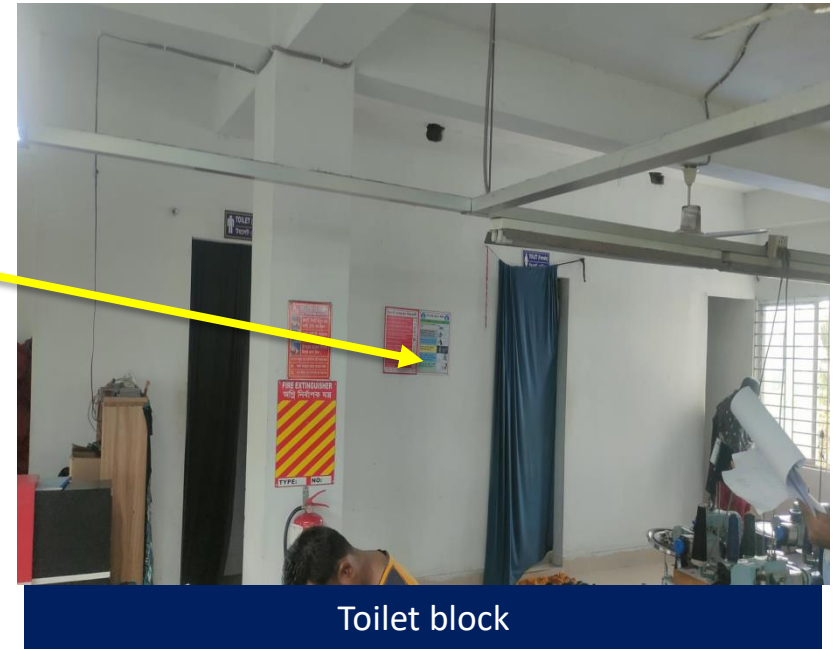
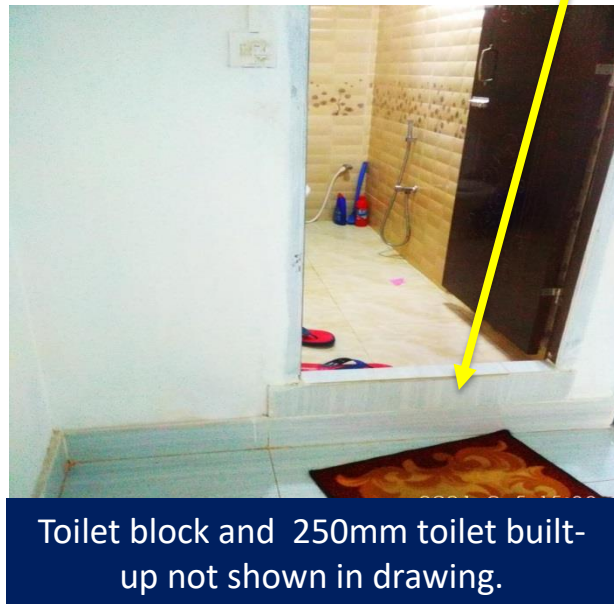
Toilet layout did not match with as-built drawings. Toilet build up was not shown in drawings.

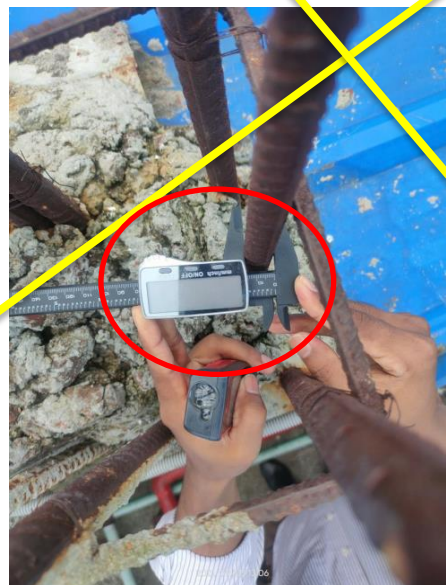
C6 column: Rebar diameter 16mm

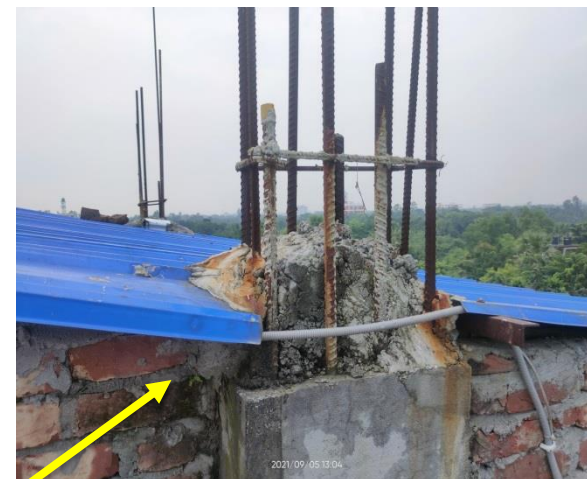
C6 Column: 8 numbers of 20mm & 2 number 16mm of Rebar counted.

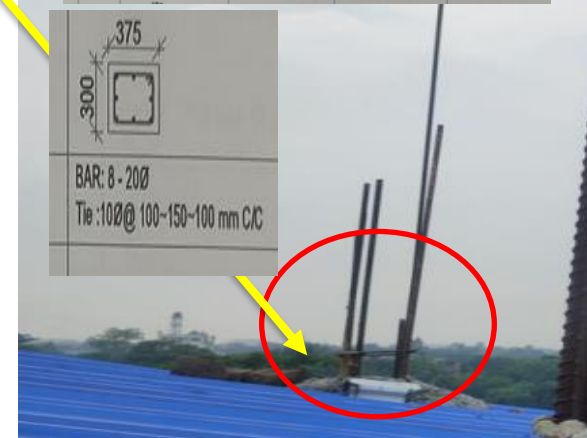
C2 type column rebar orientation did not match with drawing.

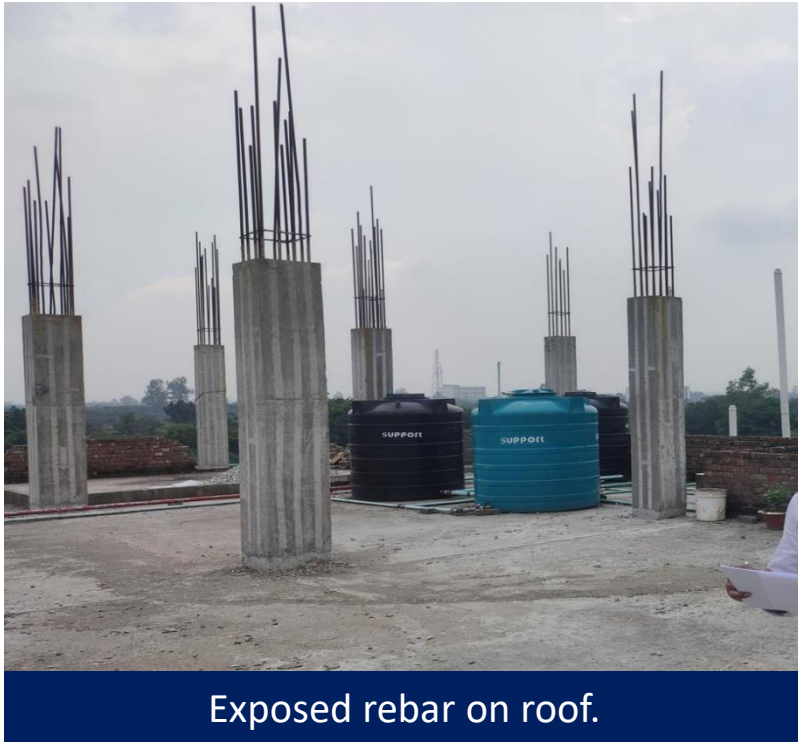
Exposed rebar on roof.

Provide rust proof coating on rebar to prevent from corrosion. And complete parapet wall on the roof.

| Item No. | Observation | Recommended Action Plan | Recommended Timeline |
|---|---|---|---|
| 11 | Exposed rebar & Falling hazard on the roof. (Main Building). | Provide rust proof coating on the exposed rebar to prevent from corrosion. | 6-weeks |

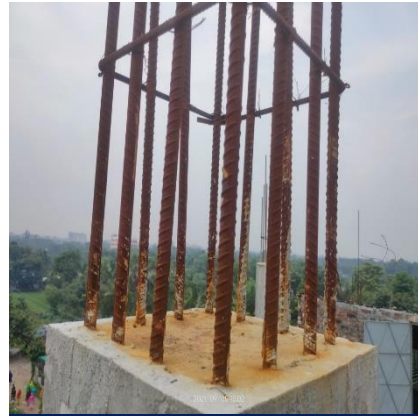
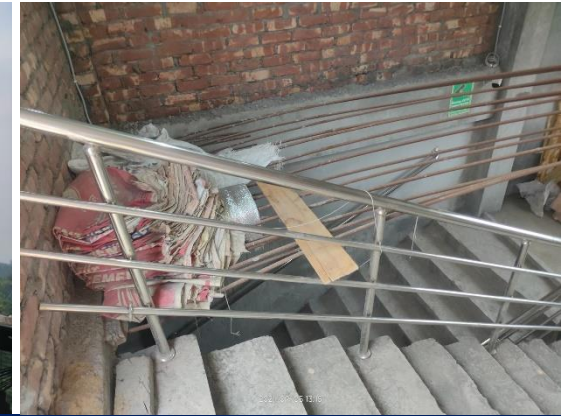
Corroded rebar

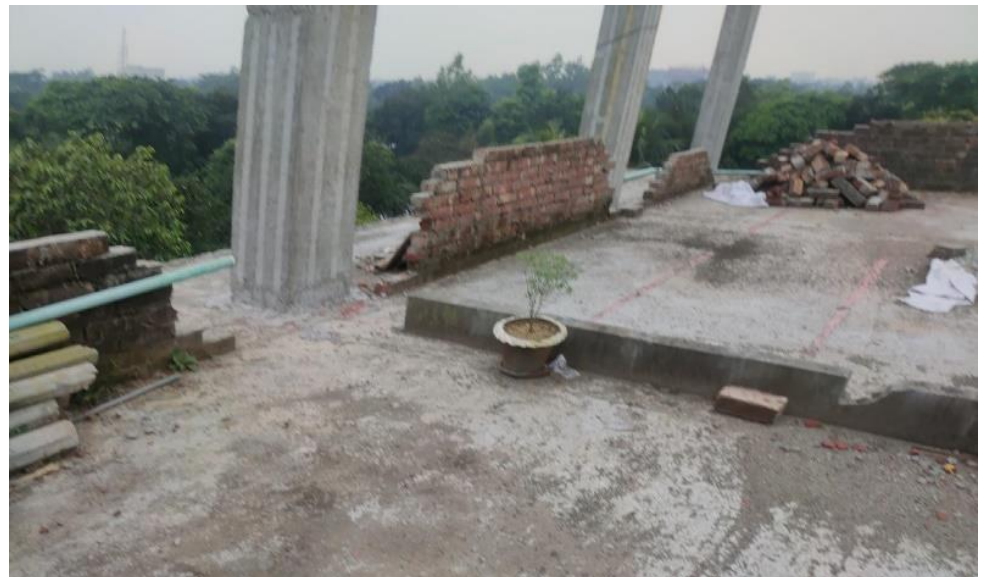
Incomplete parapet wall on the roof

| Item No. | Observation | Recommended Action Plan | Recommended Timeline |
|---|---|---|---|
| 12 | Exposed rebar & Falling hazard on the roof. (Main Building). | Complete the parapet wall on the roof to prevent falling hazard. | 6-weeks |

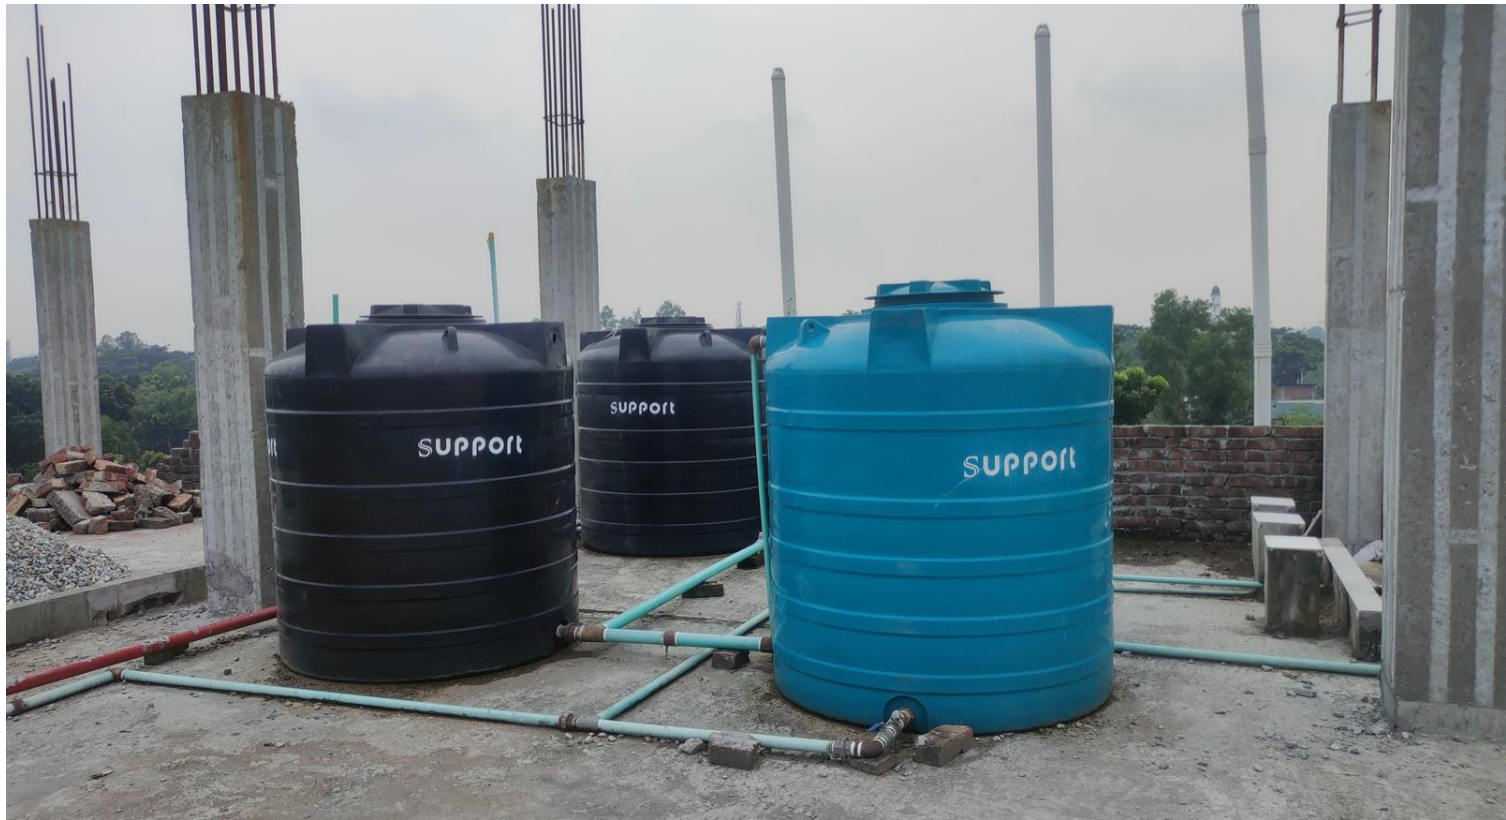
3x2000 liter plastic water tanks on the roof

| Item No. | Observation | Recommended Action Plan | Recommended Timeline |
|---|---|---|---|
| 13 | Undocumented plastic water tanks on the roof. (Main Building) | Prepare a floor loading plan considering the plastic water tanks and re-arrange the tanks accordingly. | 6-weeks |

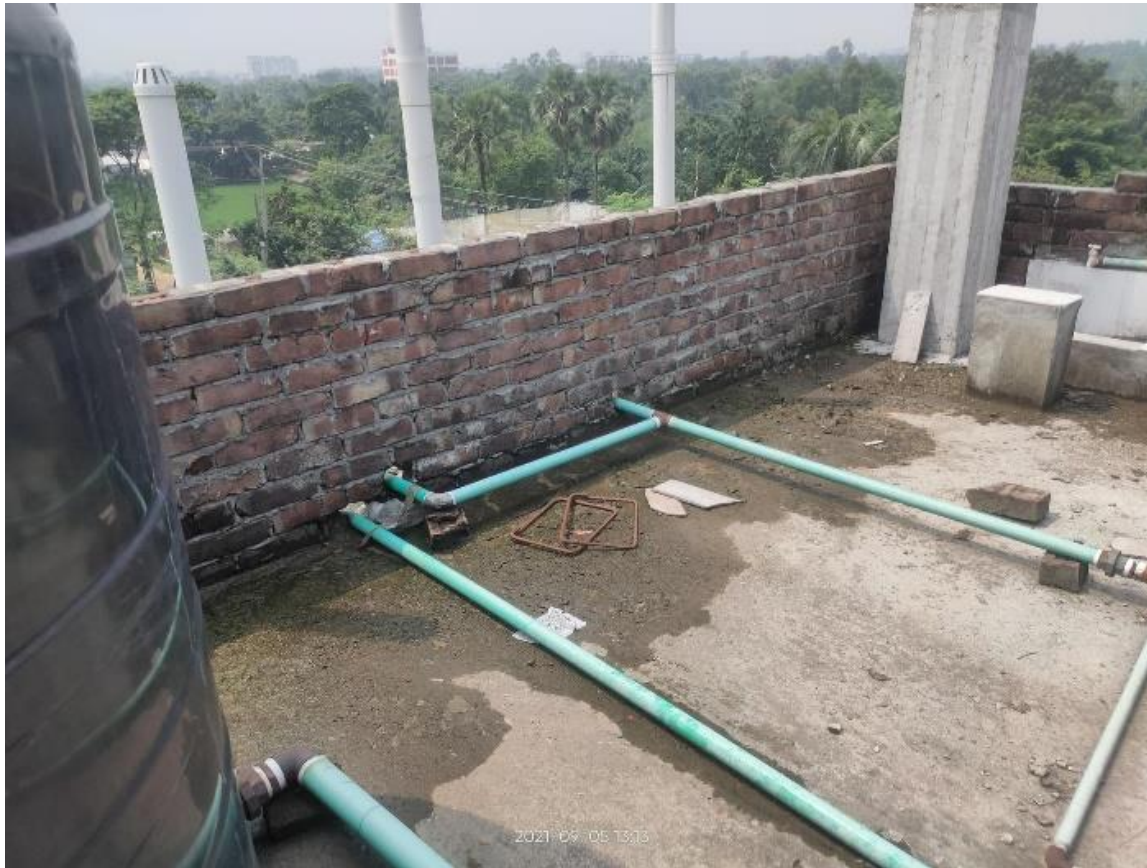
Stagnant water on the roof

Develop proper drainage system with adequate slope on roof.

| Item No. | Observation | Recommended Action Plan | Recommended Timeline |
|---|---|---|---|
| 14 | Water stagnant and drainage system on roof. (Main Building) | Develop proper drainage system on the roof with adequate slope. | 6-weeks |

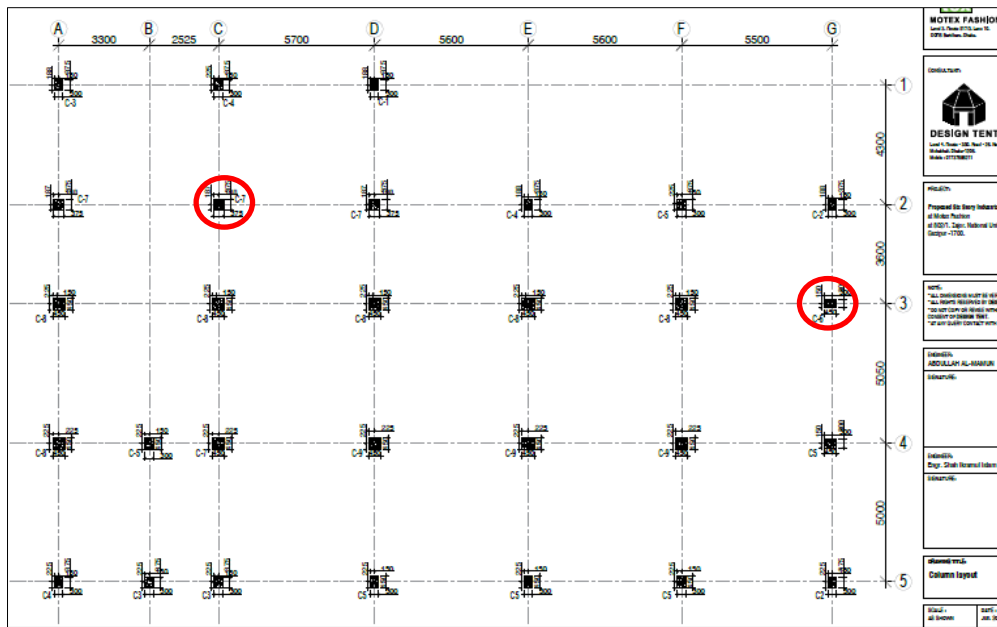
Column & footing at grid C-2 and G-3

Vertical extension work of this building is going on. Cursory calculation indicates that for proposed 6 storied building the stress in column and footing will be exceeded normal design limit. The calculation is carried out based on minimum concrete strength and proposed floor live load of design report.

| Item No. | Observation | Recommended Action Plan | Recommended Timeline |
|---|---|---|---|
| 15 | Column and Footing to be overstressed for proposed 6 storey Building. (Main Building) | Before commencing any extension works the factory is required to carryout Detailed Engineering Assessment (DEA) and required remedial works arise from DEA. | 6-weeks |

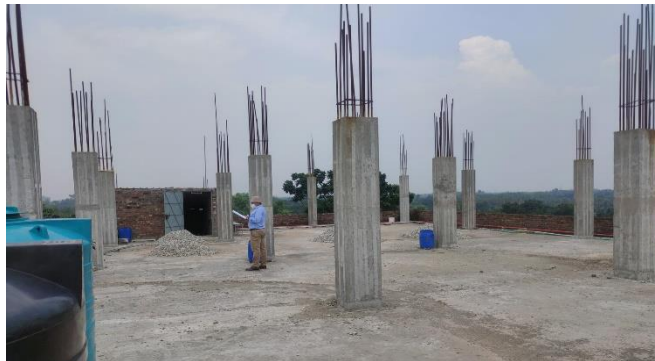
Extension work on 4th floor
