# **FIRE SAFETY INSPECTION REPORT**

**MOZART KNIT LTD**

**BASHAID, ASHULIA**

May 25, 2014

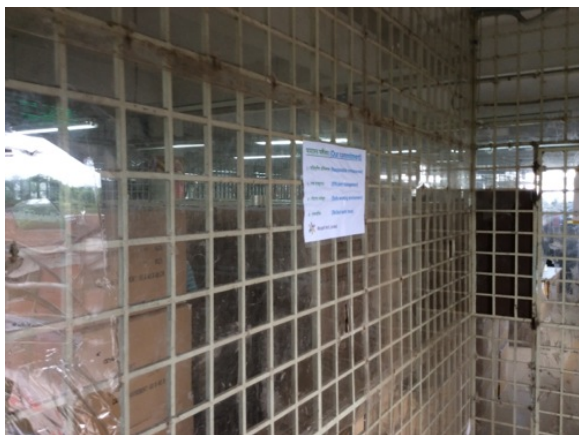
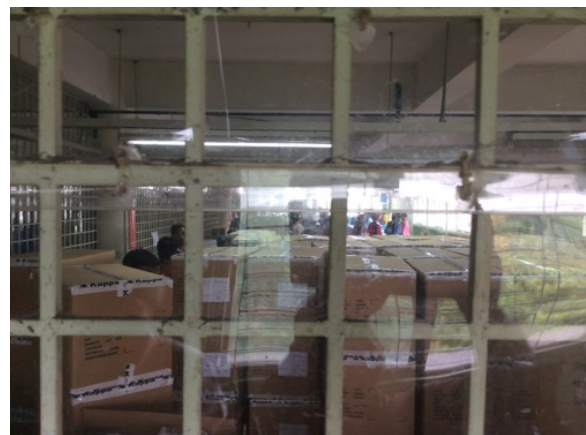
| No. | Category | Finding | Recommendation | Remediation Timeframe |
|---|---|---|---|---|
| F-1 | Fire Rated Construction | The finished goods storage on the 2nd floor is not separated from the adjacent work areas by fire-rated construction. | <p>Provide dedicated storage rooms separated by minimum 1-hr fire-rated construction.</p> <p>Where separate storage rooms are not feasible, provide defined storage areas and limit the storage arrangement as follows:</p> <ul style="list-style-type: none"> <li>- Maximum height of 2.4m and maximum area of 23m<sup>2</sup></li> <li>- If sprinkler protected: maximum height of 3.66m and maximum area of 93m<sup>2</sup></li> </ul> <p>Separate areas of unenclosed combustible storage by a minimum clear distance of 3m.</p> | Within 3 months |

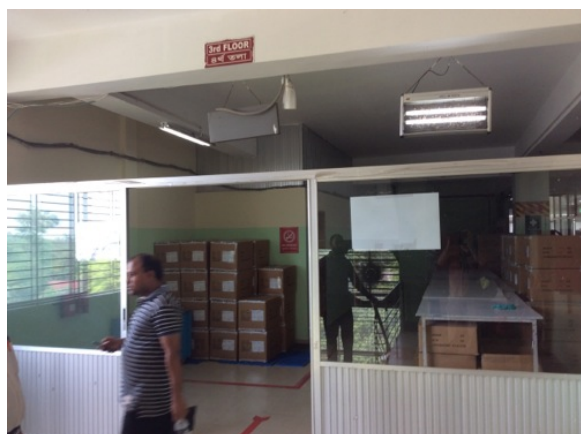
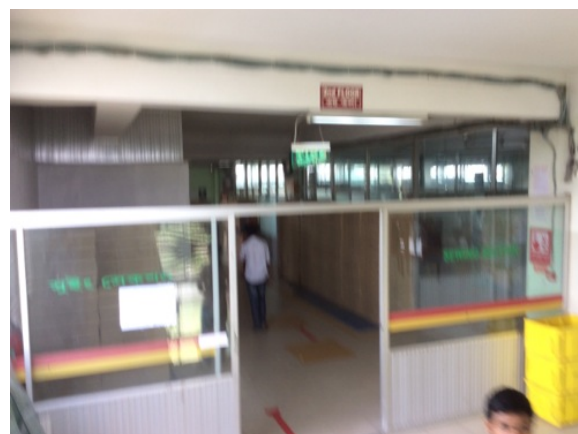
| F-2 | Fire Rated Construction | <p>The exit stairs are not separated from work areas and other spaces on each floor by fire-rated construction. The Northwest and East stairs each have no separation on one side. The East stair is completely non-separated from the storage areas on the ground floor.</p> | <p>Provide minimum 1.5-hr fire rated doors and seal all unprotected openings to separate the exit stairs from work areas and other building spaces on all floor levels. Ensure that the fire doors are self-closing and positive latching and that they are provided with fire exit (panic) hardware where serving production floors.</p> <p>If fire doors are required to be held open for functional reasons, provide automatic-closing devices tied to the fire alarm system.</p> | Within 3 months |

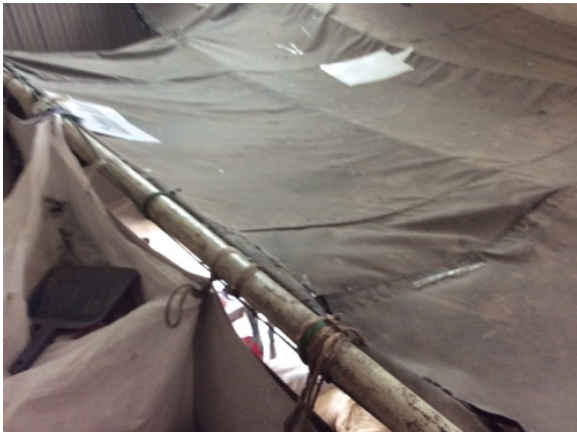
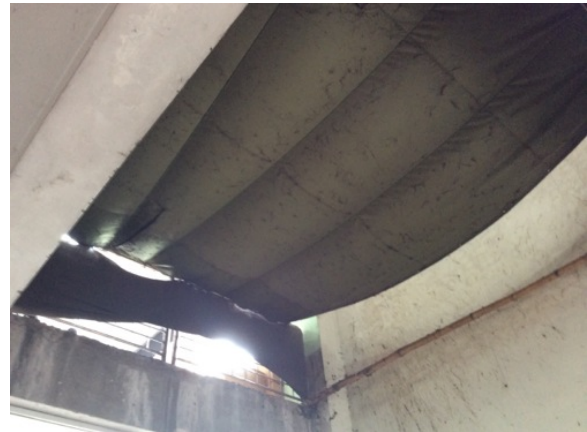
| F-3 | Fire Rated Construction | <p>Unsealed penetrations and openings are located in the fire-rated floor/ceiling assemblies. A pit on the South end of the building connects all floors of the building and has no fire-rated shaft enclosure.</p> | <p>Provide a minimum 2-hr fire-rated shaft to separate floor openings that connect multiple floors.</p> <p>Seal all penetrations and openings in floor/ceiling assemblies to maintain the fire separation.</p> | Within 3 months |

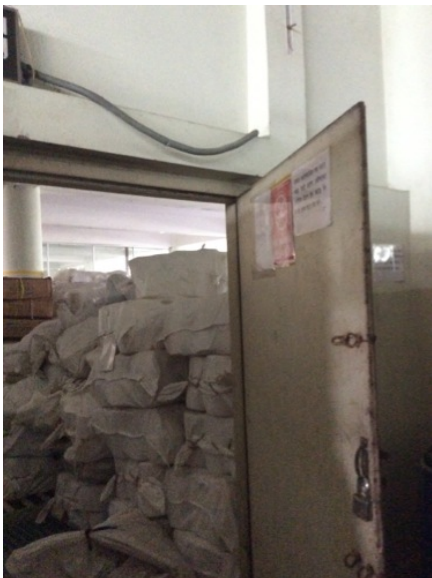
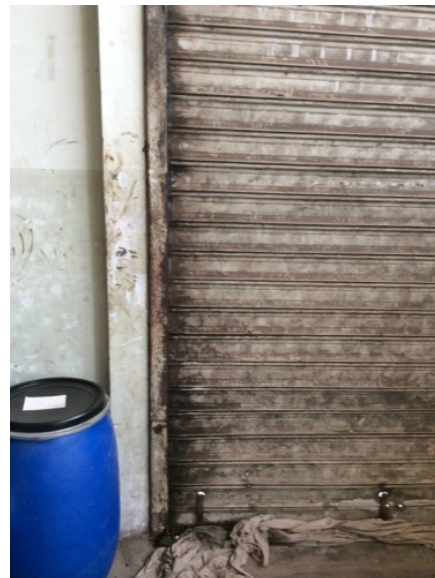
| F-4 | Egress | Egress doors with locking features are provided at multiple stair openings and exit discharges. | Remove locking features from all egress doors.<br><br>If locks are required for security reasons, utilize special door locking features complying with NFPA 101. | Immediate |

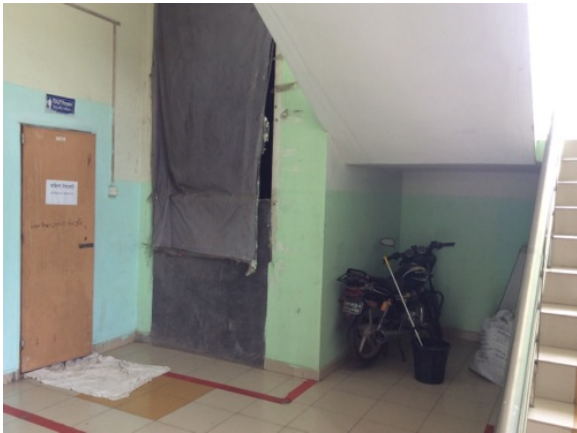
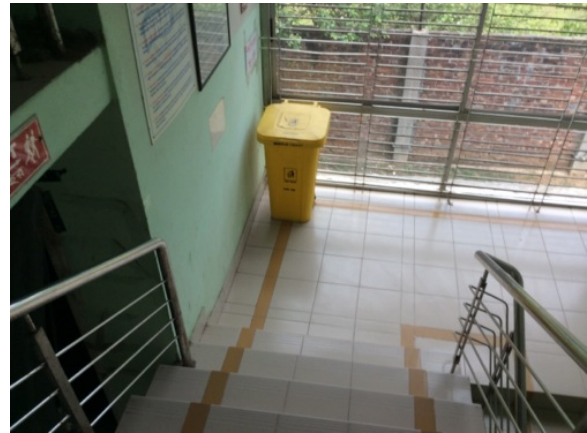
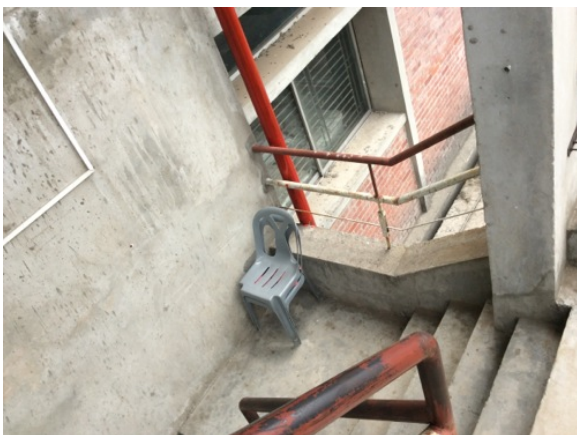
| F-5 | Egress | Storage was located in the exit stair. A motorcycle was stored at the base of the Northwest stair. A dustbin was observed at a landing in the Northwest stair. A chair was observed on a landing in the Northeast stair. | Remove all storage from exit stairs and egress paths. | Immediate |

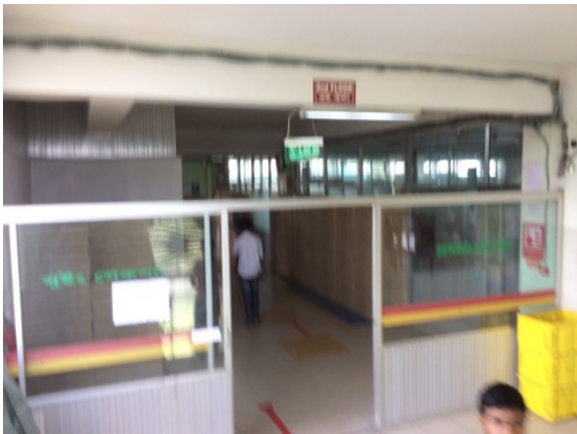
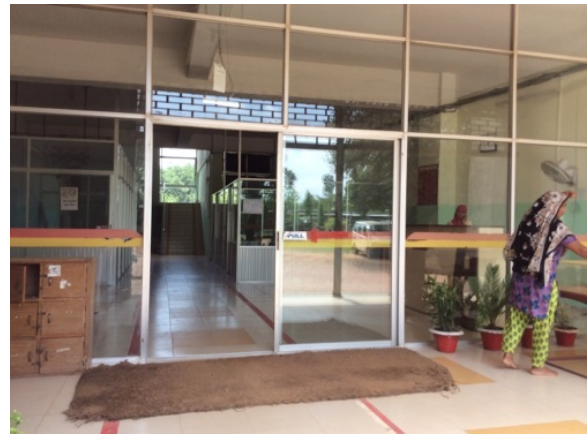
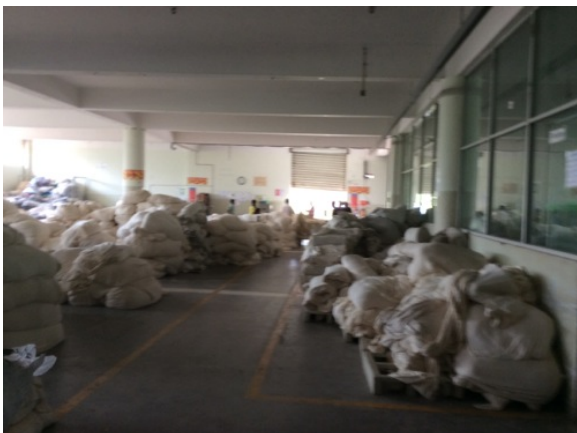
| F-6 | Egress | Sliding doors are provided at multiple Northwest and East exit stair openings and discharge. Overhead Coiling doors are used on multiple ground floor exits. | Replace all gates and sliding doors along the means of egress with side-hinged, swinging egress doors.<br><br>If locks are required for security reasons, utilize special door locking features complying with NFPA 101. | Within 1 month |

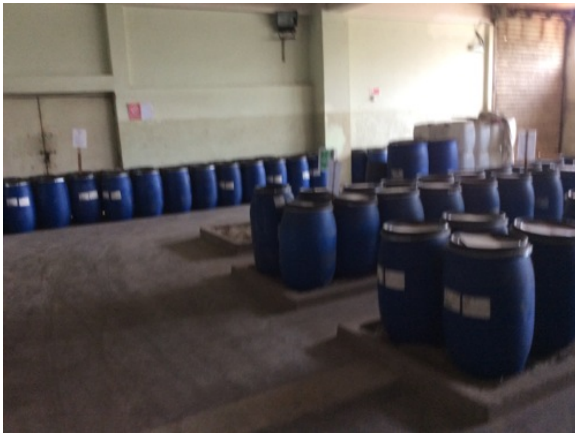
| F-7 | Egress | Common path of egress travel in the bonded warehouse exceeds 30 m, due to locked and blocked secondary exit doors. | Reconfigure the egress arrangement to reduce the maximum common path of travel to not more than 30 m. | Within 3 months |

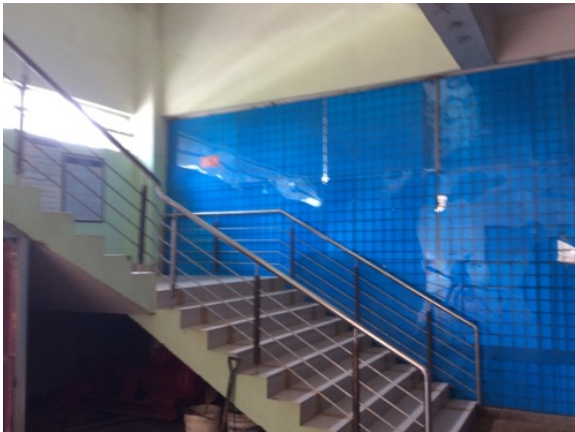
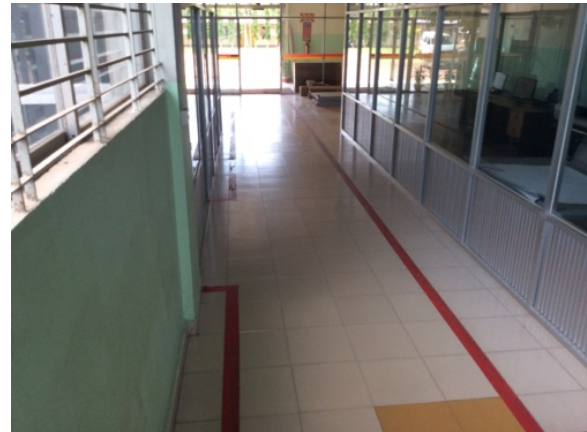
| F-8 | Egress | Exit stairs discharge inside the building. The East exit stair discharges within the storage areas on the ground floor. The Northwest exit stair discharges through a ground floor lobby which has non-rated doors connecting it to the bonded warehouse. | Correct these conditions by one of the following means:<br>- Modify stair to discharge directly outside.<br>- Provide 2-hr fire-rated exit passageway leading directly outside (vestibules to separate any storage areas). | Within 6 months |

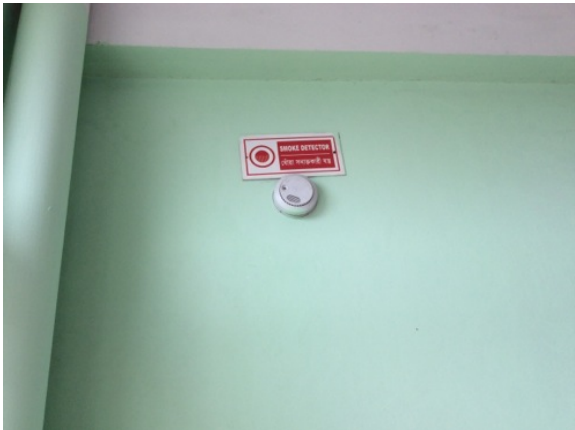
| F-11 | Fire Protection | The building is equipped with single-station smoke alarms. Smoke alarm activation sounds only a local alarm and does not provide automatic fire alarm notification of occupants. | Remove single-station smoke alarms. Provide automatic smoke detection throughout the building in accordance with NFPA 72. | Within 6 months |

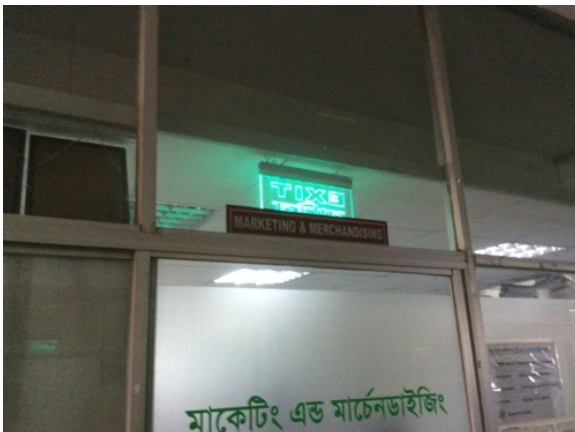
| F-12 | Egress Lighting | Multiple lighted exit signs throughout the building were two-sided, so that they were visible from the wrong direction. | Provide lighted exit signs visible only from the direction leading toward the exit path. | Within 1 month |

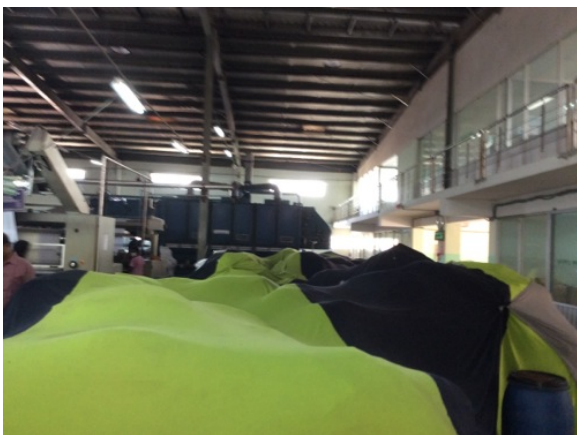
| No. | Category | Finding | Recommendation | Remediation Timeframe |
|---|---|---|---|---|
| F-1 | Fire Rated Construction | Large amounts of storage are open to the factory floor. | <p>Provide dedicated storage rooms separated by minimum 1-hr fire-rated construction.</p> <p>Where separate storage rooms are not feasible, provide defined storage areas and limit the storage arrangement as follows:</p> <ul style="list-style-type: none"> <li>- Maximum height of 2.4m and maximum area of 23m<sup>2</sup></li> <li>- If sprinkler protected: maximum height of 3.66m and maximum area of 93m<sup>2</sup></li> </ul> <p>Separate areas of unenclosed combustible storage by a minimum clear distance of 3m.</p> | Within 3 months |

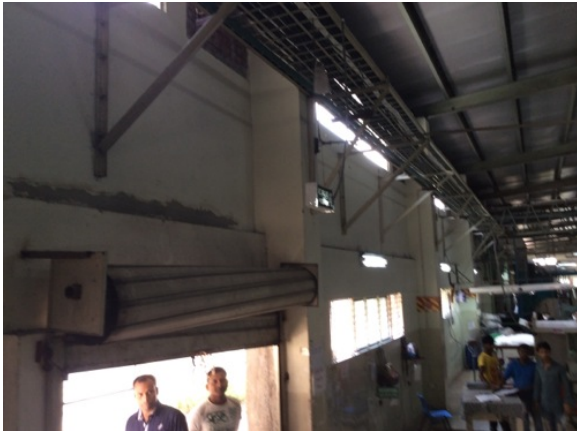
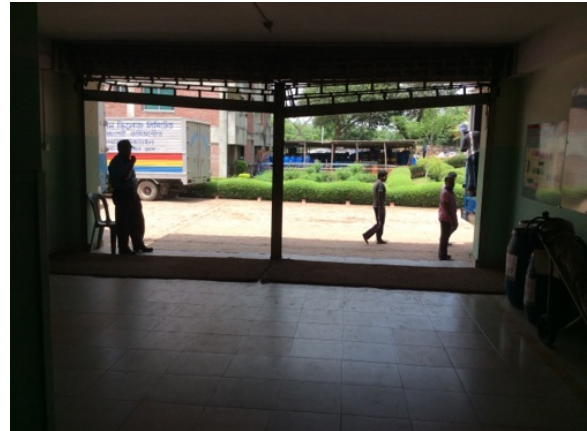
| F-2 | Egress | Egress doors with locking features are provided at multiple stair openings and exit discharges. | Remove locking features from all egress doors.<br><br>If locks are required for security reasons, utilize special door locking features complying with NFPA 101. | Immediate |

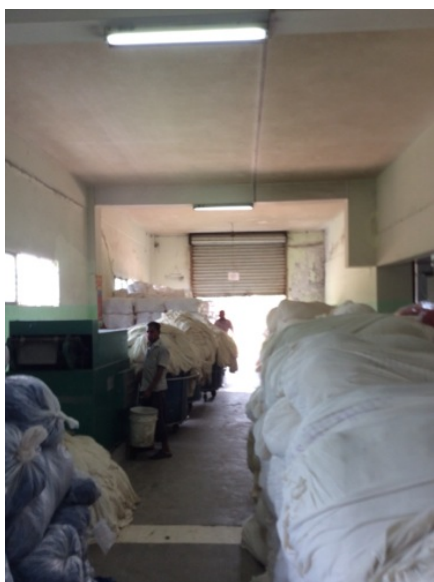
| F-3 | Egress | The path to the Northeast exit door was restricted by storage. | Keep egress paths and stairs clear of storage. | Immediate |

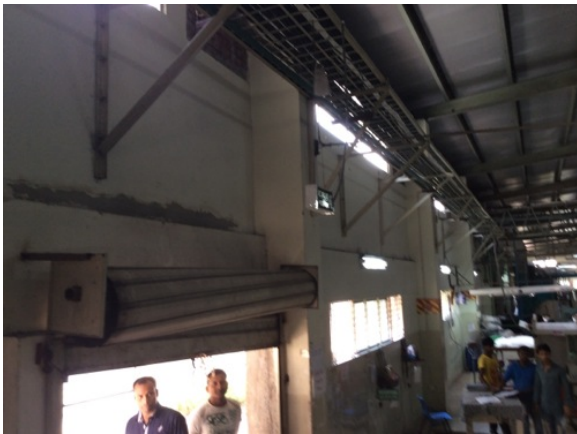
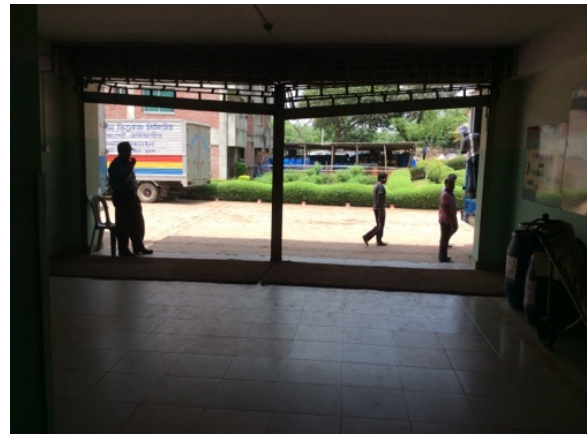
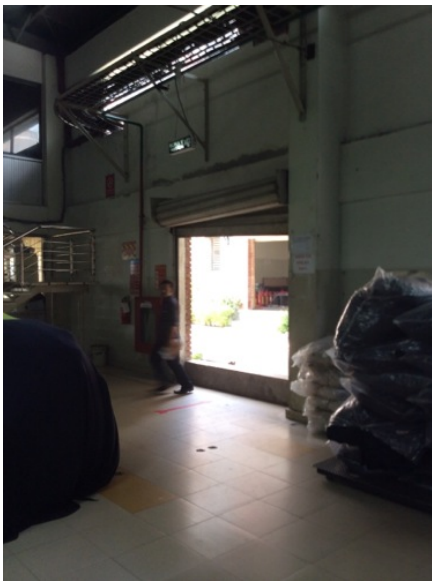
| F-4 | Egress | Overhead coiling doors were provided at all ground level exits. | Replace all gates and sliding doors along the means of egress with side-hinged, swinging egress doors. | Within 1 month |

If locks are required for security reasons, utilize special door locking features complying with NFPA 101.

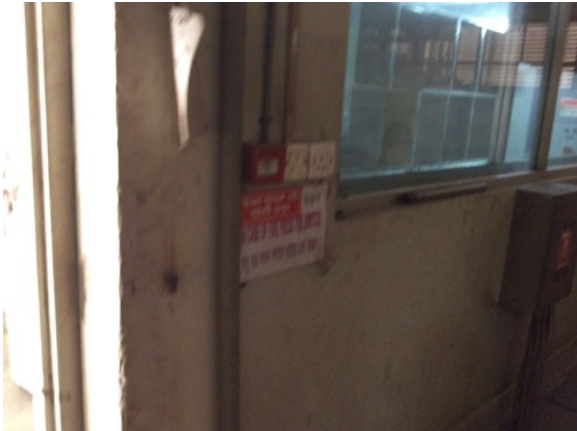
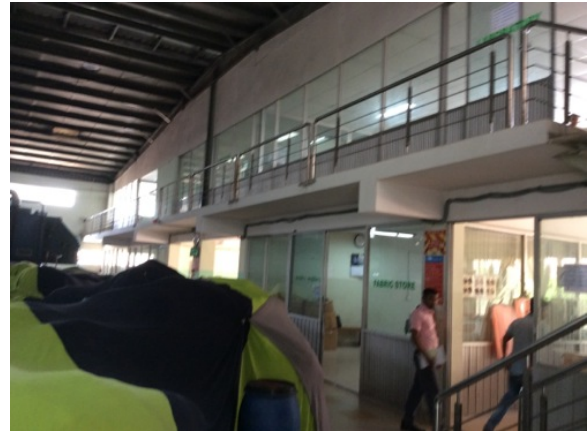
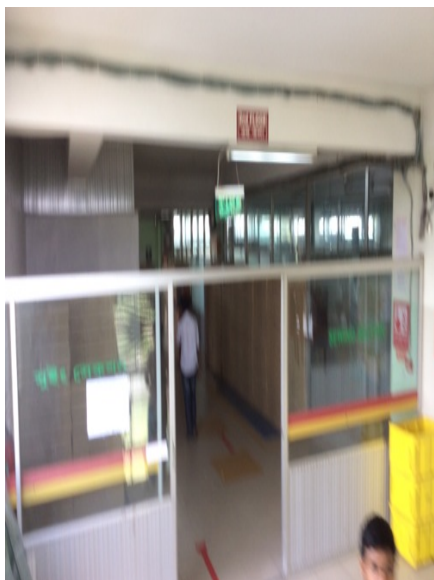
| F-5 | Fire Protection | The fire alarm system is antiquated, not a listed system, and does not provide alarm and notification features consistent with acceptable standards. | Replace the fire alarm system with a new, listed addressable fire alarm system in accordance with NFPA 72. | Design within 4 months, install within 9 months |

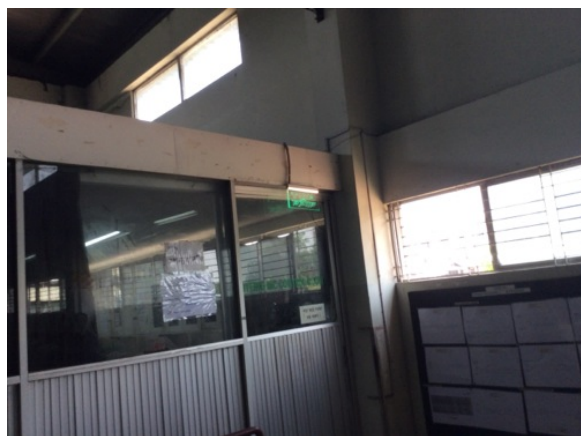
| F-8 | Egress Lighting | Multiple lighted exit signs throughout the building were two-sided, so that they were visible from the wrong direction. | Provide lighted exit signs visible only from the direction leading toward the exit path. | Within 1 month |
