# Euro Jeans Ltd (New Shed)

Vogra, Chowdhury Bari, Gazipur  
(23.978714, 90.379255)

07 September 2021

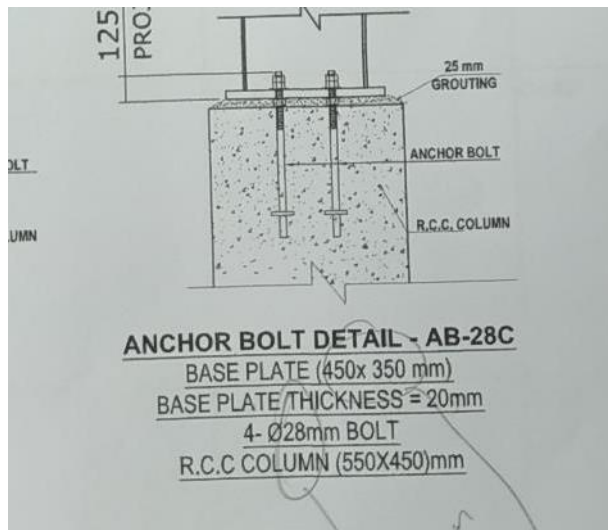
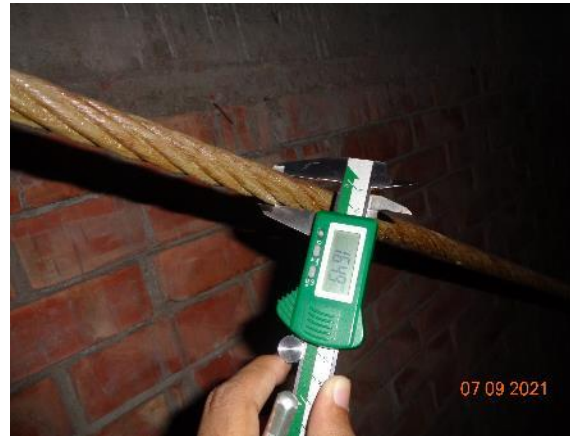
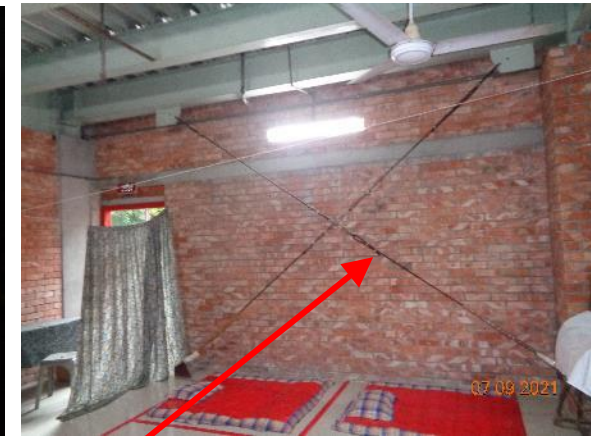
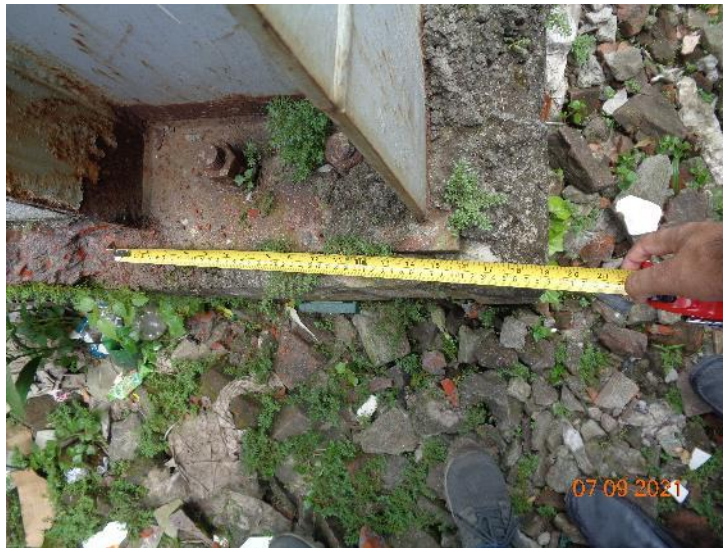
Base plate of AB-28C was found 400mm X 300mm instead of 450mm X 350mm

| Item No. | Observation | Recommended Action Plan | Recommended Timeline |
|---|---|---|---|
| 05 | Inconsistencies in the drawing. (Shed-3) | The building engineer to survey the structure and update the as-built drawings accordingly. | 6-weeks |

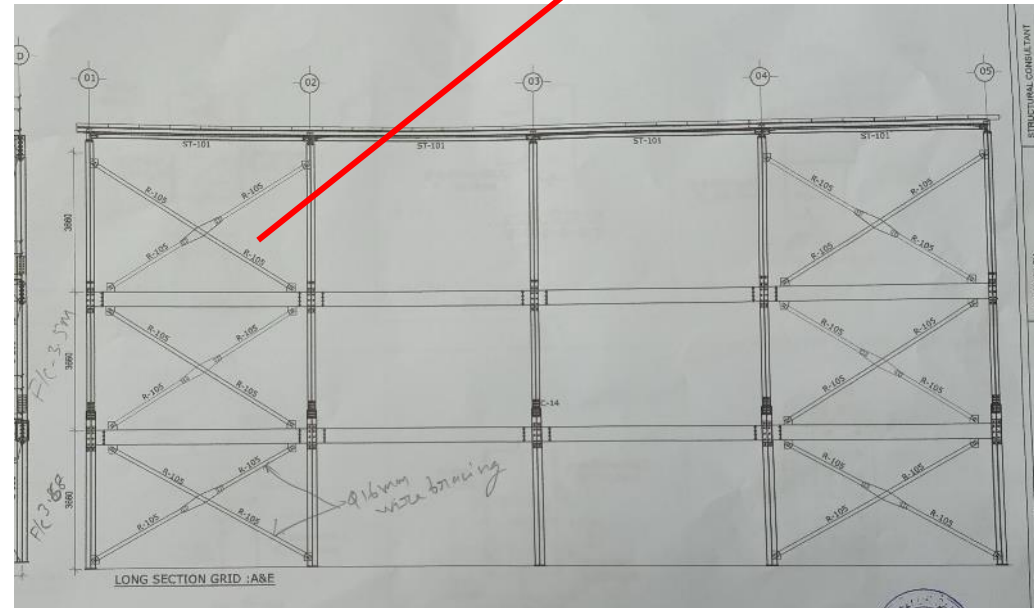
16 mm Cable bracings were found in as-built condition whereas drawing shows box bracings

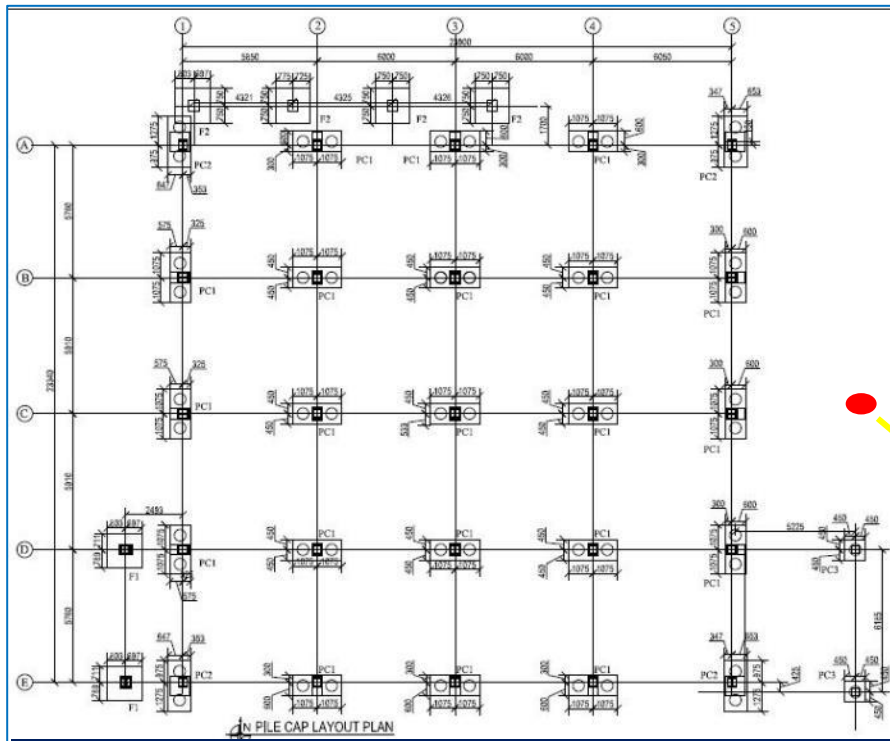
Pile Cap Layout

Marked column did not shown in drawings. Also, foundation of the column is unknown.

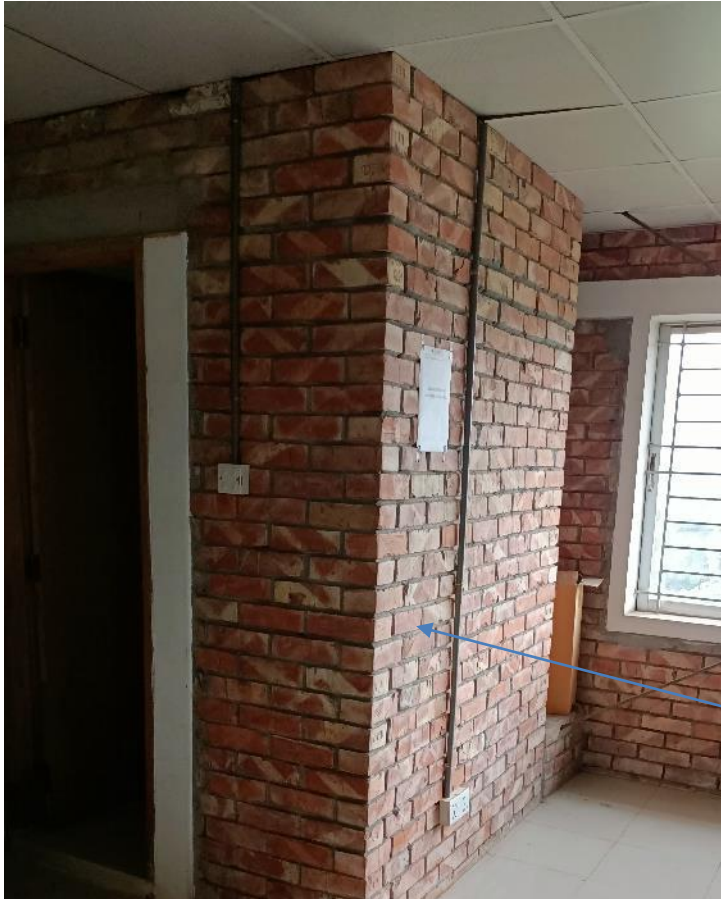
Toilet zone of 1<sup>st</sup> floor  
Not shown in drawings

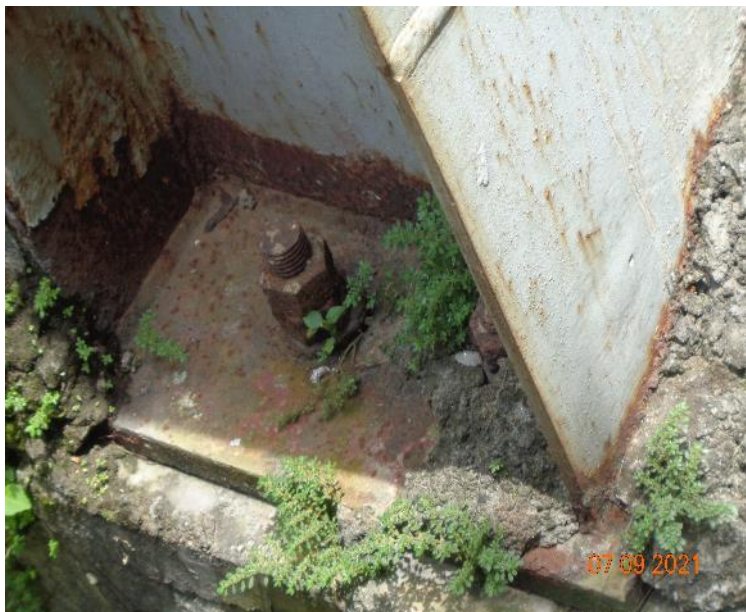
Corrosion in Base Plate

Corrosion in steel member was observed in several locations. The building engineer to investigate the reason of corrosion and suggest proper remedial measure accordingly.

| Item No. | Observation | Recommended Action Plan | Recommended Timeline |
|---|---|---|---|
| 06 | Corrosion in steel member. (Shed-3) | The building engineer to investigate the reason of corrosion and suggest proper remedial measure accordingly. | 6-weeks |
| 07 | Corrosion in steel member. (Shed-3) | Take necessary measures to prevent further corrosion and repair the corroded steel members as per engineer's suggestion. | 6-months |

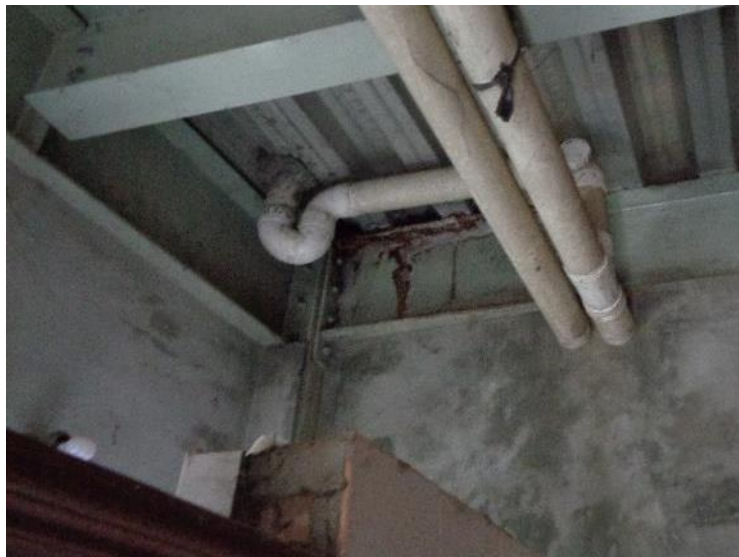
Corrosion in steel beam

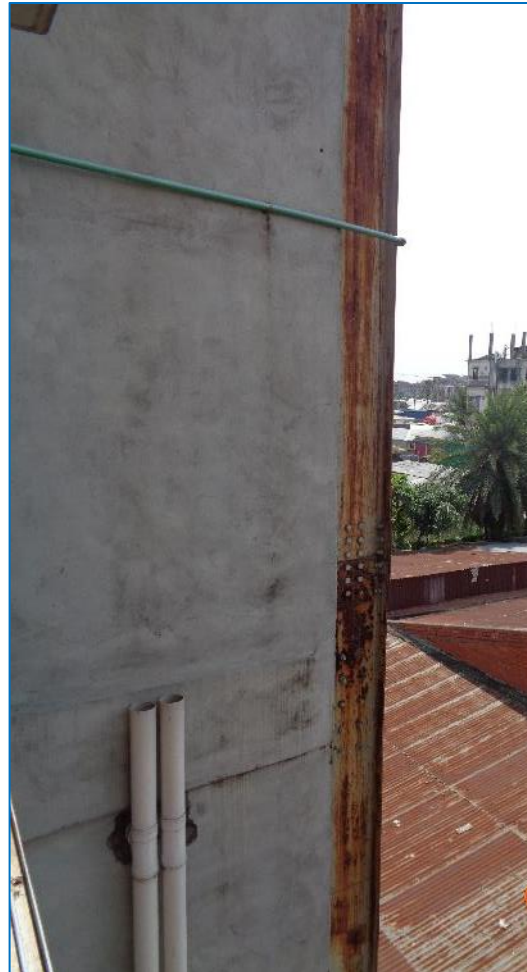
Corrosion in steel column

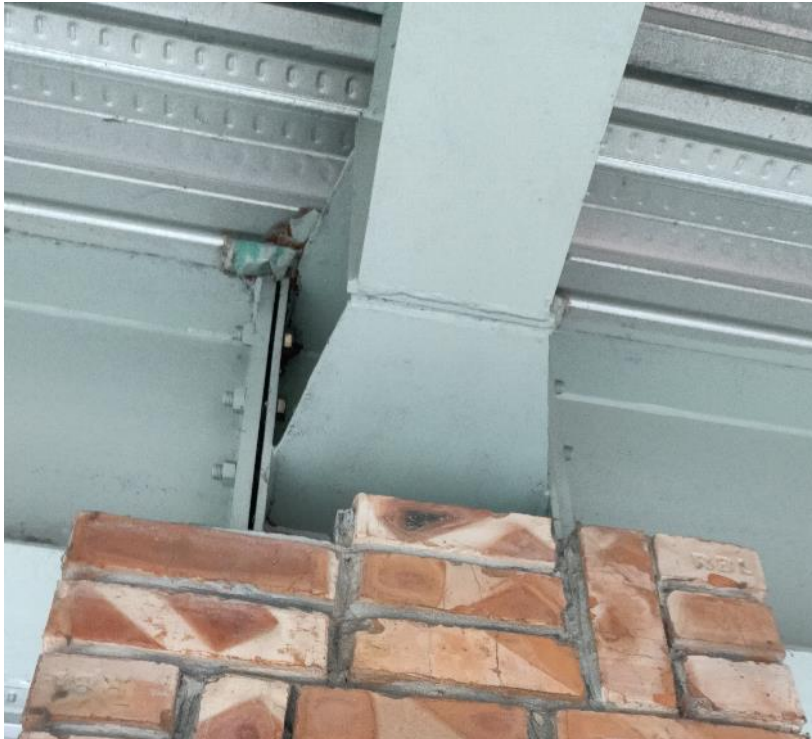
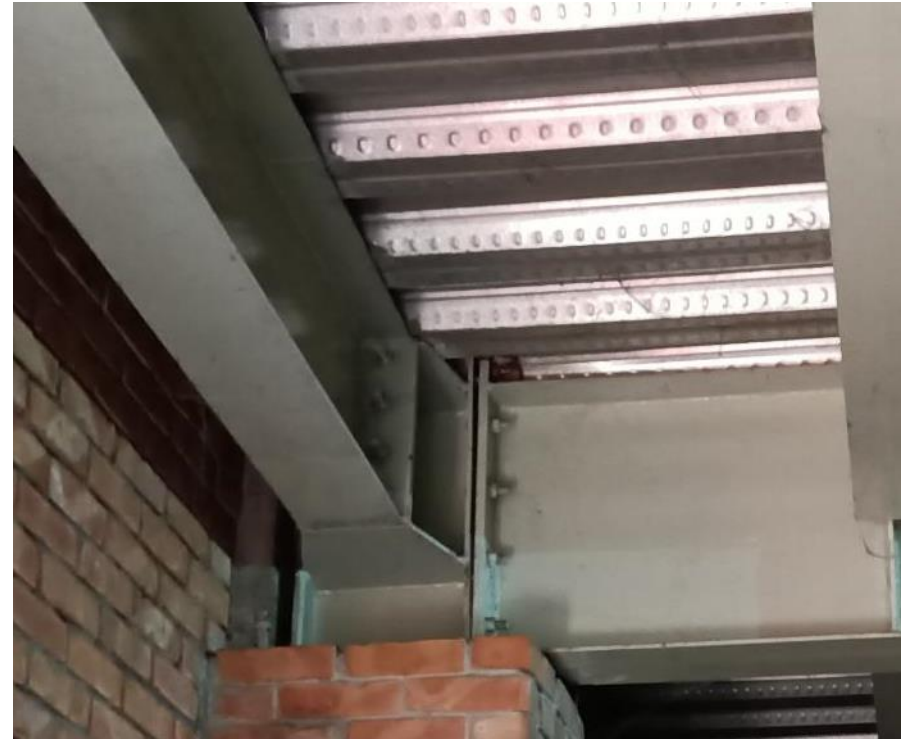
Gap observed in Beam- Column connection

Significant gaps observed at column-beam joint at several locations. Factory engineer is required to carry out suitable remedial works.

| Item No. | Observation | Recommended Action Plan | Recommended Timeline |
|---|---|---|---|
| 08 | Significant connection gap. (Shed-3) | Identify the locations of connection gaps and carryout suitable repair works where necessary. | 6-weeks |

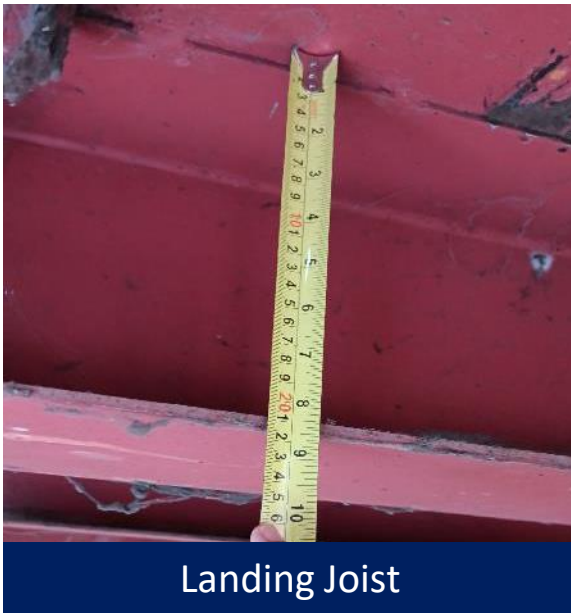
Landing Joist

The sizes of steel tie beam and landing joist are not matched with drawings. Web of landing joist was measured 210 mm instead of 250 mm. Flange thickness of tie beam was found 6 mm whereas drawing shows 10 mm. Also, the web of tie beam was measured 160 mm instead of 250 mm

| Item No. | Observation | Recommended Action Plan | Recommended Timeline |
|---|---|---|---|
| 09 | Mismatch in drawing. (Shed-3, External Steel Stair) | The building engineer to survey the structure and update the as-built drawings accordingly. | 6-weeks |

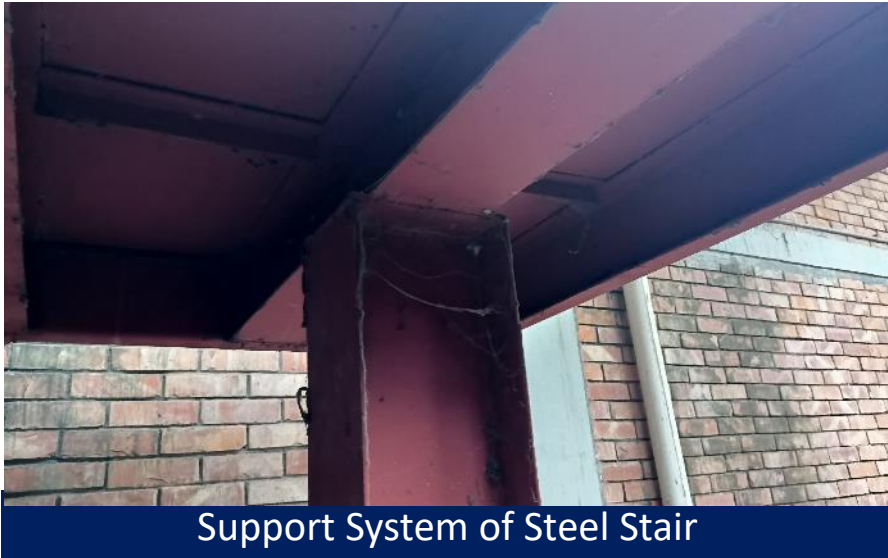
Support System of Steel Stair

External steel stair is standing on single grid column. There is no visible lateral stability system. Factory engineer is required to carry out connection adequacy & lateral stability check of the steel stair.

| Item No. | Observation | Recommended Action Plan | Recommended Timeline |
|---|---|---|---|
| 10 | Lateral Stability. (Shed-3, External Steel Stair) | The building engineer is required to carry out connection adequacy & lateral stability check of the steel stair. | 6-weeks |
| 11 | Lateral Stability. (Shed-3, External Steel Stair) | Implement remediation work where necessary. | 6-months |
