# Refat Garments Ltd (Extended Building)

144, 147-148 East Narashingapur, Ashulia, Savar, Dhaka, Bangladesh.

1<sup>st</sup> June & 5<sup>th</sup> September 2021

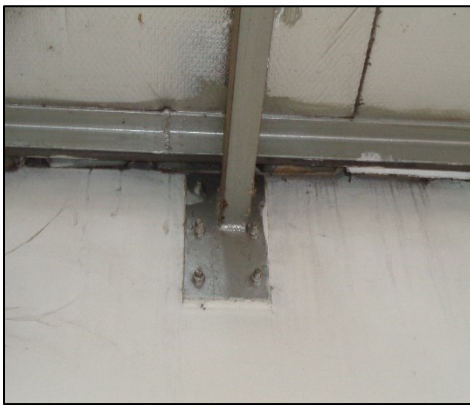
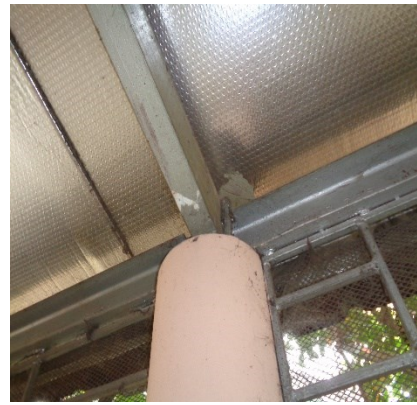
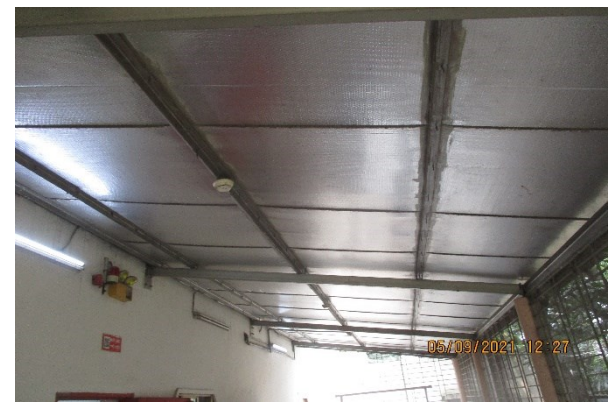
**Lack of lateral stability**

The steel roof shed made of steel truss section which is supported by RC column and brick wall in both direction. No horizontal bracing members are available for lateral stability. Apparently Inadequate structural member, poor connection details found and unclear load path. Building engineer is required to check the adequacy of the steel members & connection for uplift and lateral forces otherwise replace with engineered structure.

| Item No. | Observation | Recommended Action Plan | Recommended Timeline |
|---|---|---|---|
| 03 | Lack of stability. (New Child Care Building) | Factory engineer is required to check the stability of the structure and prepare engineering assessment (EA) for the in compliance with section 1.9.1.1 (part-6, BNBC). | 6-weeks |
| 04 | Lack of stability. (New Child Care Building) | Implement remedial work if required. | 6-months |

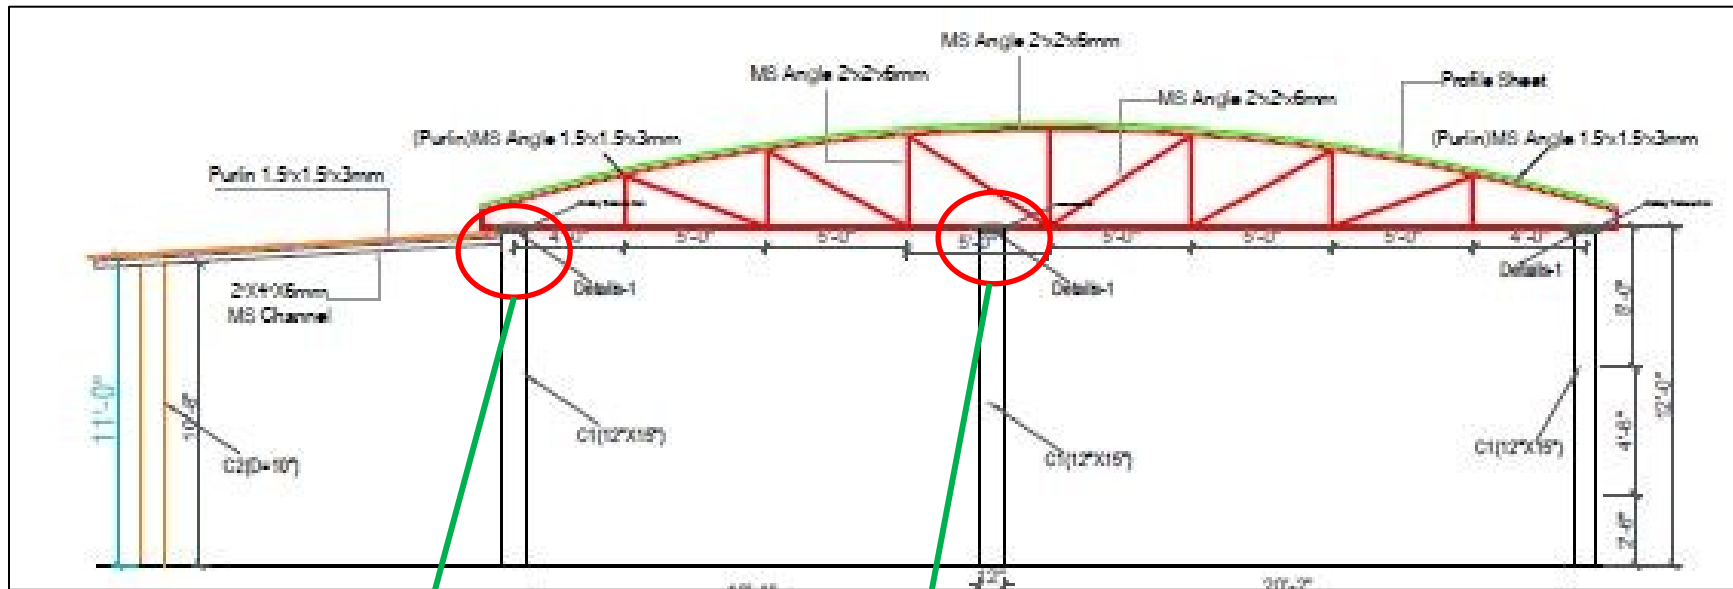
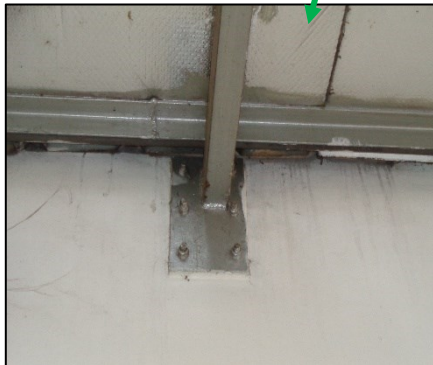
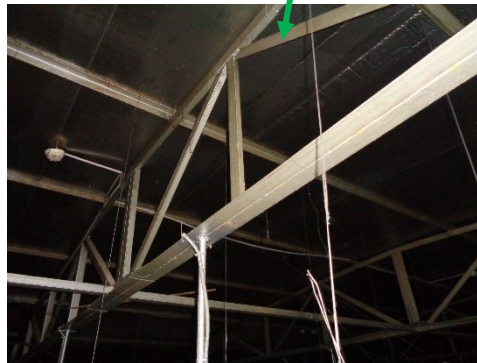
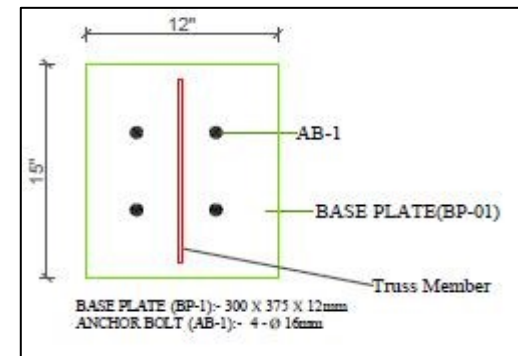
Sectional Detail of Truss

There were double angle in bottom chord which was not mentioned in as-built drawing. Also, Connection detail between column and truss was shown bolted with base plate which was found welded. C-channel was connected with brick wall not with RC column (as per provided drawing). Factory engineer to survey the structure and update as-built drawings for the structure.

| Item No. | Observation | Recommended Action Plan | Recommended Timeline |
|---|---|---|---|
| 05 | Discrepancies in as-built drawings. (New Child Care Building) | Factory engineer is required to survey the whole structure and prepare “as constructed” drawings (Architectural & Structural), in compliance with section 1.9.1.2 as per BNBC 2006. | 6-weeks |

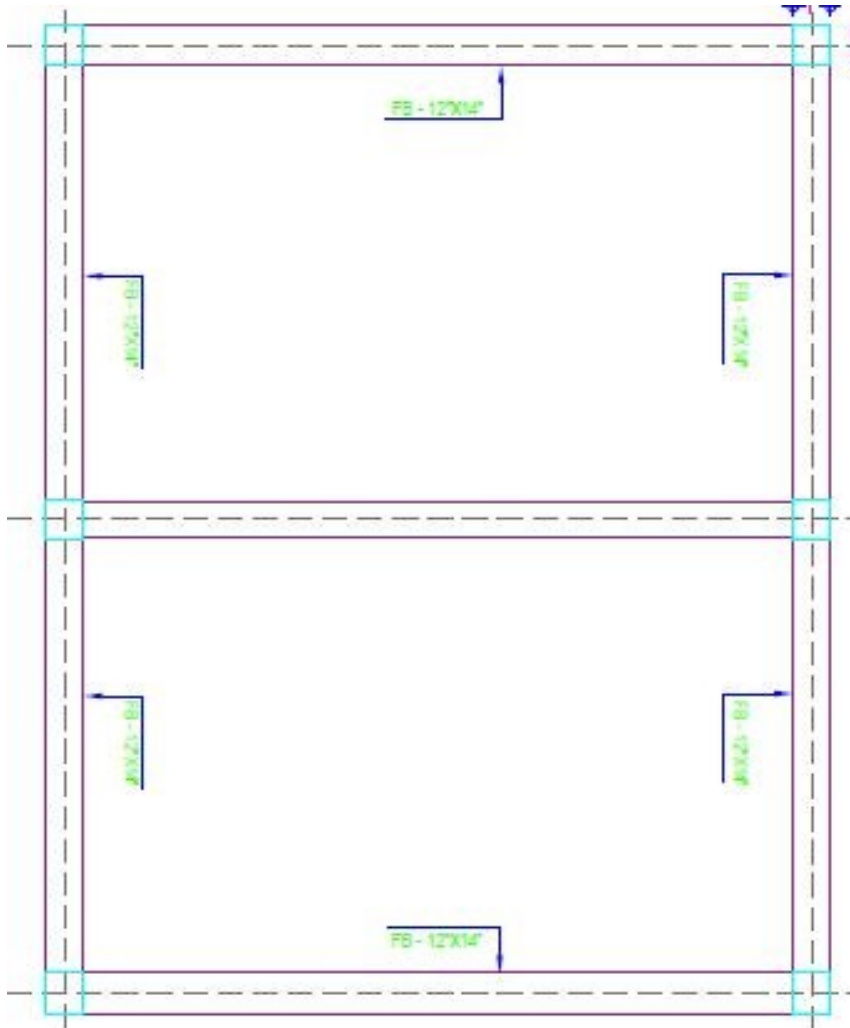
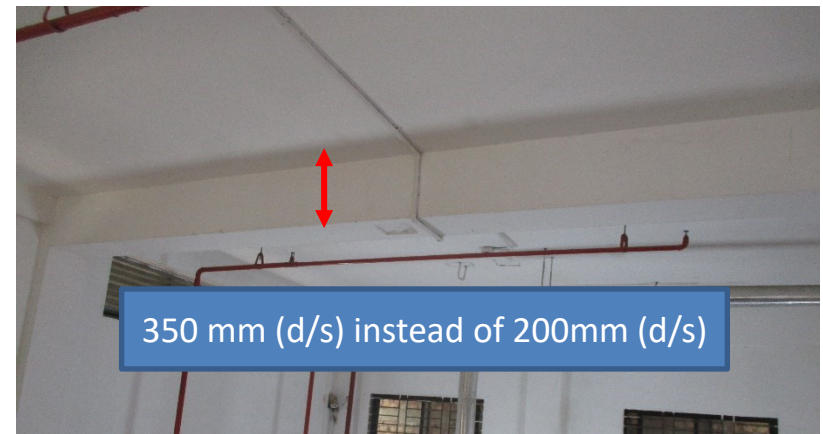
Beam layout

Beam size found 250 X 350 mm (d/s) instead of 250 X 200 mm (d/s) in transverse direction. Undocumented steel stair not mentioned in as-built drawing. Factory engineer to survey the structure and update as-built drawings for the structure.

| Item No. | Observation | Recommended Action Plan | Recommended Timeline |
|---|---|---|---|
| 06 | Discrepancies in as-built drawings. (Fire Pump House) | Factory engineer is required to survey the whole structure and prepare “as constructed” drawings (Architectural & Structural), in compliance with section 1.9.1.2 as per BNBC 2006. | 6-weeks |

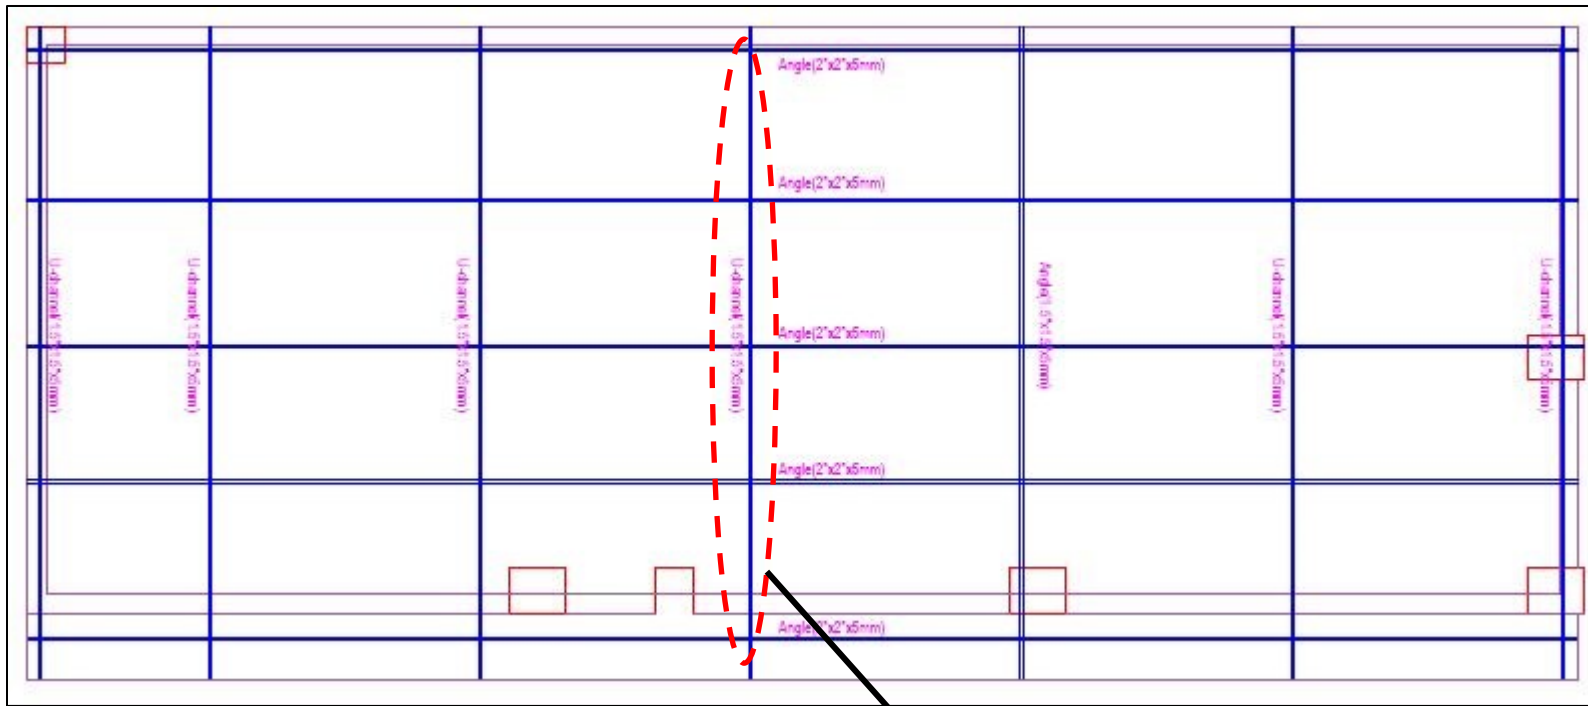
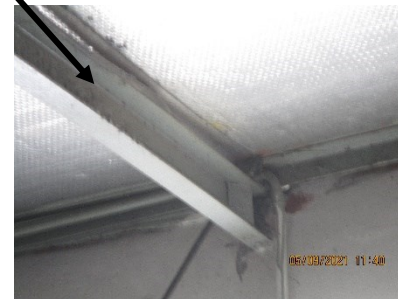
Roof truss layout

C channel size was found 38x75x5 mm instead of 38x38x5 mm. Factory engineer to survey the structure and update as-built drawings for the structure.

| Item No. | Observation | Recommended Action Plan | Recommended Timeline |
|---|---|---|---|
| 07 | Discrepancies in as-built drawings. (Water Pump Room) | Factory engineer is required to survey the whole structure and prepare “as constructed” drawings (Architectural & Structural), in compliance with section 1.9.1.2 as per BNBC 2006. | 6-weeks |

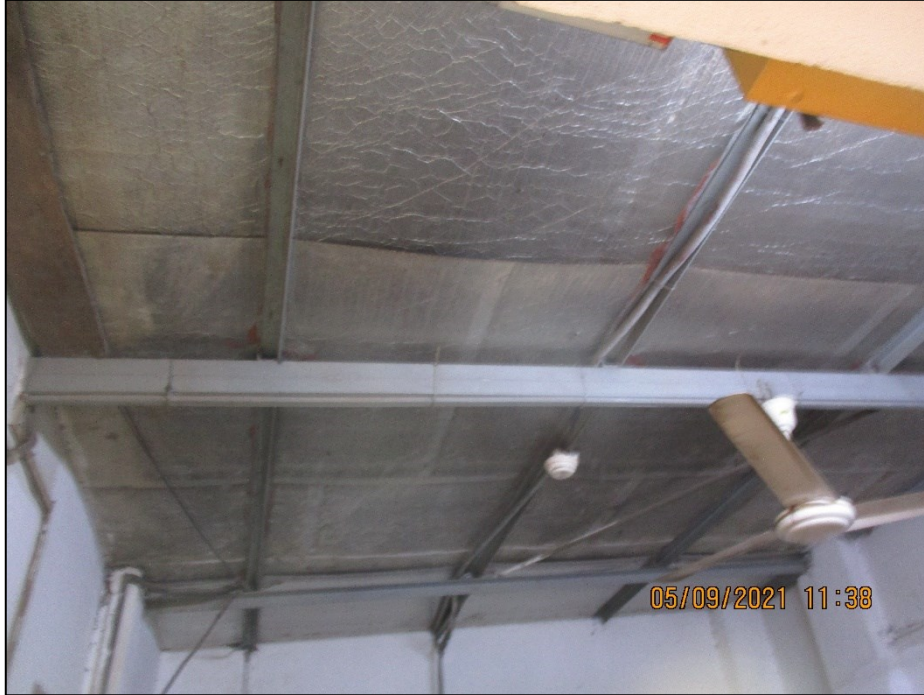
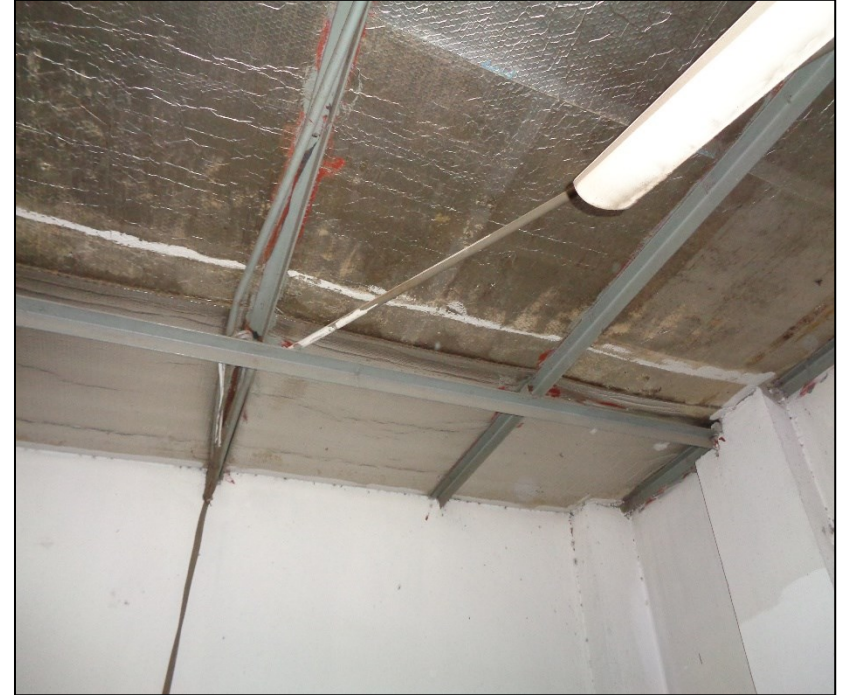
Apparently inadequate structural members

Apparently Inadequate structural member, poor connection details found. Building engineer is required to check the adequacy of the steel members & connection for uplift and lateral forces otherwise replace with engineered structure.

| Item No. | Observation | Recommended Action Plan | Recommended Timeline |
|---|---|---|---|
| 08 | Apparently Non-engineered shed. (Water Pump Room) | Factory engineer is required to check the adequacy of the steel members and prepare engineering assessment (EA) for the in compliance with section 1.9.1 (part-6, BNBC). | 6-weeks |

| Item No. | Observation | Recommended Action Plan | Recommended Timeline |
|---|---|---|---|
| 09 | Apparently Non-engineered shed. (Water Pump Room) | Implement remedial work if required. | 6-months |

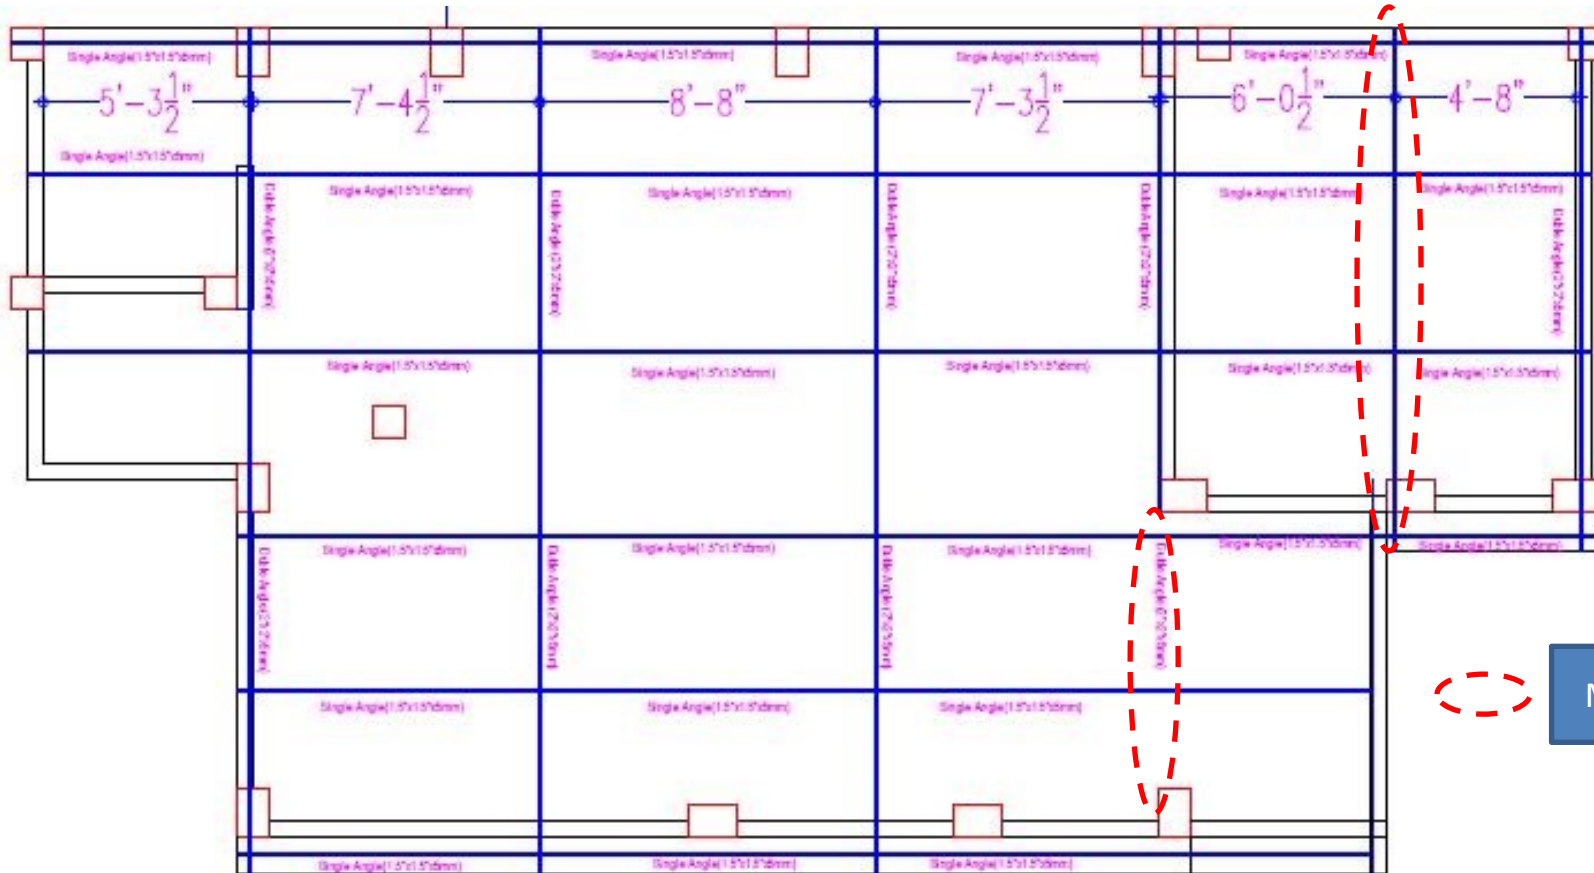
Roof truss layout

Marked members were missing in the provided drawing. Factory engineer to survey the structure and update as-built drawings for the structure.

| Item No. | Observation | Recommended Action Plan | Recommended Timeline |
|---|---|---|---|
| 10 | Discrepancies in as-built drawings. (Fire Control Room & Folder House) | Factory engineer is required to survey the whole structure and prepare “as constructed” drawings (Architectural & Structural), in compliance with section 1.9.1.2 as per BNBC 2006. | 6-weeks |

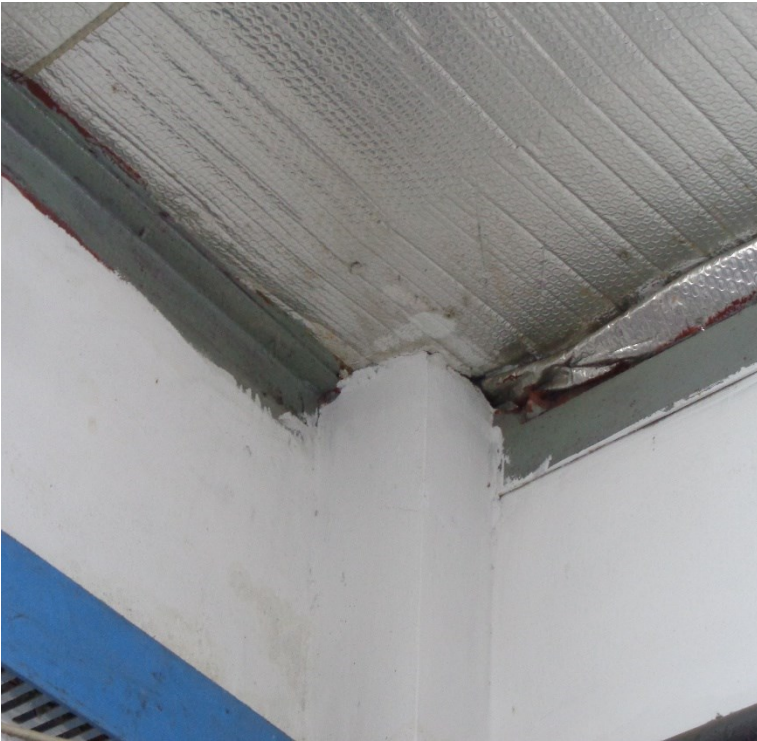
Poor connection details

Apparently Inadequate structural member, poor connection details found. Building engineer is required to check the adequacy of the steel members & connection for uplift and lateral forces otherwise replace with engineered structure.

| Item No. | Observation | Recommended Action Plan | Recommended Timeline |
|---|---|---|---|
| 11 | Apparently Non-engineered shed. (Fire Control Room & Folder House) | Factory engineer is required to check the adequacy of the steel members and prepare engineering assessment (EA) for the in compliance with section 1.9.1 (part-6, BNBC). | 6-weeks |
| 12 | Apparently Non-engineered shed. (Fire Control Room & Folder House) | Implement remedial work if required. | 6-months |

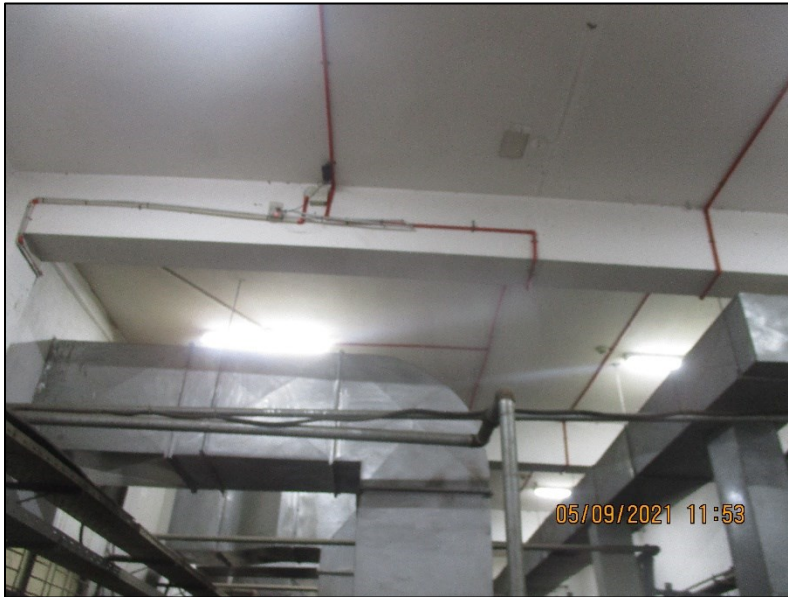
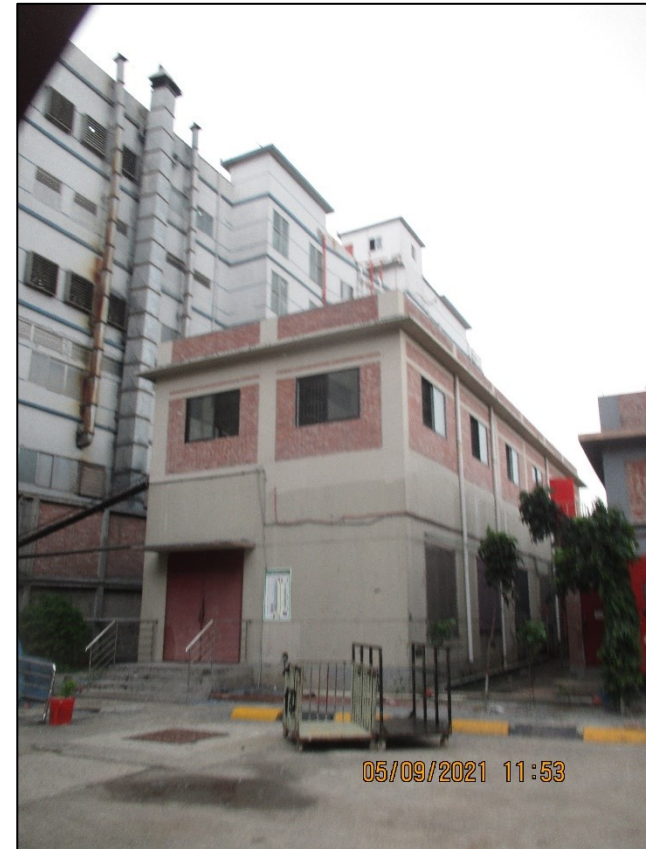
As per BNBC Section 1.9.1, every structure should have design documents.

There is no design documents for above mentioned structures. So, the factory engineer is required to prepare a set of design report as per BNBC part-6, section 1.9.1.1

| Item No. | Observation | Recommended Action Plan | Recommended Timeline |
|---|---|---|---|
| 13 | Lack of design documents. (Compressor Building) | Building engineer to prepare the Design Report for the full structure, in compliance with section 1.9.1.1 as per BNBC. | 6-weeks |
| 14 | Lack of design documents. (Compressor Building) | Implement remedial work if required. | 6-months |

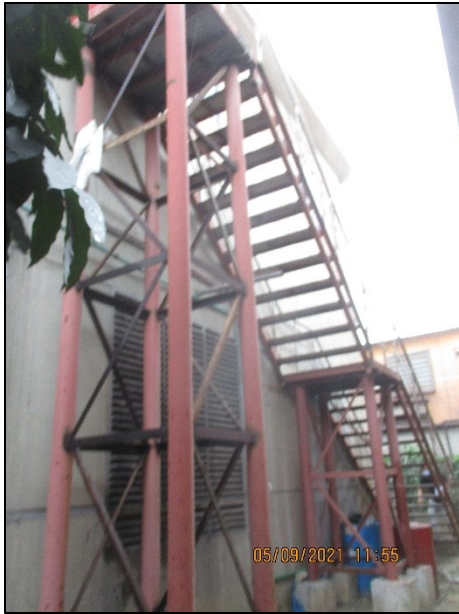
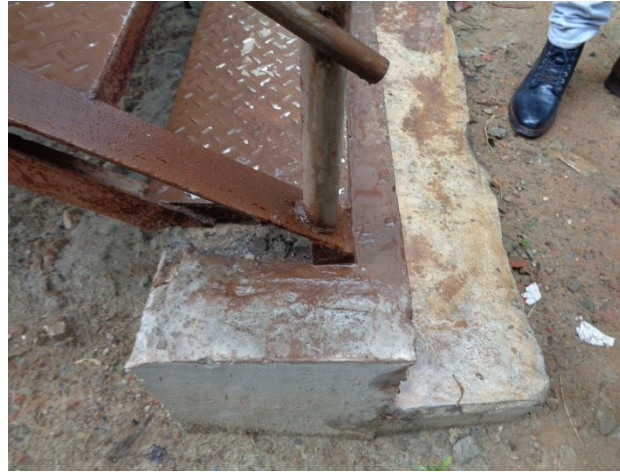
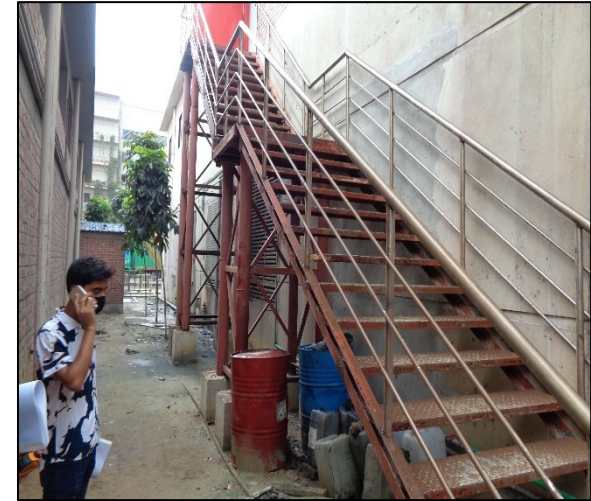
Undocumented Steel Stair found at East corner of the compressor building. No as-built drawing was found. The factory engineer is required to prepare as-built drawing and check the structural integrity for the steel stair.

| Item No. | Observation | Recommended Action Plan | Recommended Timeline |
|---|---|---|---|
| 15 | Undocumented steel stair. (Compressor Building) | Building engineer is required prepare as-built drawings, check the structural stability for the steel stair and incorporate in design report, in compliance with section 1.9.1.1 as per BNBC. | 6-weeks |
| 16 | Undocumented steel stair. (Compressor Building) | Implement remedial work if required. | 6-months |
