# AKH ECO APPARELS LTD.

## - Extended Buildings

07 September 2021

# Observations

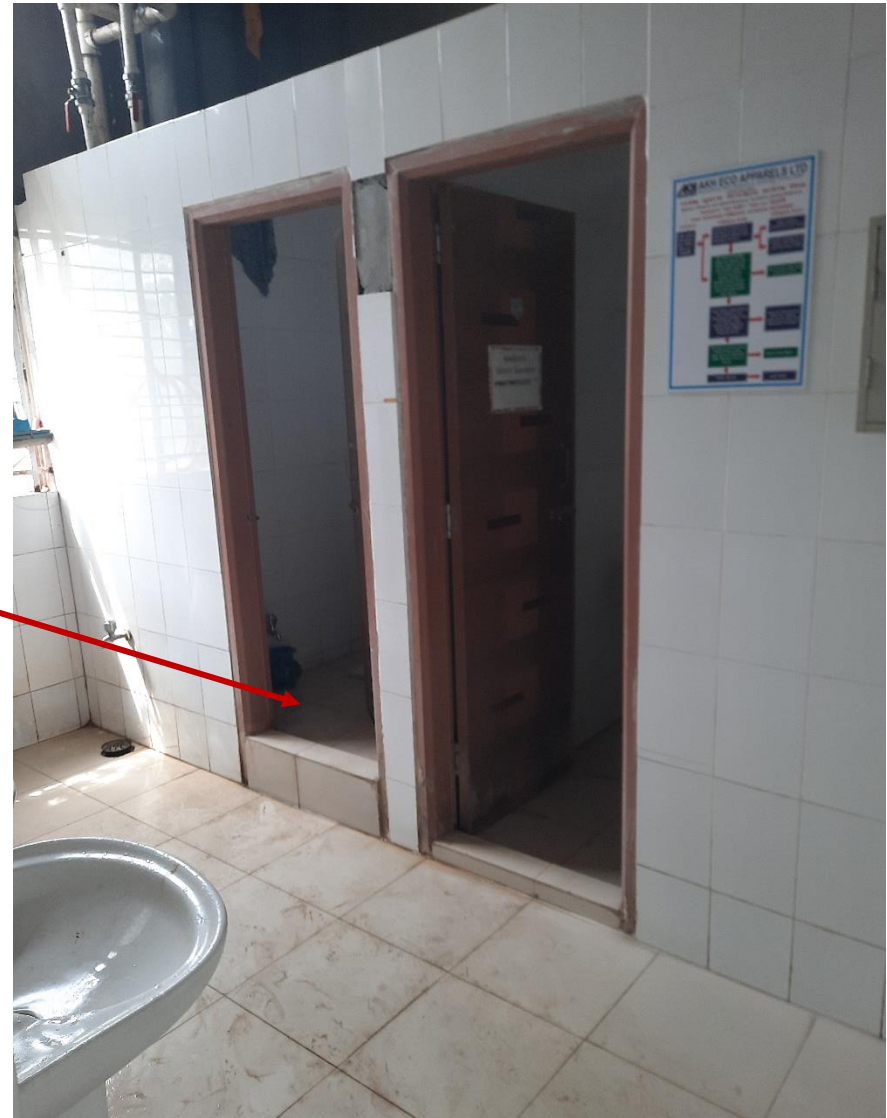
# **Mismatch between architectural and as-built condition**

This toilet zone with built-up (200 mm) in north-east corner is not shown in architectural drawing.

| Item No. | Observation | Recommended Action Plan | Recommended Timeline |
|---|---|---|---|
| 03 | Mismatch between architectural and as-built condition (Building- 03) | Building engineer is required to update the architectural drawing. | 6-weeks |

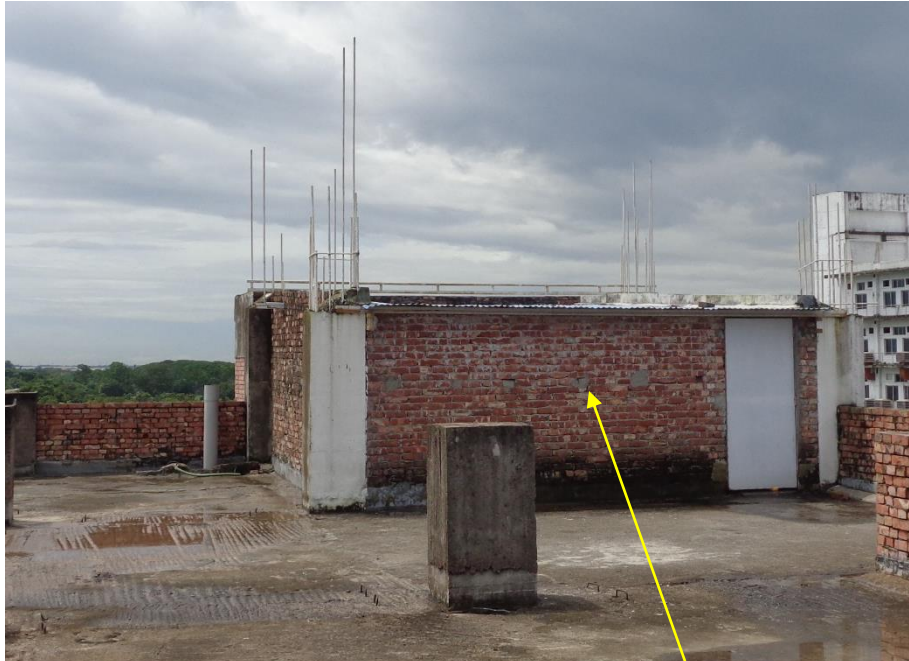
## **Non-engineered shed over staircase**

Non-engineered shed over staircases

| Item No. | Observation | Recommended Action Plan | Recommended Timeline |
|---|---|---|---|
| 04 | Non-engineered shed over staircase (Building 3) | Building engineer is required to check the connection adequacy of the roof member for lateral load. | 6-weeks |
| 05 | Non-engineered shed over staircase (Building 3) | Carryout remedial works if required. | 6-months |

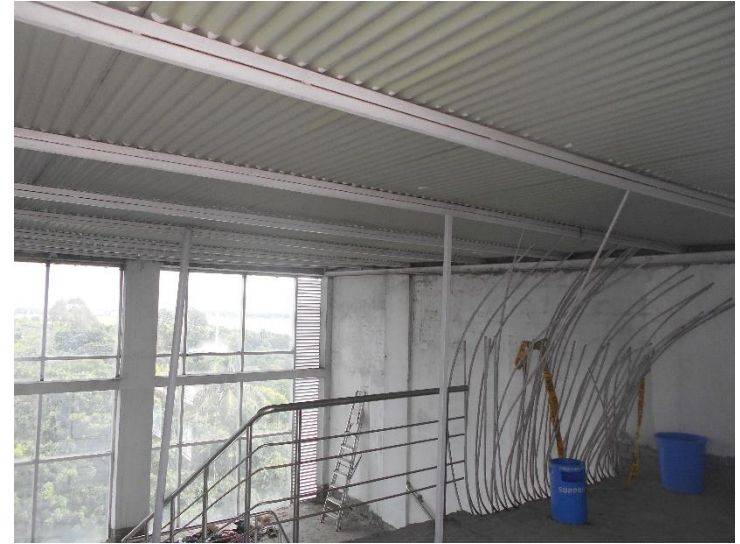
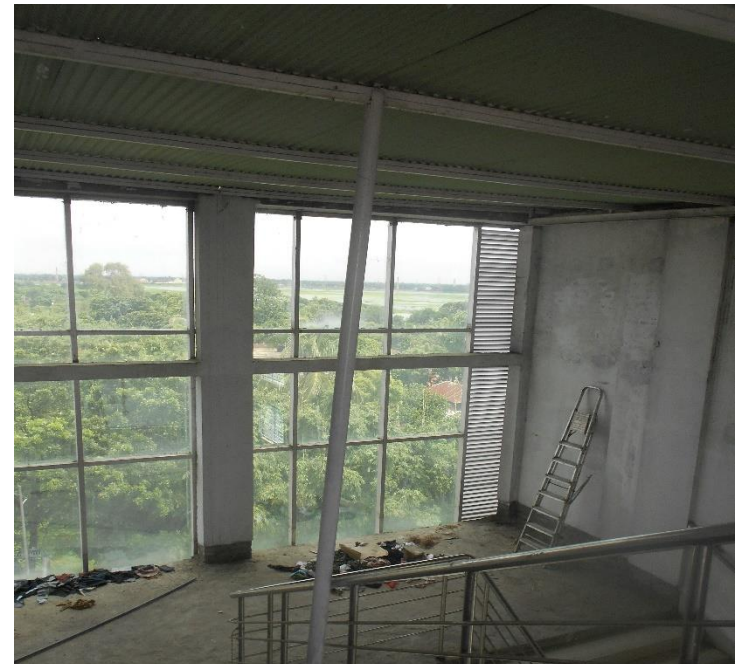
Apparently inadequate member & poor connection details

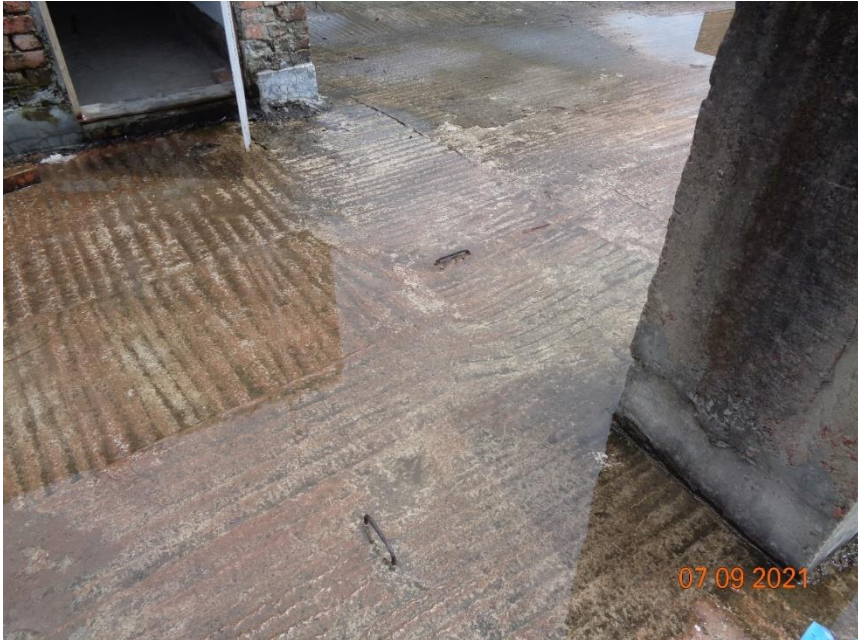
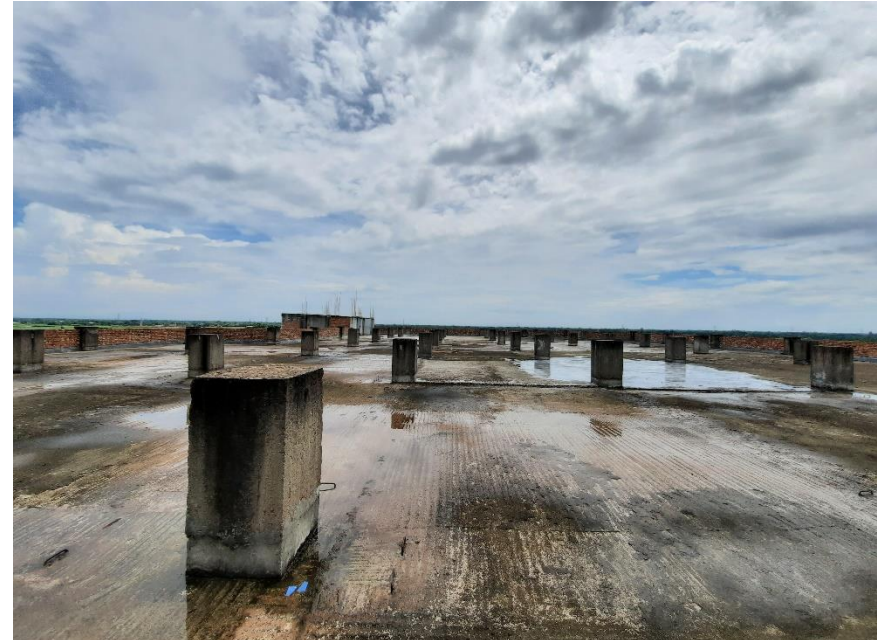
**Water ponding due to poor roof drainage system**

Water ponding observed on roof. Poor roof drainage system observed. Building engineer is required to improve the roof drainage system.

| Item No. | Observation | Recommended Action Plan | Recommended Timeline |
|---|---|---|---|
| 06 | Water ponding due to poor roof drainage system (Building 3) | Building engineer is required to improve the roof drainage system. | 6-months |

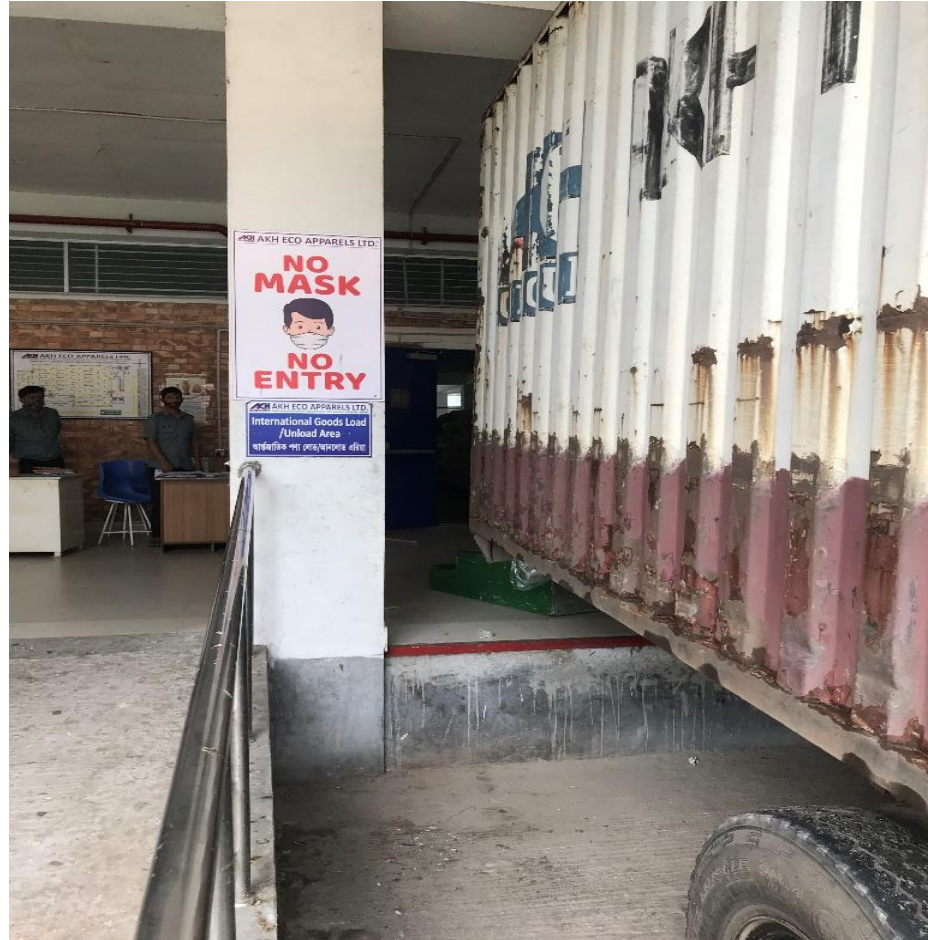
## **Possible vehicle impact on column**

Loading-Unloading bay columns not protected from traffic collision prone to damage. Provide vehicle impact protection to the susceptible column.

| Item No. | Observation | Recommended Action Plan | Recommended Timeline |
|---|---|---|---|
| 07 | Possible vehicle impact on column (Building -03) | Provide vehicle impact protection to the susceptible column. | 6-weeks |

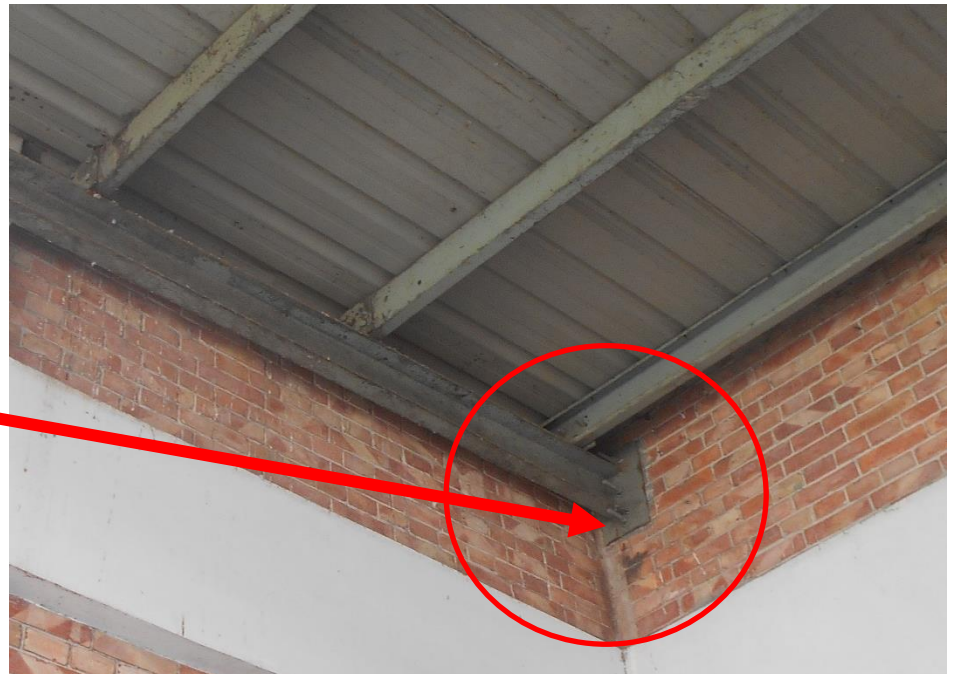
Connection between steel rafter and the brick façade wall.

Two end beams are shown connect to column in the design report but, they were connected to brick wall in as-built condition. Hence, the load path is not regular. Building engineer is required to check the adequacy of the connection of canopy.

| Item No. | Observation | Recommended Action Plan | Recommended Timeline |
|---|---|---|---|
| 08 | Irregular load path of the Canopy (Building- 03) | Building engineer is required to check the adequacy of the connection of canopy. | 6-weeks |
| 09 | Irregular load path of the Canopy (Building- 03) | Carryout remedial works if required. | 6-months |

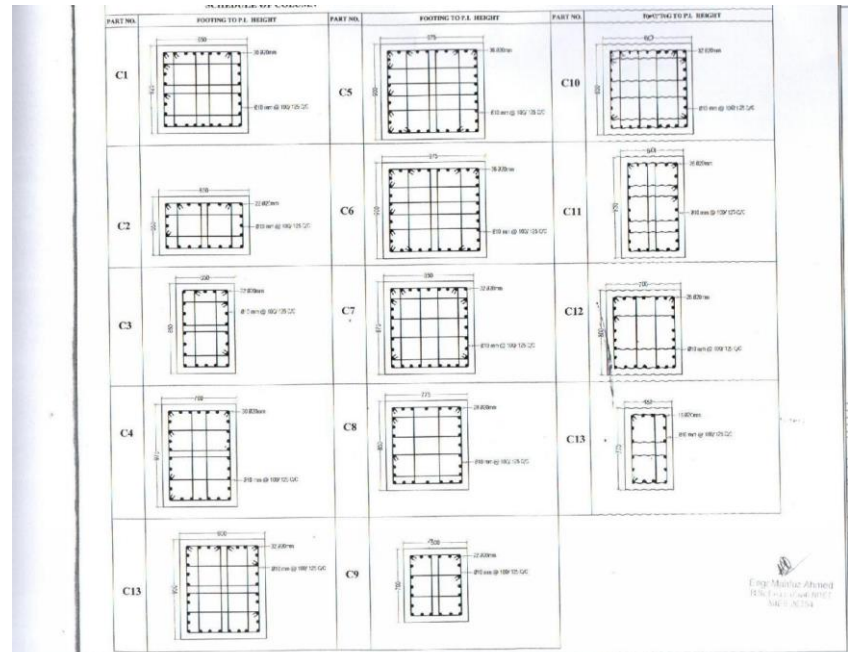
**Adequacy of foundation & RC member  
not addressed in design report**

Adequacy of foundation & RC member not address in design report. Building engineer is required to prepare design report in compliance with section 1.9.1.1 (part 6 BNBC).

| Item No. | Observation | Recommended Action Plan | Recommended Timeline |
|---|---|---|---|
| 10 | Adequacy of foundation & RC member not address in design report (Building- 09) | Building engineer is required to address the adequacy of foundation & RC member in design report which is required to prepared in compliance with section 1.9.1.1 (BNBC-2006, Part 6). | 6-weeks |

| Item No. | Observation | Recommended Action Plan | Recommended Timeline |
|---|---|---|---|
| 11 | Adequacy of foundation & RC member not address in design report (Building- 09) | Carryout remedial works if required. | 6-months |

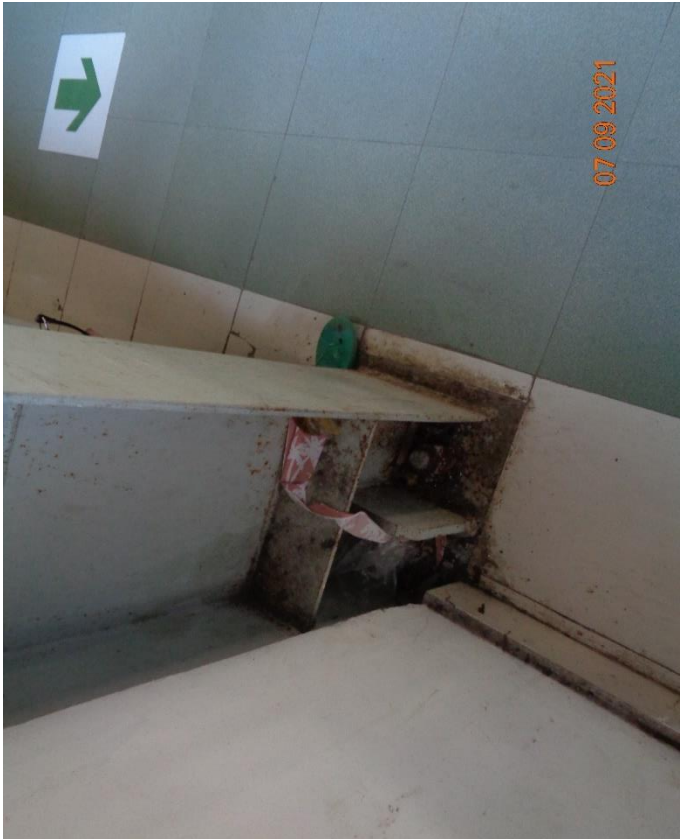
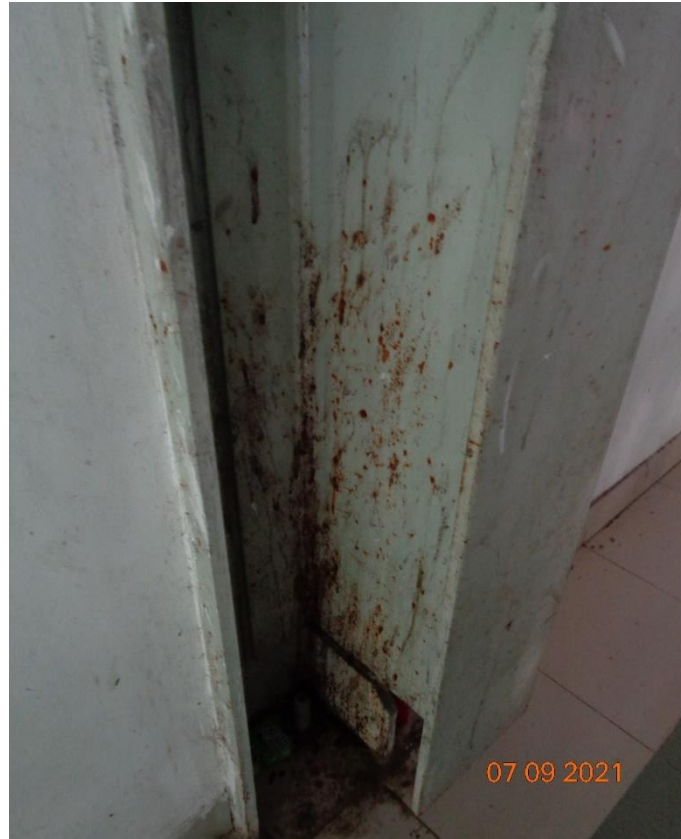
## **Corrosion in steel member**

Corrosion observed at several location in the dinning area. Building engineer is required remove the rust from the steel member and apply rust proofing to the steel member.

| Item No. | Observation | Recommended Action Plan | Recommended Timeline |
|---|---|---|---|
| 12 | Corrosion in steel member (Building- 09) | Building engineer is required remove the rust from the steel member and apply rust proofing to the steel member. | 6-months |

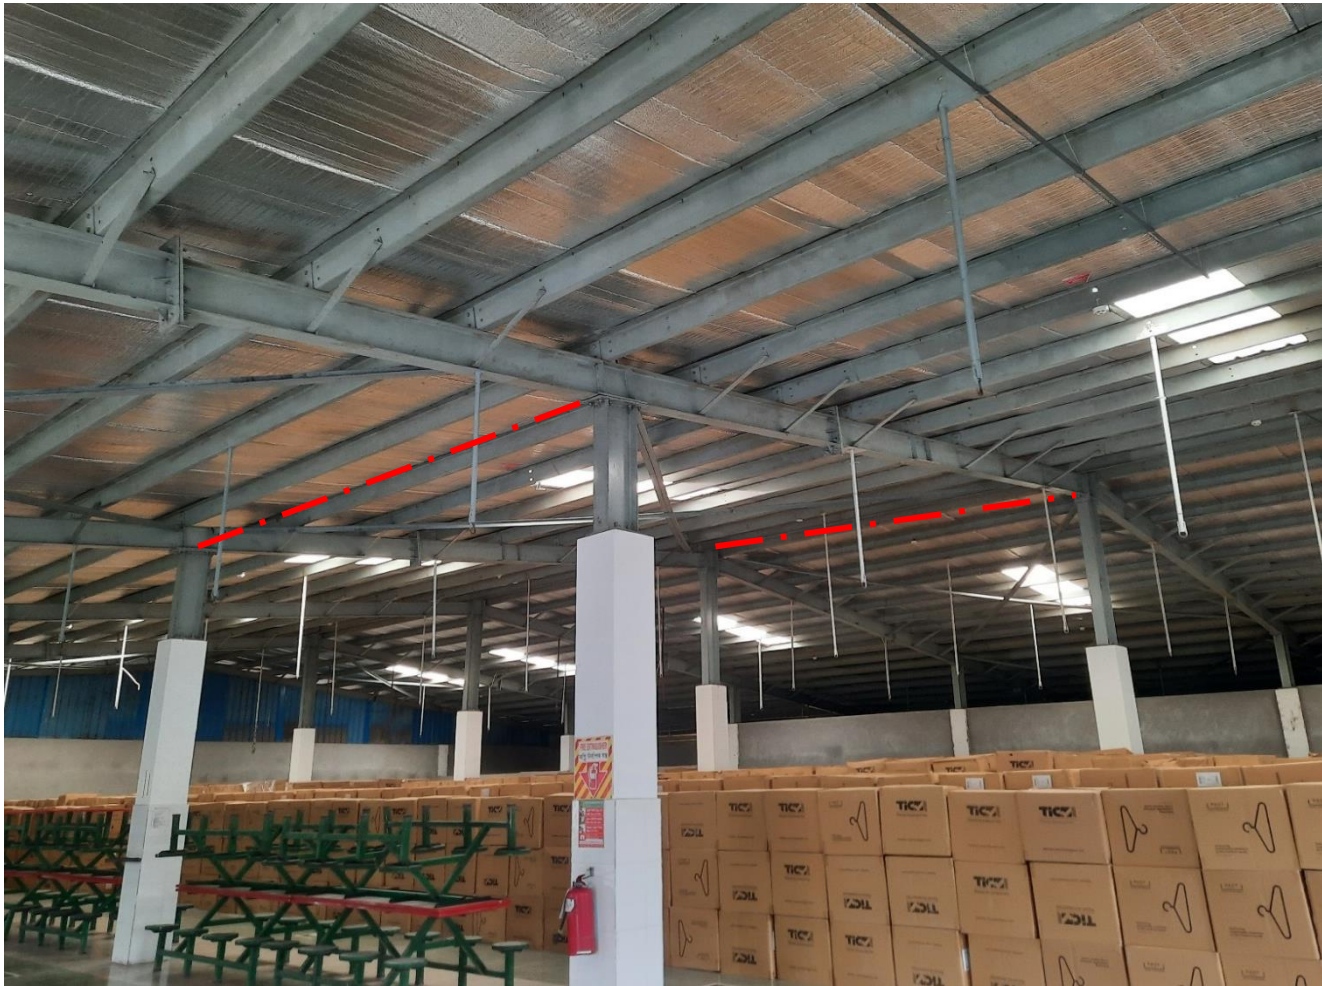
**Lack of lateral stability system**

Load transfer media/compression strut not provided in long direction. Therefore, no obvious lateral stability system in long direction. Building engineer is required to check the lateral stability system of the shed.

| Item No. | Observation | Recommended Action Plan | Recommended Timeline |
|---|---|---|---|
| 13 | Lack of lateral stability system (Shed- 11) | Building engineer is required to check the lateral stability of the shed. | 6-weeks |
| 14 | Lack of lateral stability system (Shed- 11) | Carryout remedial works if required. | 6-months |

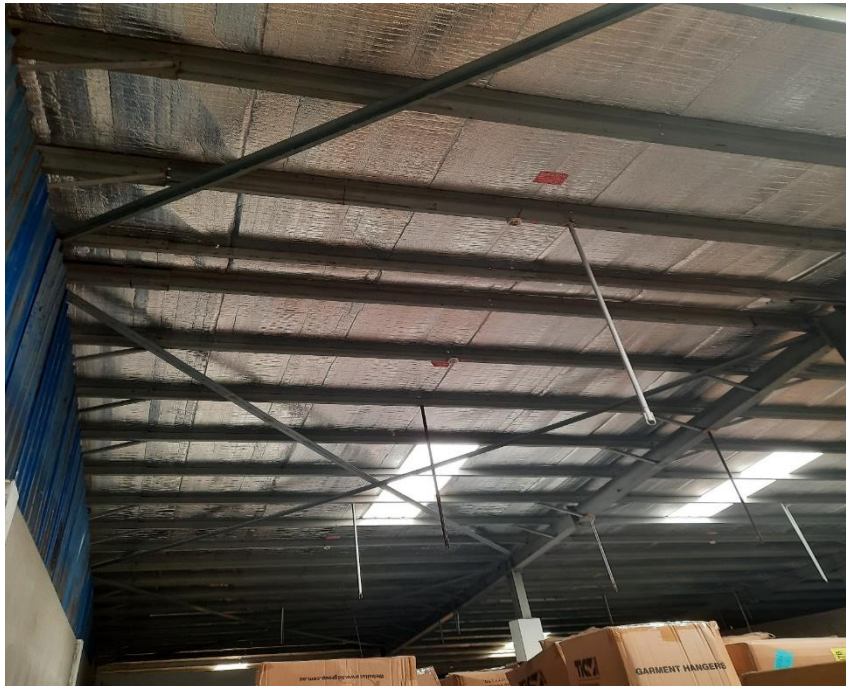
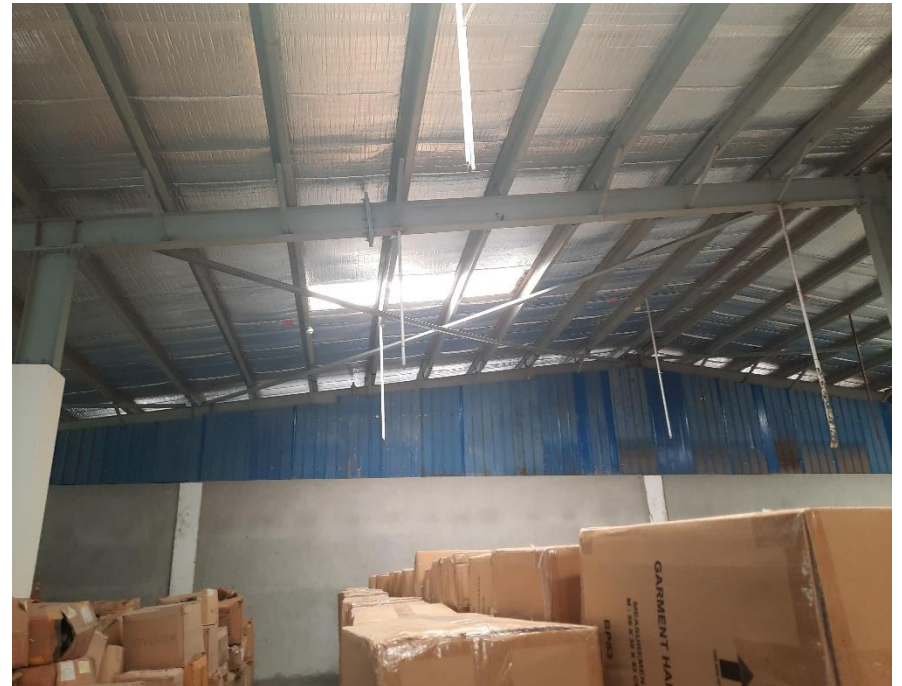
## **Sagging of roof bracing**

Sagging observed in roof bracing. Building engineer is required to tighten the roof bracing.

| Item No. | Observation | Recommended Action Plan | Recommended Timeline |
|---|---|---|---|
| 15 | Sagging of roof bracing (Shed- 11) | Building engineer is required to tighten the roof bracing. | 6-weeks |
