# CORTZ APPARELS LTD (UNIT 2)

## Extended Shed

Hakim master complex, Newjor, Kadda, Gazipur  
(23.988479N, 90.363028E)  
19 September 2021

Shed Building-1: (Single-story shed)

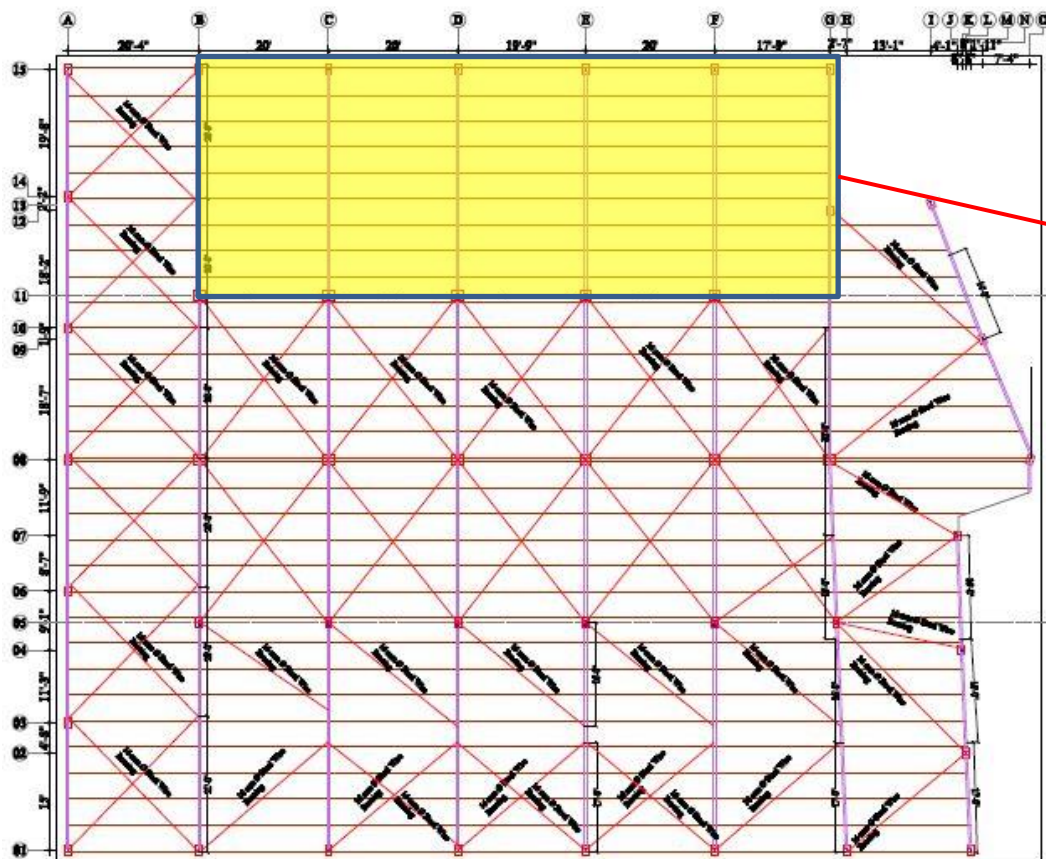
Horizontal bracing layout

## **Discontinuity in load path**

| Item No. | Observation | Recommended Action Plan | Recommended Timeline |
|---|---|---|---|
| 01 | Discontinuity in load path | Factory engineer is required to check the lateral stability of the structure. | 6-weeks |
| 02 | Discontinuity in load path | Implement remedial actions from stability check. | 6-months |

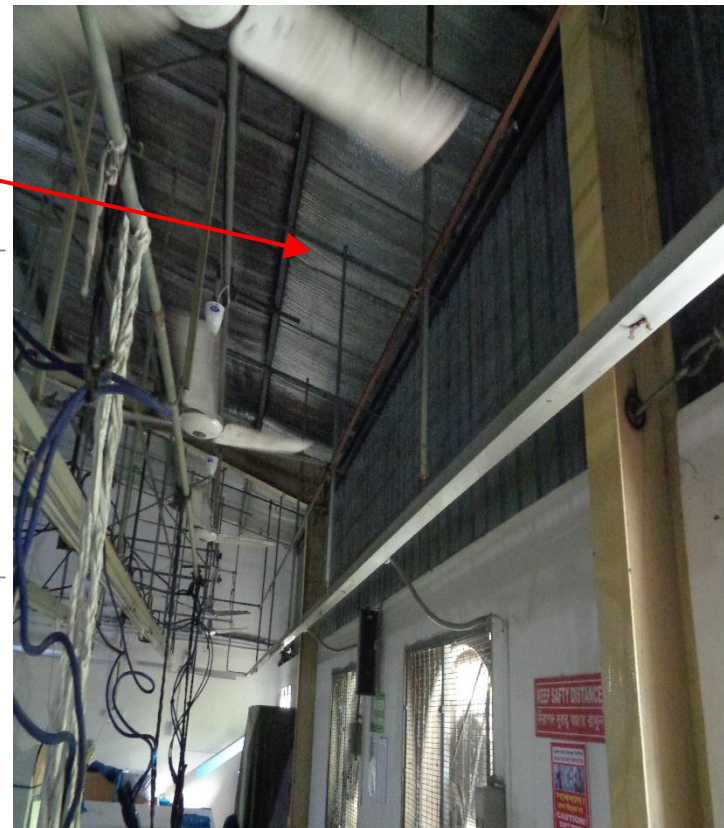
No bracing system

No bracing system provided at the highlighted area. Therefore, load path for lateral loading is not clear for this portion. Factory engineer is required to check the lateral stability system for the shed.

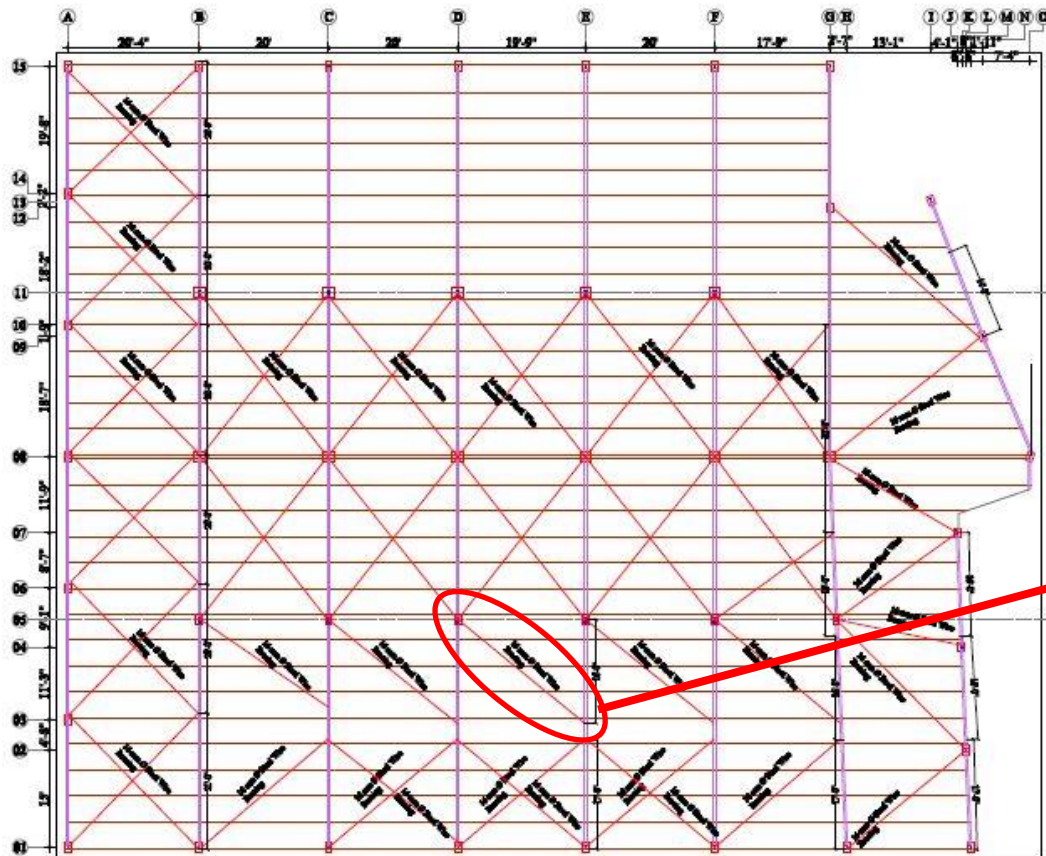
Horizontal bracing layout of retrofitting drawing

**Missing horizontal & vertical bracing**

Horizontal and vertical bracings at roof and wall were missing in the highlighted locations. Factory engineer is required to check the bracing requirements and install the bracings accordingly.

| Item No. | Observation | Recommended Action Plan | Recommended Timeline |
|---|---|---|---|
| 03 | Missing horizontal & vertical bracing | Factory engineer is required to check the bracing requirements and install the bracings accordingly. | 6-weeks |

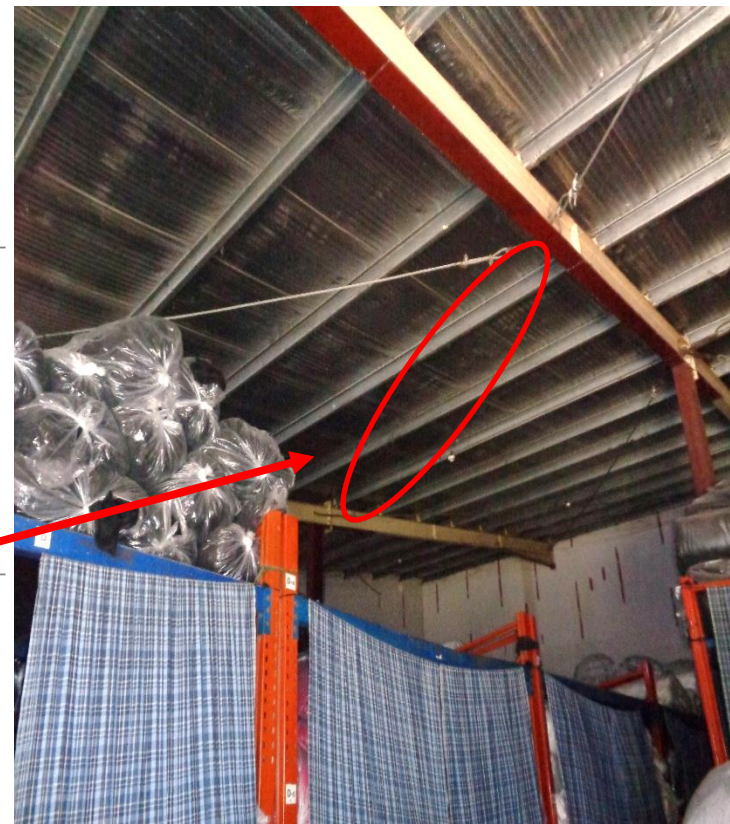
Missing horizontal bracing at roof

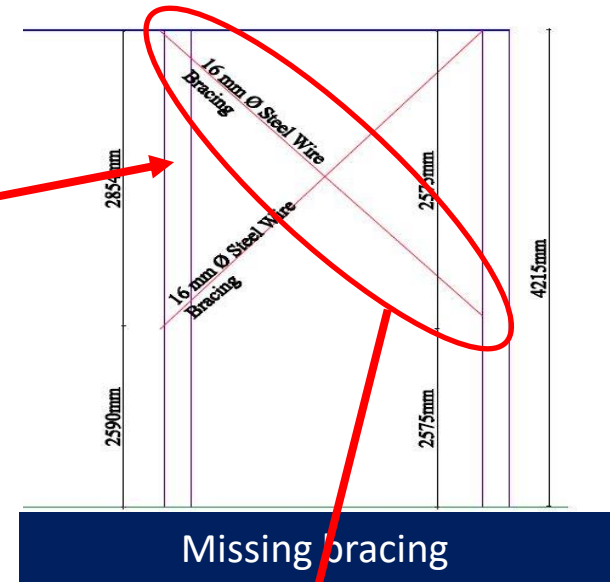
Missing bracing

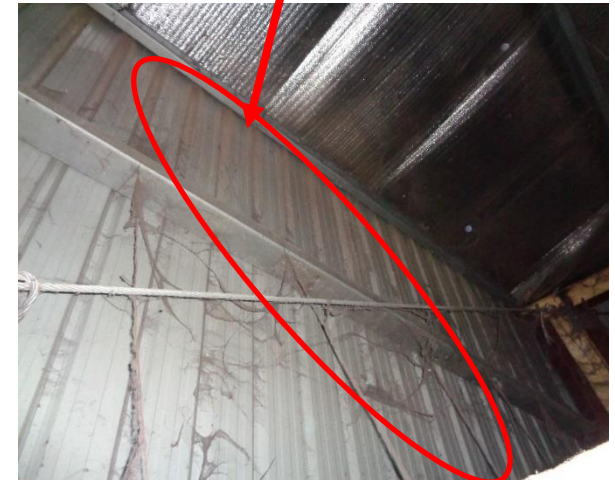
Missing vertical bracing at wall

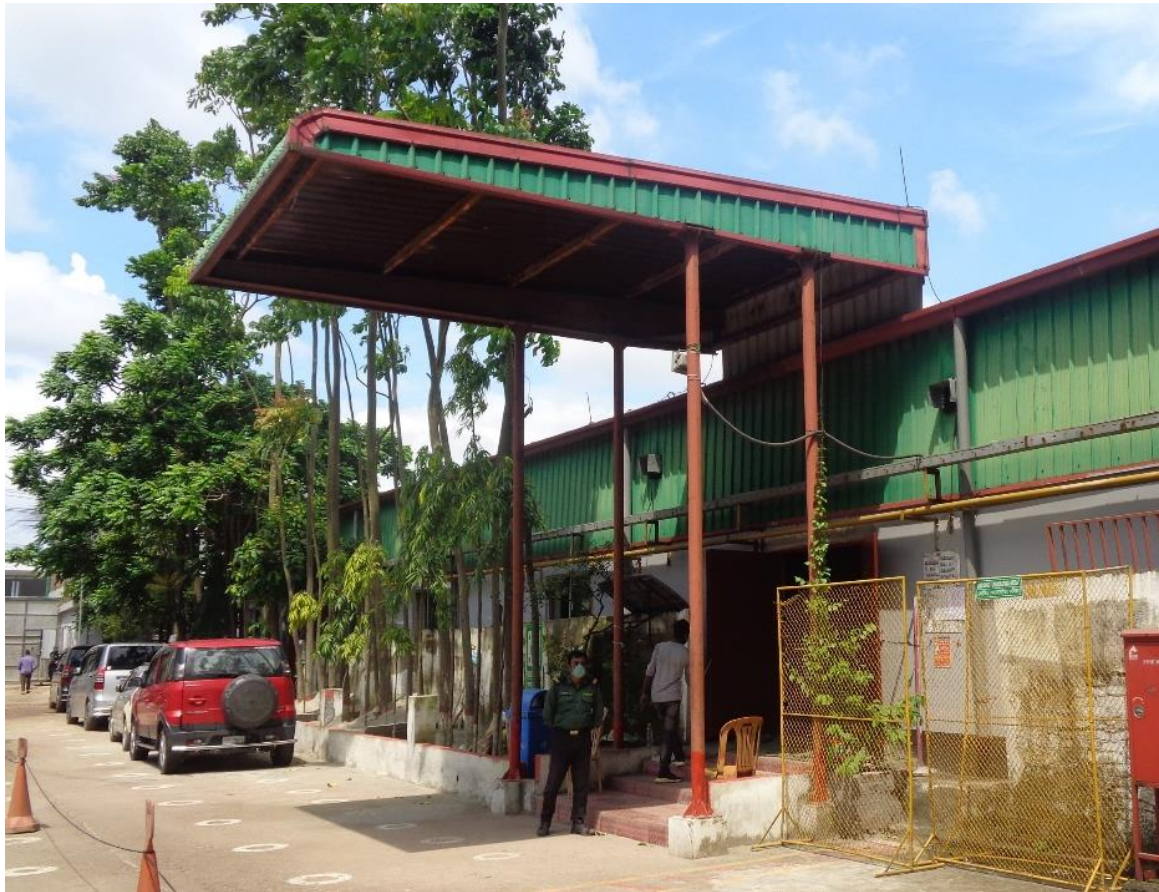
Canopy at front side

The canopy at the front side of the shed has no stability system and appeared to be unstable. Factory engineer is required to check the lateral stability of the canopy.

| Item No. | Observation | Recommended Action Plan | Recommended Timeline |
|---|---|---|---|
| 04 | Apparently unstable canopy | Factory engineer is required to check the lateral stability of the structure. | 6-weeks |
