IRIS FABRICS LIMITED (Extension Building)

Zirani Bazar, Kashimpur, Gazipur
(23.999028, 90.251593)

20 September 2021

5 Observation: Printing and Dyeing Building

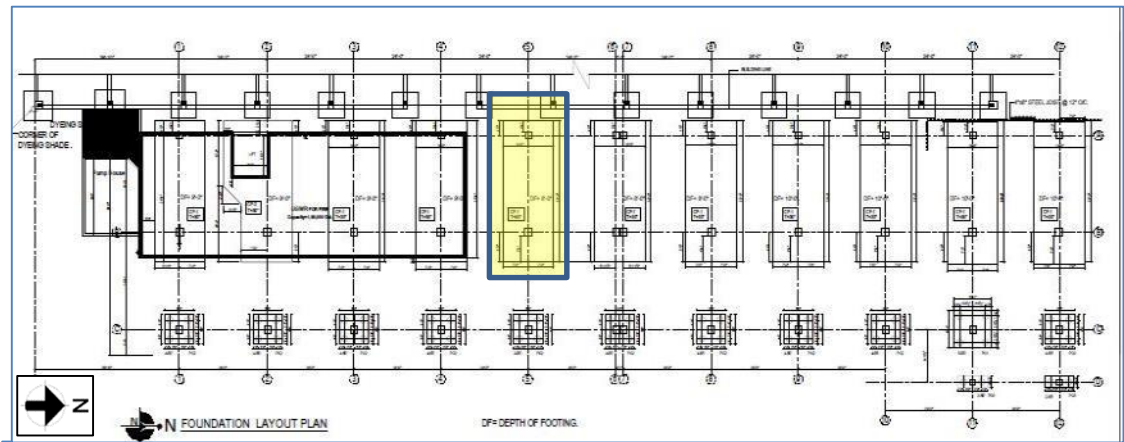
Foundation layout

Cursory calculation indicates that footing (under the overhead water tank) appears to be stressed above normal design limits considering the live load provided in design report (4kPa) & equivalent concrete strength (26.22MPa). Also, considered the recommended allowable average soil bearing capacity 14.22 ton/m² (FoS- 3.0) at 2.5 m depth based on 8 bore logs data in geotechnical report and footing sizes in drawing. Factory engineer is required to review the adequacy of footings and comply with BNBC.

Item No.	Observation	Recommended Action Plan	Recommended Timeline
01	Column and foundation stressed above normal design limit	Building engineer is required to review the design, loads and stress of column & foundation.	6-weeks
02	Column and foundation stressed above normal design limit	Produce and actively manage a loading plan for all floor plates within the factory Building considering floor, column, foundation capacity and comply with BNBC.	6-weeks
03	Column and foundation stressed above normal design limit	Carryout remedial works where necessary.	6-months
04	Column and foundation stressed above normal design limit	Implement floor loading plan.	6-months

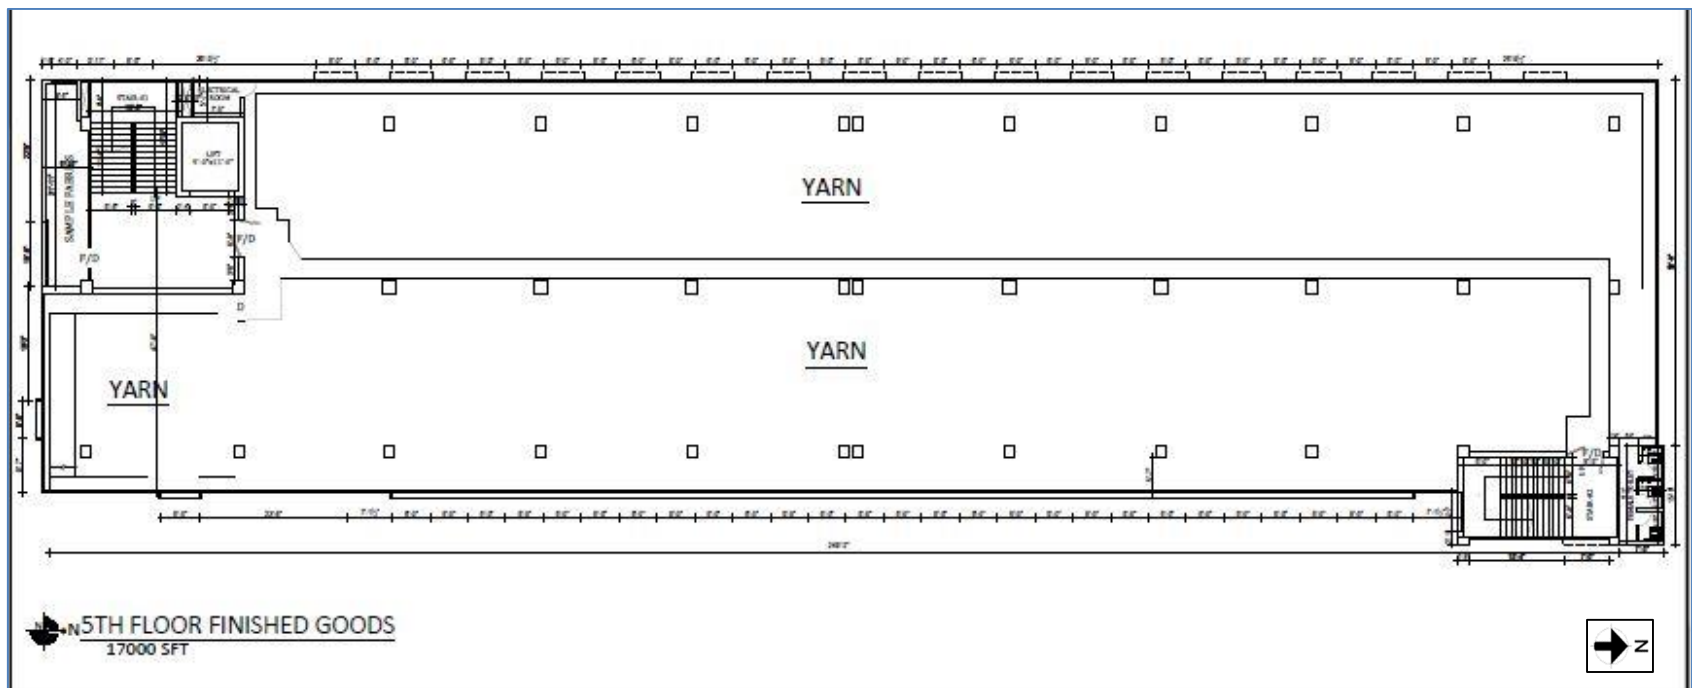
Columns appears to be stressed above normal design limits considering the considering the live load as per BNBC (minimum storage live load 6kPa) and equivalent concrete strength (26.22MPa). Factory engineer is required to review the adequacy of column and comply with BNBC.

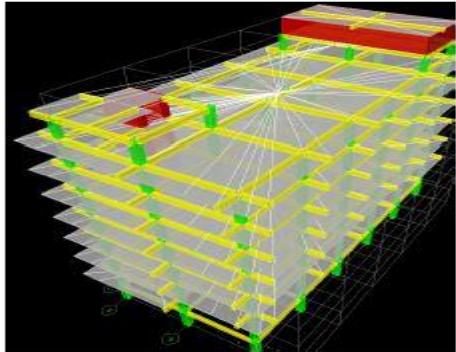
Design report not fully comply with BNBC

As per BNBC, every building or structure designed shall have its design documents prepared in accordance with the provision of Section 1.9.1. The design document shall include a design report, and a set of structural drawings, which shall be prepared in compliance with section 1.9.1.1 and section 1.9.1.2 of part-6, BNBC.

Item No.	Observation	Recommended Action Plan	Recommended Timeline
05	Design report not fully comply with BNBC	Building Engineer to prepare design report as per BNBC (part-6; Article 1.9.1) by reviewing design, loads and capacity of structural members.	6-weeks
06	Design report not fully comply with BNBC	Implement the recommendation of design report.	6-months
07	Inconsistencies in as-built drawing	The factory engineer is required to survey the structure and update the as-built drawings.	6-weeks
08	Mismatch in drawing (Rooftop connecting bridge)	The building engineer to survey the structure and update the as-built drawings with connection details.	6-weeks

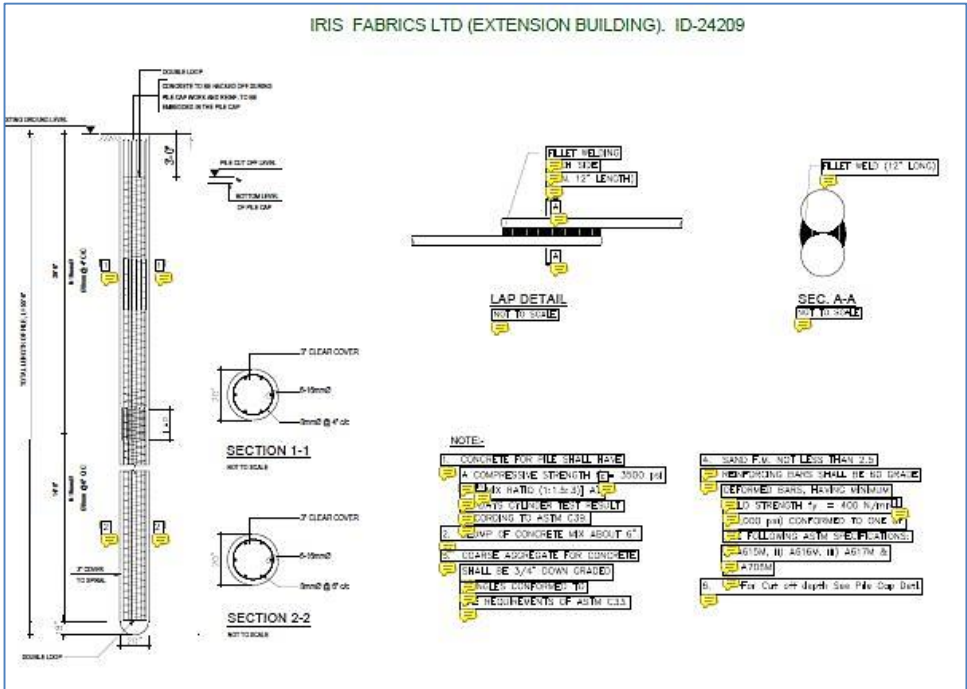
Pile details

A Design Report was provided for Printing and Dyeing Building. Information of pile was provided in the drawings. But detail calculation was not found in the design report regarding the pile capacity. Moreover, serviceability checks were not provided in the design report.

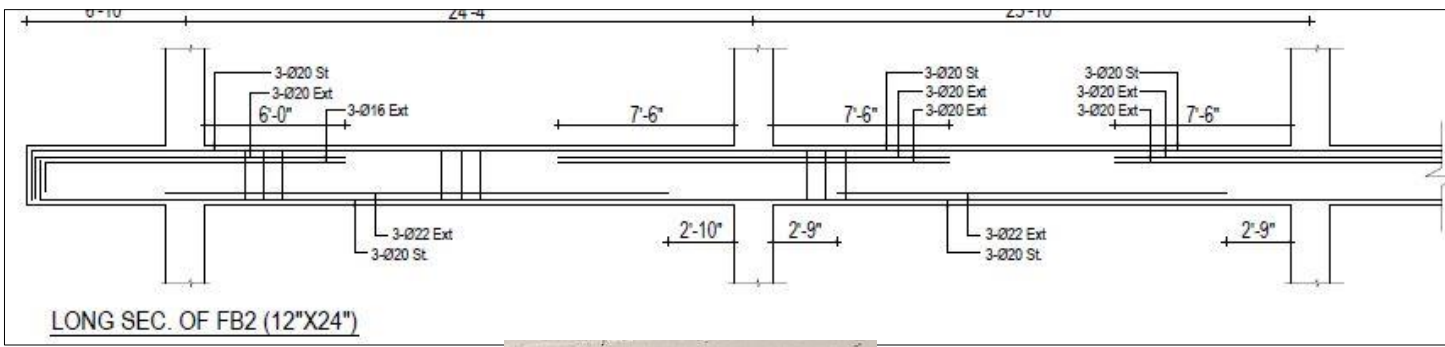
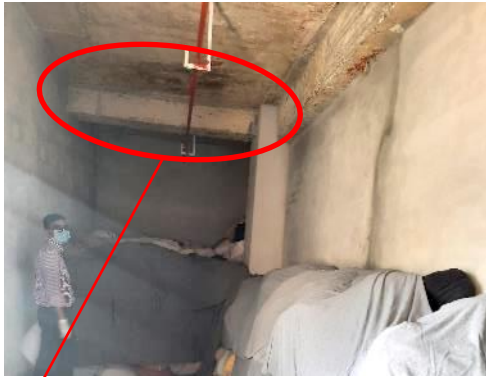
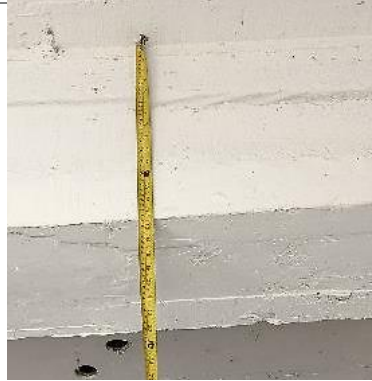
Typical beam size was found 12" X 22" instead of 12" X 24". Also cantilever beam was found all side of the building which was not match with the provided structural drawing.

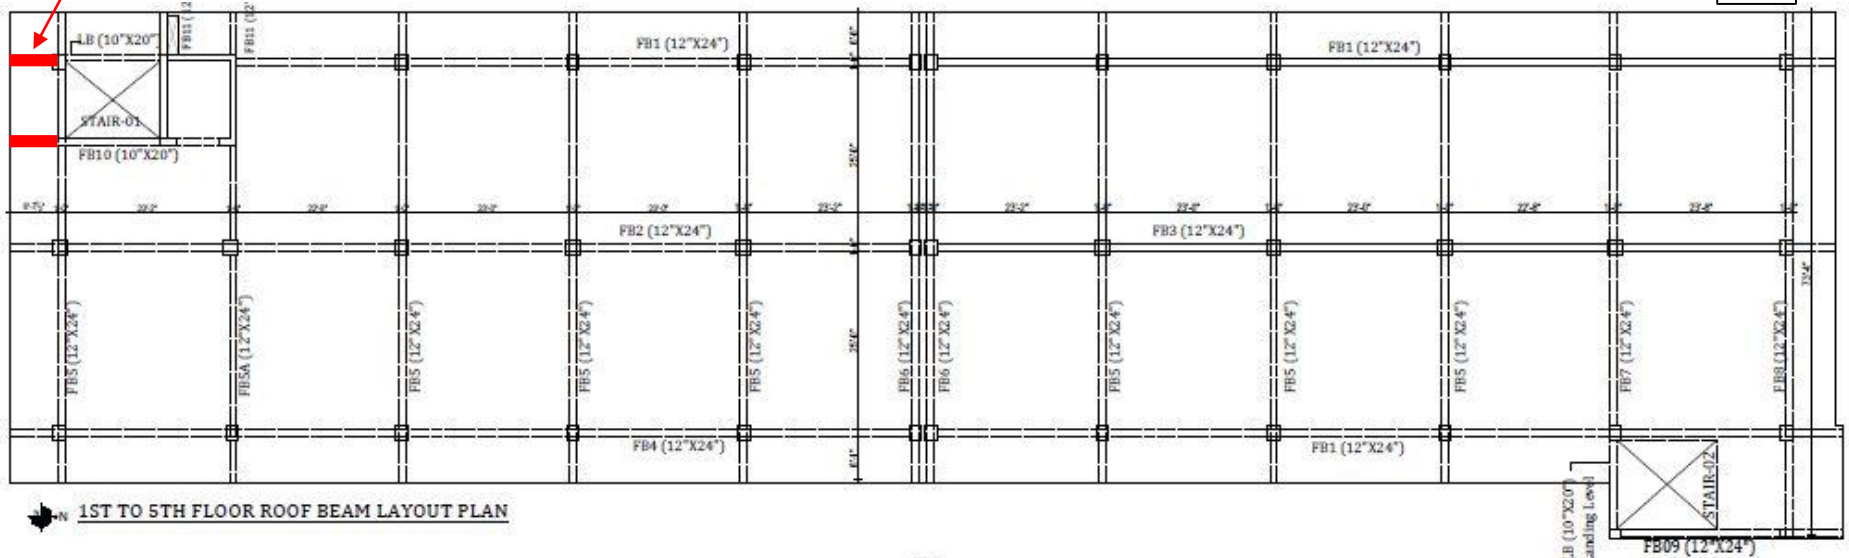
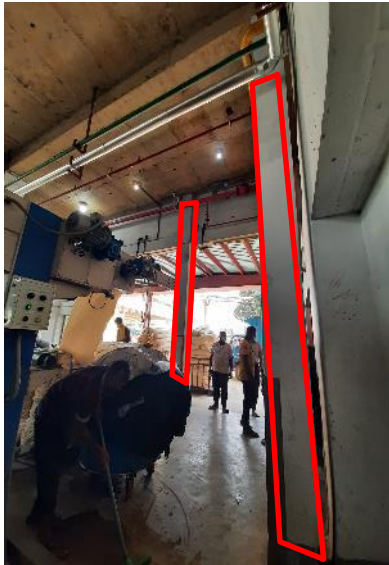
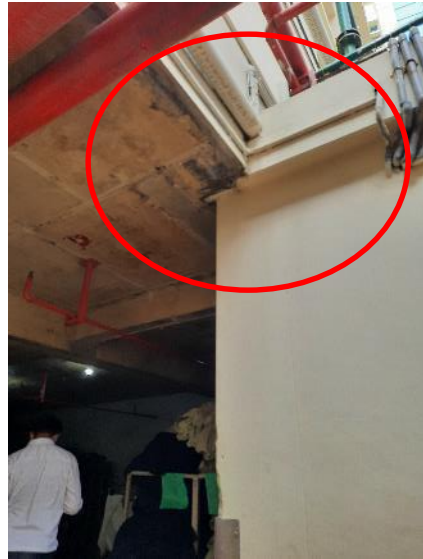
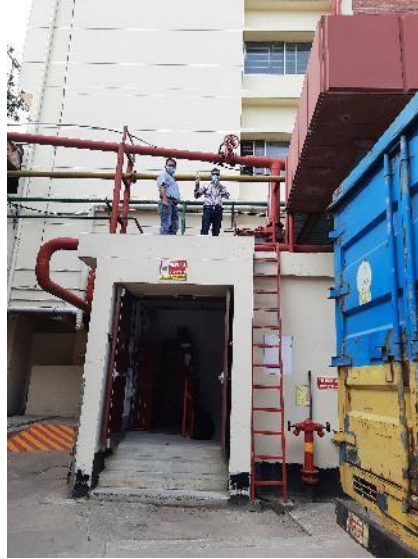
In the architectural drawing, few RC columns in ground floor was shown but no structural information was found for that RC columns and foundation system. Also, pump room was structurally connected with the mezzanine floor slab, which was not shown in drawing.

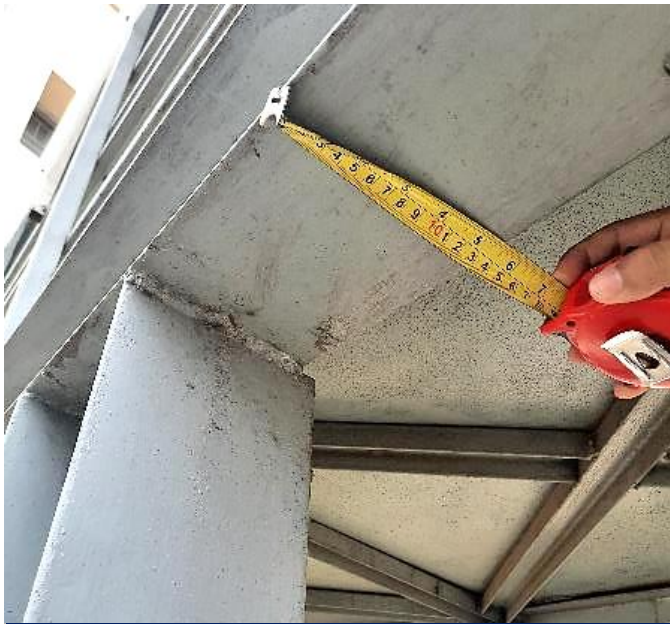
Landing Joist

The flange width of steel joist was found 130 mm instead of 150 mm. Also, no connection details have been found in the drawings.

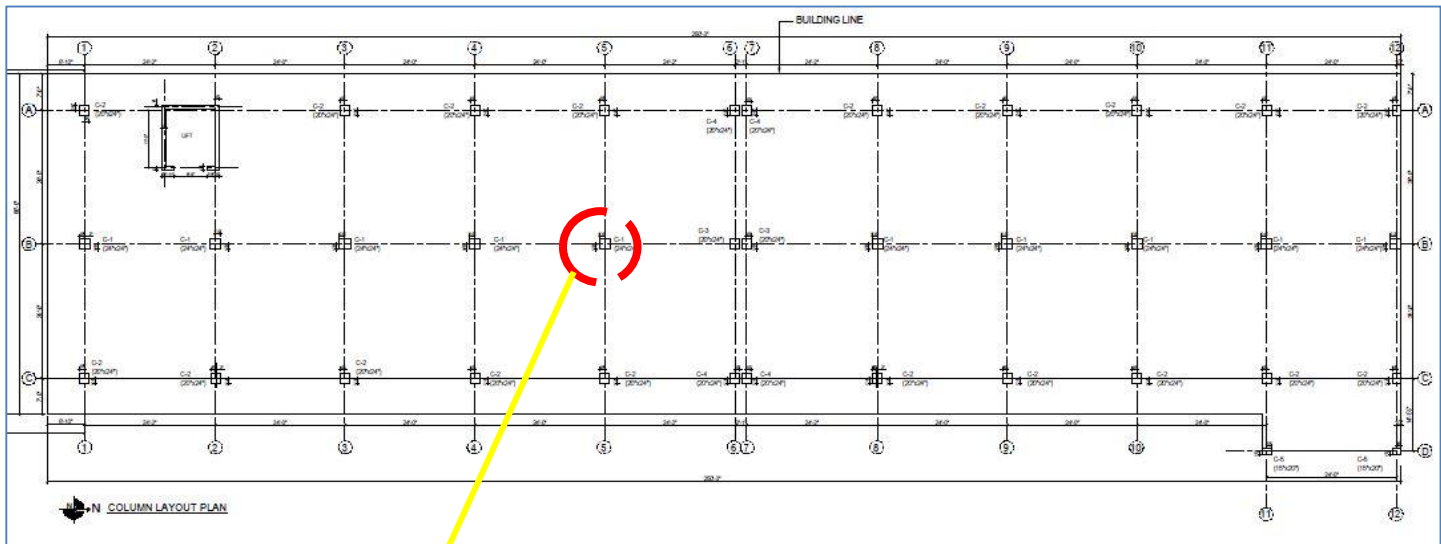
Column Layout

Marked column was tested for aggregate type and stone aggregate was found.
