# BIG BOSS WASHING LTD

Aptech Industrial Park, 30, Sarabo, Kashimpur, Gazipur

21st September 2021

# Observations

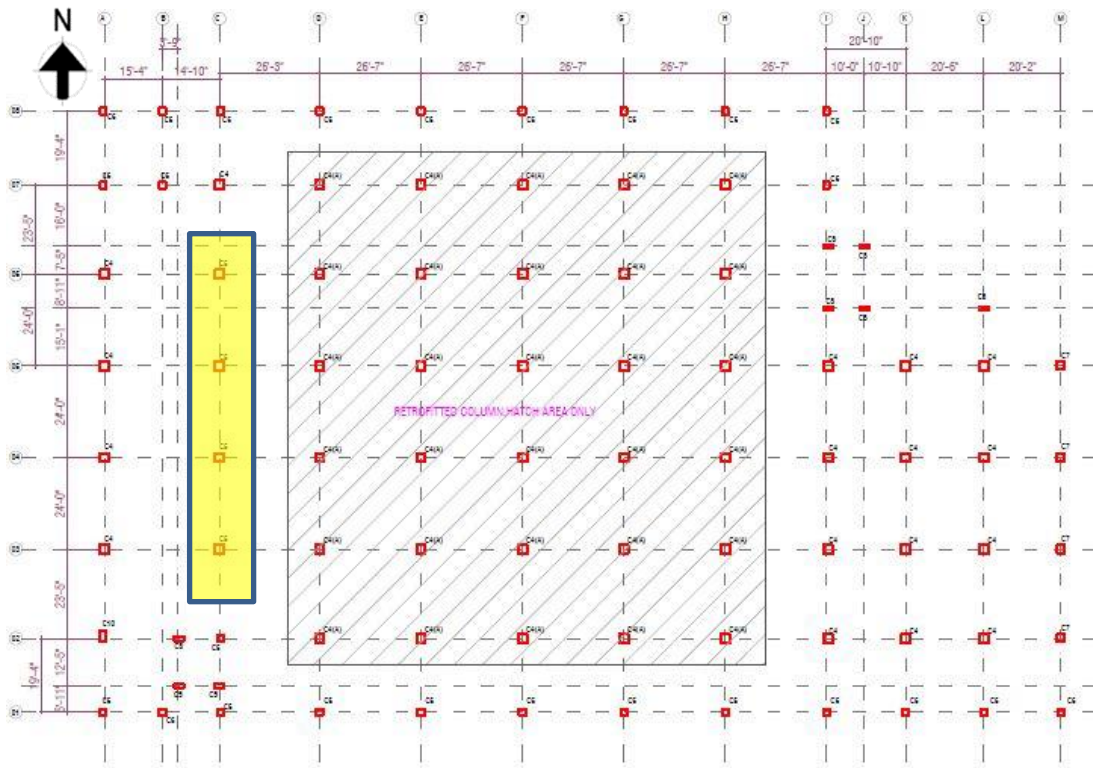
Marginally stressed column/foundation layout

**Stress in column and foundation marginally  
exceeds normal design limit**

Cursory calculation shows that stress in marked columns and foundations marginally exceeds the normal design limit considering the floor live load 4 kPa for typical floors (as per load plan) and 6 kPa for storage areas only. Factory engineer is required to review the design, loads and column/foundation stresses based on in-situ concrete strength.

| Item No. | Observation | Recommended Action Plan | Recommended Timeline |
|---|---|---|---|
| 01 | Stress in column and foundation marginally exceeds normal design limit (Washing Building) | <ul style="list-style-type: none"> <li>Factory engineer is required to review the design, load, column and foundation stresses based on in-situ concrete strength.</li> </ul> | 6-weeks |
| 02 | Stress in column and foundation marginally exceeds normal design limit (Washing Building) | <ul style="list-style-type: none"> <li>Verify in-situ concrete strength by take minimum 4 concrete cores (100mm diameter) from lower tier of the buildings.</li> </ul> | 6-weeks |
| 03 | Stress in column and foundation marginally exceeds normal design limit (Washing Building) | <ul style="list-style-type: none"> <li>Implement any remediation work if required.</li> </ul> | 6-months |

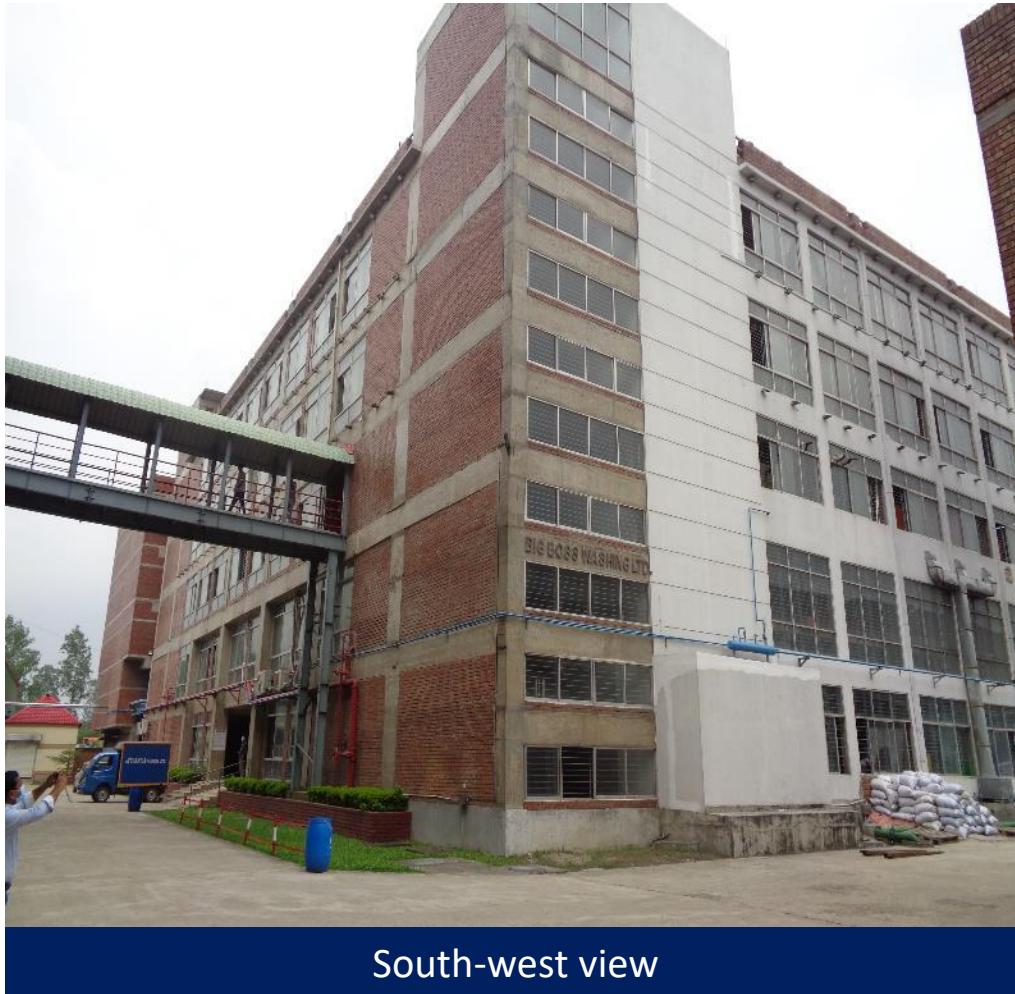
South-west view

**Design Report needs to be prepared**

As per BNBC, every building or structure designed shall have its design documents prepared in accordance with the provision of Section 1.9.1. The design document shall include a design report, and a set of structural drawings, which shall be prepared in compliance with section 1.9.1.1 and section 1.9.1.2 as per BNBC. At the time of inspection, only as-built drawing and load plan were available, but no design report was available which is required to be prepared in compliance with section 1.9.1.1 (part-6, BNBC).

| Item No. | Observation | Recommended Action Plan | Recommended Timeline |
|---|---|---|---|
| 04 | Design Report needs to be prepared (Washing Building) | <ul style="list-style-type: none"> <li>Factory engineer is required to prepare the Design Report in compliance with section 1.9.1.1 (part-6, BNBC).</li> </ul> | 6-weeks |

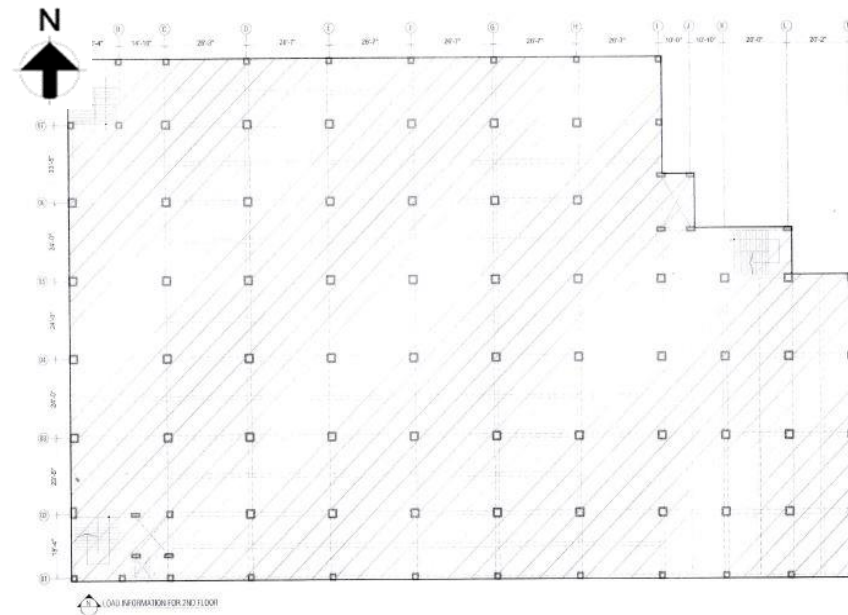
**Prepared load plan to be revised**

Live load on typical floor is considered as 4 kPa in prepared load plan. As per BNBC- Part 6, live load for light storage areas is required to be considered minimum 6 kPa. Also, value of R is mentioned as 6 which should be 5 or 8 based on the rebar detail. However, the factory engineer is required to revise the load plan as per BNBC requirement and check the design accordingly.

| Item No. | Observation | Recommended Action Plan | Recommended Timeline |
|---|---|---|---|
| 06 | Prepared load plan to be revised (Washing Building) | <ul style="list-style-type: none"> <li>Produce and actively manage a set of floor live loading plan following BNBC minimum live load requirement and considering foundation &amp; column capacity of the building.</li> </ul> | 6-weeks |
| 07 | Prepared load plan to be revised (Washing Building) | <ul style="list-style-type: none"> <li>Implement floor loading plan</li> </ul> | 6-months |

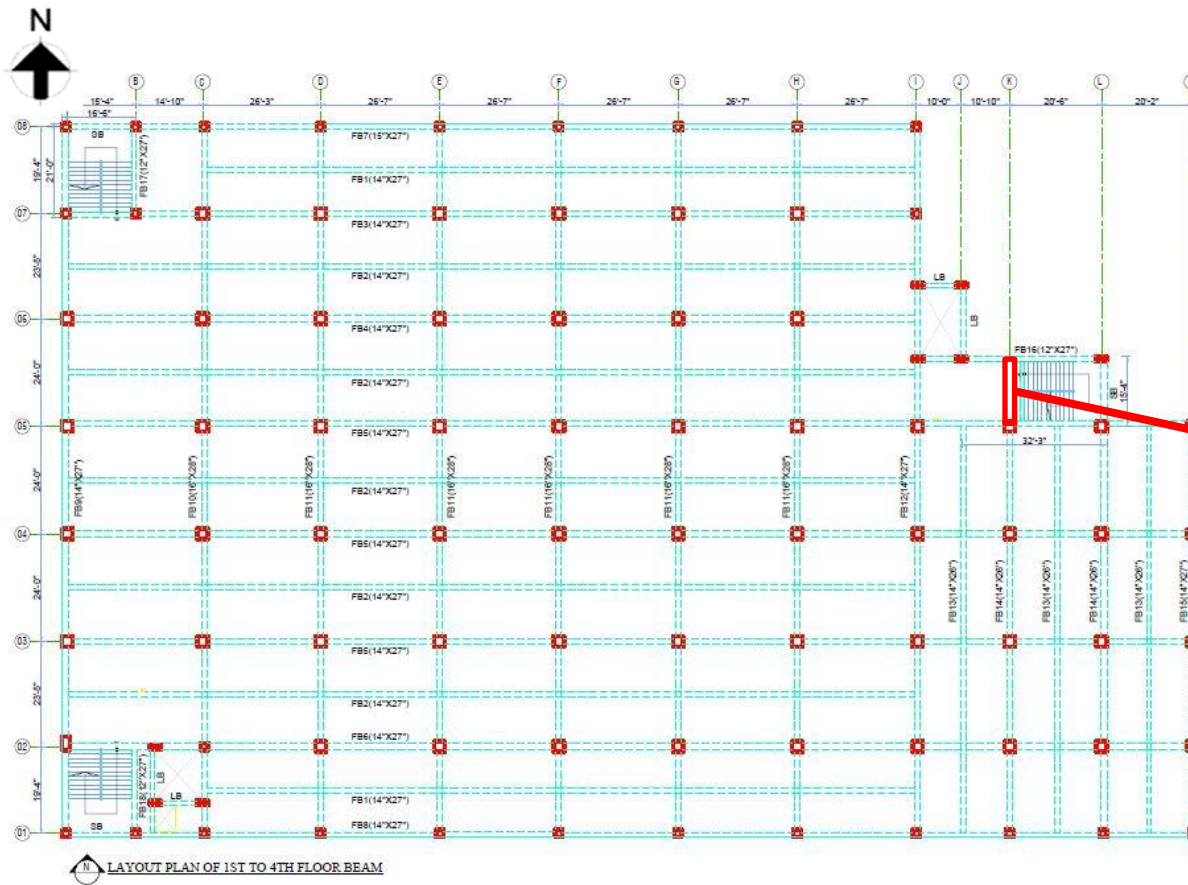
Beam found but not shown in layout

Beam at highlighted location was not shown in beam layout but found at site (every floor). Factory engineer is required to update the as-built structural drawing.

| Item No. | Observation | Recommended Action Plan | Recommended Timeline |
|---|---|---|---|
| 08 | Inconsistency in as-built drawing (Washing Building) | <ul style="list-style-type: none"> <li>Factory engineer is required to update the as-built structural drawing.</li> </ul> | 6-weeks |
