# GMS Composite Knitting Ind. Ltd. (New Building)

Sardaganj, Kashimpur, Gazipur-1346, Bangladesh,  
(23.96859, 90.29699)

24<sup>th</sup> & 31<sup>st</sup> May & 06<sup>th</sup> September 2021

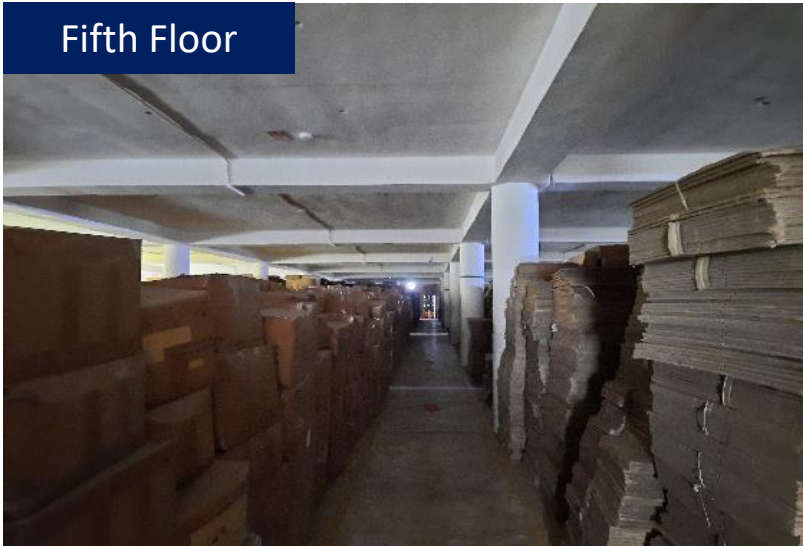
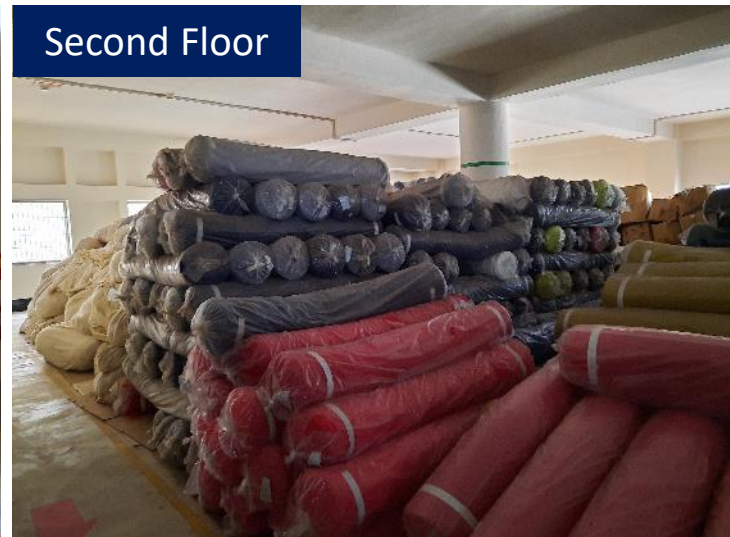
Heavy loading observed throughout the building which exceeds the prepared live load of 3 kPa (3<sup>rd</sup>, 4<sup>th</sup>, 5<sup>th</sup> floor), 5kPa (2<sup>nd</sup>, 1<sup>st</sup>, Ground floor). Building engineer is required to actively manage the floor load plan also maintain floor loading below 3 kPa.

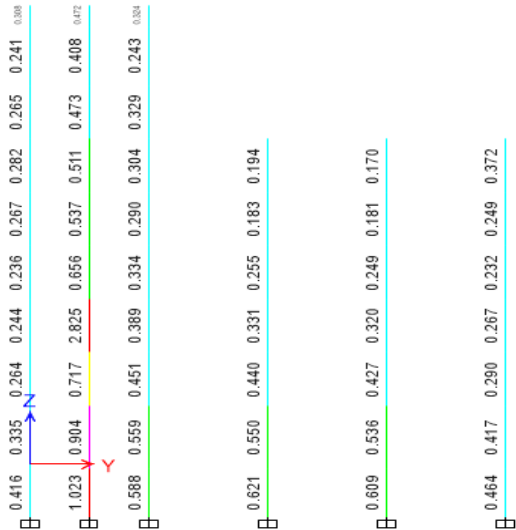
Column shows overstressed as per PMM ratio > 1.  
 But no recommendation provided in the design report.

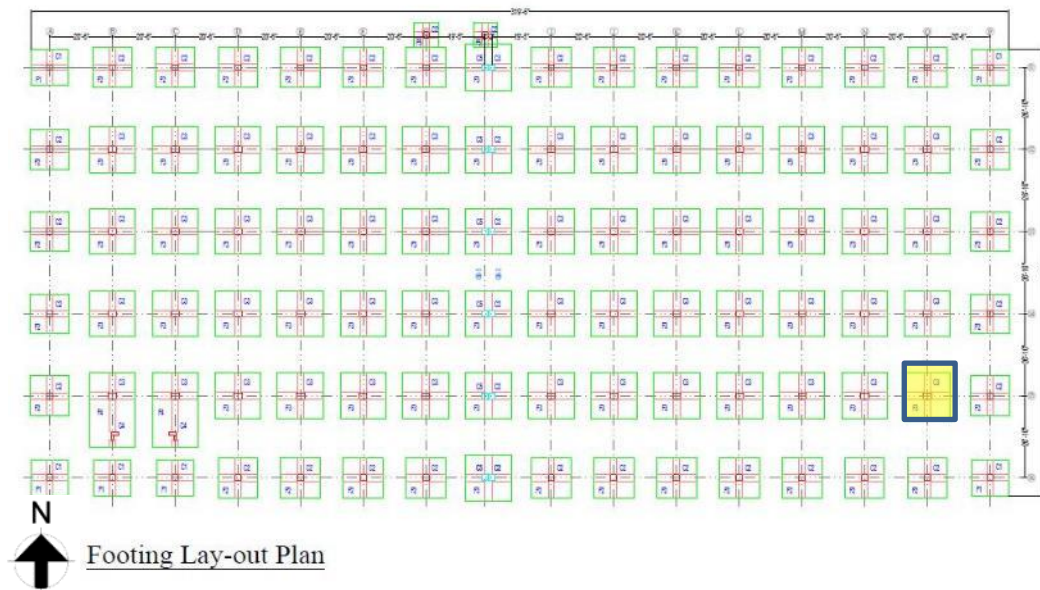
Foundation Layout plan

Cursory calculation indicates that foundation is stressed above normal design limits at the marked locations considering 3 kPa live load on typical floor. Building engineer to review design, loads and foundation stresses.

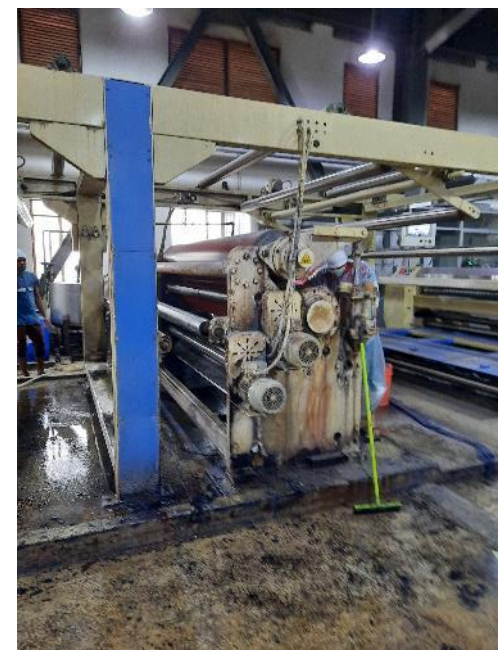
Heavy machineries

Significant vibration was felt on the first floor due to operation of heavy machineries. Building engineer is required to investigate the long-term effect of the vibration and suggest remediation.

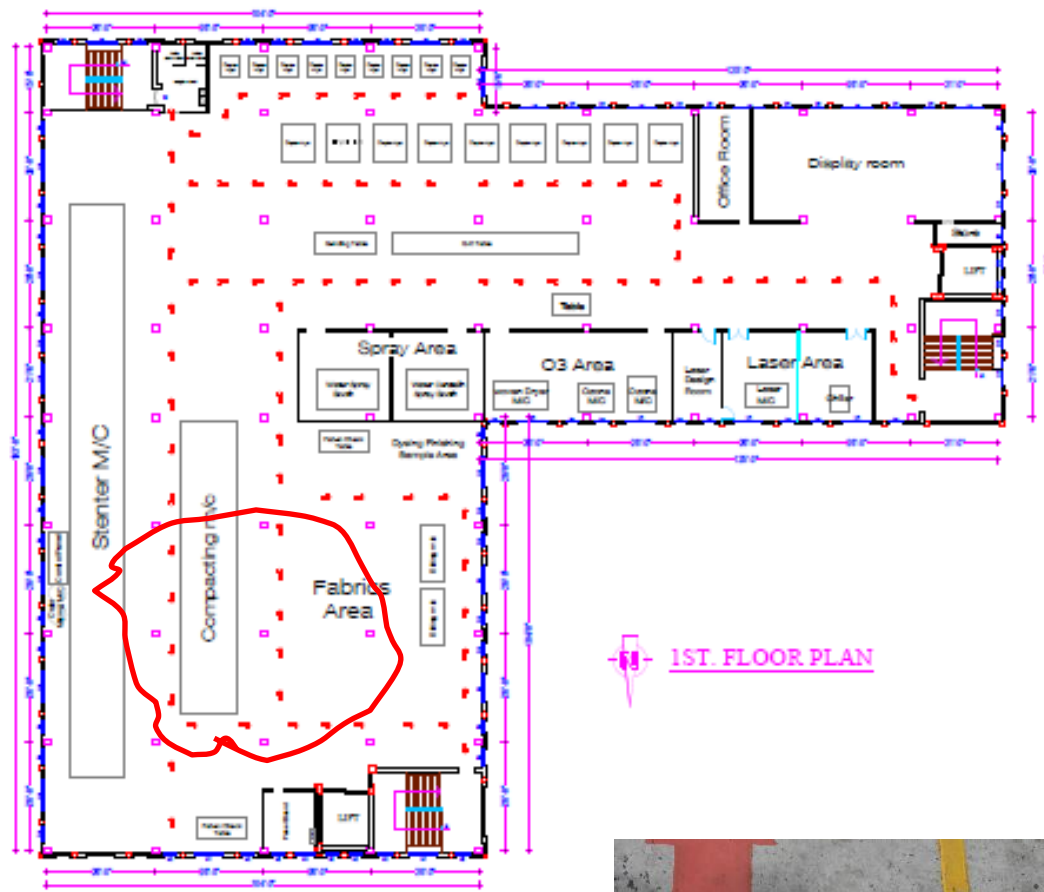
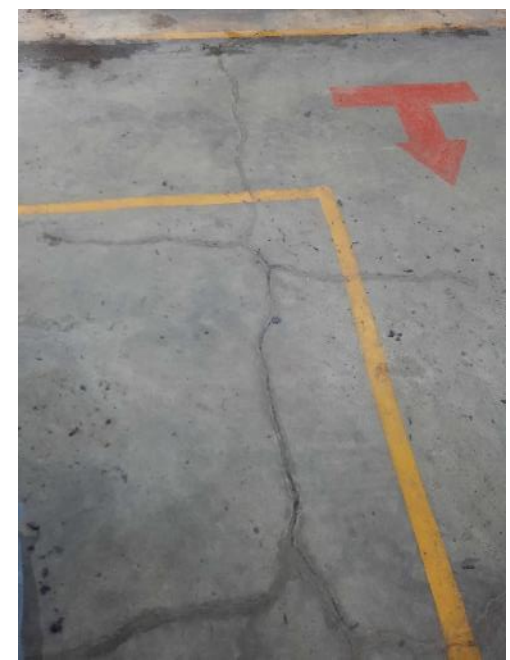
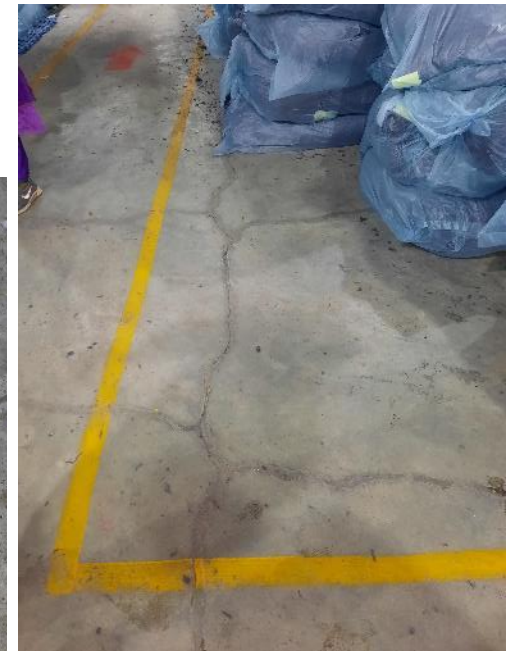
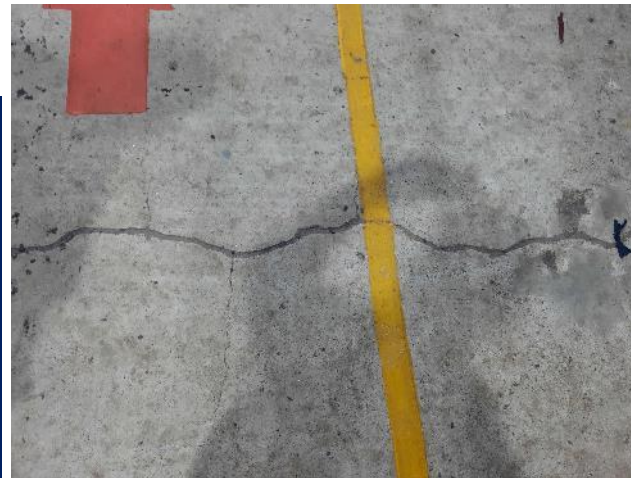
Crack observed on the 1st floor slab apparently due to presence of heavy machineries and vibration. Building engineer is required to check the extent of the crack and suggest remediation.

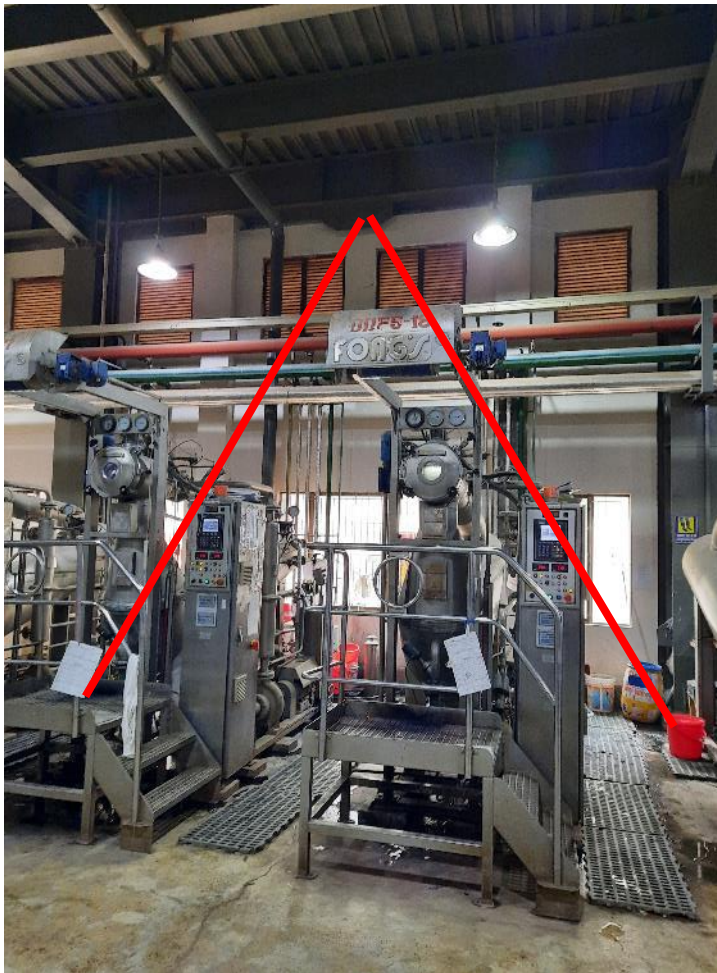
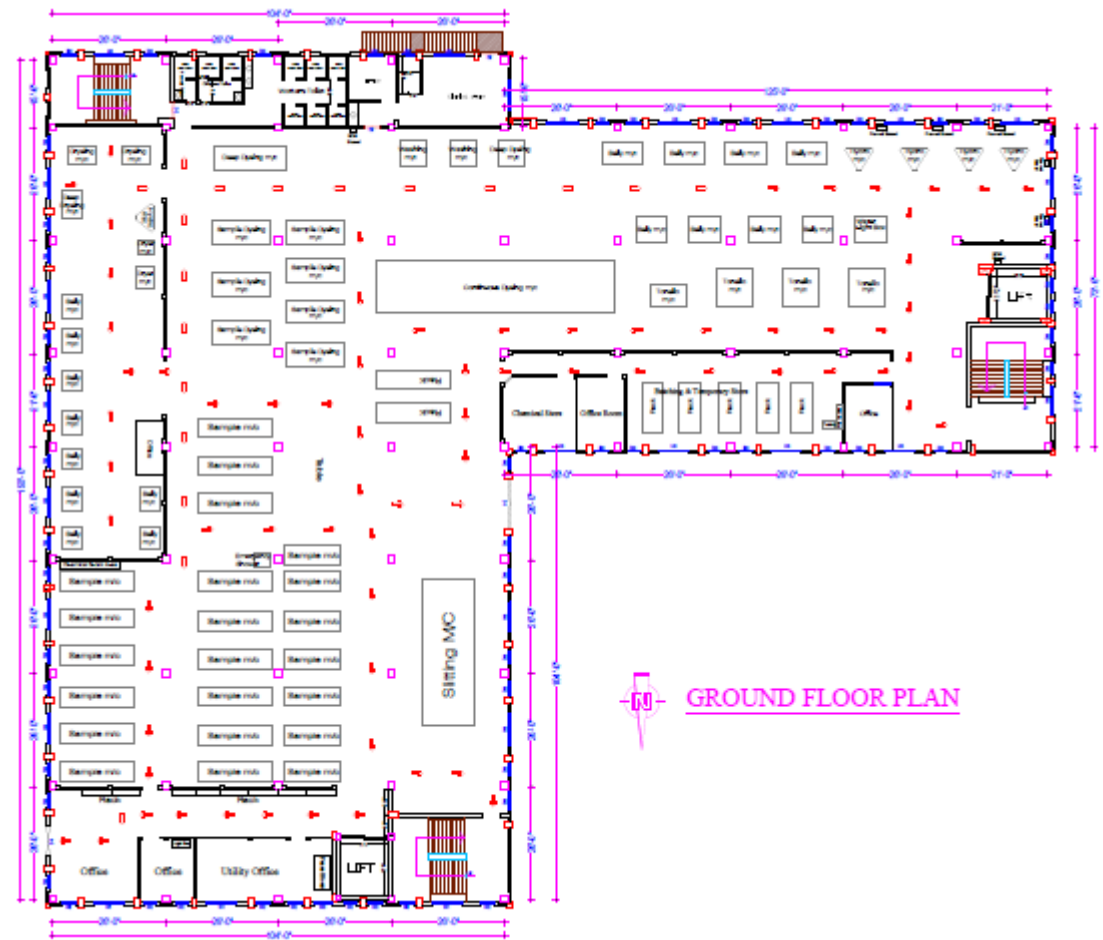
Vertical bracing at ground floor found missing in the marked location. Building engineer is required to install the missing bracing also check the lateral stability in long direction.

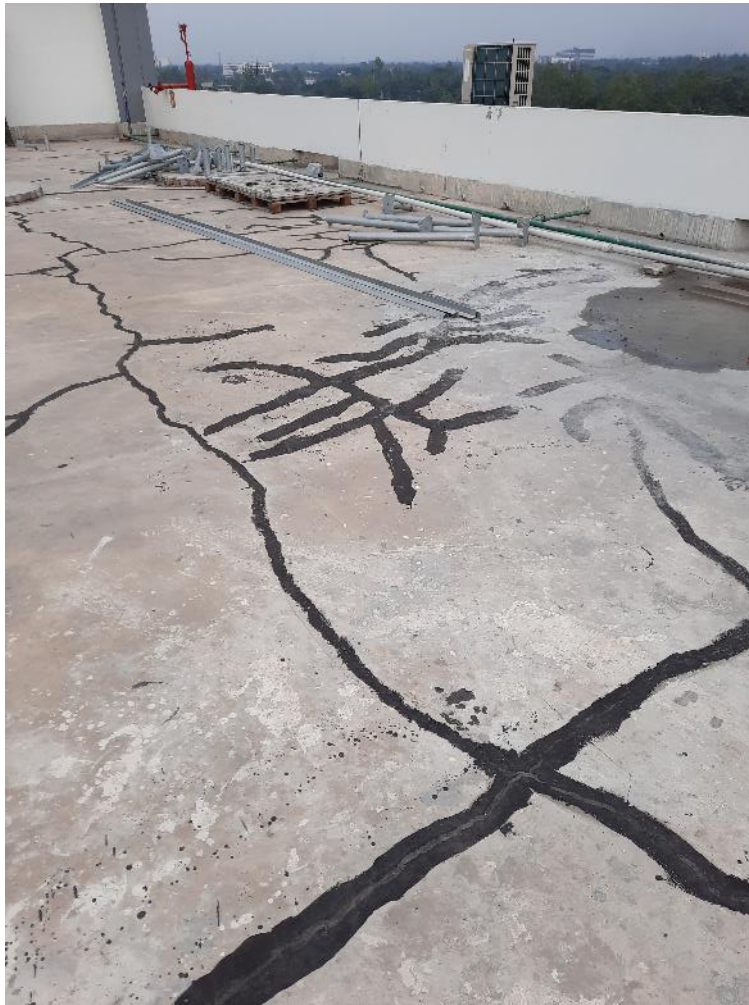
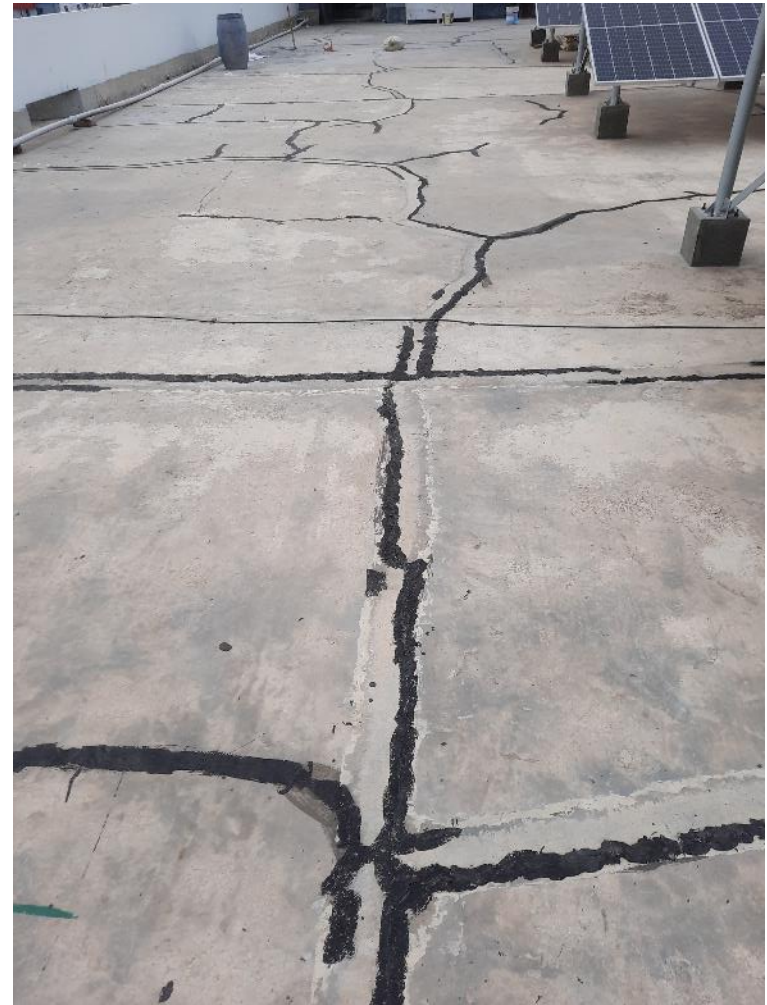
Crack observed on roof slab. However, the factory has repaired the crack by bituminous treatment. No investigation report was available to determine the reason of crack, extent of crack & detail repair methodology. Building engineer is required to investigate the reason of crack, extent of crack and check whether the crack are repaired with suitable method.

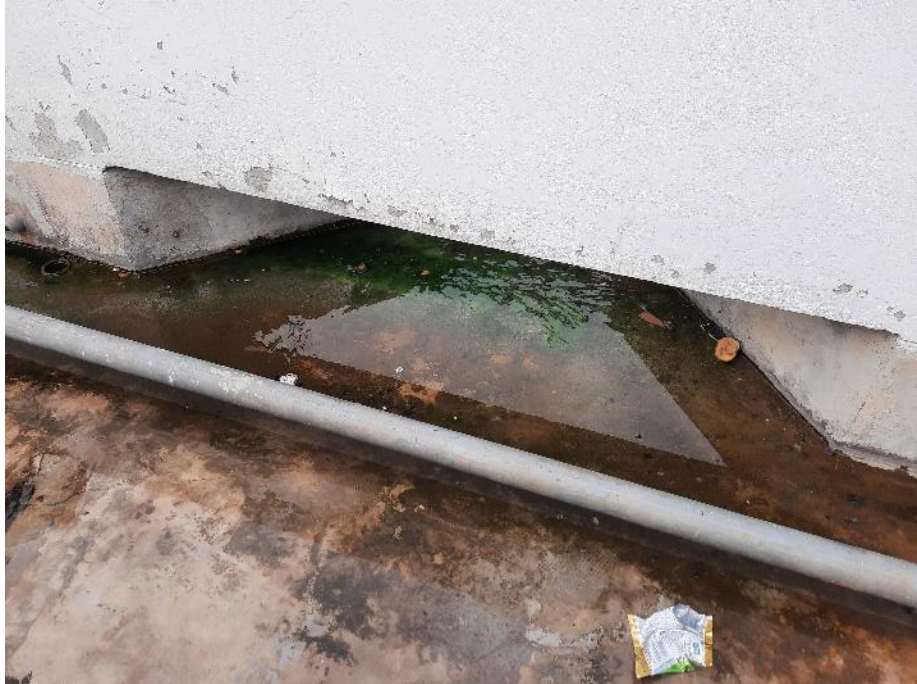
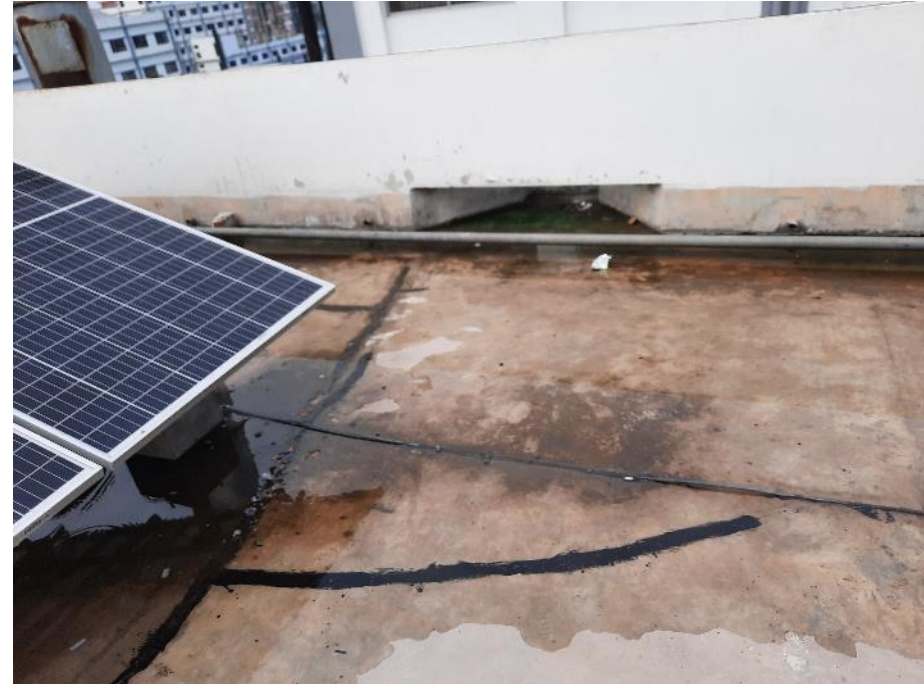
Stagnant of water observed on roof. Building engineer is required to improve the roof drainage system.

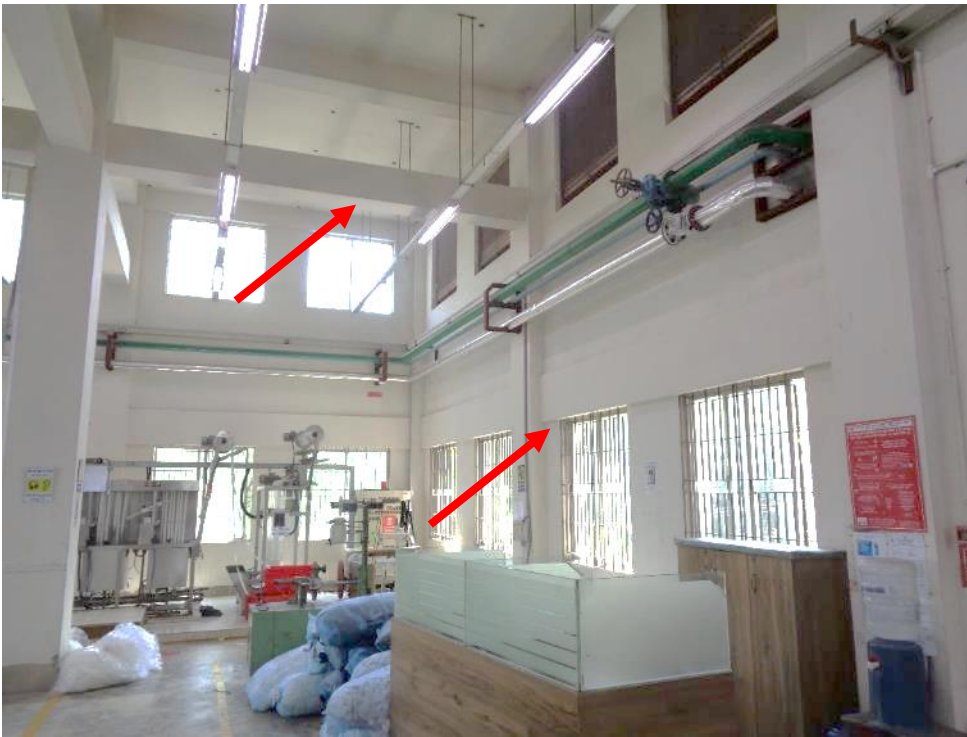
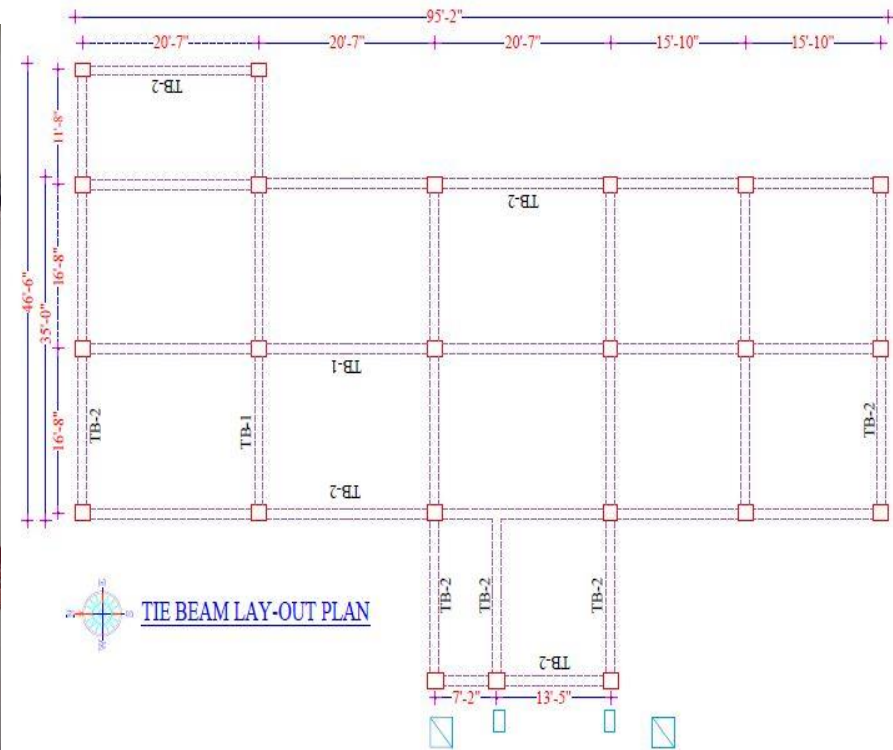
Tie beam of 1<sup>st</sup> floor found at different levels

Tie beam of 1<sup>st</sup> floor were found at different levels but not shown in drawing. Also, dimension of tie beam at different levels differs from each other which is not shown in drawing. Building engineer is required to update the as-built drawing.

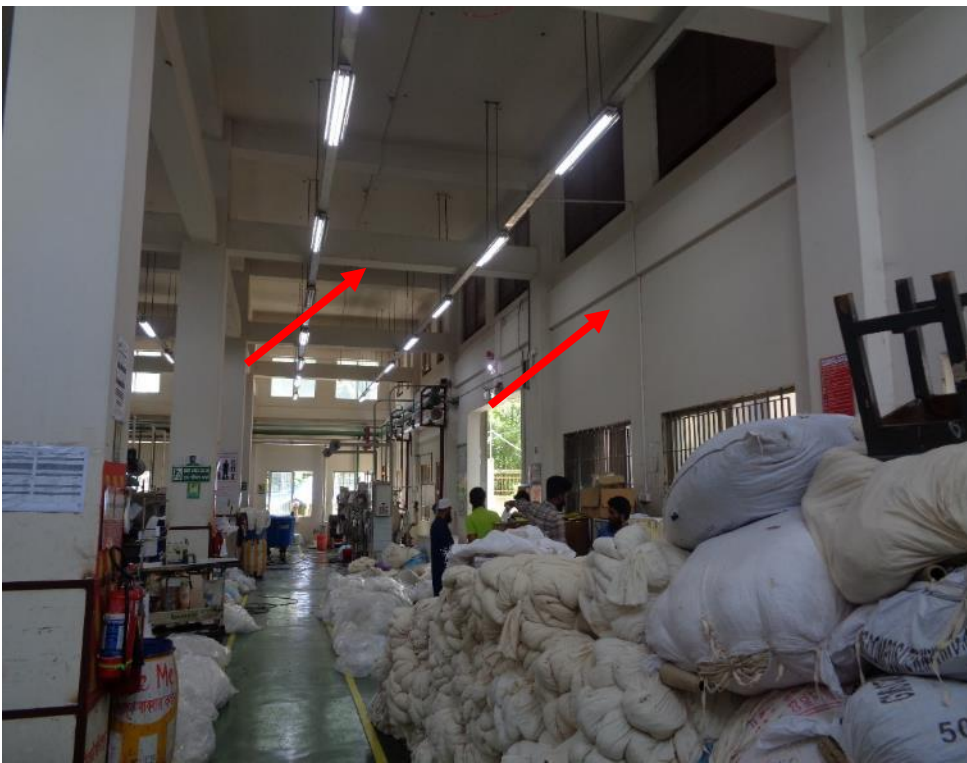
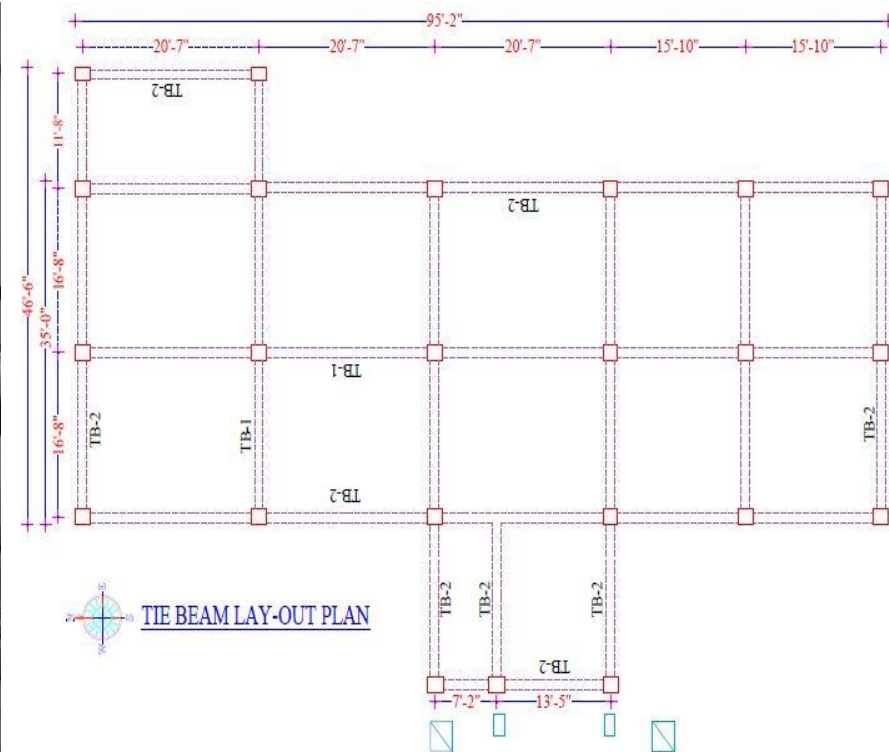
Tie beam of Ground floor found at different levels

Tie beam of Ground floor were found at different levels but not shown in drawing. Also, dimension of tie beam at different levels differs from each other which is not shown in drawing. Building engineer is required to update the as-built drawing.

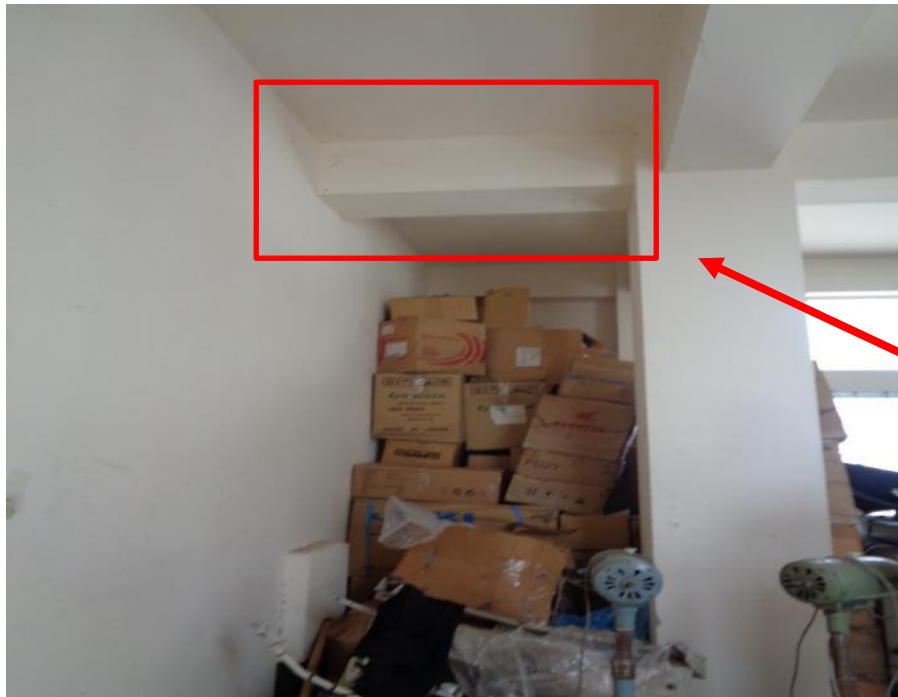
Cantilever beam not shown in layout

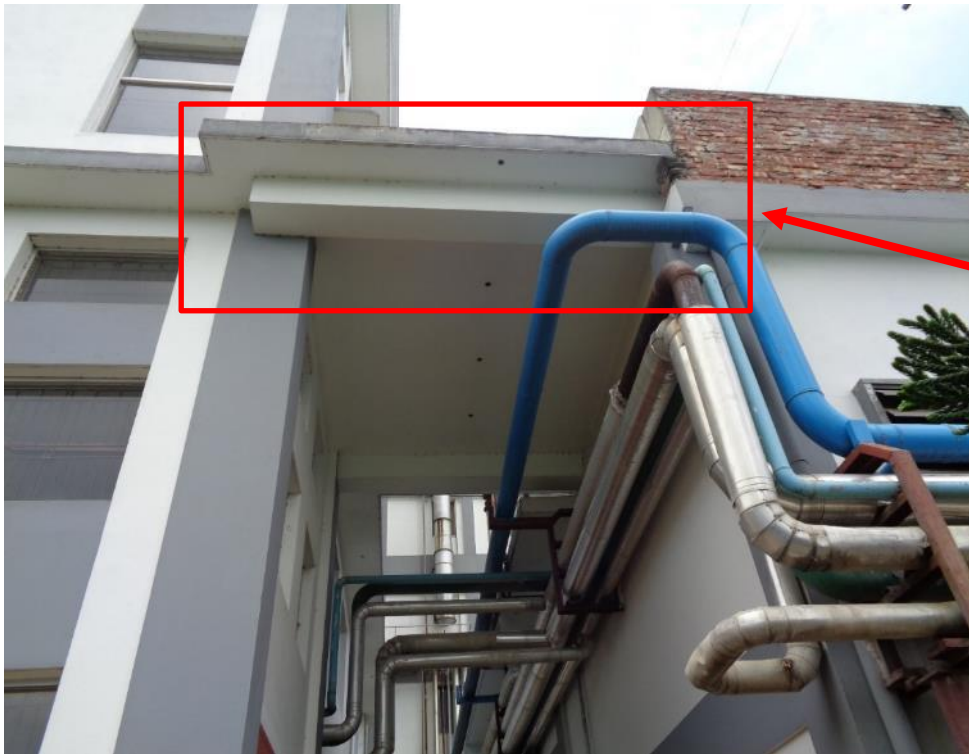
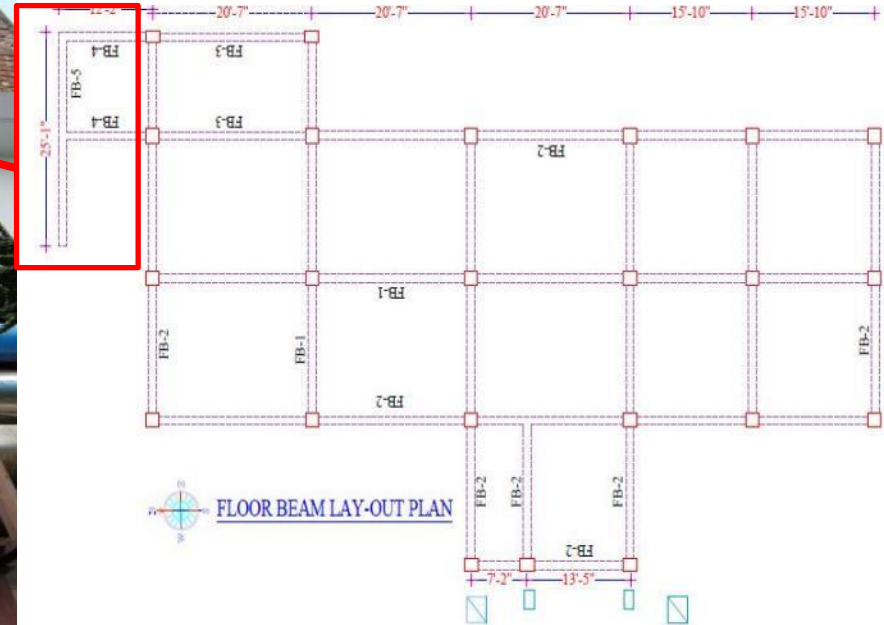
Marked portion was found only at 1<sup>st</sup> floor

Beams at marked portion are not found as per beam layout and regular pattern which indicates irregularity in load transfer system. Also, marked portion of Building-10 was appeared to be structurally connected with Boiler building but these two structures have been analysed separately. Building engineer is required to update the as-built drawing, check adequacy of the highlighted beams. In-case of any structural connection between Building-10 and Boiler Building, separate the two structures. Otherwise review the lateral load transformations between the buildings.

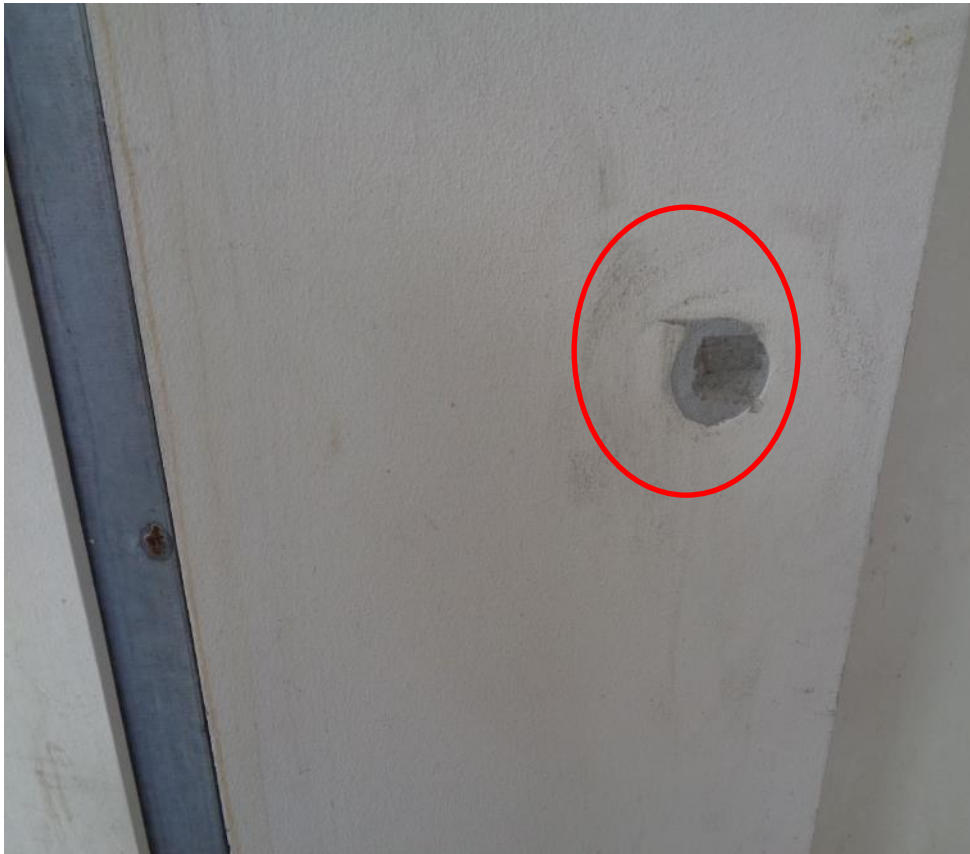
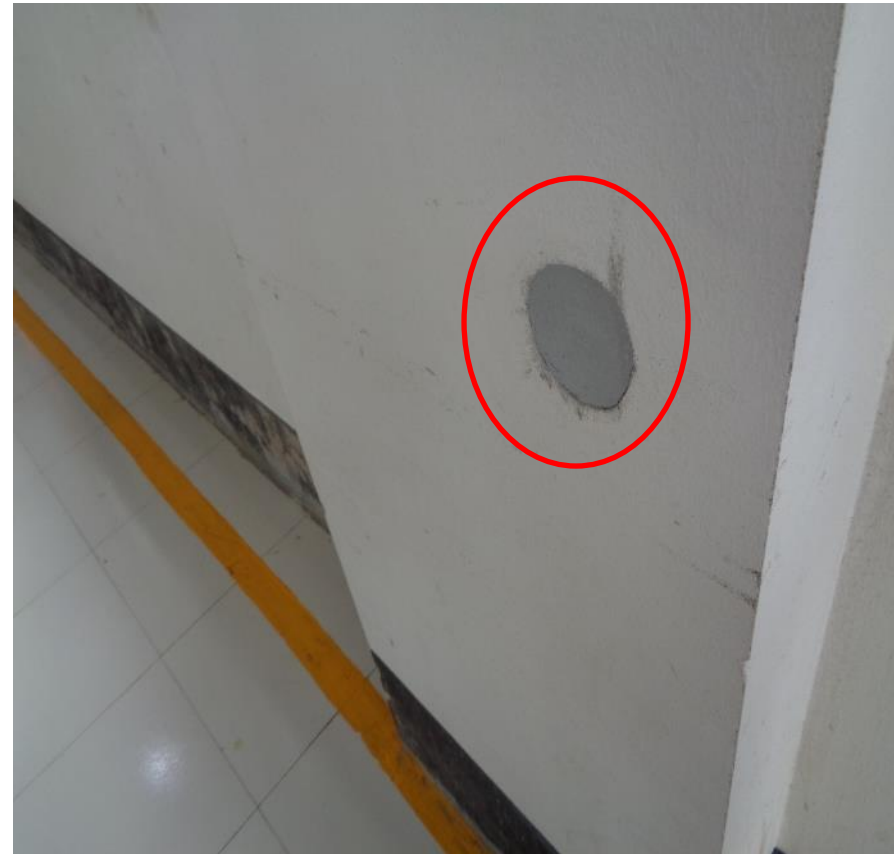
Core cutting hole filled with mortar

Core cutting hole were found filled with only mortar which may impact on column stress level.  
Building engineer is required to fill all the core cutting hole with micro-concrete.

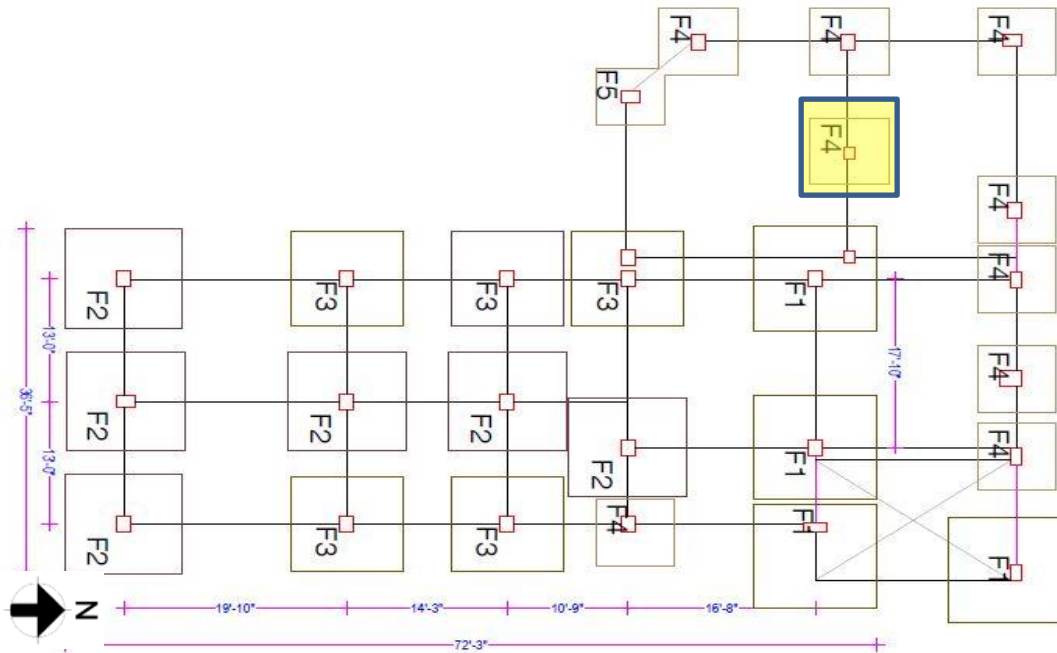
Foundation Layout plan

Cursory calculation indicates that foundation is stressed above normal design limits at the marked locations considering 3 kPa live load on typical floor as per prepared live load plan. Building engineer to review design, loads and foundation stresses.

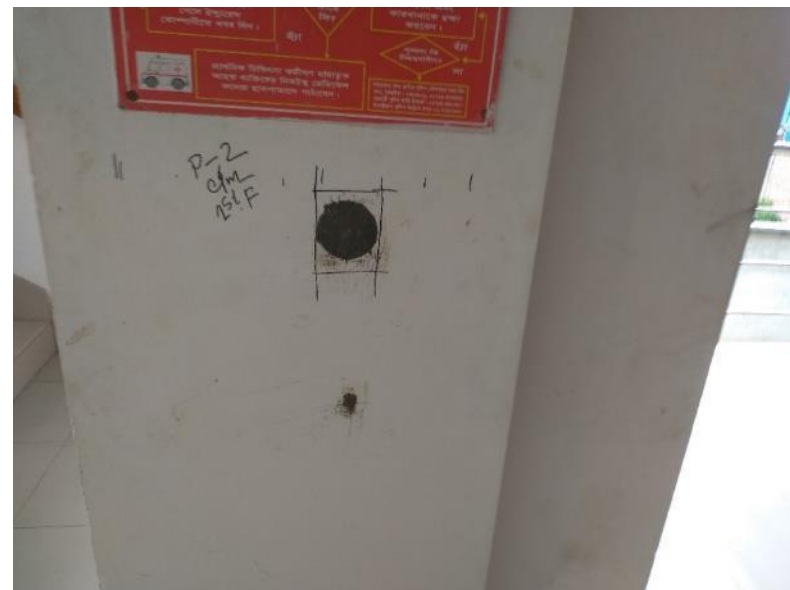
One location of concrete core on column

At the time of inspection one set of concrete cylinder core test report from column was available for this structure. However, only one location of the cores was found at site. Building engineer is required to produce a core layout and mark all the locations of the taken cores.

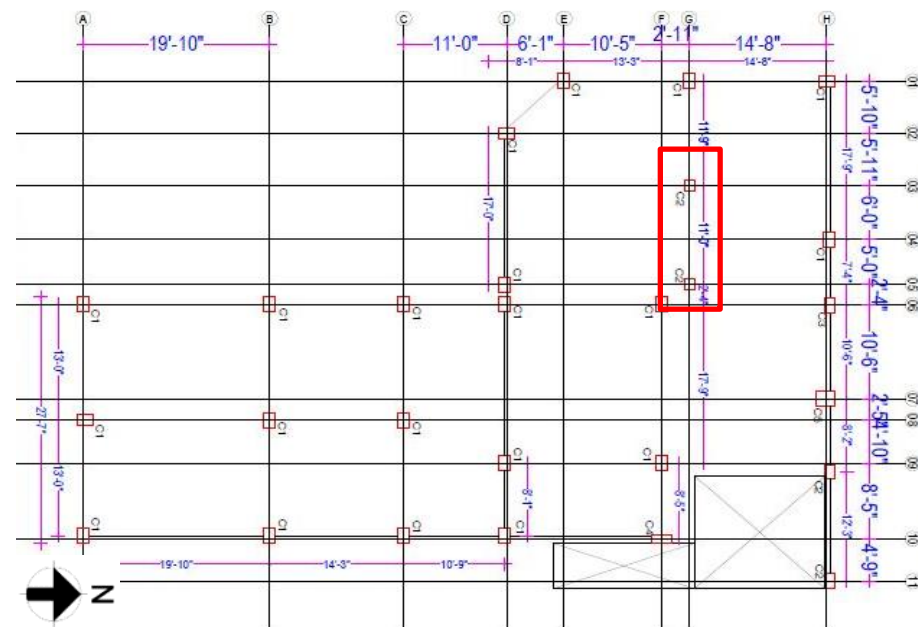
Column layout

Dimension of Columns at grid and were mentioned as 375mmX500mm but actual dimension of these two columns measured as 300mmX375mm. Building engineer is required to re-survey the whole structures and update as-built drawing as per actual site condition.

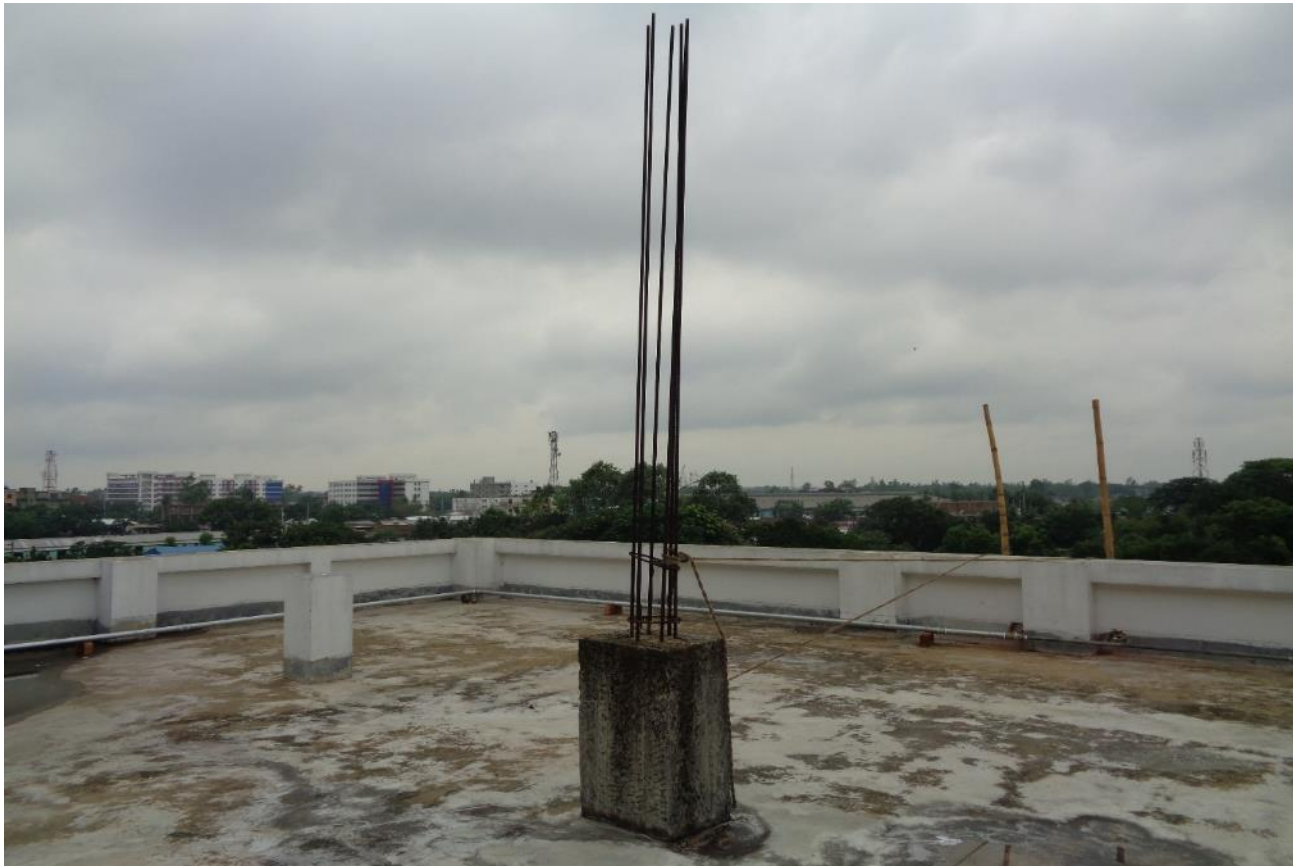
Exposed reinforcement at roof level

Exposed reinforcement was found left at roof level. Building engineer is required to provide rust proof paint on the exposed rebar.

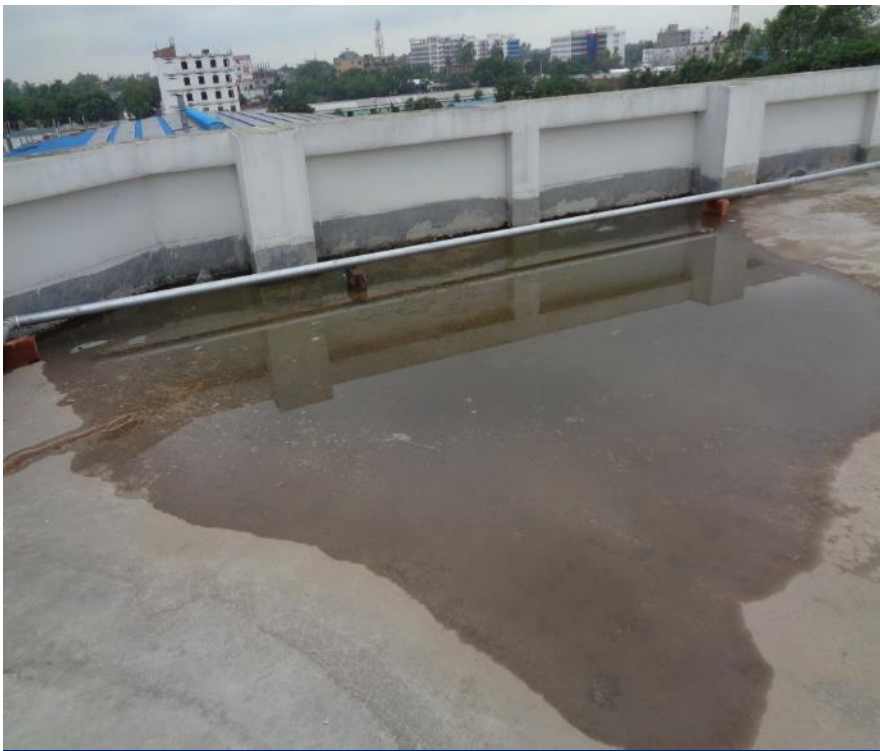
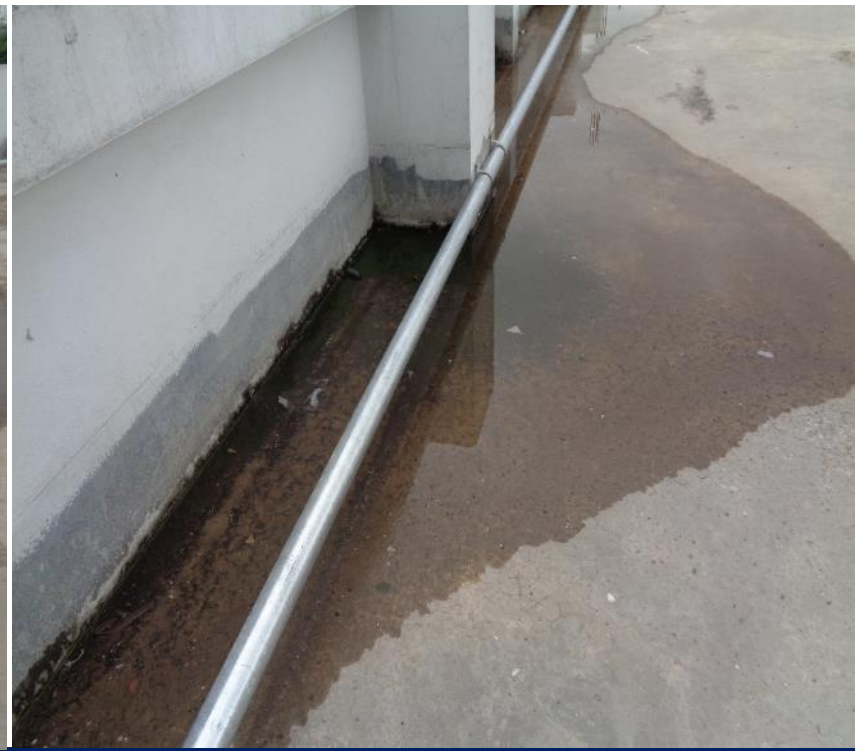
Water ponding on roof slab

Water ponding was found on roof slab. Any cracks or damage on the roof surface will allow water to seep into the concrete slab beneath the finishes and cause long term soaking of the slab and corrosion of the rebar. Factory is required to provide necessary slope and improve drainage system to prevent water ponding.

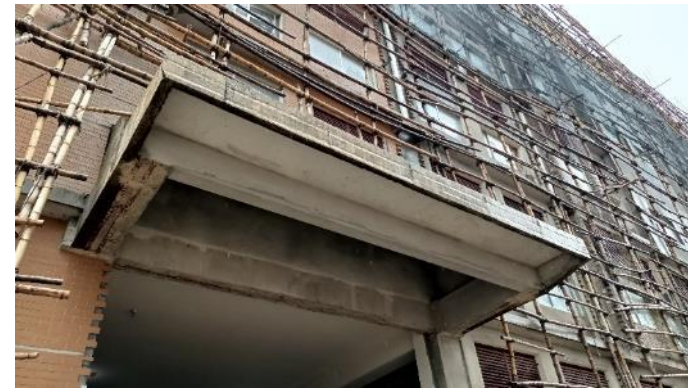
Architectural drawings are not updated as per as built condition. Toilet zone and partition walls of 3<sup>rd</sup> and 4<sup>th</sup> floor are found different with the drawings. Also, the porch of both exits are shown in the drawings.

Undocumented Porch at Exits

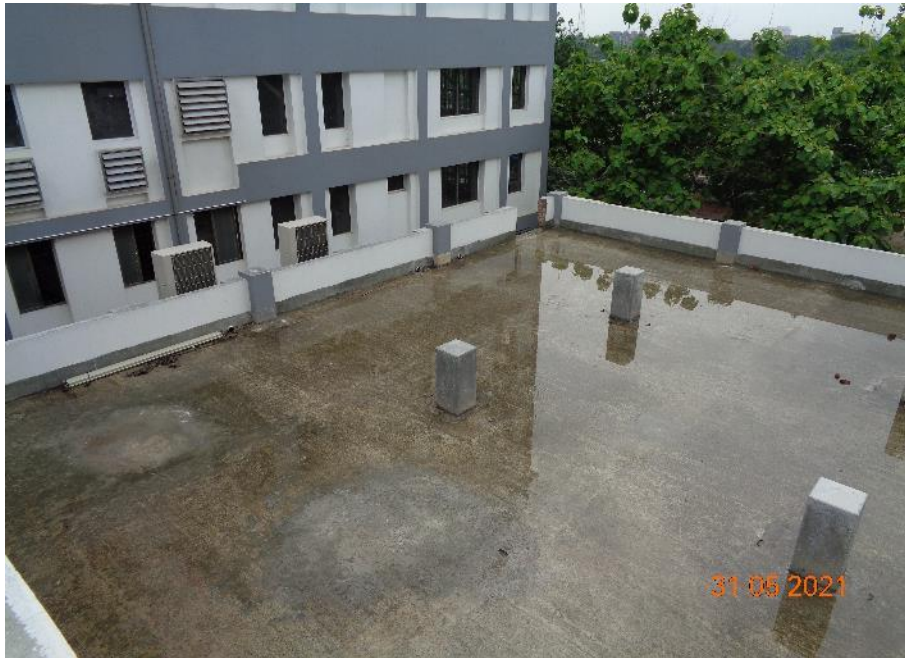
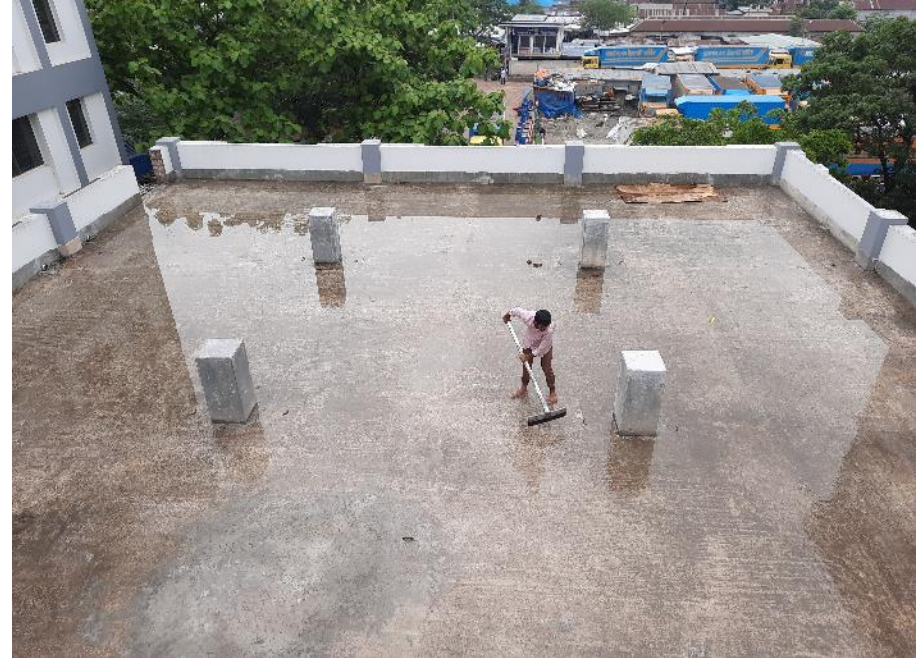
Stagnant of water observed on roof. Building engineer is required to improve the roof drainage system.

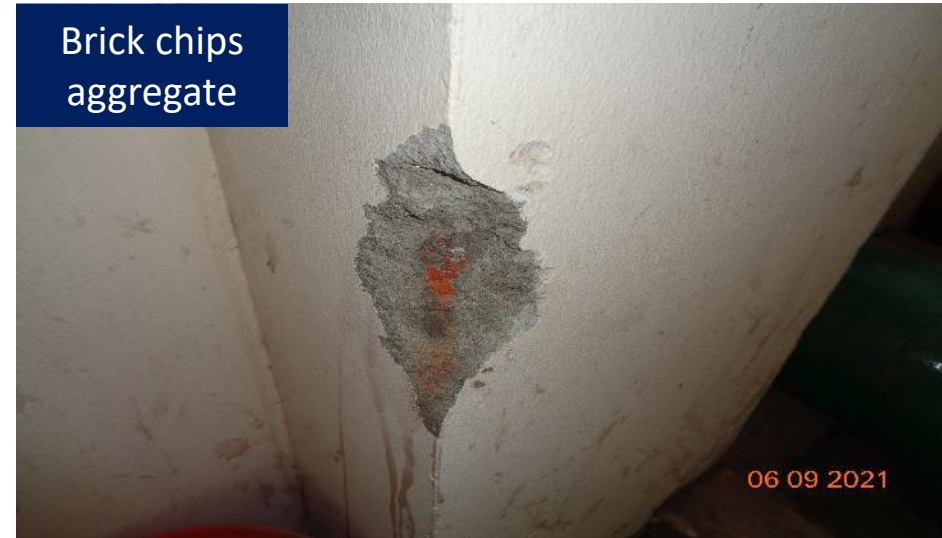
In design report concrete strength considered 4223 psi from the core test report. During inspection core test report available on site. Stone chips aggregate mentioned in core test report, but onsite brick chips aggregate found. Building engineer is required to verify in-situ concrete strength. Incorporate the concrete strength in design report
