# GMS Composite Knitting Ind. Ltd. (New Building)

Sardaganj, Kashimpur, Gazipur-1346, Bangladesh,  
(23.96859, 90.29699)

24<sup>th</sup> & 31<sup>st</sup> May & 06<sup>th</sup> September 2021

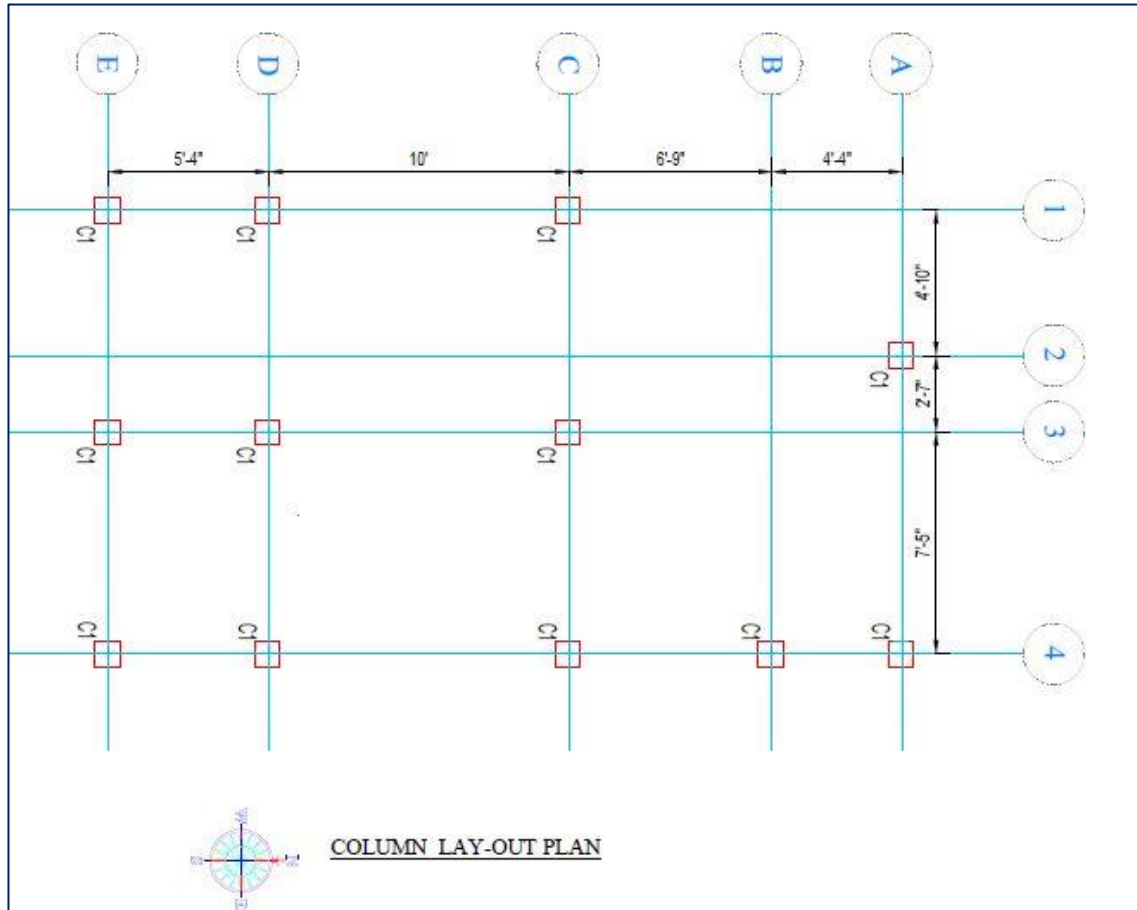
Column layout plan of 01 No Security Office

Details drawing were not found for the fire pump room. On the other hand, the 01 Security Office was a masonry structure with a RC slab having 3-inch thickness. But provided as-built drawing shows RC beam-column frame structure with isolated footings.

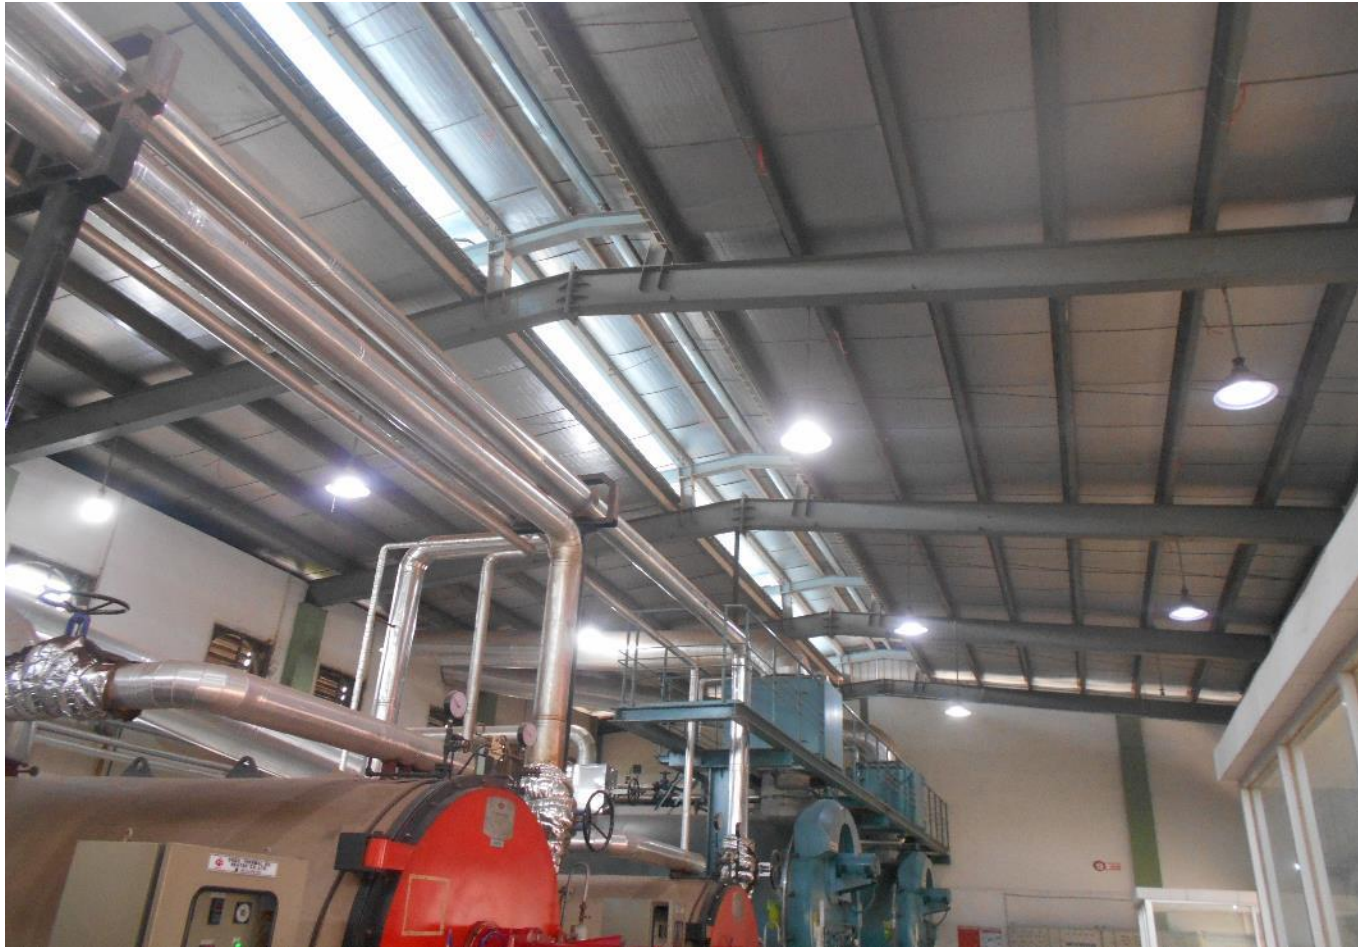
No vertical bracings/ compression struts were provided in the long direction. No roof bracings provided along the short direction. Apparently lack of lateral stability observed.  
The building engineer is required to check the lateral stability system of the shed.

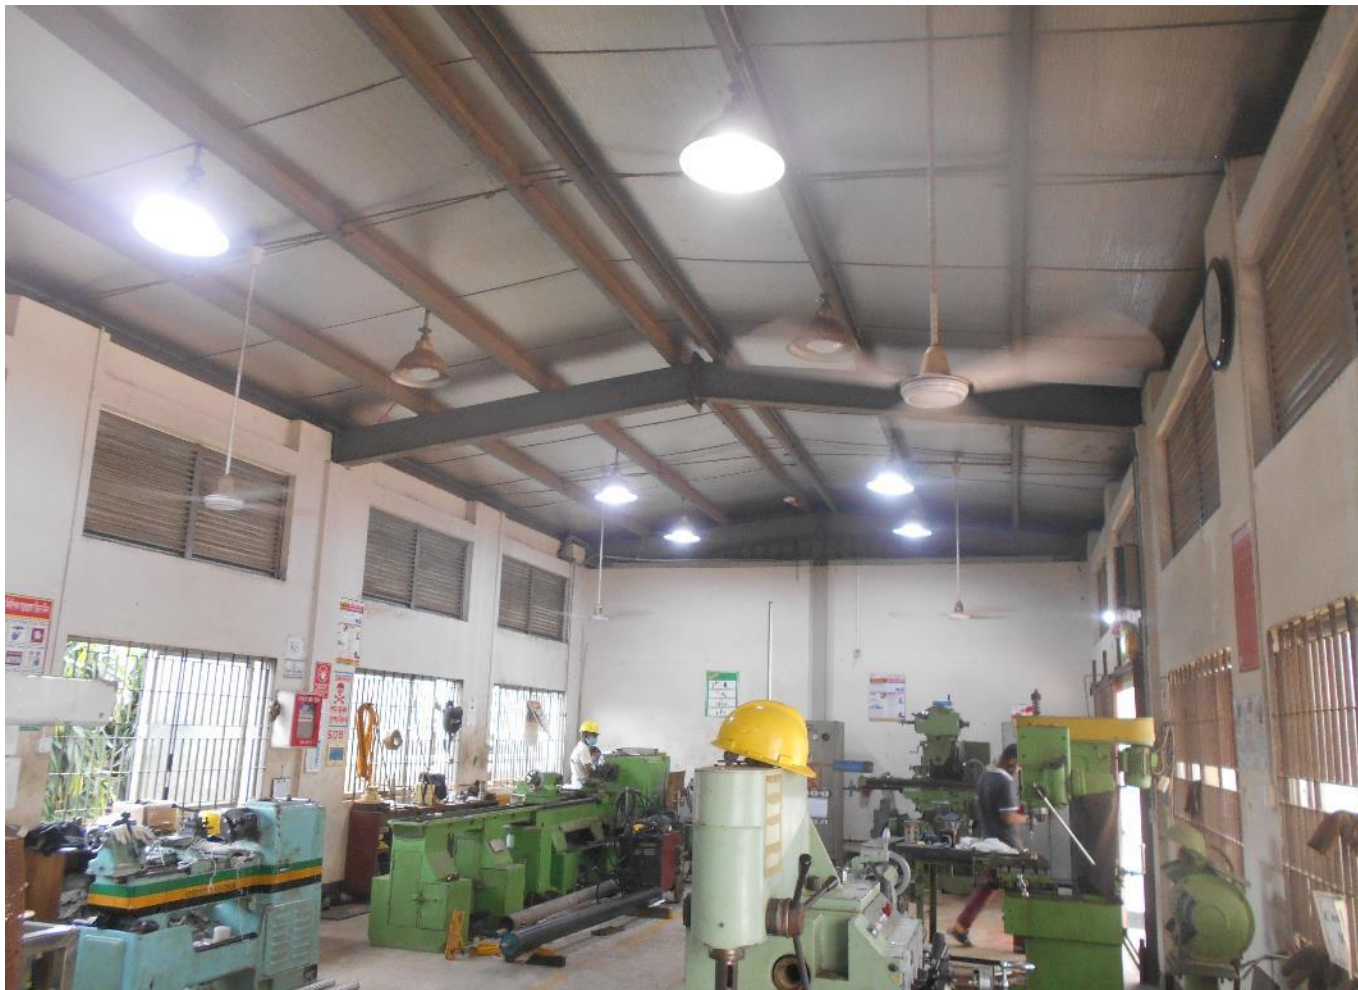
No vertical bracings/ tie beam/ compression struts were provided in the long direction. No roof bracings provided along the short direction. Apparently lack of lateral stability observed. The building engineer is required to check the lateral stability system of the shed.

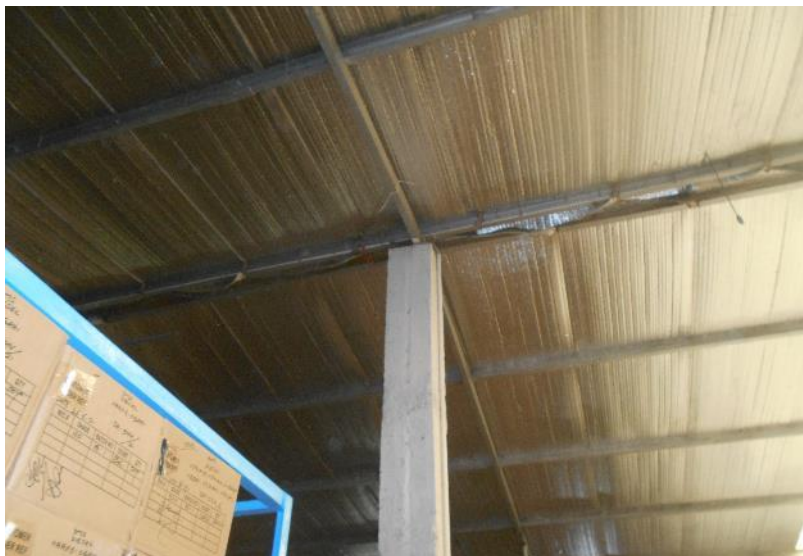
Lack of lateral stability system

Lack of lateral stability system, inadequate structural member & poor connection details. Building engineer is required to check the lateral stability system or replace the non-engineering shed.

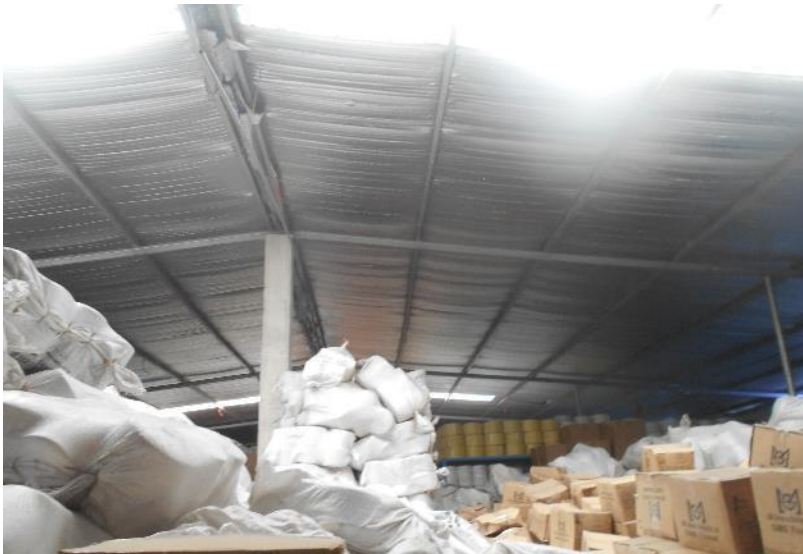
Inadequate structural member

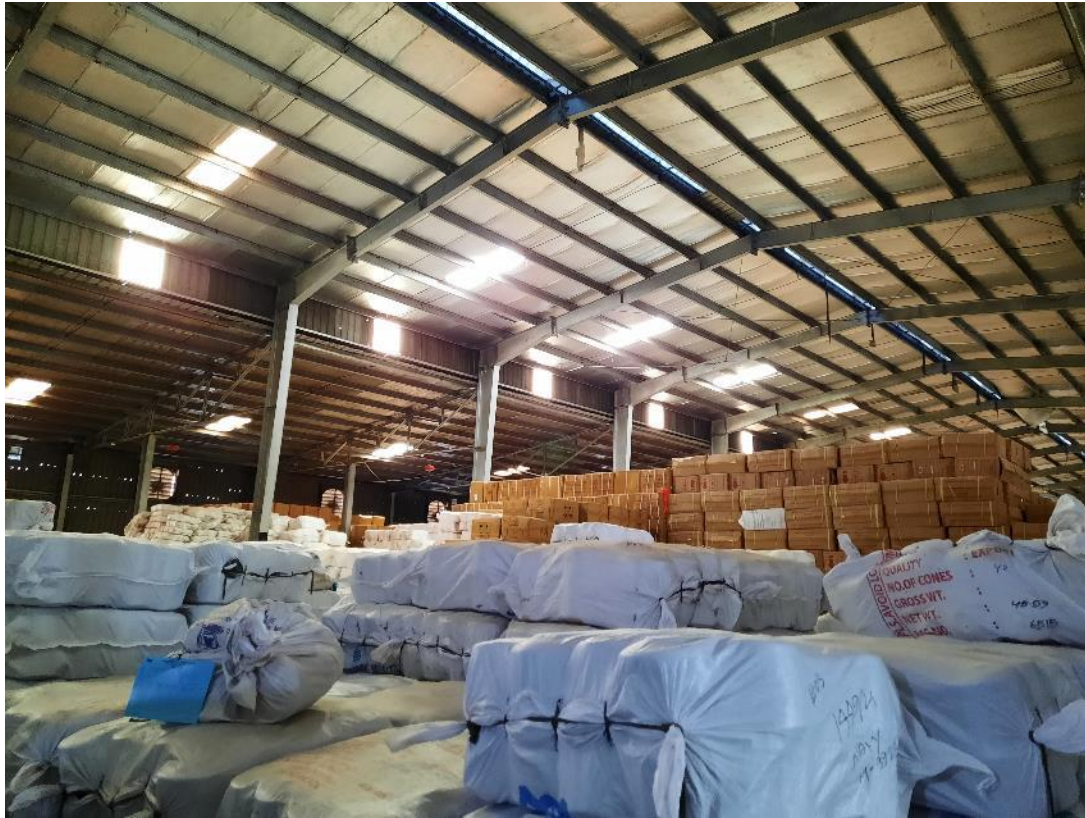
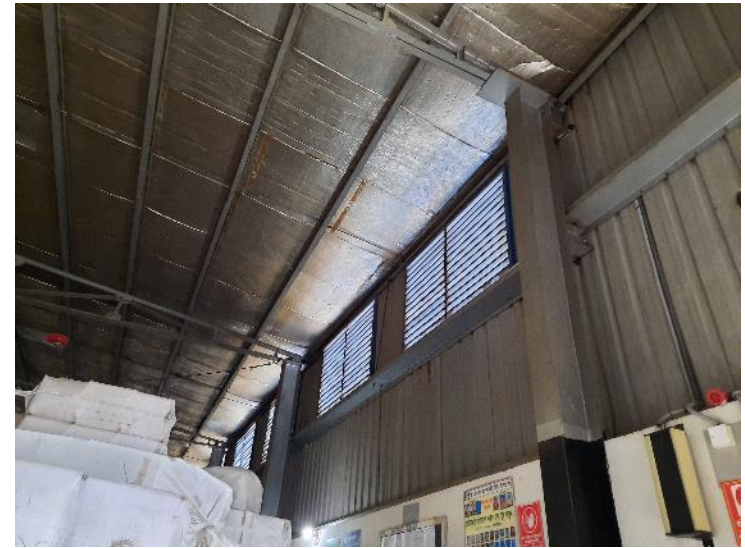
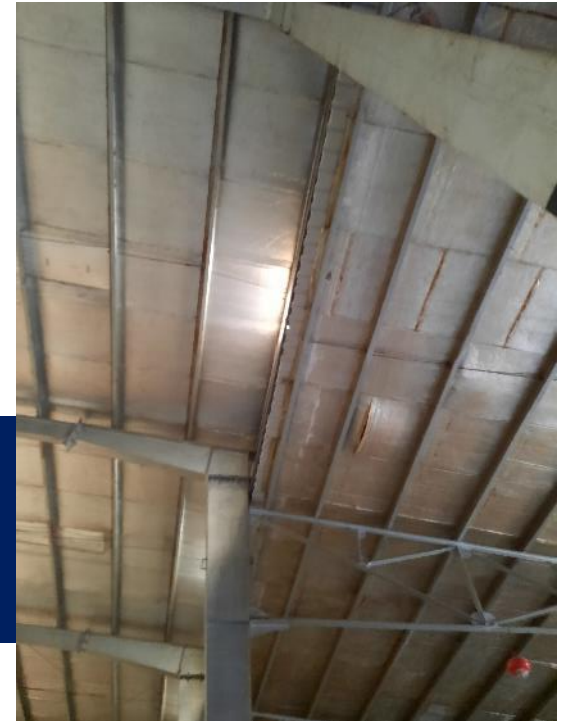
No vertical bracings / tie beam / compression struts were provided in the long direction. Lateral stability along the long direction is appeared to be incomplete. The building engineer is required to check the lateral stability system of the shed.

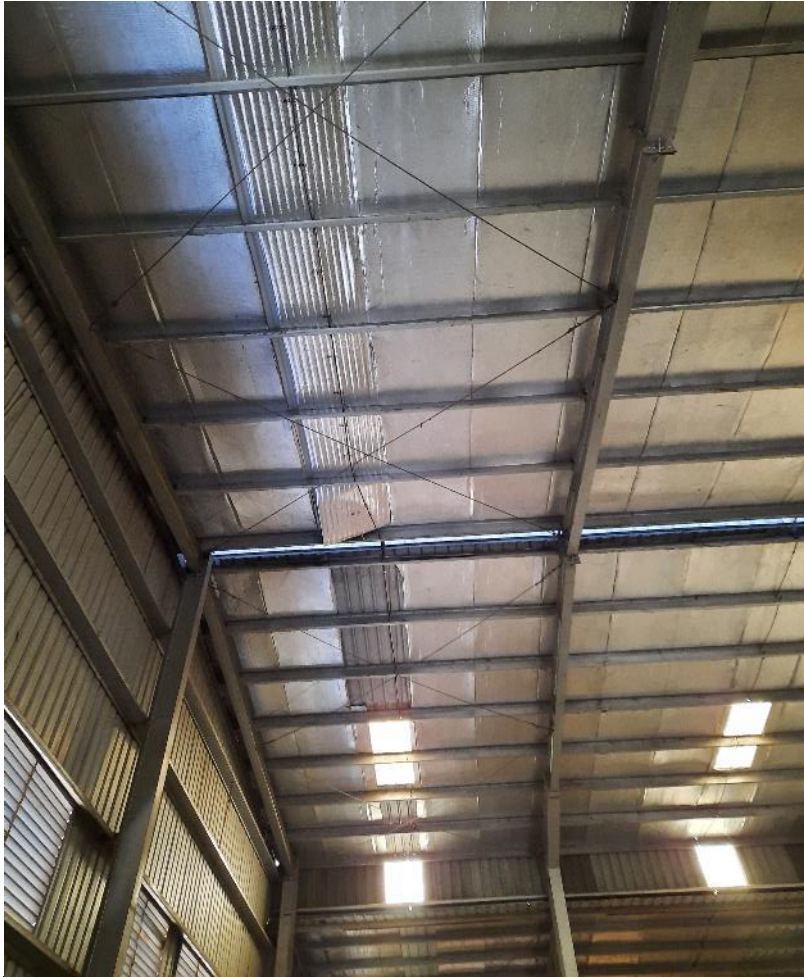
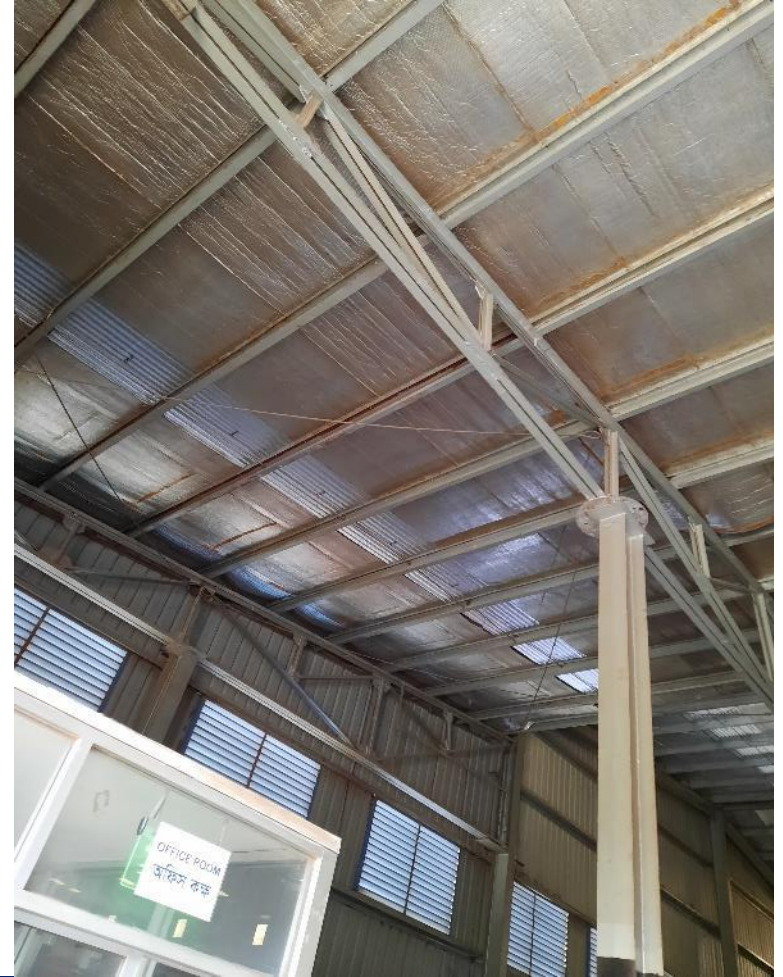
Loose cable bracing observed on roof. Building engineer is required to tighten the bracing.

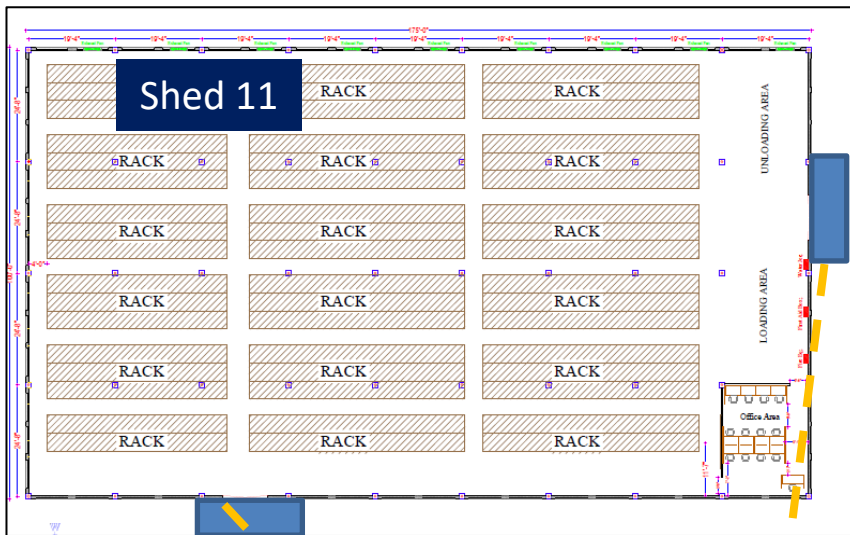
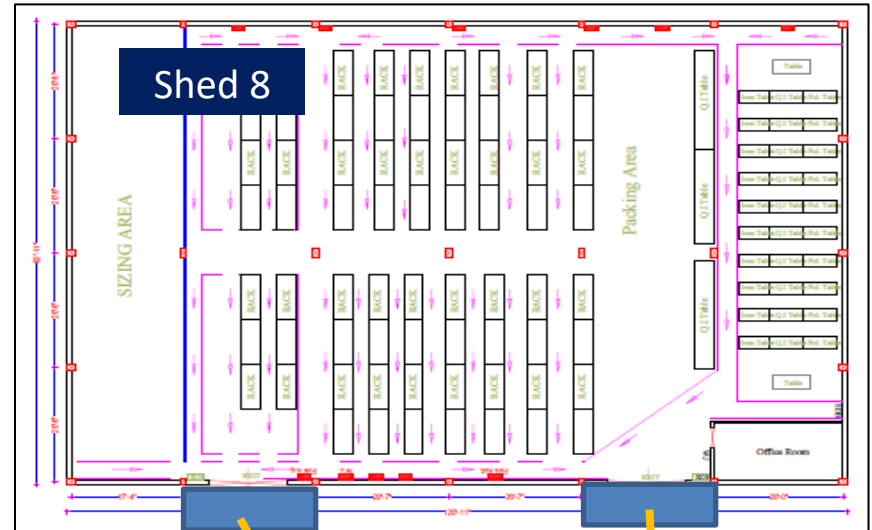
Undocumented canopy at shed 8, 10, 11 & 12.

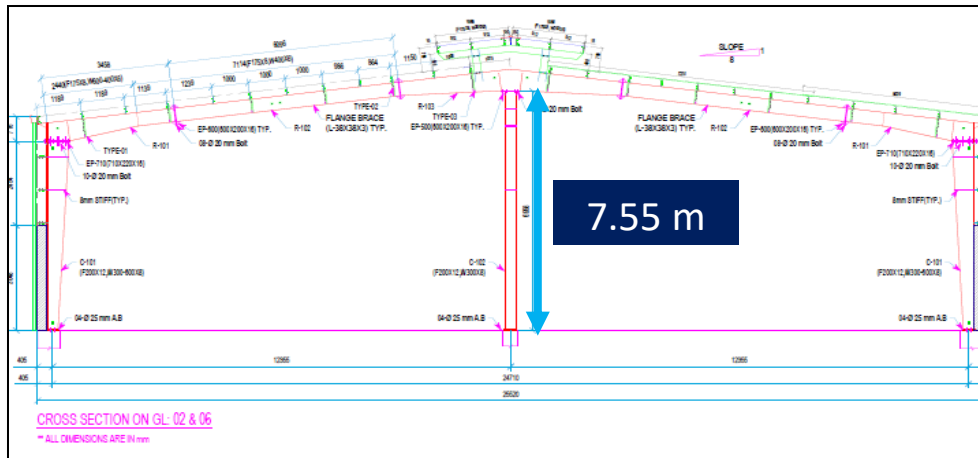
Shed height found 7.55 m instead of 6.9 m mentioned in the as-built drawing at shed 8

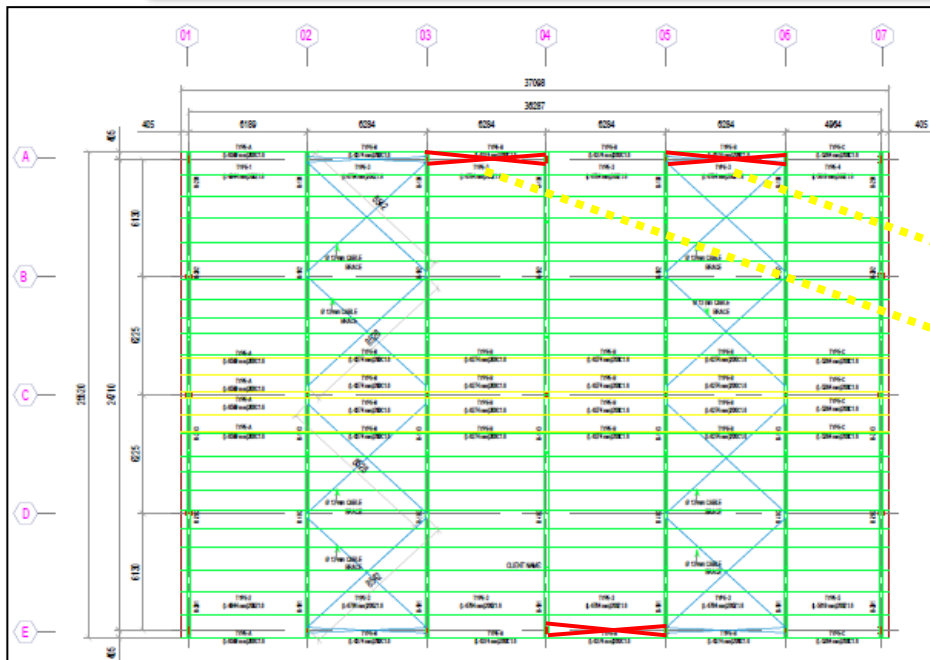
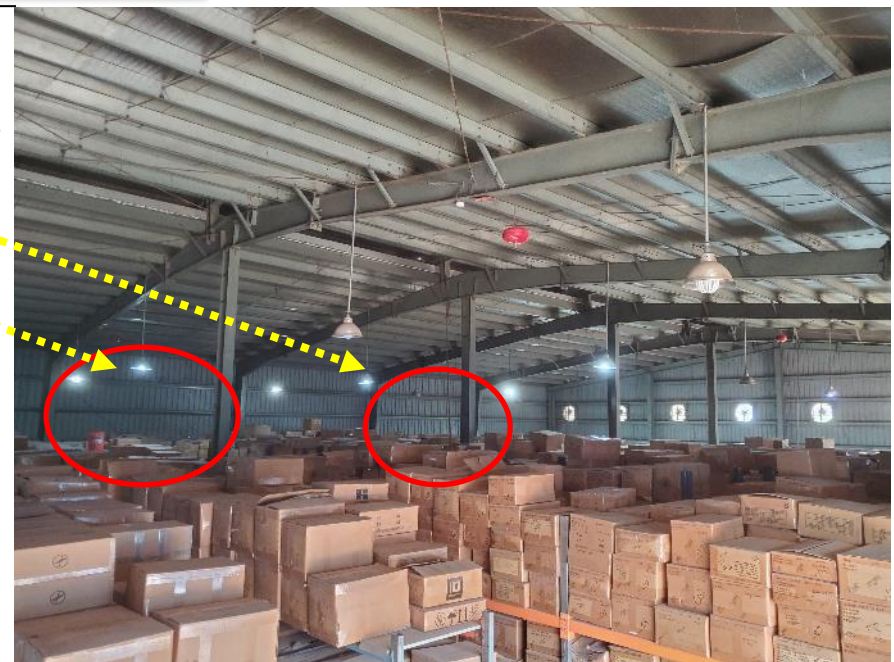
Location of horizontal wire brace is different than the provided drawing at shed 8.

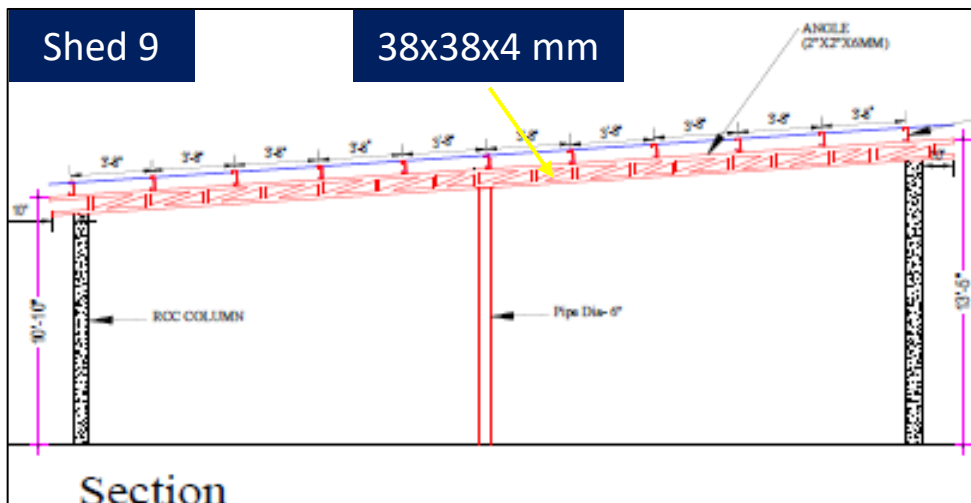
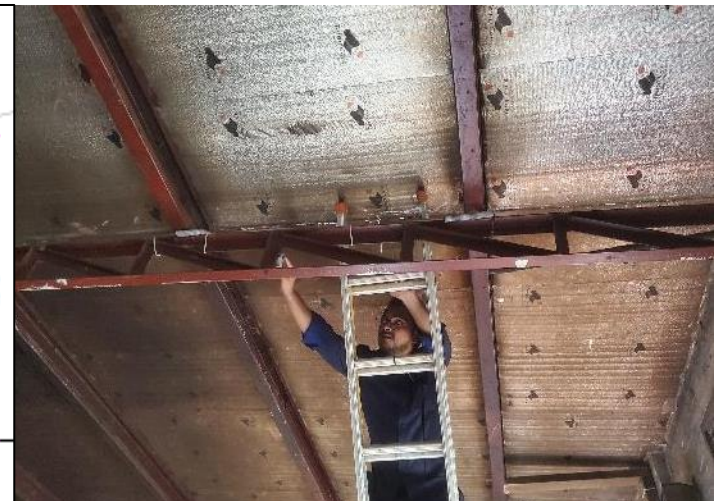
Roof truss internal chord found 38x38x4 mm instead of 50x50x6 mm at shed 9

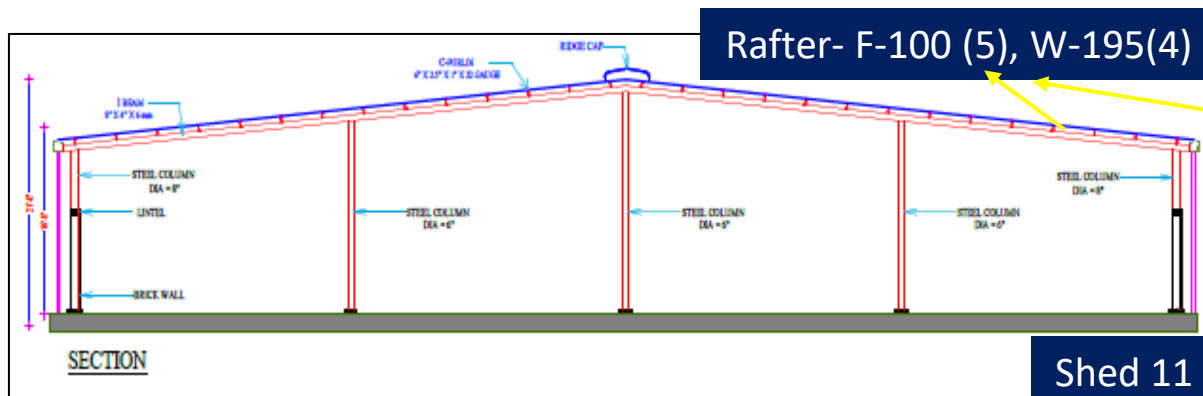
Rafter size found F-100 (5) x W-195(4) instead of F-100 (6) x W-200(6) at shed 11

Similarly, Rafter size found F-100 (6) x W-200(4) instead of F-75 (6) x W-150(6) at shed 14

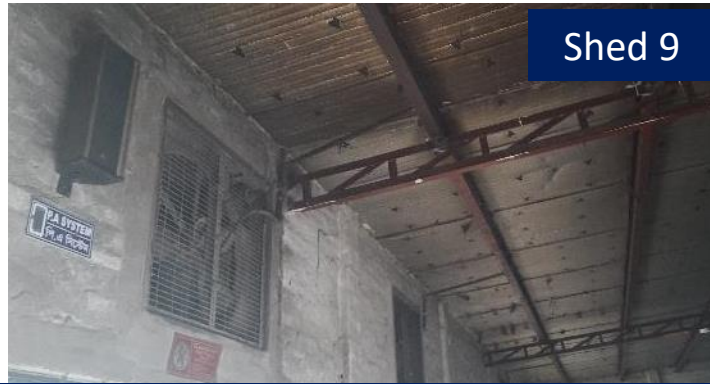
Shed 9

Angle truss and C purlin is embedded in peripheral brick wall

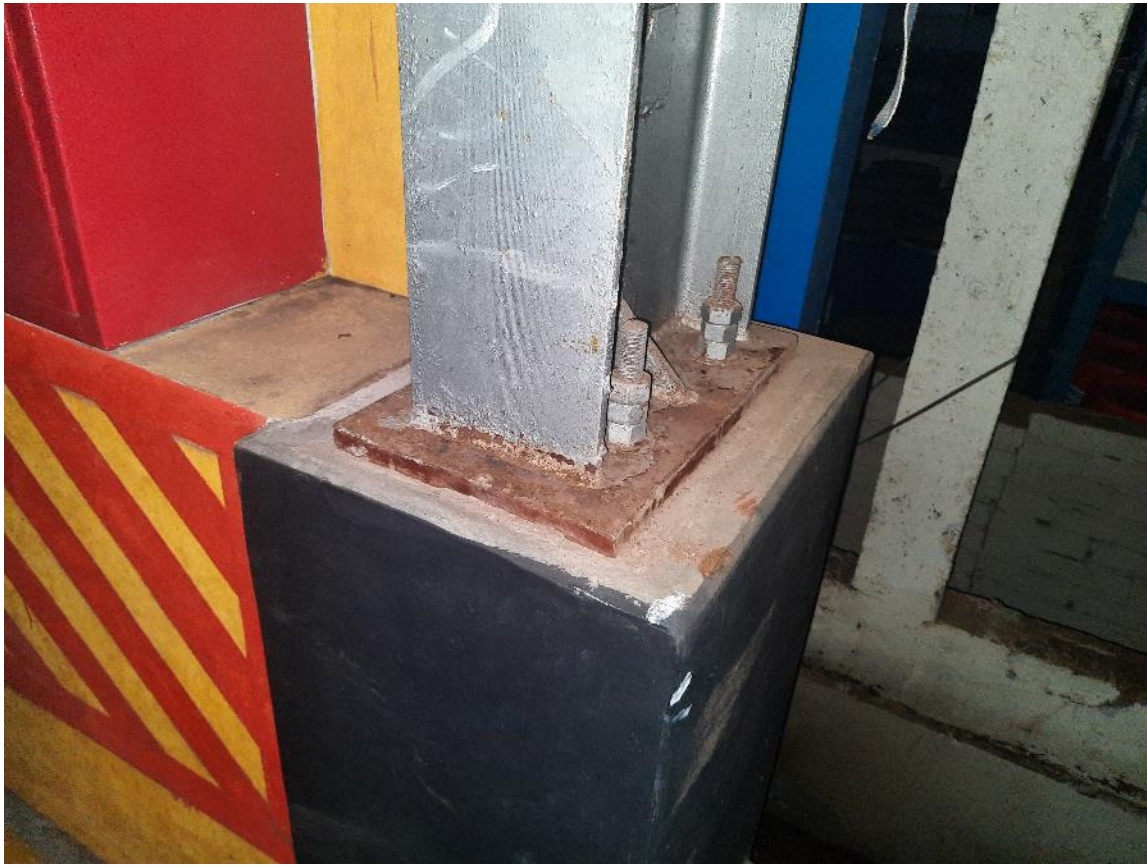
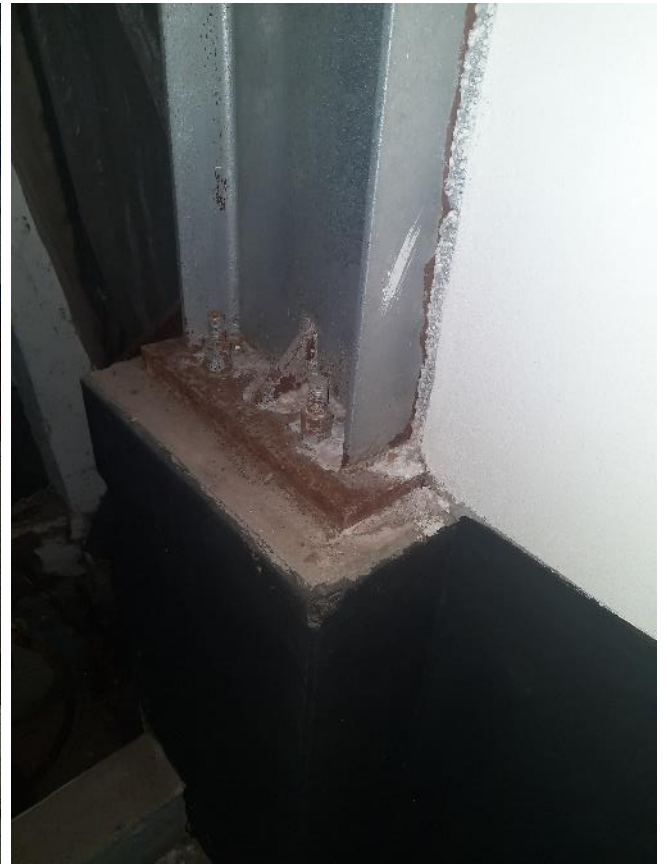
Corrosion in steel column

Corrosion in steel member was observed in various locations. The building engineer to investigate the reason & extent of corrosion and suggest proper remedial measure accordingly.

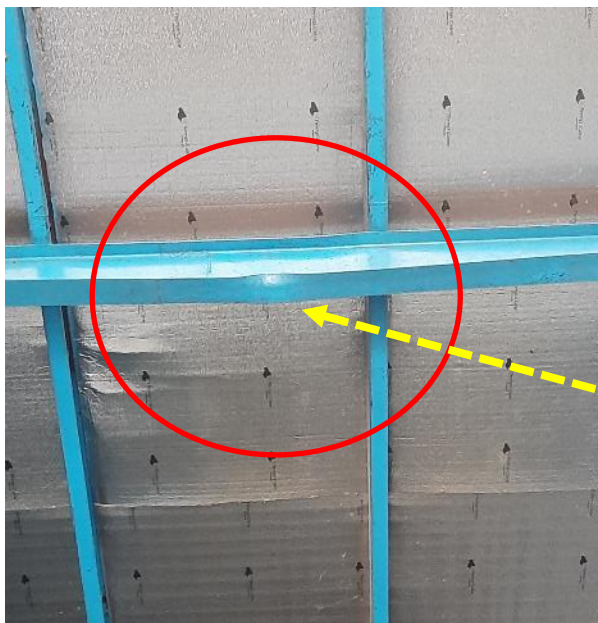
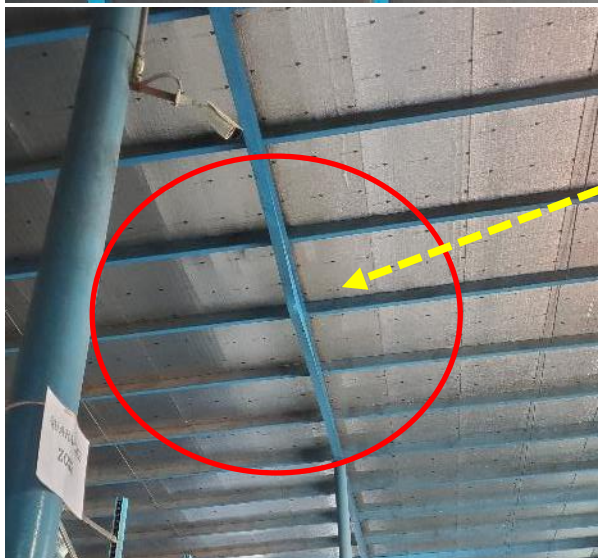
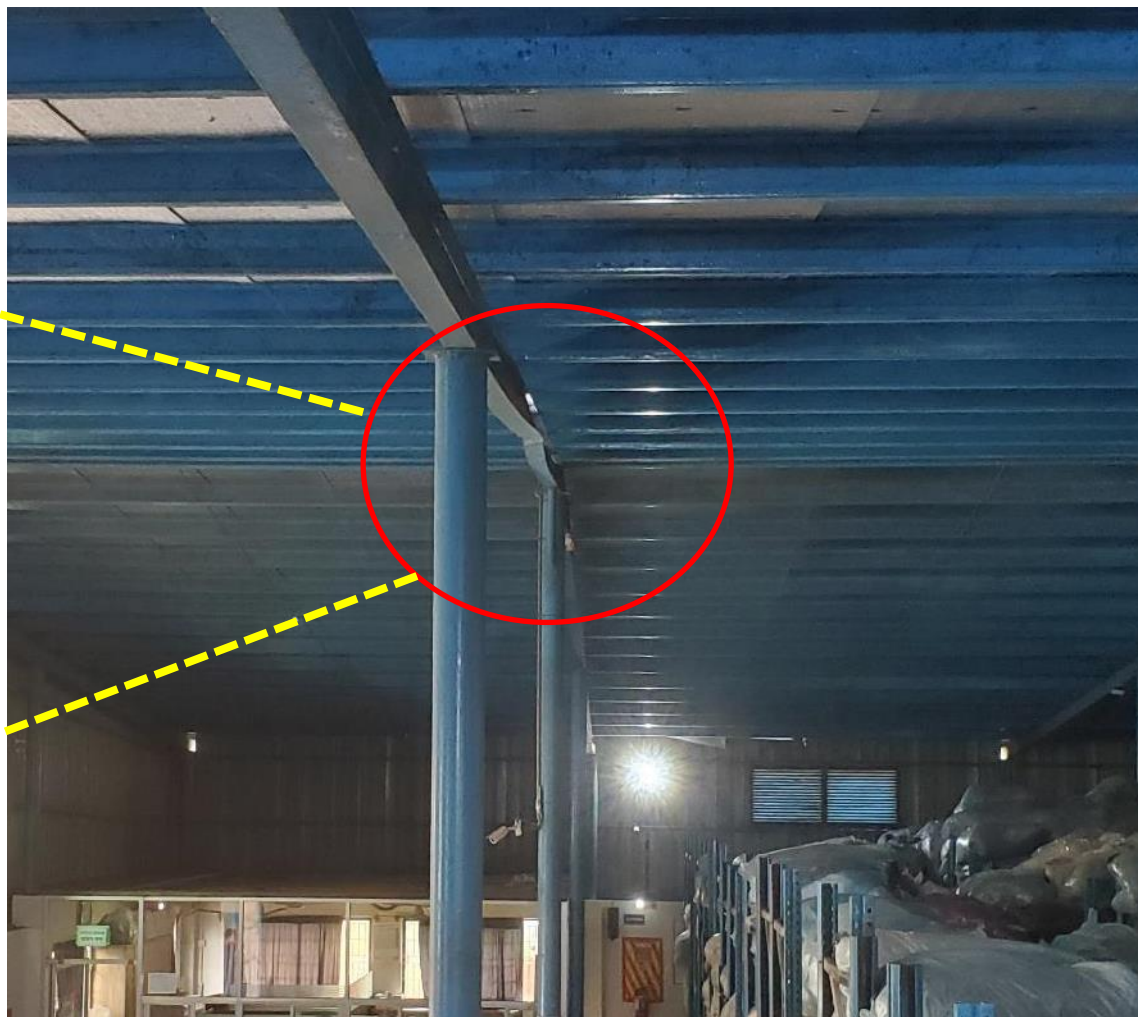
Damaged and twisted rafter observed at grid-B of the shed. Building engineer is required investigate the damaged rafter and suggest a suitable repair method.

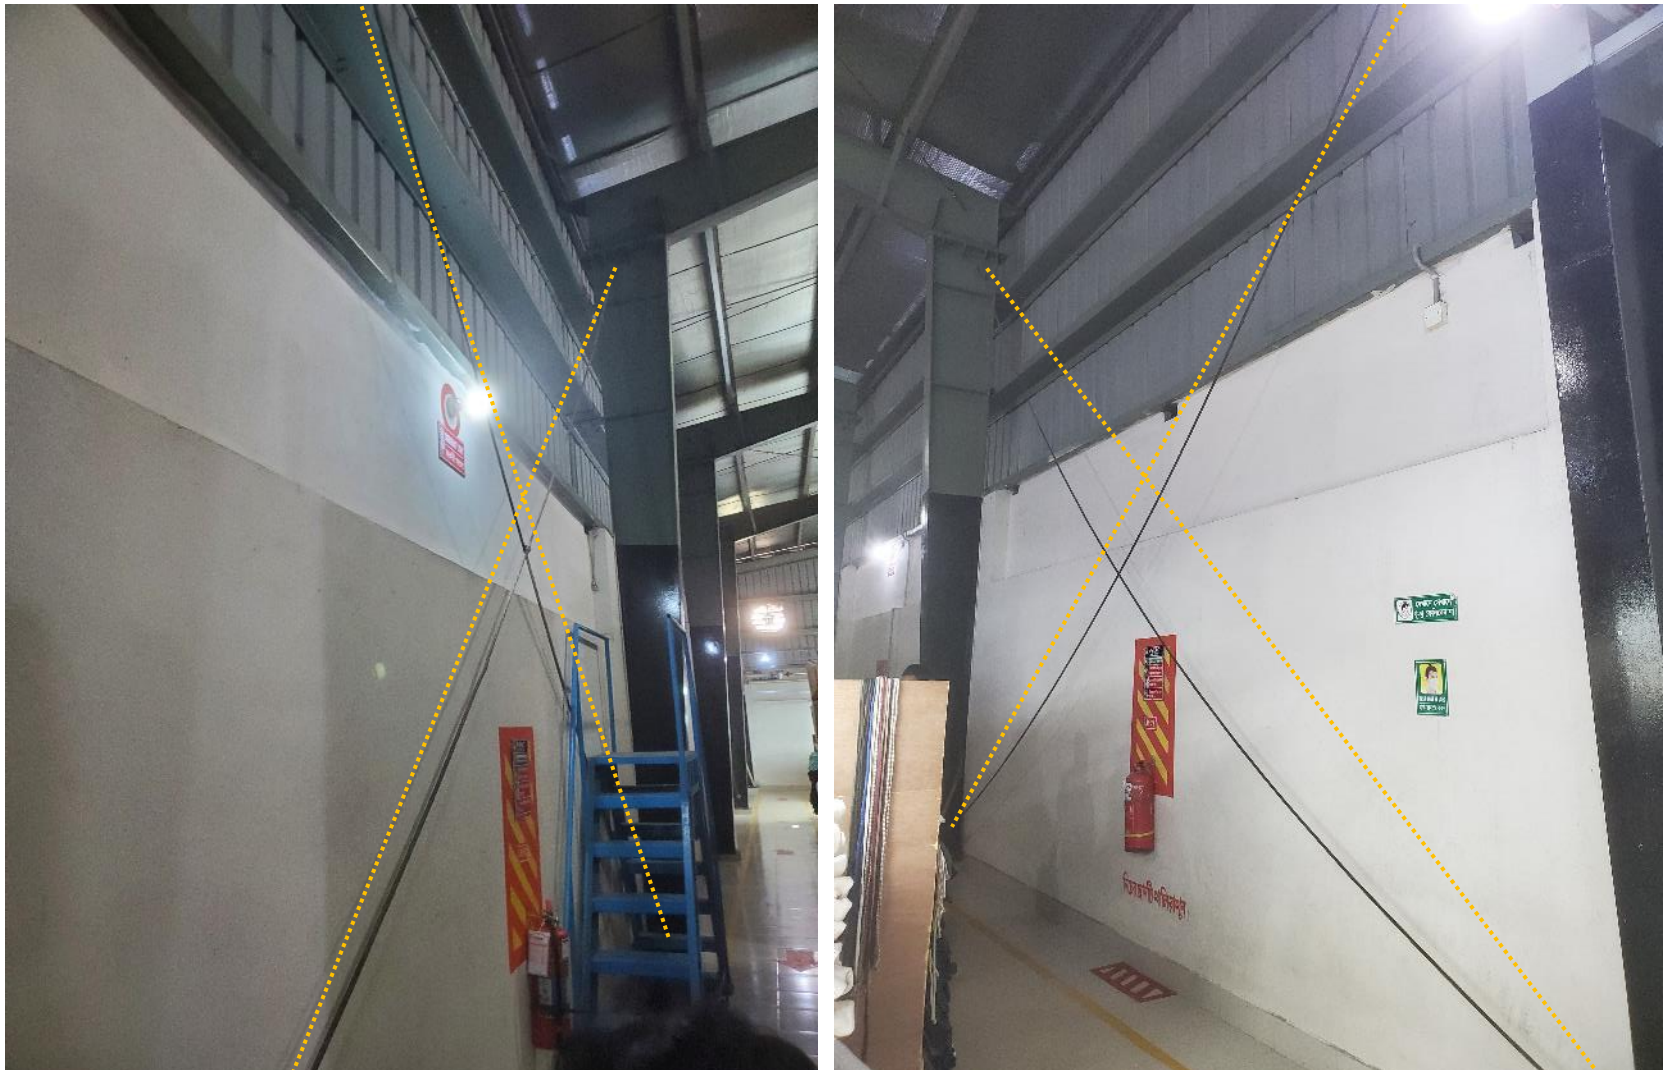
Horizontal wire bracings were found loose. Building Engineer to survey the whole structure and tighten loose bracings where necessary.

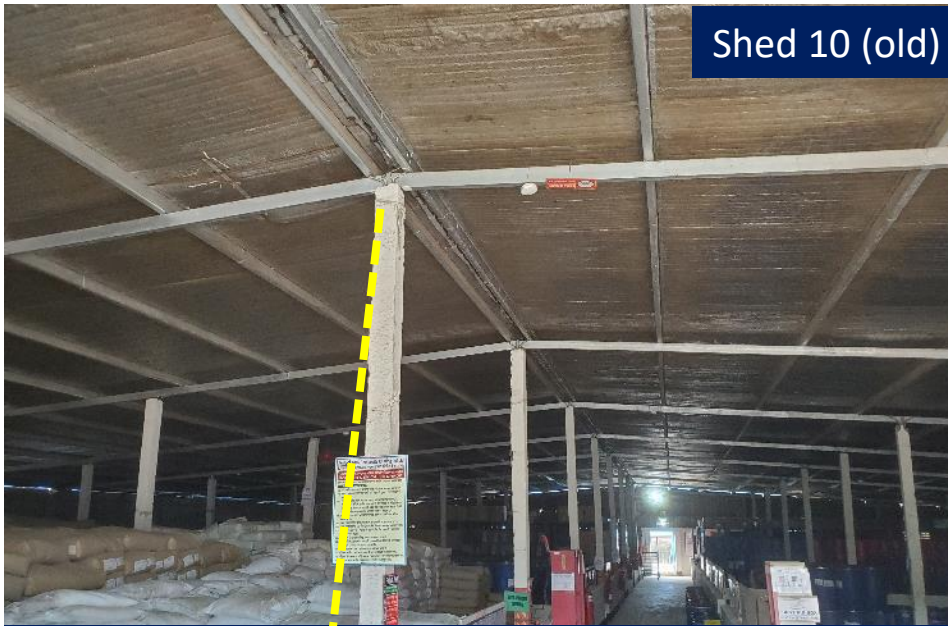
Shed 10 (old)

Inadequate structural members

Apparently inadequate steel members,  
Poor connection details and no clear/defined load path observed.  
Seemingly non-engineered shed.  
Building engineer is required to check  
the stability of the shed or replace by an  
engineered structure.

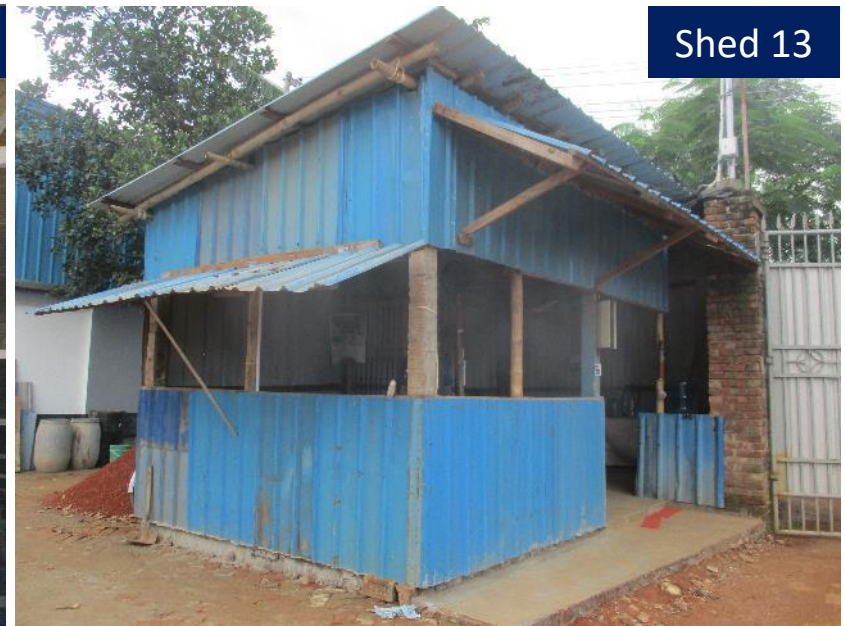
Shed 13

Inadequate structural members
