# Denim Asia Limited (Extension Building)

Ratanpur Road, Taltola Shafipur, Kaliakair, Gazipur, Bangladesh  
(24.0341, 90.2792)

21<sup>st</sup> September 2021

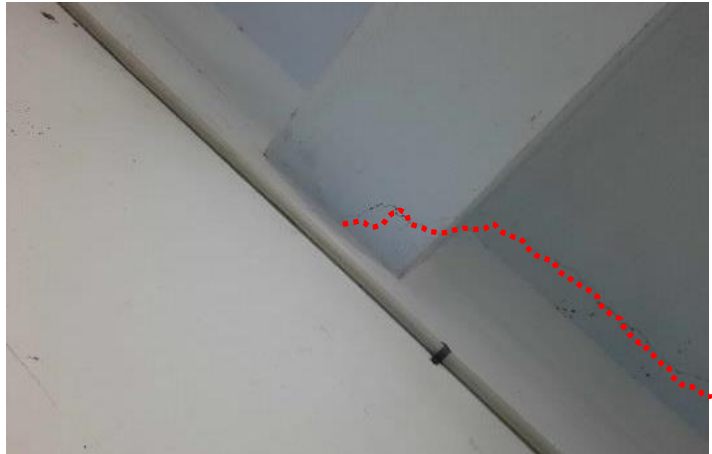
Crack on 1<sup>st</sup> floor Slab Soffit

Crack observed on 1<sup>st</sup> floor slab soffit. Building engineer is required to check the reason, determine the extents of crack and prepare an investigation report with remedial actions.

Item 01: Cracks on 1<sup>st</sup> floor slab soffit.

| Item No. | Observation | Recommended Action Plan | Recommended Timeline |
|---|---|---|---|
| 01 | Cracks on 1st floor slab soffit. (Building 1) | Building engineer is required to check the reason, determine the extents of crack and prepare an investigation report with remedial actions. | 6-weeks |
| 02 | Cracks on 1st floor slab soffit. (Building 1) | Check whether any settlement issue arises. | 6-weeks |
| 03 | Cracks on 1st floor slab soffit. (Building 1) | Carryout remedial works where necessary | 6-weeks |

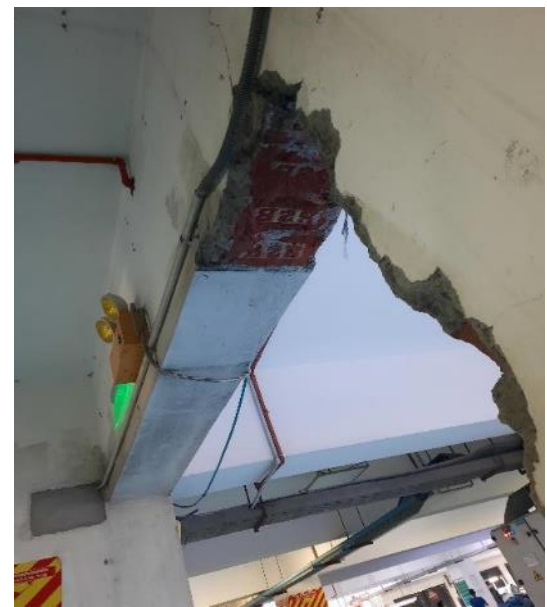
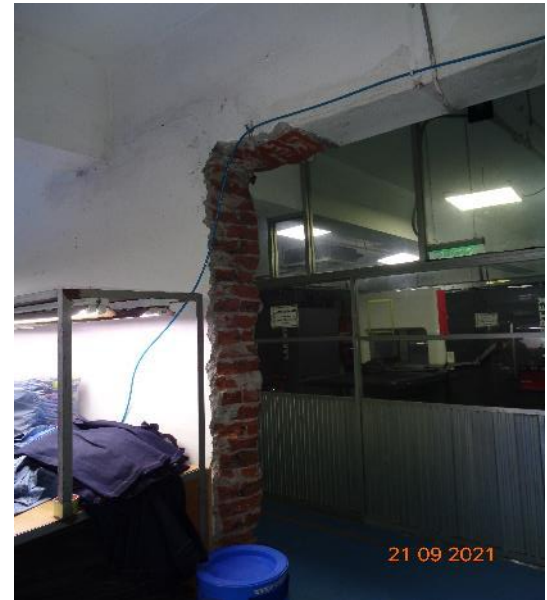
Unrestrained brick wall observed on 1<sup>st</sup> floor. Building engineer is required to provide temporary support to the unrestrained walls and suggest appropriate remedial measures.

Overhang brick wall without lintel

Item 02: Unrestrained brick walls.

| Item No. | Observation | Recommended Action Plan | Recommended Timeline |
|---|---|---|---|
| 04 | Unrestrained brick walls. (Building 1) | Provide temporary support to the unrestrained walls. | Immediate - Now |
| 05 | Unrestrained brick walls. (Building 1) | Building engineer is required to prepare remedial plan. | 6-weeks |

| Item No. | Observation | Recommended Action Plan | Recommended Timeline |
|---|---|---|---|
| 06 | Unrestrained brick walls. (Building 1) | Carryout remedial works. | 6-weeks |

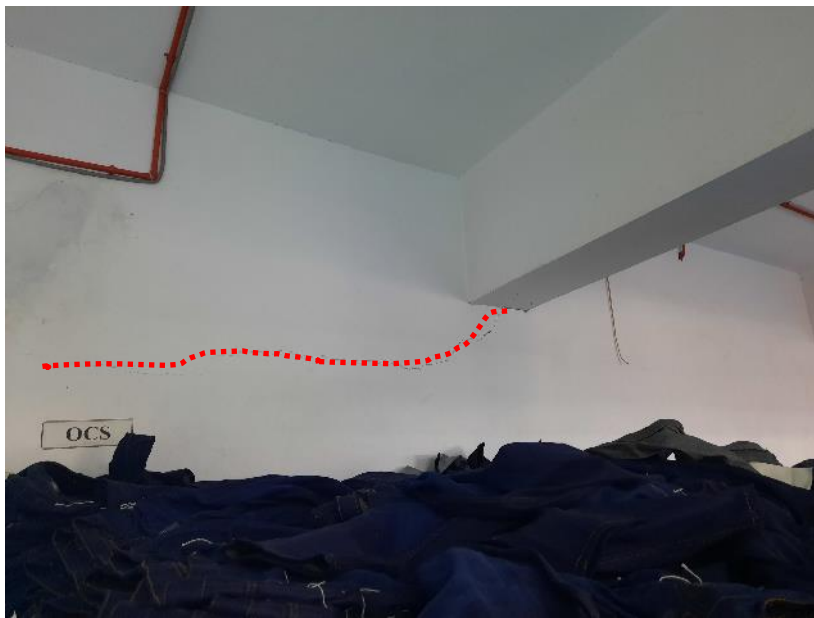
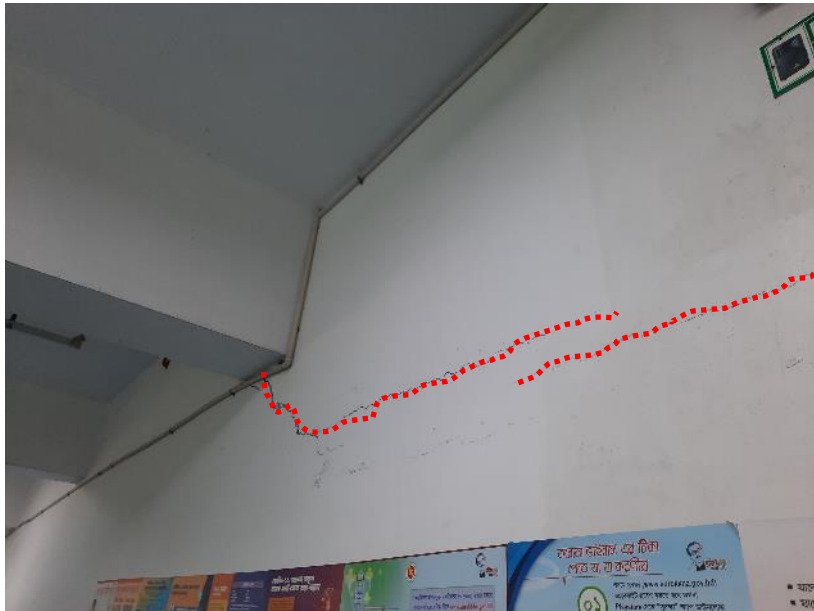
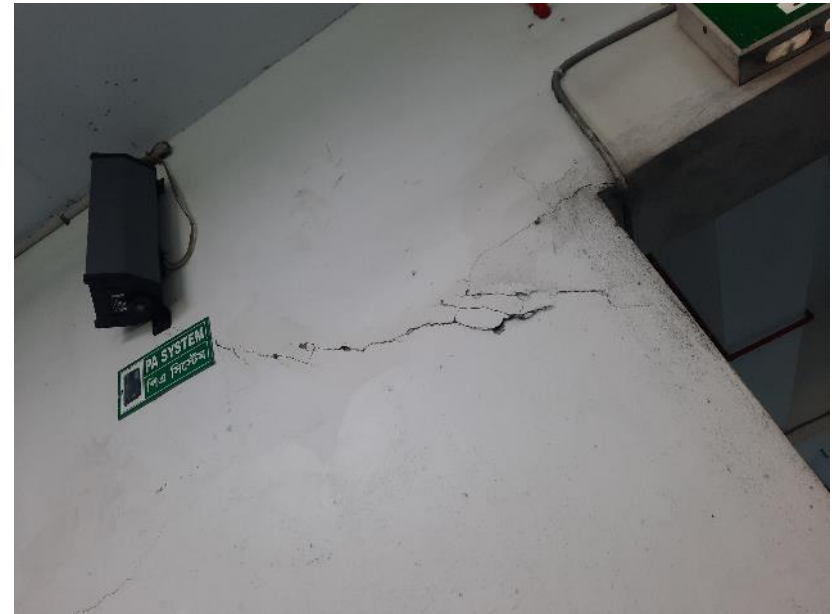
Crack on brick walls

Crack on brick wall observed throughout the building. Building engineer is required to check the reason, determine the extents of crack and prepare an investigation report with remedial actions. Also check whether any settlement issue present in there or not.

Item 03: Crack on brick walls.

| Item No. | Observation | Recommended Action Plan | Recommended Timeline |
|---|---|---|---|
| 07 | Crack on brick walls.(Building 1) | Building engineer is required to check the reason, determine the extents of crack and prepare an investigation report with remedial actions. | 6-weeks |
| 08 | Crack on brick walls.(Building 1) | Check whether any settlement issue arises. | 6-weeks |
| 09 | Crack on brick walls.(Building 1) | Carryout remedial works where necessary. | 6-weeks |

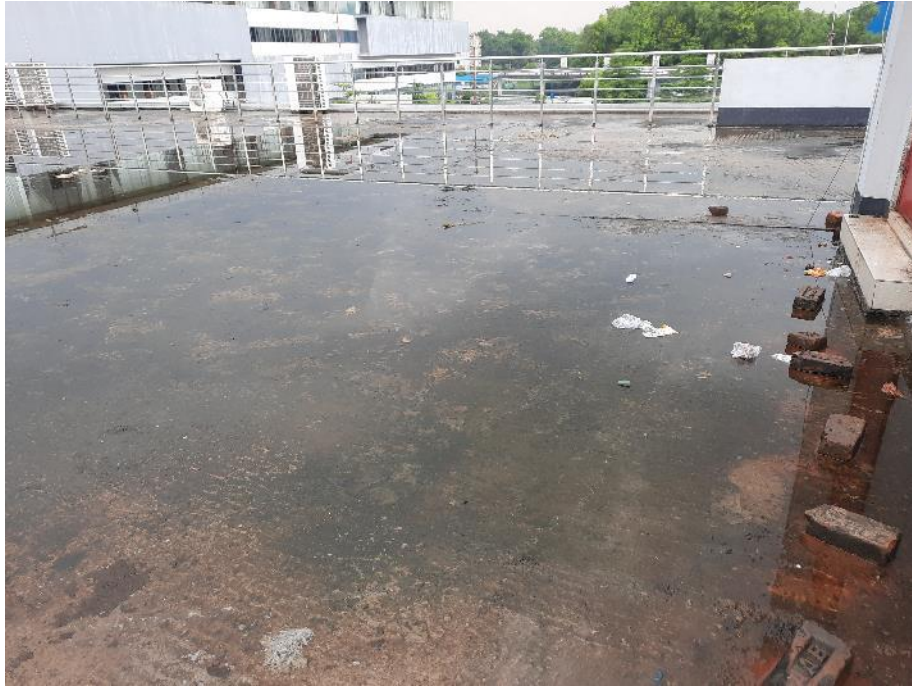
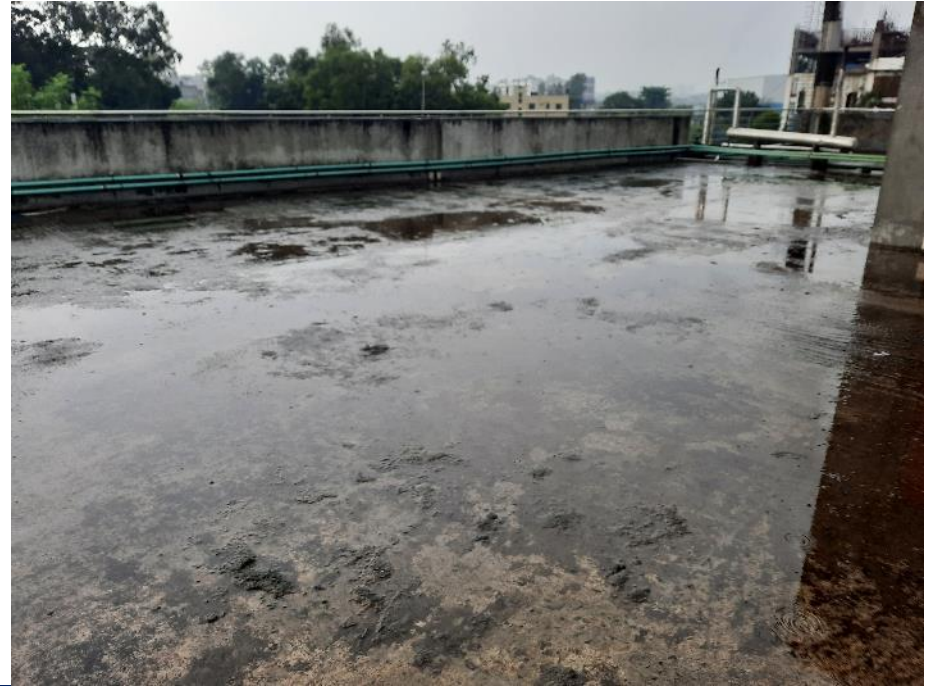
Water ponding observed on the roof. Also, poor roof drainage system observed. Building is required to improve the roof drainage system and apply water proofing membrane on the roof.

Item 04: Water ponding & poor roof drainage system.

| Item No. | Observation | Recommended Action Plan | Recommended Timeline |
|---|---|---|---|
| 10 | Water ponding & poor roof drainage system. (Building 1) | Building is required to improve the roof drainage system and apply water proofing membrane on the roof. | 6-weeks |

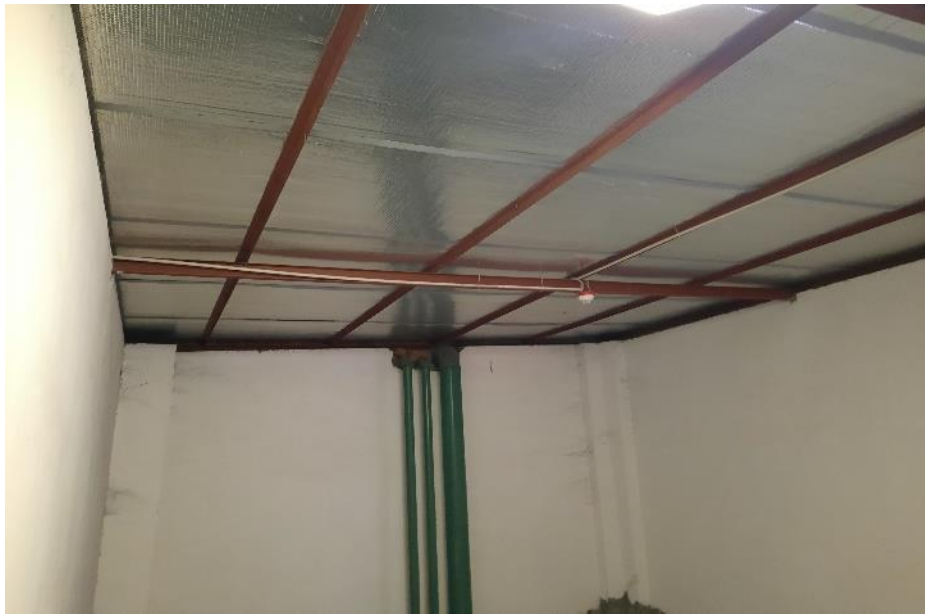
**Shed 1, 2**

Apparently inadequate member, lack of lateral stability system. Building engineer is required to check the lateral stability of these shed or replace with engineered structure.

Item 05: Apparently non-engineered roof.

| Item No. | Observation | Recommended Action Plan | Recommended Timeline |
|---|---|---|---|
| 11 | Apparently non-engineered roof.<br>(Shed 1 & 2 and 3) | Building engineer is required to check the lateral stability system and uplift capacity for the wind forces of the shed or replace those shed with an engineered structure. | 6-weeks |
| 12 | Apparently non-engineered roof.<br>(Shed 1 & 2 and 3) | Carryout remedial works where necessary. | 6-months |
