# Ratool Apparels (Extension Sheds)

Ansar Road, Vangnahati, Sreepur Paurosova, Gazipur.  
(24.199391N, 90.461407E)  
26 September 2021

# Building Information

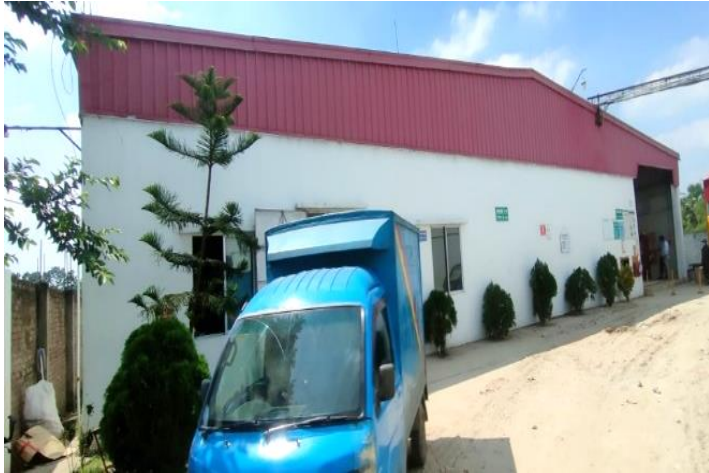
Shed-4 (Bonded Warehouse)

There was no as-built architectural drawings for all of the structures. Building engineer is required to survey the structures and produce as-built architectural drawings.

| Item No. | Observation | Recommended Action Plan | Recommended Timeline |
|---|---|---|---|
| 01 | Lack of as-built architectural drawings. (All structures) | The building engineer is required to survey the structure and produce accurate as-built architectural drawings. | 6-weeks |

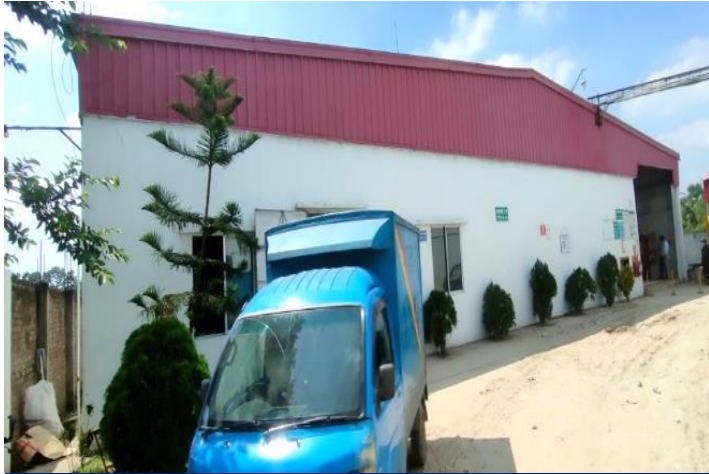
Shed-4 (Bonded Warehouse)

As per BNBC, every building or structure designed shall have its design documents prepared in accordance with the provision of Section 1.9.1. The design document shall include a design report, and a set of structural drawings, which shall be prepared in compliance with section 1.9.1.1 and section 1.9.1.2 of part-6, BNBC.

However, design report was not available during inspection. The building engineer is required to prepare a design report in compliance with BNBC.

| Item No. | Observation | Recommended Action Plan | Recommended Timeline |
|---|---|---|---|
| 02 | Absence of design report. (All structures) | Prepare a set of design documents including Engineering Assessment (EA) report as per BNBC (part-6, section 1.9.1). | 6-weeks |

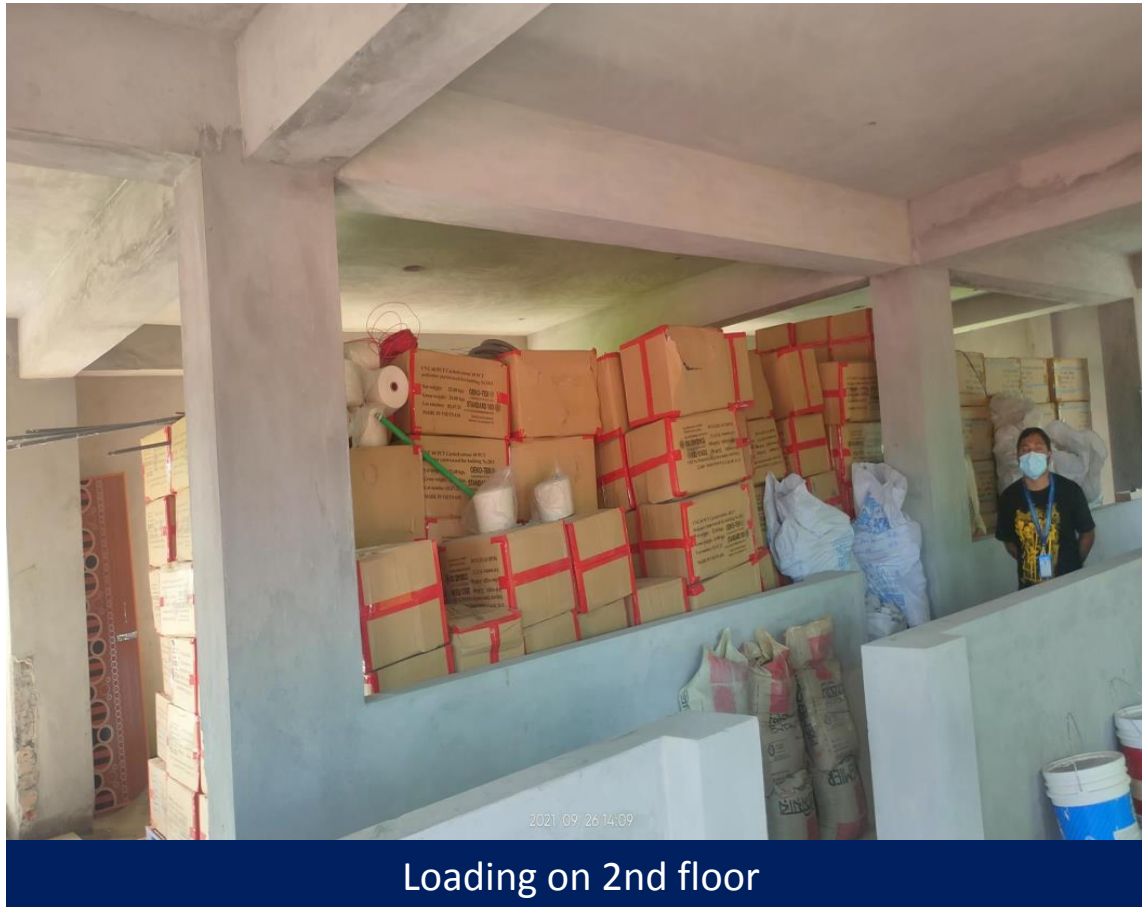
No load plan was prepared. Uncontrolled loading was observed on 2nd floor. As part of design report, building engineer is required to produce a set of floor live load plan. Post the floor load plan and maintain the loading accordingly.

| Item No. | Observation | Recommended Action Plan | Recommended Timeline |
|---|---|---|---|
| 05 | Floor load plan not available. (Office Building) | Produce and actively manage of floor live loading plan for the building considering the floor, column & foundations capacity. | 6-weeks |
| 06 | Floor load plan not available. (Office Building) | Implement the floor loading plan (by posting in each floor level, providing signage and maintaining loadings) | 6-month |

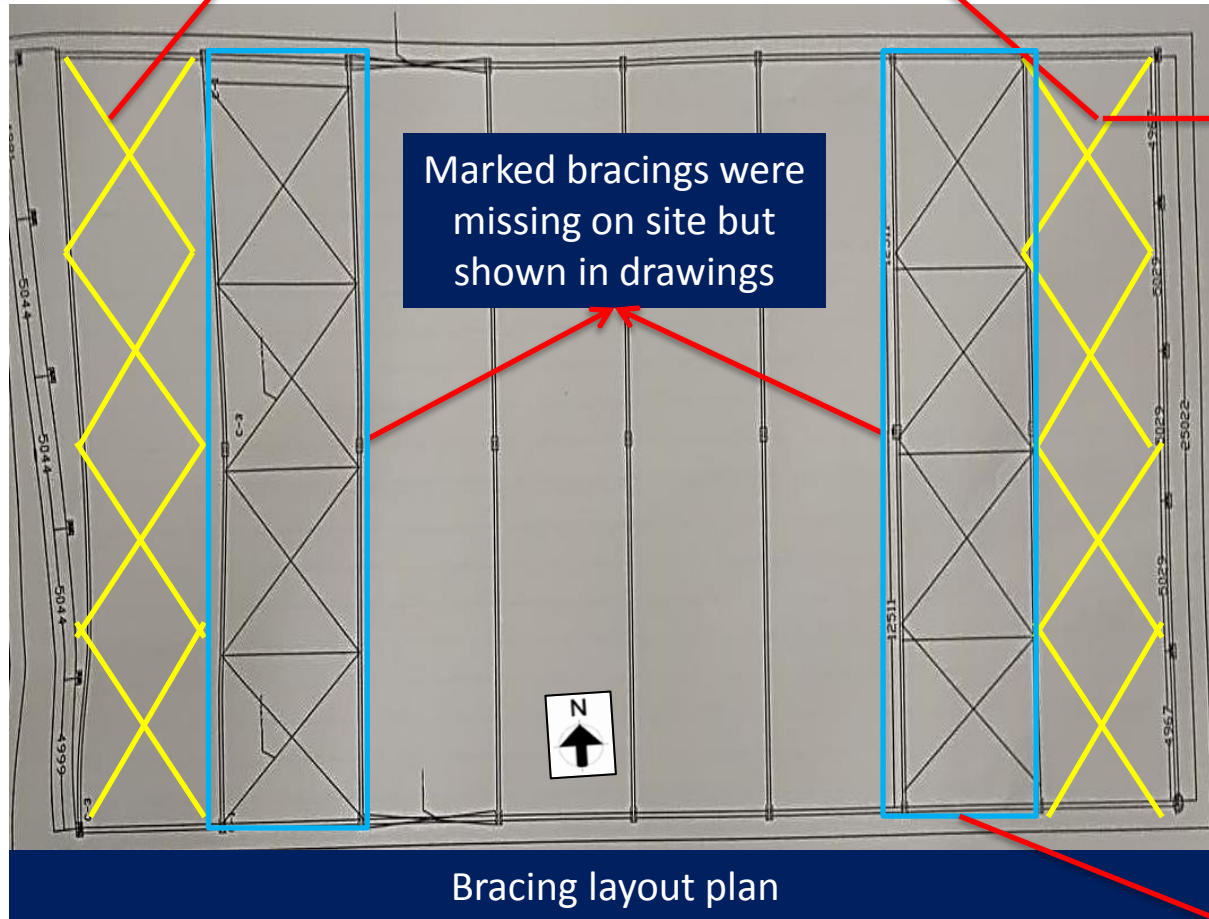
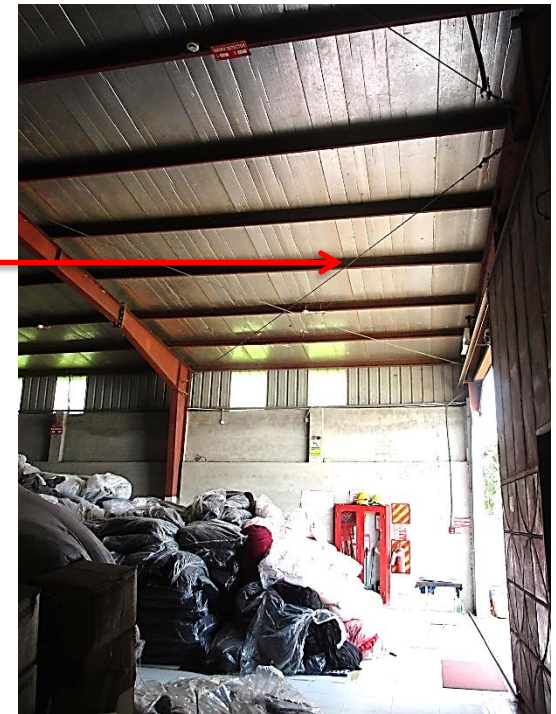
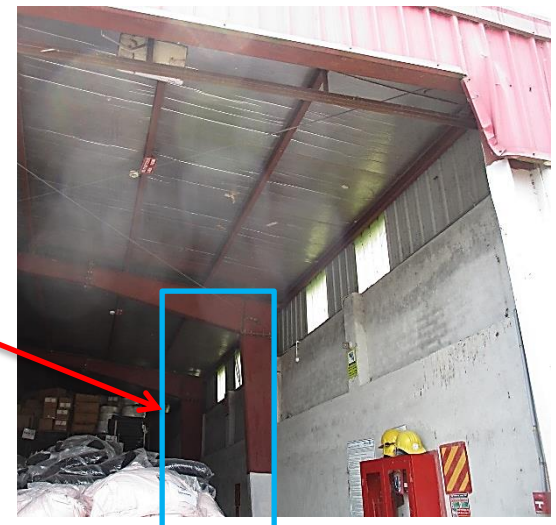
Marked bracings were found on site but not shown in drawings

Marked bracings were missing on site but shown in drawings

Building engineer is required to survey the structure and produce accurate as-built drawings with all structural and architectural details.

| Item No. | Observation | Recommended Action Plan | Recommended Timeline |
|---|---|---|---|
| 09 | Discrepancy in as-built drawings. (Shed-4) | The building engineer is required to survey the structural components and produce accurate as-built structural details. | 6-weeks |

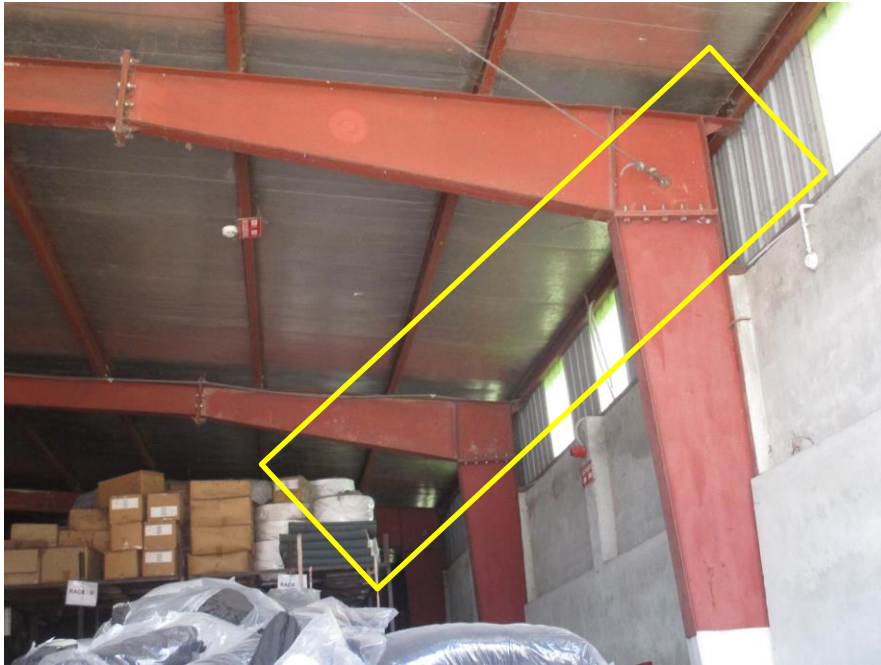
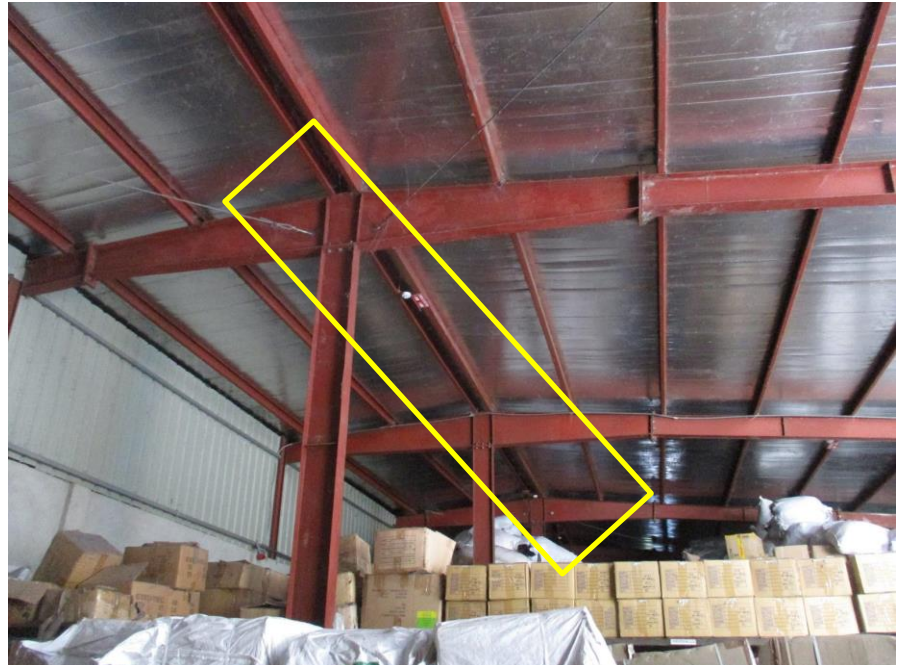
Absence of lateral load transfer media (compression strut) along the eave and ridge

Lack of lateral stability system observed along the eave and ridge. Building engineer is required to check the lateral stability of the structure and suggest proper remedial actions accordingly.

| Item No. | Observation | Recommended Action Plan | Recommended Timeline |
|---|---|---|---|
| 07 | Lack of lateral stability. (Shed-4) | As part of EA, building engineer is required to check the lateral stability of the structure and suggest proper remedial actions accordingly. | 6-weeks |
| 08 | Lack of lateral stability. (Shed-4) | Carry out remedial works suggested in EA report. | 6-month |

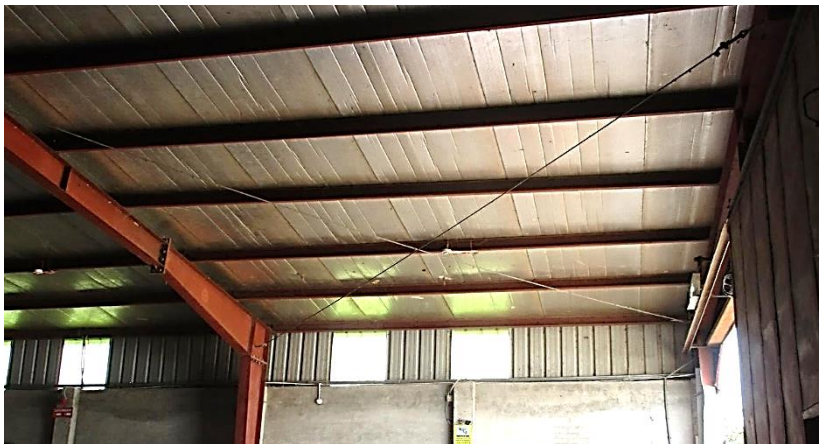
Bracing system has no compression element

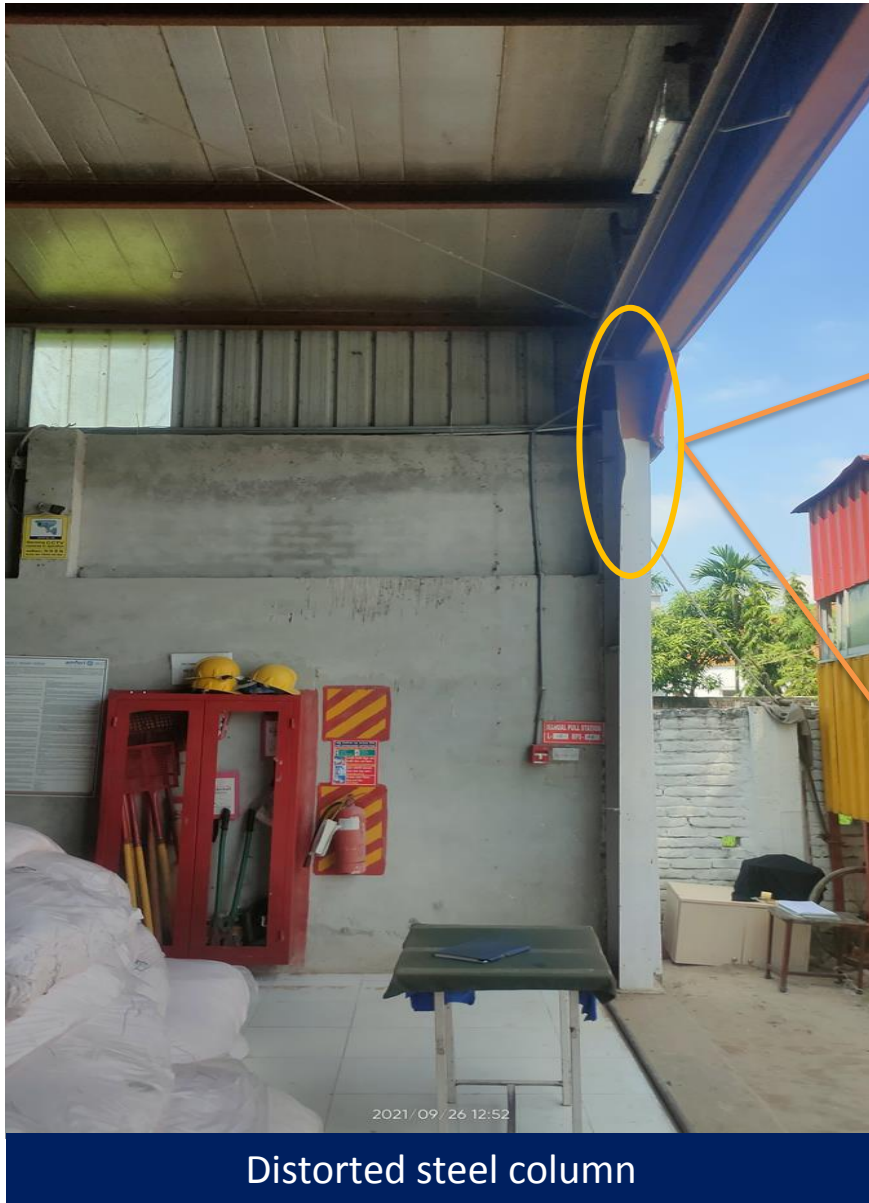
Distorted steel column

A steel column in the marked location was found distorted. Building engineer is required to repair the distorted column.

| Item No. | Observation | Recommended Action Plan | Recommended Timeline |
|---|---|---|---|
| 10 | Distorted steel column. (Shed-4) | The building engineer is required to carryout suitable repair works to the distorted steel member. | 6-weeks |

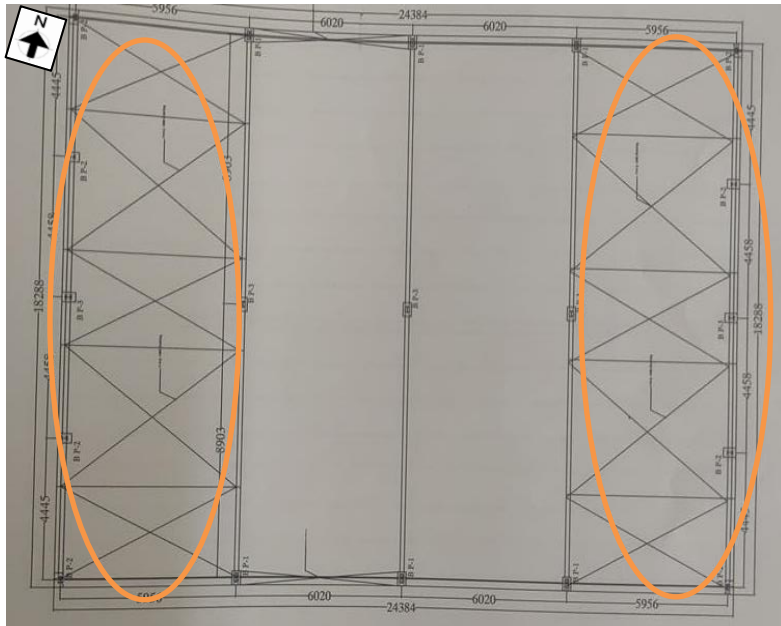
Bracing layout plan.

Bracings were shown in drawing but not found on site. Building engineer is required to survey the structure and produce accurate as-built drawings with all structural and architectural details.

| Item No. | Observation | Recommended Action Plan | Recommended Timeline |
|---|---|---|---|
| 13 | Discrepancy in as-built drawings. (Shed-9) | The building engineer is required to survey the structural components and produce accurate as-built structural details. | 6-weeks |

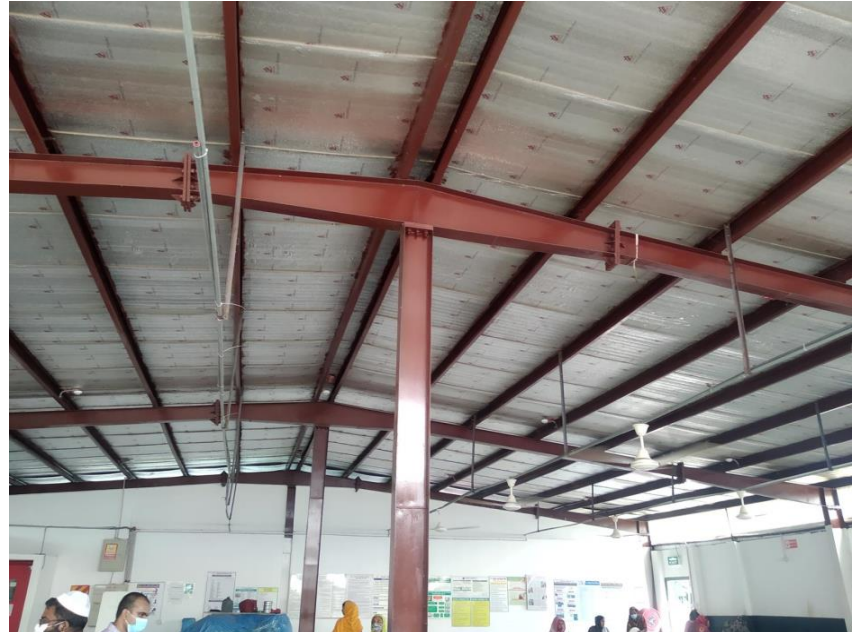
No bracing at roof and wall

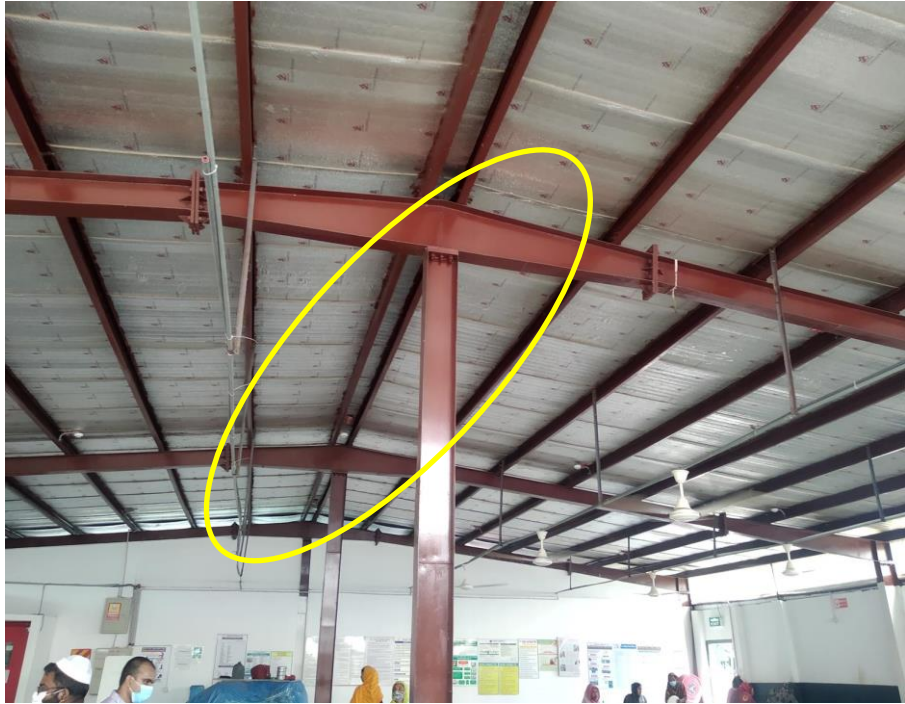
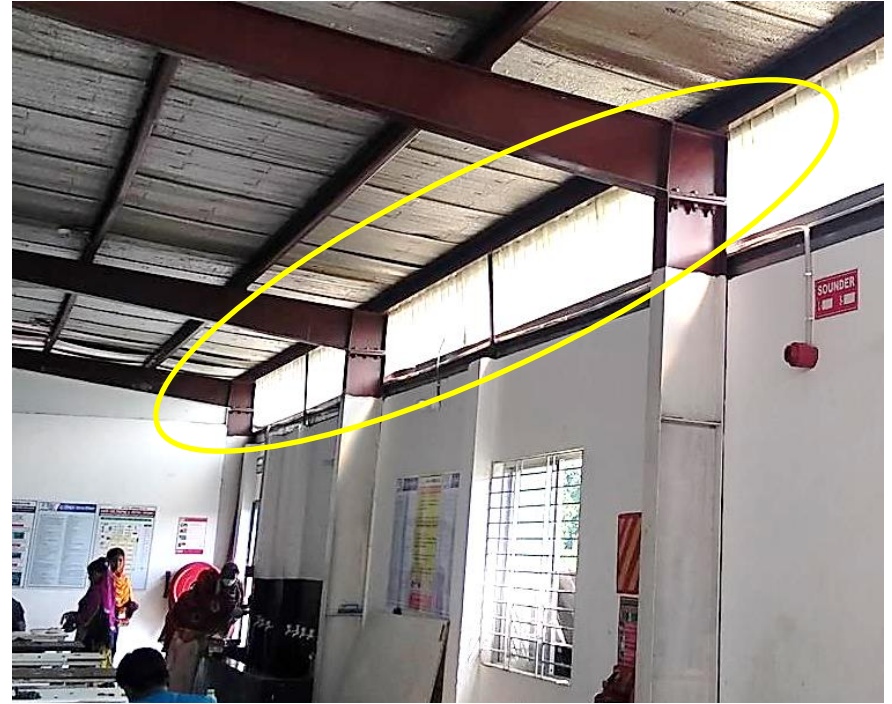
Absence of lateral load transfer media (compression strut) along the eave and ridge

Lack of lateral stability system observed along the eave and ridge. Building engineer is required to check the lateral stability of the structure and suggest proper remedial actions accordingly.

| Item No. | Observation | Recommended Action Plan | Recommended Timeline |
|---|---|---|---|
| 11 | Lack of lateral stability. (Shed-9) | As part of EA, building engineer is required to check the lateral stability of the structure and suggest proper remedial actions accordingly. | 6-weeks |
| 12 | Lack of lateral stability. (Shed-9) | Carry out remedial works suggested in EA report. | 6-month |

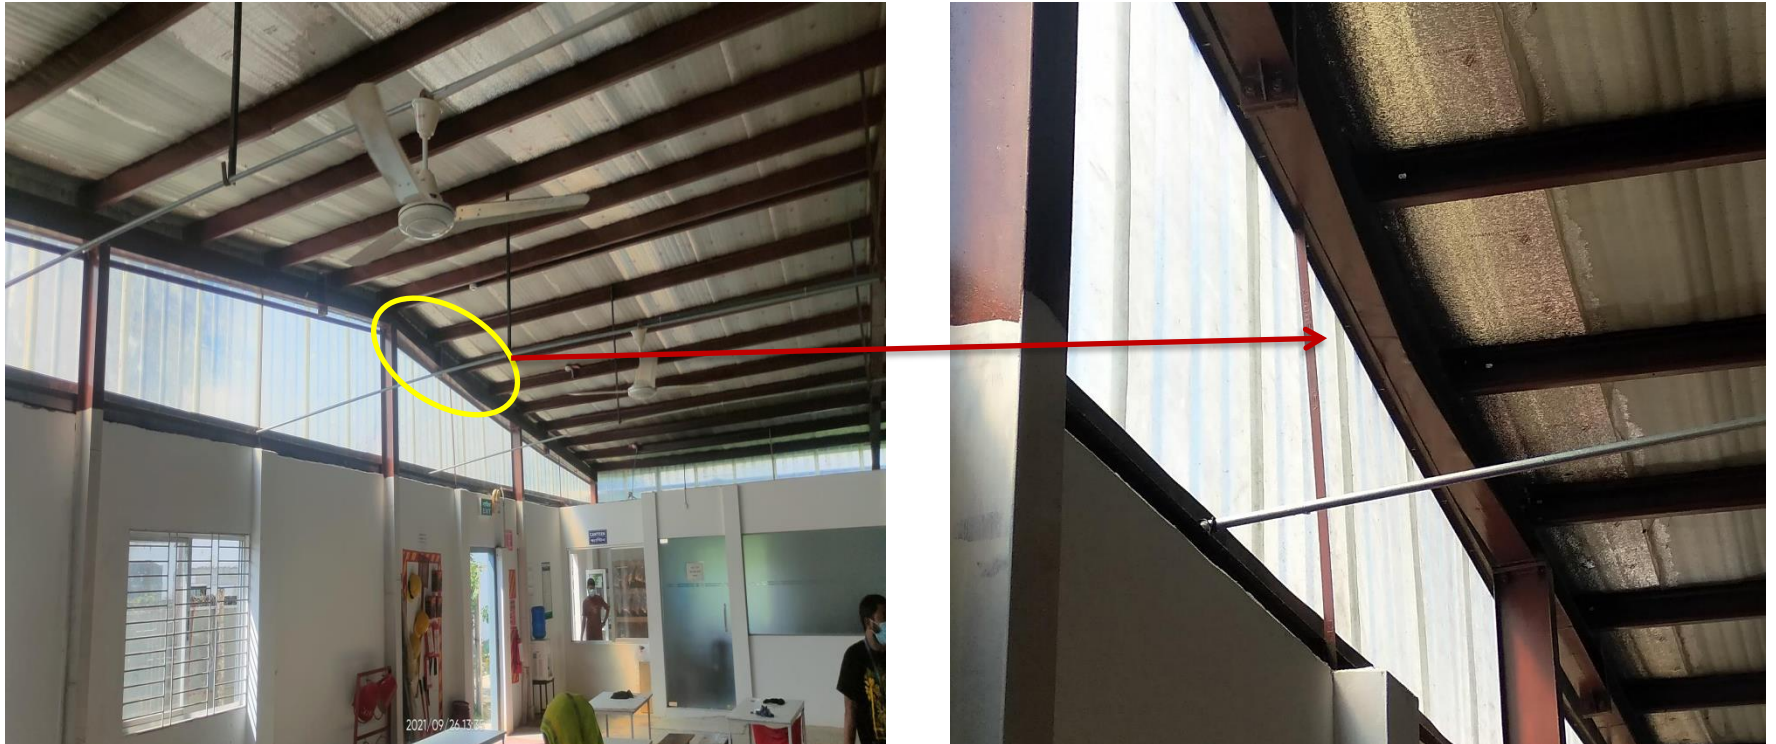
Distorted structural member

A steel rafter in the marked location was found distorted. Building engineer is required to repair the distorted rafter.

| Item No. | Observation | Recommended Action Plan | Recommended Timeline |
|---|---|---|---|
| 14 | Distorted steel rafter. (Shed-9) | The building engineer is required to carryout suitable repair works to the distorted steel member. | 6-weeks |

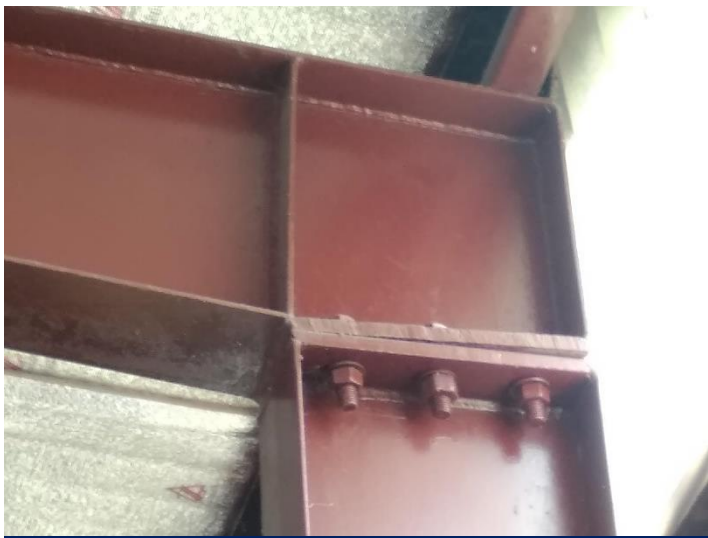
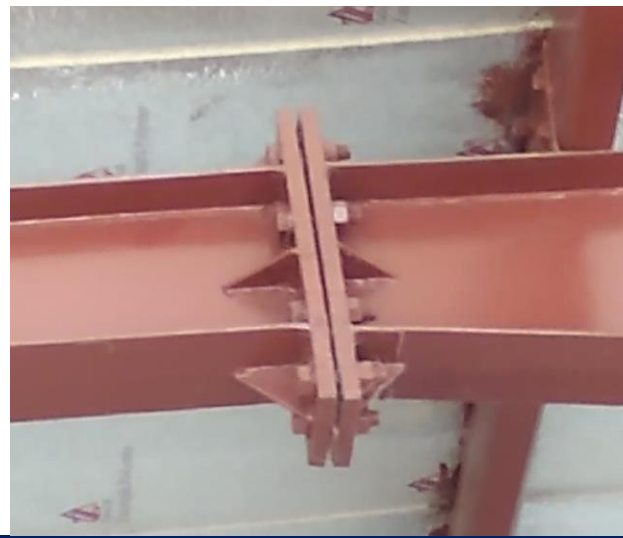
Gap between connection plates

Gap between connection plates observed in several locations. Also, some connections have and missing bolt. Building engineer is required to check all the connections, fill the gap between plates and install missing bolt.

| Item No. | Observation | Recommended Action Plan | Recommended Timeline |
|---|---|---|---|
| 15 | Gap between connection plates and bolt missing. (Shed-9) | Building engineer is required to check all the joint and fill the gap between connection plates with suitable materials. | 6-weeks |

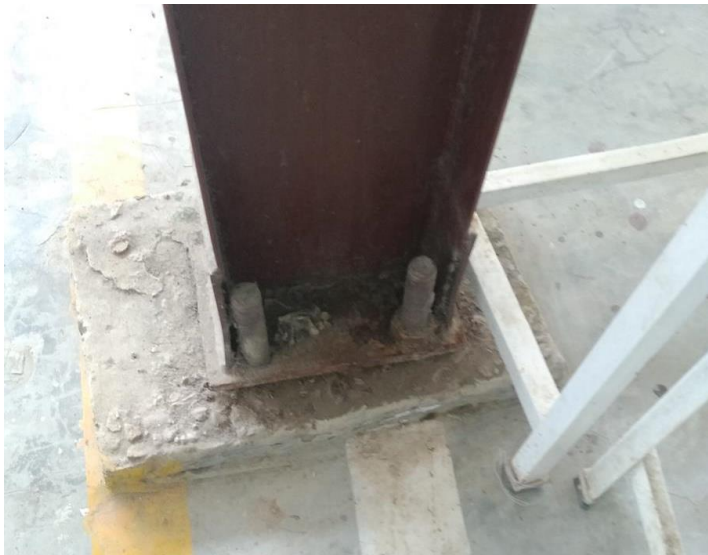
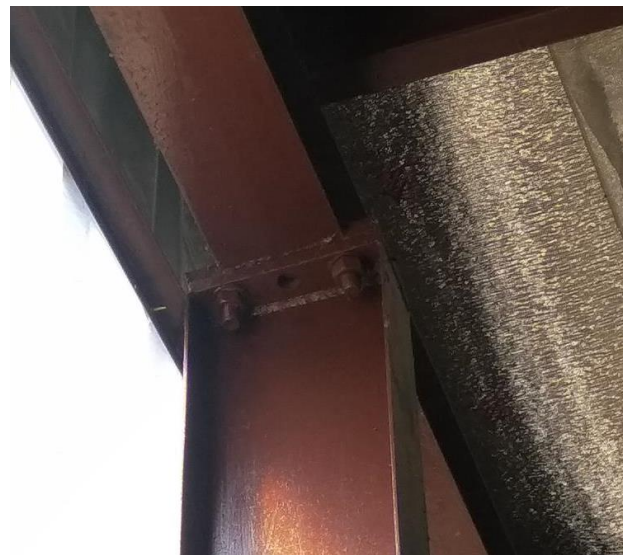
Bolt missing in column-pedestal and column-rafter connections

| Item No. | Observation | Recommended Action Plan | Recommended Timeline |
|---|---|---|---|
| 16 | Gap between connection plates and bolt missing. (Shed-9) | Install missing bolt where required. | 6-month |
