# INITIAL FIRE SAFETY INSPECTION REPORT

**Factory Name:** RATOOL APPARELS LTD. (EXTENSION SHEDS)

**Factory ID:** 24223

**Date:** 26 September 2021

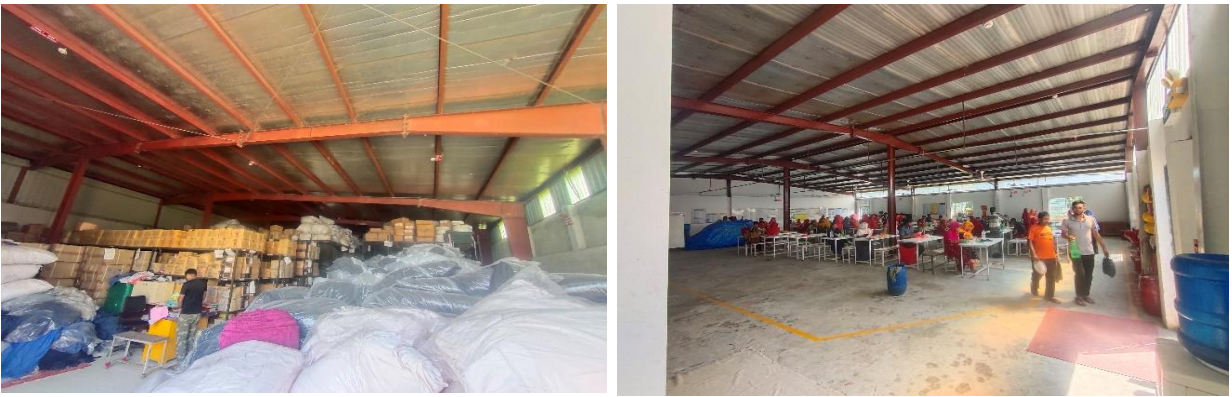
| Sl No. | Category | Findings | Required Action | Remediation Time Frame |
|---|---|---|---|---|
| 1 | <b>Fire Rated Construction</b> | The new construction of both Shed 04 & Shed 09 are prefabricated steel type which is not rated. | Provide fire resistive rated insulation of structural members of each shed following section 4.4 and table 4.4.1 of the Accord Standard or table 3.3.1 (Part 3, BNBC 2006) and table 4.4.1 from BNBC part 4.<br>Consult a qualified fire protection engineer to design the rated insulation. | Within 3 months |

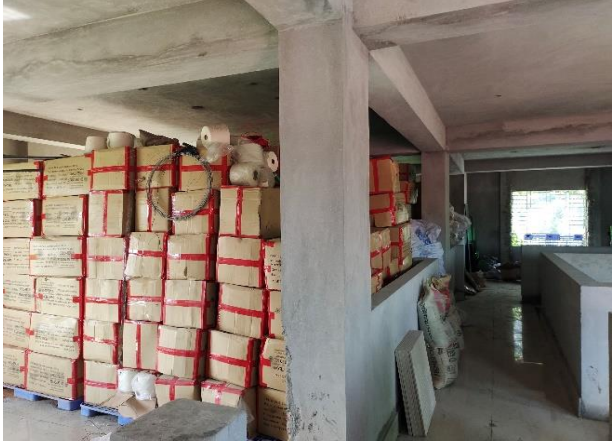
| 2 | <b>Fire Rated Construction</b> | <p>Areas used for in-process storage of combustible materials are open to the surrounding occupancy.</p> <p><b>Location: 1st floor, Office Building</b></p> | <p>Provide defined storage areas and limit the storage arrangement as follows:-</p> <ol style="list-style-type: none"> <li>1. General Condition: Maximum height of 2.4m and maximum area of 23m<sup>2</sup>. Separate areas of unenclosed combustible storage by a minimum clear distance of 3m.</li> </ol> <p>Or</p> <ol style="list-style-type: none"> <li>2. Enclose the storage area from the surrounding occupancy with a minimum 1 hour construction.</li> </ol> | Within 3 months |

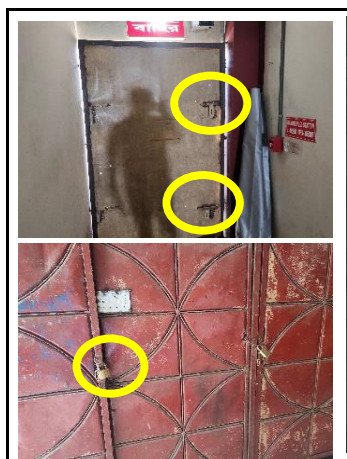
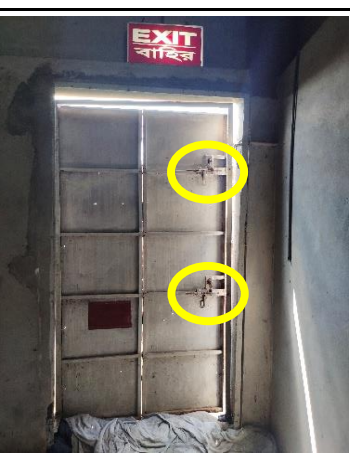
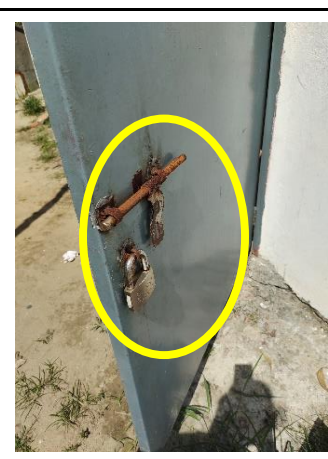
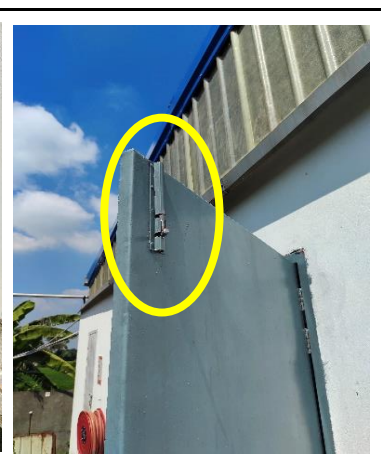
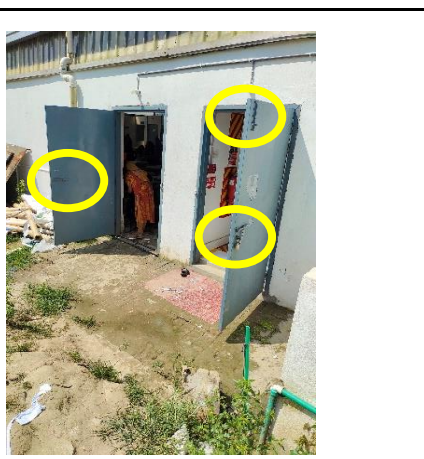
| 3 | Egress | <p>Doors along means of egress are provided with non compliant locking system.</p> <p><b>Location: Shed 04, Shed 09</b></p> | <ol style="list-style-type: none"> <li>1. Remove all non compliant locking features from egress doors.</li> <li>2. If locks are required for security reasons, utilize special door locking features complying with NFPA 101.</li> <li>3. Doors may be locked where the latch and lock are disengaged with one motion where the occupant load does not exceed 49 persons.</li> <li>4. Doors may be provided with locking hardware from the ingress side provided that a panic bar is installed on any door with an occupant load exceeding 49 persons.</li> </ol> | Immediate |

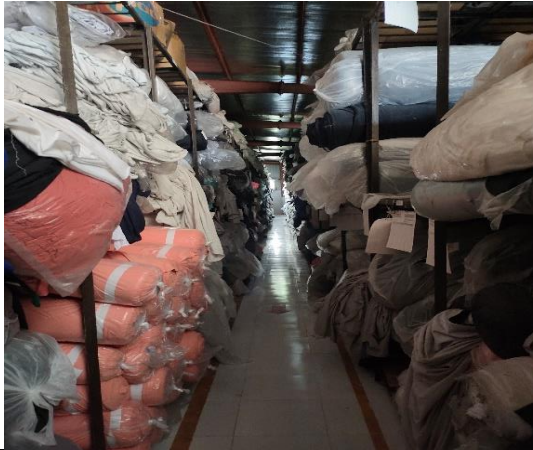
| 4 | <b>Egress</b> | <p>The egress path along means of egress has interrupted by obstruction/storage. (Aisles)</p> <p><b>Location: Shed-04</b></p> | <p>Means of egress shall be maintained continuously free and clear of all obstructions/storage.</p> <p>Or</p> <p>Keep egress paths and stairs clear of storage.</p> | Immediate |

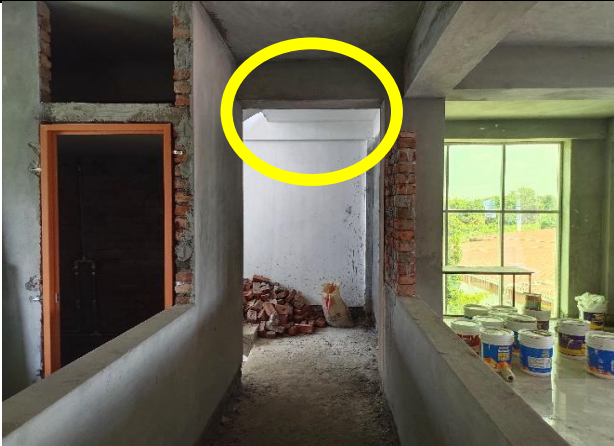
| 7 | <b>Egress Lighting</b> | Exit sign is not provided at exits. It appeared that overall layout making work was still ongoing.<br><b>Location: Office Building</b> | <p>Lighted exit signs shall be placed at entrance to an exit when the construction is completed..</p> <p>Additional exit signs shall be placed throughout the facility anywhere the continuation of the egress is not obvious.</p> <p>Lighted exit signs shall be provided with either battery backup or uninterruptable power supply systems and shall be continuously illuminated.</p> | Within 3 months |

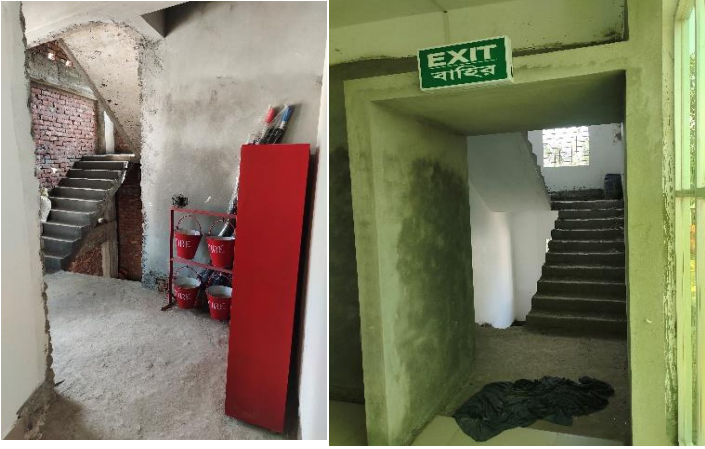
| 8 | <b>Fire Rated Construction</b> | <p>The exit stairs are not separated from floor areas on each floor by fire-rated construction.</p> <p><b>Location: Office Building</b></p> | <p>Stair shall be enclosed with a minimum 2-hr fire-rated construction. Seal all unprotected openings and provide minimum 1.5-hr fire rated doors to separate the exit stairs from work areas and other building spaces on all floor levels. Ensure that the fire doors are self-closing, positive latching and that they are provided with fire exit (panic) hardware where serving production floors.</p> <p>If fire doors are required to be held open for functional reasons, provide automatic-closing devices tied to the fire alarm system.</p> | Within 3 months |

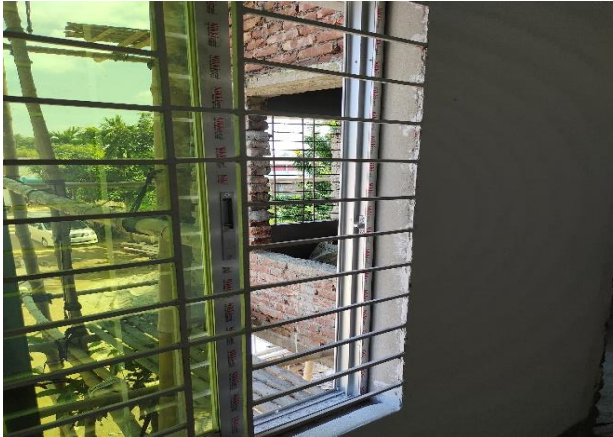
| 9 | <b>Fire Rated Construction</b> | Unsealed penetrations and openings are located in exit stair enclosures.<br><b>Location(s): First floor, Office Building</b> | Seal all penetrations and openings in the wall of exit enclosure walls (full thickness of the wall) by fire rated materials to maintain the fire resistance rating. | Within 3 months |

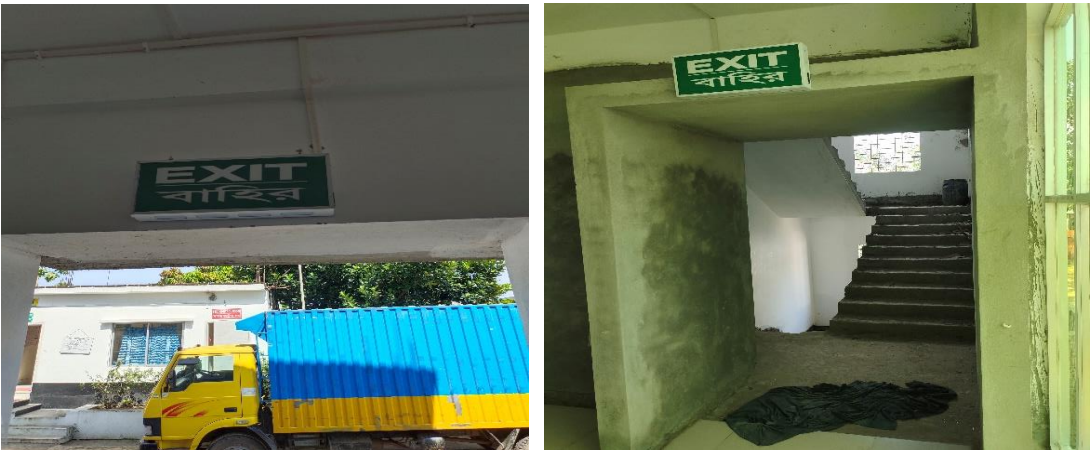
| 10 | <b>Egress Lighting</b> | Exit signage not illuminated during testing (burned out, broken, etc.).<br><b>Location: Office Building</b> | Regularly inspect all exit signage as per Accord standard and replace/install lights as needed to illuminate signs. | Within 3 months |

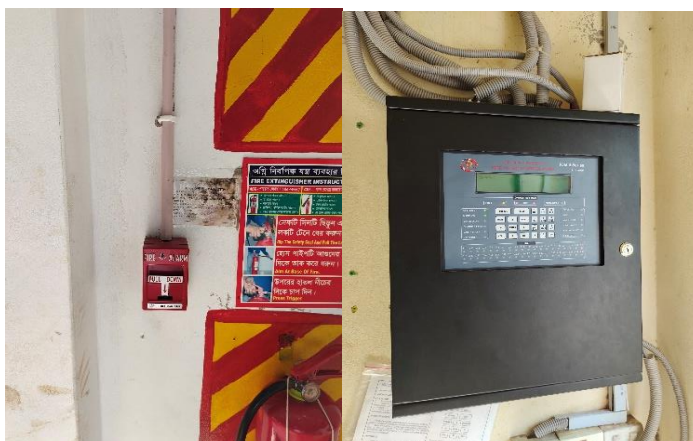
| 13 | <b>Fire Alarm &amp; Detection System</b> | <p>Fire alarm system installation requires detailed review to confirm compliance with NFPA 72 and ACCORD standards.</p> <p><b>Location(s): Shed 04, Shed 09, Office Building</b></p> | <p>Submit as-built drawings, testing records, equipment certification and other relevant documentation to the RSC for review and approval.</p> <p>And</p> <p>Inspect, test and maintain the fire alarm system, and keep written records on-site, in accordance with NFPA 72 or as per Accord standard.</p> | <p>Design within 3 months, Modification within 6 months</p> |
