Cotton Field (BD) Ltd (Relocated)

Plot- 42/3, Rajnagar, Sataish Road, Tongi, Gazipur
(23.920396N, 90.363708E)
28th September 2021

Observations

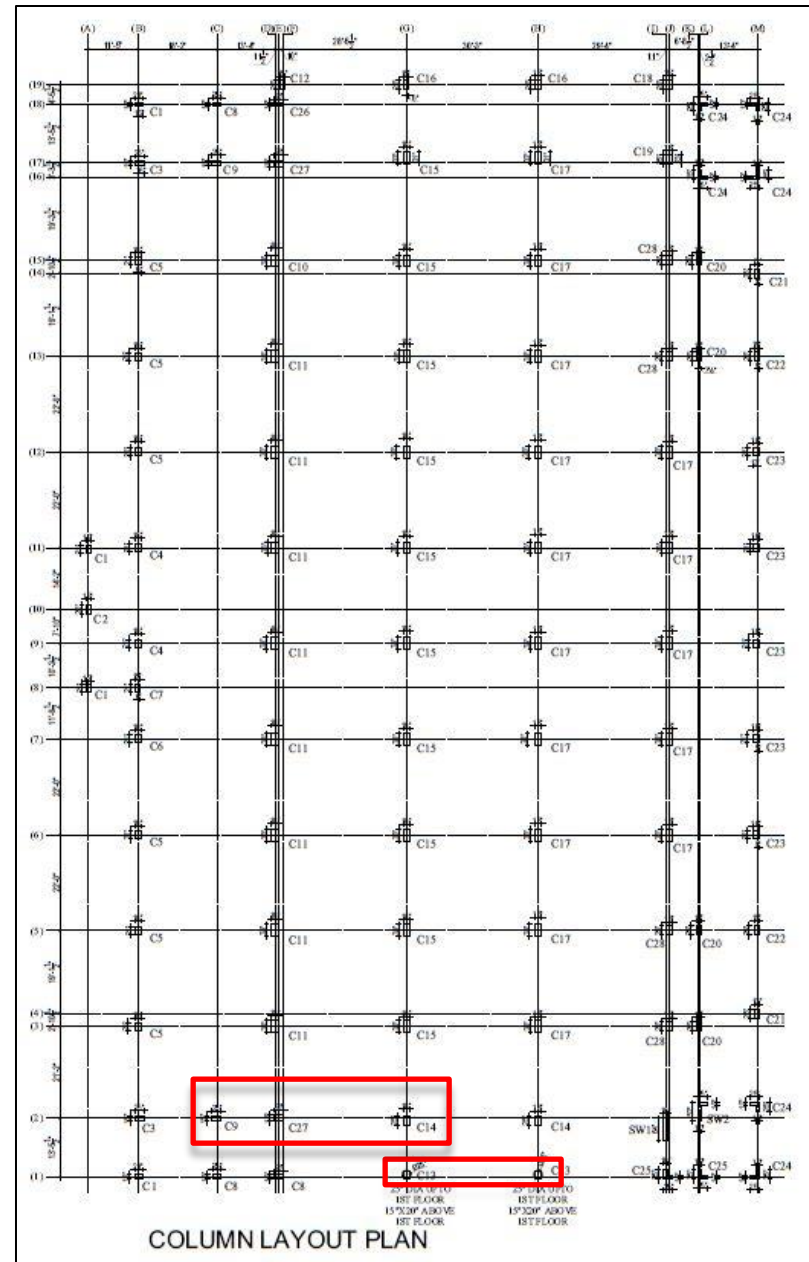
Lower Factor of safety of pile foundations

Factor of safety for Pile foundations at grid 1G, 1H, 2C, 2E, 2G were found below 2.50. In the DEA report their no recommendation for those pile foundations.

The factory engineer is required to check the foundation adequacy and suggest proper remedial actions accordingly.

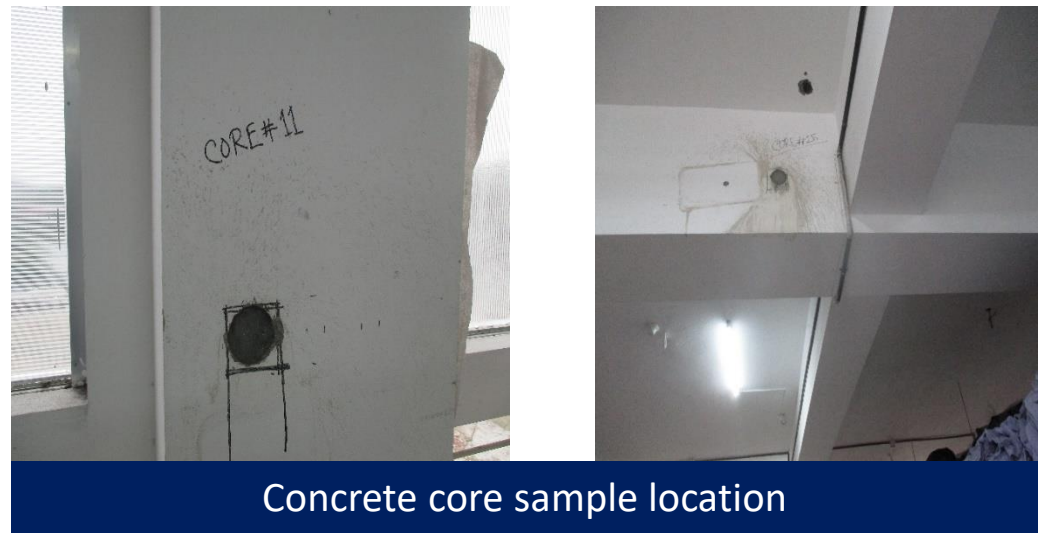
Concrete core sample location

Mismatch in concrete core layout

As per core test report and layout plan, 25 number of concrete cores were taken from different locations of beam and column. But we identified only 19 core locations. Factory engineer to identify the missing core locations and revise core layout plan properly.

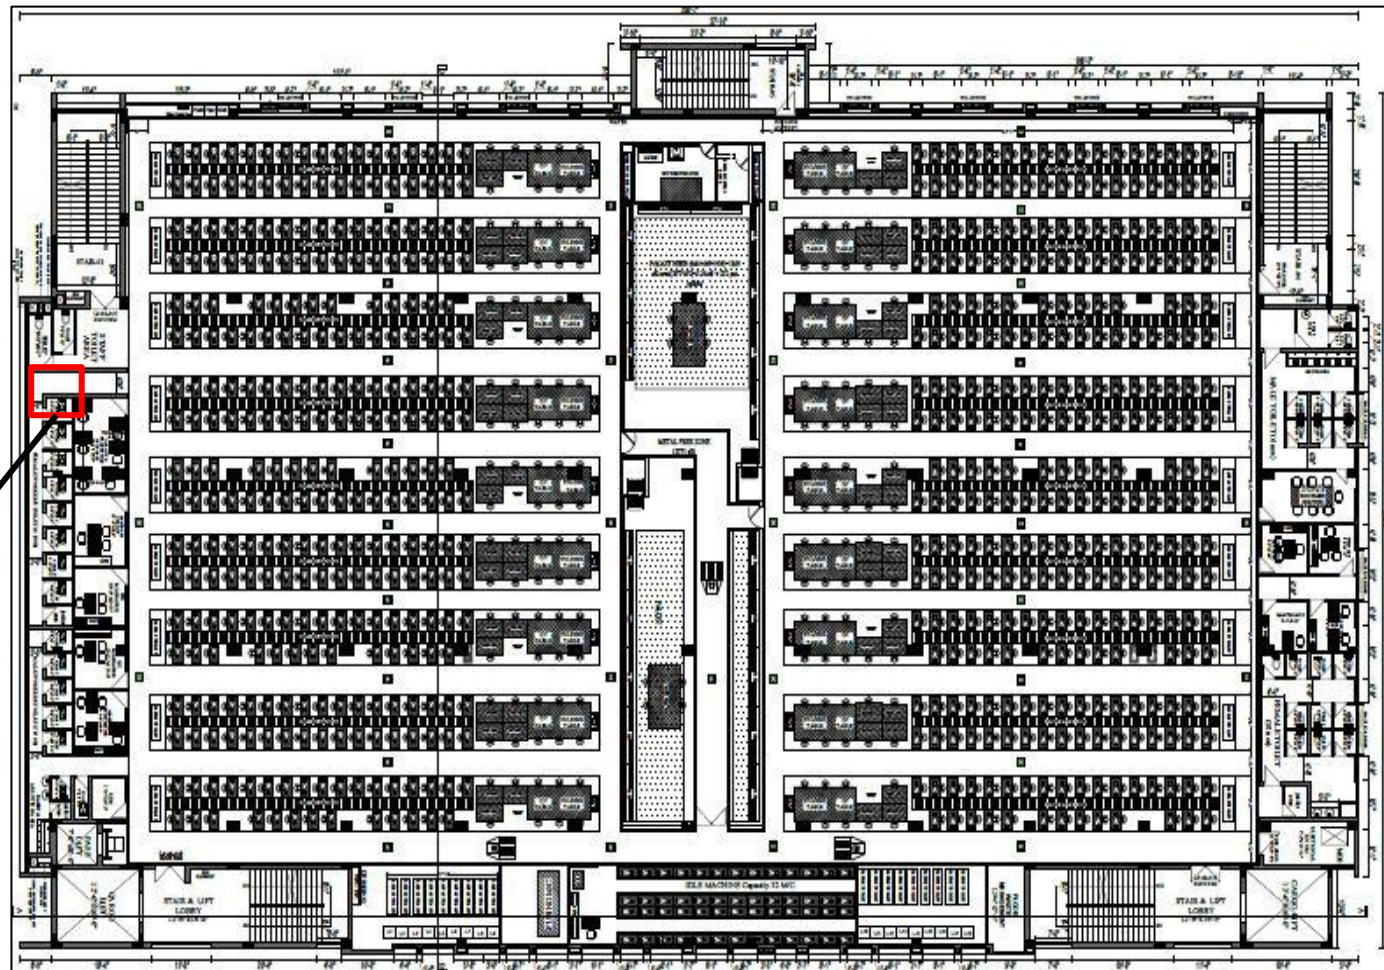
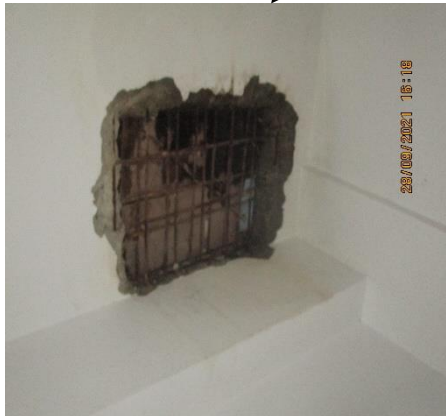
1st floor layout

Perforation of 1st floor slab

Slab perforation at 1st floor toilet zone

Factory engineer is required to check the adequacy of slab panel having perforation and implement strengthening or remedial works as per engineer's advice.

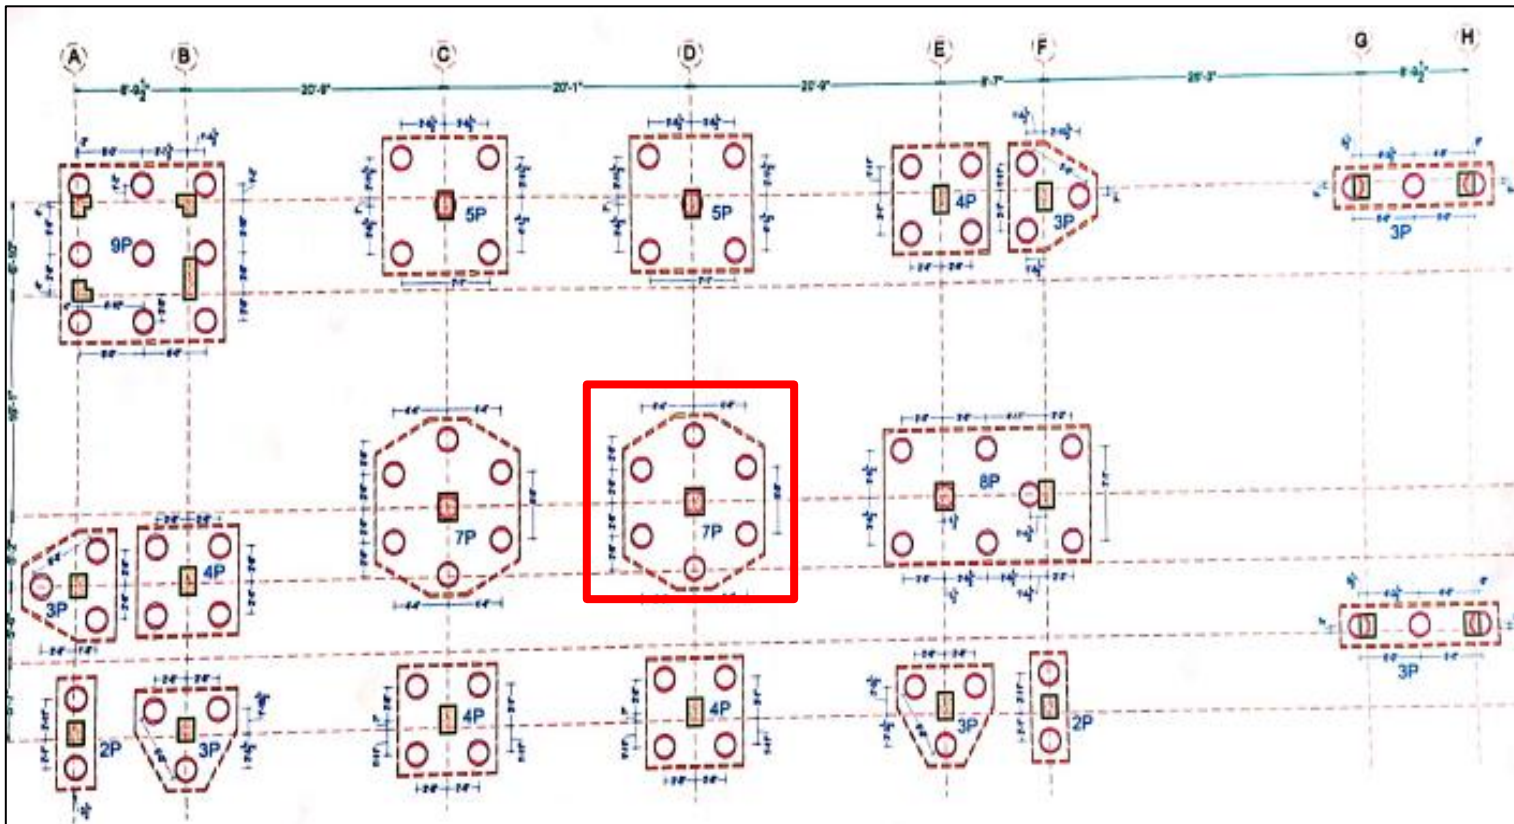
Pile foundation layout

Lower Factor of safety of pile foundations

Cursory calculation indicate that the factor of safety of marked pile foundation is below 2.50 considering live load 3 kPa on typical floors, 1.5 kPa on roof & each pile capacity from soil test report (30 ton). The factory engineer is required to check the foundation adequacy and suggest proper remedial actions accordingly.

06	Lower Factor of safety of pile foundations (Admin Building)	The factory engineer is required to check the foundation adequacy, suggest proper remedial actions in design report and submit the design report to RSC.	6-weeks
07	Lower Factor of safety of pile foundations (Admin Building)	Implement any remediation work if required.	6-months

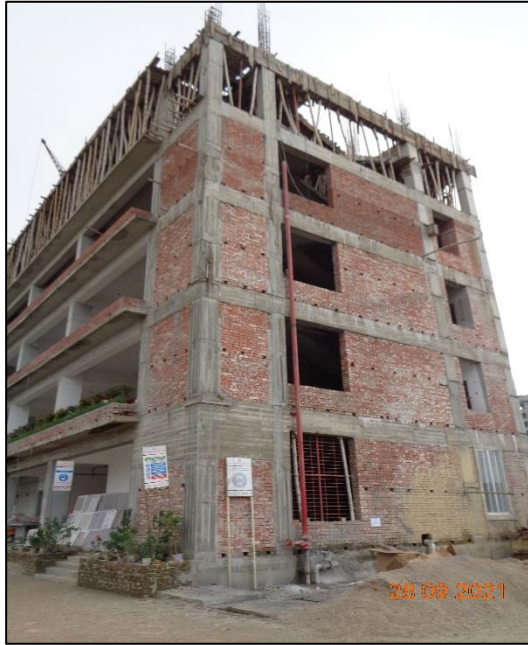
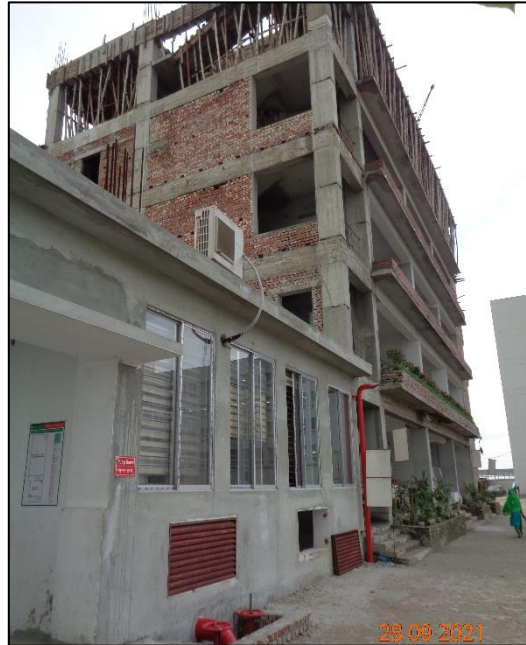
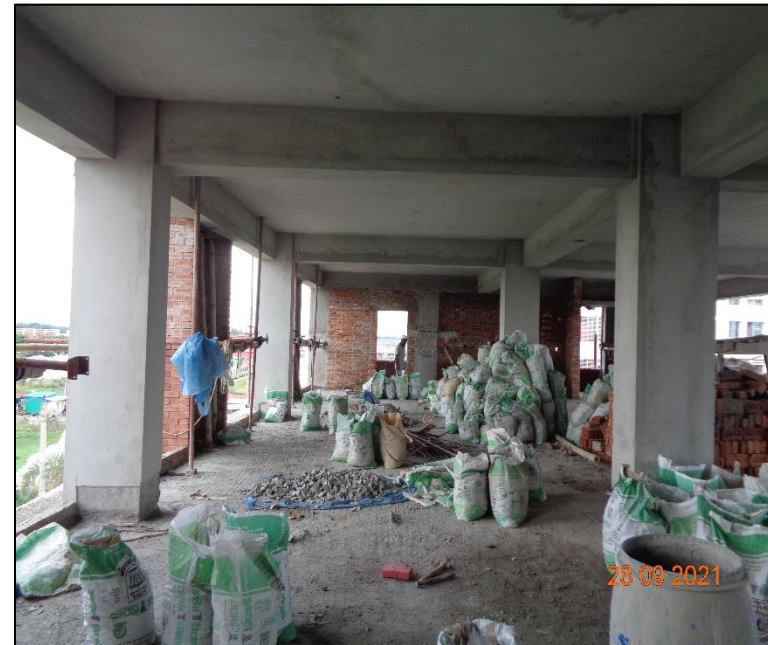
Absence of design documents

No design documents were available for Admin Building

As per BNBC, every building or structure designed shall have its design documents prepared in accordance with the provision of Section 1.9.1. The design document shall include a design report, and a set of structural drawings, which shall be prepared in compliance with section 1.9.1.1 and section 1.9.1.2 as per BNBC. At the time of inspection, no design report was available which is required to be prepared in compliance with section 1.9.1.1 (part-6, BNBC).

Item No.	Observation	Recommended Action Plan	Recommended Timeline
08	Absence of design documents (Admin Building)	Factory engineer is required to prepare the design documents including a design report, and a set of structural drawings in compliance with section 1.9.1.1 and section 1.9.1.2 as per BNBC part 6 and submit to RSC for review.	6-weeks
09	Absence of design documents (Admin Building)	Produce and actively manage load plan for all floors considering floor, column and foundation capacity.	6-weeks
10	Absence of design documents (Admin Building)	Complete remedial works arising from design report.	6-months
11	Absence of design documents (Admin Building)	Implement floor loading plan.	6-months
12	Exposed rebar at 1st floor (south portion) (Admin Building)	Remove the rusting and provide rust proof paint to avoid further corrosion.	6-weeks
13	Falling Hazard (Admin Building)	The factory is required to provide proper barrier (parapet/railing) to avoid falling hazard.	Immediate-Now

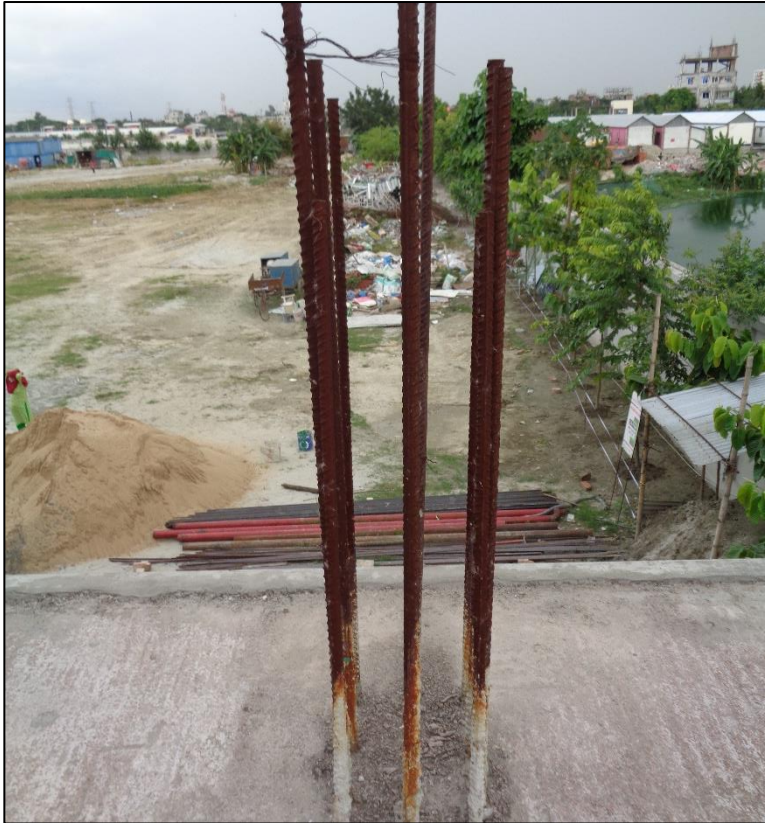
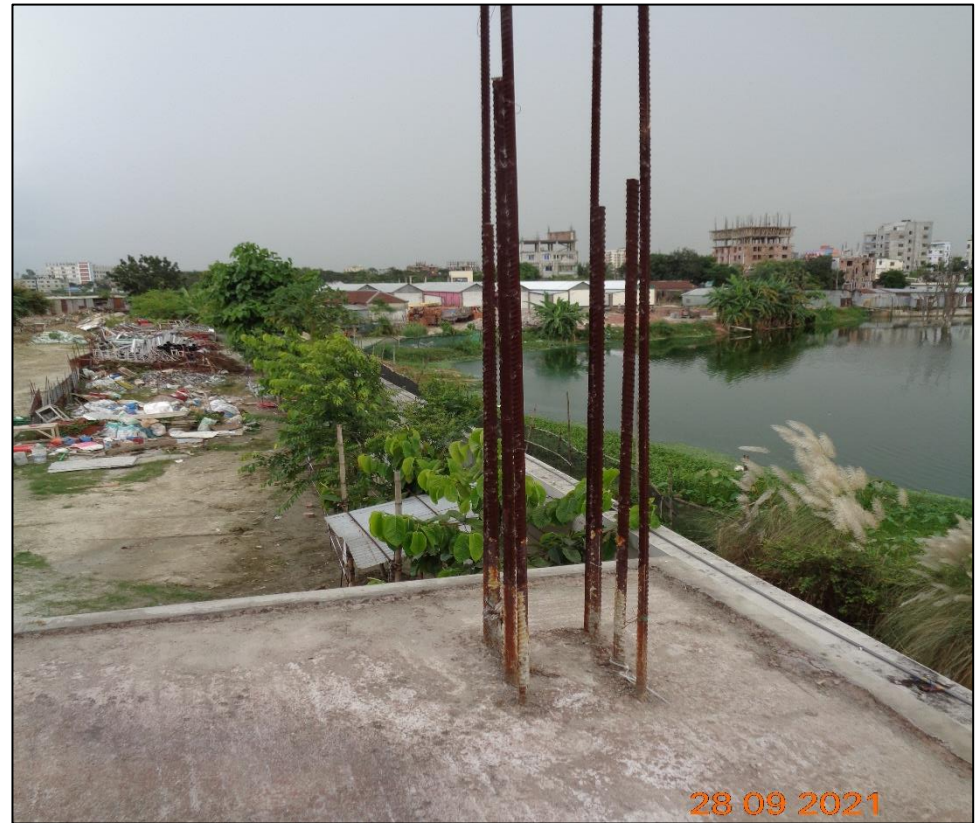
Exposed rebar at 1st floor (south portion)

Exposed rebar of Column

Exposed reinforcement was found on 1st floor (south portion) columns. Factory engineer is required to take necessary measures to prevent the corrosion in exposed rebar.

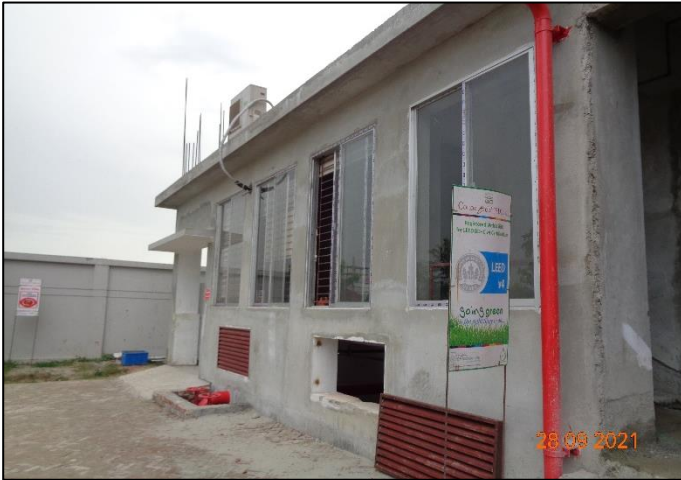
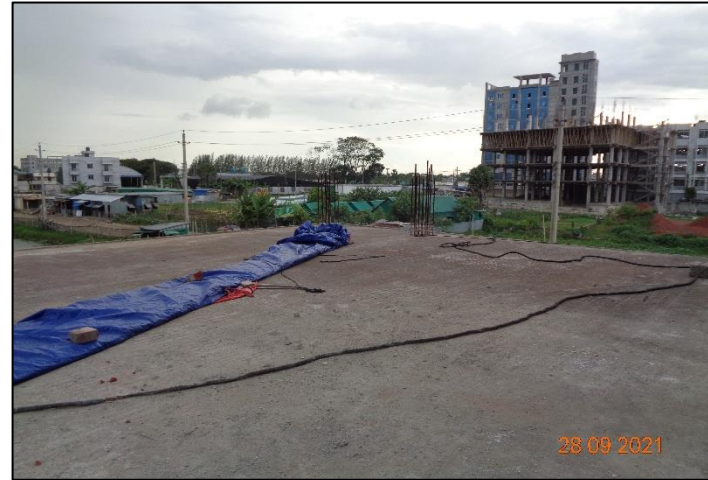
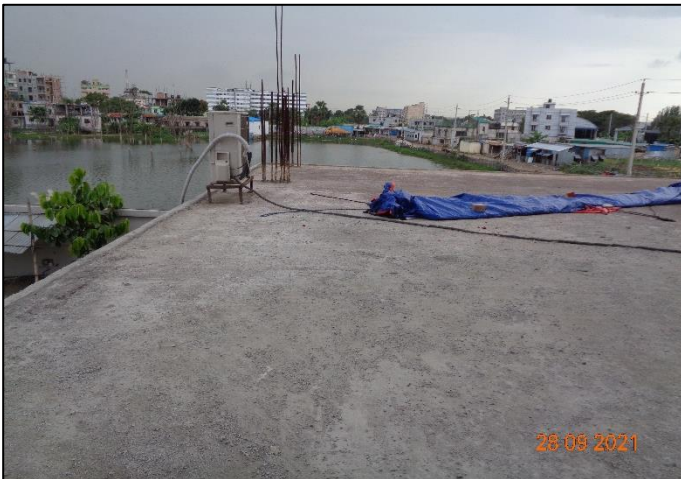
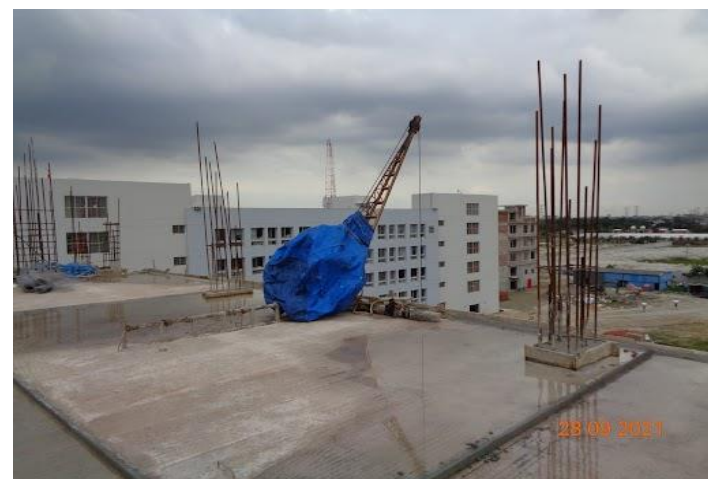
Falling Hazard

No barrier at 1st floor and roof

No parapet wall or railing was found at 1st floor (south portion) and roof of north portion which may cause falling hazard. The factory is required to provide proper barrier (parapet/railing) to avoid falling hazard.

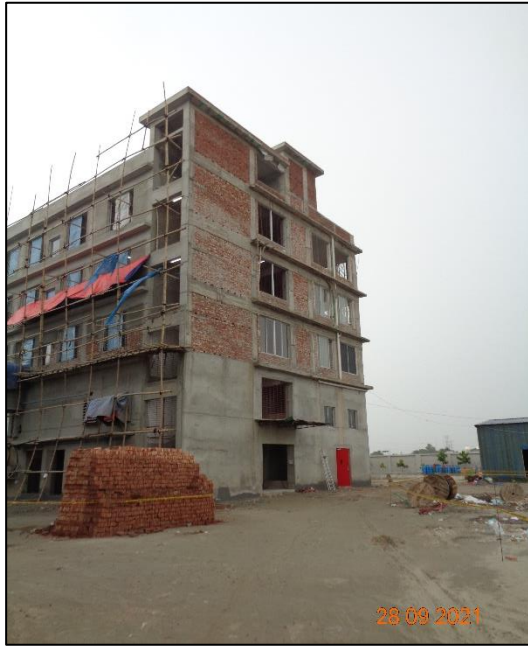
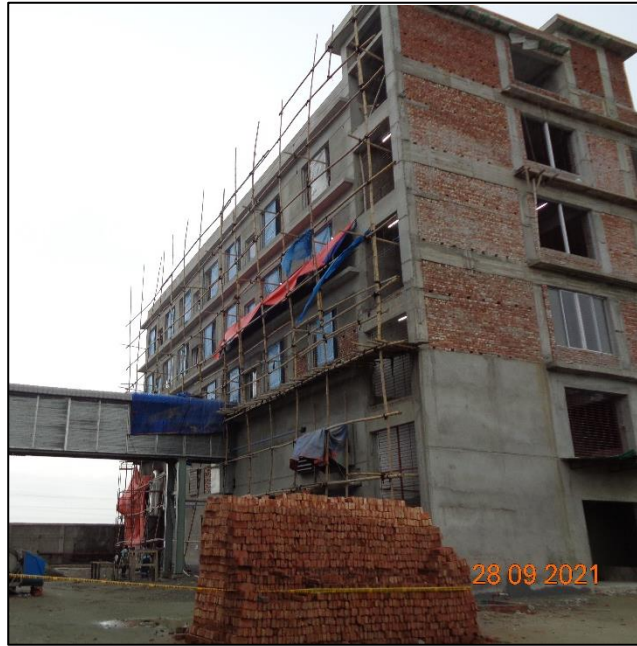
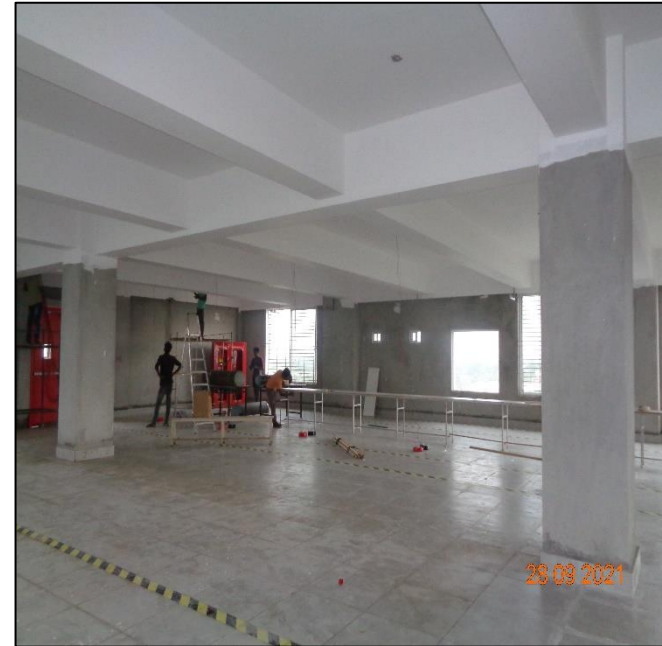
Absence of design documents

No design documents were available for Utility Building

As per BNBC, every building or structure designed shall have its design documents prepared in accordance with the provision of Section 1.9.1. The design document shall include a design report, and a set of structural drawings, which shall be prepared in compliance with section 1.9.1.1 and section 1.9.1.2 as per BNBC. At the time of inspection, no design report was available which is required to be prepared in compliance with section 1.9.1.1 (part-6, BNBC).

Item No.	Observation	Recommended Action Plan	Recommended Timeline
14	Absence of design documents (Utility Building)	Factory engineer is required to prepare the design documents including a design report, and a set of structural drawings in compliance with section 1.9.1.1 and section 1.9.1.2 as per BNBC part 6 and submit to RSC for review.	6-weeks
15	Absence of design documents (Utility Building)	Produce and actively manage load plan for all floors considering floor, column and foundation capacity.	6-weeks
16	Absence of design documents (Utility Building)	Complete remedial works arising from design report.	6-months
17	Absence of design documents (Utility Building)	Implement floor loading plan.	6-months
18	Lack of information in as built drawings (Utility Building)	The factory engineer to survey the structure and update the as-built drawings accordingly.	6-weeks
19	Apparently non-engineered canopy (Utility Building)	The factory engineer is required to either demolish the canopy or build an engineered canopy.	6-weeks

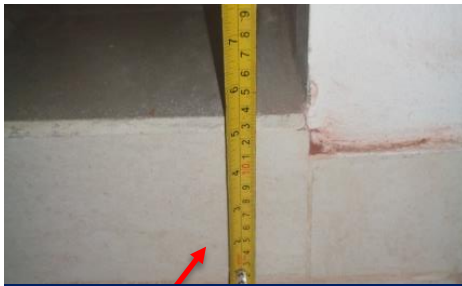
100 mm build-up at toilet

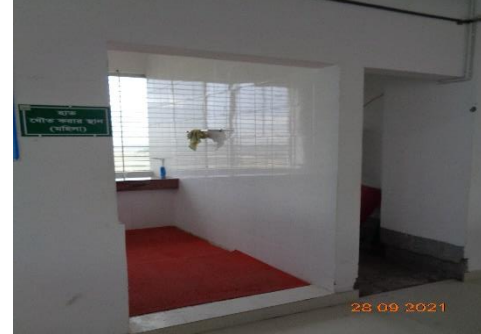
25 mm build-up at toilet

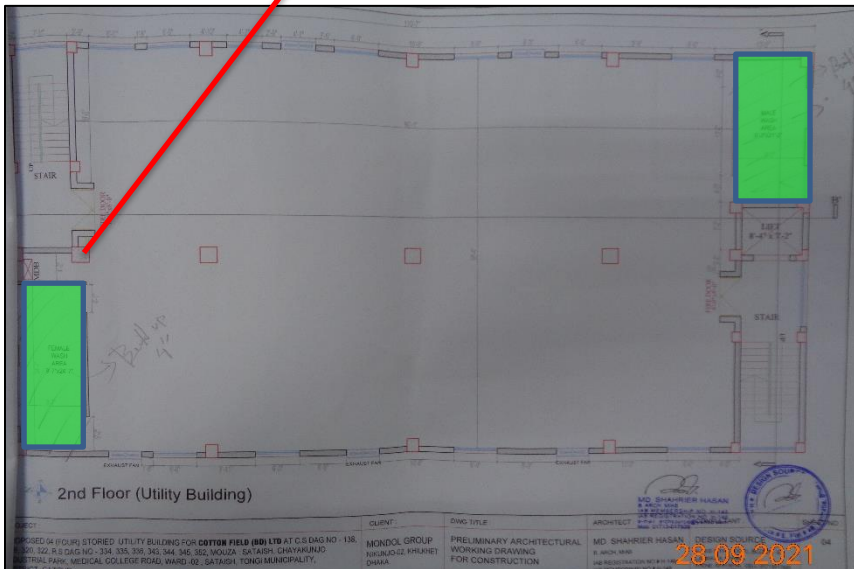
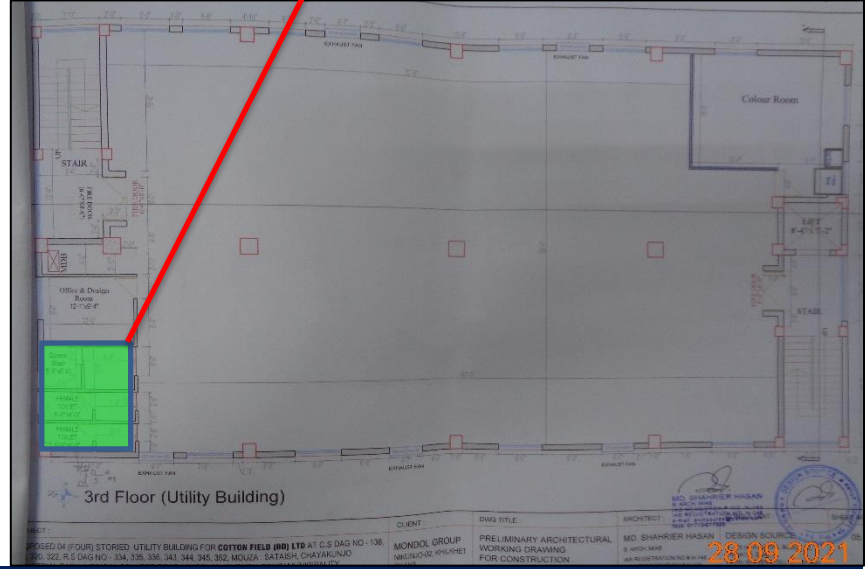
2nd floor & 3rd floor layout

Lack of information in as-built drawing

Approx. 100mm build-up was found in toilet area which is not mentioned in as-built drawing. The factory engineer to survey the structure and update the as-built drawings accordingly.

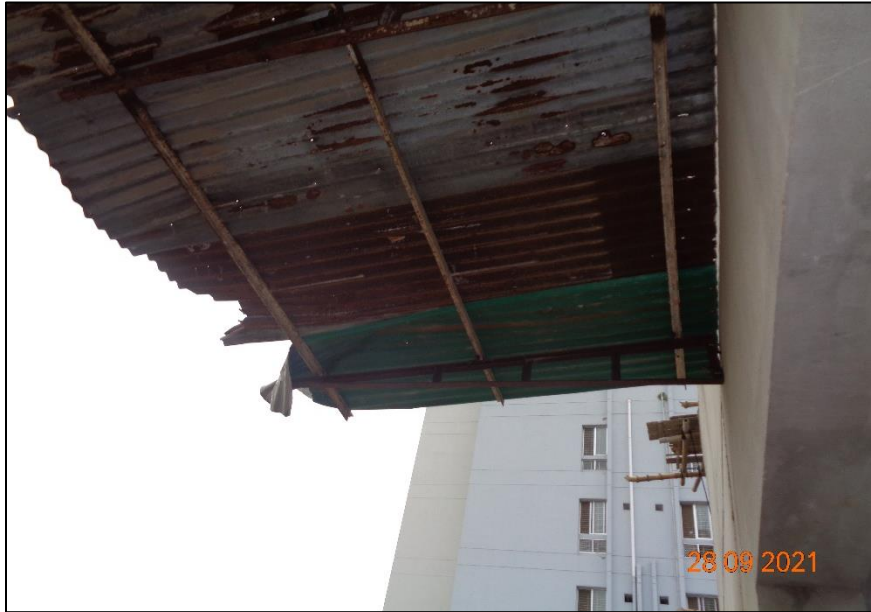
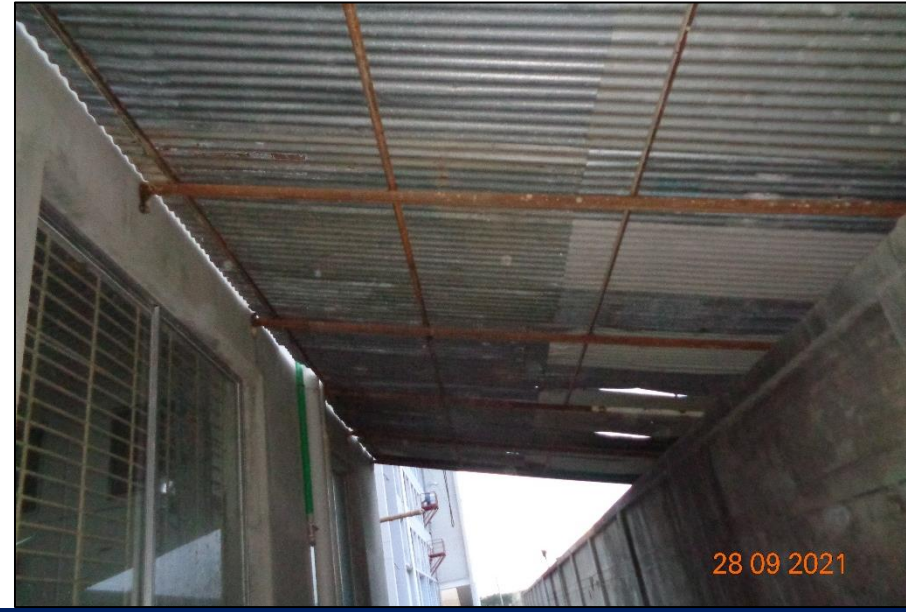
Apparently non-engineered canopy

Non-engineered canopy at Utility building

Non-engineered canopy was found in entrance & back side of the Utility building. The factory engineer is required to either demolish the canopy or build an engineered canopy.
