# MM Knit Wear (Extension Buildings)

Ambagh Road, Konabari, Nilnagar, Gazipur

8 June, 25 August & 6 September 2021

# Observations

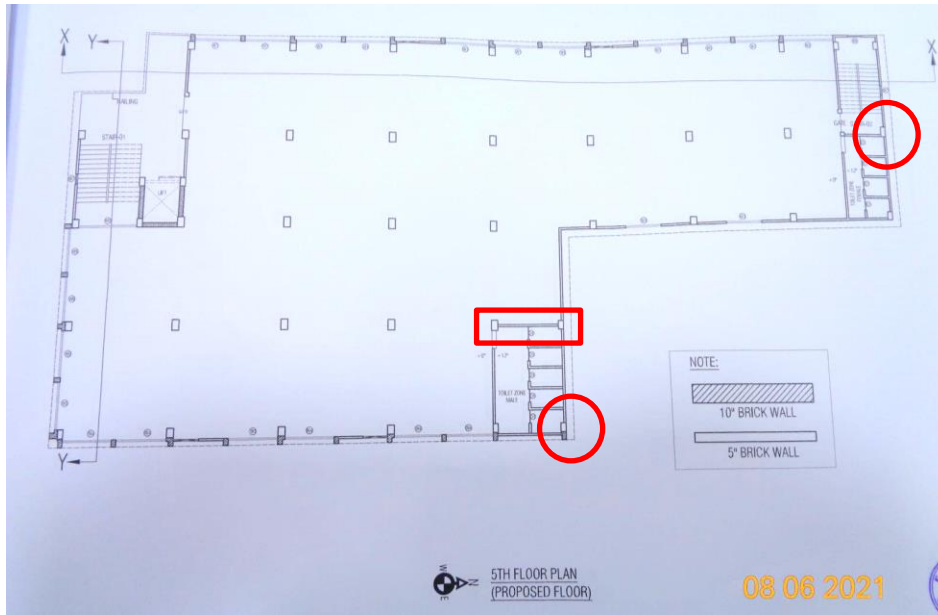
Column Layout Plan

Cursory calculation indicates that columns are stressed above normal design limit considering observed 2 kPa live load and equivalent concrete strength (11.87 Mpa) based on core test results. Factory engineer is required to review design, load & column stresses of the building.

| Item No. | Observation | Recommended Action Plan | Recommended Timeline |
|---|---|---|---|
| 01 | High stress column and foundation. (Building 4) | Maintain live loading below 2 kPa in all floor levels. | Immediate - Now |
| 03 | High stress column and foundation. (Building 4) | Factory Engineer to review design, loads and column stresses in all column and foundations. | 6-weeks |

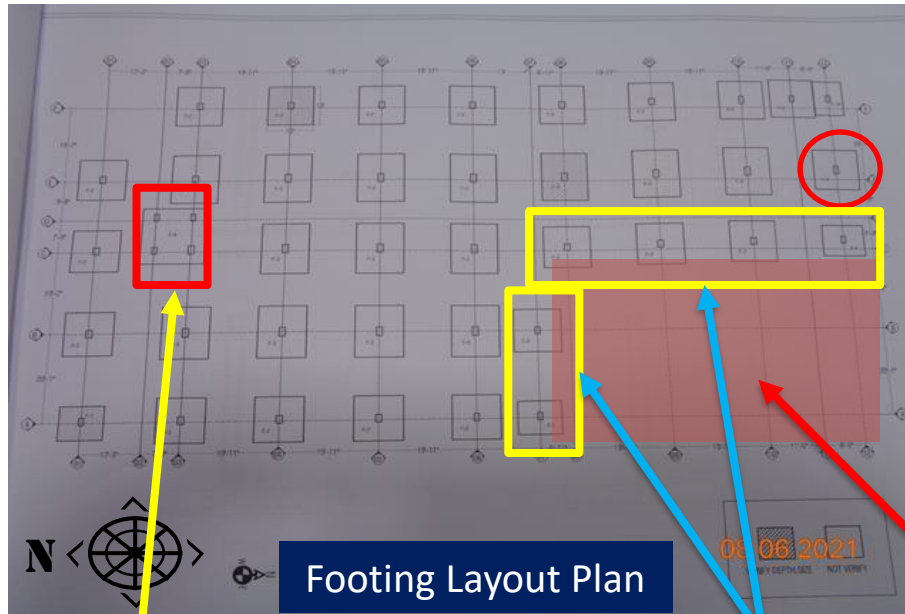
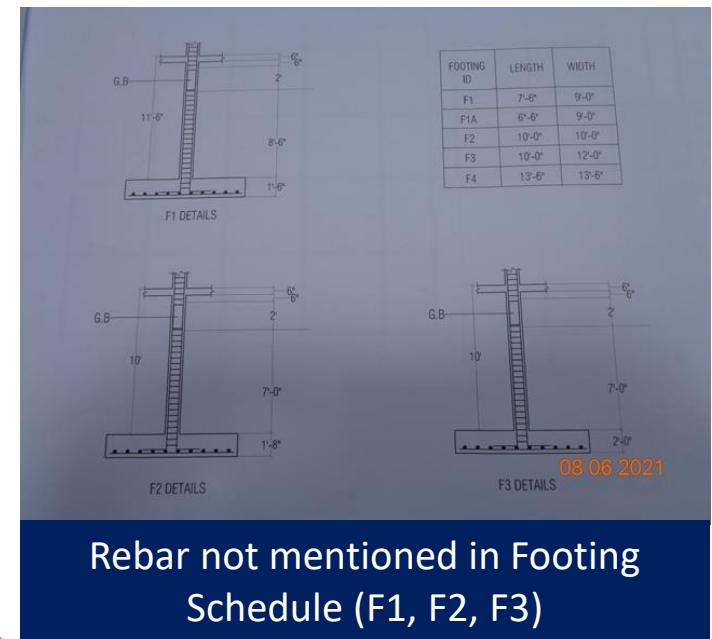
No details of "F4" footing was found in drawing.

Footings may be shared with columns of adjacent buildings (Building 3).

Cursory calculation indicates that footings are stressed above normal design limit considering observed live load (2 kPa), equivalent concrete strength (17.17 MPa) based on core test results and ultimate soil bearing capacity 7.5 ksf (359.1 kN/m<sup>2</sup>). Factory engineer is required to review design, load & footing stresses of the building and suggest remedial actions accordingly.

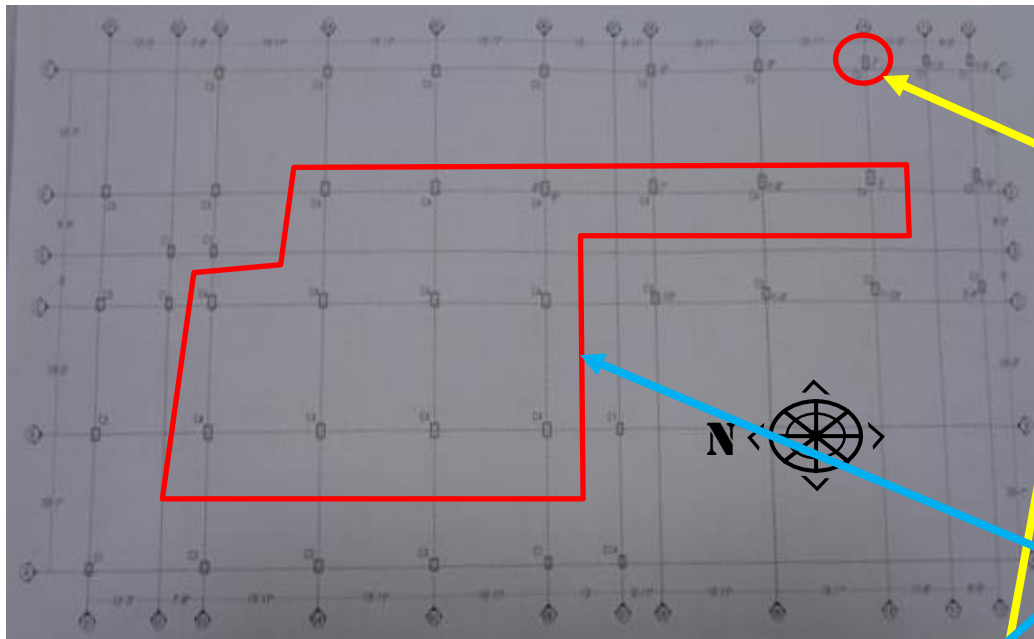
Rebar number of exterior column, (C2 type) was found less than mentioned in column schedule above roof level. On short face, the number of rebar was found 2 instead of 3.

Rebar number of interior column, (C4 type) was found less than mentioned in column schedule. On long face, the number of rebar was found 6 instead of 7.

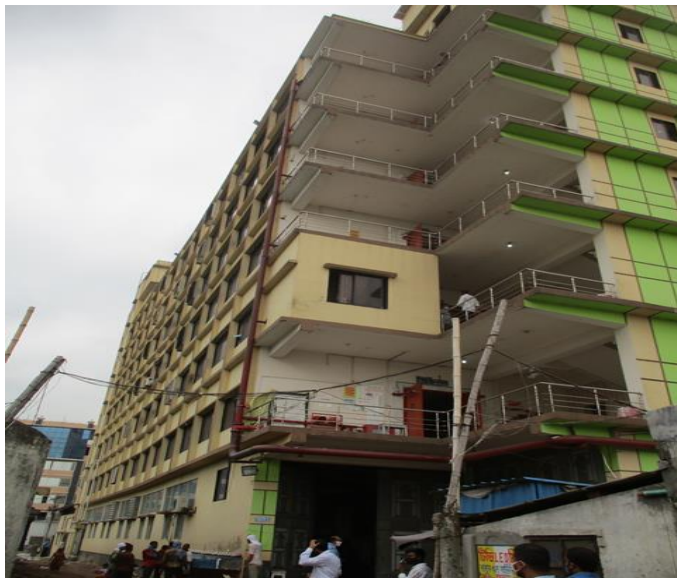
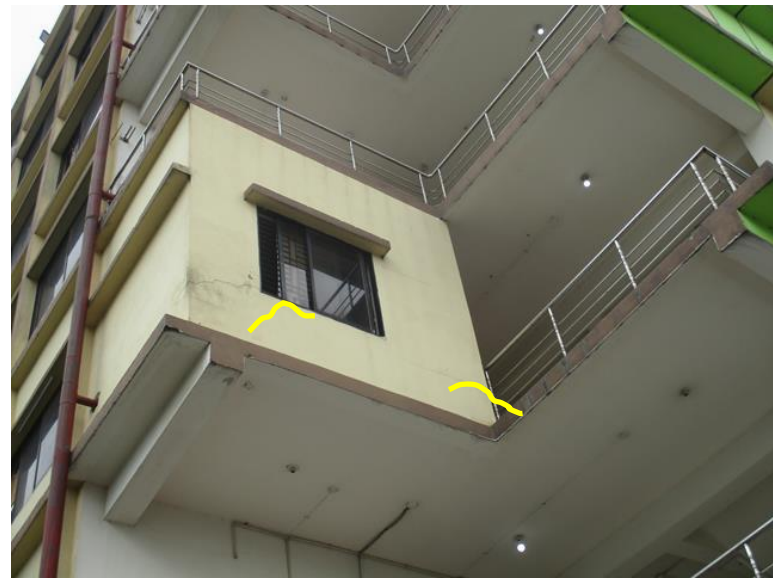
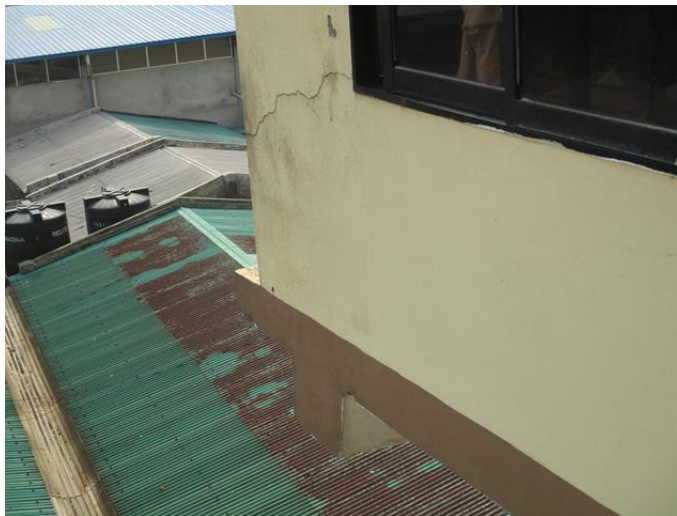
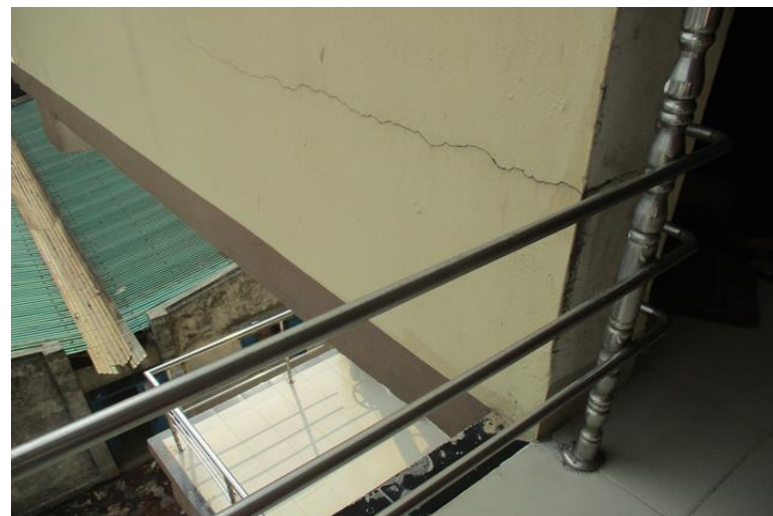
Some cracks were found in brick wall at 2<sup>nd</sup> floor. Factory engineer is required to investigate the cause of cracks and suggest proper remedial actions in the crack investigation report.

| Item No. | Observation | Recommended Action Plan | Recommended Timeline |
|---|---|---|---|
| 11 | Crack in brick wall [Building 4]. | Factory engineer is required to investigate the cause of crack and repair the crack as per recommendation from investigation report. | 6-weeks |

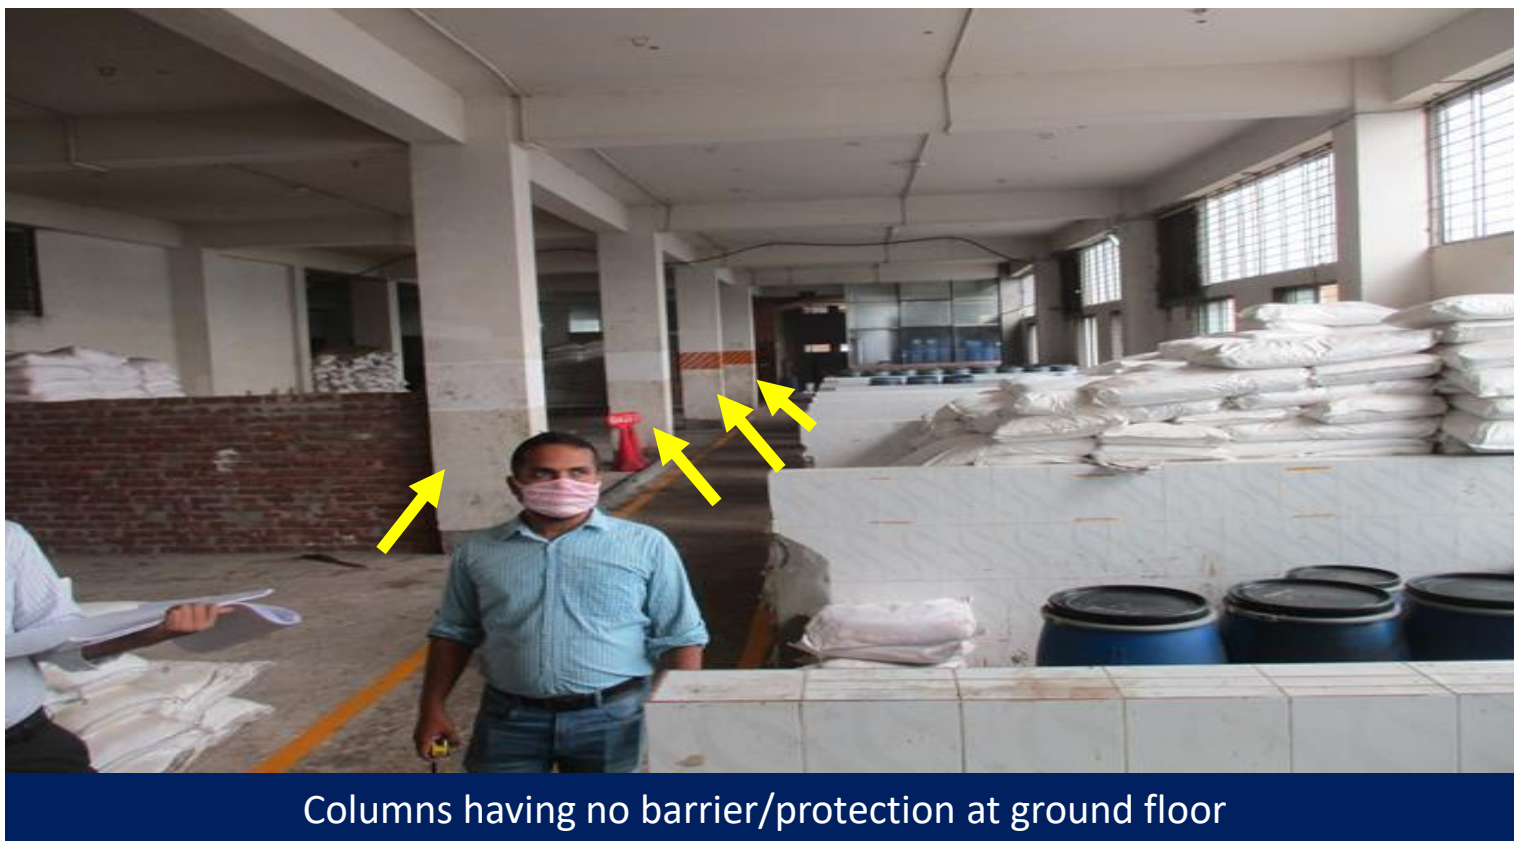
Columns having no barrier/protection at ground floor

Columns of the chemical storage area are susceptible to trolley impact. The factory engineer is required to take necessary measures to prevent the vehicle impact by providing the barrier around the columns.

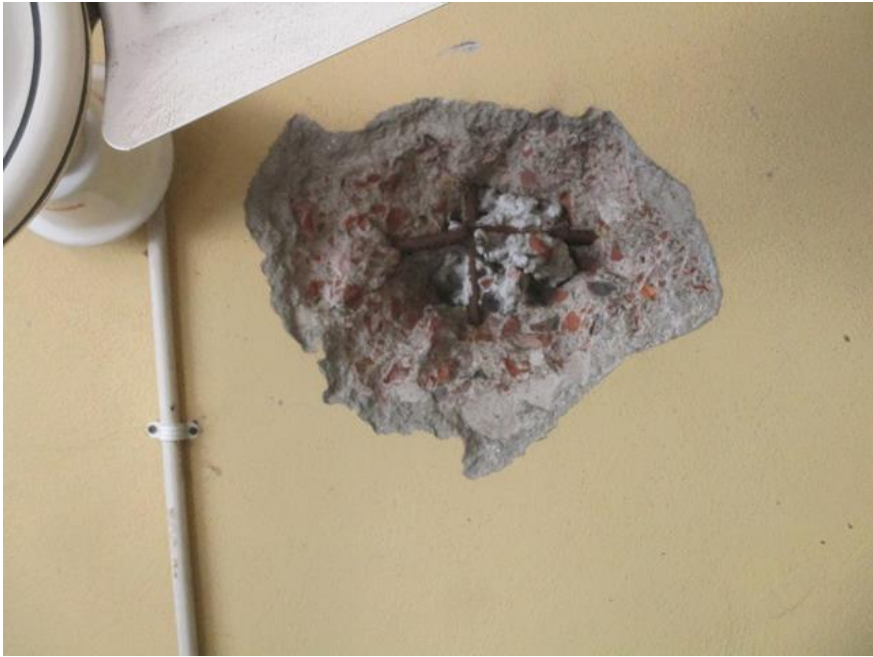
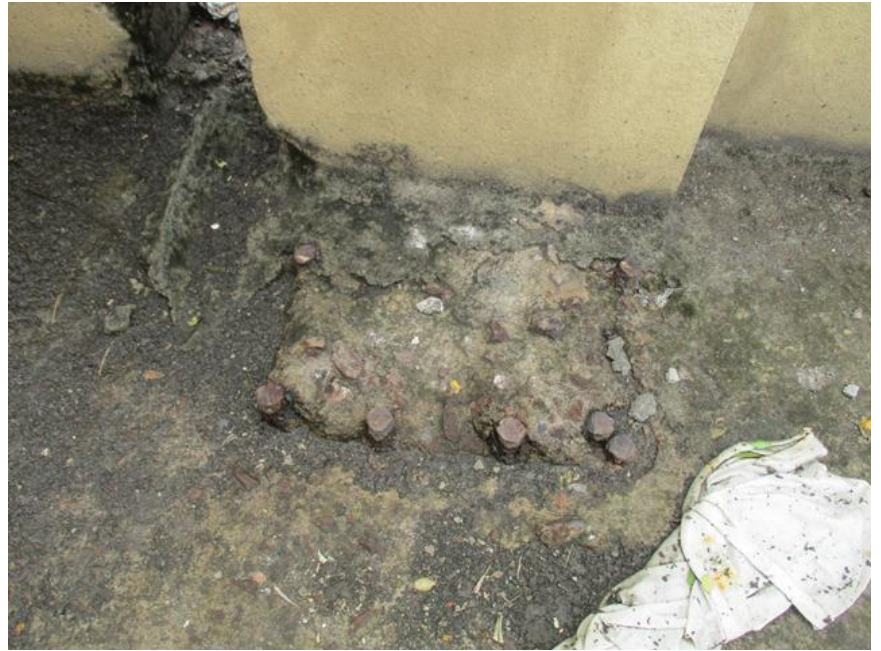
**Corroded rebar at roof**

Cover the exposed rebar or provide rust proof paint on rebar.

| Item No. | Observation | Recommended Action Plan | Recommended Timeline |
|---|---|---|---|
| 13 | Corroded rebar at roof [Building 4]. | All exposed reinforcement is to be protected from corrosion which may cause degradation of the concrete. | 6-weeks |

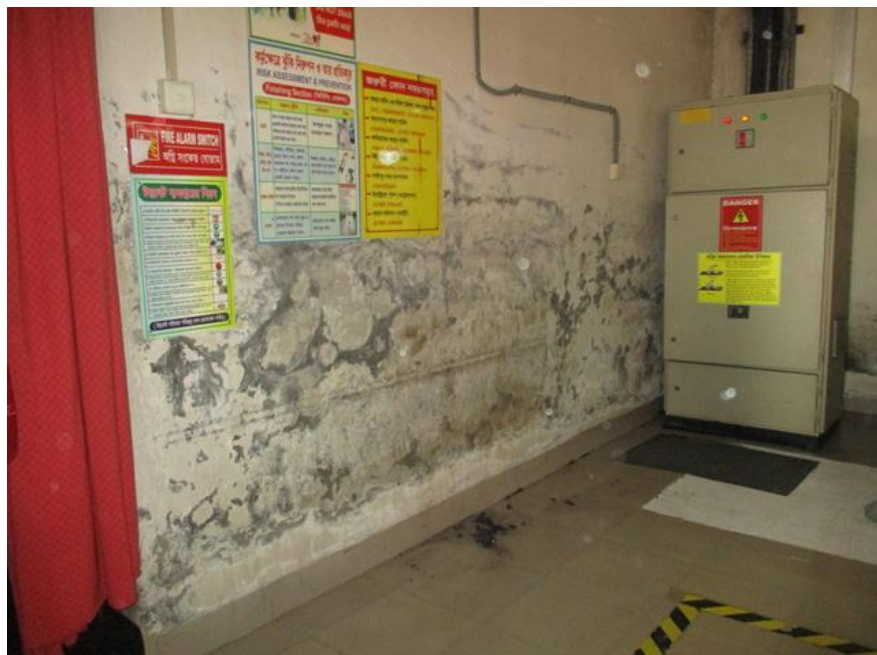
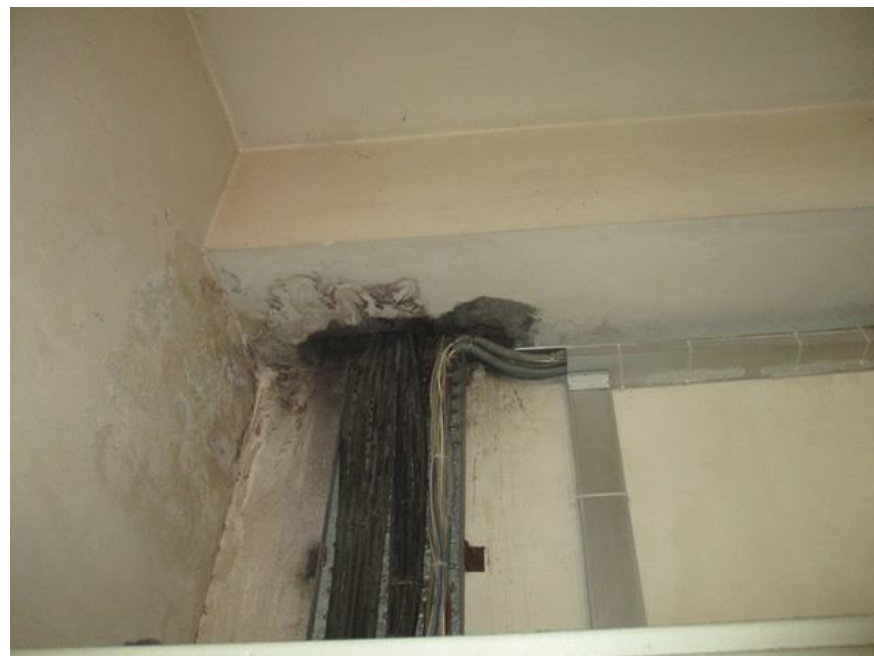
Dampness was found on toilet block wall. Factory engineer is required to investigate the source of dampness and take necessary measures to prevent the dampness.

| Item No. | Observation | Recommended Action Plan | Recommended Timeline |
|---|---|---|---|
| 14 | Dampness on toilet block wall (Building 4) | Building Engineer is required to investigate the reason of dampness & apply suitable method to repair dampness. | 6-weeks |

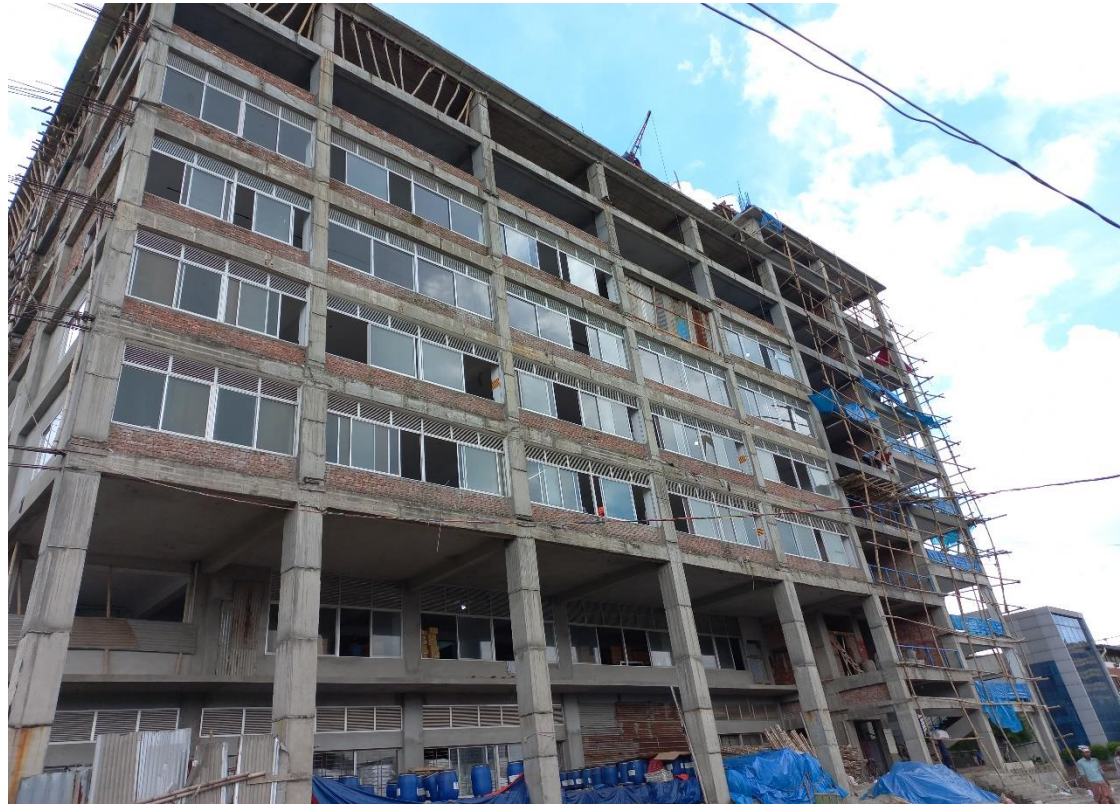
As per BNBC every building or structure designed shall have its design documents prepared in accordance with the provision of Section 1.9.1. The design document shall include a design report, and a set of structural drawings, which shall be prepared in compliance with section 1.9.1.1 and section 1.9.1.2 as per BNBC. Design report was not found which is required to be prepared in compliance with section 1.9.1.1 (part-6, BNBC).

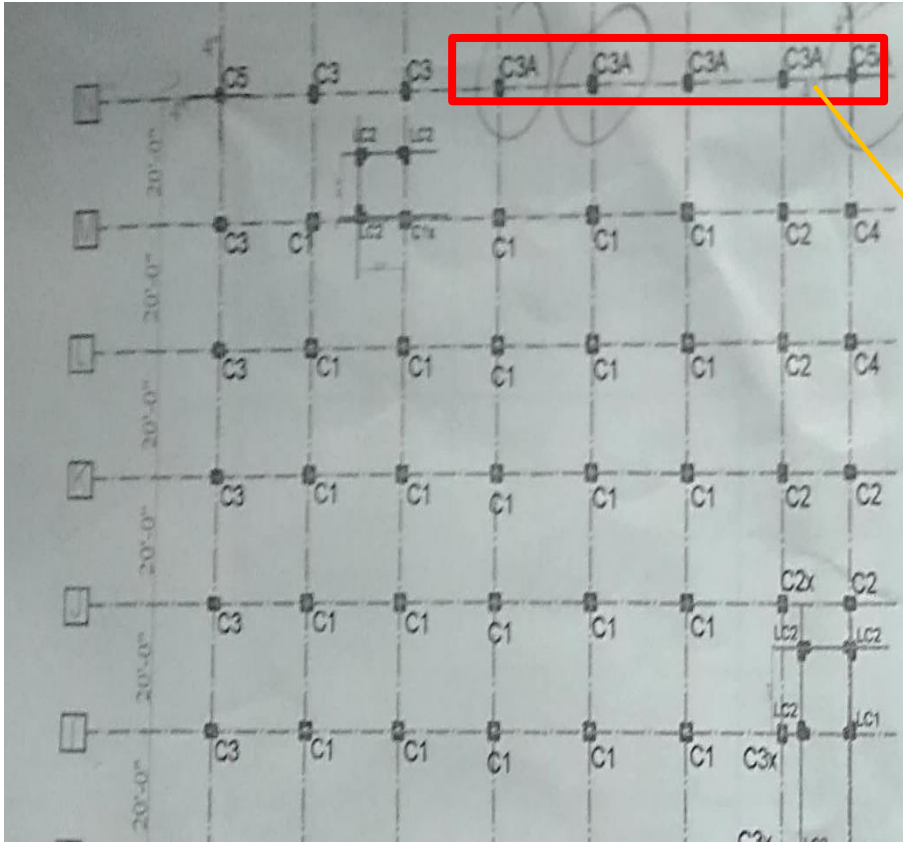
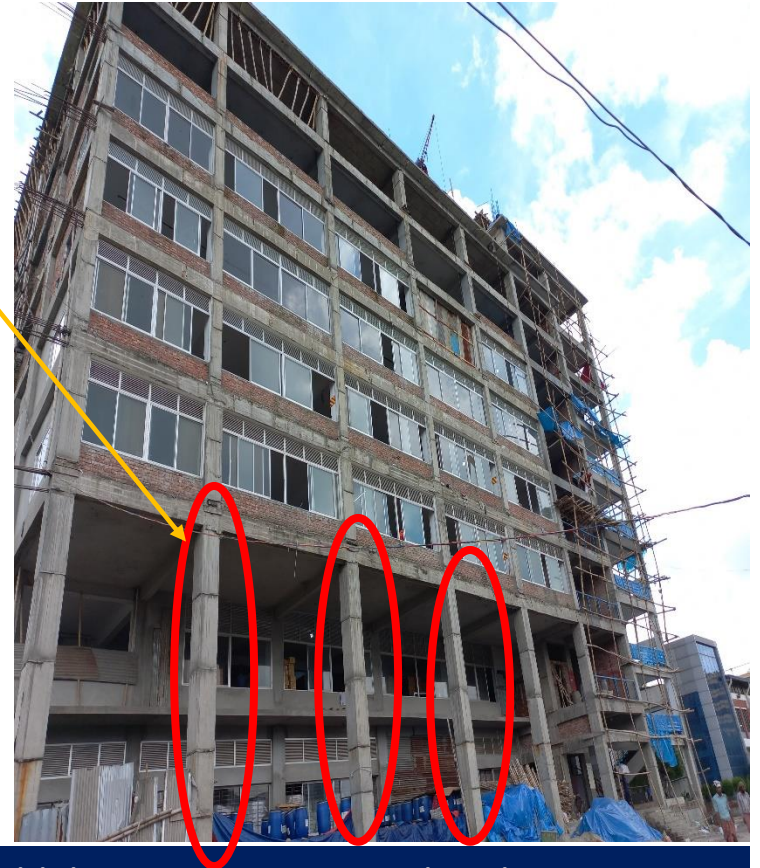
The adequacy check of (C3A and C5A) columns should be incorporate in the design report considering slenderness effects.

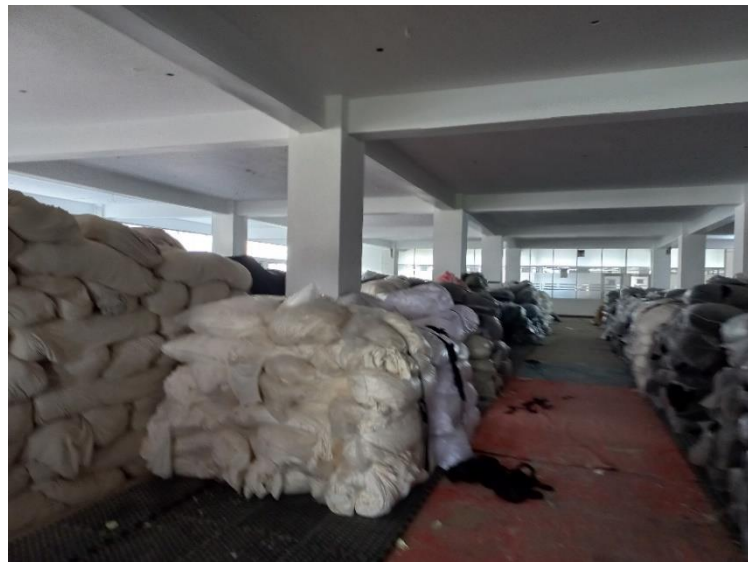
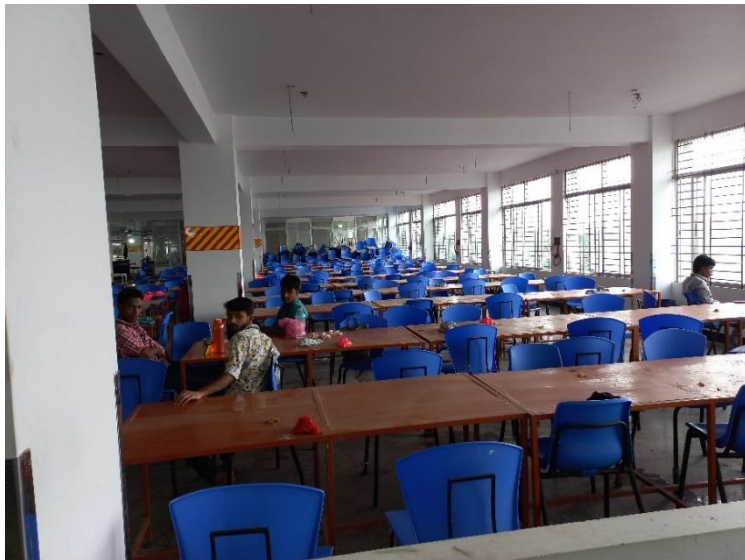
Dining area

Uncontrol loading on floor

Load plan of the building was not produced. Also, load management program (load plan posting, stack height restriction and signage) was not implemented. Produce and actively manage a loading plan for all floor plates within the factory considering the floor, column and foundation capacity.

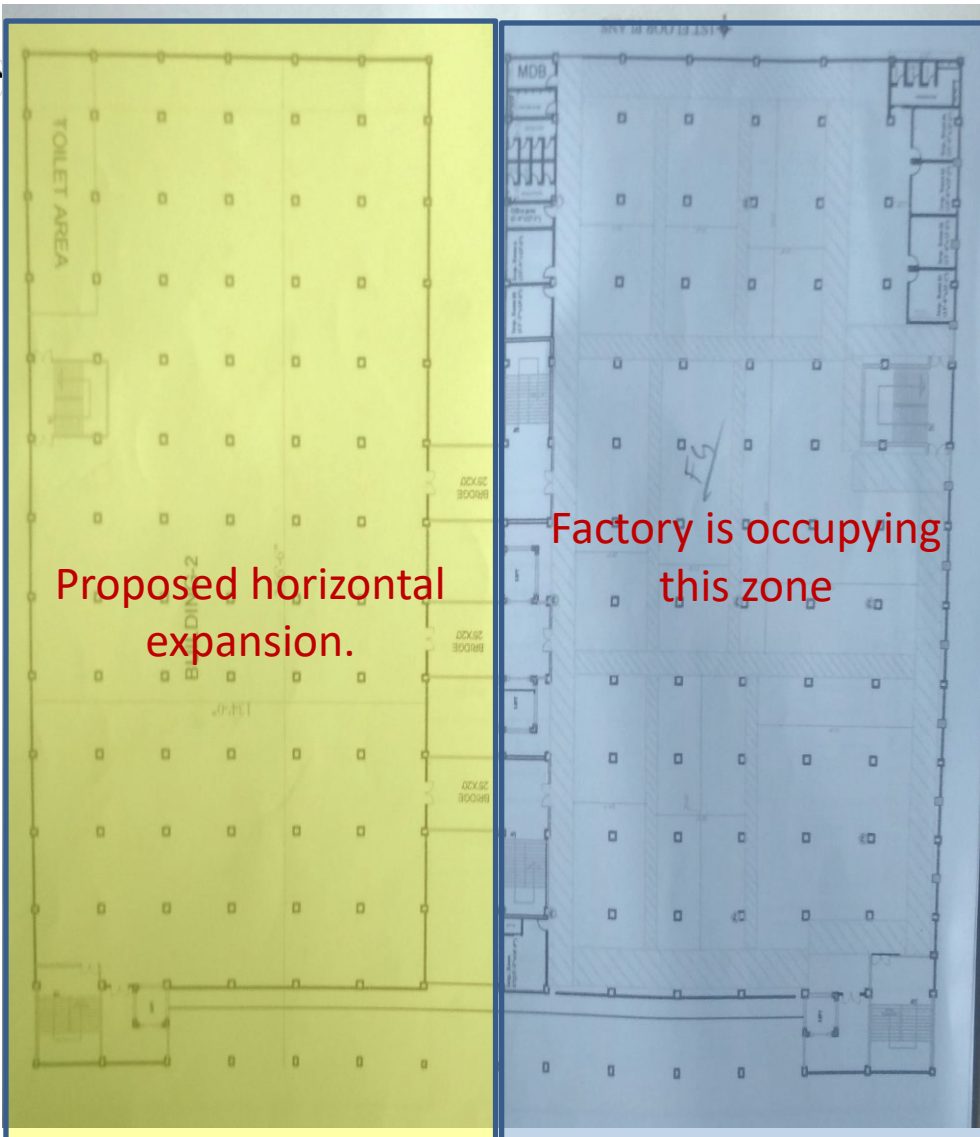
Proposed building layout plan

If the factory plan to horizontally expand the structure, prior to commencement of further construction a Details Engineering Assessment (DEA) is required to carry out as per BNBC guideline.

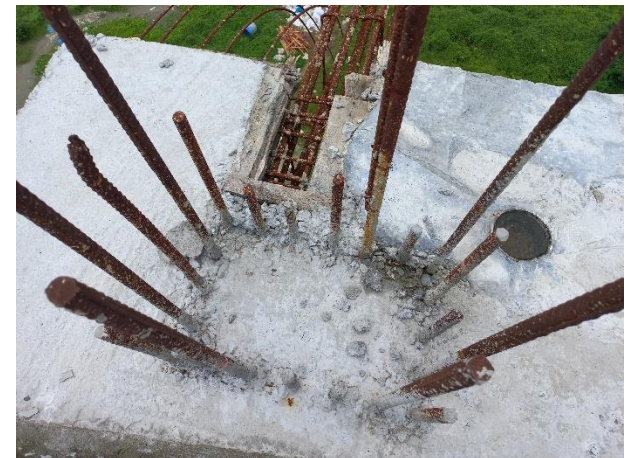
# **Construction debris and exposed rebar**

The construction debris at different floor should be removed.

The factory engineer is required to cover the exposed rebar with concrete or apply rust proof paint to protect the rebar from the corrosion.

| Item No. | Observation | Recommended Action Plan | Recommended Timeline |
|---|---|---|---|
| 25 | Construction debris and exposed rebar. [Building 5]. | Apply rust proof agents on the exposed rebar to prevent corrosion. | 6-weeks |

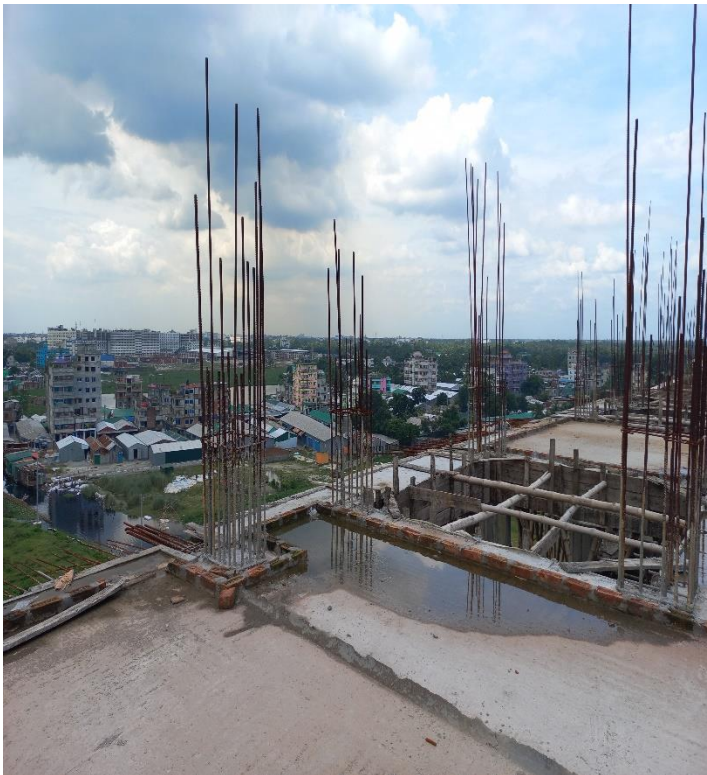
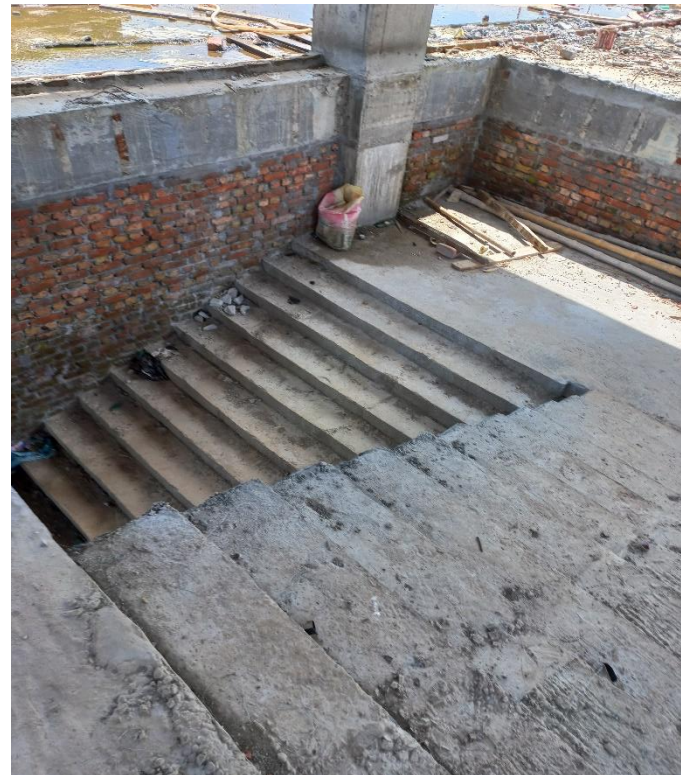
## Falling hazard at roof and stair: No guard rails

The factory engineer is required provide parapet wall along the periphery of the roof slab and install railing at stairs to prevent falling hazards.

| Item No. | Observation | Recommended Action Plan | Recommended Timeline |
|---|---|---|---|
| 26 | Falling hazard at roof and stair. [Building 5]. | Take appropriate measure to prevent falling hazards at roof and stair. | 6-weeks |

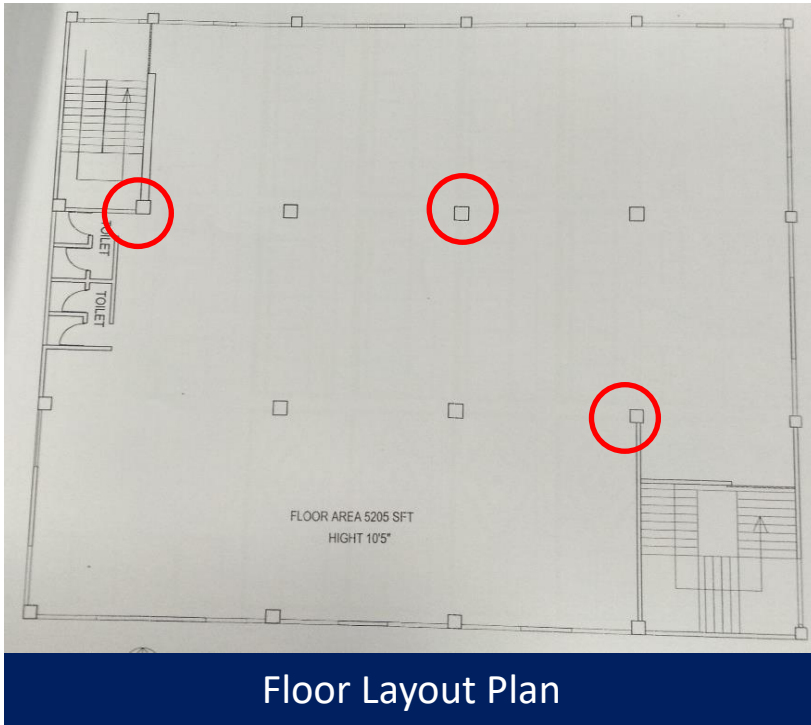
Floor Layout Plan

Toilet zone with 325 mm floor buildup

Cursory calculation indicates that columns are stressed above normal design limit considering observed 2 kPa live load. Factory engineer is required to review design, load & column stress.

No geotechnical report was available. Factory engineer is required to prepare a geotechnical investigation report and check the foundation adequacy.

| Item No. | Observation | Recommended Action Plan | Recommended Timeline |
|---|---|---|---|
| 31 | High stress column. (Building 6) | Conduct geotechnical investigation, prepare report and check the foundation adequacy. | 6-weeks |

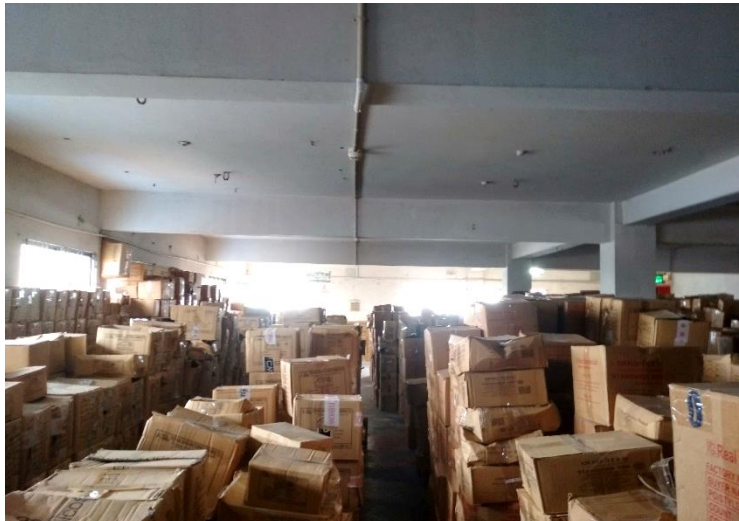
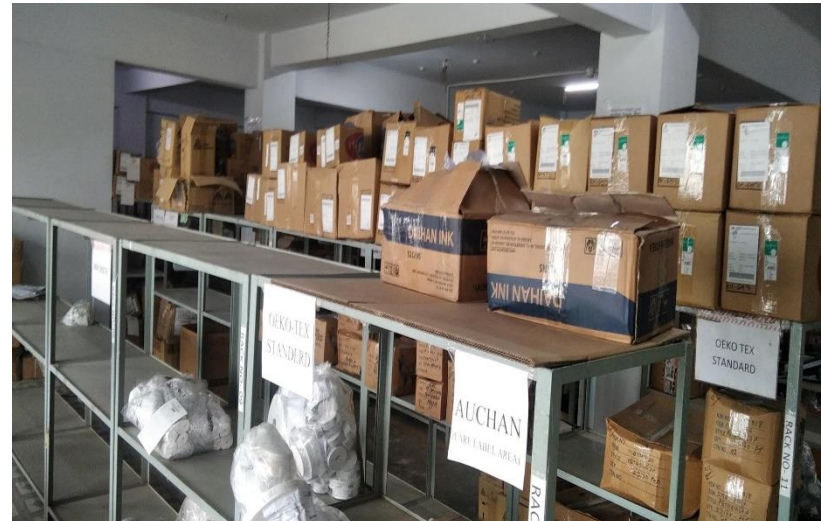
Uncontrol floor Loading

Floor Load plan of the building was not produced. Also, load management program (load plan posting, stack height restriction and signage) was not implemented. Produce and actively manage floor loading plan for all floor plates within the factory considering the floor, column and foundation capacity.

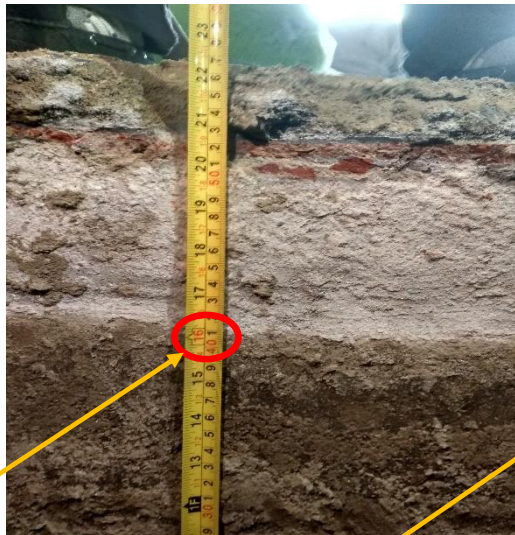
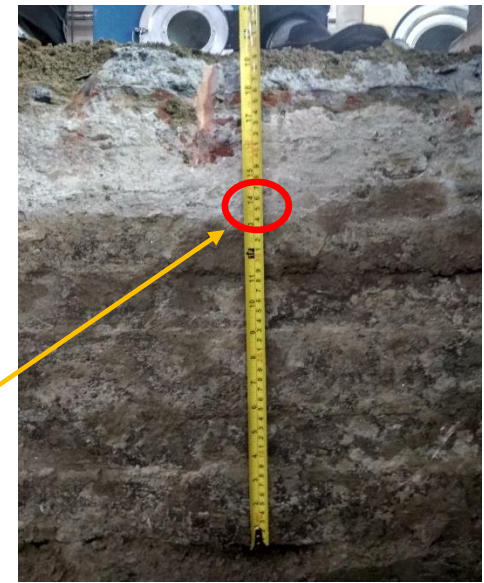
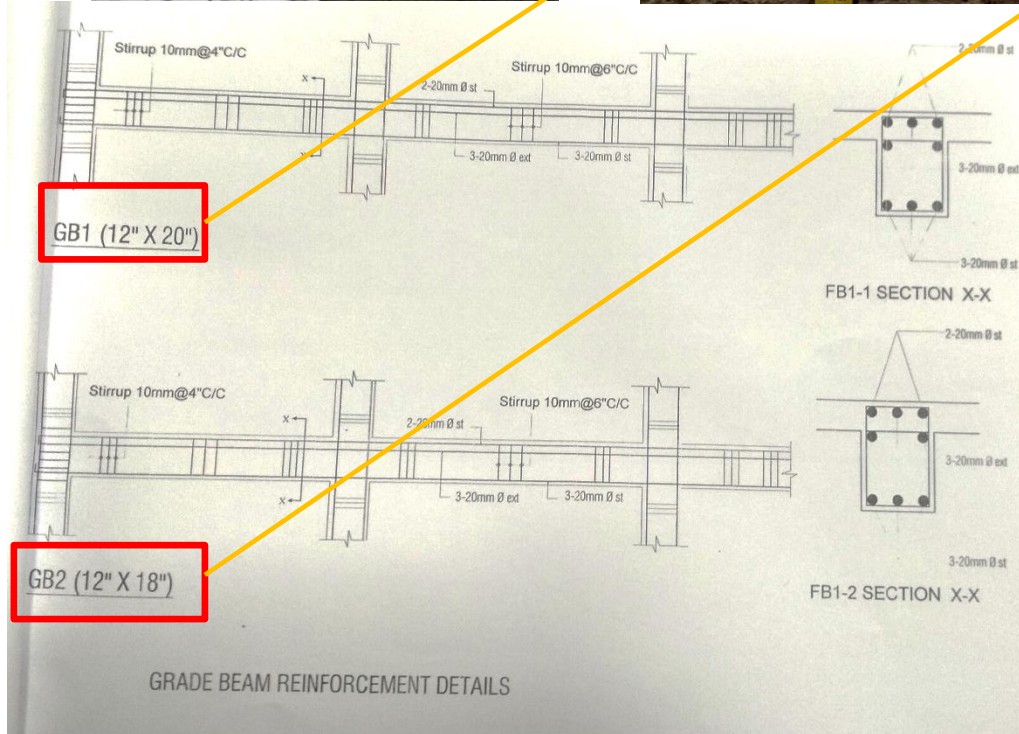
The size of grade beam GB-1 and GB-2 were mentioned 12"X20" and 12"X18". But at site the depth of GB-1 and GB-2 were found 16" and 14" respectively instead of 20" and 18".

Factory engineer is required to up prepare update as built drawing for this structures. Also, incorporate adequacy check for these parts against lateral load.

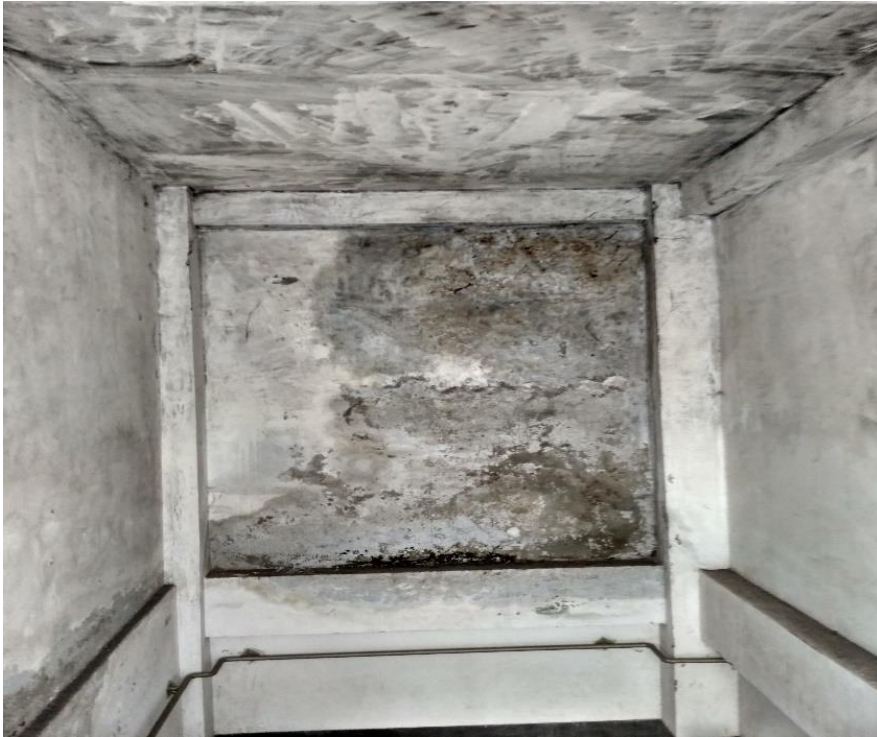
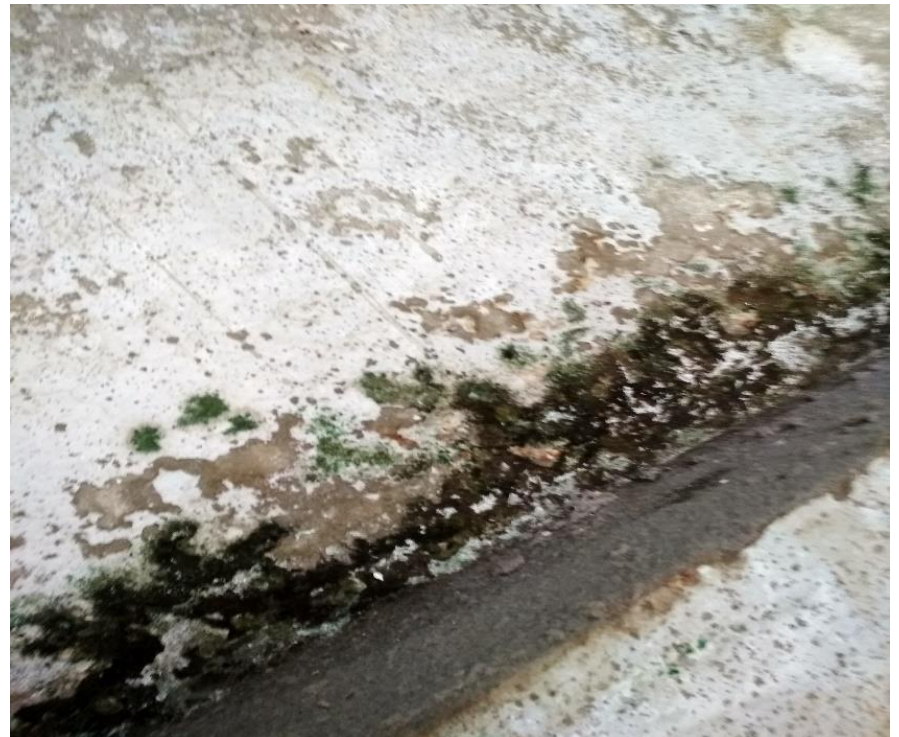
Dampness was found on wall at several locations of different floors. Factory engineer is required to investigate the source of dampness and take necessary measures to prevent the dampness.

| Item No. | Observation | Recommended Action Plan | Recommended Timeline |
|---|---|---|---|
| 40 | Dampness at wall. (Building 6) | Building Engineer is required to investigate the reason of dampness & apply suitable method to repair dampness. | 6-weeks |

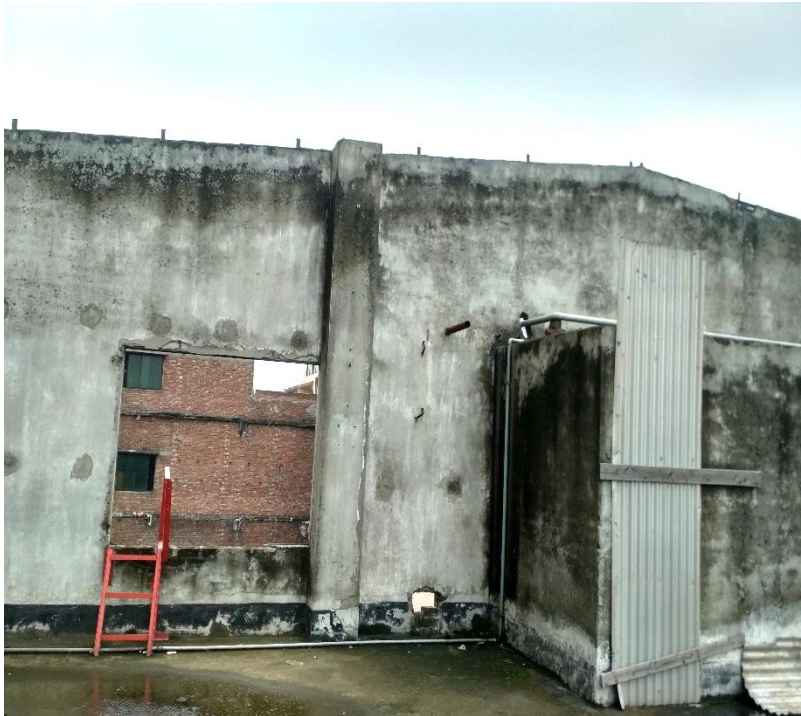
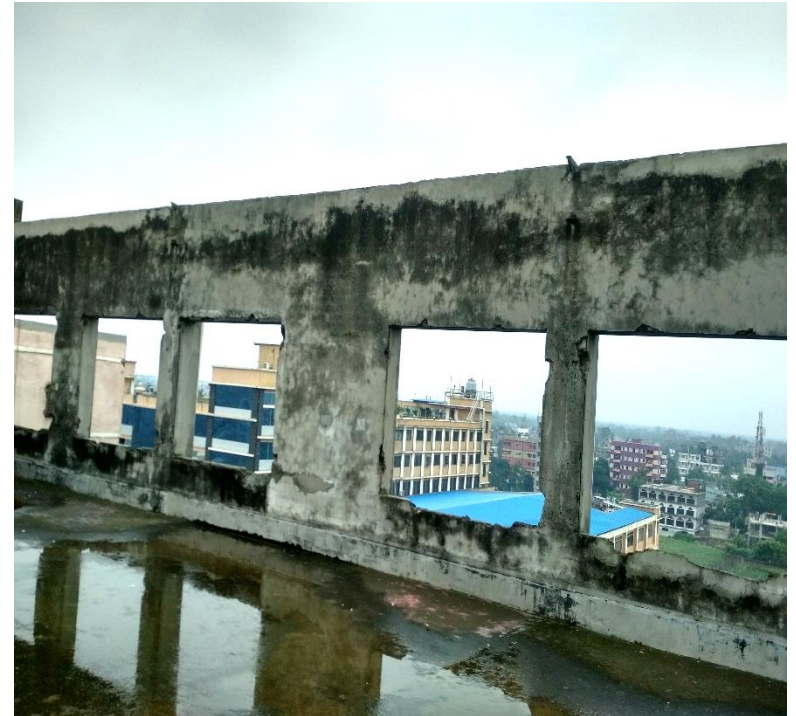
The top end of peripheral walls are unrestrained. The heights of these wall varies from 5.5m to 7.5 m. Factory engineer is required check the lateral stability of this walls or reduce the heights to a minimal level.

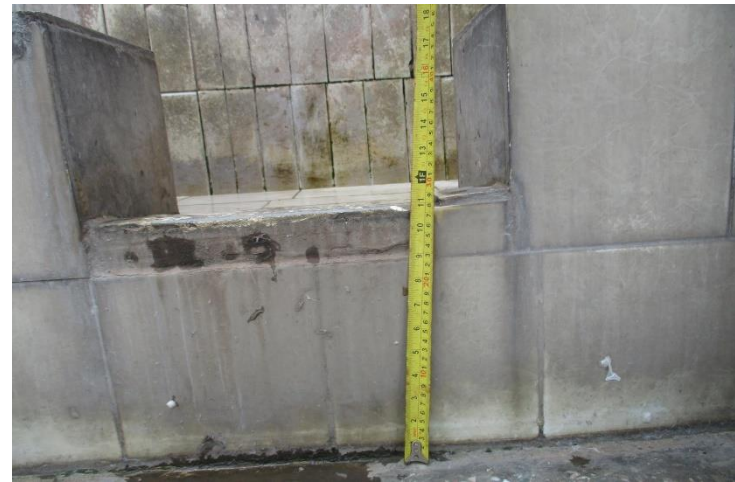
225 mm built-ups at rooftop wash zone

At open area of the roof, undocumented toilet zone & wash space with floor built-ups and pump room with lightweight steel shed was observed.

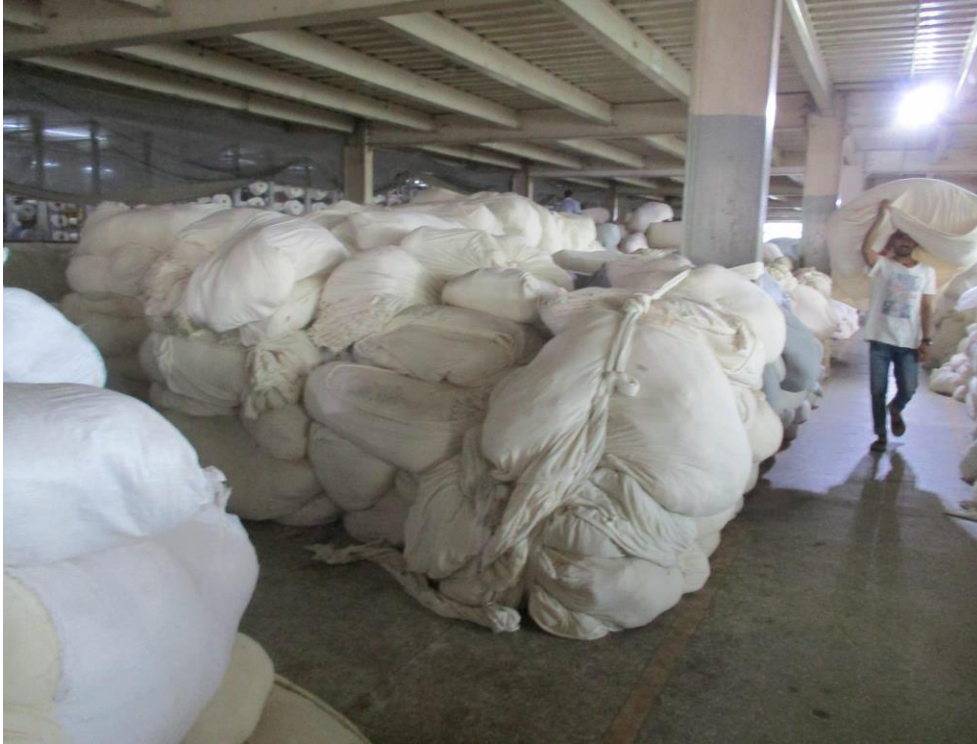
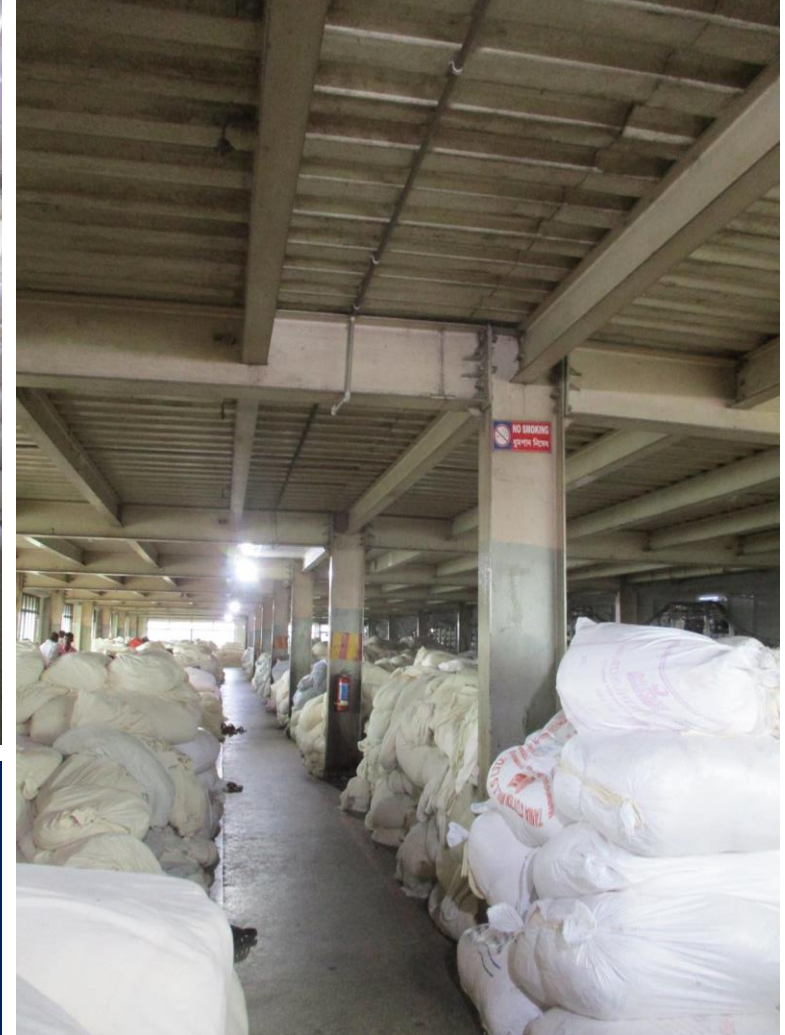
Storage was observed on Mezzanine, 1<sup>st</sup> and 2<sup>nd</sup> floor of the building. Floor load plan was not available. The factory is required to produce and actively manage floor load plan based on foundation, column and floor capacity.

About 3 kPa live load was observed on Mezzanine, 1<sup>st</sup> and 2<sup>nd</sup> floor

| Item No. | Observation | Recommended Action Plan | Recommended Timeline |
|---|---|---|---|
| 51 | Floor load plan to be prepared. (Building 7) | Produce and actively manage a loading plan for all floor plates within the factory building considering column, floor and foundation capacity. | 6-weeks |
