# MM Knit Wear (Extension Buildings)

Ambagh Road, Konabari, Nilnagar, Gazipur

8 June, 25 August & 6 September 2021

# Observations

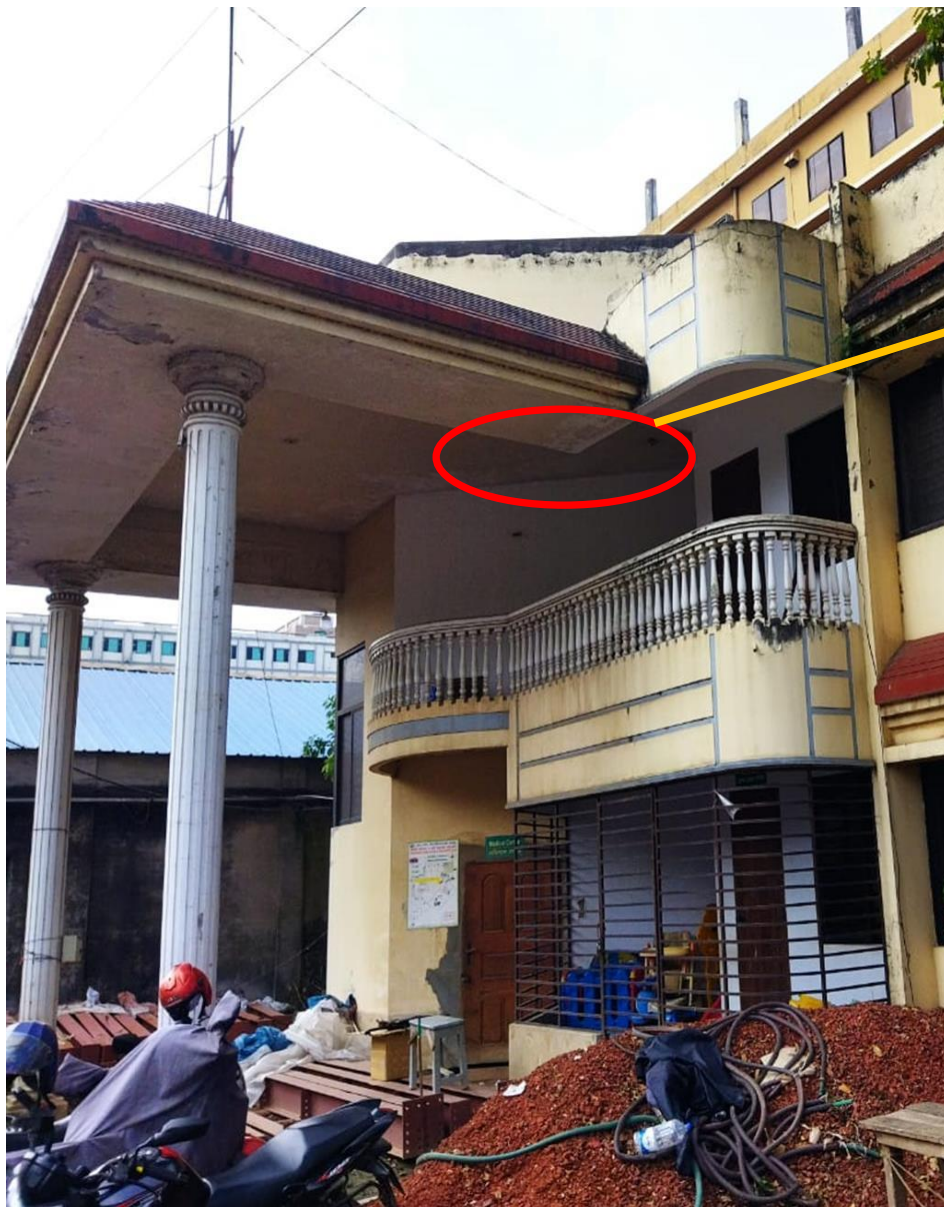
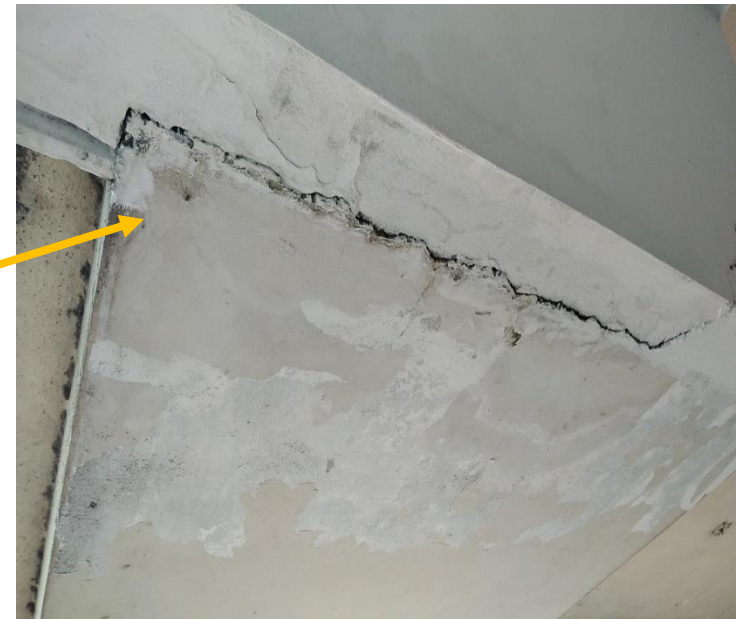
Crack of drop wall

A crack on the drop wall of porch was found. Factory engineer is required to investigate reason of this crack and suggest proper recommendation in the investigation report.

| Item No. | Observation | Recommended Action Plan | Recommended Timeline |
|---|---|---|---|
| 54 | Crack on the drop wall of porch(Building 8) | The factory is required to engage a consultant to investigate the reason and extent of the crack. | 6-weeks |
| 55 | Crack on the drop wall of porch(Building 8) | Carry out the suitable remedial works as per the crack investigation report. | 6-weeks |

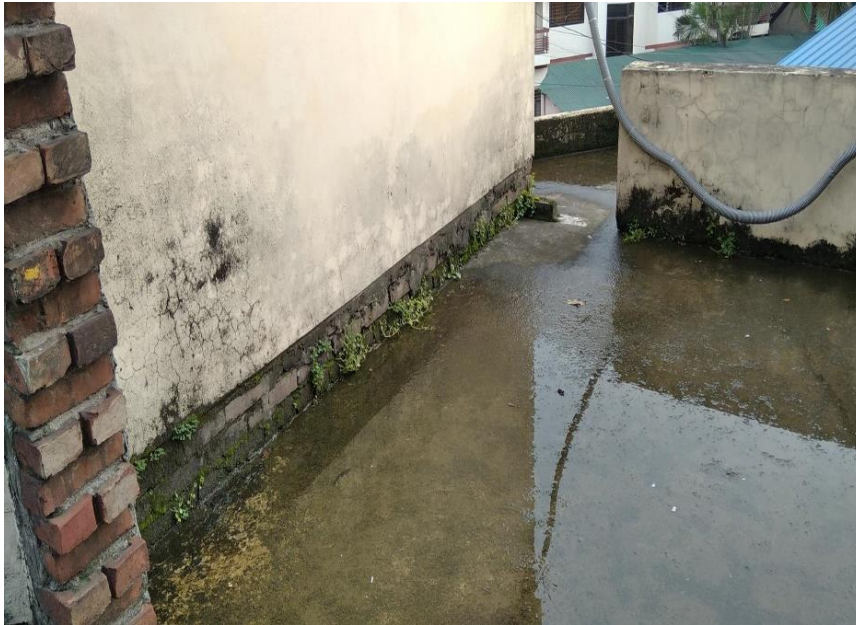
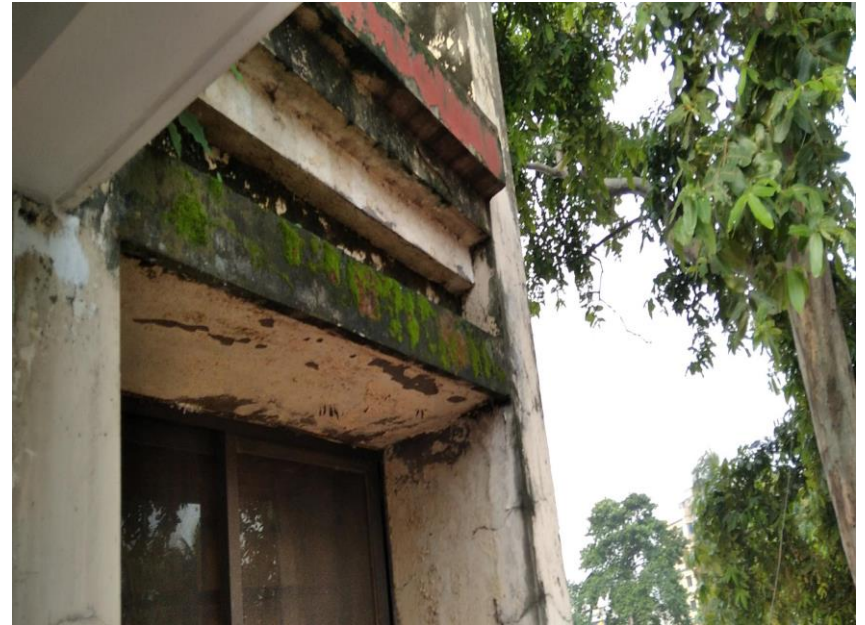
# **Water ponding and vegetation growth**

Factory is required to develop proper drainage system on roof with adequate slope and apply water proofing compound on roof slab to resist water ingress. Remove the vegetation and apply appropriate remedial measure.

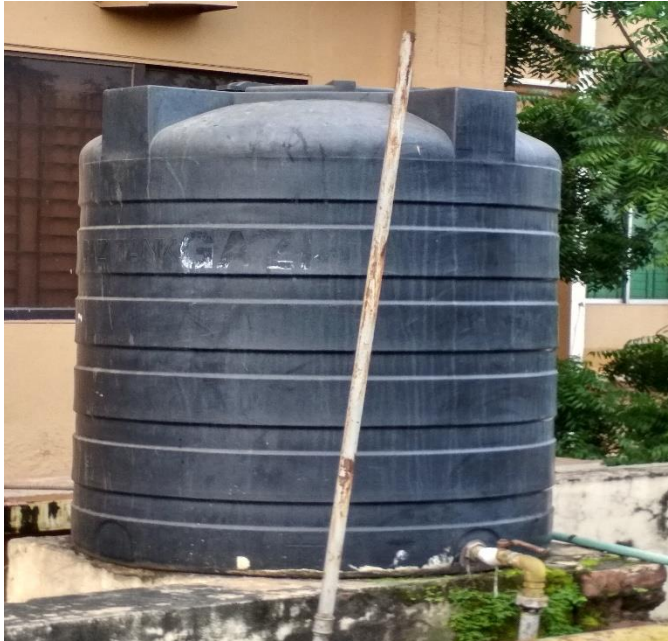
PVC water tank rest on parapet wall

Provide adequate support to the water tank to prevent accidental event cause by lateral load. Check the load bearing capacity of the wall beneath the water tank. Construct parapet wall at all edges of the roof.

| Item No. | Observation | Recommended Action Plan | Recommended Timeline |
|---|---|---|---|
| 57 | Water tank mounted on parapet wall & falling hazard at roof [Building 8]. | Provide adequate support to the water tank to prevent accidental event cause by lateral load. | Immediate - Now |
| 58 | Water tank mounted on parapet wall & falling hazard at roof [Building 8]. | Check the load bearing capacity of the wall beneath the water tank. | 6-weeks |

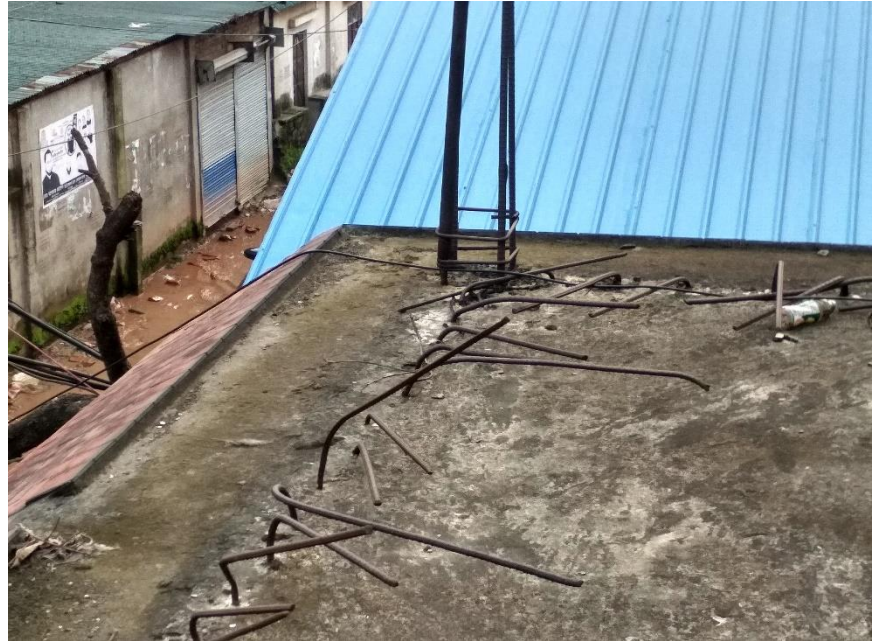
No parapet wall in some area of the roof

| Item No. | Observation | Recommended Action Plan | Recommended Timeline |
|---|---|---|---|
| 59 | Water tank mounted on parapet wall & falling hazard at roof [Building 8]. | Construct parapet wall at all edges of the roof. | 6-weeks |

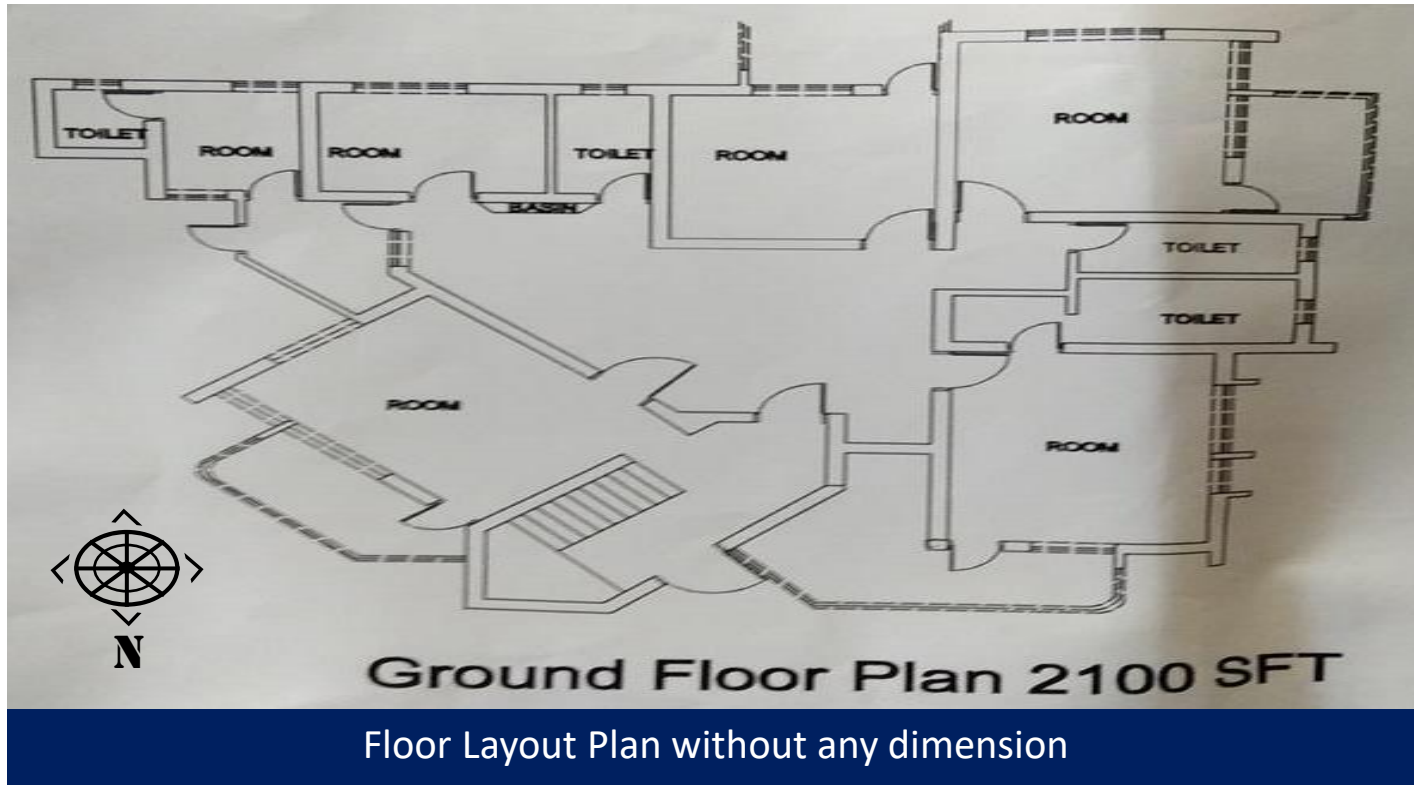
In the factory provide drawing, there is no dimensions of building and walls. Also, there was no appropriate structural details available for this structure.

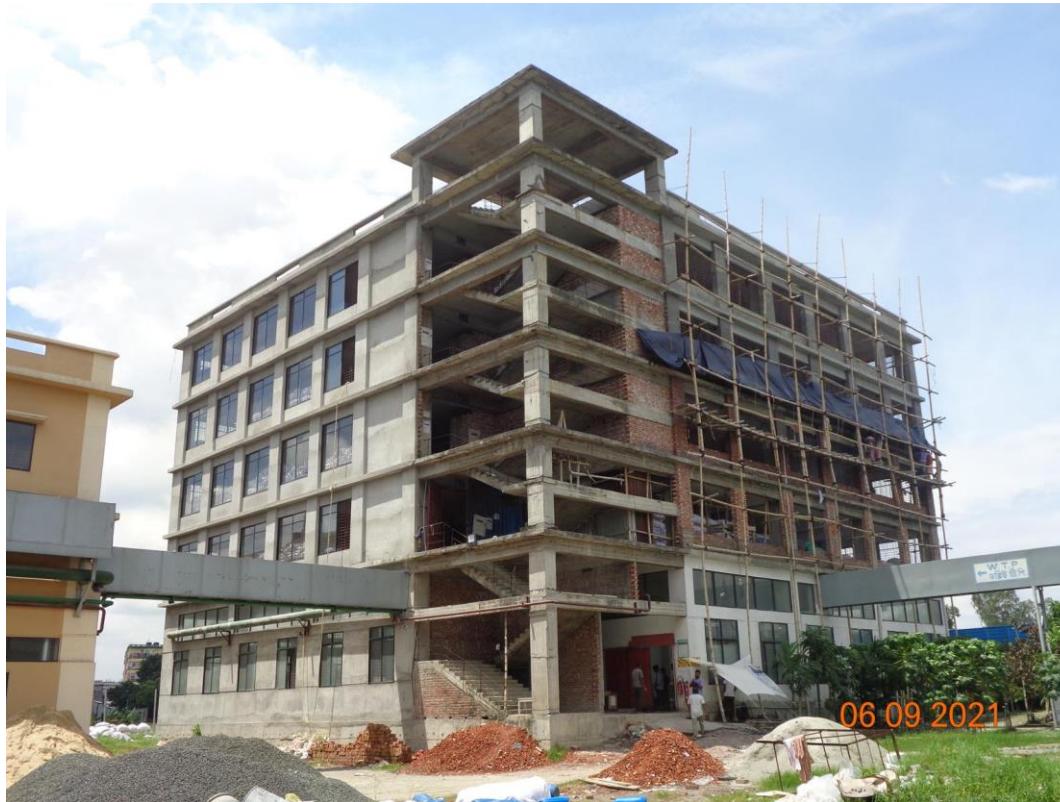
As per BNBC every building or structure designed shall have its design documents prepared in accordance with the provision of Section 1.9.1. The design document shall include a design report, and a set of structural drawings, which shall be prepared in compliance with section 1.9.1.1 and section 1.9.1.2 as per BNBC. Design report was not found which is required to be prepared in compliance with section 1.9.1.1 (part-6, BNBC).

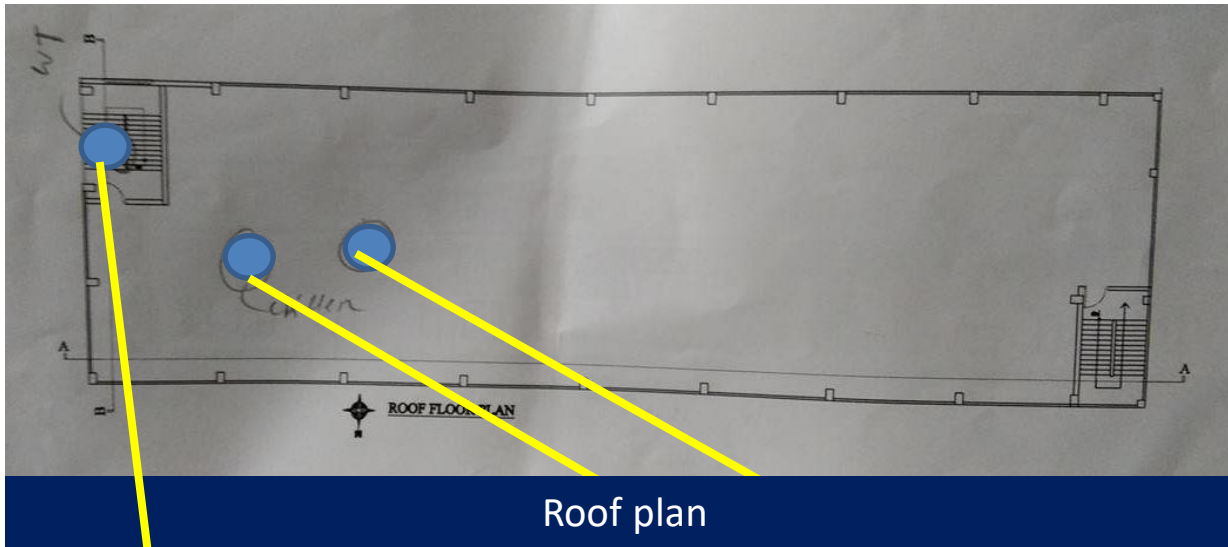
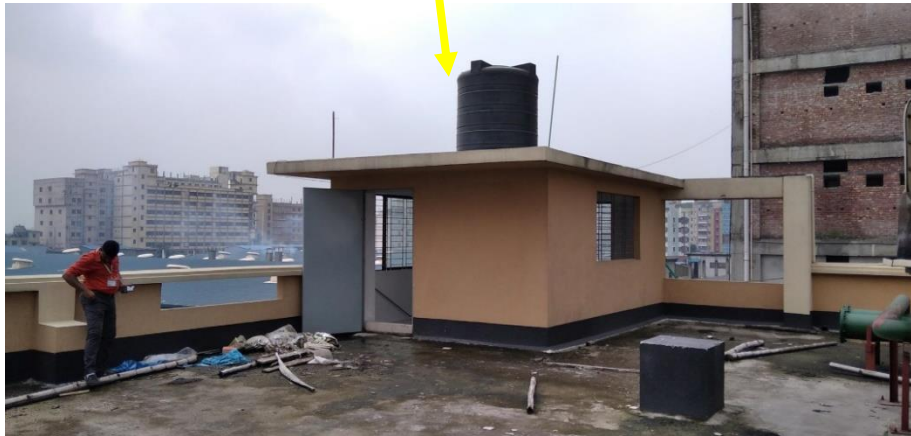
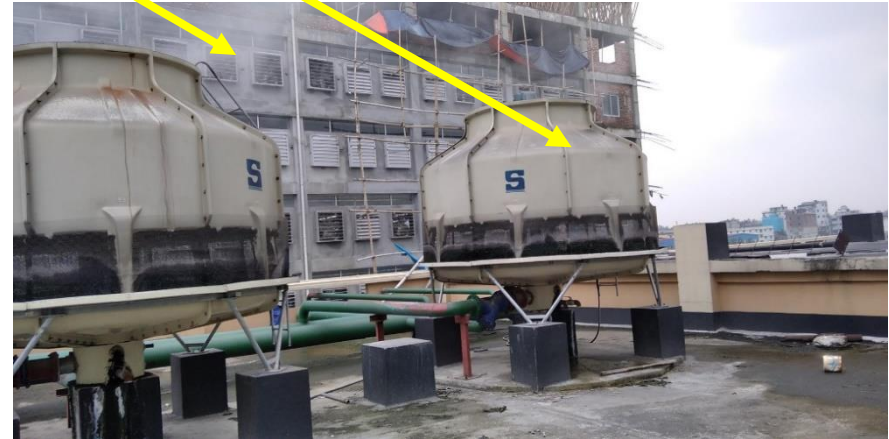
Chiller Machines and water tank not shown in the roof plan

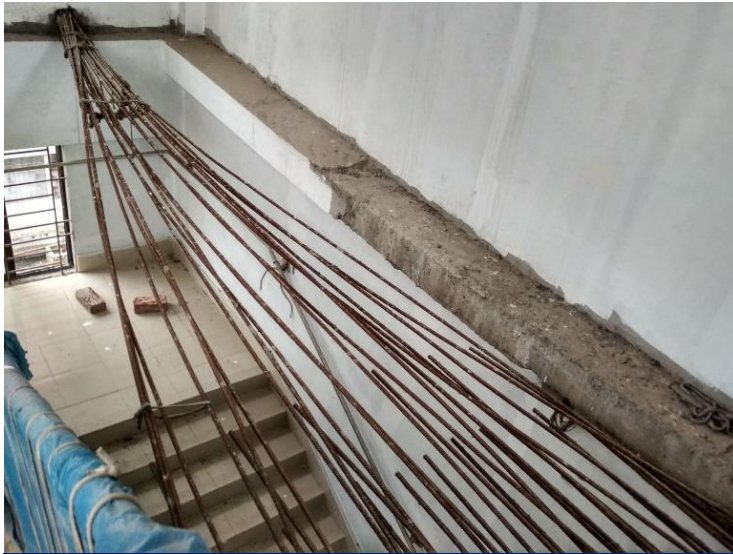
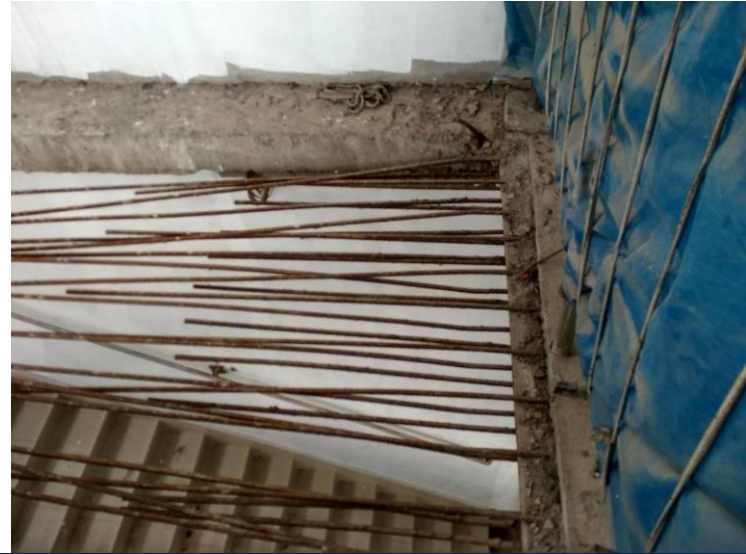
Exposed rebar at stair landing slab

Exposed reinforcement is left unchecked at staircase which is prone to corrosion and hazardous as well. Factory is required to provide rust proof paint on exposed reinforcement to protect from corrosion and rearrange the rebars; so that people climbing the stair are not prone to any danger.

| Item No. | Observation | Recommended Action Plan | Recommended Timeline |
|---|---|---|---|
| 72 | Exposed reinforcement left at staircase [Building 10]. | Factory is required to provide rust proof paint on exposed reinforcement to protect from corrosion and re-arrange the rebars; so that people climbing the stairs are not prone to danger. | 6-months |

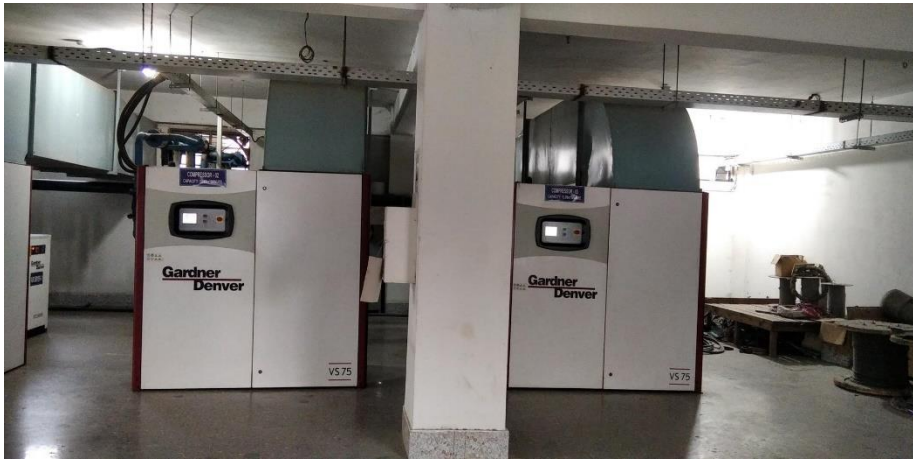
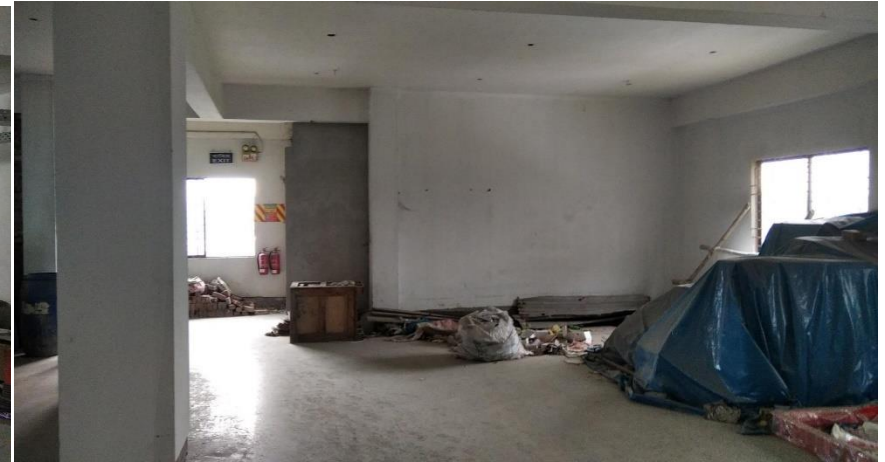
Load plan of the building was not produced. Also, load management program (load plan posting and signage) was not implemented. Produce and actively manage a loading plan for all floor plates within the factory considering the floor, column and foundation capacity.

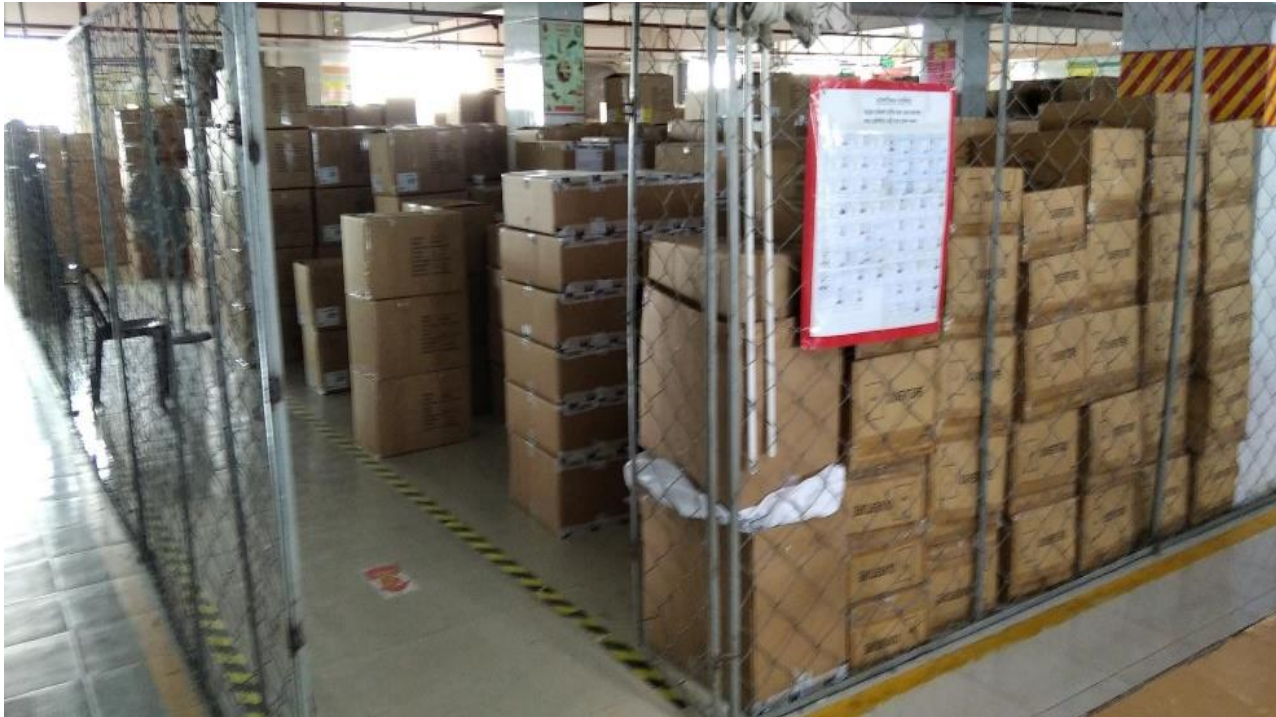
4 kPa floor loading on storage area

The produced load plan of this building does not comply with BNBC. Also, load management program (posting load plan, marking stack height and signage) was not implemented. Produce and actively manage a loading plan for all floor plates within the factory considering the floor, column and foundation capacity.

| Item No. | Observation | Recommended Action Plan | Recommended Timeline |
|---|---|---|---|
| 79 | Floor load management program [Building 11]. | The factory engineer is required to produce floor loading plan for each floor considering floor, column & foundation capacity. | 6-weeks |

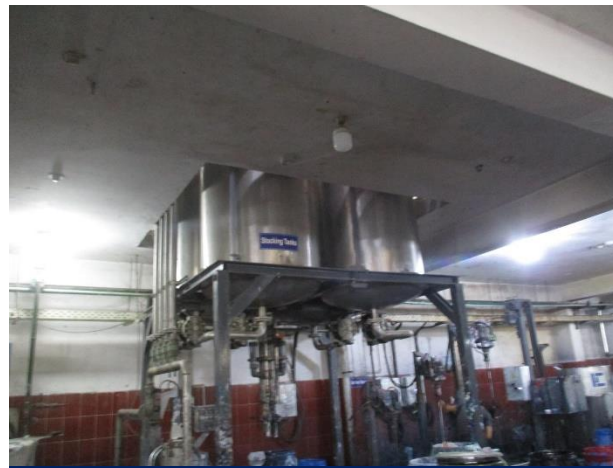
Floor void not shown in drawing

Number of column grid did not match with provided drawings. Roof bracing layout, void in floor, stair steel framing and ground floor accessories rooms were missing in the provided drawings. The factory engineer is required to survey the structure and prepare a set of as-built drawings accordingly.

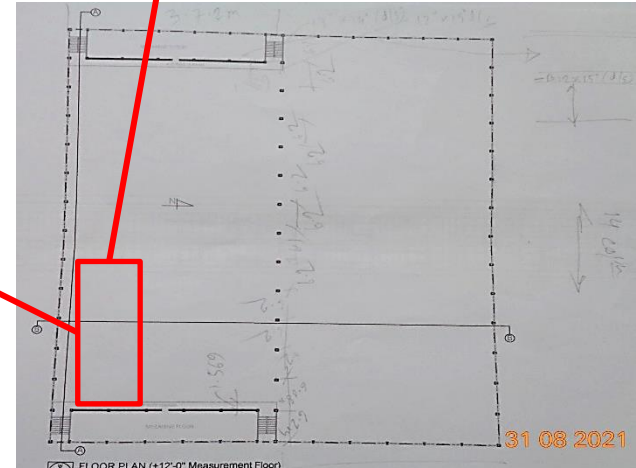
15 column grid in drawing

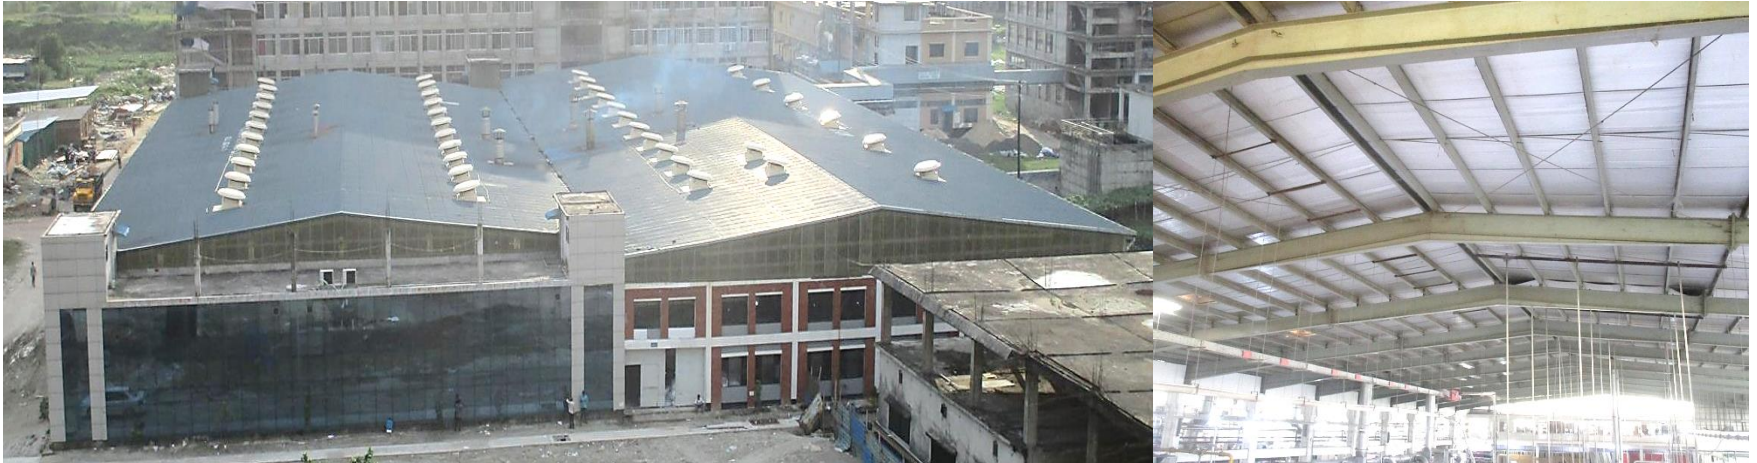
Shed-2

Only structural drawings were available for shed-2. No lateral load transfer media was observed along the ridge of the steel roof. Also, stability check was not available. As per BNBC, every building designed shall have its design documents prepared in accordance with the provision of Section 1.9.1. The design document shall include a design report, and a set of structural drawings, which shall be prepared in compliance with section 1.9.1.1 and section 1.9.1.2 as per BNBC. However, the factory is required to prepare full set of Engineering Assessment (EA) report with adequacy check of all structural members (for both stress and stability) and submit to RSC for review.

| Item No. | Observation | Recommended Action Plan | Recommended Timeline |
|---|---|---|---|
| 85 | Absence of Design Documents. [Shed 2]. | Implement recommendation of design report. | 6-months |

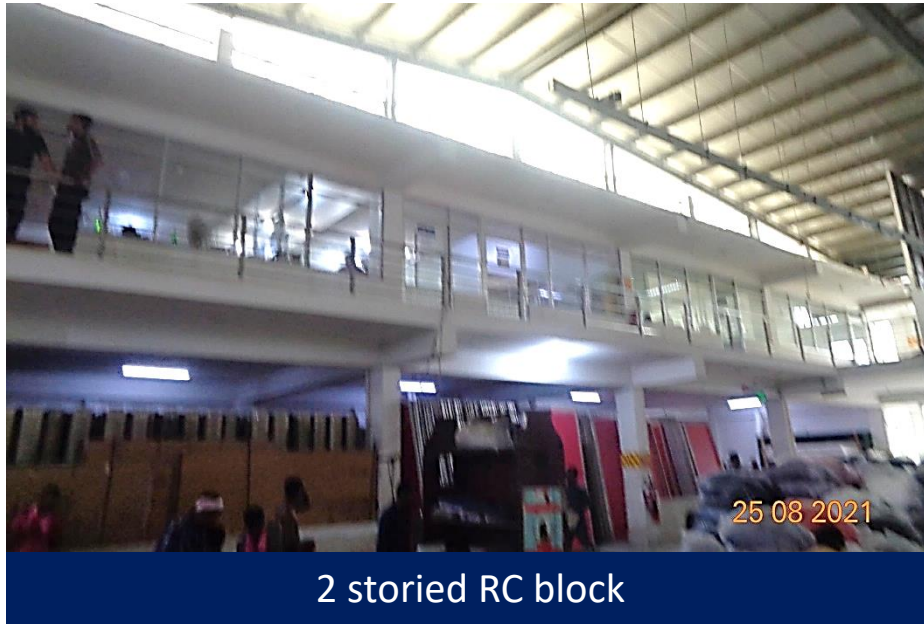
2 storied RC block

Floor load plan was not available for the 2 storied RC blocks. There was two large voids in floor slab have not shown in the drawings. The factory engineer is required to check the floor capacity and prepare a set of floor load plan for the RC blocks based on foundation and floor capacity of the structure.

| Item No. | Observation | Recommended Action Plan | Recommended Timeline |
|---|---|---|---|
| 86 | Floor Load Plan of RC Blocks. [Shed 2]. | Produce and actively manage a floor loading plan within the factory building considering floor, column and foundation | 6-weeks |

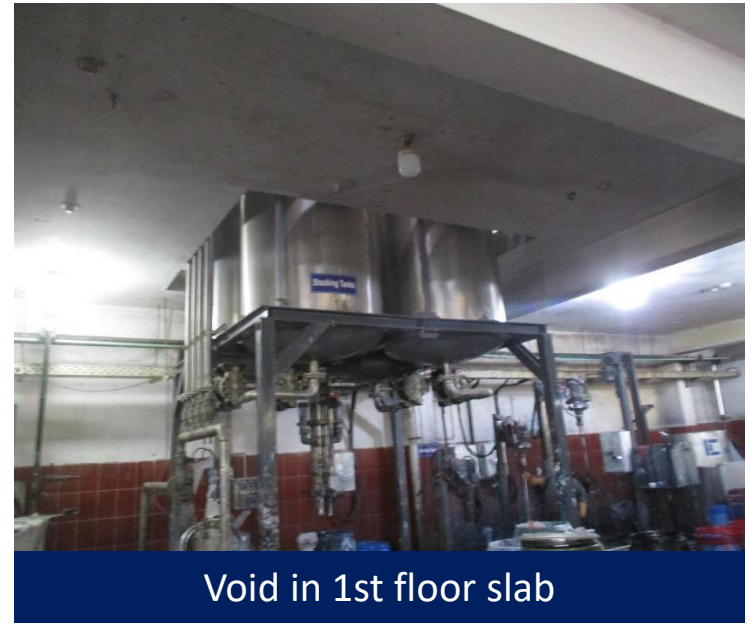
Void in 1st floor slab

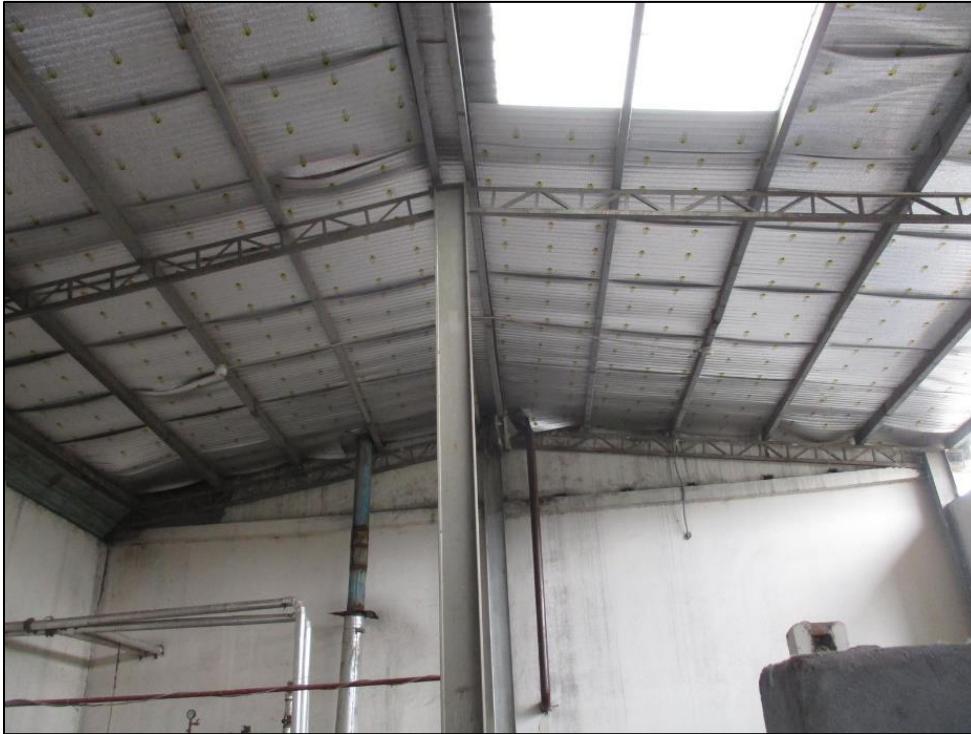
No bracing system at roof

No bracing and lateral load transfer media is provided in the roof of this structure. Also, poor connection details of truss observed. The factory engineer is required to check lateral stability of the structure and suggest necessary measure accordingly.

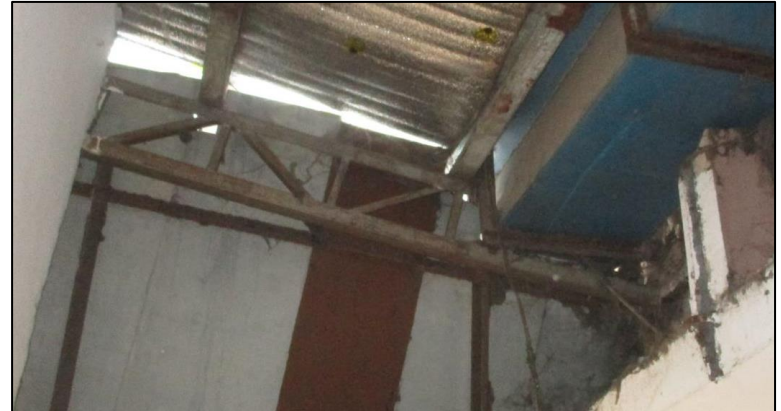
Poor connections

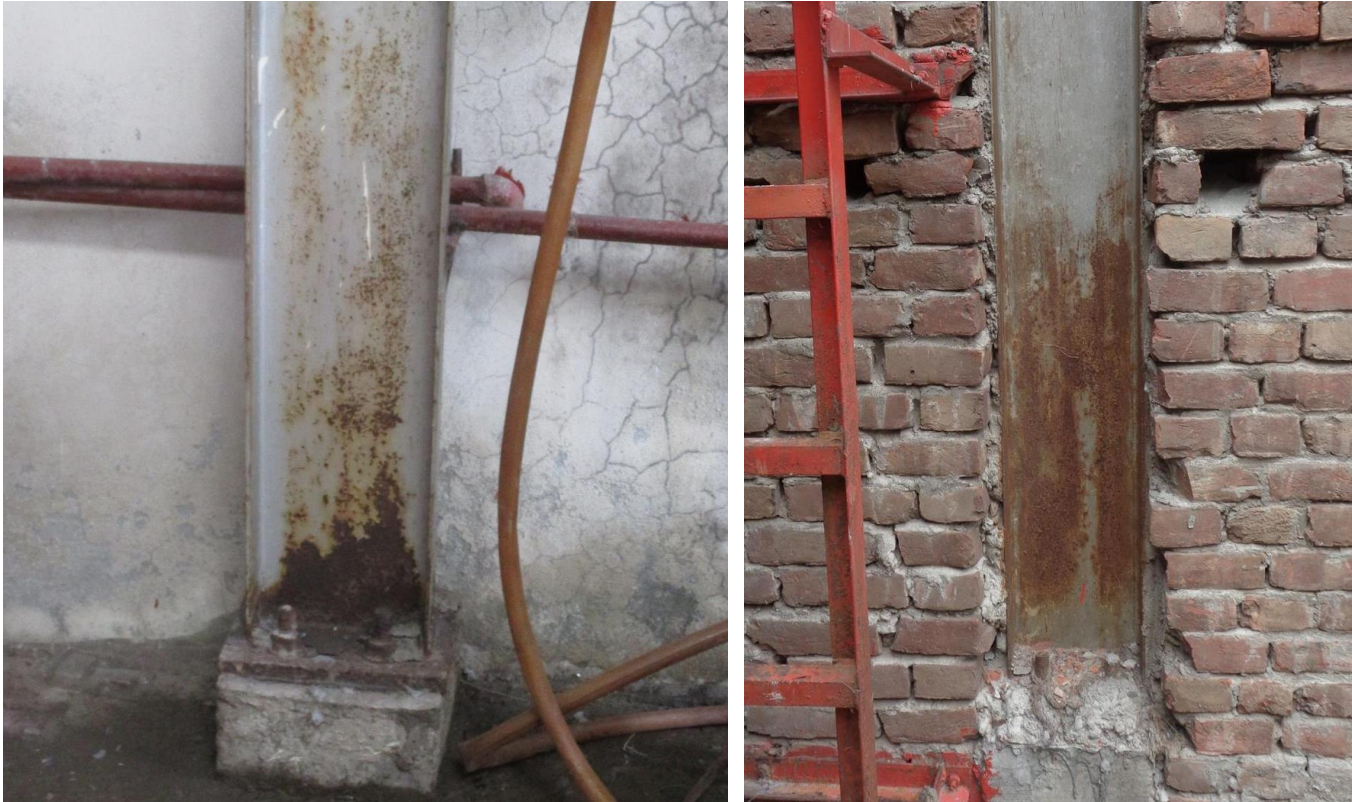
Corrosion on steel member.

Remove rust and apply anti rust proofing paint on steel member.

| Item No. | Observation | Recommended Action Plan | Recommended Timeline |
|---|---|---|---|
| 90 | Corrosion on steel member [Shed 3]. | Remove rust and apply anti rust proofing paint on steel | 6-weeks |

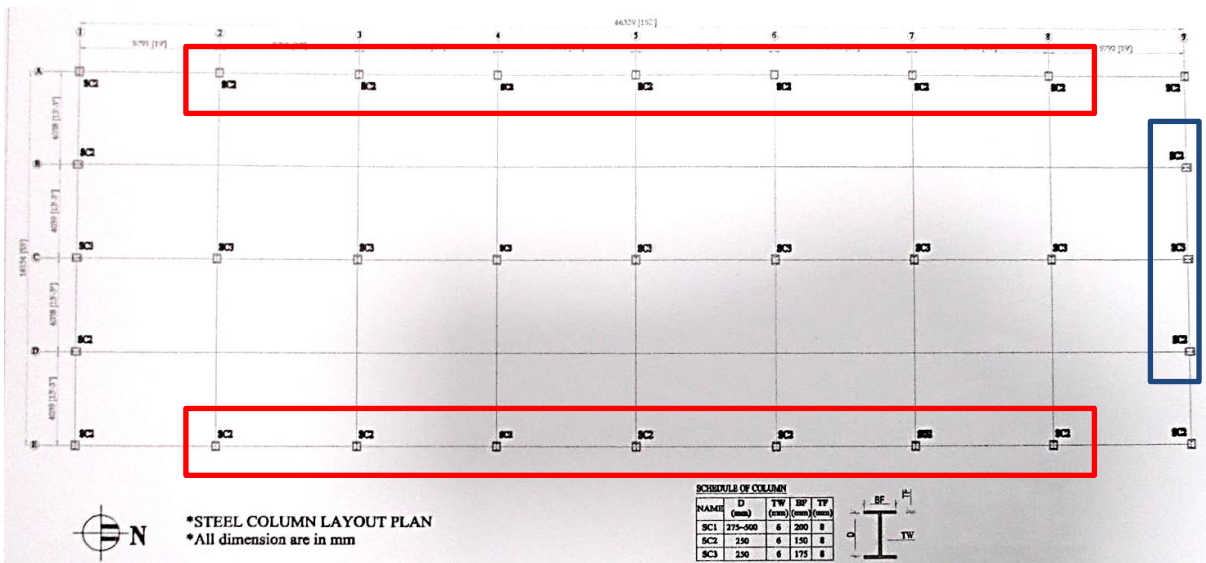
Column layout plan of Shed-4 (Part-B)

The column in red marked area is SC1 but in drawing it shown as SC2. The column web in blue marked area is placed along the frame but in drawing it shown as perpendicular to the frame. Wall bracing was observed onsite but only the roof bracing layout was shown in drawings. The factory is required to prepare the as-built drawings.

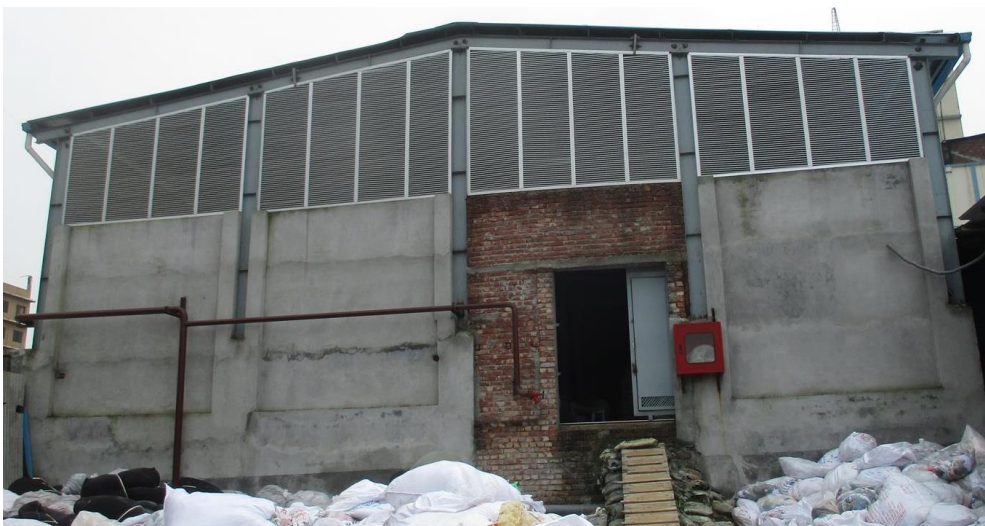
Gable column web along the frame

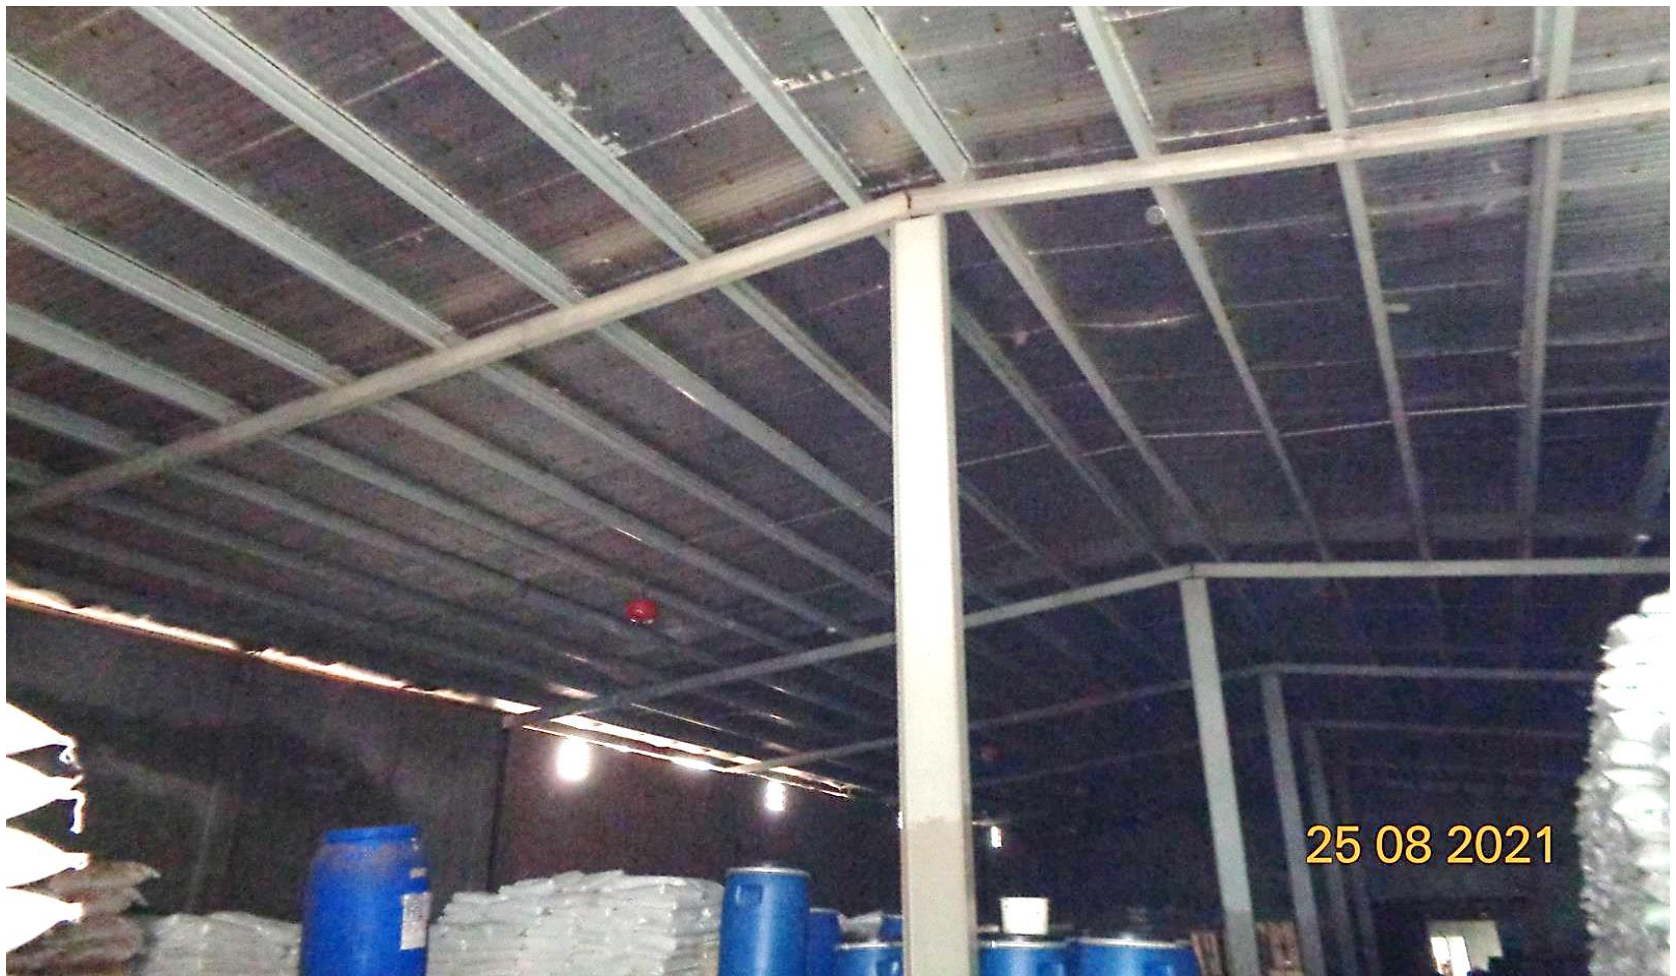
No roof bracing and lateral load transfer media in Part-A of Shed-4.

The factory engineer is required to check the stability system and determine the size & position of bracing & compression strut accordingly.

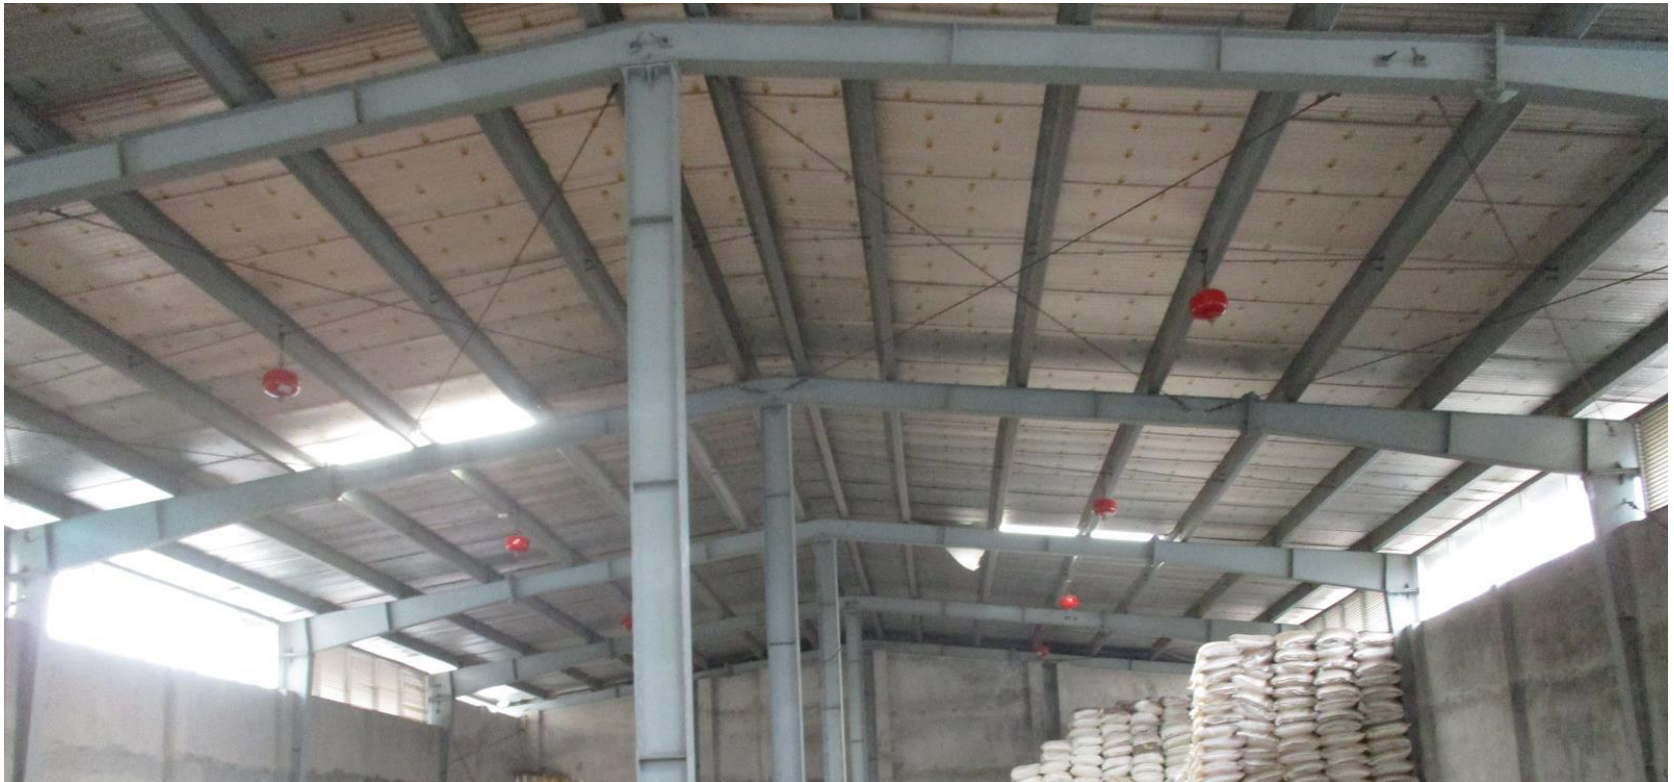
Lateral load transfer media is missing in Part-B of Shed-4. Also, compression member absence in cable bracing system.
