Jamuna Apparels Ltd. (Extension Buildings)

94/95 (Old), 46 (New), Block - C, Tongi Industrial Area, Tongi
(23.900612, 90.400296)
27th Sept 2021

Observations

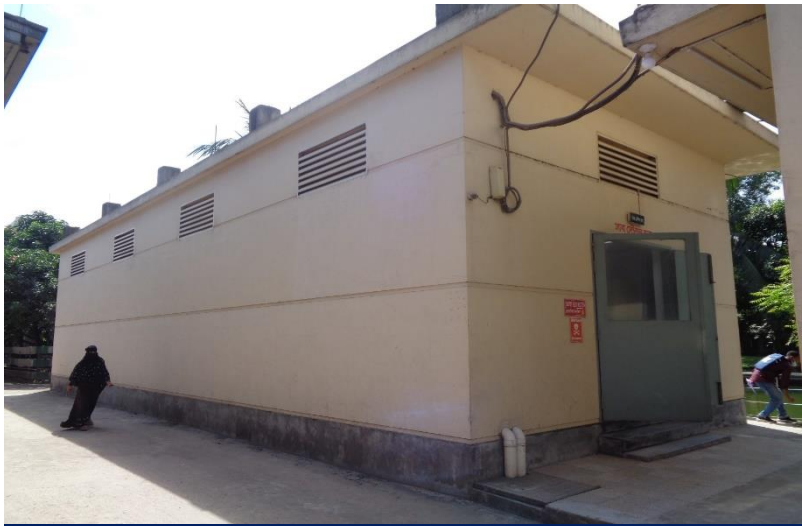
Building-2

Foundation adequacy to be carried out

No geotechnical investigation report was provided for those aforementioned structures. Factory engineer is required to carry out foundation adequacy check for all of these structures by confirming foundation size, thickness and geotechnical investigation report.

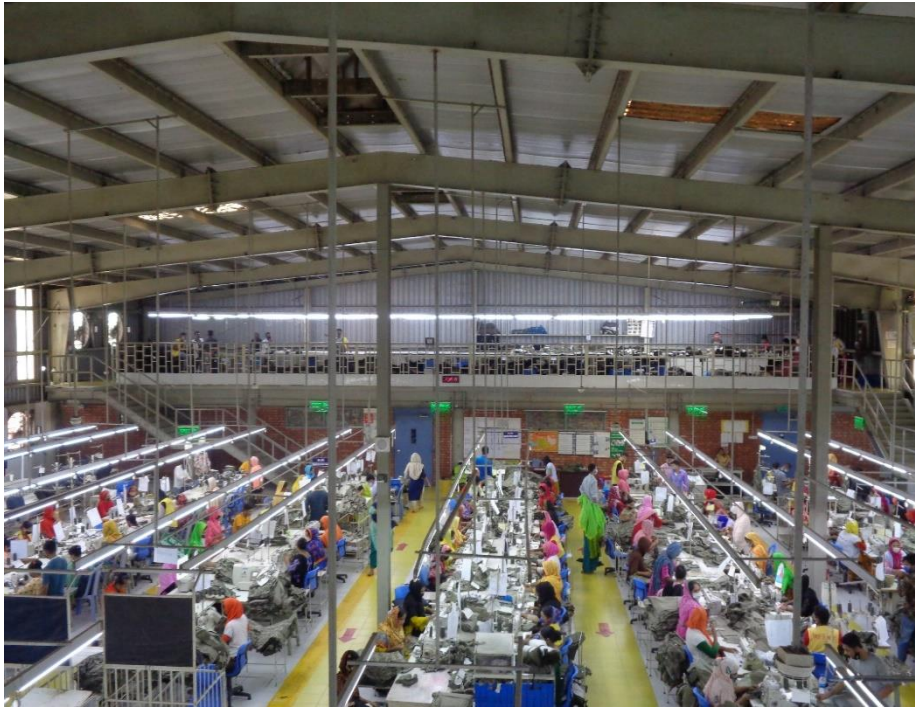
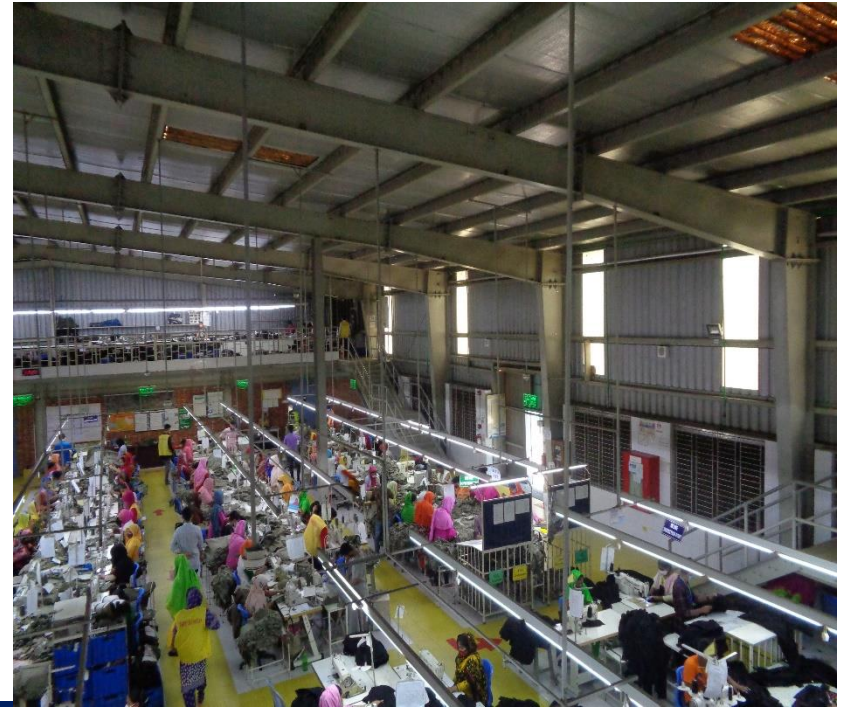
No compression member/load transfer media provided along long direction

Roof and vertical bracings are provided in some bays but there is no compression member/load transfer media provided along the long direction therefore load path along the long direction is incomplete. Factory engineer is required to check the lateral stability of this shed.

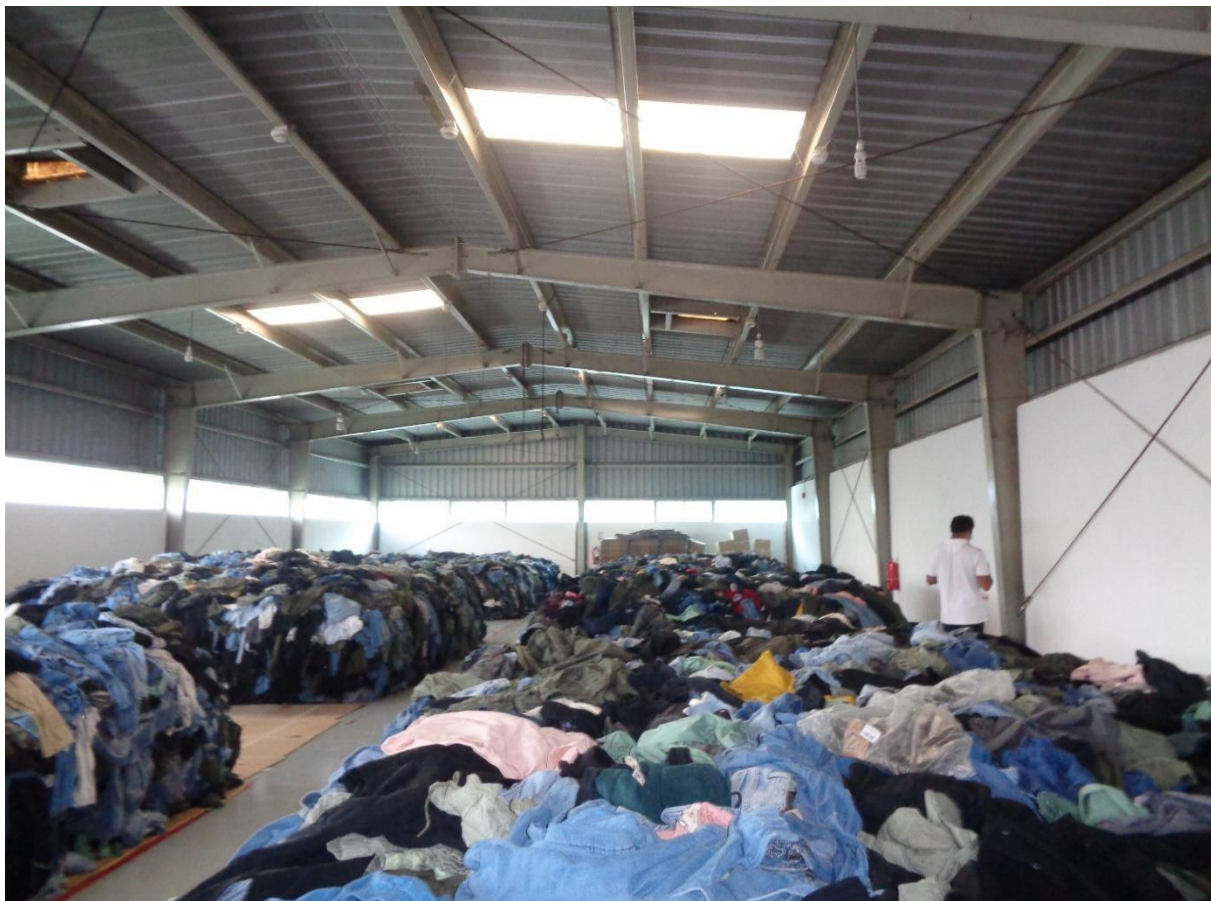
No compression member/load transfer media provided along long direction

Roof and vertical bracings are provided in some bays but there is no compression member/load transfer media provided along the long direction therefore load path along the long direction is incomplete. Factory engineer is required to check the lateral stability of this shed.

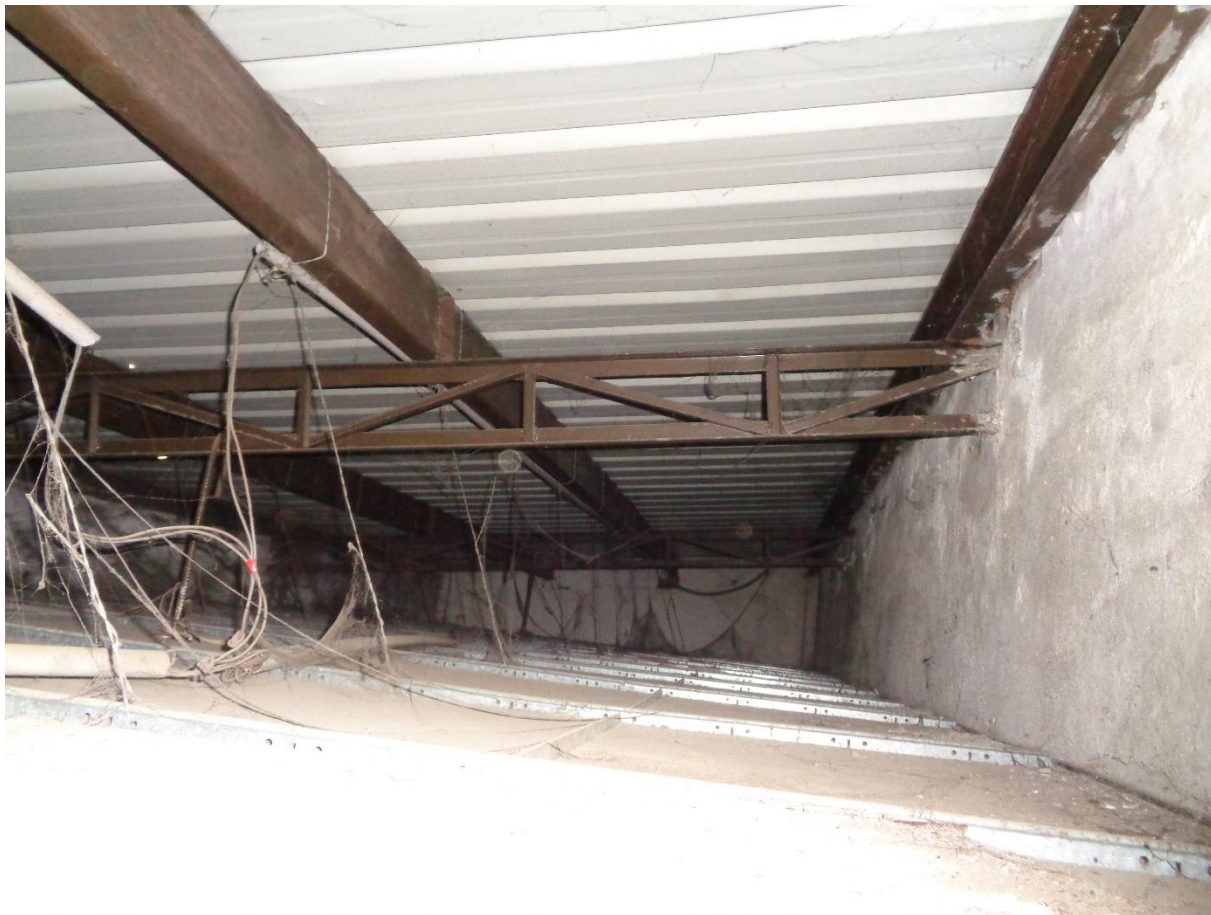
No framing/bracing system/load transfer media provided along long direction

Lateral stability is provided by truss frame action only along the short direction but there is no framing/bracing system/load transfer media provided along the long direction to transfer the lateral load therefore there is no obvious lateral stability system along long direction. In addition, details of truss connection to brick wall is not provided in the drawing. Factory engineer is required to check the lateral stability of this shed. Also, check the connection adequacy for all steel connections.

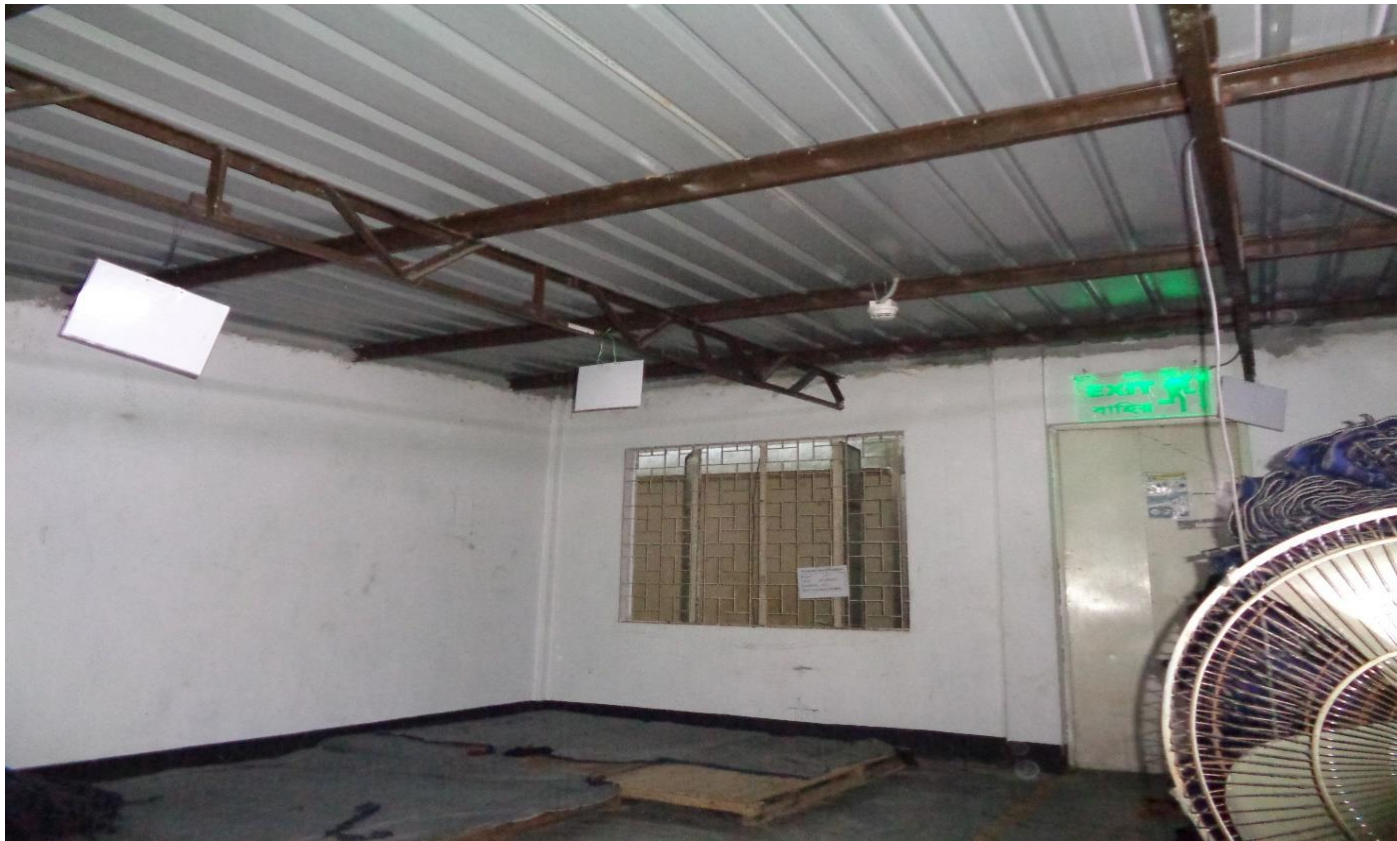
No framing/bracing system/load transfer media provided along long direction

Lateral stability is provided by truss frame action only along the short direction but there is no framing/bracing system/load transfer media provided along the long direction to transfer the lateral load therefore there is no obvious lateral stability system along long direction. In addition, details of truss connection to brick wall is not provided in the drawing. Factory engineer is required to check the lateral stability of this shed. Also, check the connection adequacy for all steel connections.

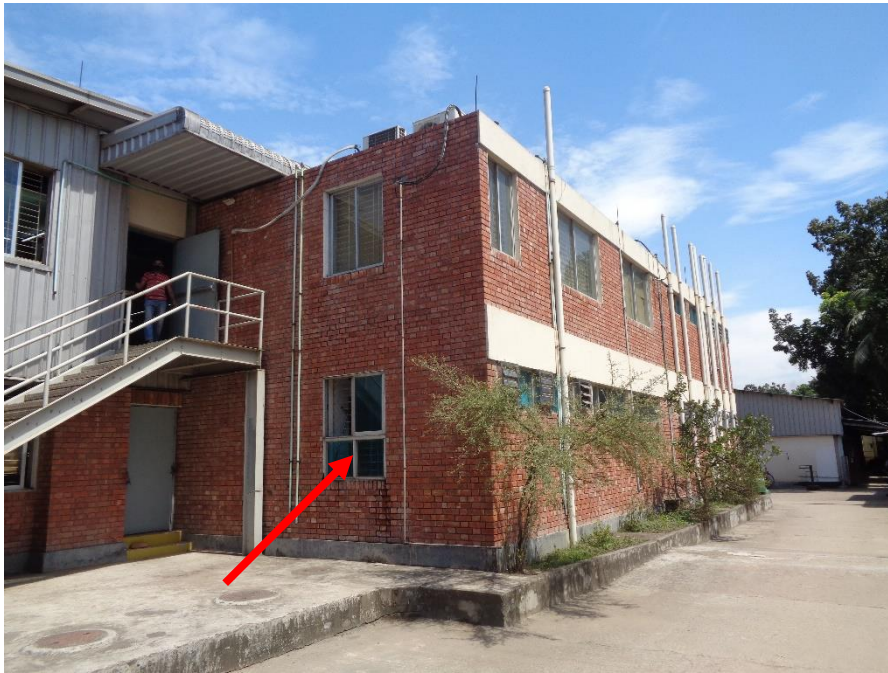
Undocumented extension

An undocumented extension found at south side of Shed-1 which is a multistoried masonry structure, and slab is structurally connected with the deck slab of shed-1 (Mezzanine floor). Factory is required to review the design considering the extension.

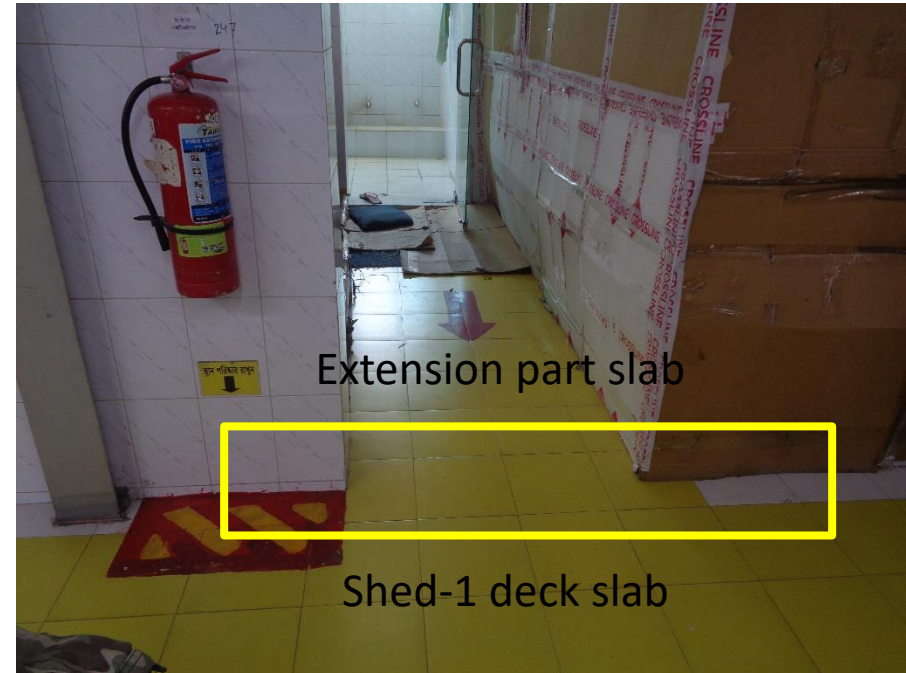
Connected slab

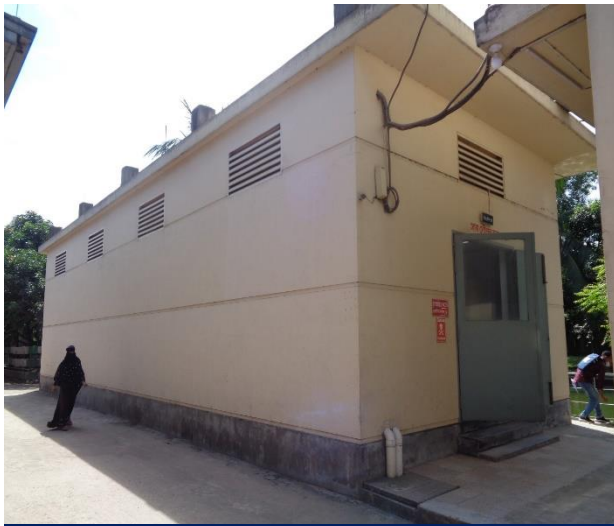
Building-2

No as-built drawing was provided for those aforementioned structures. Factory engineer is required to prepare full set of as-built drawing for all of these structures.

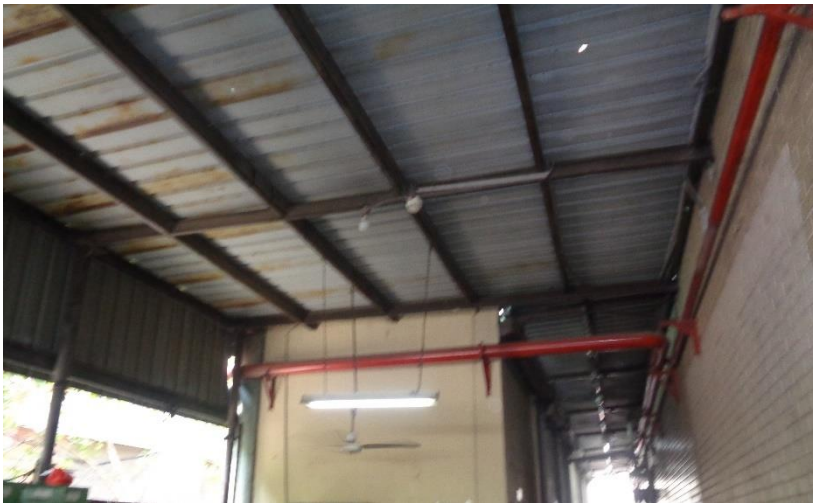
Inadequate structural members (Shed-5)

Lack of lateral stability system, poor connection details and apparently inadequate members observed.

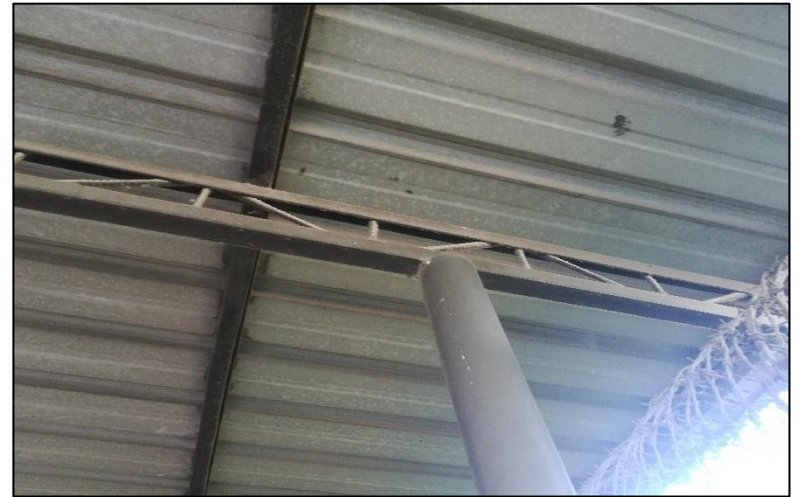
Poor connection details (Shed-6)

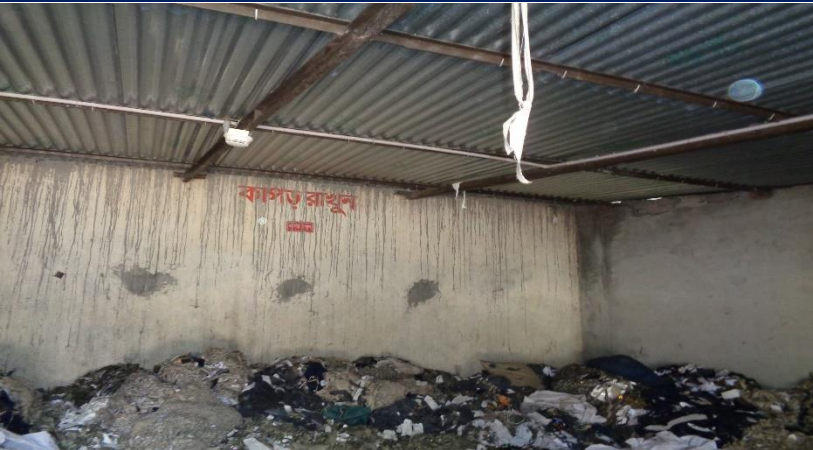
Inadequate structural members (Shed-7)

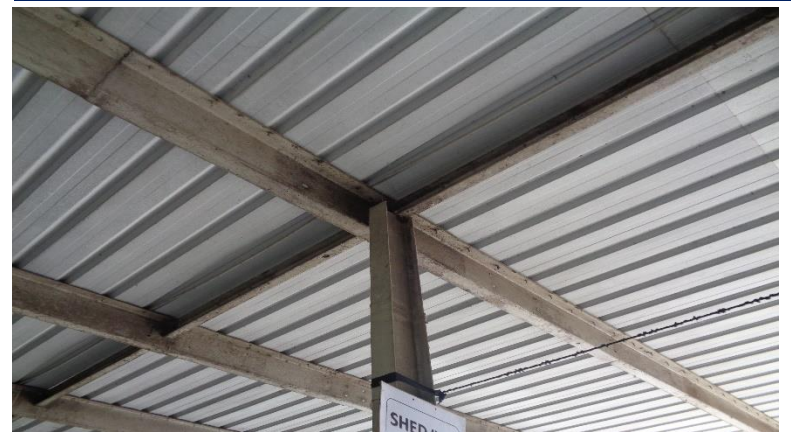
Poor connection details (Shed-10)

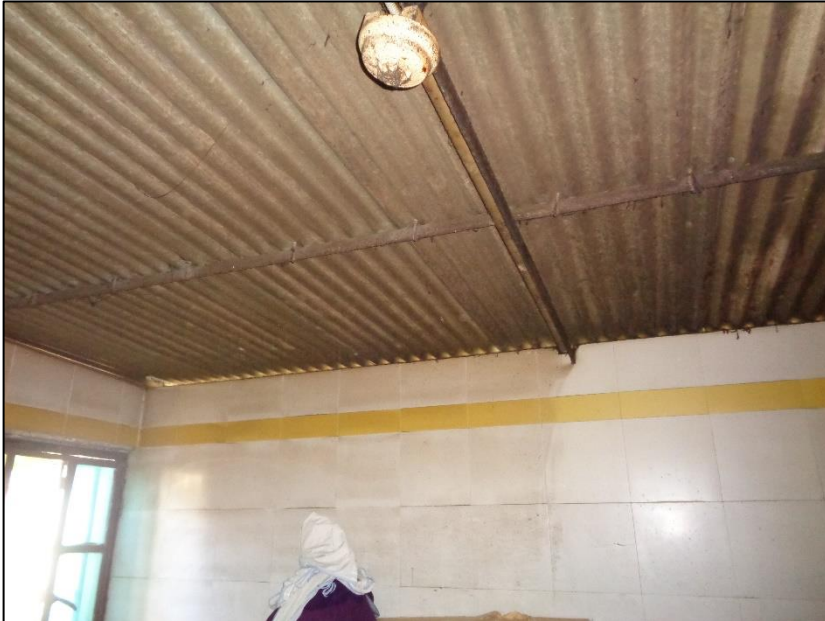
Inadequate structural members (Shed-11)

Lack of lateral stability system, poor connection details and apparently inadequate members observed.

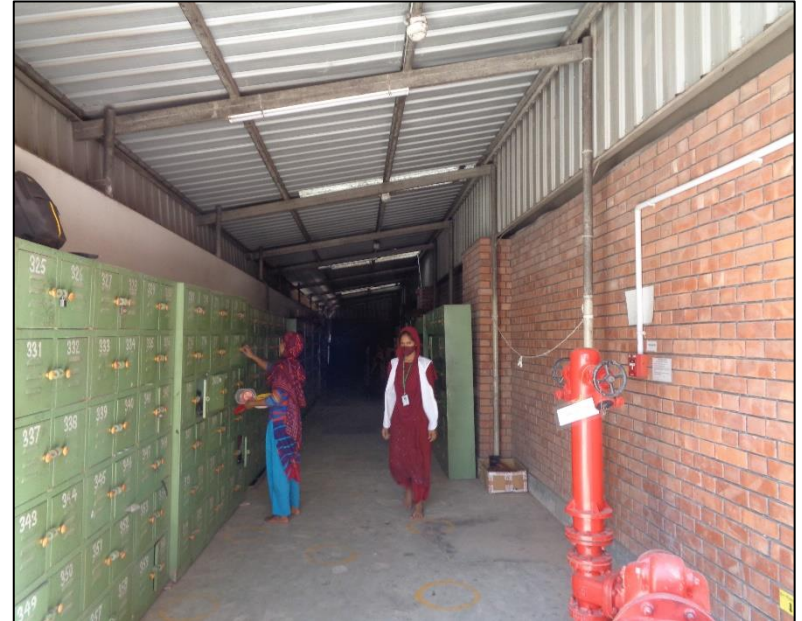
Inadequate structural members (Shed-12)
