# KAC Fashion Wear Ltd (Extension)

12/13 Tetui Bari, Sarabo, Gazipur

14<sup>th</sup> September and 11<sup>th</sup> October 2021

# Observations

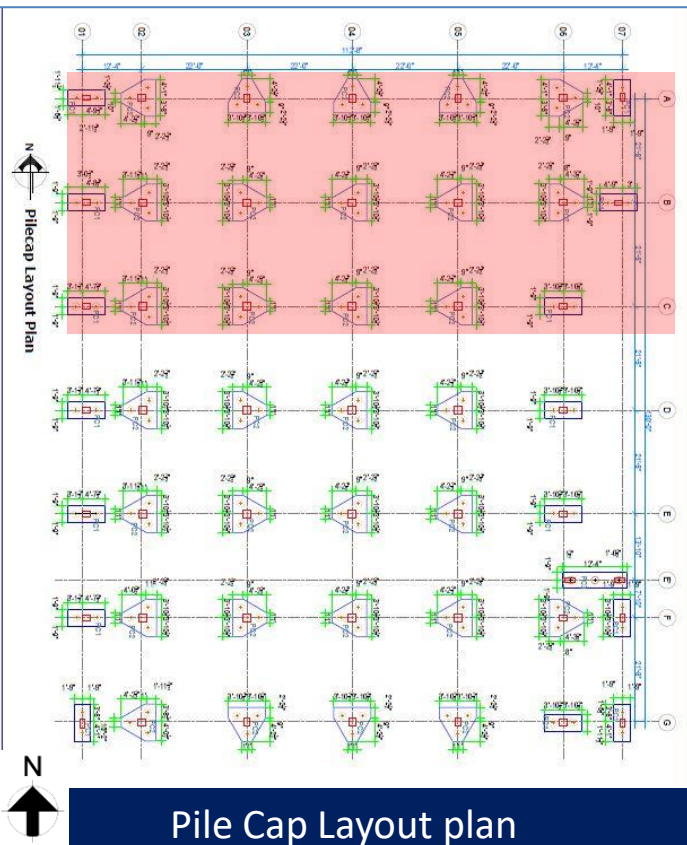
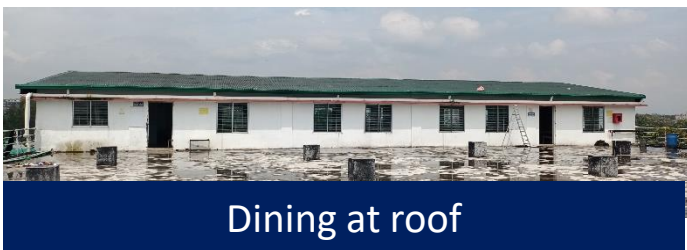
**Foundation stressed above normal design limit**

Cursory calculation indicates that bearing capacity of pile exceeds the normal design limit under dining area, considering 3 kPa live load on typical floors. Factory Engineer to review design, loads and foundation stresses.

| Item No. | Observation | Recommended Action Plan | Recommended Timeline |
|---|---|---|---|
| 01 | Foundation stressed above normal design limits. [Fashion-2] | Factory Engineer to review design, loads, and footings stresses. | 6-weeks |
| 02 | Foundation stressed above normal design limits. [Fashion-2] | Produce and actively manage a loading plan for all floor plates within the factory, considering floor, column and foundation capacity. | 6-weeks |

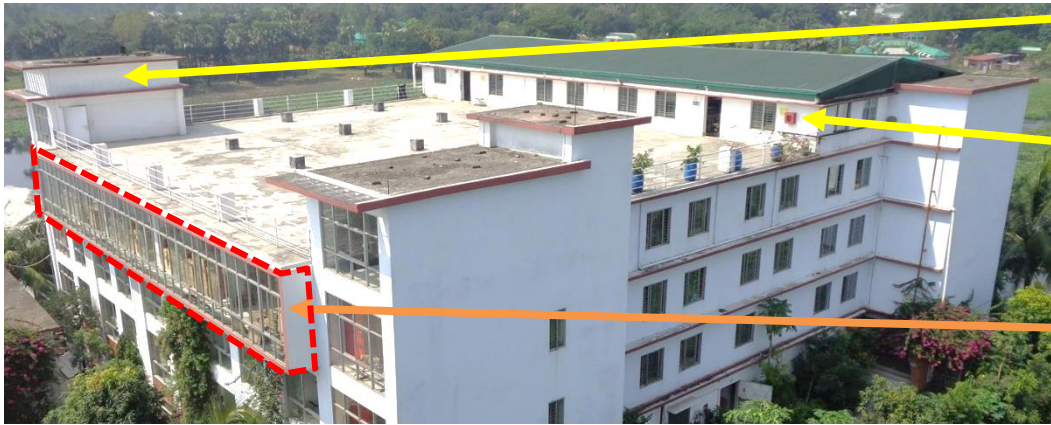
# **Discrepancies in as-built drawing**

OHWT (not shown in drawing)

Dining shed (not shown in drawing)

Southside cantilever portion at 3<sup>rd</sup> floor (not shown in drawing)

| Item No. | Observation | Recommended Action Plan | Recommended Timeline |
|---|---|---|---|
| 05 | Discrepancies in as-built drawing. [Fashion 2] | Factory Engineer is required to survey the structure and prepare accurate as-built (architectural and structural) drawings in compliance with section 1.9.1.2 as per BNBC. | 6-weeks |

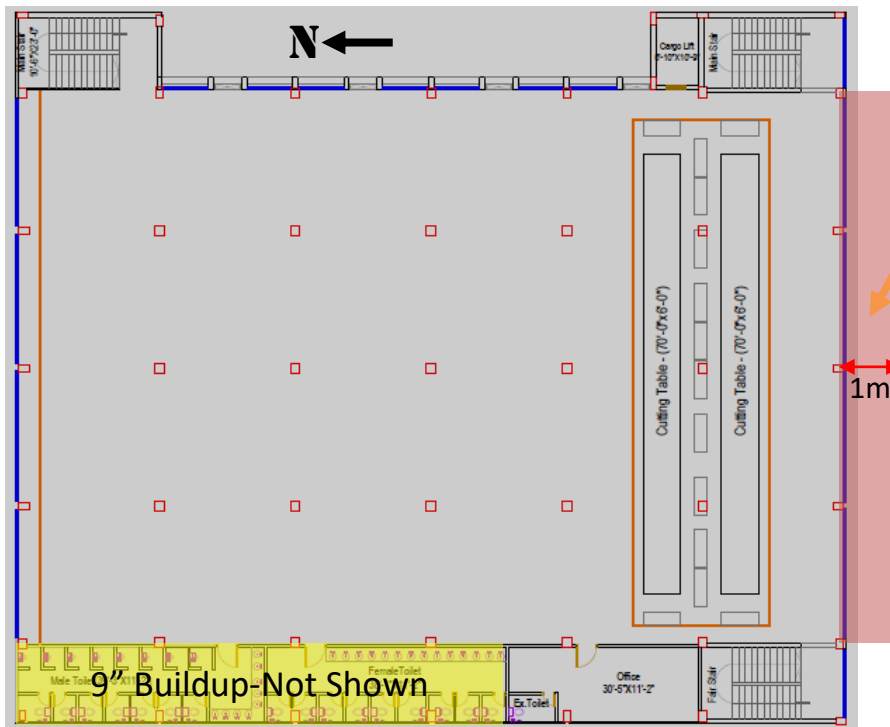
3<sup>rd</sup> floor layout plan

Buildup

125 mm brick wall

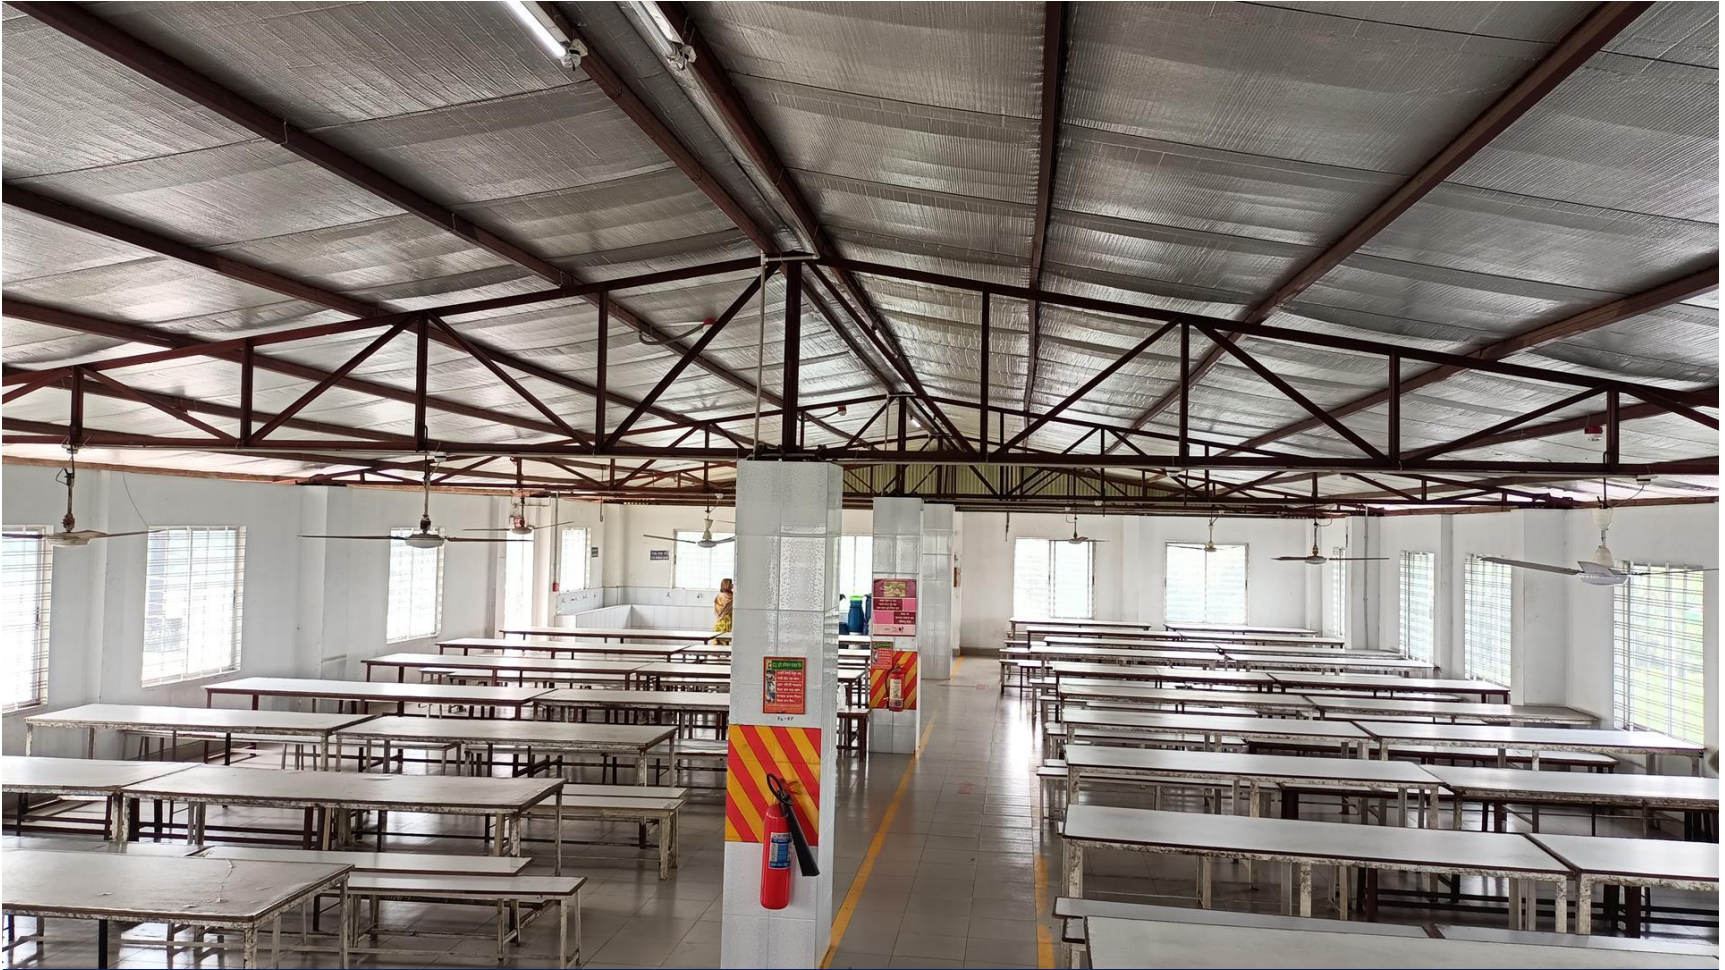
## **Lack of lateral stability system**

No roof bracing and lateral load transfer media

Factory engineer is required to check the stability system and suggest proper actions accordingly.

| Item No. | Observation | Recommended Action Plan | Recommended Timeline |
|---|---|---|---|
| 06 | Lack of lateral stability system. [Fashion 2] | Factory engineer is required to carry out lateral stability check of the shed against lateral forces. | 6-weeks |

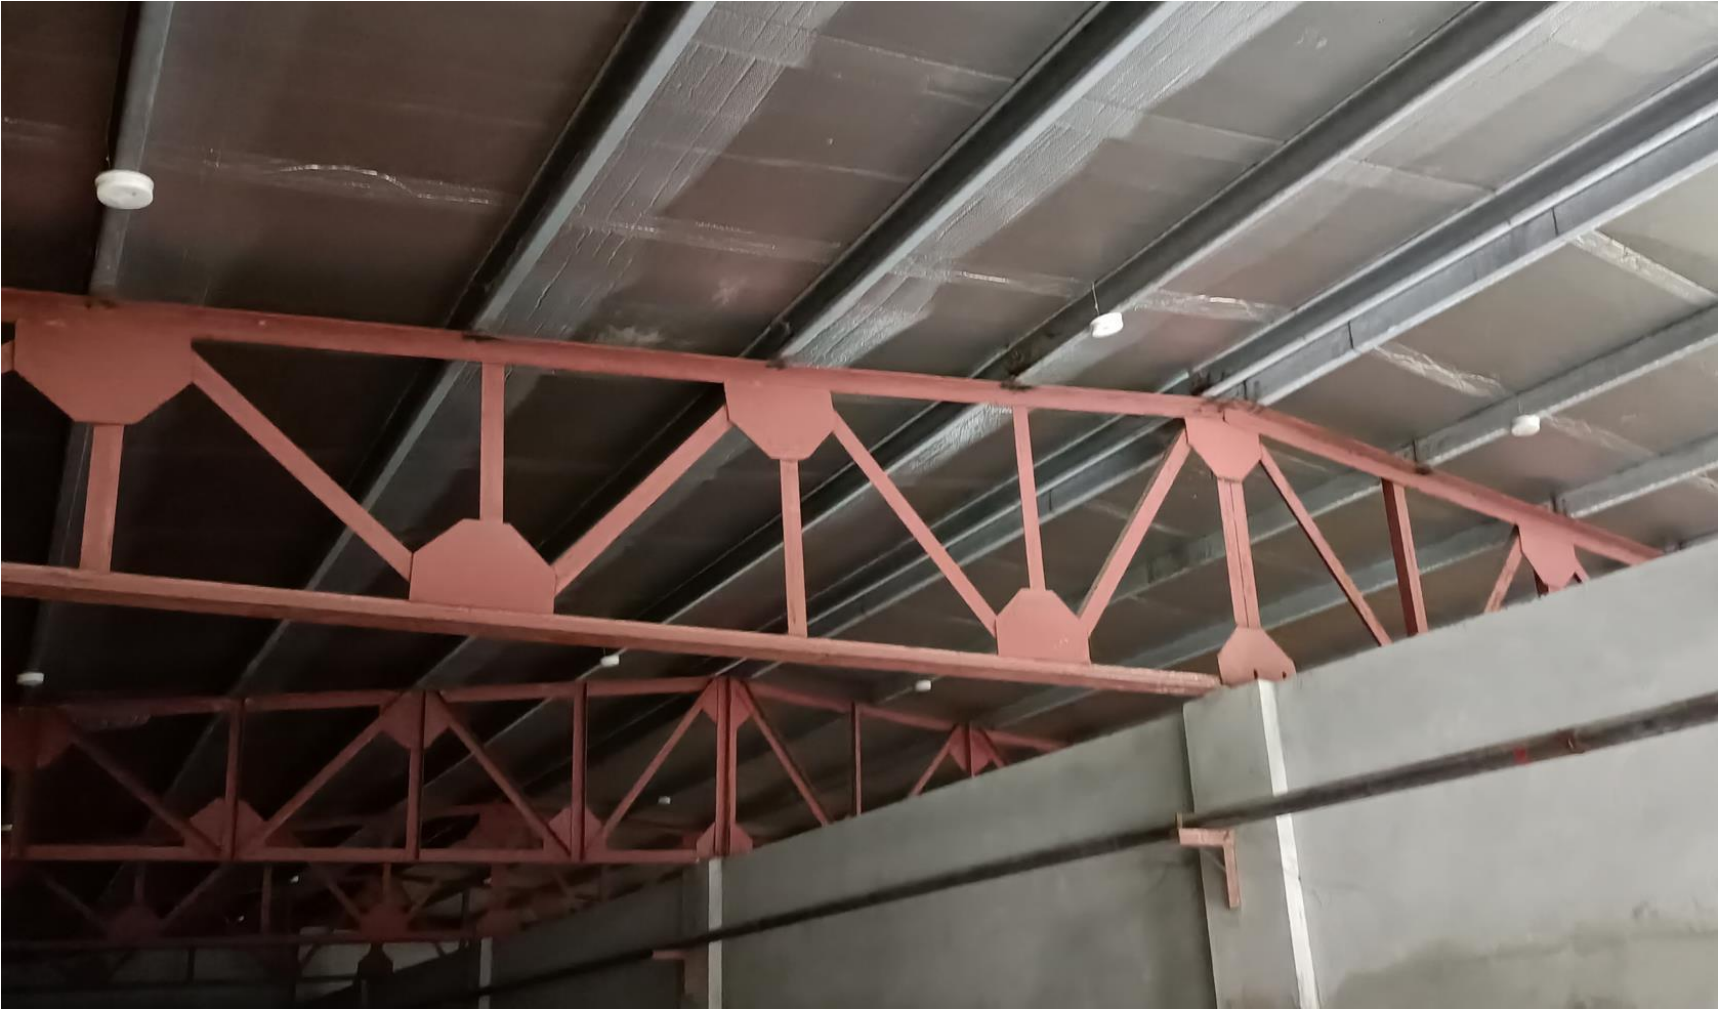
**Lack of lateral stability system**

No roof bracing and lateral load transfer media

Factory engineer is required to check the stability system and suggest proper actions accordingly.

| Item No. | Observation | Recommended Action Plan | Recommended Timeline |
|---|---|---|---|
| 09 | Lack of lateral stability system. [Godown] | Factory engineer is required to carry out lateral stability check of the shed against lateral forces. | 6-weeks |

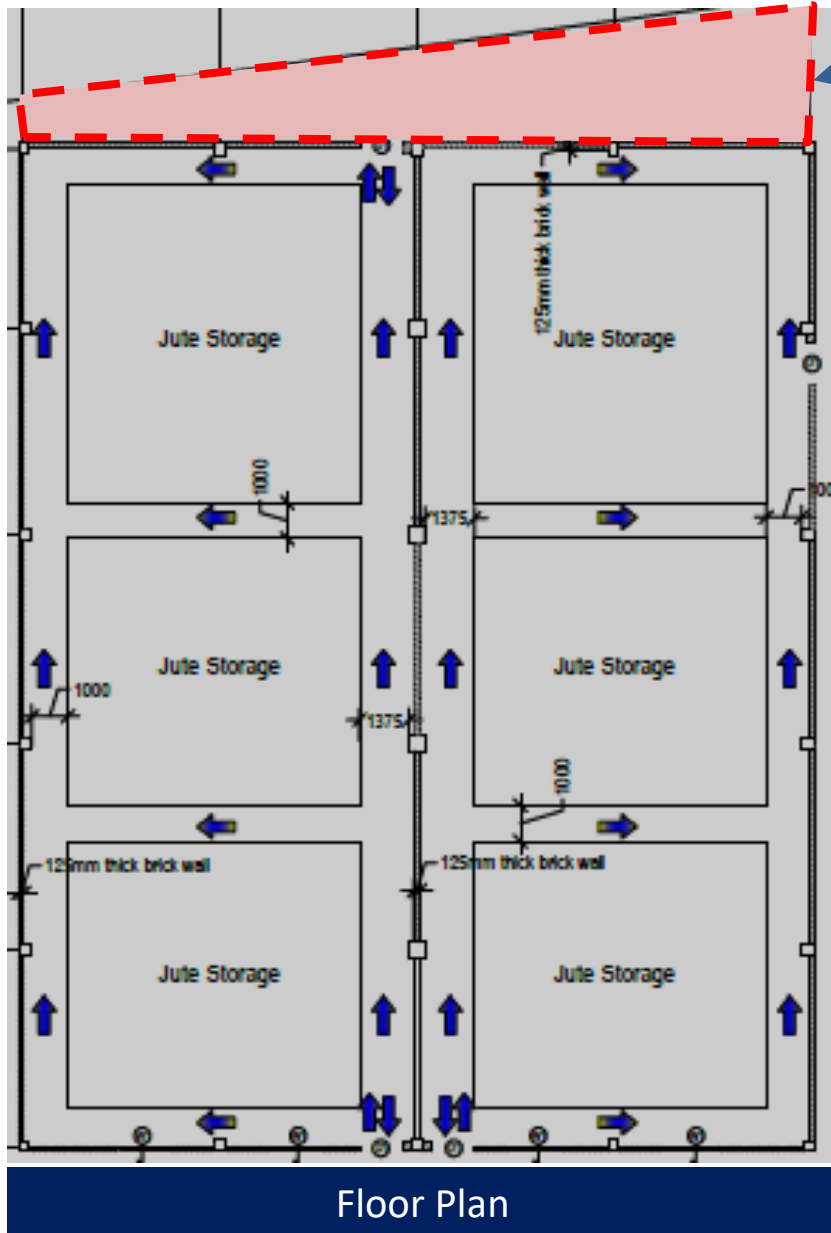
Undocumented extension

Factory Engineer is required to survey the structure and prepare accurate as-built (architectural and structural) drawings.

| Item No. | Observation | Recommended Action Plan | Recommended Timeline |
|---|---|---|---|
| 11 | Inconsistency in as-built drawing. [Godown] | Factory engineer is required to survey the structure and prepare accurate as-built drawings. | 6-weeks |

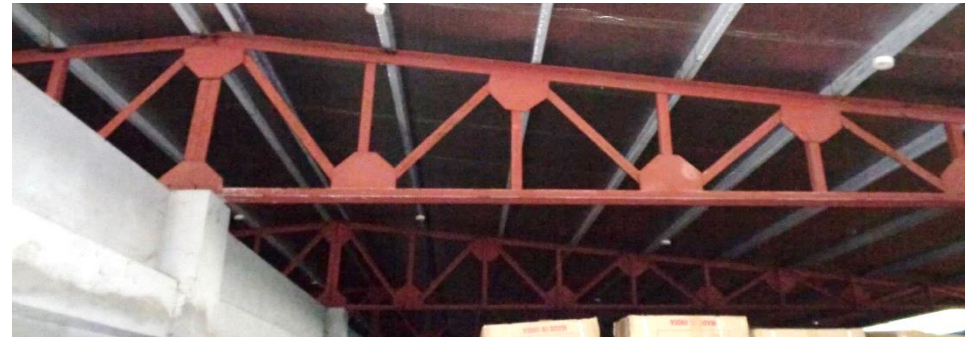
No gusset plate at joint between top & vertical chord

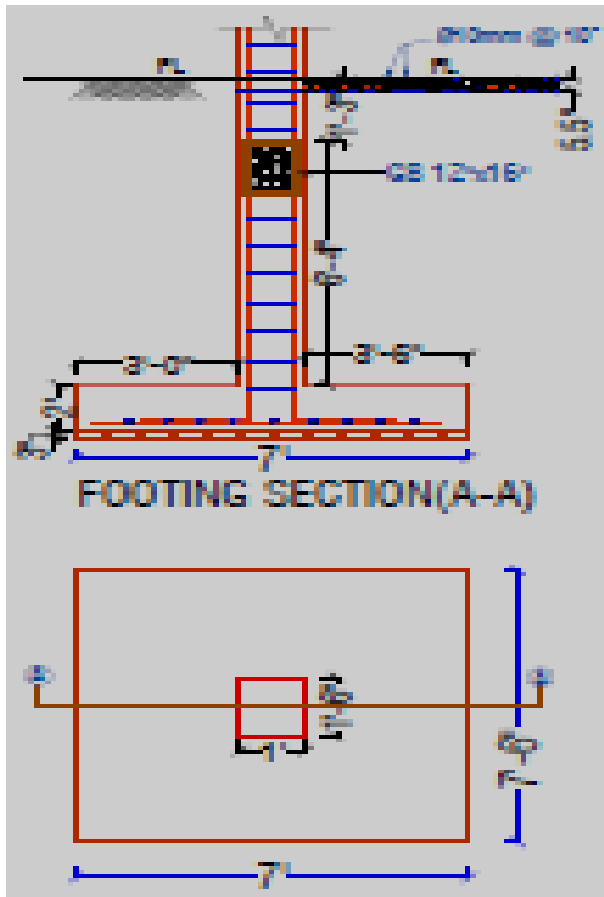
No details of combined footing was found in drawing.

Footing type not mentioned in layout

Footing rebar not mentioned

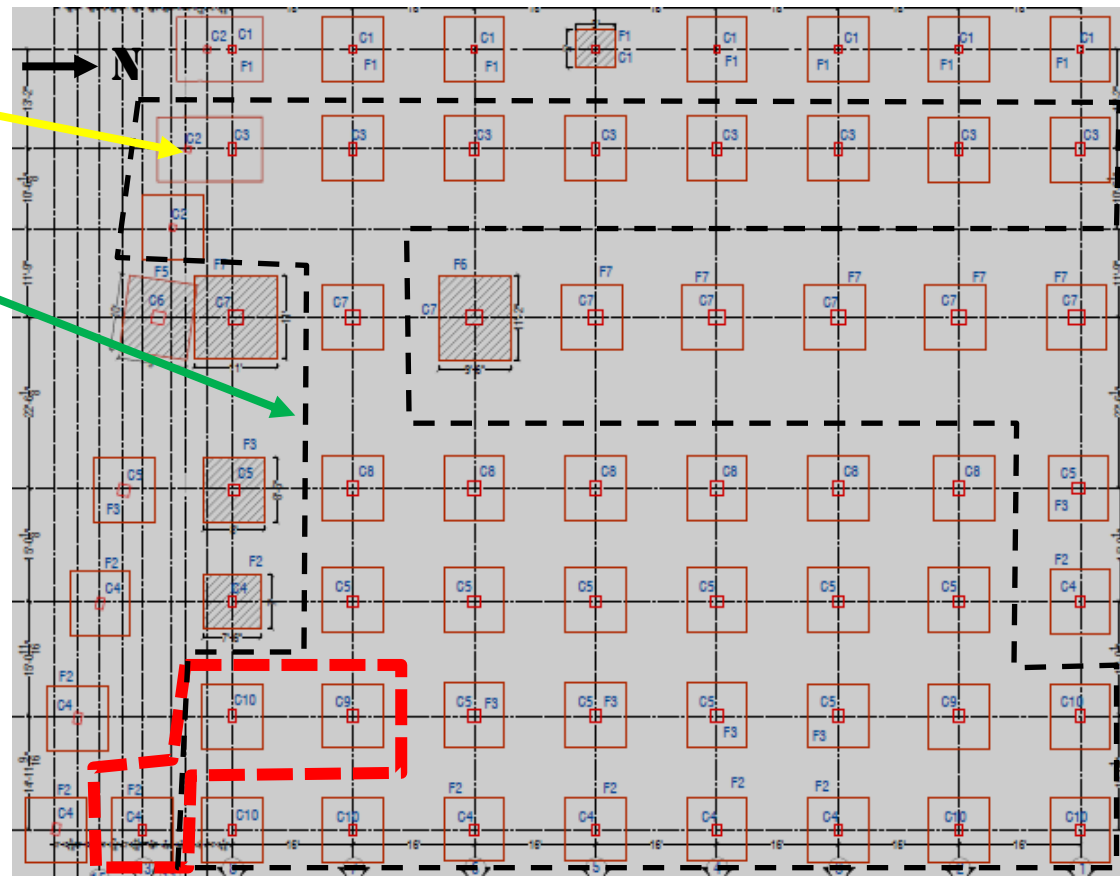
Footing Layout Plan

Cursory calculation indicates that red marked footings are stressed above normal design limit considering observed live load (2 kPa), minimum concrete strength (14.1 MPa) based on aggregate type and ultimate soil bearing capacity 6.88 ksf (330 kPa). Factory engineer is required to review design, load & footing stresses of the building and suggest remedial actions accordingly.

| Item No. | Observation | Recommended Action Plan | Recommended Timeline |
|---|---|---|---|
| 12 | High stress in foundation and column. [Fashion 3] | Factory Engineer to review design, loads and column stresses in all column and foundations. | 6-weeks |

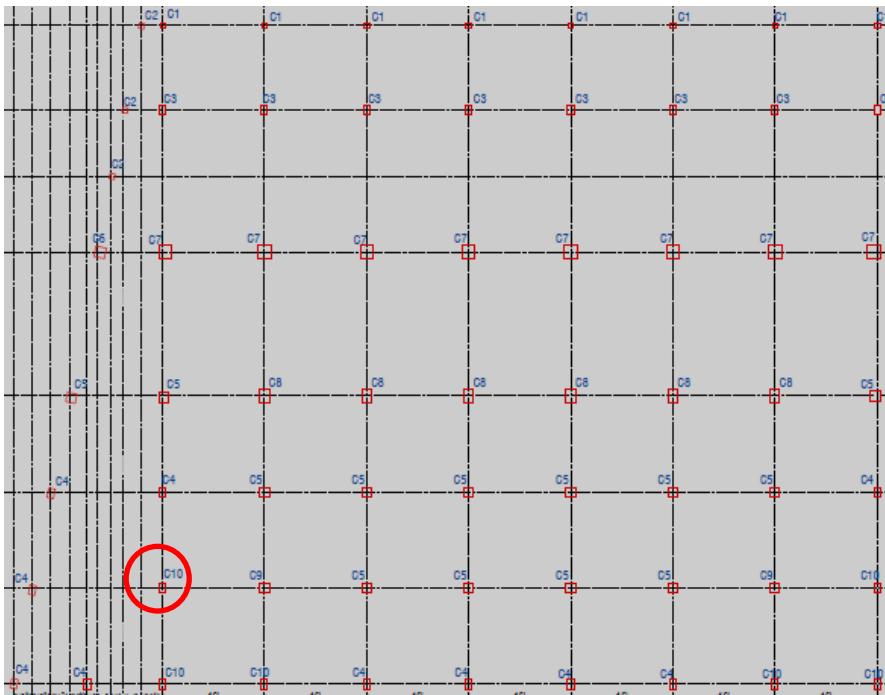
Column Layout Plan

Cursory calculation indicates that columns are stressed above normal design limit considering observed 2 kPa live load and minimum concrete strength (14.1 MPa) based on aggregate type. Factory engineer is required to review design, load & column stresses of the building.

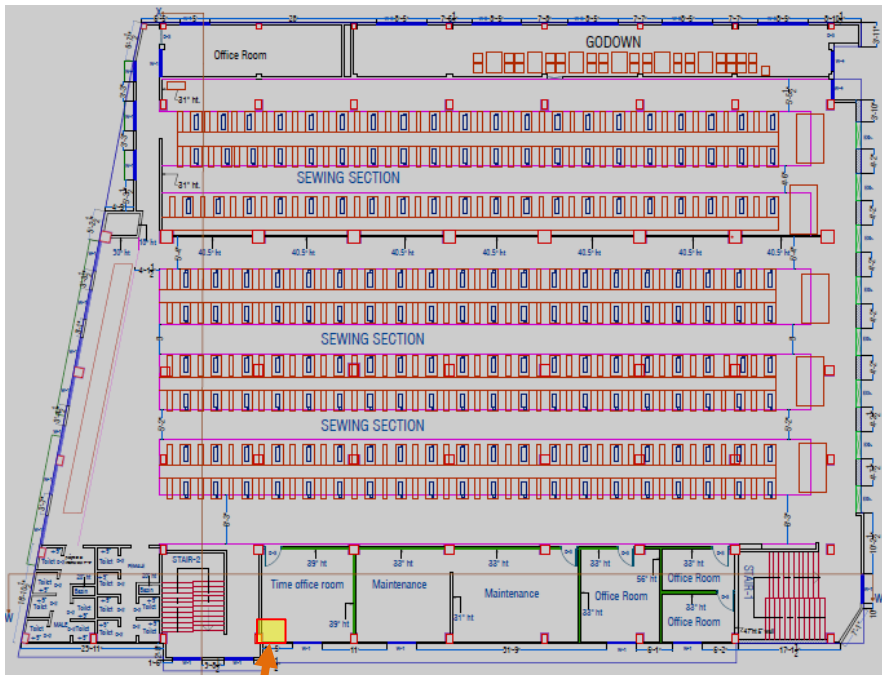
1<sup>st</sup> floor layout plan

Toilet with 275 mm buildup-not shown in drawing

Beam size –  
250mm X 425mm (d/s)  
instead of  
250mm X 350mm (d/s)

| Item No. | Observation | Recommended Action Plan | Recommended Timeline |
|---|---|---|---|
| 17 | Mismatches in as-built drawing. [Fashion 3] | Factory Engineer is required to survey the structure and prepare accurate as-built (architectural and structural) drawings in compliance with section 1.9.1.2 as per BNBC. | 6-weeks |

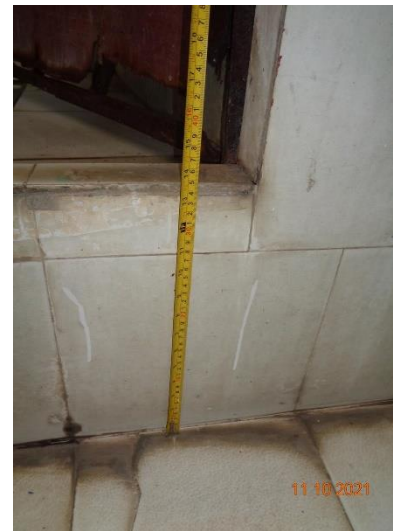
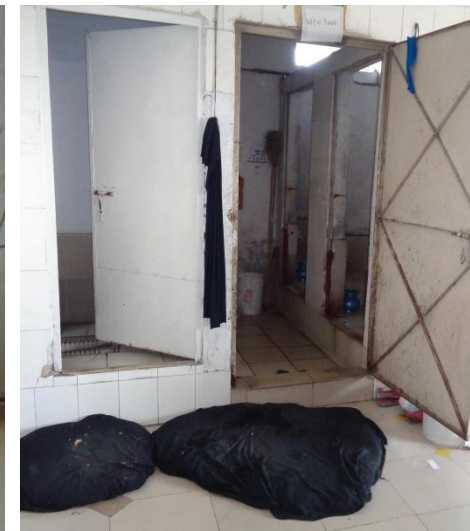
150~275 mm Buildup at each floor toilet area

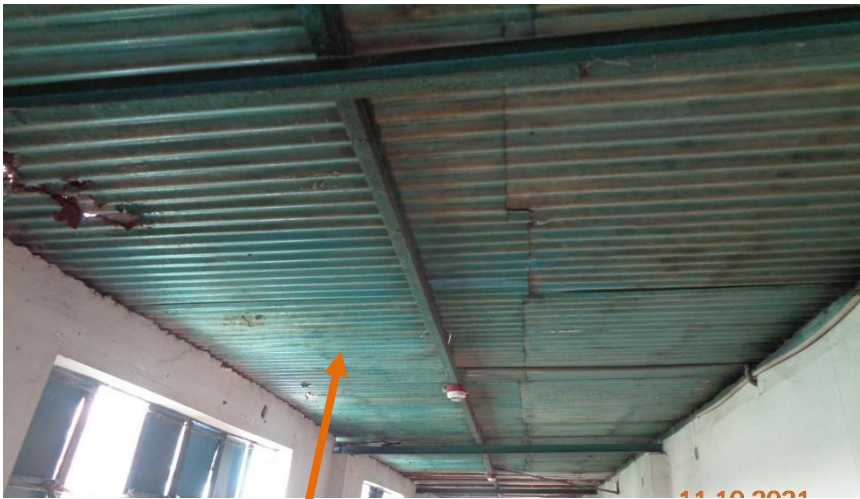
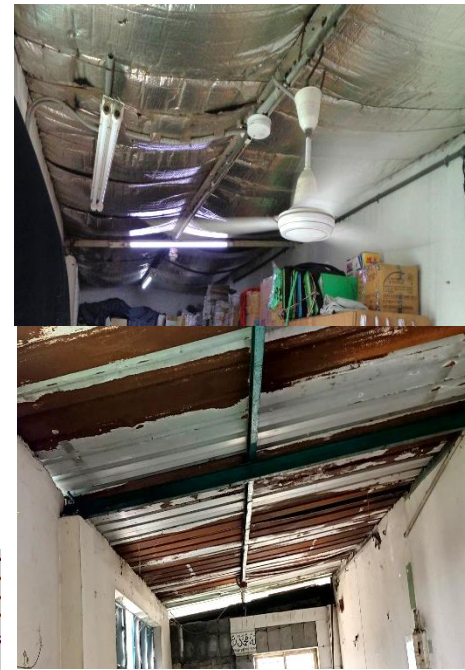
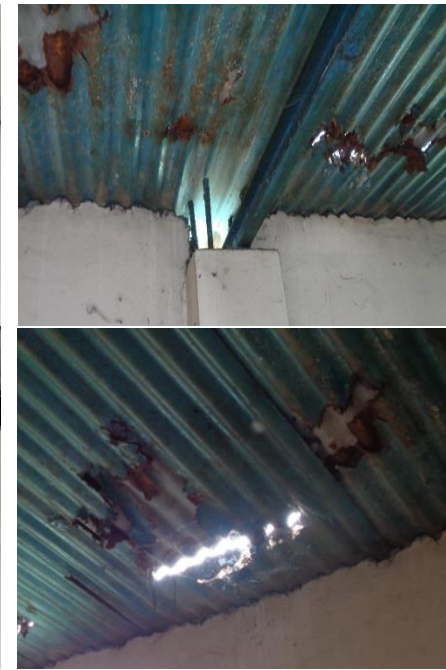
**Non-engineered shed at 1<sup>st</sup> floor**

Roof sheet worn out

Factory engineer is required to check the member adequacy of the shed for both gravity and lateral forces or replace the shed by an engineering structure.

| Item No. | Observation | Recommended Action Plan | Recommended Timeline |
|---|---|---|---|
| 18 | Non-engineered shed at 1st floor. [Fashion 3] | Factory engineer is required to check the member adequacy of the shed for both gravity and lateral forces or replace the shed by an engineering structure. | 6-weeks |

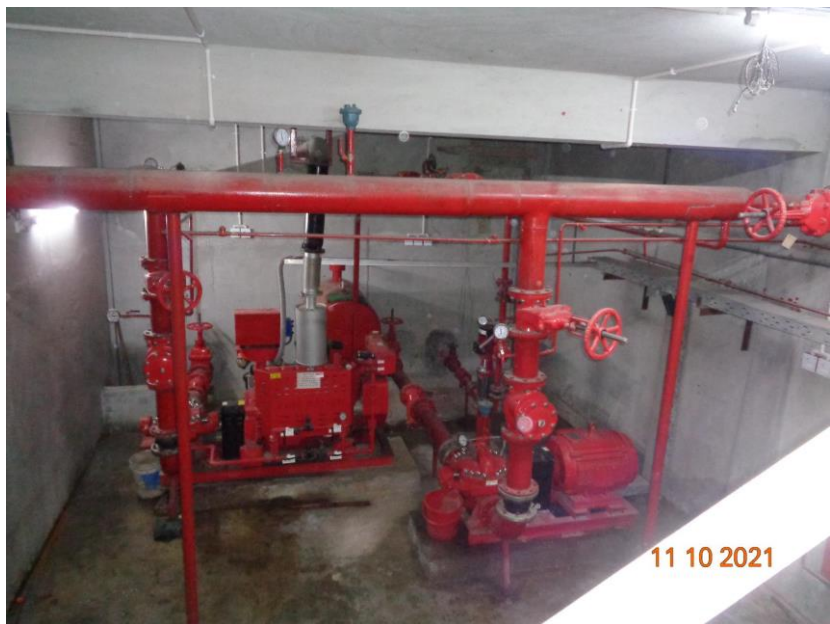
Basement

Foundation details and roof truss connection details are not found in provided drawings. The building engineer is required to survey the whole structure and produce accurate as-built drawings with connection details.

| Item No. | Observation | Recommended Action Plan | Recommended Timeline |
|---|---|---|---|
| 19 | Lack of information in provided drawings. [Pump House] | The building engineer is required to survey the whole structure and produce accurate as-built drawings with connection details. | 6-weeks |

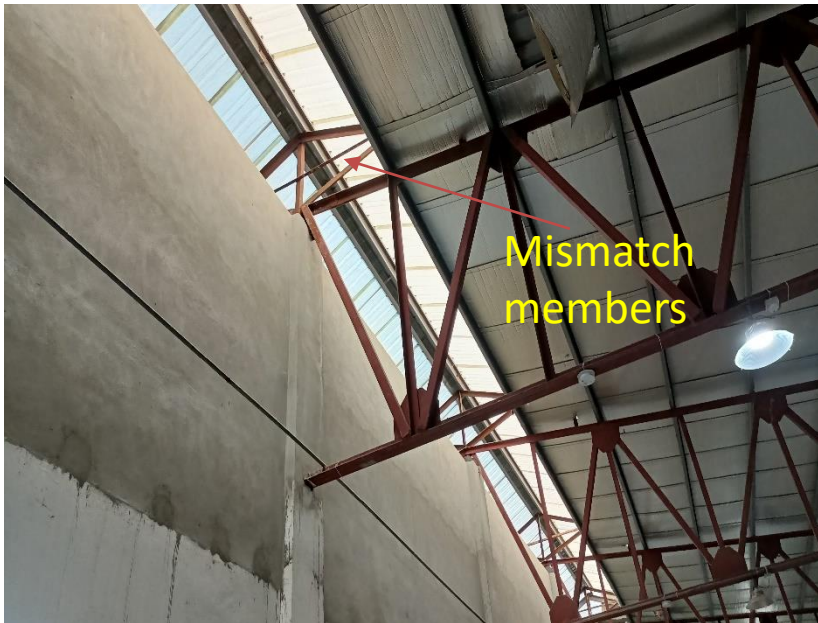
Mismatch has been found in member size

As per above discrepancies building engineer is required to survey the structural components and produce accurate structural details.

| Item No. | Observation | Recommended Action Plan | Recommended Timeline |
|---|---|---|---|
| 20 | Lack of connection details and mismatches in drawings. [Accessories shed] | The building engineer is required to survey the whole structure and produce accurate as-built drawings with connection details. | 6-weeks |

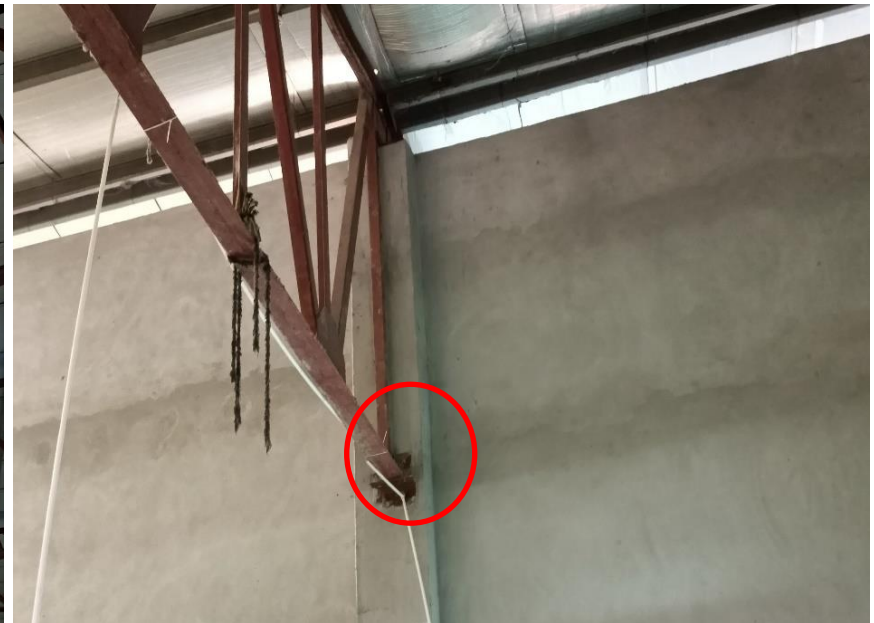
No connection details found for seat connection at grid-7

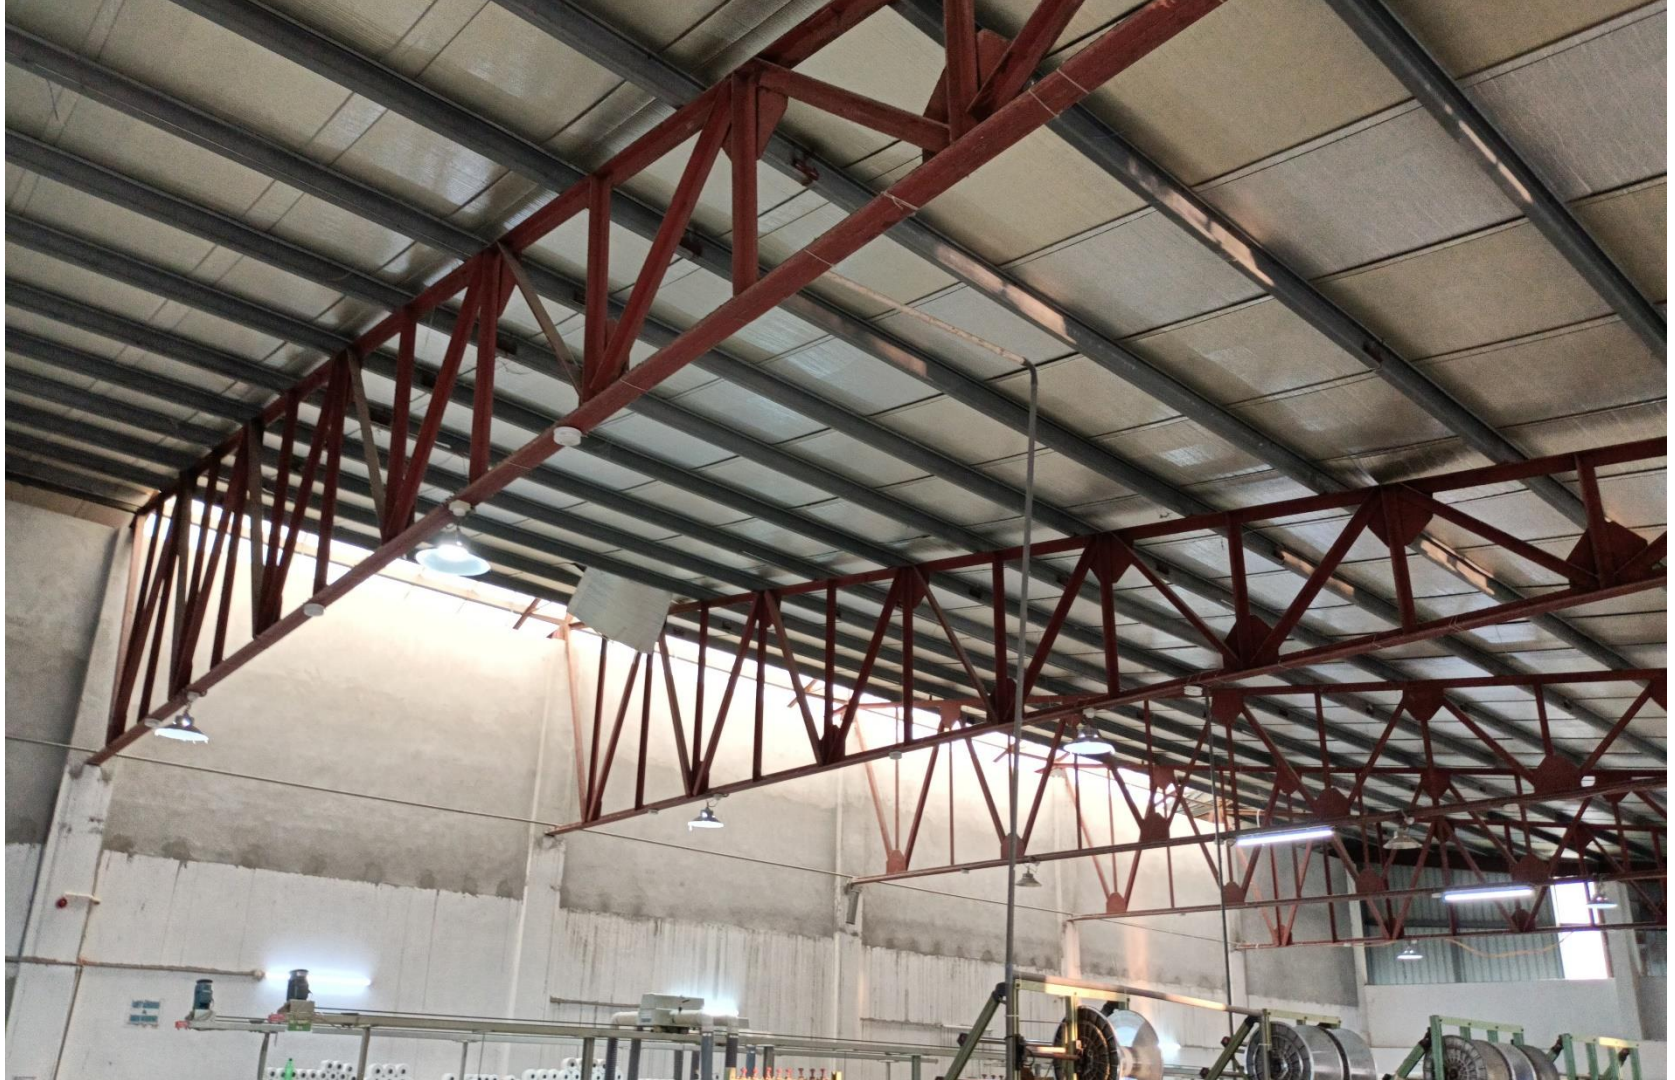
No roof bracing has been found on roof

The factory engineer is required to check the stability system and determine the size & position of bracing & compression strut accordingly.

| Item No. | Observation | Recommended Action Plan | Recommended Timeline |
|---|---|---|---|
| 21 | Lack of lateral stability system. [Accessories shed] | Factory engineer is required to carry out lateral stability check of the shed against lateral forces. | 6-weeks |

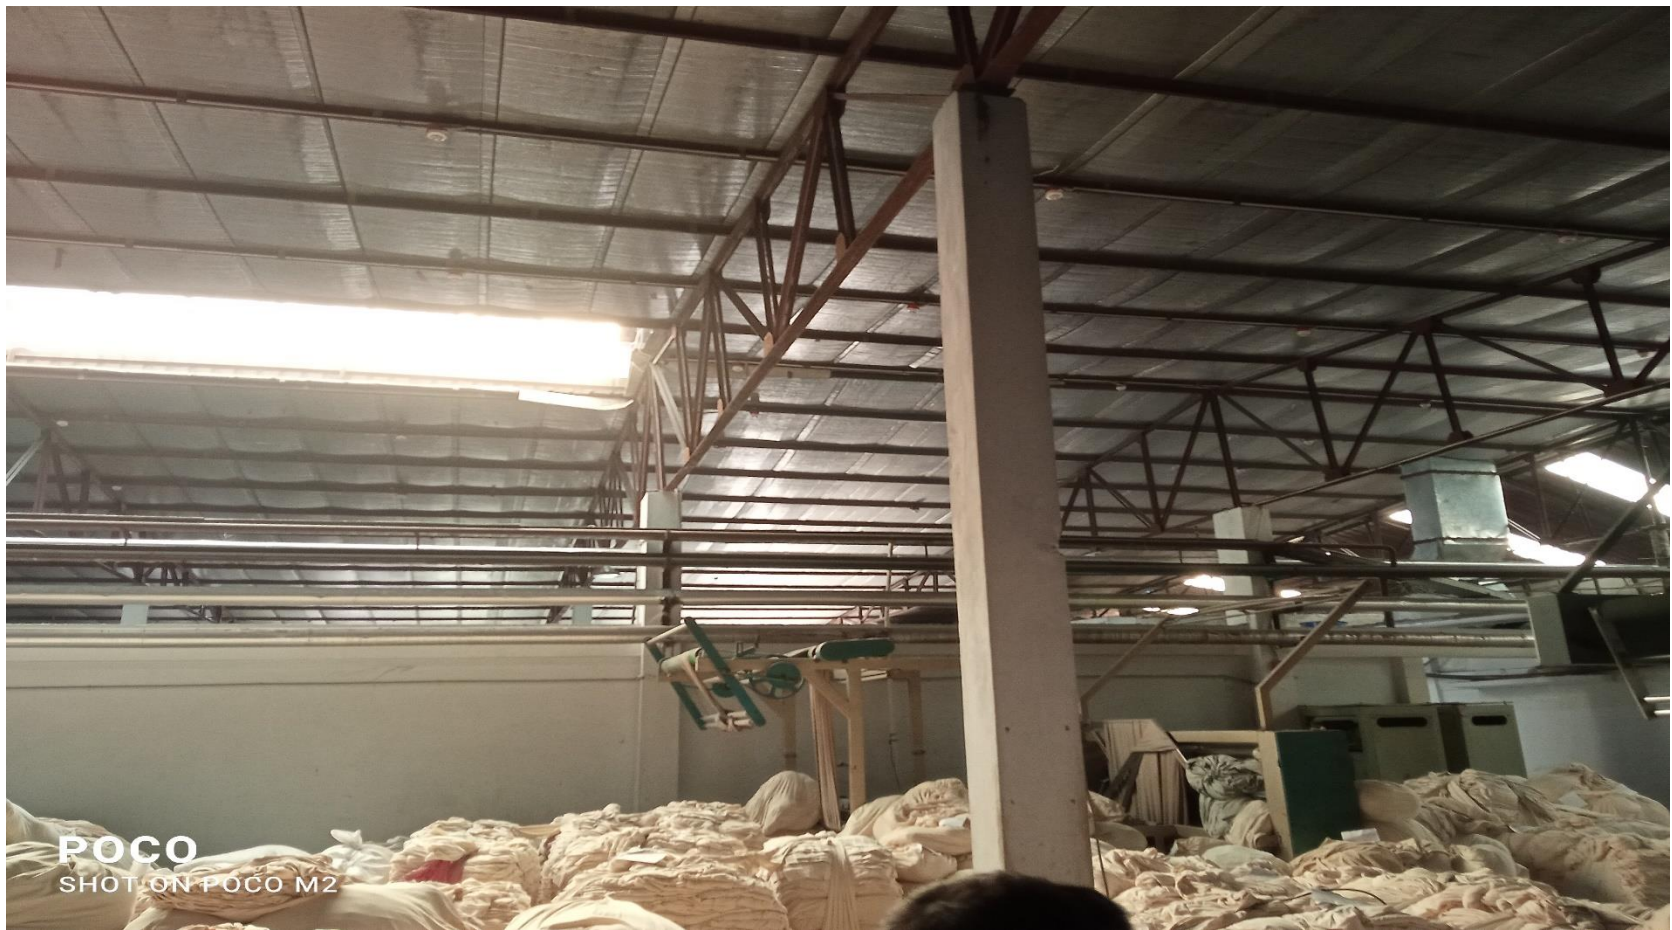
Lateral load transfer media is missing

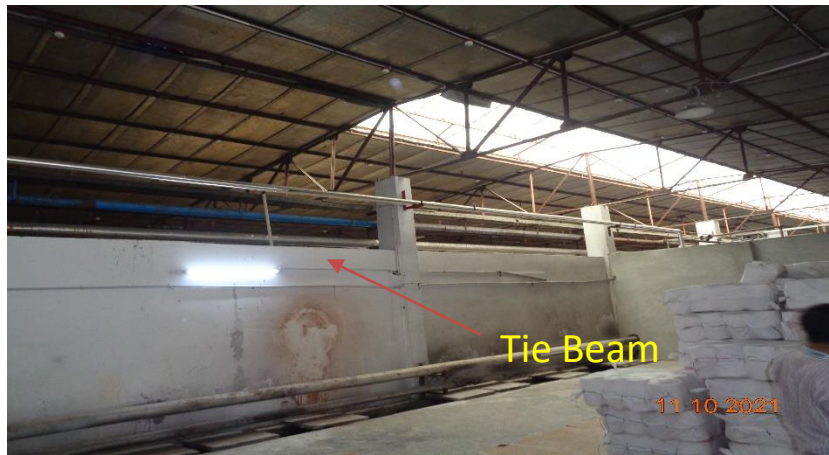
No tie beam has been found at 5m level where drawing shows at 3.0 m level.

Building engineer to survey the structural components and produce accurate structural details.

| Item No. | Observation | Recommended Action Plan | Recommended Timeline |
|---|---|---|---|
| 23 | Discrepancies between drawings with as-built condition & lack of connection details. [Washing shed] | The building engineer is required to survey the structure and produce accurate as-built drawings. | 6-weeks |

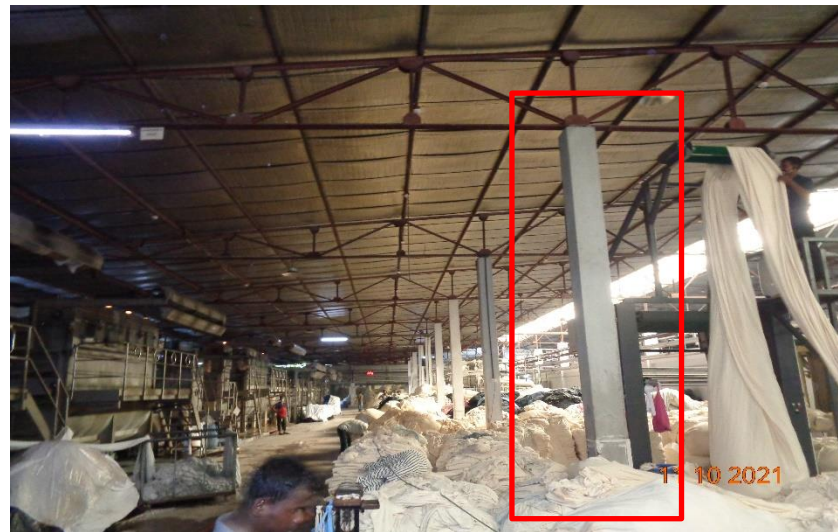
Brick column support of truss

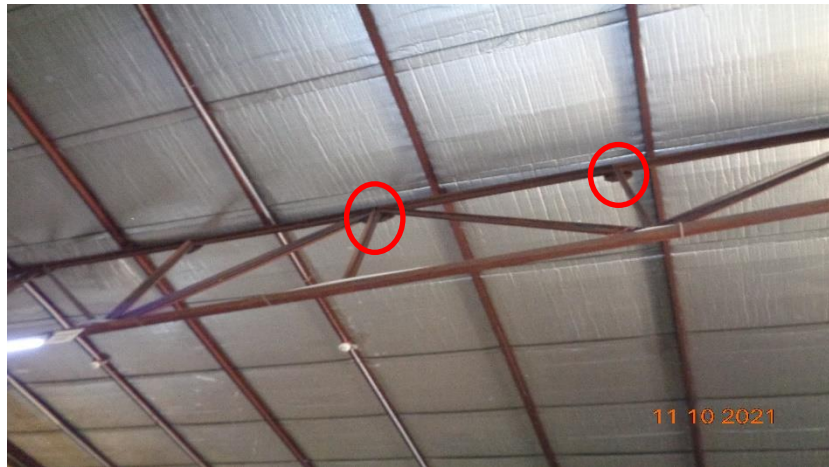
Missing gusset plate at some points

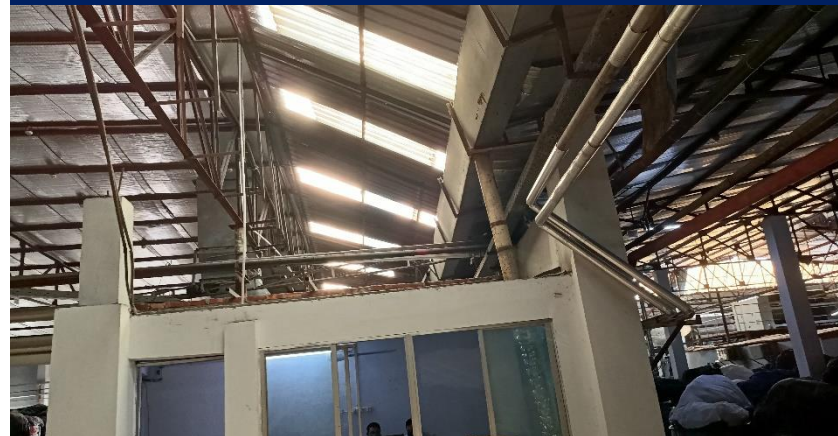
At grid 1/11 half truss shown but full truss found onsite

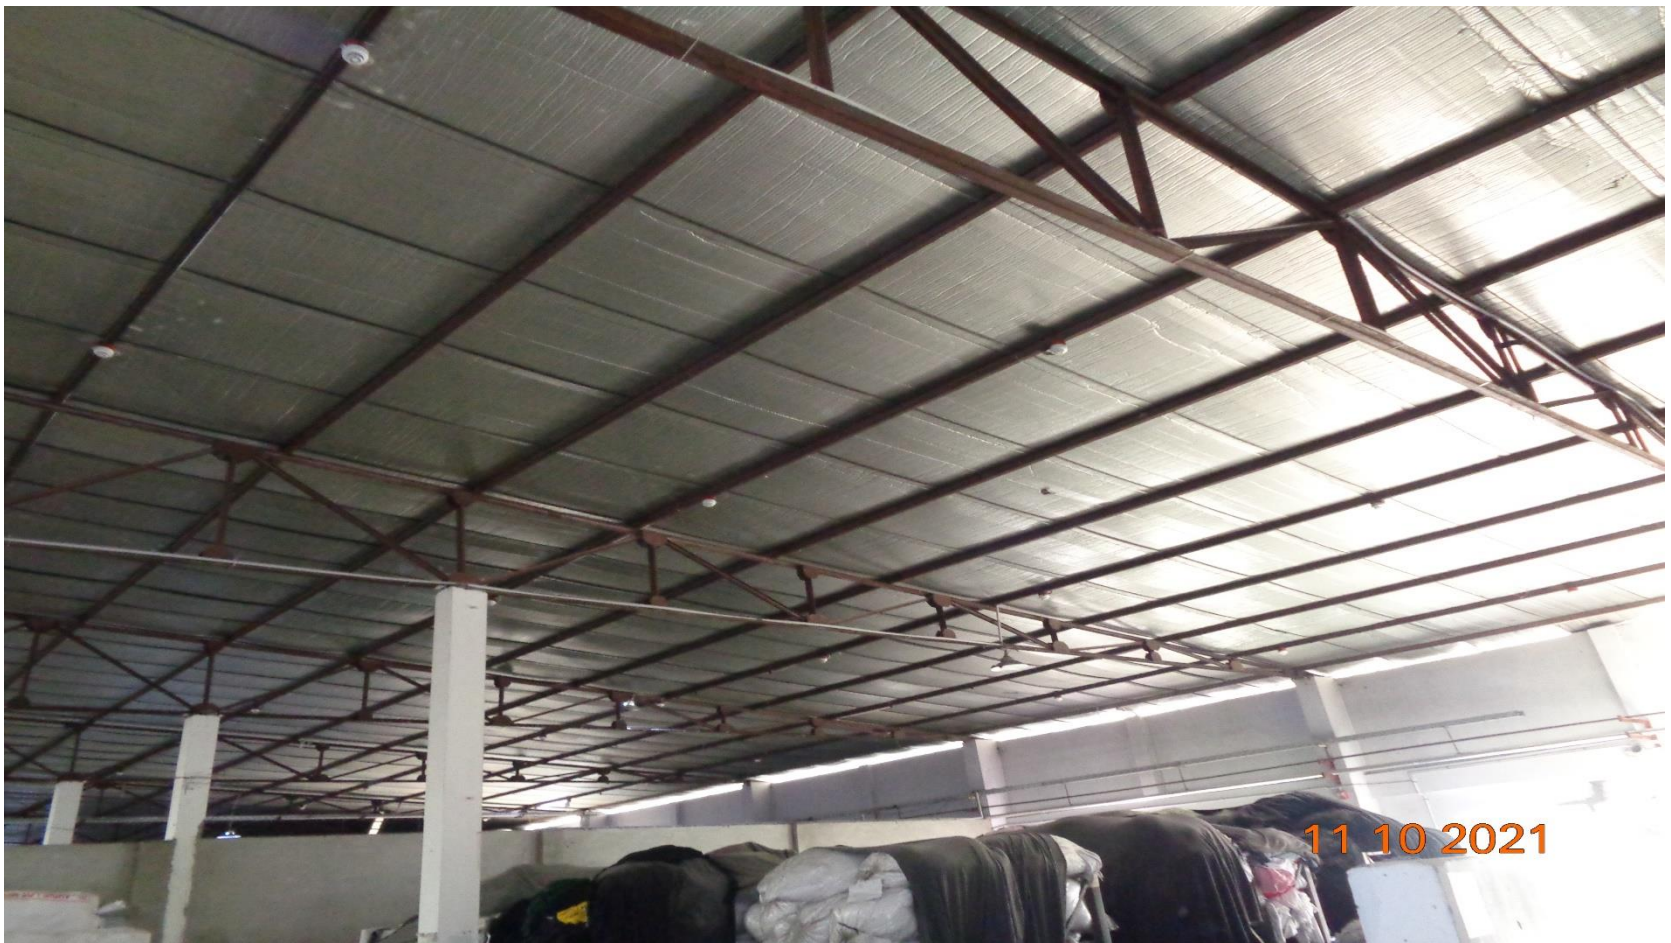
No roof bracing has been found on roof and lateral load transfer media is missing

The factory engineer is required to check the stability system and determine the size & position of bracing & compression strut accordingly.

| Item No. | Observation | Recommended Action Plan | Recommended Timeline |
|---|---|---|---|
| 24 | Lack of lateral stability system. [Washing shed] | Factory engineer is required to carry out lateral stability check of the shed against lateral forces. | 6-weeks |

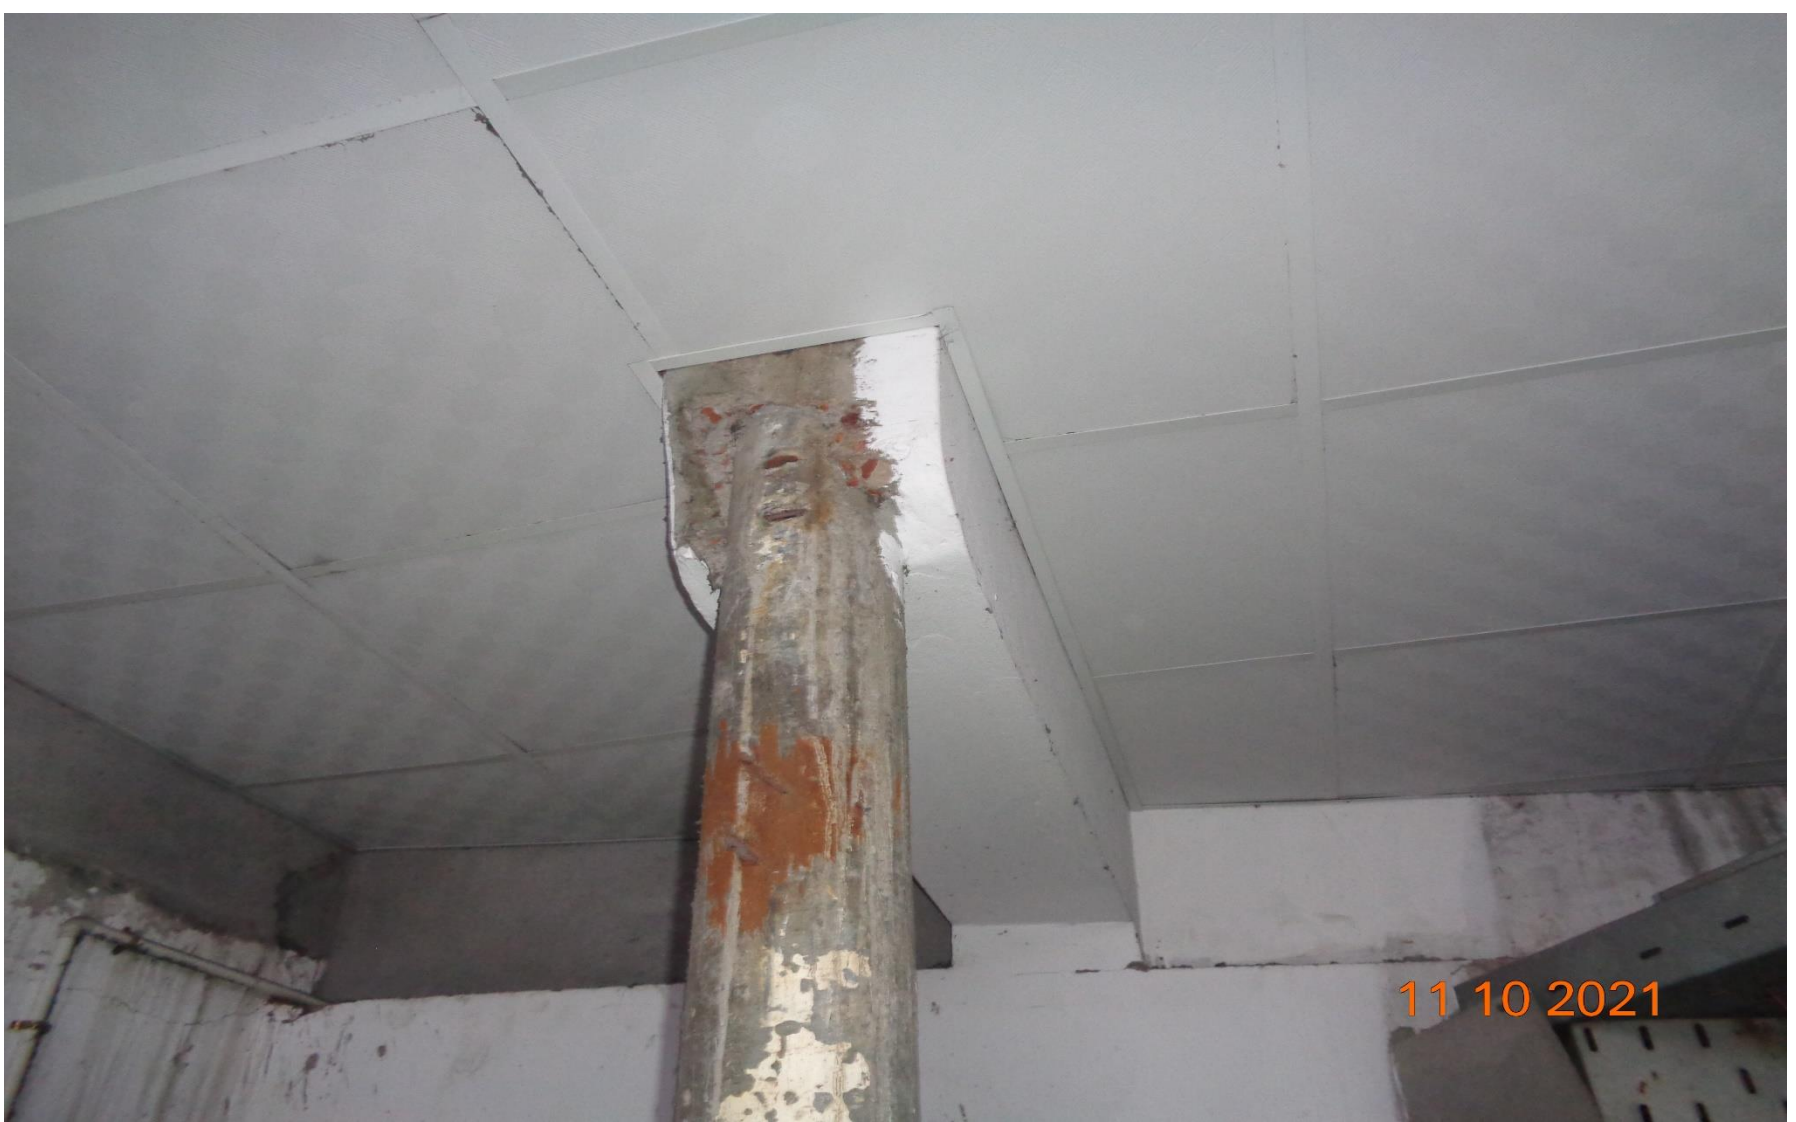
Tie beam has been found supported by a steel pipe column. Building engineer is required to check the connection of tie beam & steel column also need to check the capacity of that steel column

| Item No. | Observation | Recommended Action Plan | Recommended Timeline |
|---|---|---|---|
| 26 | RC tie beam resting on a circular steel column. [Washing shed] | Factory engineer is required to verify the connection and prepare structural details. | 6-weeks |
