# KAC Fashion Wear Ltd (Extension)

12/13 Tetui Bari, Sarabo, Gazipur

14<sup>th</sup> September and 11<sup>th</sup> October 2021

# Observations

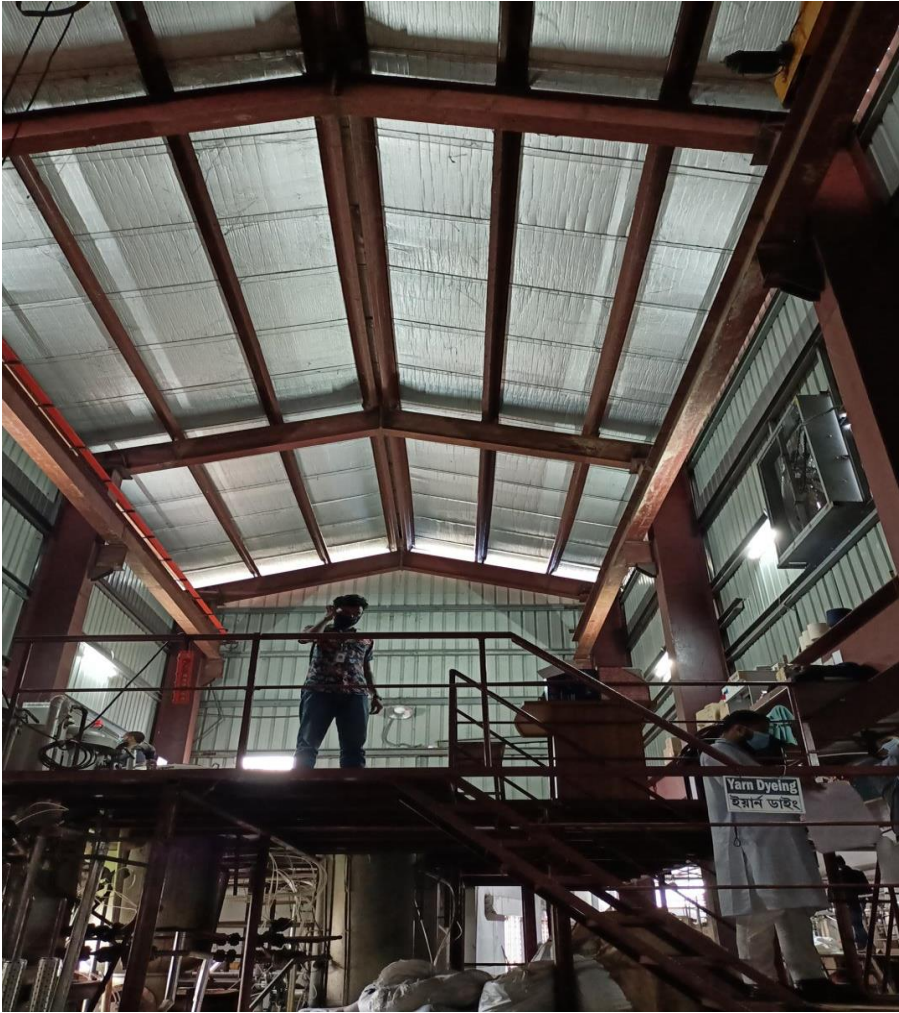
No roof bracing

Factory engineer is required to check the adequacy of shed & mezzanine floor for gravity, lateral & moving load due to crane movement and suggest remedial actions accordingly.

| Item No. | Observation | Recommended Action Plan | Recommended Timeline |
|---|---|---|---|
| 29 | Lack of lateral stability system. [Yarn Dying Shed] | Factory engineer is required to check the adequacy of shed & mezzanine floor for gravity, lateral & moving load due to crane movement and suggest remedial actions accordingly. | 6-weeks |

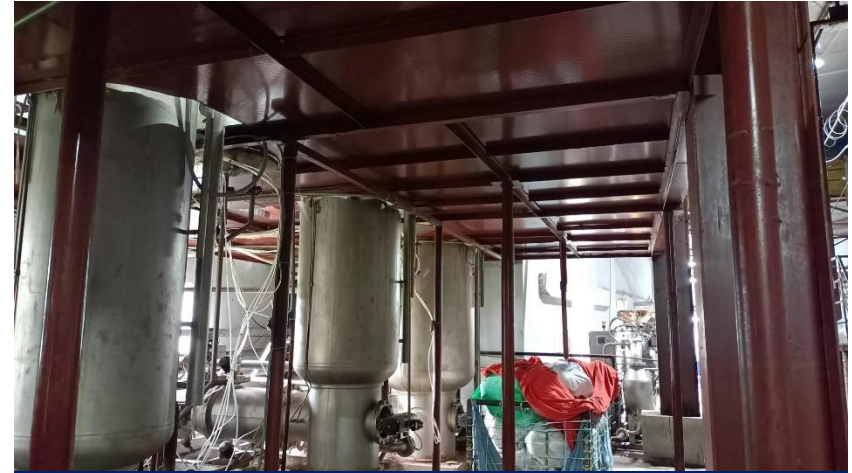
Undocumented mezzanine

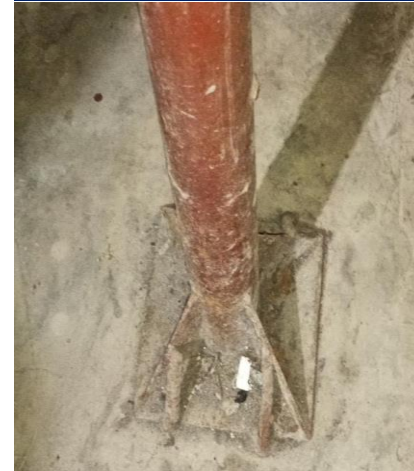
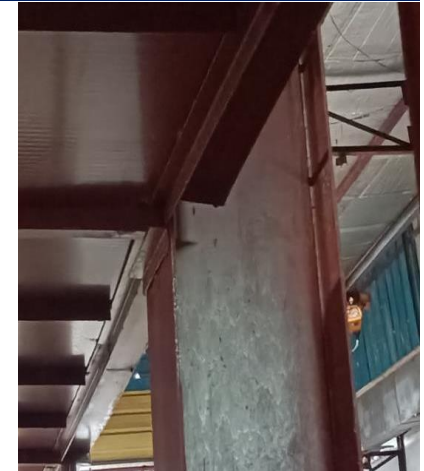
Poor connection

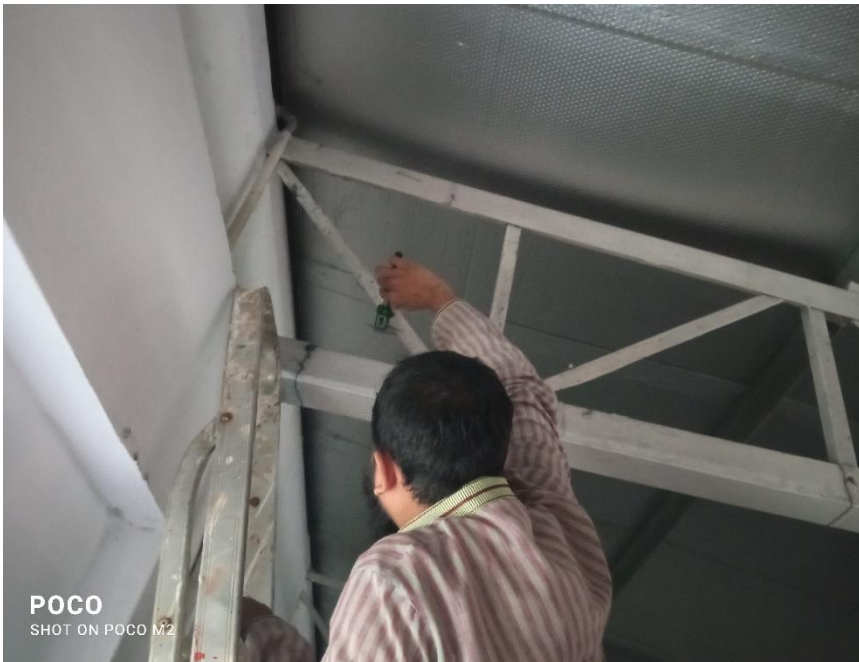
Member size mismatch has been found at grid 2,4 in part 1, 11-13 in part 2, grid dimension mismatch has been found in part 2

As per above discrepancies building engineer is required to survey the structural components and produce accurate structural details.

| Item No. | Observation | Recommended Action Plan | Recommended Timeline |
|---|---|---|---|
| 31 | Mismatches in drawings & lack of connection details. [Canal shed] | The building engineer is required to survey the structure and produce accurate as-built drawings. | 6-weeks |

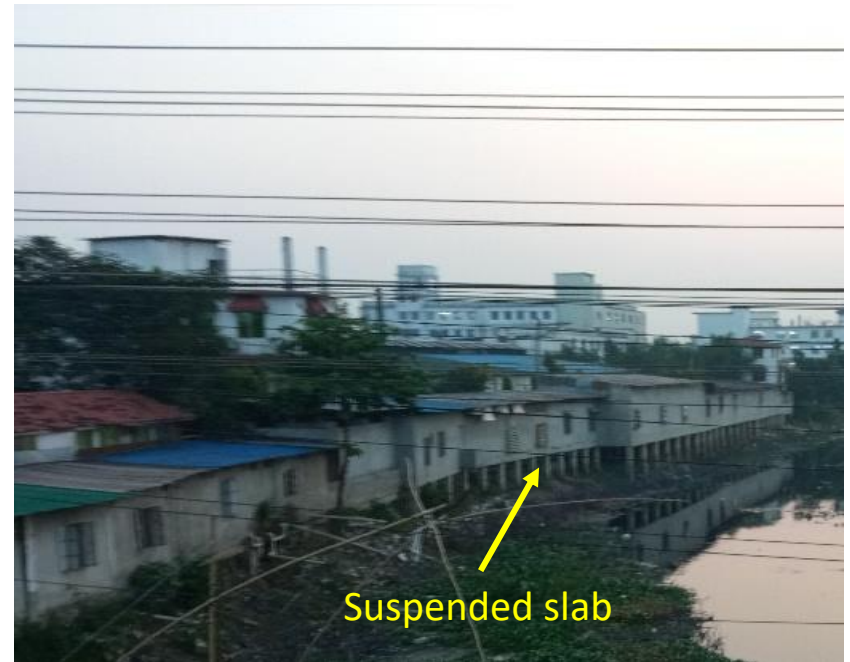
No details has been found for suspended slab, on grade slab details has been found instead of suspended slab.

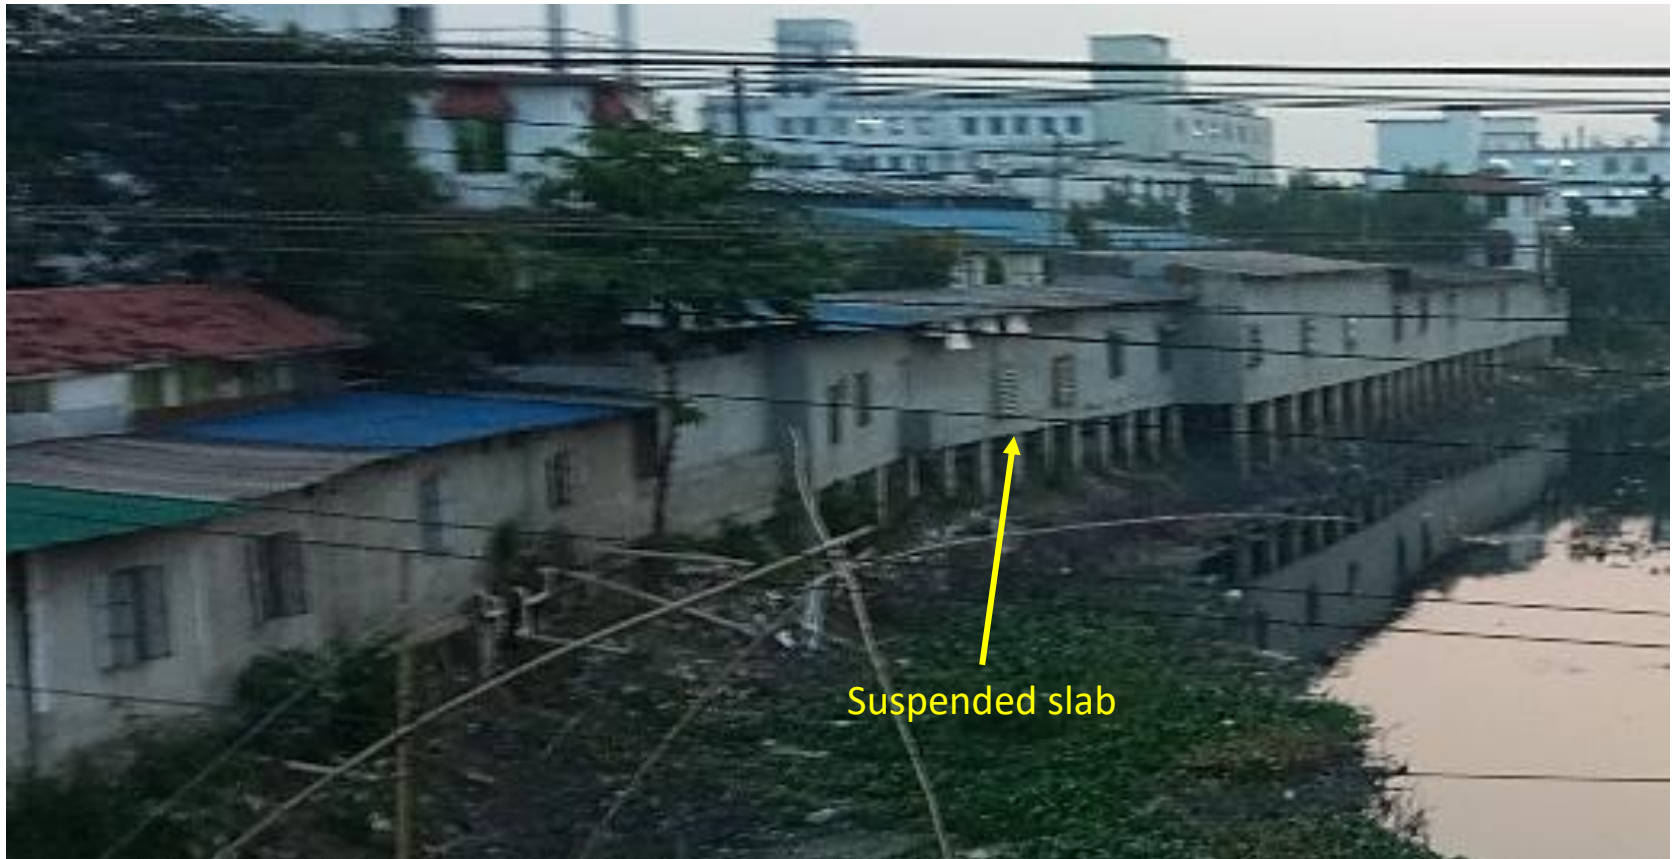
Suspended slab has been found instead of on grade slab.

The factory engineer is required to check the adequacy of the suspended slab considering maximum loading condition.

| Item No. | Observation | Recommended Action Plan | Recommended Timeline |
|---|---|---|---|
| 32 | Suspended slab at grade level. [Canal shed] | The building engineer is required to check the adequacy of the suspended slab. | 6-weeks |

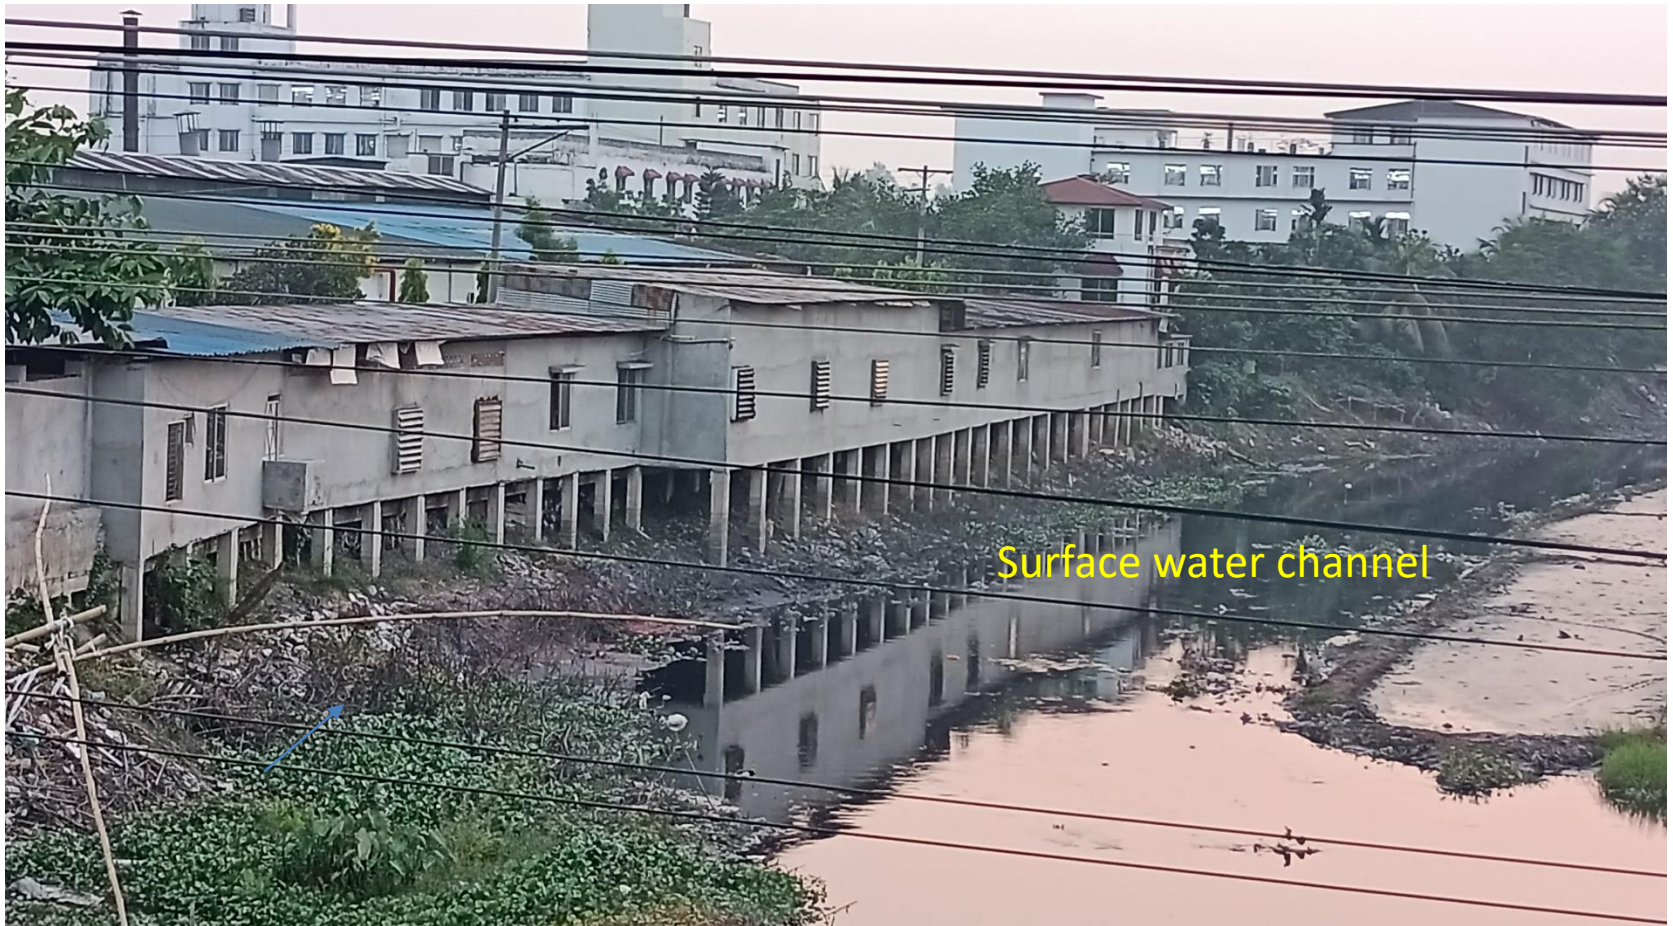
Water body near Canal Shed

Lake is very close to structure. Building engineer to check the footing adequacy considering high flood level and take necessary steps to prevent soil erosion during high flood.

| Item No. | Observation | Recommended Action Plan | Recommended Timeline |
|---|---|---|---|
| 36 | Proximity of Lake/Surface water channel. [Canal Shed] | Check the foundation adequacy based on soil capacity. | 6-weeks |
| 37 | Proximity of Lake/Surface water channel. [Canal Shed] | Building Engineer to monitor the structure for signs of water ingress and take preventative action if necessary. | 6-months |
