# Prudent Fashions Ltd

Gazir Chart Alia Madrasa, Kaichabari Road, Dhamsona Ashulia, Dhaka-1344  
(23.947001N, 90.269128E)  
12 October 2021

# Observations

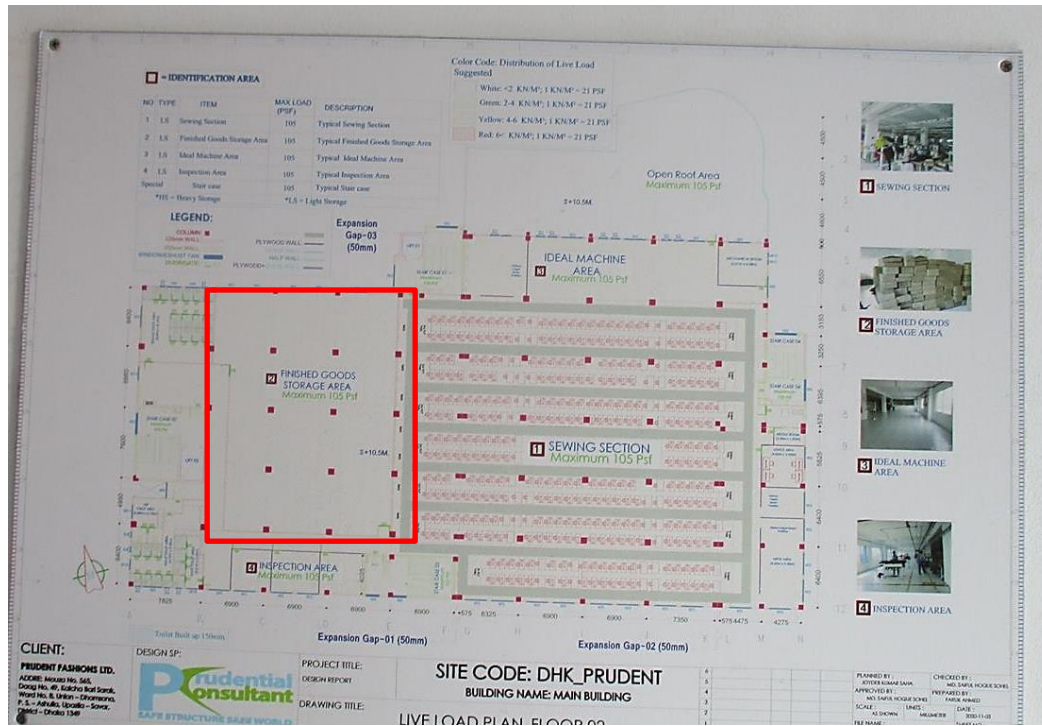
Floor live load plan with 105 psf (5 kN/m<sup>2</sup>) loading limit

As per BNBC, the minimum floor live load for light storage is 6 kN/m<sup>2</sup> (125 psf). The storage in this building is designed for 5 kN/m<sup>2</sup> live loads. The building engineer is required to revise the storage live load limit based on BNBC requirement and update the load plan and design report accordingly.

| Item No. | Observation | Recommended Action Plan | Recommended Timeline |
|---|---|---|---|
| 01 | Floor live load plan do not comply with BNBC. Building-1 | The building engineer to check the occupancies and update the floor live loading plan for the building based on BNBC loading requirements and capacity of building floor, column & foundations. | 6-weeks |
| 02 | Floor live load plan do not comply with BNBC. Building-1 | Implement the floor loading plan (posting load plan, providing signage and maintaining loadings) | 6-months |

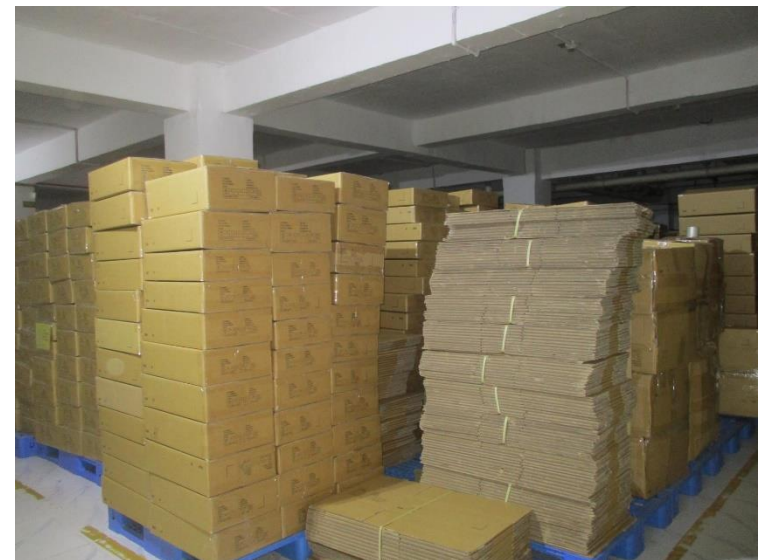
5 kN/m<sup>2</sup> live load in design report

Storage on 1st and 2nd floor

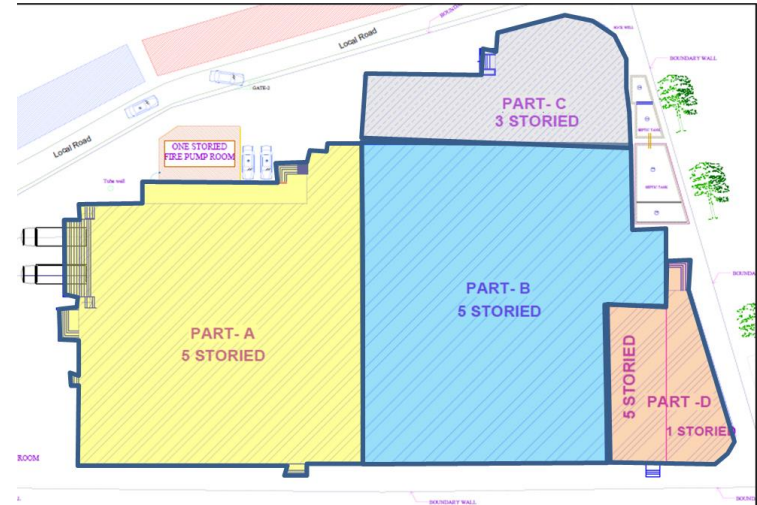
Irregular building plan

The shape of building-1 is irregular. There are four building parts and three expansion joints. During seismic event, movement of building parts may be different. The part-D has no shear wall and partially 5 storey. The position of shear walls are not symmetric.

The building engineer to incorporate irregularities check in the design report and suggest required recommendations.

| Item No. | Observation | Recommended Action Plan | Recommended Timeline |
|---|---|---|---|
| 03 | Design Report needs to be reviewed. Building-1 | As part of Engineering Assessment (EA), building engineer to incorporate irregularities check in the design report and suggest required recommendations. | 6-weeks |

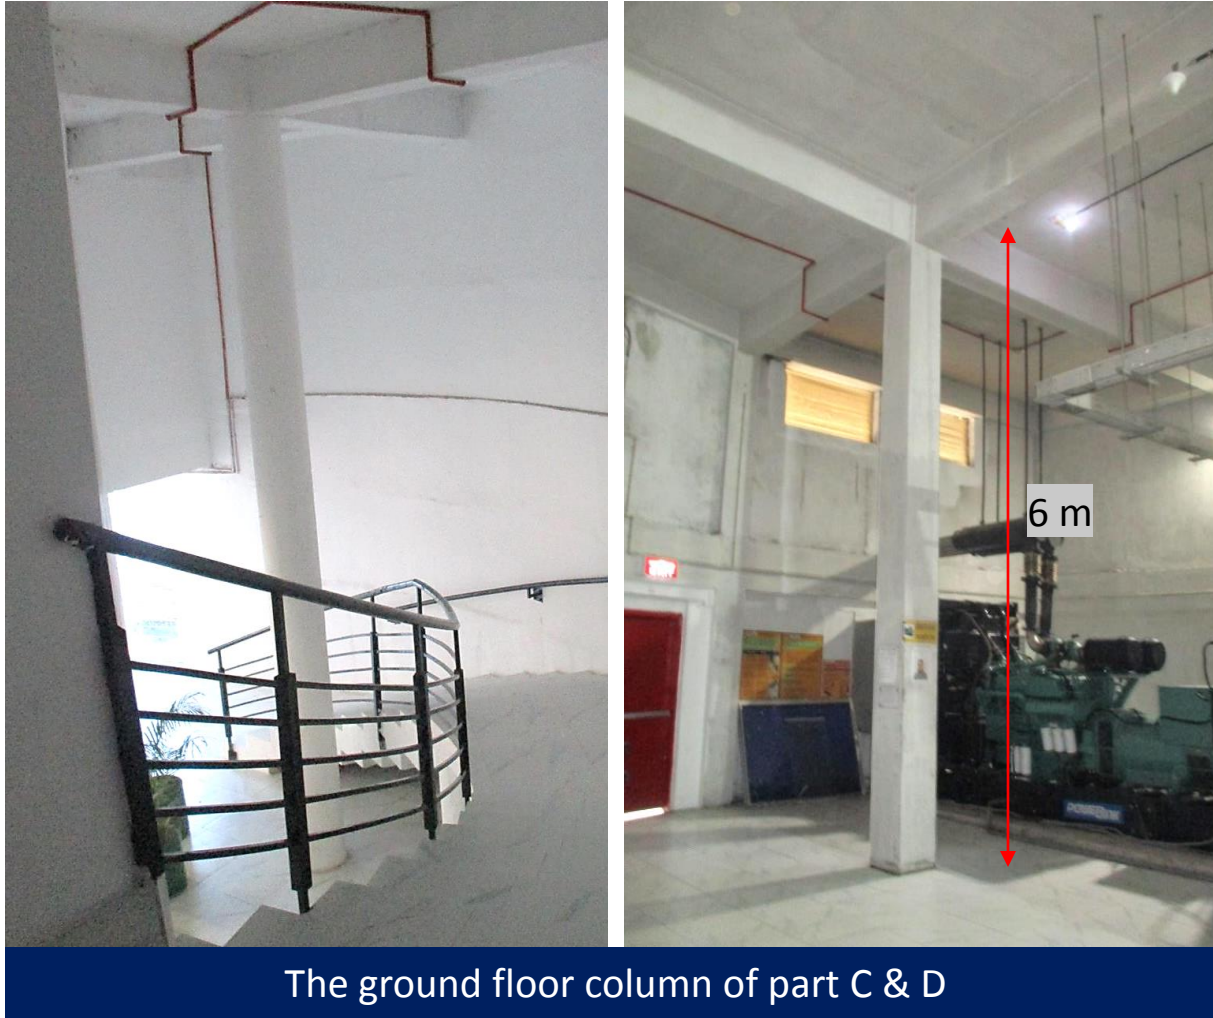
The ground floor column of part C & D

The ground floor height is 6.0 m. The diameter of column of part C is 375 mm and width of column of part D is 375 mm. The building engineer to check the slenderness effect for those columns and incorporate the design in the report.

| Item No. | Observation | Recommended Action Plan | Recommended Timeline |
|---|---|---|---|
| 04 | Design Report needs to be reviewed. Building-1 | Consider and check the slenderness effect of column. | 6-weeks |

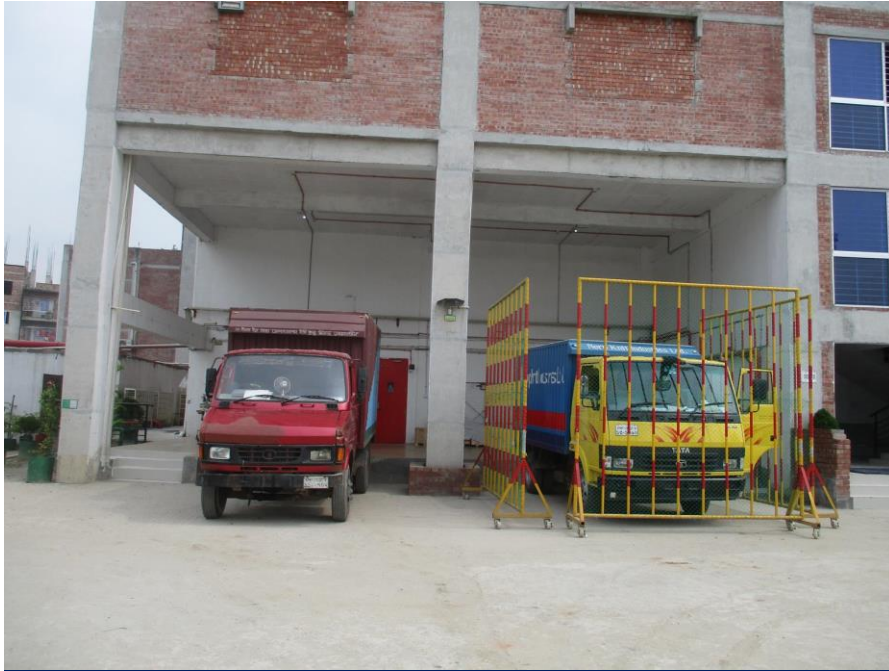
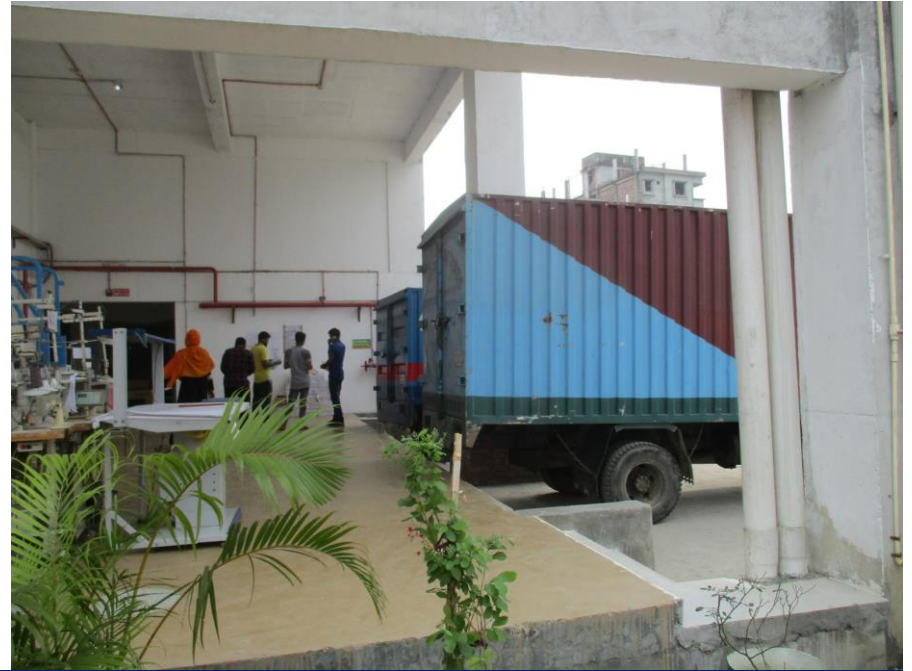
Column in loading/unloading areas have no safety barrier.

Column in loading/unloading areas have no safety barrier which are susceptible to possible vehicle impact. Factory is required to provide barrier around all the exposed columns to protect the columns from possible vehicle impact.

| Item No. | Observation | Recommended Action Plan | Recommended Timeline |
|---|---|---|---|
| 06 | Column susceptible to vehicle impact. Building-1 | Factory is required to provide barrier around all the exposed columns to protect the columns from possible vehicle impact. | 6-weeks |

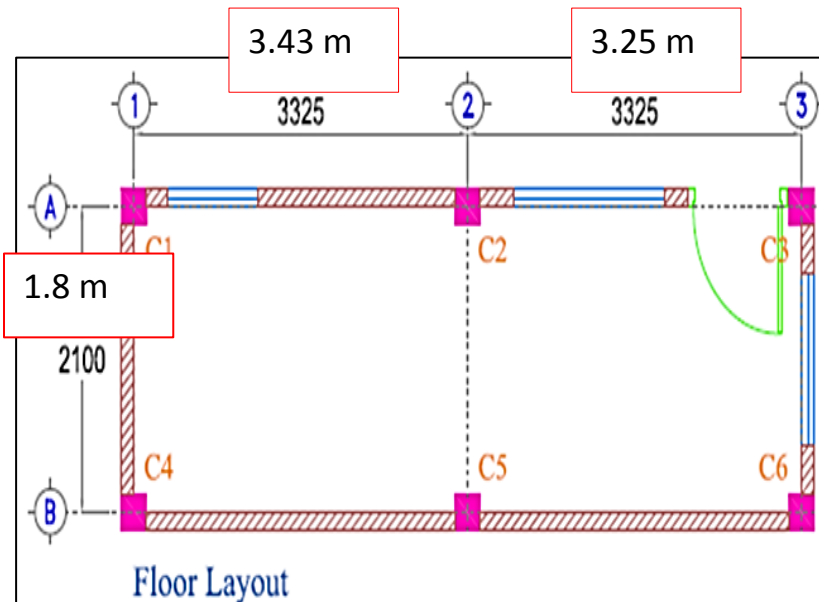
Column spacing was observed 5.25m, 3.43m instead of 3.35m and 1.8m instead of 2.1m for Building-3

The building engineer to survey the structures and update drawings to the as-constructed status.

| Item No. | Observation | Recommended Action Plan | Recommended Timeline |
|---|---|---|---|
| 07 | Mismatch in drawings. Building- 2 & 3 | The building engineer to survey the structures and update drawings to the as-constructed status. | 6-weeks |

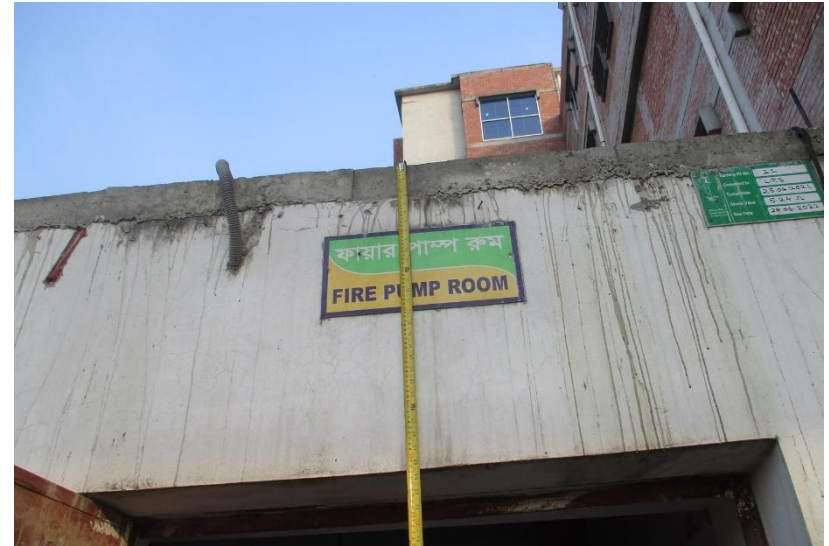
Roof slab thickness measured 125 mm instead of 150 mm for Building-2
