Jericho Imex Ltd (Extension Building)

DAG NO. 1726 & 856, MONTRIBARI ROAD, SOUTH SHALNA, SHALNA BAZAR, GAZIPUR-1703.
(24.031022, 90.390951)

17 October 2021

Executive Summary

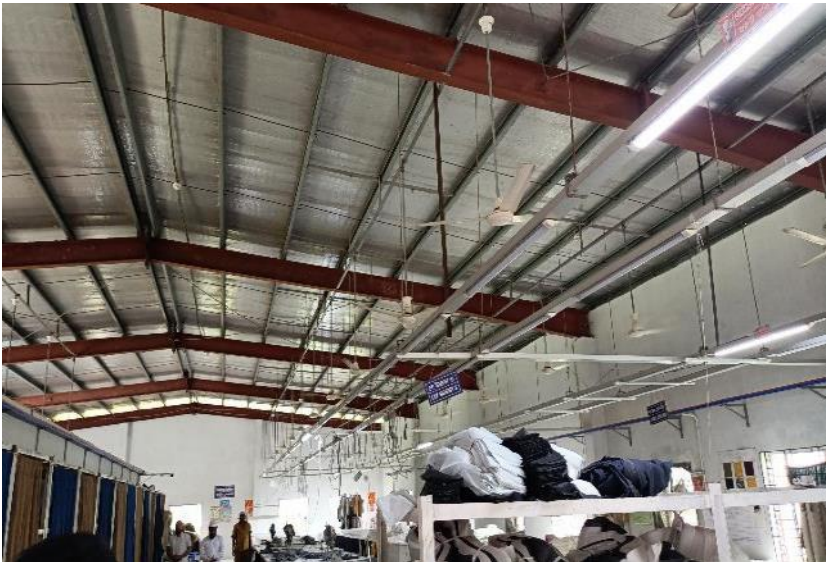
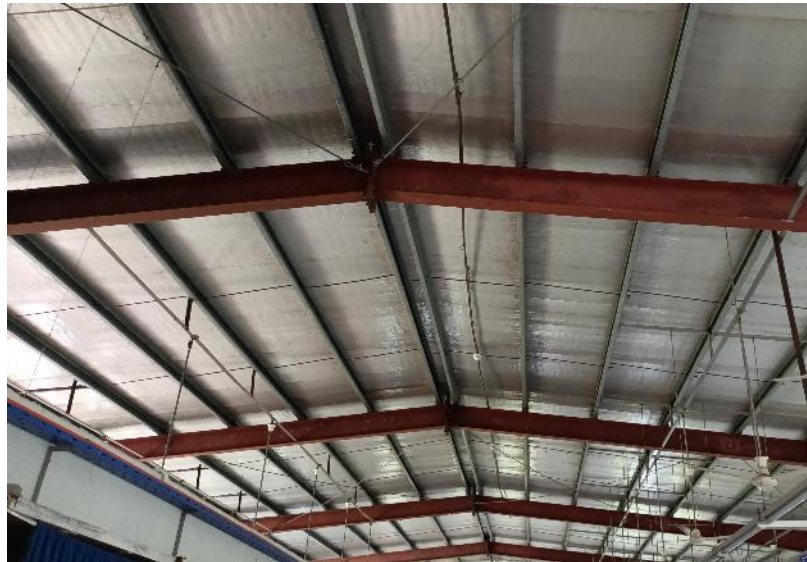
No compression strut/ lateral load transfer media at the roof level

No lateral load transfer media observed in roof. Also, bracing system has no compression member. As part of Engineering Assessment (EA) building engineer is required to check the stability system of the building and design the size & position of necessary compression element accordingly.

Item No.	Observation	Recommended Action Plan	Recommended Timeline
01	Apparently lack of lateral stability system (Shed-3).	As part of Engineering Assessment (EA) building engineer is required to check the stability system of the Building and design the size & position of necessary compression elements accordingly.	6-weeks
02	Apparently lack of lateral stability system (Shed-3).	Implement remedial actions where necessary.	6-months
03	Inconsistencies in as-built drawing (Shed-3).	The building engineer to survey the structure and prepare as-built structural drawings with connection details.	6-weeks
04	Design report required to be revised and submit to RSC (Shed-3).	Building Engineer to prepare design report as per BNBC (part-6; Article 1.9.1).	6-weeks

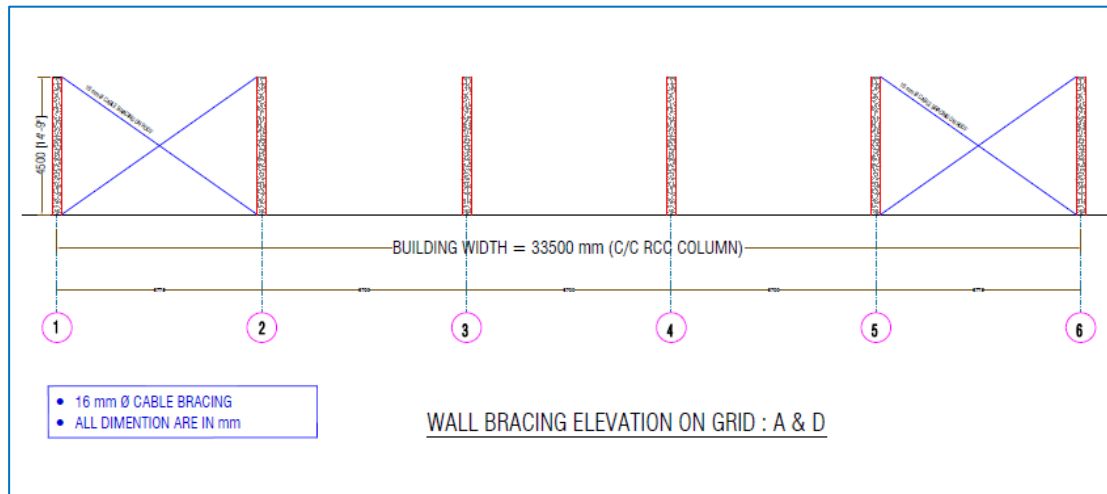
Vertical bracings on drawings which are not found onsite

Details of RC tie beams were not found in provided drawings. Vertical cross-bracing and flange bracings were shown in drawings but onsite those are not found. Moreover, connection details of bracings were not found in drawings.

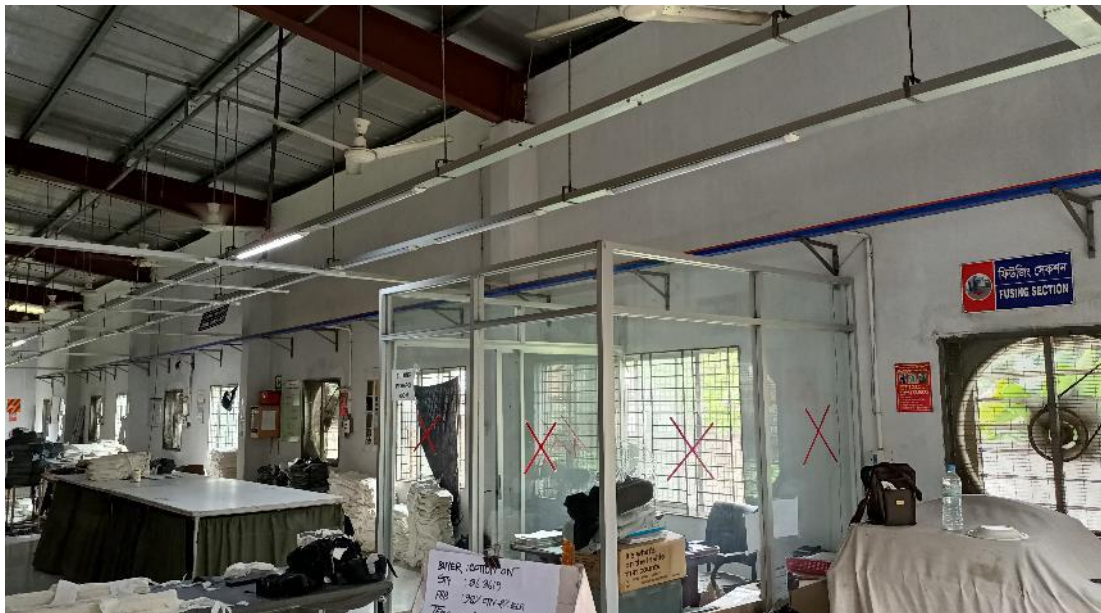
No vertical Bracings on site

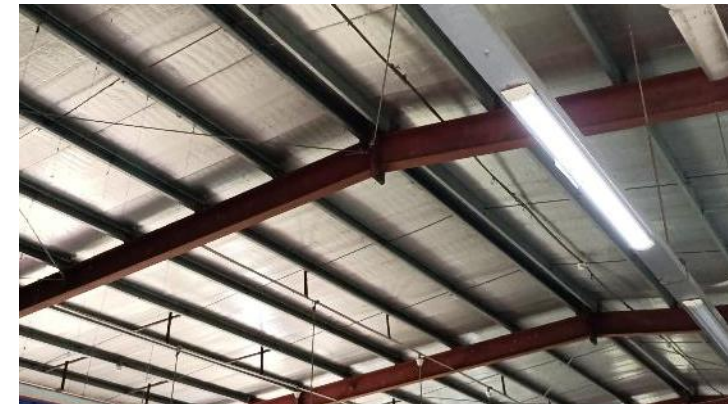
No flange bracing onsite

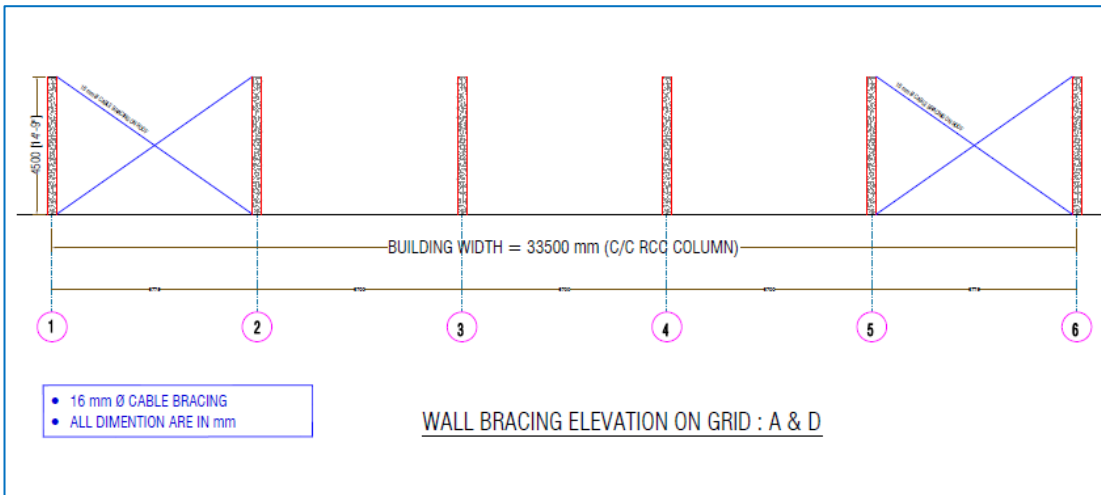
Vertical Bracings on drawings

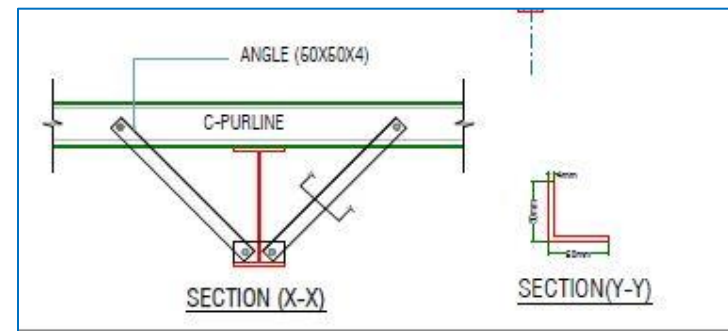
Flange bracing on drawings

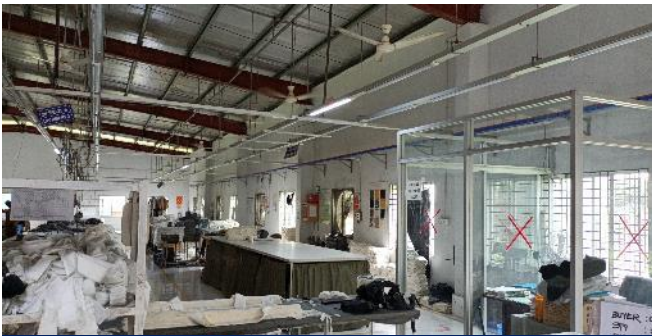
No vertical Bracings

As per BNBC, every building or structure designed shall have its design documents prepared in accordance with the provision of Section 1.9.1. The design document shall include a design report, and a set of structural drawings, which shall be prepared in compliance with section 1.9.1.1 and section 1.9.1.2 of part-6, BNBC.

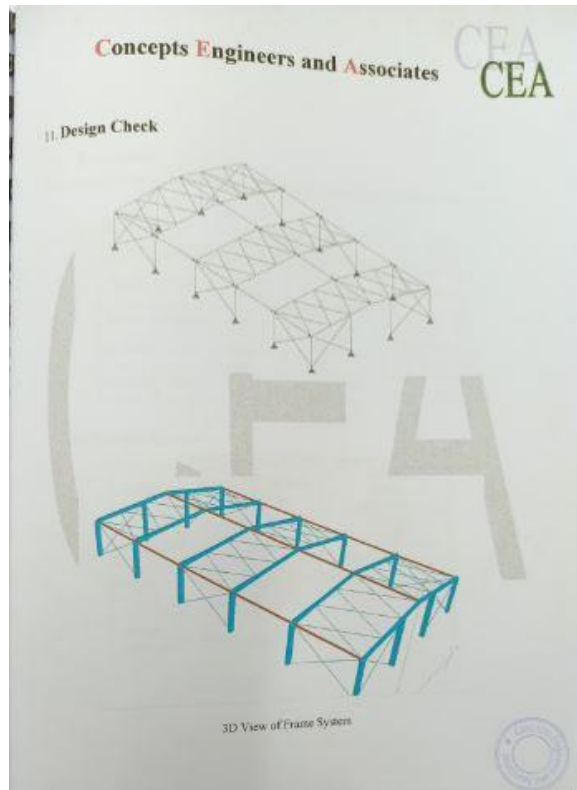
A Design Report with software-based analysis file was provided for Shed-3. Purlins are considered as compression strut, but adequacy check of the purlins are not provided in the design report. Tensile strength of MS plate 50 ksi has been considered in design report but no test report was found. Vertical bracings were not found on site whereas design report shows vertical bracings in both direction.

Item No.	Observation	Recommended Action Plan	Recommended Timeline
05	Design report required to be revised and submit to RSC (Shed-3).	The factory is required to carryout tensile test of MS plate from existing elements of the Shed-3 and fill the cutting space by same specification.	6-weeks
06	Design report required to be revised and submit to RSC (Shed-3).	Revise design report based on the result of MS plate test report.	6-weeks
07	Design report required to be revised and submit to RSC (Shed-3).	Implement the recommendation of design report.	6-months
08	Loose cable bracing (Shed-3)	The building engineer to check the bracing and tighten it properly.	6-weeks

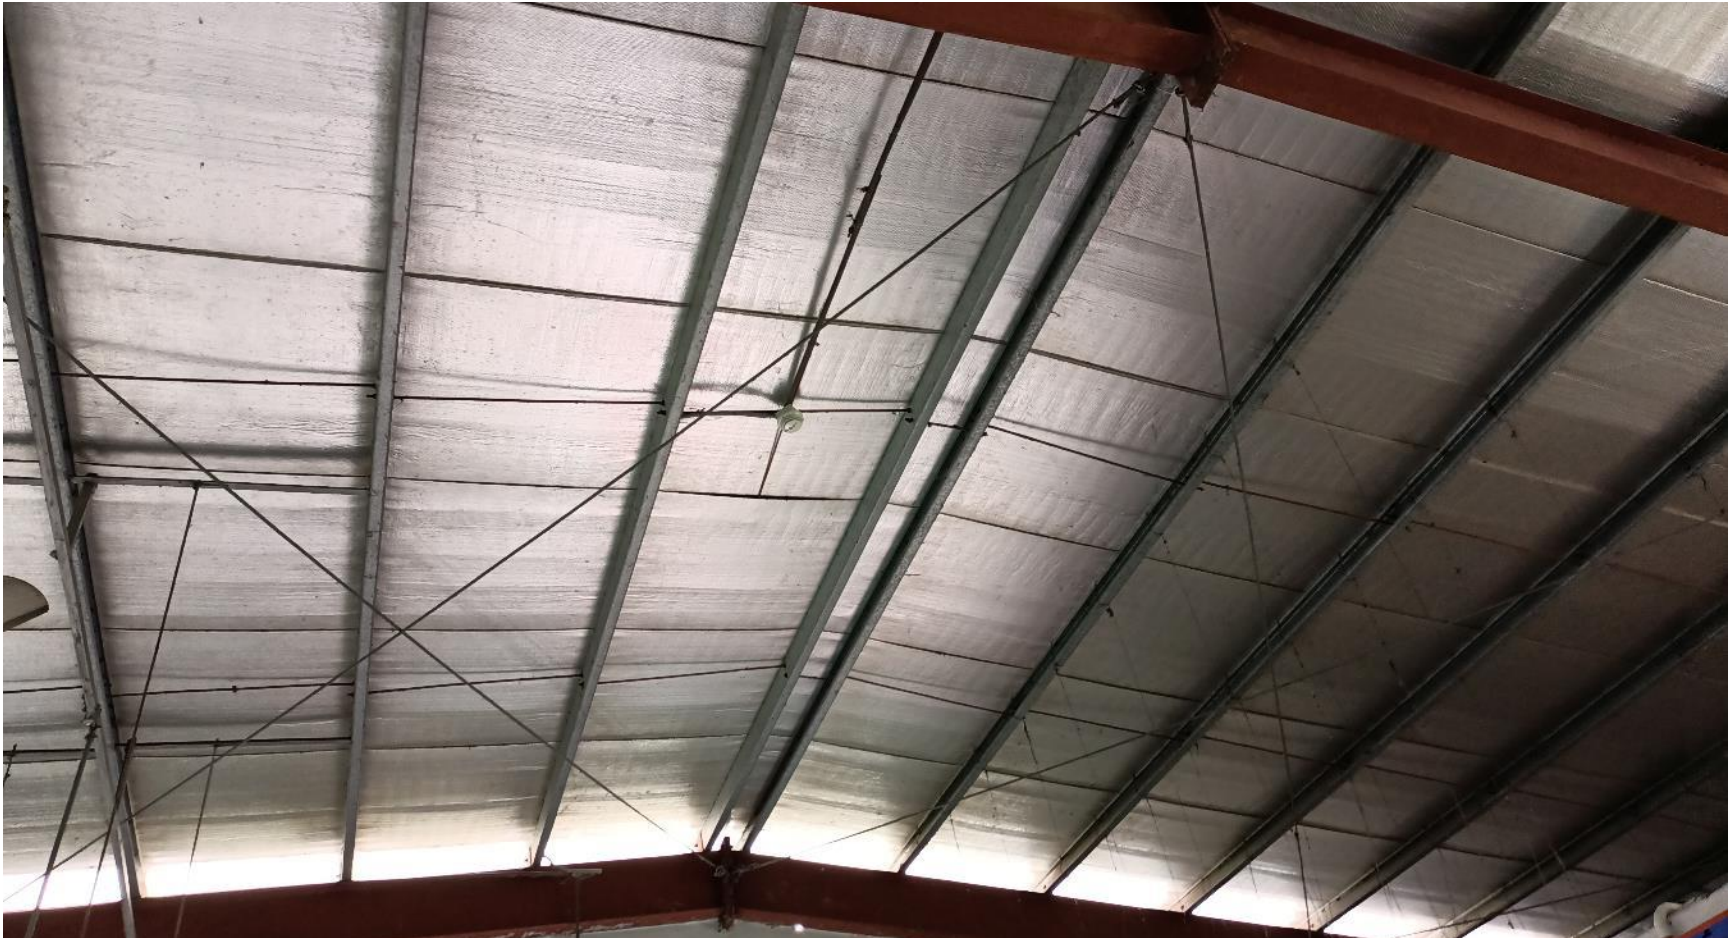
Some of the horizontal cable bracings were found loose. The factory is required to tight the bracings for transferring the lateral loads properly.

Loose cable bracing at roof

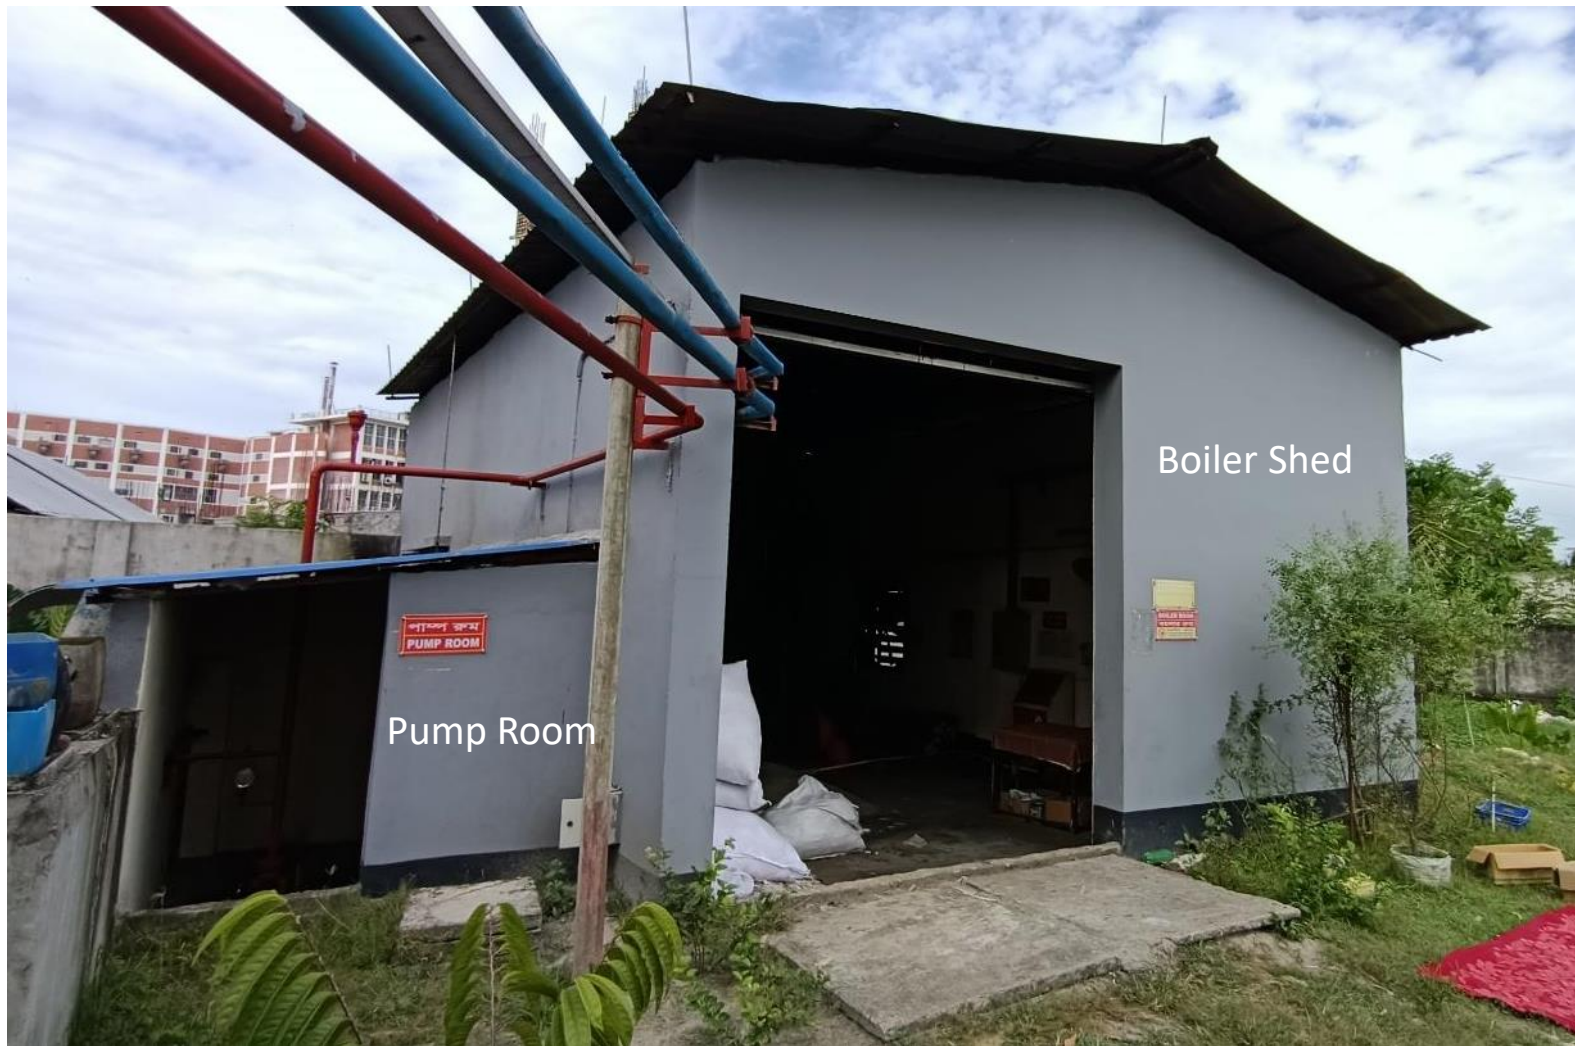
Observation: Boiler Shed & Pump Room

No drawings were available for these ancillary structures.

Item No.	Observation	Recommended Action Plan	Recommended Timeline
09	Undocumented Structure (Boiler Shed and Pump Room).	The building engineer to survey the structures and prepare full set of as-built drawings.	6-weeks
