# C & R Sweater Limited

Votulia (Nayeb Ali Market), P.O-Gazipur, P.S-Sreepur, Gazipur, Bangladesh.  
(24.279432, 90.358833)

21<sup>st</sup> January & 13<sup>th</sup> February 2020

# Observations

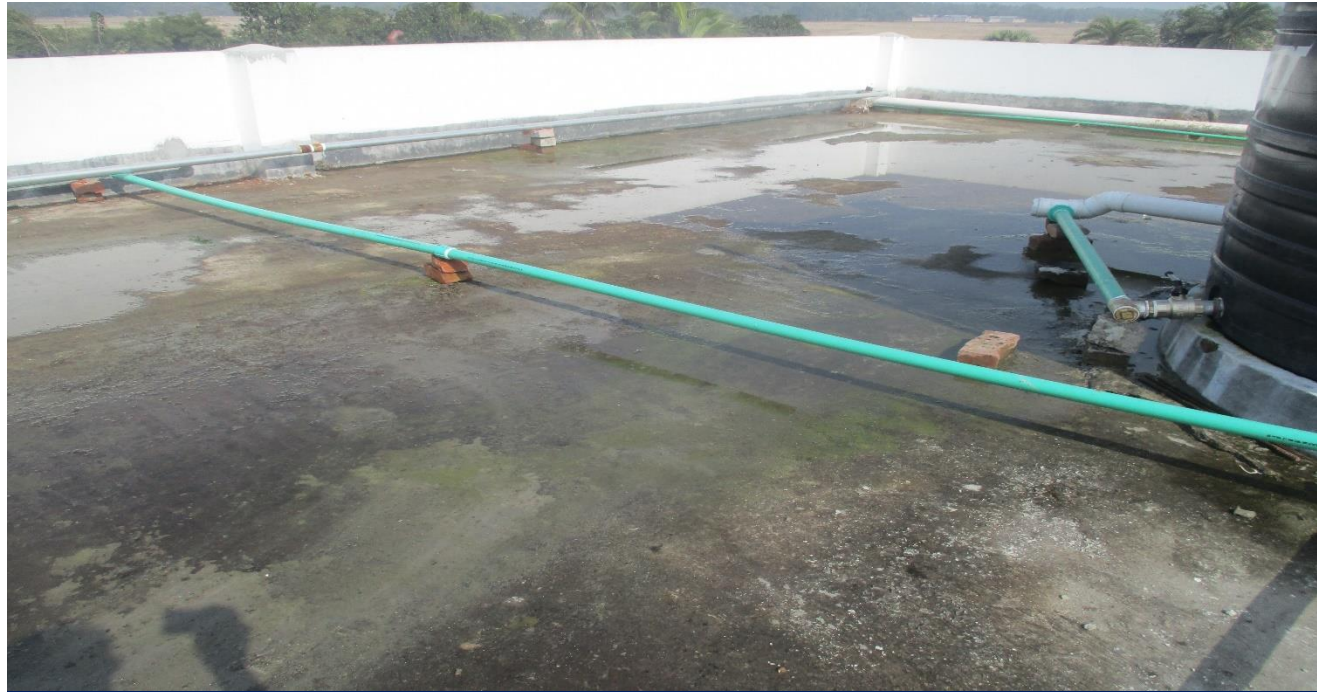
Water ponding was found at roof of Building-1. During inspection sign of water ponding was found. Factory is required to provide water proofing layer and improve drainage system to avoid water ponding.

Water ponding on roof slab at Building-1

| Item No. | Observation | Recommended Action Plan | Recommended Timeline |
|---|---|---|---|
| 04 | Lack of Water Proofing on Roof (Building-1) | Factory is required to provide water proofing layer and improve drainage system to avoid water ponding. | within 6-weeks |

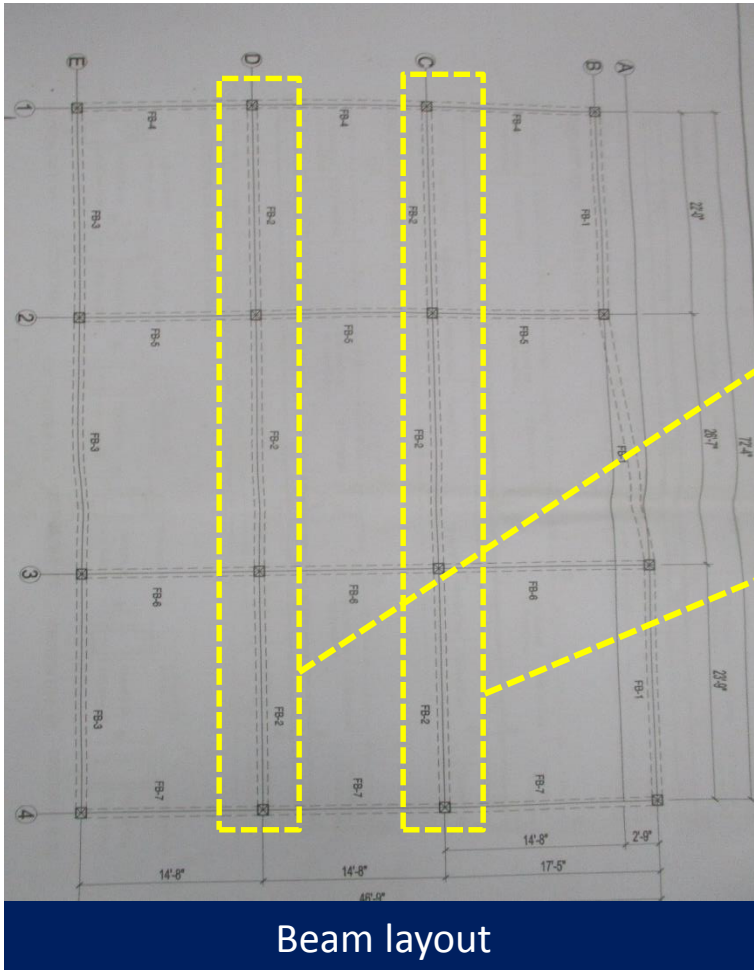
Beam layout

Length of Span in longitudinal direction is 9.7m but beam size is 250mm (W)X 315mm (d/s) which appeared to be undersized. Beam were also found sagged. Factory engineer is required to carry out the adequacy check of all beams.

| Item No. | Observation | Recommended Action Plan | Recommended Timeline |
|---|---|---|---|
| 05 | Beam appeared to be undersized and sagged (Utility Building) | Factory engineer is required to carryout the adequacy check of all beams. | within 6-weeks |
| 06 | Beam appeared to be undersized and sagged (Utility Building) | Implement remediation works if required. | within 6-months |

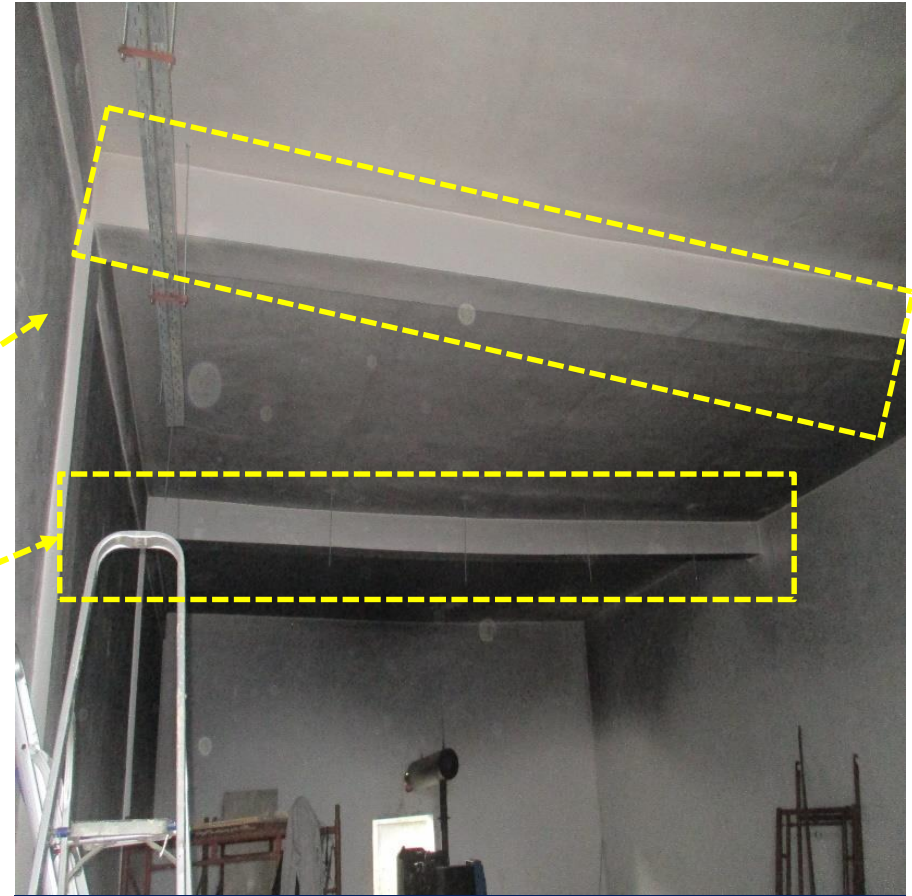
Longitudinal sagged beam

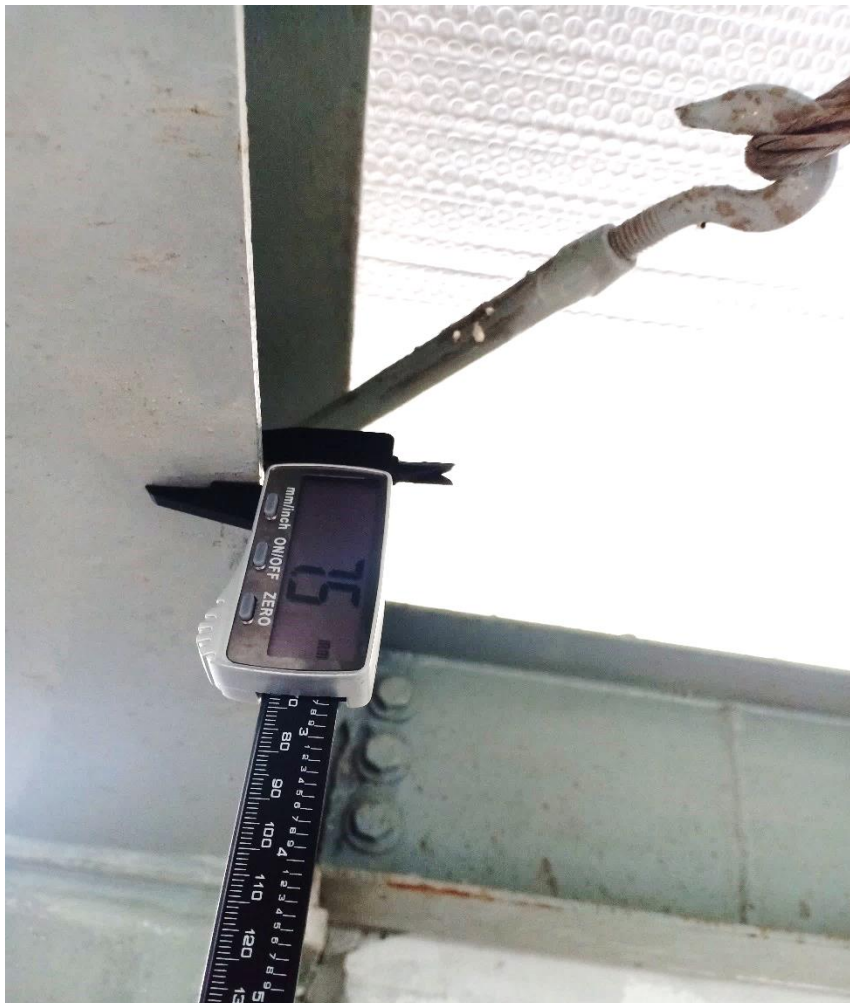
Flange thickness of end rafter was found 7 mm instead of 8 mm. Also, Connection details were not shown in drawing.

Flange thick 7 mm

| Item No. | Observation | Recommended Action Plan | Recommended Timeline |
|---|---|---|---|
| 07 | Inconsistency in drawing (Main Production shed) | Building Engineer to survey the structures and prepare accurate as-built documents with connection details. | within 6-weeks |

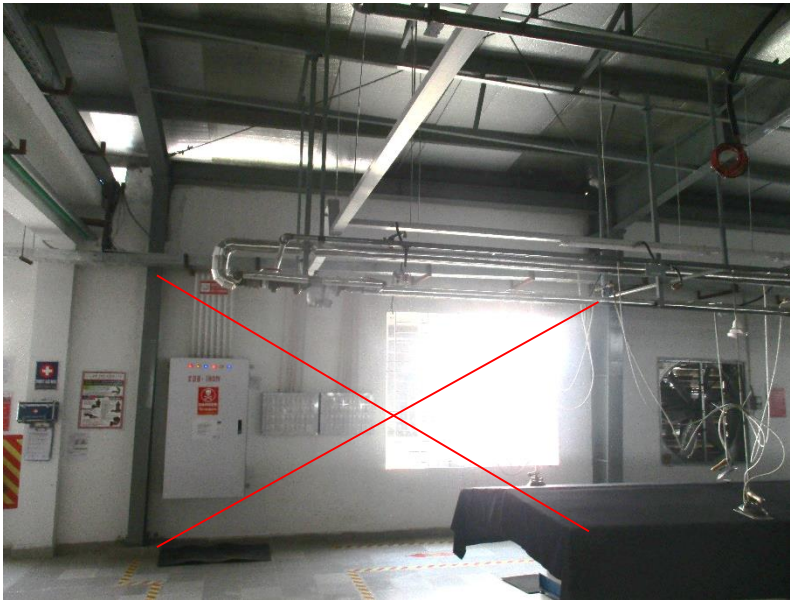
Missing vertical bracing

Vertical bracings are missing at all location which are shown in drawing. Also horizontal roof cable bracings were found loose.

| Item No. | Observation | Recommended Action Plan | Recommended Timeline |
|---|---|---|---|
| 08 | Missing vertical bracings & loose roof bracings (Main Production shed) | Factory Engineer to survey the whole structure to identify locations of all missing vertical bracings and install them. | within 6-weeks |

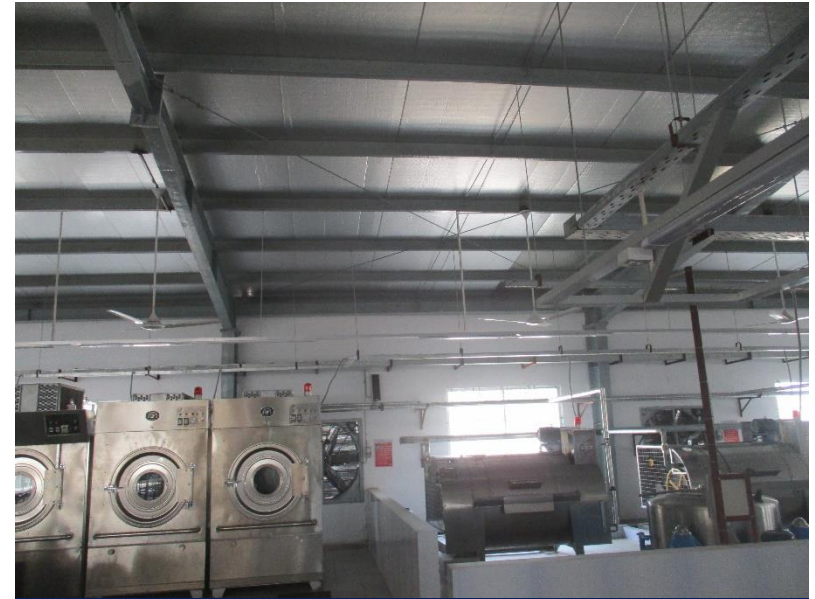
Loose roof bracing

| Item No. | Observation | Recommended Action Plan | Recommended Timeline |
|---|---|---|---|
| 09 | Missing vertical bracings & loose roof bracings (Main Production shed) | Factory Engineer to tighten loose bracings where necessary. | within 6-weeks |

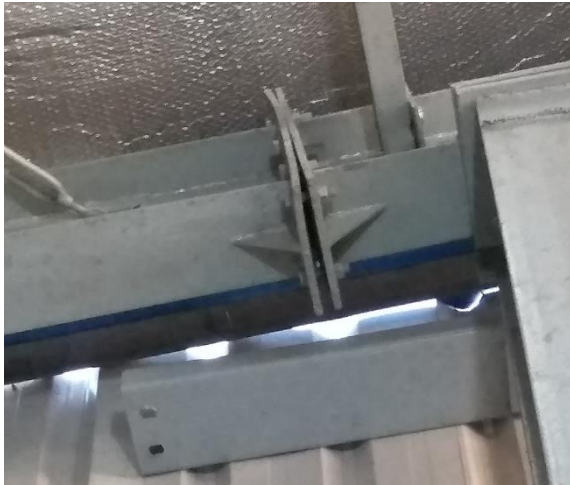
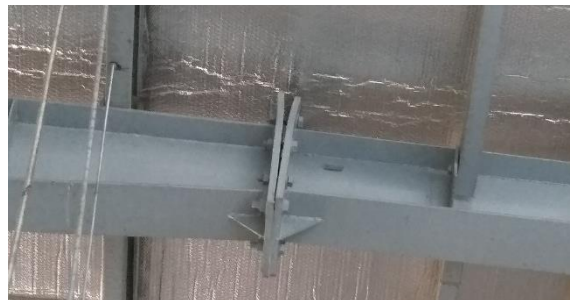
Existence of significant gap was observed between rafter-rafter connections at several locations. Factory is required to fill the gaps as suggested by the engineer.

Gap between rafter-rafter connections

| Item No. | Observation | Recommended Action Plan | Recommended Timeline |
|---|---|---|---|
| 10 | Existence of significant gap between connections (Main Production shed) | Factory is required to fill the gaps as suggested by the engineer. | within 6-weeks |

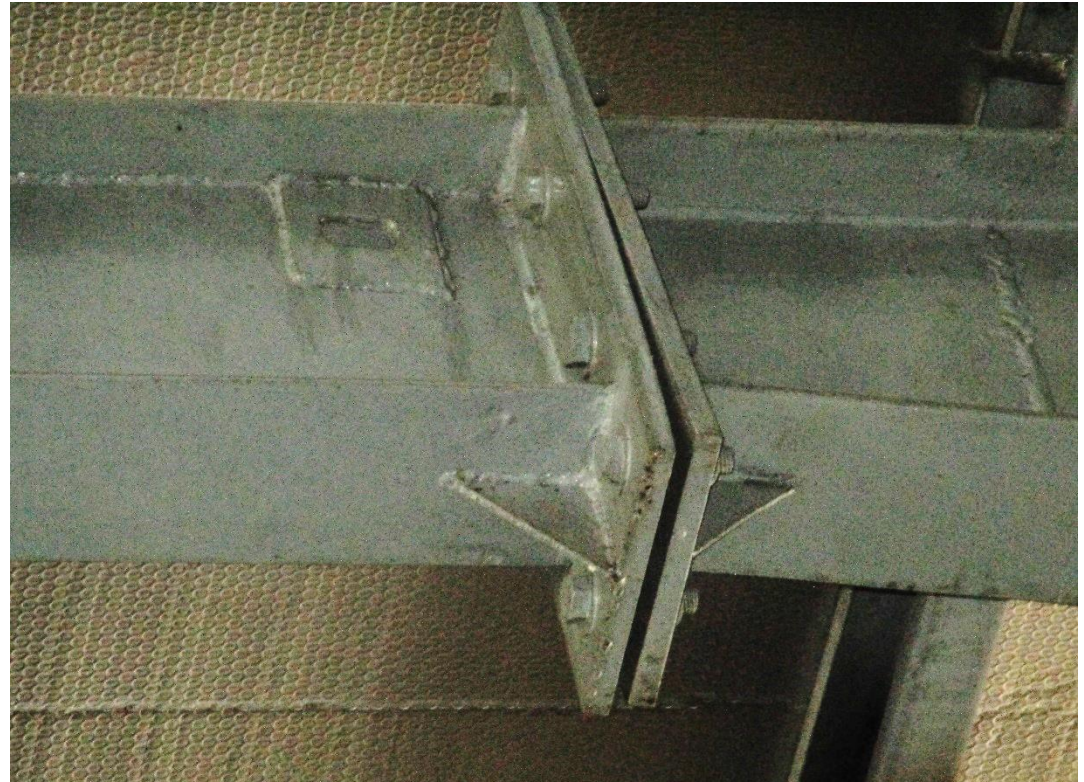
Gap between rafter-rafter connections

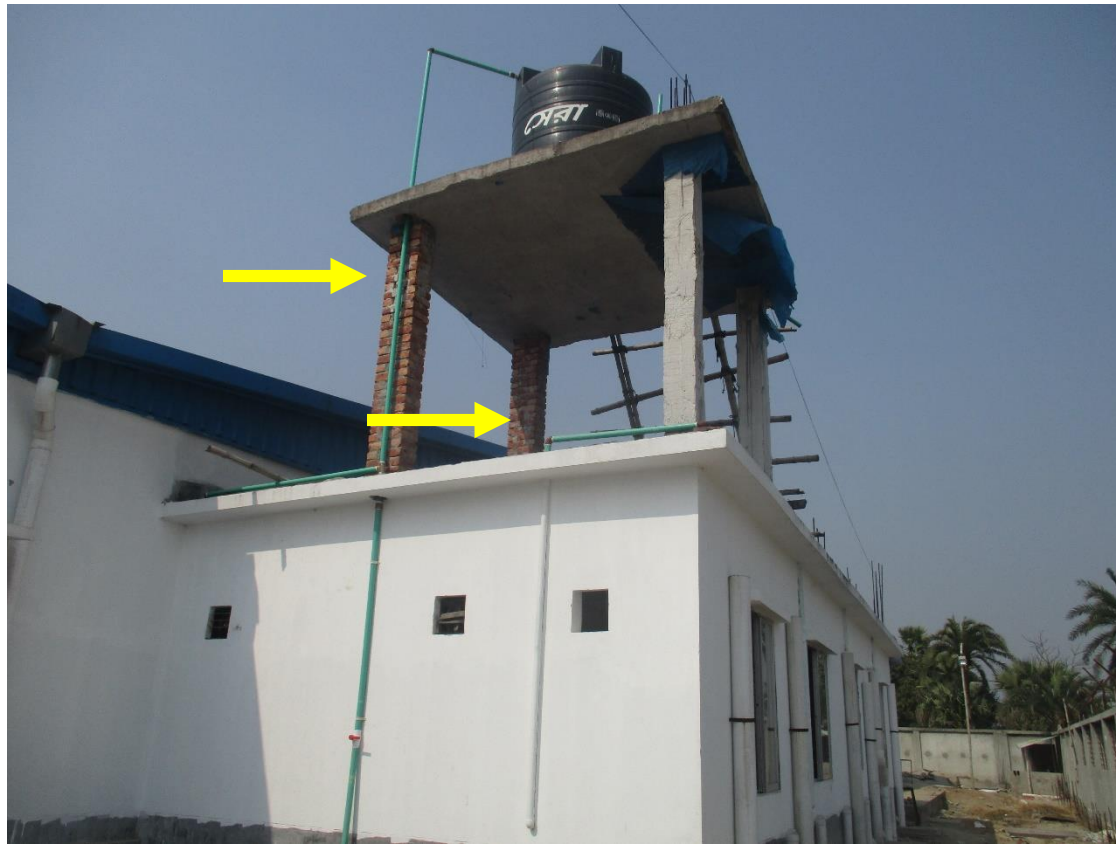
Water tank supported on unstable platform

Water tank supporting slab is resting on two RC and two brick columns. Factory is required to remove the slab and water tank. Alternatively the water tank must be supported on properly designed structure.

| Item No. | Observation | Recommended Action Plan | Recommended Timeline |
|---|---|---|---|
| 11 | Water tank above unstable platform (Toilet Block) | Factory is required to remove the slab and water tank. Alternatively the water tank must be supported on properly designed structure. | within 6-weeks |
