ELECTRICAL SAFETY INSPECTION REPORT

UNICORN SWEATERS LTD (EXTENSION BUILDING)

Inspected on: October 19, 2021

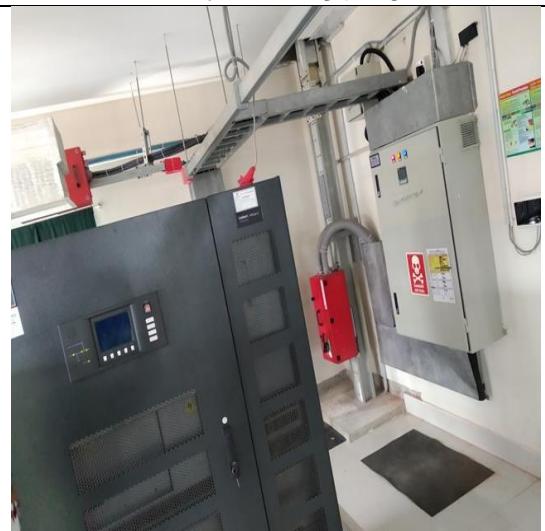
Electrical wiring duct with LED tube light shed.

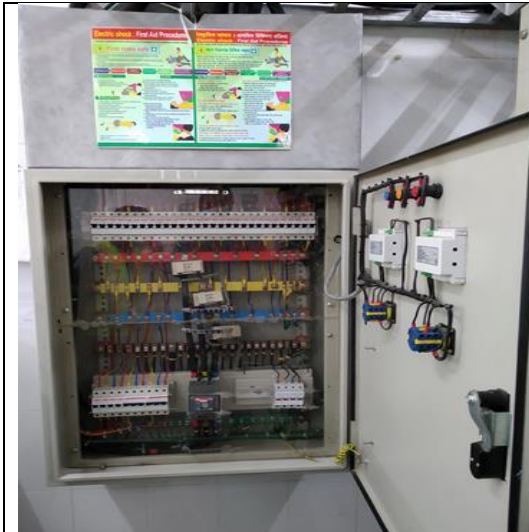
Typical cable entry system into electrical panel in production floors.

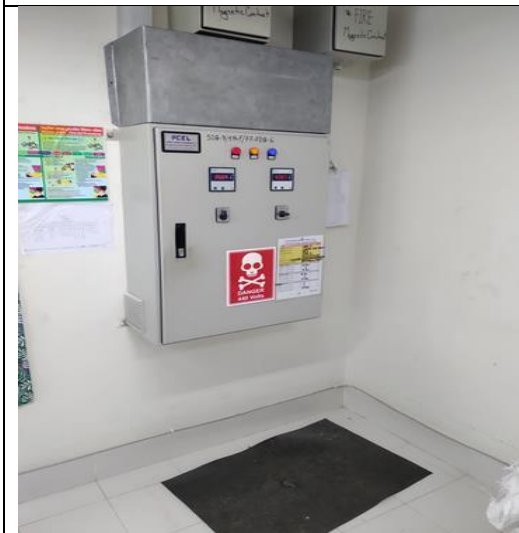
Cable entry is done through cable gland with base plates.

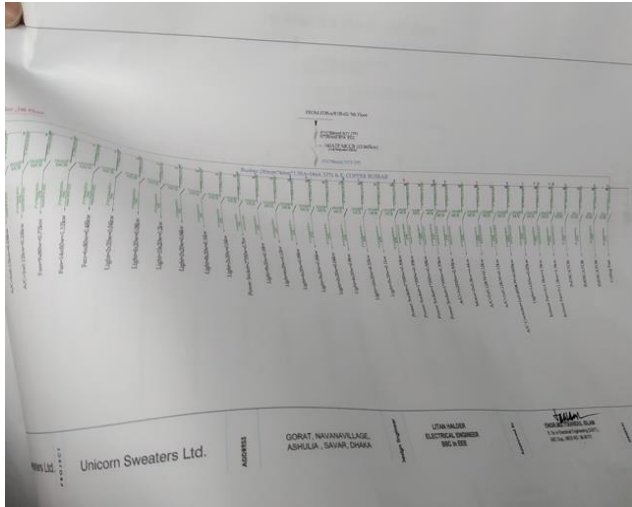
FINDING NO:	E - 1
CATEGORY:	DOCUMENTATION
FINDING:	
Field information has no/less reflection in existing SLD	
RECOMMENDATION:	
Draw as built electrical SLD mentioning all required information by qualified engineer and get it reviewed by Accord. Electrical SLD must be updated properly when electrical system is modified.	
PRIORITY:	P2
REMIATION TIME FRAME:	3 MONTHS

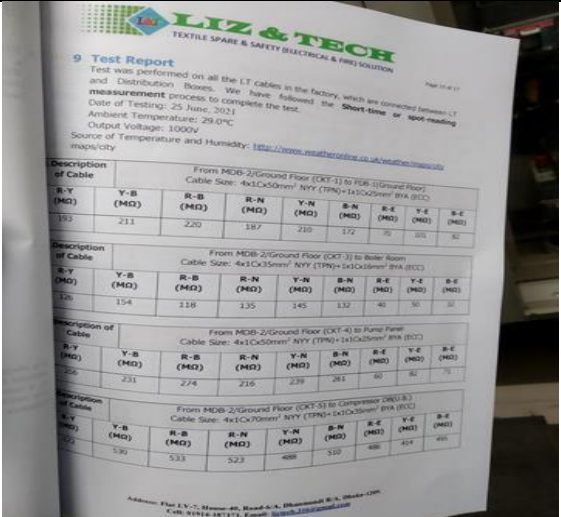
FINDING NO:	E - 2
CATEGORY:	TESTING & PERIODIC MAINTENANCE
FINDING:	
Insulation resistance test did not cover all system.	
RECOMMENDATION:	
Insulation resistance test of all the cables (you can avoid less than 25 sq.mm) must be performed once in every 2 years' cycle and recorded (this must require a complete power shut off).	
PRIORITY:	P2
REMIATION TIME FRAME:	1 MONTH

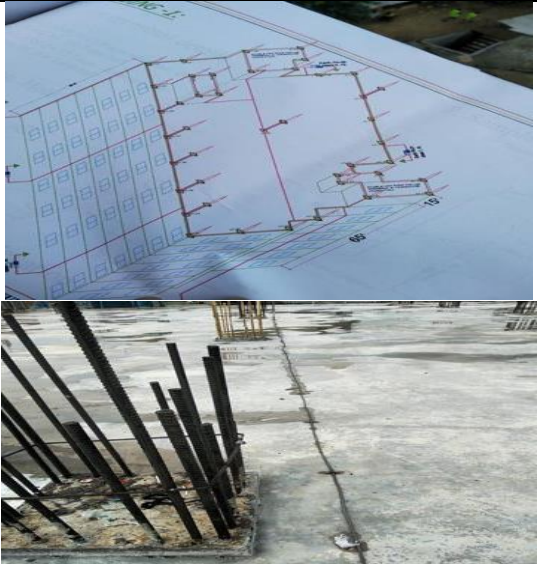
FINDING NO:	E - 3

CATEGORY:	LIGHTNING PROTECTION SYSTEM	
FINDING:		
<p>i. LPS drawing and installation needs modification. ii) Bonding not done properly.</p>		
RECOMMENDATION:		
<p>Factory has to redesign Lightning Protection system (LPS) for the whole premises (where necessary and the Risk index is more than 40) and install the system with appropriate materials according to the acknowledged standard.</p>		
PRIORITY:	P2	
REMIATION TIME FRAME:	2 MONTHS

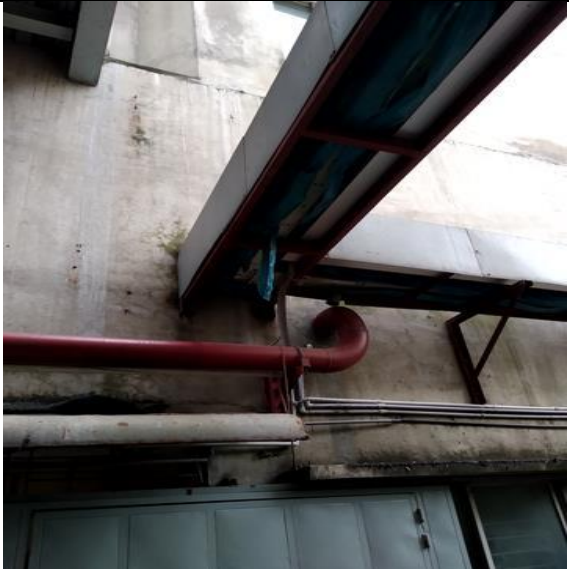
FINDING NO:	E - 5

CATEGORY:	CABLE RACEWAY & TRENCH	
FINDING:		
<p>Combustible material attached with BBT.</p>		
RECOMMENDATION:		
<p>BBT must be kept neat and clean; these must be free from combustible material.</p>		
PRIORITY:	P2	
REMIATION TIME FRAME:	1 MONTH
