TEB Fashions International Ltd (9265)

27.MARCH.2014

ACCORD
on Fire and Building Safety in Bangladesh

Identified Priority 1 Concerns

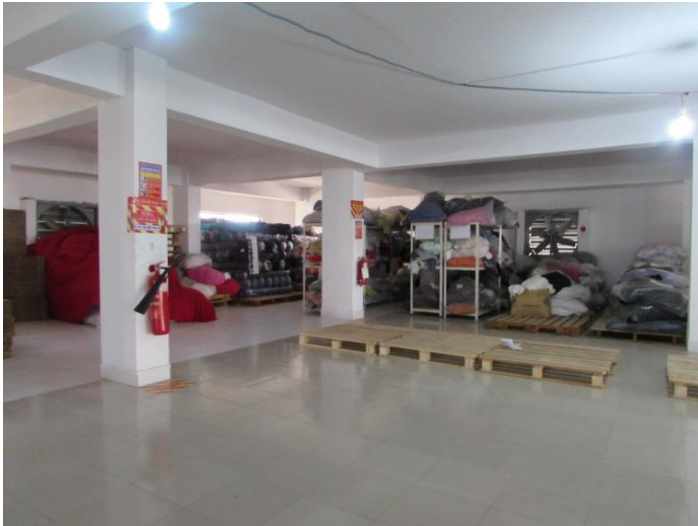
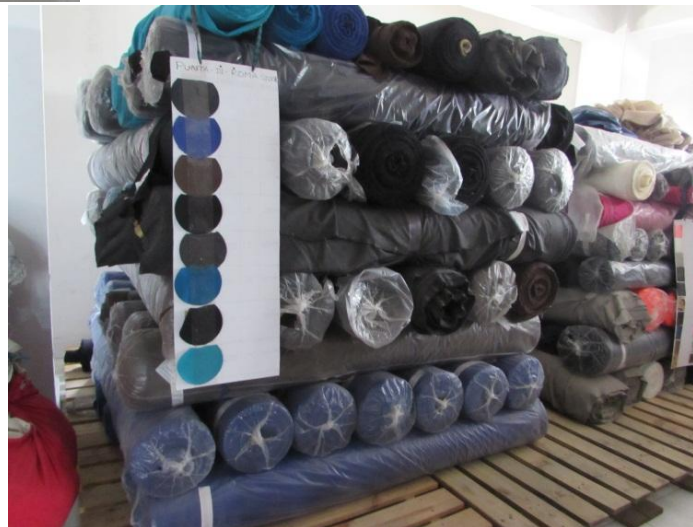
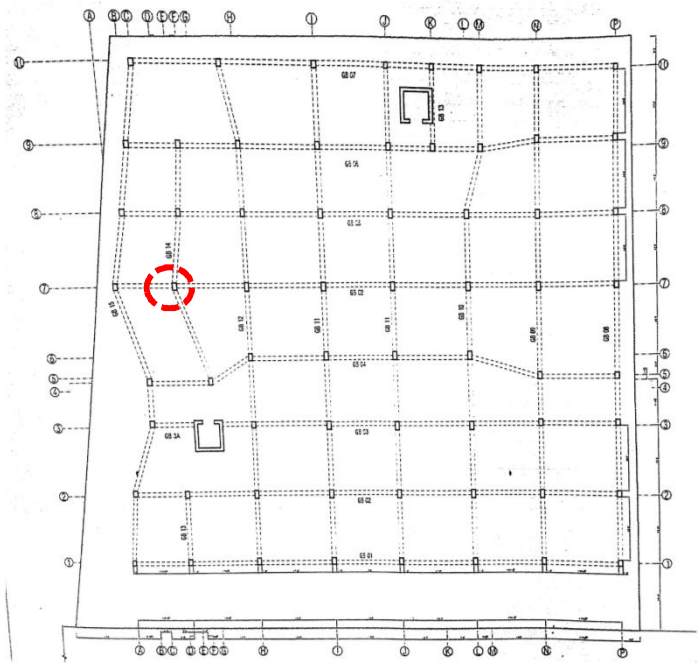
Each roll of fabric is estimated to be approximately 30kg. As they are stacked 8 rolls high, and arranged 7 rolls per layer, the weight of each layer is approx 210kg, resulting in a total weight of 1680kg (16.5kN) per stack.

Based on a plan area of 1.5m x 1.5m per stack, the equivalent live load per stack is estimated to be:

$$16.5\text{kN} / (1.5 \times 1.5)\text{m}^2 = 7.33\text{kPa}.$$

The allowable live load is max. 3.0kPa

Excessive Storage Height on Level 5

Storage area on Level 5 appeared to have stored materials exceeding the permissible floor load.

- Redistribute fabric rolls around the floor area to ensure that no stack exceeds 300kg/m²

- Implement loading plan and oversee that storage of finished goods and raw materials are stored in accordance with the loading plan.

- Maintain loading plan

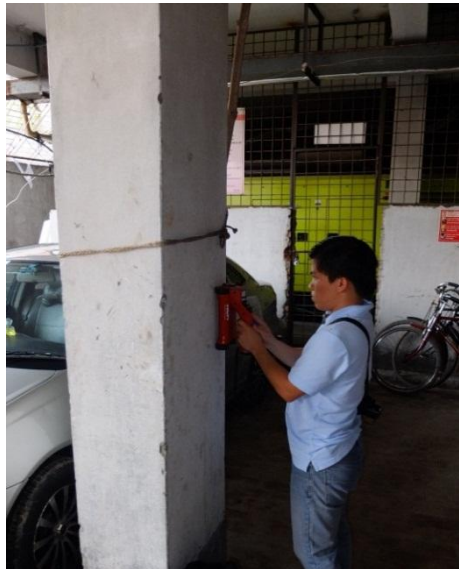
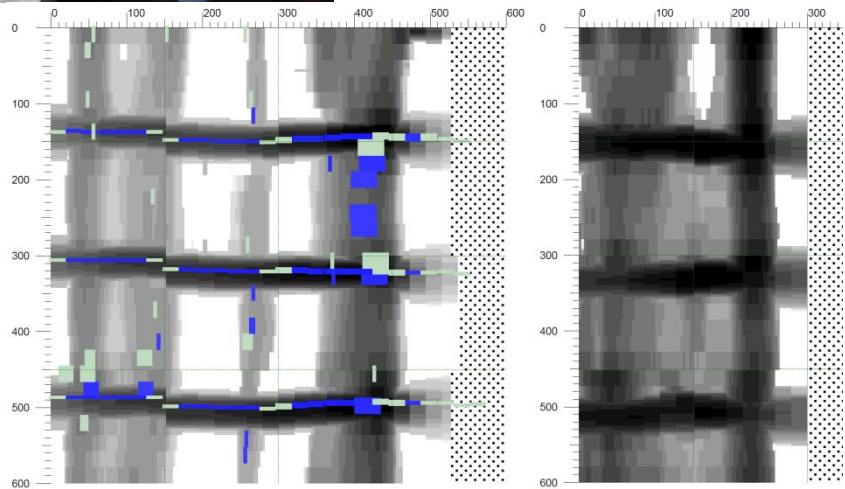
The original structural drawings denote that column C3 (circled in Red) has an RC detail of 24 no #6 bars. However, the ferroscope of the column at G/F level revealed only a maximum of 12 bars. Further investigations were carried out to determine the composition of the structure

Rebar of Column C3 is not in accordance with structural drawings

- 1) Brick aggregate instead of stone aggregate
- 2) Mild steel bars instead of high-yield steel bars
- 3) 12-#6 instead of 24 #6 rebars (19mm diameter)
- 4) Greatly reduced loading capacity

Reinforcement provision and concrete composition does not match with the record drawings. Load rundown shows that the concrete column is loaded to a very low factor of safety

- Factory Engineer to review design, loads and columns stresses in all areas
- Verify insitu concrete stresses either by 100mm dia. cores or existing cylinder strength data.

- A full structural survey of the building is to be carried out using intrusive and non-intrusive methods to ascertain the overall accuracy of the existing record drawings.
- All roof activities and buildings are to be terminated and demolished respectively

- Prepare new as-built drawings and a new loading plan for each floor which should be maintained and monitored regularly

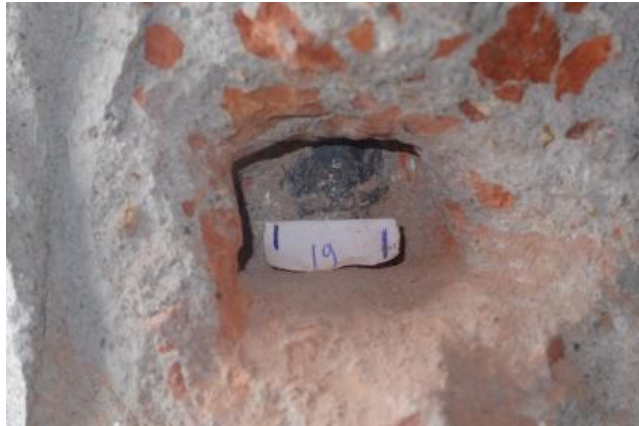
The original drawings specify a concrete using stone aggregate, and using high-yield steel for the main bars, and mild-steel bars for the ties and links. It was noted on the roof floor that high-yield bars were used, but the concrete used contained brick aggregate.

In addition to the ferroskan, exposing the rebar also appeared to indicate that the bar was mild steel instead of high yield steel, as no rib pattern was observed on the rebar.

With this in hand, and based on the observed loading conditions, i.e. imposed load of factory floor not envisaged to exceed 2.0kPa with the exception of the storage floor at level 5, the column load rundown returned an AMBER warning, meaning that there was a very small factory of safety remaining in the loading capacity of the column.

Rebar of Column C3 is not in accordance with structural drawings

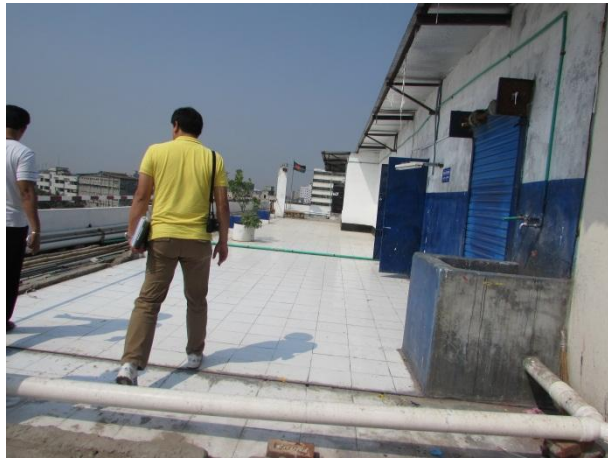
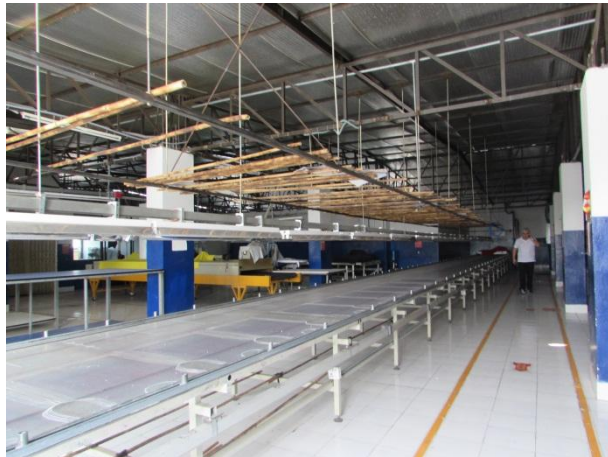
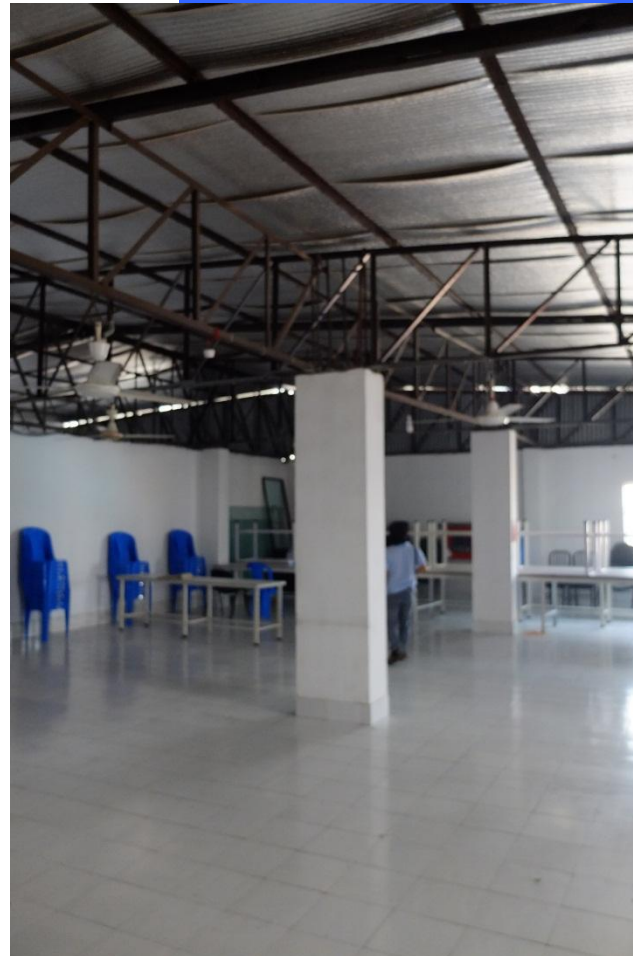
The current planning and permission drawings do not permit any activities on the roof floor, and only 6 storeys (G/F, 1/F-5/F) have permitted usage. It is worth noting that the original building use was intended to be commercial from G/F-3/F, and residential for 4/F and 5/F. The roof floor houses some factory facilities (although partially decommissioned), such as printing room, and dining area.

Additional roof level occupied floor doesn't have a permit

Additional roof activities and buildings are not permitted, according to the approved planning drawings

In order to maintain accordance with the planning drawings, all activities on the roof should cease and the buildings be demolished.

- In accordance with the actions in Item 2, terminate all activities on the roof, and demolish the existing buildings to free up loads from the roof.

- Apply waterproof treatment to the roof to ensure no water seepage to the floor below.
