# Epyllion Knitwears Limited (Madanpur Project)

Village: Madanpur, P.O: Madanpur, Bondor, Narayangonj, Post code- 1411.  
(23.69205, 90.54470)  
26<sup>th</sup> September 2021

# Buildings Information

# Observations

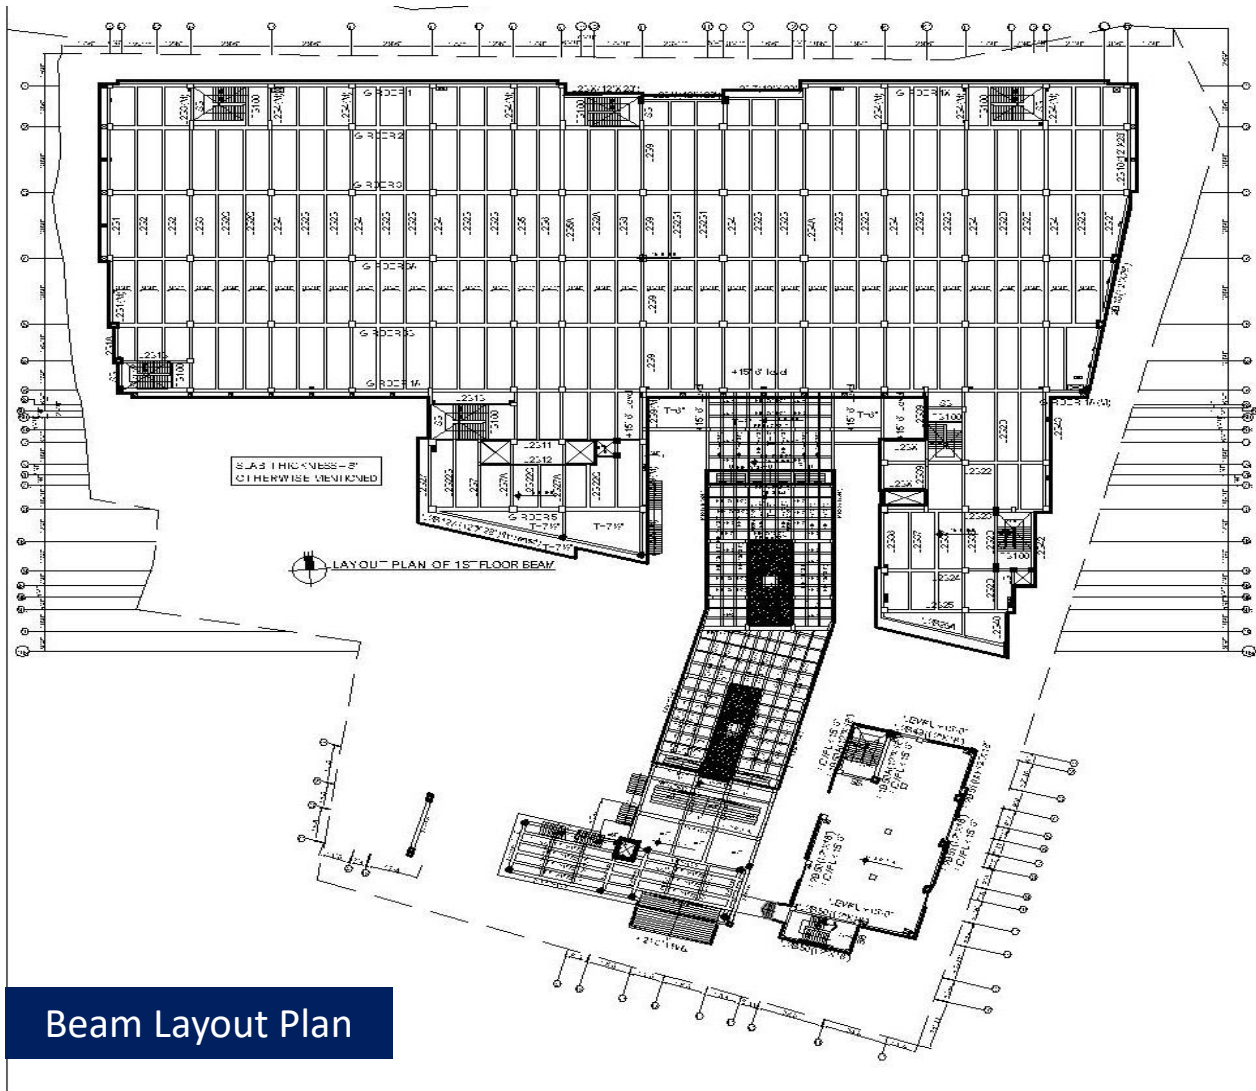
Beam Layout Plan

The building is geometrically irregular shaped. Torsional irregularity check was not included in the design report. Due to lateral forces, the building might be affected for torsional irregularity. Building engineer is required to check the torsional effect of the building for lateral forces.

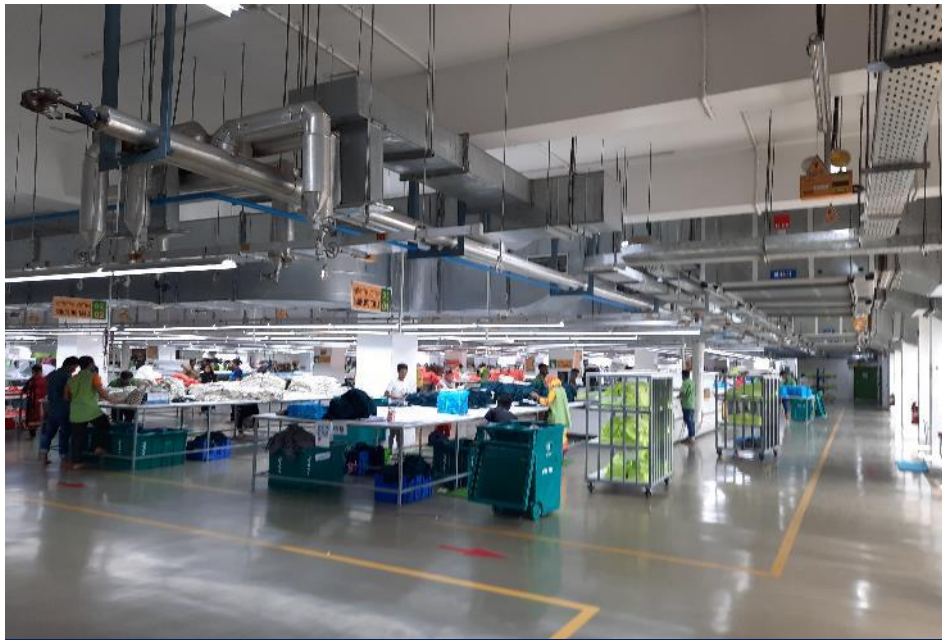
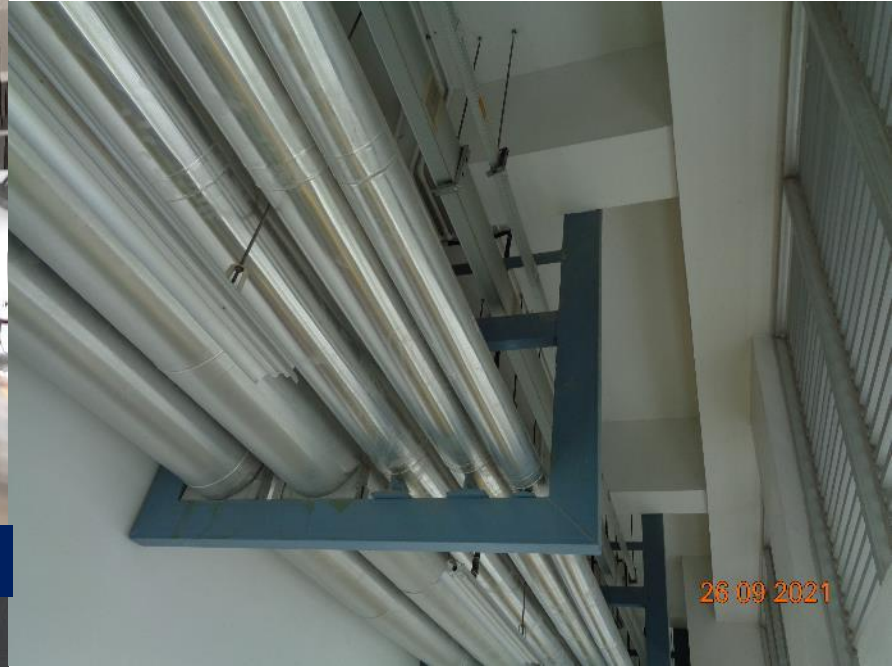
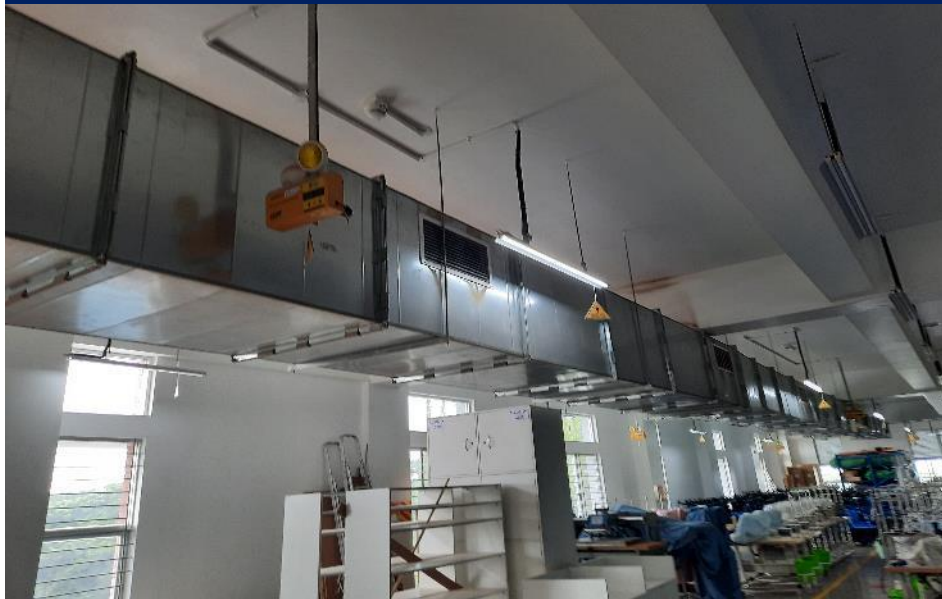
Over hanged non-structural elements

Over hanged non-structural elements observed throughout the production building. Building engineer is required to check whether the non-structural elements are adequately braced & anchored for the seismic movement.

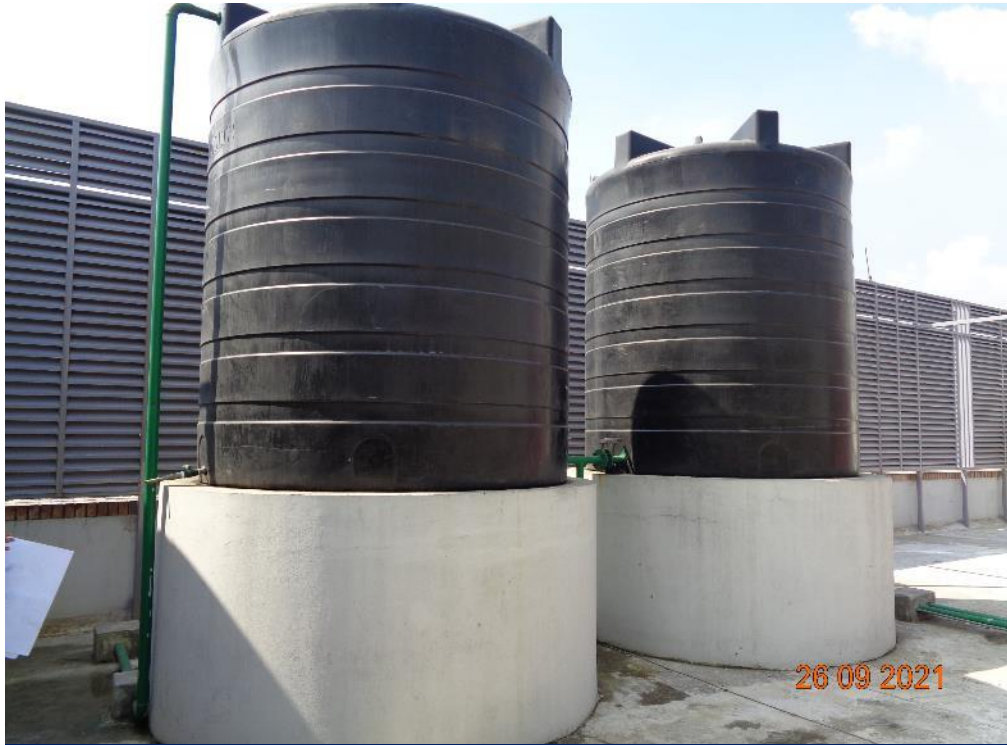
10,000-liter water tanks with 1.3 m buildup

Water tank and cooling towers with additional build up observed on the roof slab. Building engineer is required to check the flexure capacity of the slab.

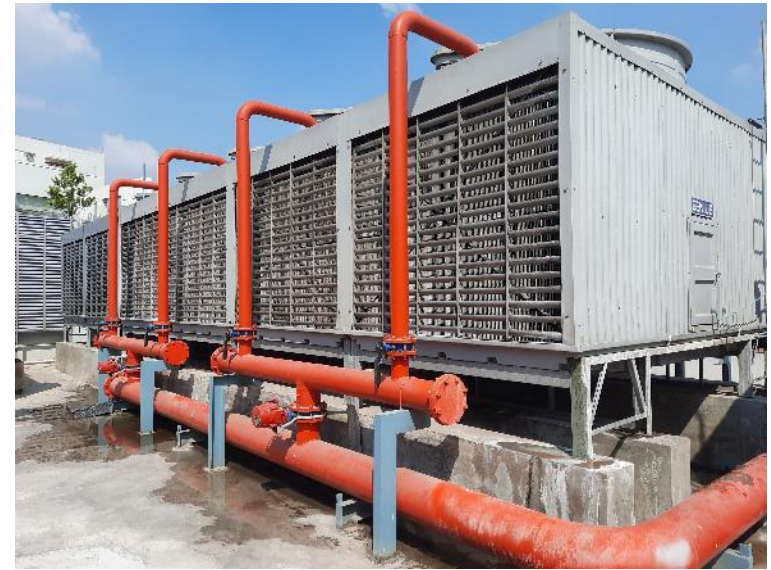
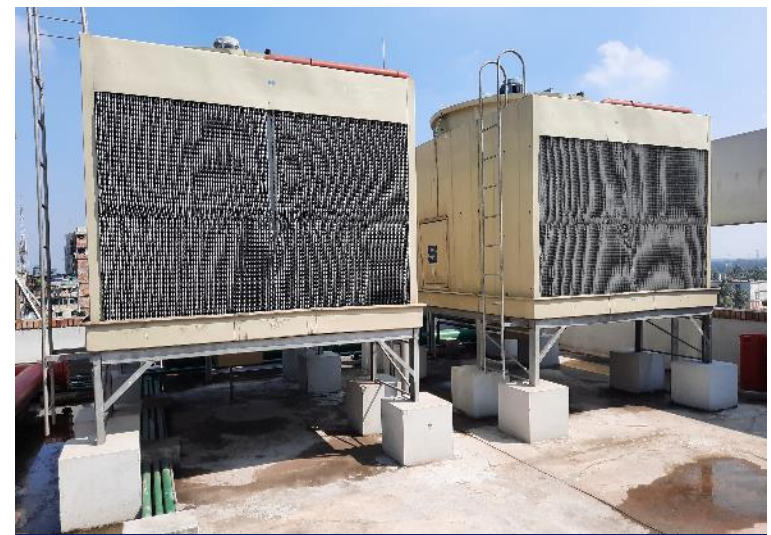
Cooling tower with build ups

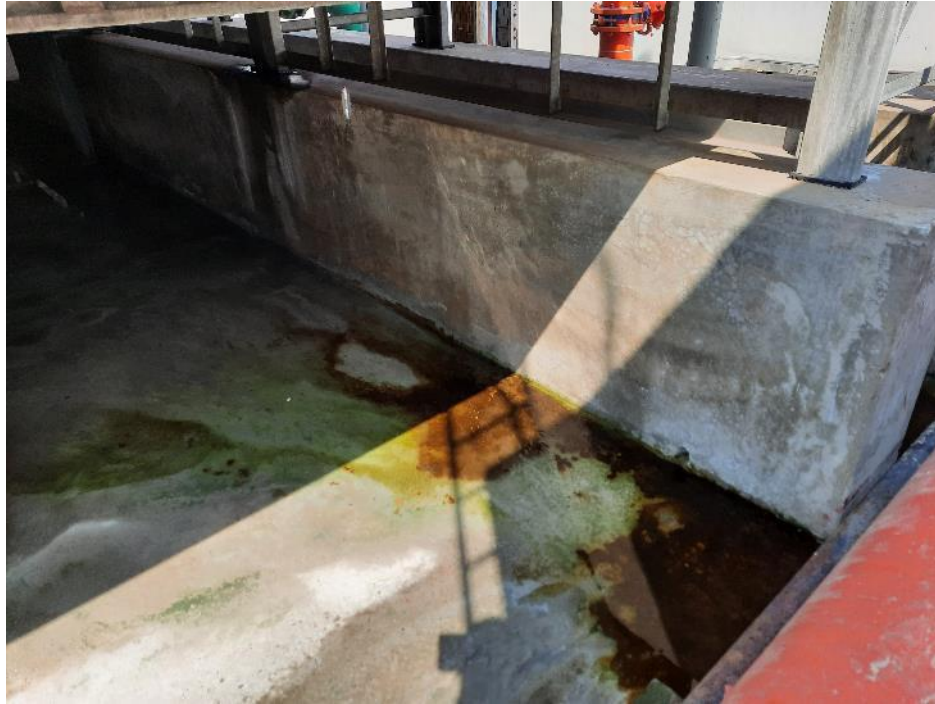
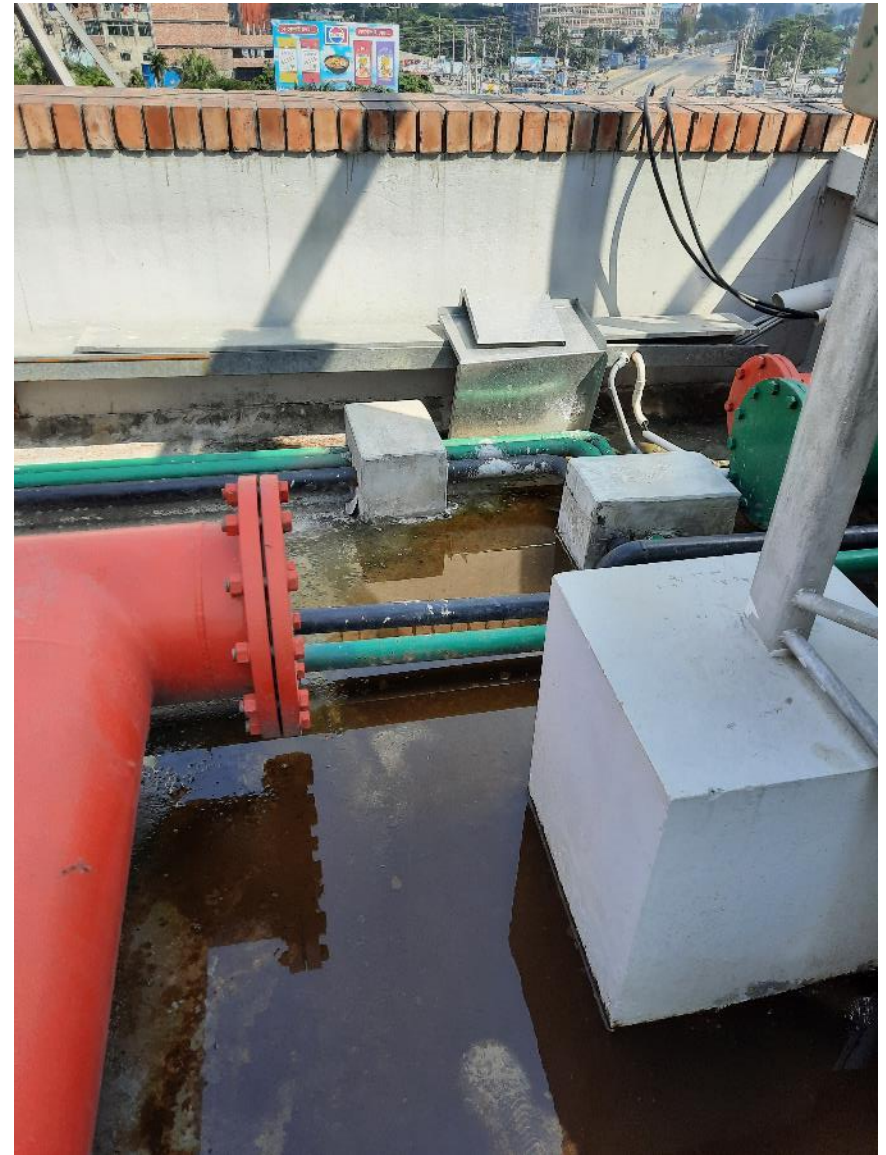
Water ponding observed on the roof. Building engineer is required to improve the roof drainage system.

Water ponding on the roof
