# Minimax Ltd. (Relocated)

20 September 2021

# Observations

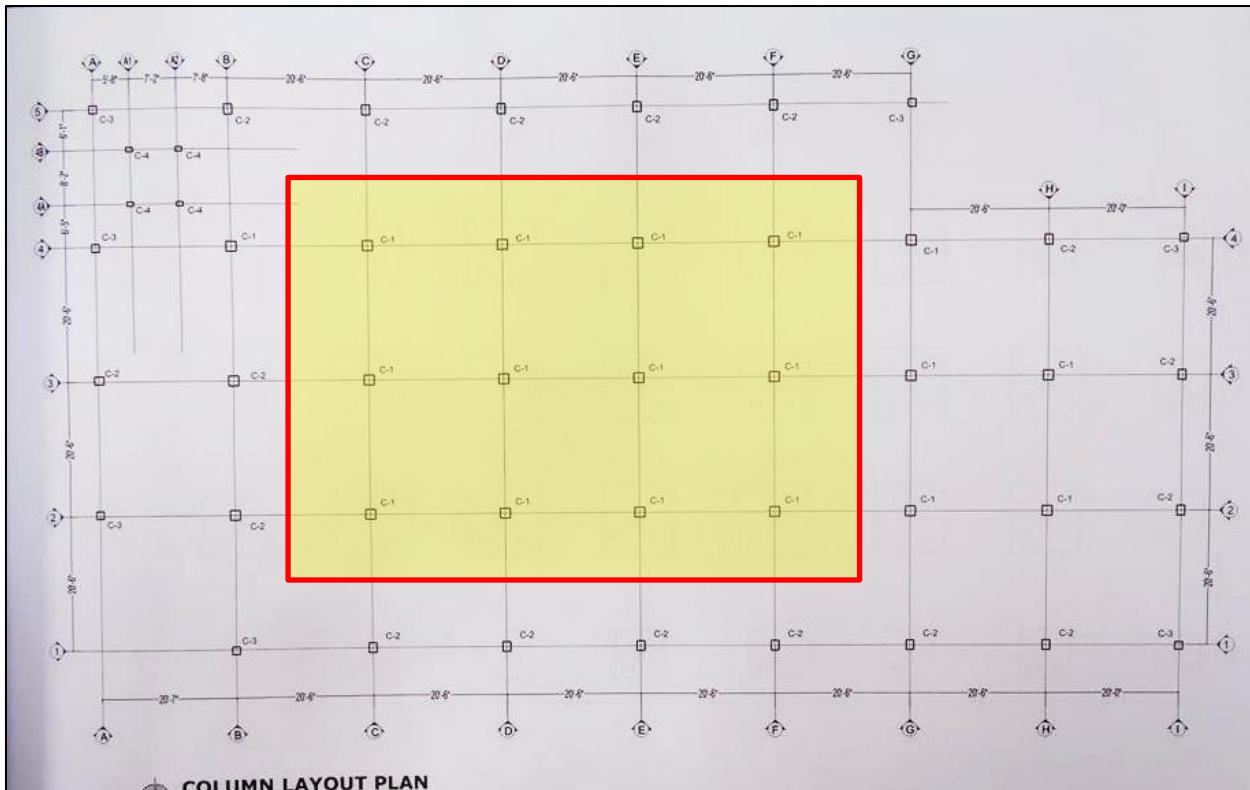
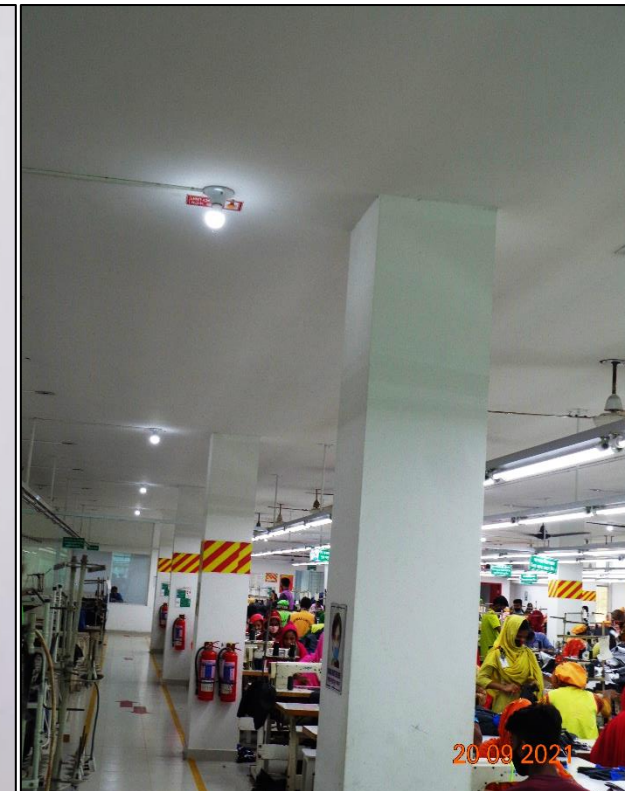
Column Layout plan

**Punching stress in flat slab exceeds  
normal design limit**

Cursory calculation indicates that the punching stress in flat slab of the highlighted area exceeds normal design limit. Considering 3 kPa live load on typical floor, 1.5 kPa on roof and equivalent concrete strength for brick chips, flat slab have been found stressed in excess of normal design limit. Factory Engineer to review design, loads and punching stresses in area identified above. Verify in-situ concrete strength by 100mm dia. cores from existing flat slab. Produce and actively manage a live loading plan for all floor plates within the factory considering floor capacity.

| Item No. | Observation | Recommended Action Plan | Recommended Timeline |
|---|---|---|---|
| 01 | Punching stress in flat slab exceeds normal design limit. (Building-1) | As part of Detail Engineering Assessment (DEA), factory engineer to review design, loads and punching stresses of flat slab. | 6-weeks |
| 02 | Punching stress in flat slab exceeds normal design limit. (Building-1) | Verify in-situ concrete strength by 100mm dia. cores from existing flat slab. | 6-weeks |
| 03 | Punching stress in flat slab exceeds normal design limit. (Building-1) | Produce and actively manage a loading plan for all floor plates within the factory considering floor capacity. | 6-weeks |
| 04 | Punching stress in flat slab exceeds normal design limit. (Building-1) | Implement floor loading plan (posting load plan, marking storage height and monitoring live loads). | 6-months |

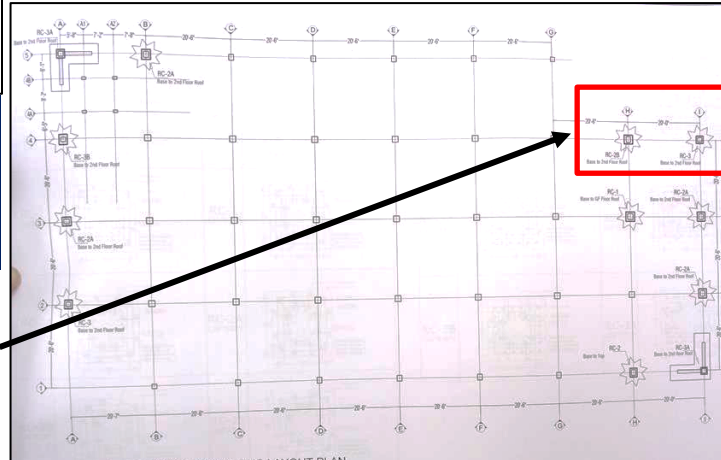
Column retrofitting & shear wall layout plan

Retrofitting of these two column was not completed at 2<sup>nd</sup> floor as per retrofitting drawing.

Factory engineer is required to check the requirement of strengthening of these two columns and revise the Detail Engineering Assessment (DEA) report accordingly. Submit DEA report to RSC for further review.

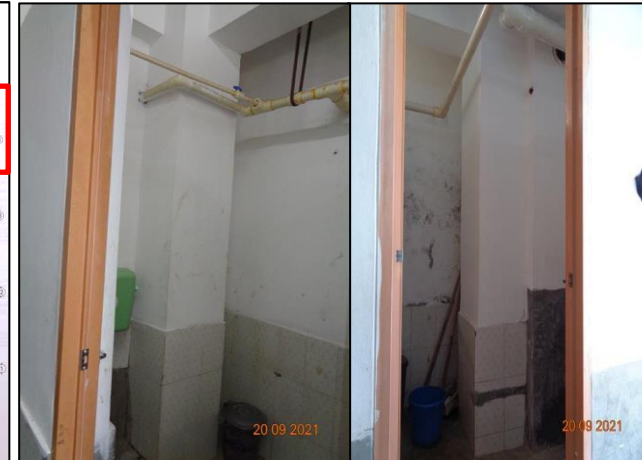
These two column has not been retrofitted

| Item No. | Observation | Recommended Action Plan | Recommended Timeline |
|---|---|---|---|
| 05 | DEA report needs to be reviewed by RSC (Building-1) | Factory engineer to revise the DEA documents including a DEA report, load plan and a set of structural drawings in compliance with BNBC-2006 and submit to RSC for further review. | 6-weeks |
| 06 | DEA report needs to be reviewed by RSC (Building-1) | Carry out remedial/alteration works if necessary. | 6-months |

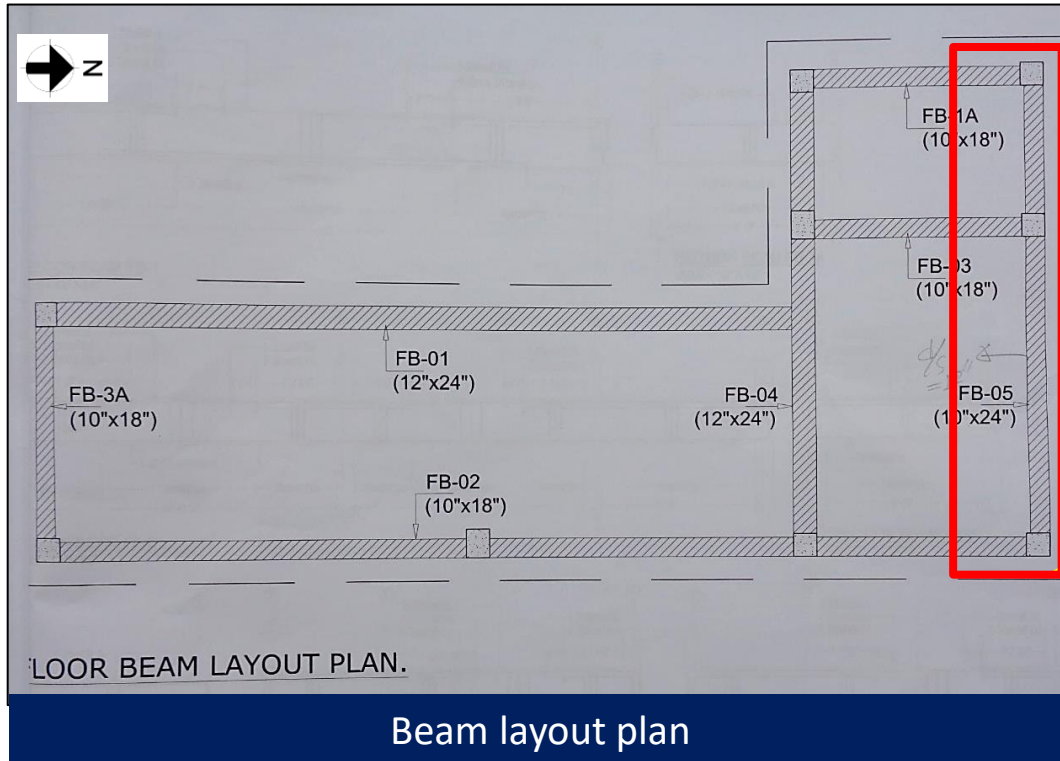
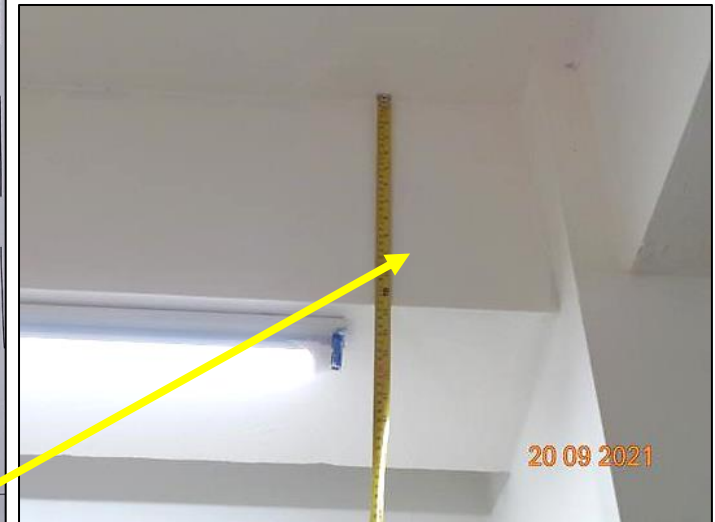
Down-stand depth of the beam was found 300 mm

During inspection, down-stand depth of the beam was found 300 instead of 465 mm (considering 135 mm slab thickness).

Factory engineer is required to survey the whole structure and update the as-built drawing in compliance with the article 1.9.1 of BNBC 2006 (part-6)

| Item No. | Observation | Recommended Action Plan | Recommended Timeline |
|---|---|---|---|
| 07 | Discrepancies in as-built drawings (Building-4) | Building Engineer is to survey the whole structure and update as-built drawings representing accurate site condition. | 6-weeks |
