# Amigo Bangladesh Ltd.

RS No: 1408 - 1416, Khalapara, Dakkhinbag, Kaliganj, Gazipur-1613  
(23.951914, 90.613541)

3<sup>rd</sup> & 11<sup>th</sup> October 2021

# Observations

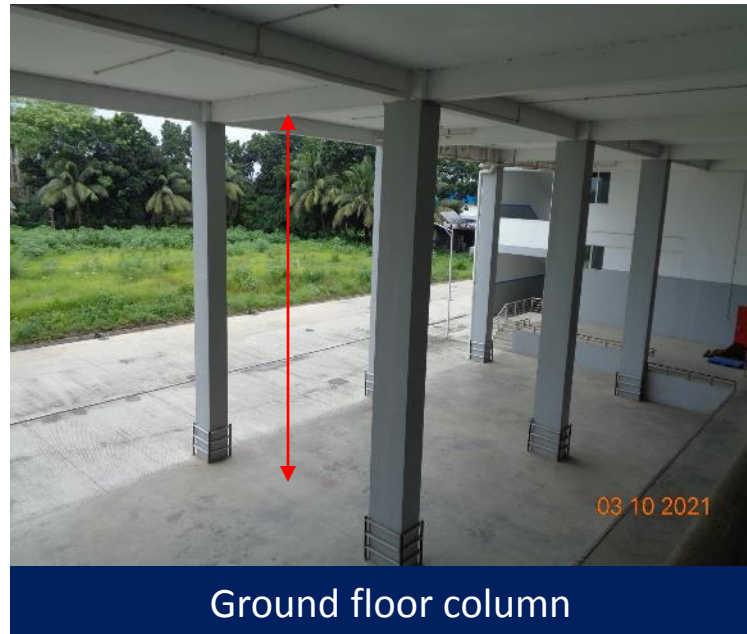
Clear height of ground floor is 9.65 m. The least dimension of column is 600 mm. The building engineer to check the slenderness effect for those columns and incorporate the design in the report.

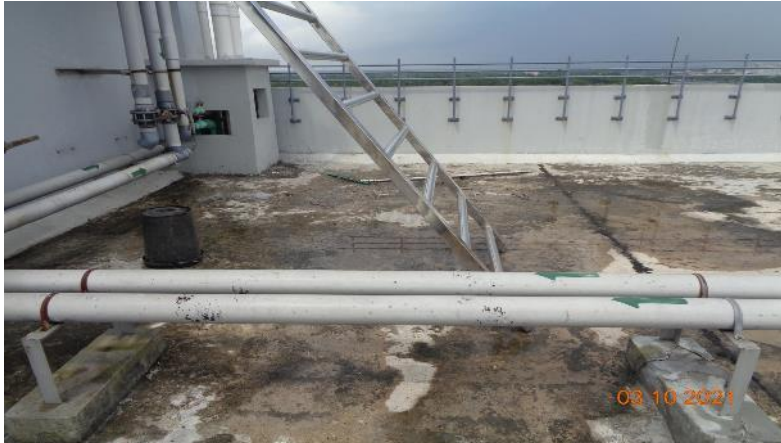
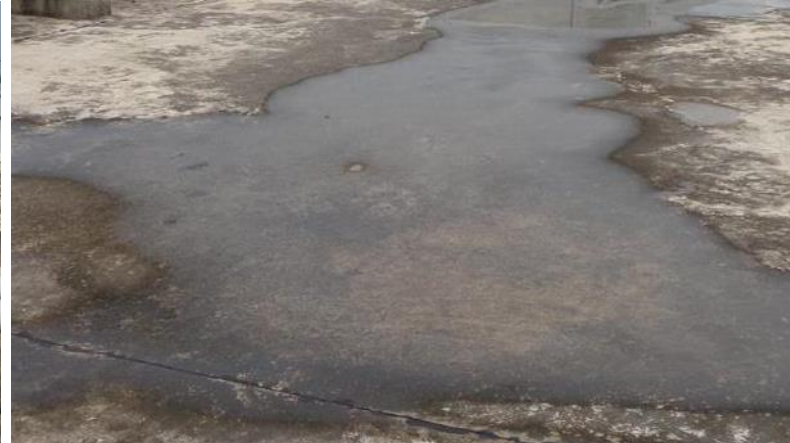
Block 1 roof

# Water ponding on roof

Factory is required to develop proper drainage system on roof with adequate slope or apply water proofing compound on roof slab to resist water ingress.

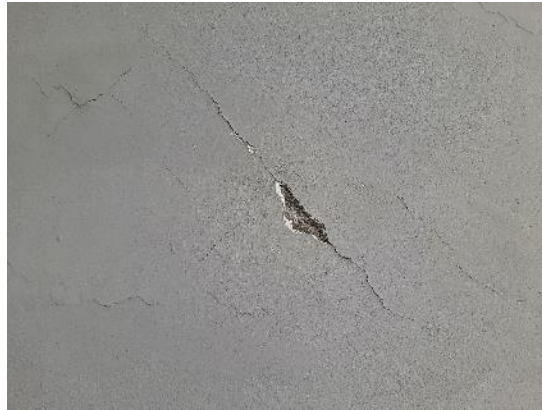
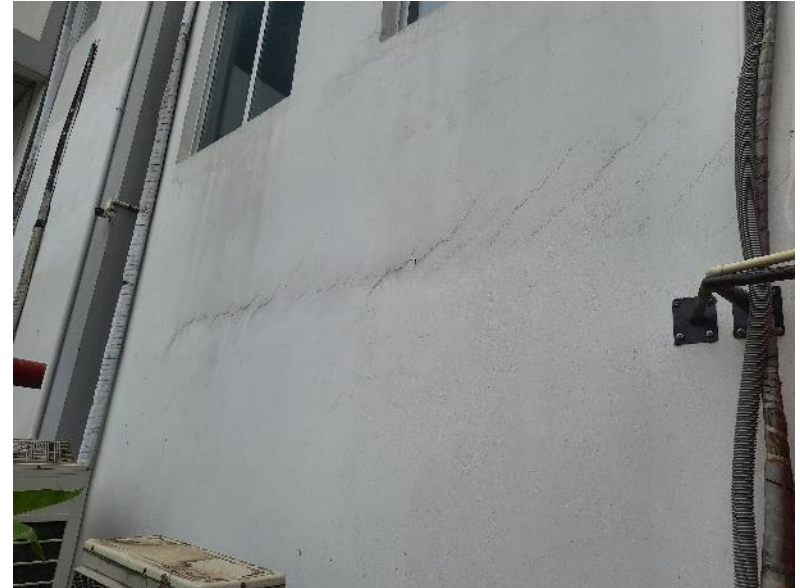
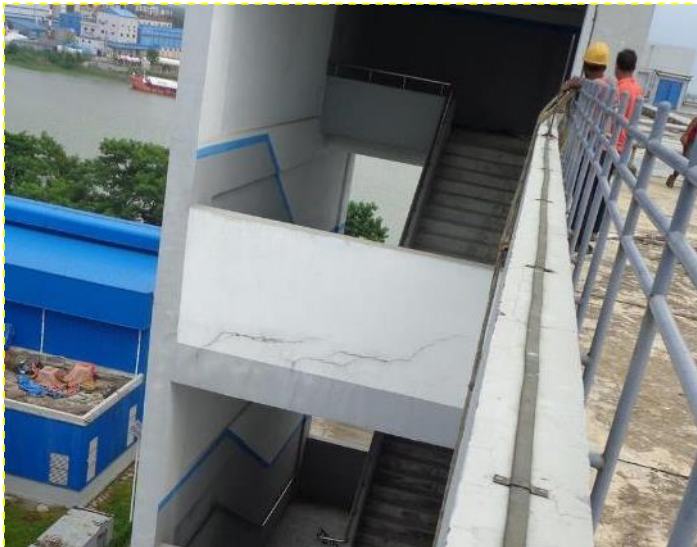
Some cracks were found in brick wall at several place of ground floor and stair of block 1 & 2. Factory engineer is required to investigate the cause of cracks and suggest proper remedial actions in the crack investigation report.

Item No.	Observation	Recommended Action Plan	Recommended Timeline
05	Crack in brick wall (Block 1 & 2).	Building engineer is required to investigate the cause of crack and repair the crack as per recommendation from investigation report.	6-weeks
06	Lack of design documents. (Link Bridge & Canteen Ramp)	Building engineer is required to prepare a set of design documents for all structures as per BNBC part-6, section 1.9.1	6-weeks
07	Lack of design documents. (Link Bridge & Canteen Ramp)	<ul style="list-style-type: none"> <li>Carry out remedial works where necessary.</li> </ul>	6-months
08	Missing Bolts (Canteen Ramp & Link Bridge)	Building engineer is required to install the missing bolts	6-weeks

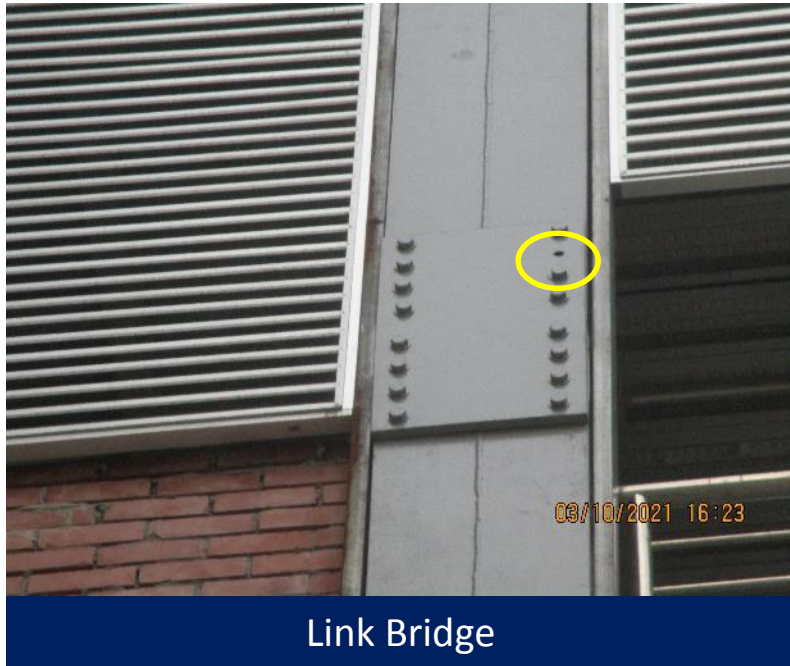
Link Bridge

# Missing bolts on canteen ramp and link bridge

Factory Engineer is required to find the missing bolts and install the bolts as per specification.

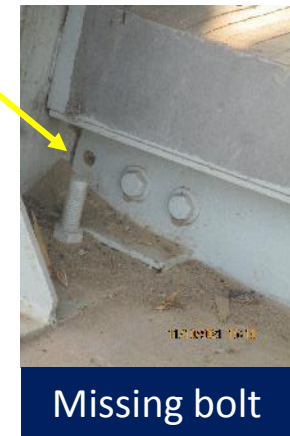
Missing bolt

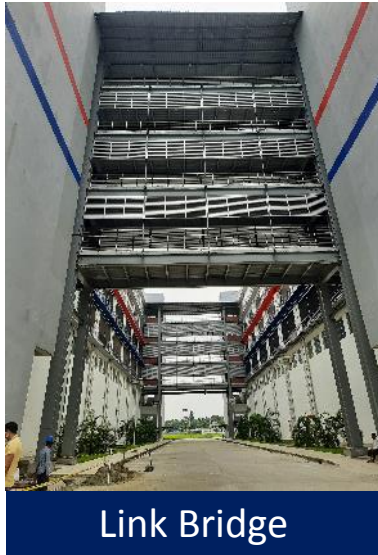
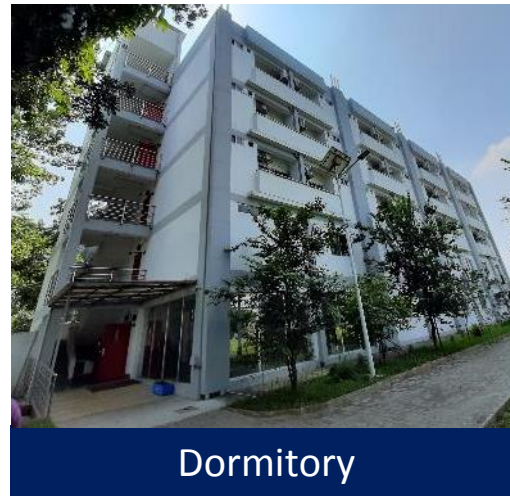
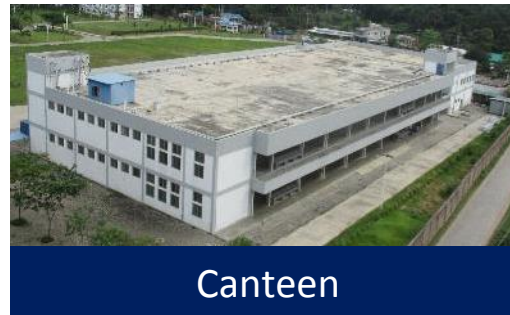
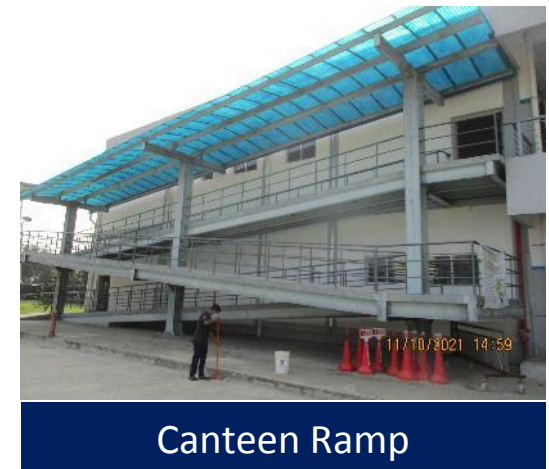
**Observation: Dormitory, Canteen, Canteen Ramp, & Link Bridge**

As per BNBC Section 1.9.1, every structure should have design documents. There is no design documents for above mentioned structures. So, the factory engineer is required to prepare a set of design documents for all structures as per BNBC part-6, section 1.9.1.

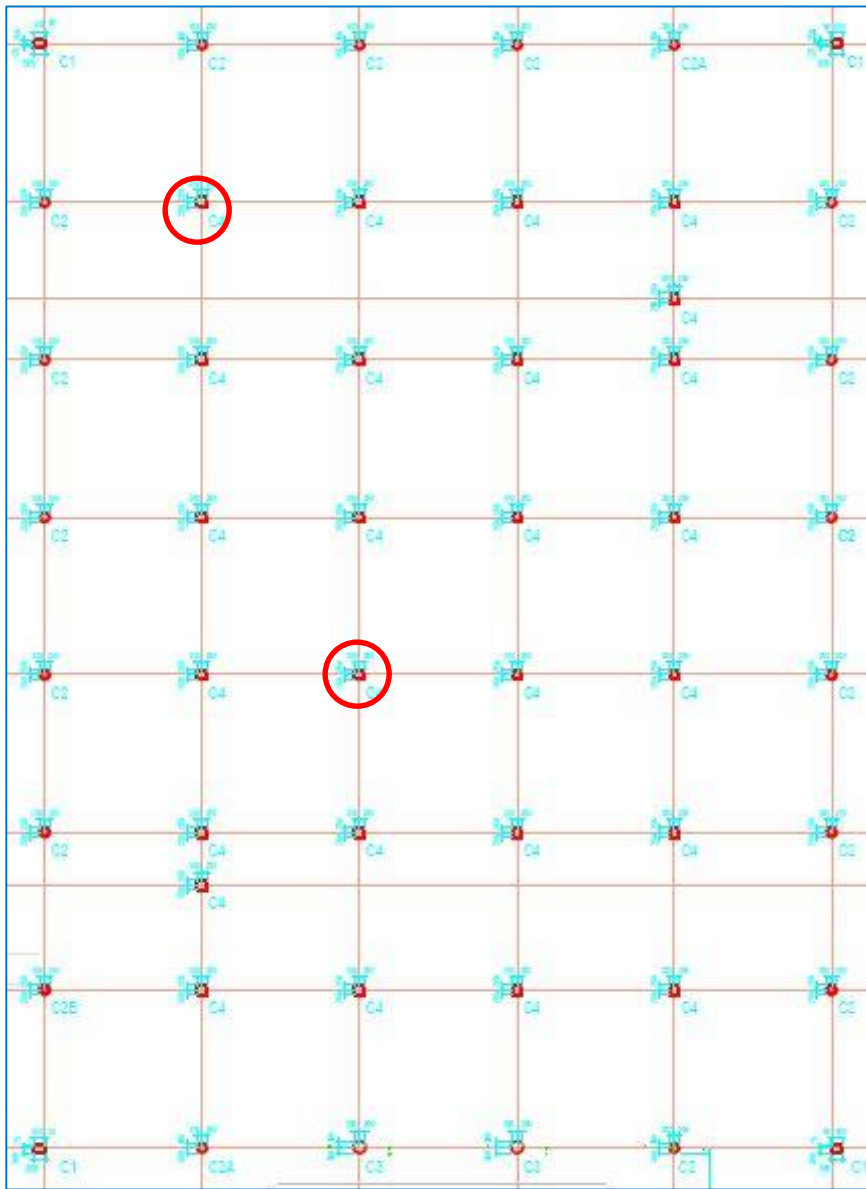
Column Layout Plan

**Column stress exceeds normal design limit**

Cursory calculation indicate that the working stress of the marked columns exceed the normal design limit due to O.HWT and large span(8m) considering 3 kPa live load on typical floor, 1.5 KPa live load on roof and 16.37 MPa concrete strength. As part of Engineering Assessment (EA), factory engineer is required to verify the in-situ concrete strength, check the column capacity and suggest proper remedial actions accordingly.

Item No.	Observation	Recommended Action Plan	Recommended Timeline
13	Column stress exceeds normal design limit.(Main Office Building)	As part of Engineering Assessment (EA), building engineer is required to verify the in-situ concrete strength, check the column capacity and suggest proper remedial actions accordingly.	6-weeks
14	Column stress exceeds normal design limit.(Main Office Building)	Produce and actively manage a loading plan for all floor plates considering floor, column and foundation capacity..	6-weeks
15	Column stress exceeds normal design limit.(Main Office Building)	Building engineer is required to prepare a set of design documents for all structures as per BNBC part-6, section 1.9.1	6-weeks
16	Column stress exceeds normal design limit.(Main Office Building)	Carry out remedial works if suggested in the EA report.	6-months

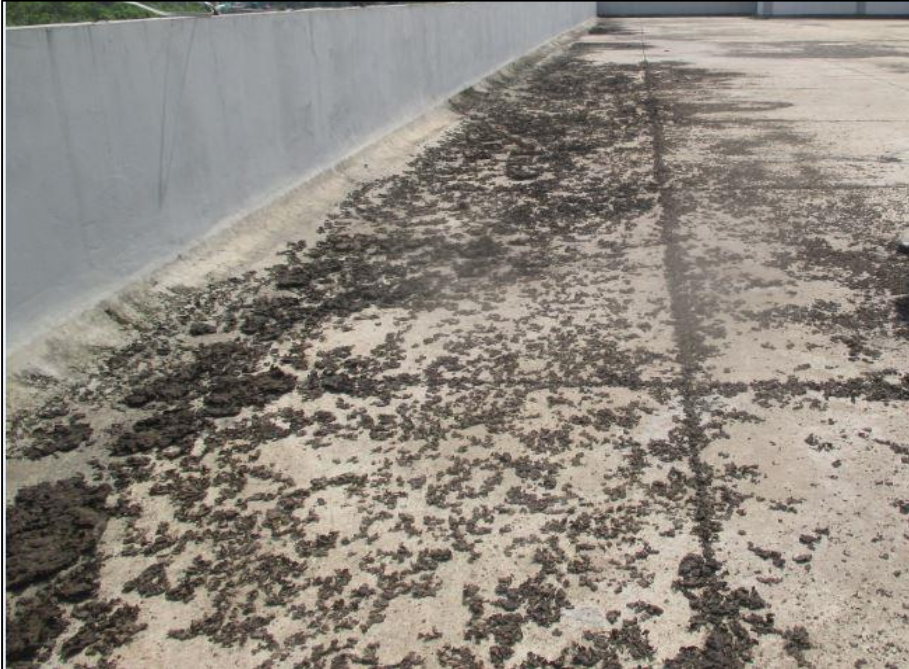
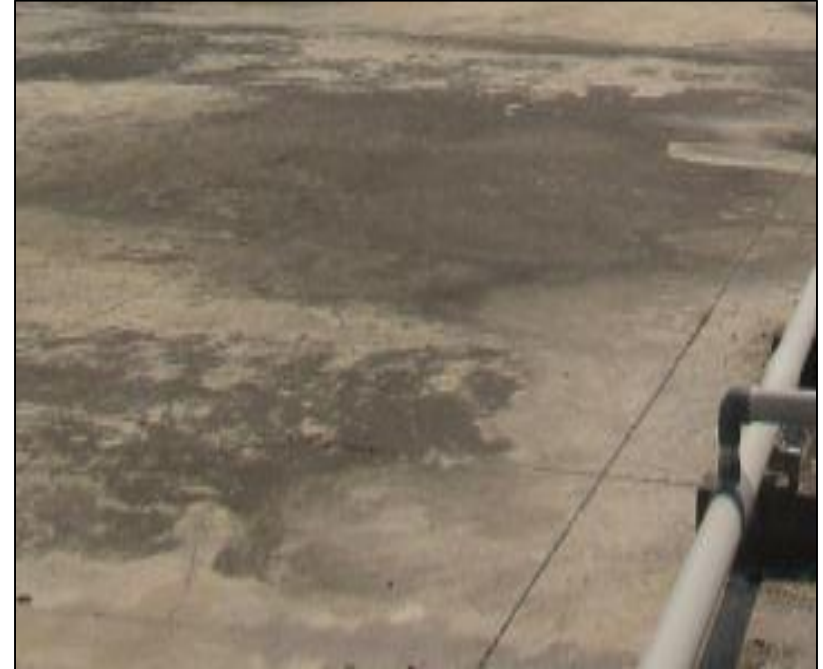
Sign of stagnant Water observed on the roof. Building engineer is required to improve the roof drainage system.

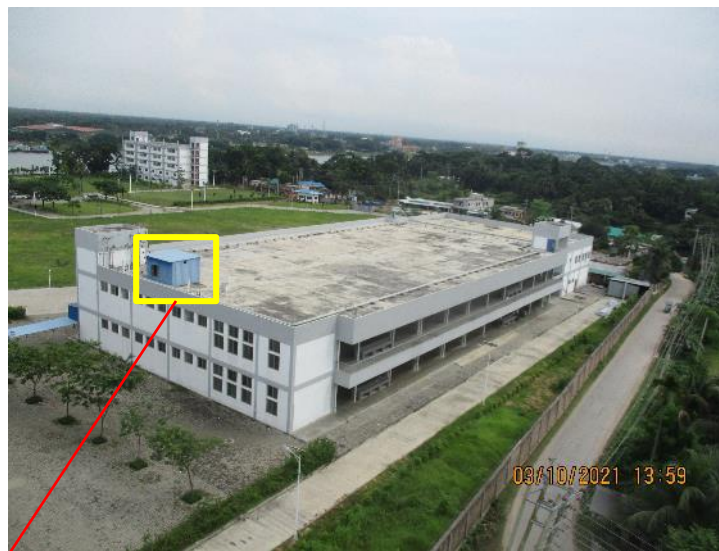
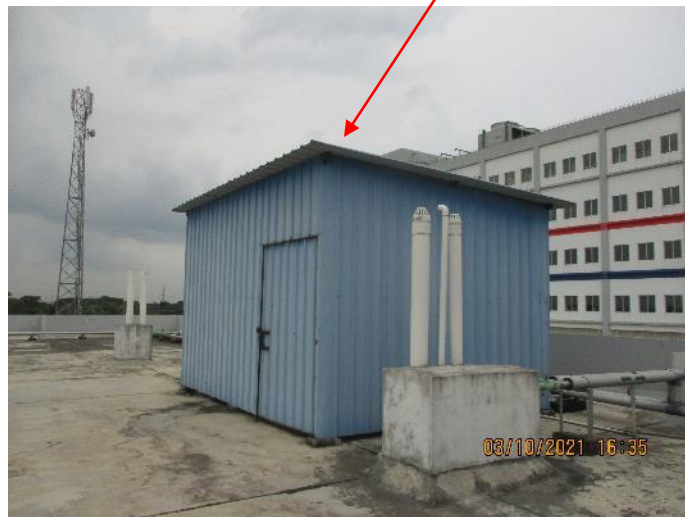
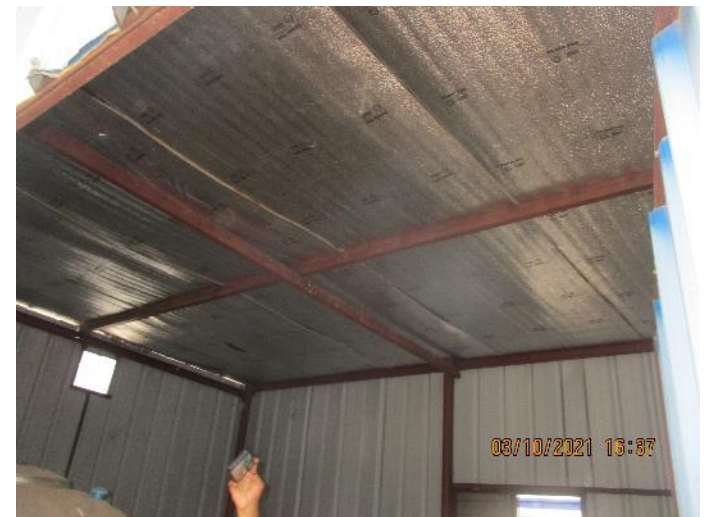
Undocumented and apparently non-engineered Steel Shed found at roof top of the building. No as-built drawing was found. The factory engineer is required to prepare as-built drawing and check the structural integrity for the steel shed.

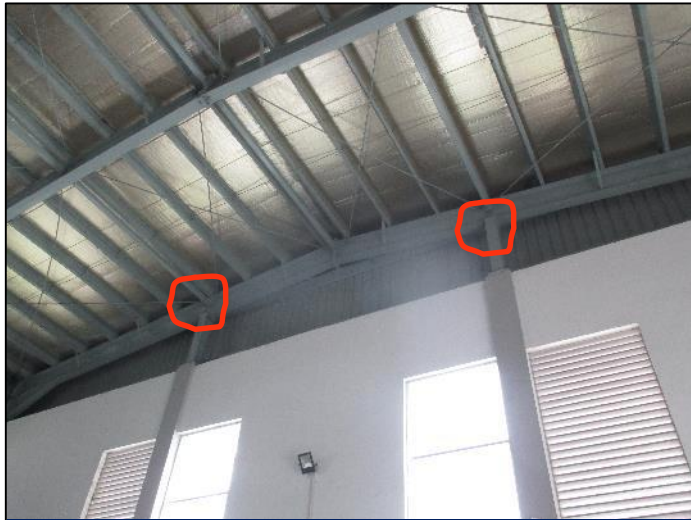
Gable frame

No connection details were found at red marked portion in drawing. Building engineer is required to update the as-built drawing.

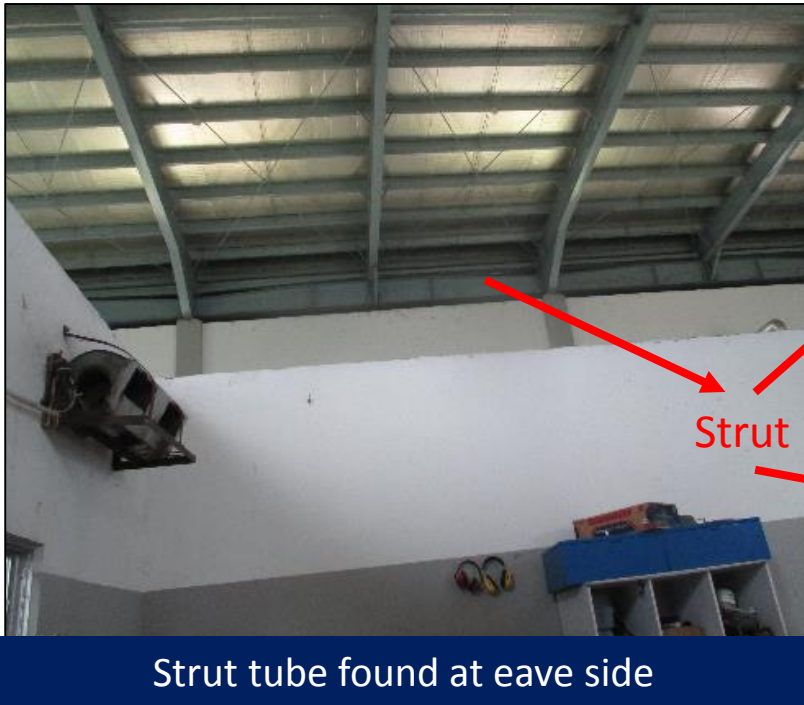
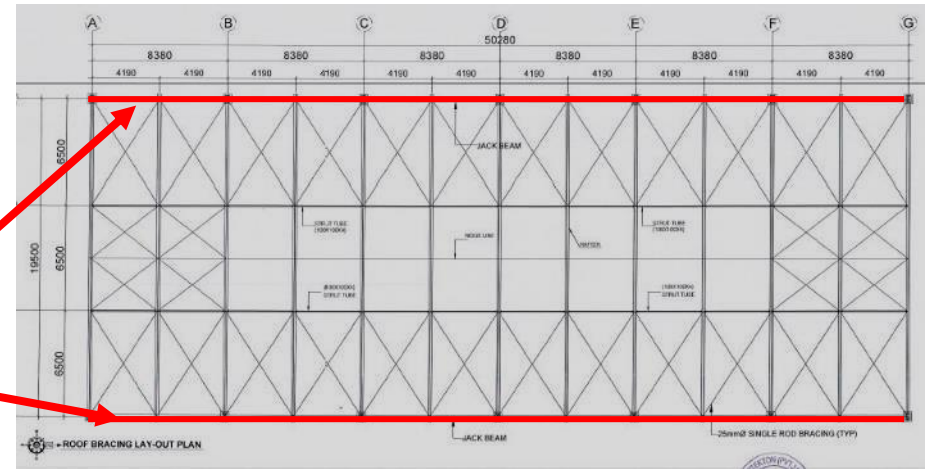
Strut tube layout

Strut tubes were found at red marked area which is not shown in drawing. Building engineer is required to update the as-built drawing.

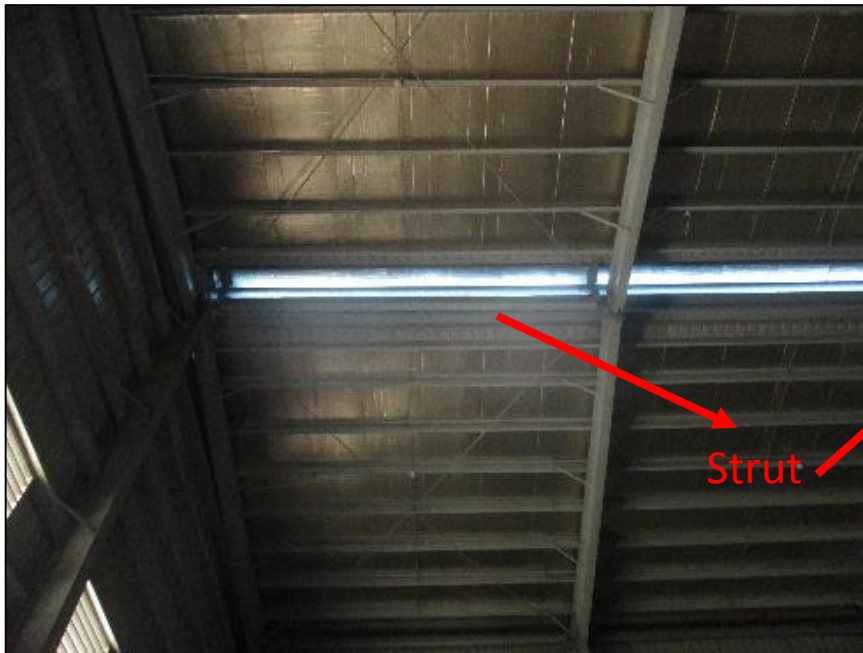
Strut tube found at Ridge

Strut tubes were found at red marked area which is not shown in drawing. Building engineer is required to update the as-built drawing.

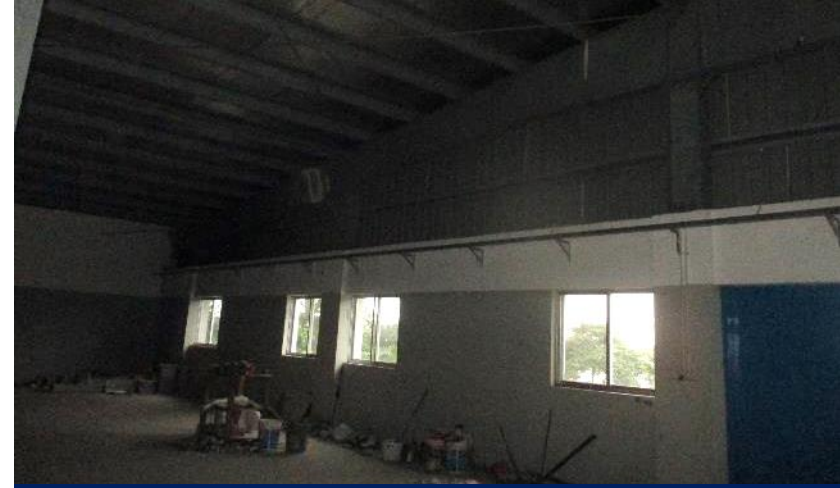
No load plan was prepared for  
mezzanine floor

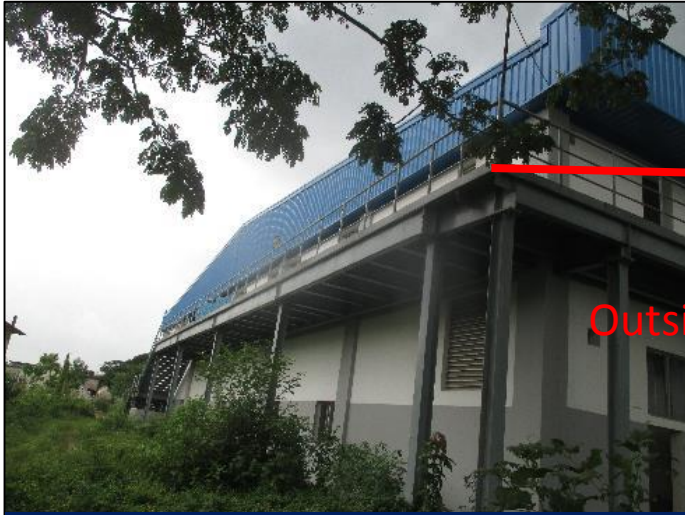
Outside stair & pedestrian platform

At grid 15, column & rafter connection is not shown in drawing as well as outside stair details not found in drawing. Building engineer is required to update the as-built drawing.

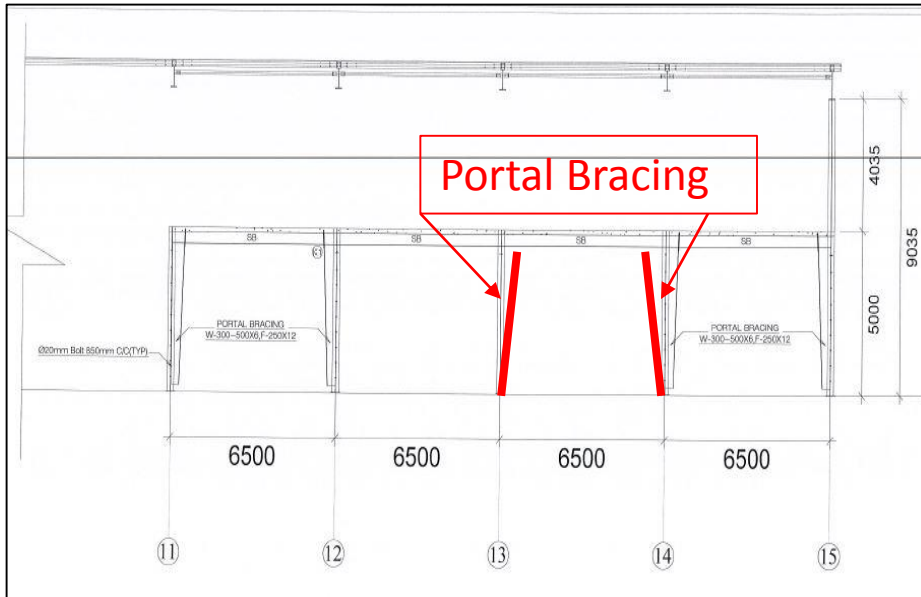
Portal bracing layout

Portal bracing were found at grid 13~14 whereas in drawing there is shown at 14~15. Also, Steel main beam is connected to RC beam at Grid-15. But as per drawing steel main beam is connected to RC column. Building engineer is required to update the as-built drawing.

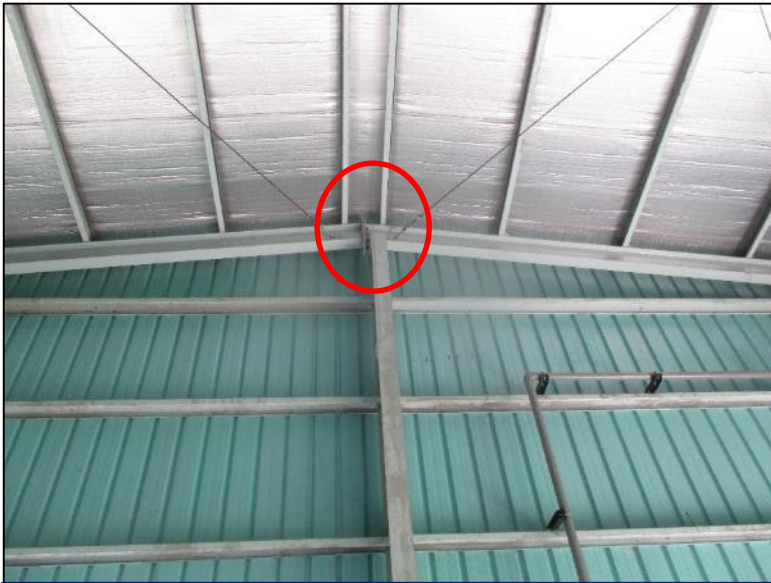
Gable frame ridge point connection

Connection mismatch found red marked area in both gable frames.  
Building engineer is required to update the as-built drawing.

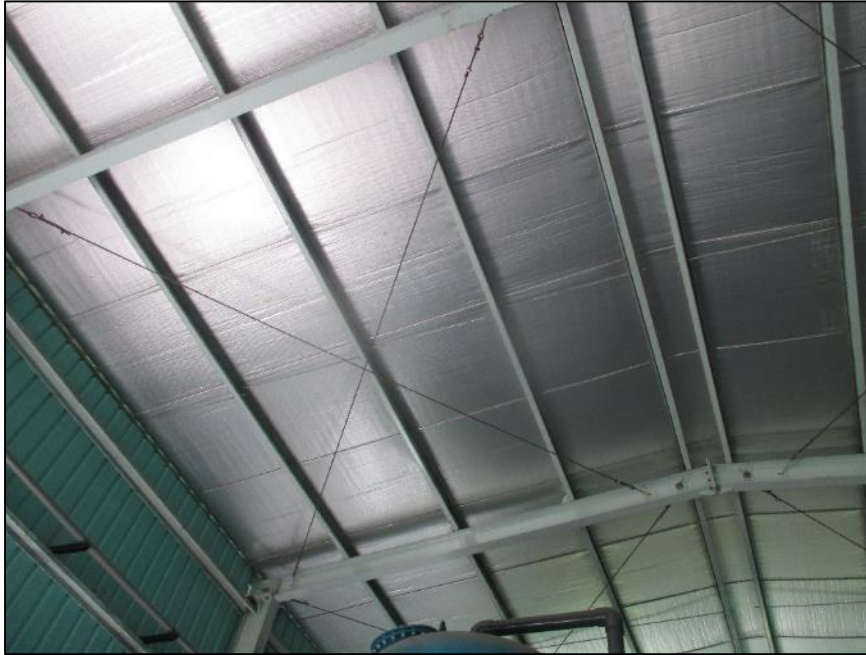
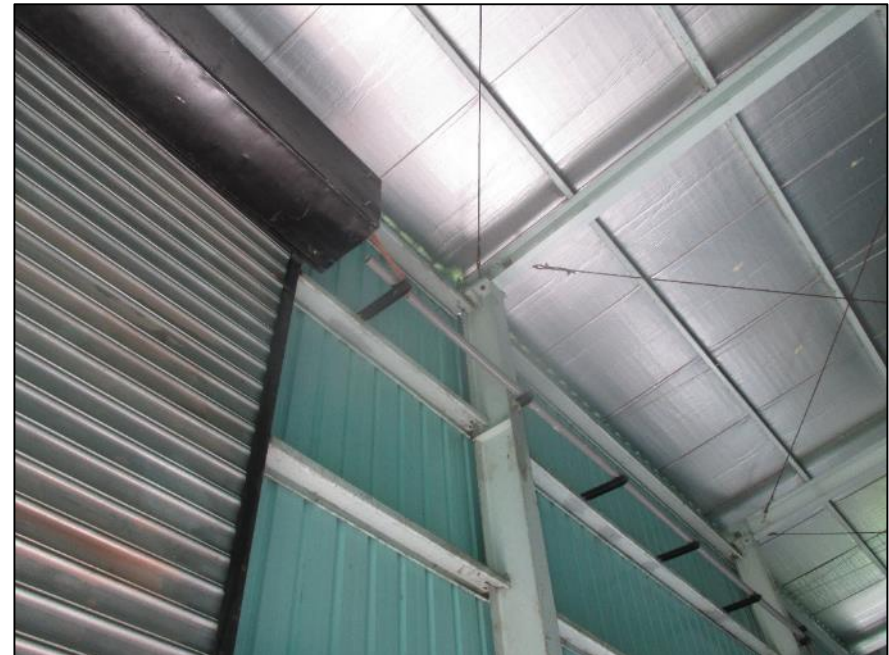
No vertical bracings/ compression struts were provided in the long direction. Apparently lack of lateral stability observed. The building engineer is required to check the lateral stability system of the shed.

Item No.	Observation	Recommended Action Plan	Recommended Timeline
43	Apparently lack of lateral stability system. (WTP)	Building engineer is required to check the lateral stability of the shed.	6-weeks
44	Apparently lack of lateral stability system. (WTP)	Carryout remedial works where necessary.	6-months
45	Undocumented and apparently non-engineered steel shed. (Generator Shed)	Building engineer is required to prepare as-built documents and check the structural integrity as part of Engineering Assessment (EA) for the steel shed or replace the shed.	6-weeks
46	Undocumented and apparently non-engineered steel shed. (Generator Shed)	Implement necessary remediation works as per EA Report.	6-months

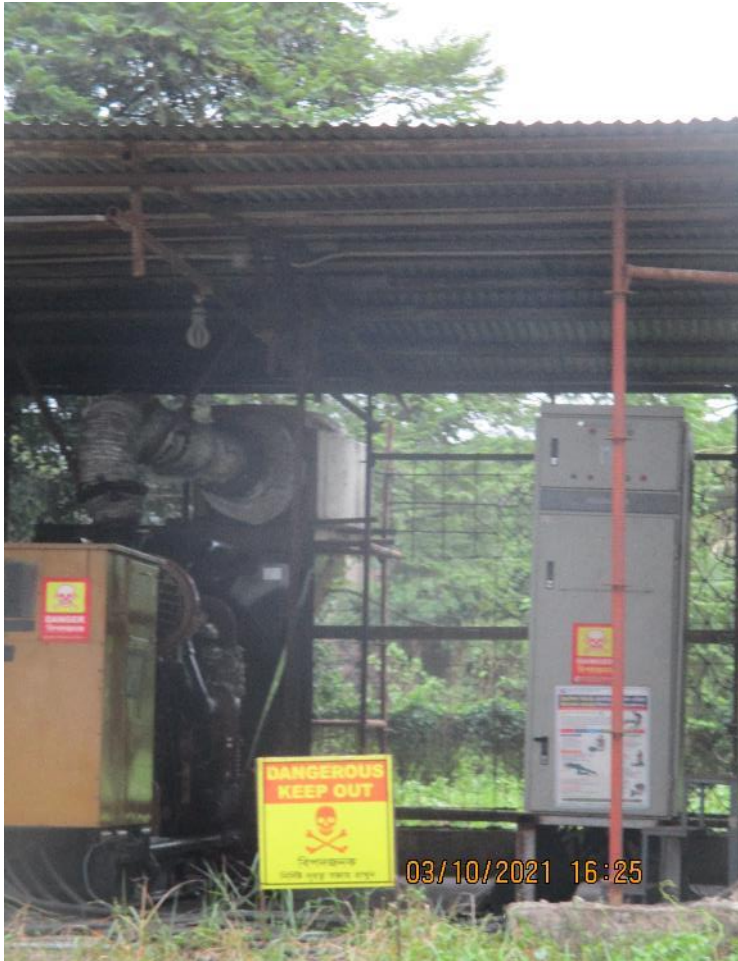
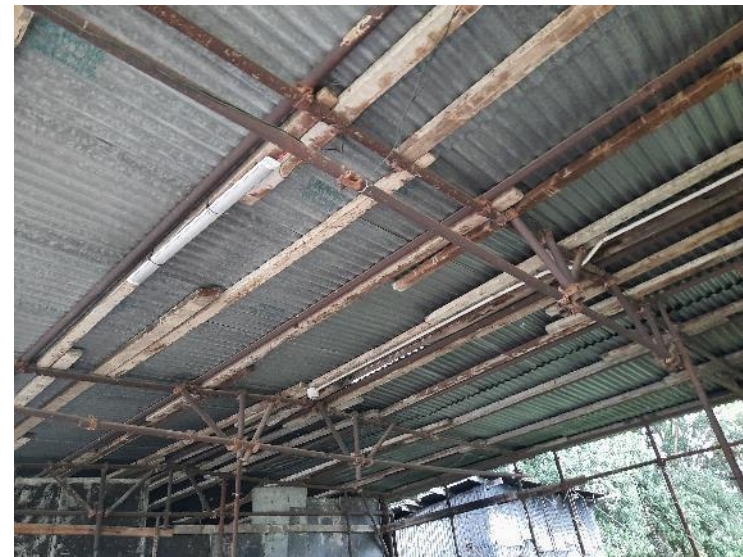
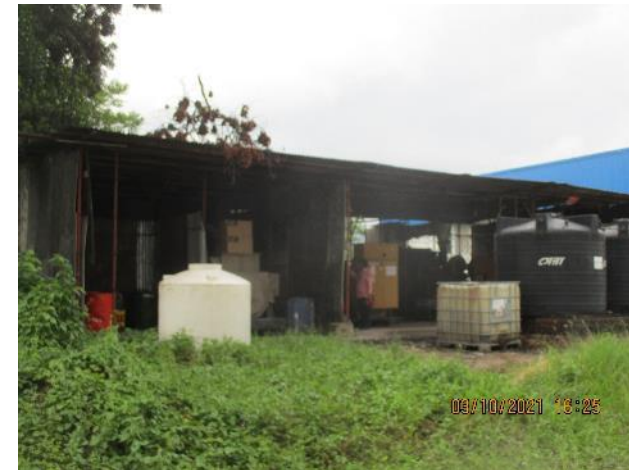
Undocumented and apparently non-engineered Steel Shed found used as generator shed. No as-built drawing was found. The factory engineer is required to prepare as-built drawing and check the structural integrity for the steel shed or replace the shed.
