# Sadma Fashion Wear Ltd. (Extension)

Mouchack, KaliaKoir, Gaziupr

4<sup>th</sup> October 2021

# Observations

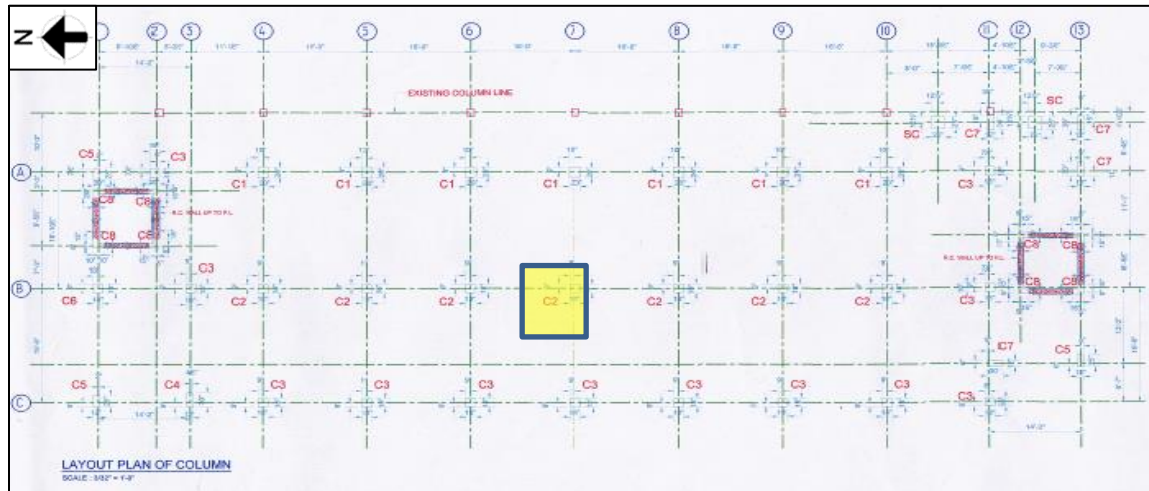
Stressed column (yellow marked) in Layout

Cursory calculation indicates that the working stress of ground floor column exceeds the normal design limit considering the live load 6 KPa on first floor (storage area), 3 kPa on typical floor, 1.5 KPa on roof top and minimum concrete strength based on aggregate type. Factory engineer is required to review design, load & column stress for the area identified above.

| Item No. | Observation | Recommended Action Plan | Recommended Timeline |
|---|---|---|---|
| 01 | Column to be stressed above normal design limit (Main Building (Extension)) | Factory Engineer to review design, loads and columns stresses in area identified above. | 6-weeks |
| 02 | Column to be stressed above normal design limit (Main Building (Extension)) | Verify in-situ concrete strength either by taking 100mm dia. cores or existing cylinder strength data for [the identified columns] or [100mm dia. cores from 4 columns]. | 6-weeks |

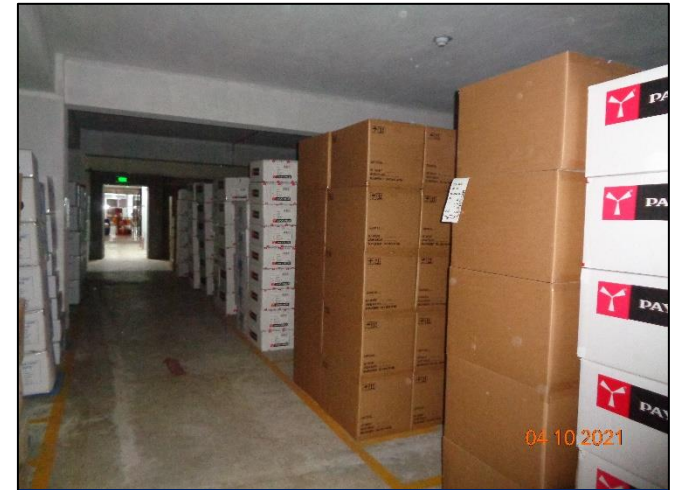
Typical floor loading at 1<sup>st</sup> floor

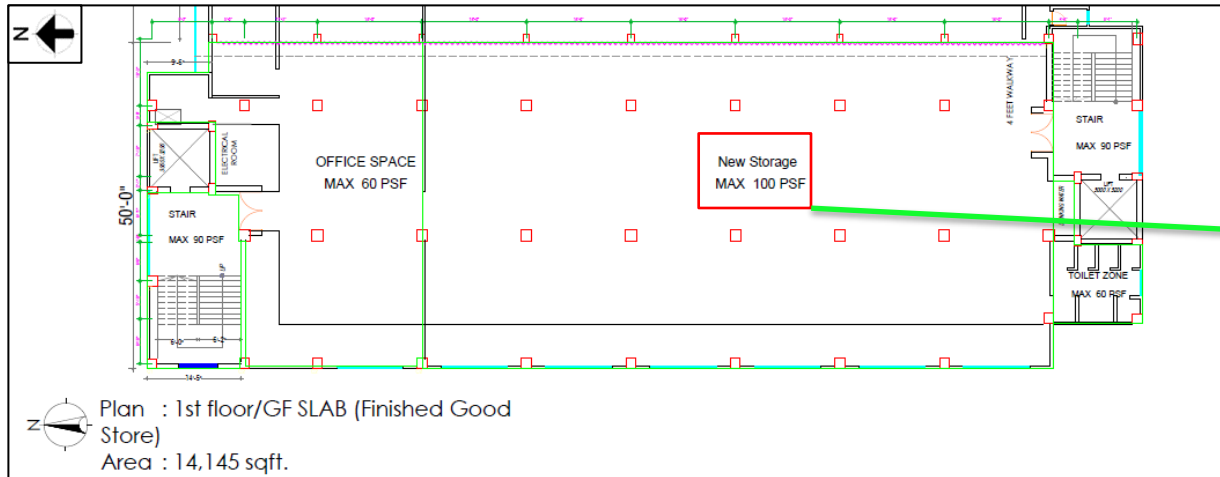
1<sup>st</sup> floor live load plan

Live load on 1st floor is considered as 4.8 kPa in prepared load plan. As per BNBC- Part 6, live load for light storage areas is required to be considered minimum 6 kPa. However, the factory engineer is required to revise the load plan as per BNBC requirement and check the design accordingly.

| Item No. | Observation | Recommended Action Plan | Recommended Timeline |
|---|---|---|---|
| 05 | Prepared load plan to be revised (Main Building (Extension)) | Factory engineer is required to revise the load plan as per BNBC requirement and check the design accordingly. | 6-weeks |

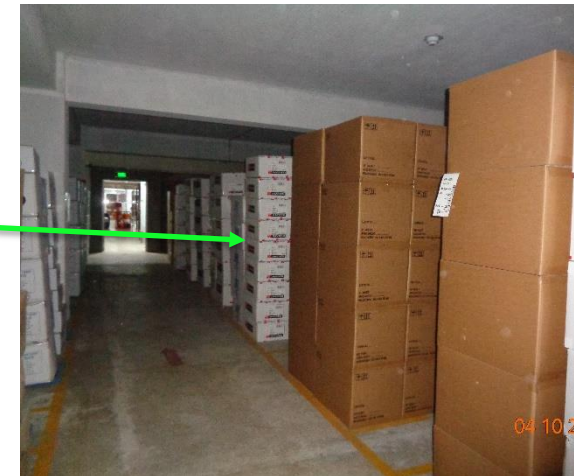
Storage on 1<sup>st</sup> floor

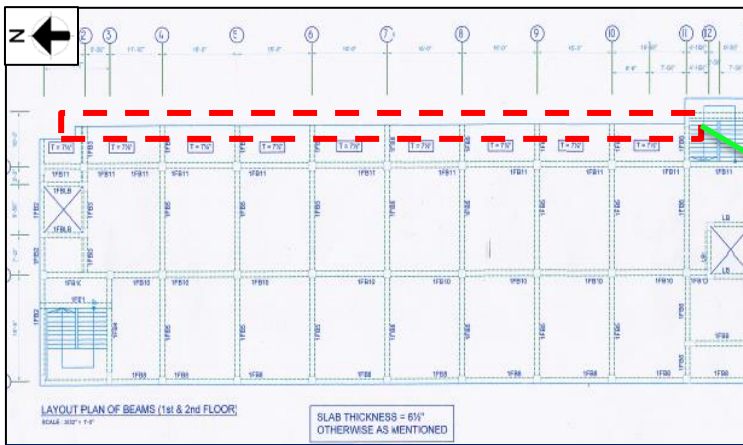
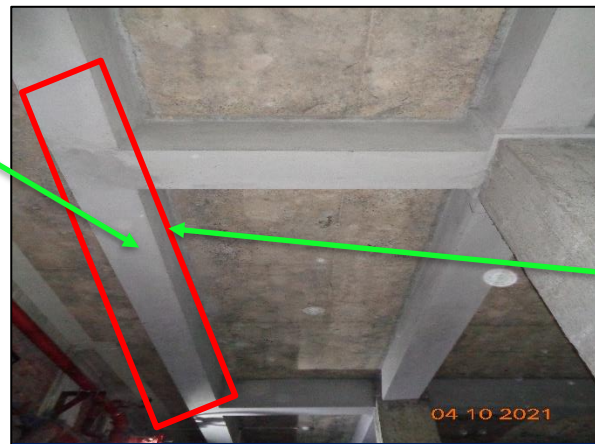
Beam layout at 1<sup>st</sup> & 2<sup>nd</sup> floor

1<sup>st</sup> floor beam

No beam along longitudinal direction has been shown on cantilever part at 1<sup>st</sup> & 2<sup>nd</sup> floor in beam layout. But a beam has been found on-site measuring width 250mm & d/s= 450mm.

Beam layout have been found mismatched with as-built drawing. Factory engineer is required to update the as-built drawing with accurate on-site condition.

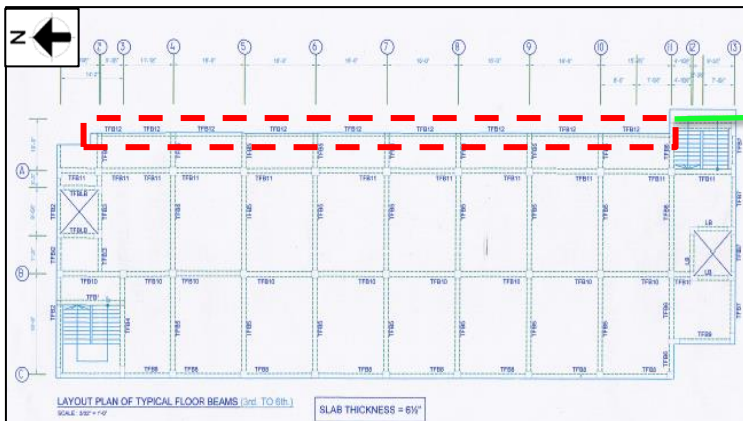
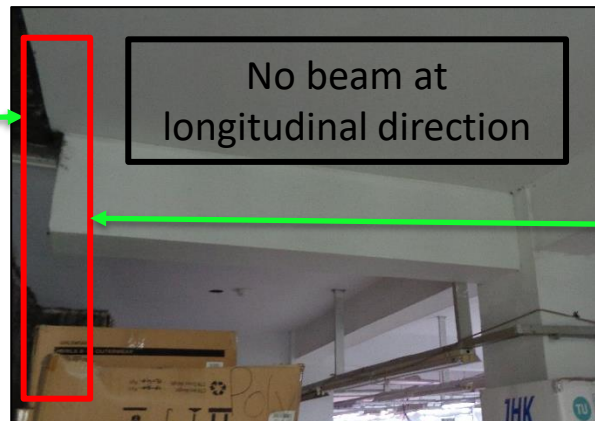
Beam layout at 3<sup>rd</sup> to roof floor

5<sup>th</sup> floor beam

A beam (250mm X d/s = 400mm) along longitudinal direction has been shown on cantilever part from 3<sup>rd</sup> to roof floor. But no beam has been found on-site.

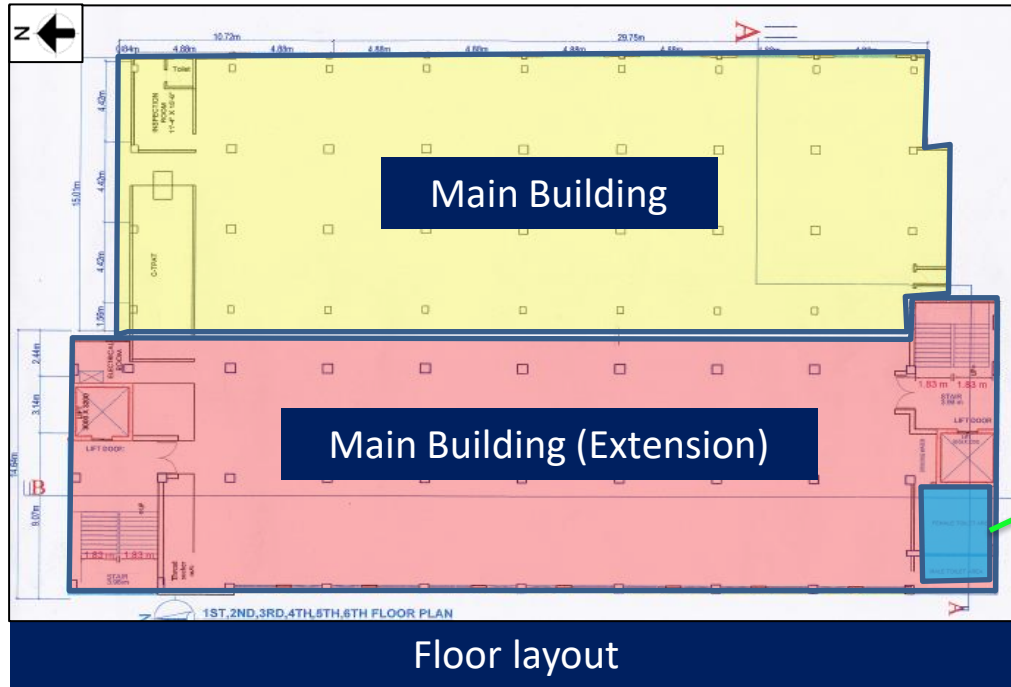
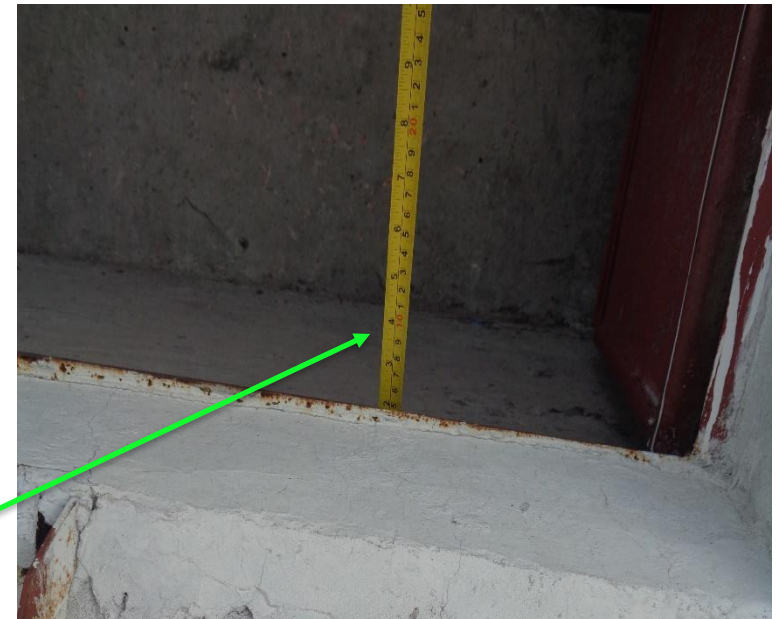
Toilet built-up

Build-up was found on toilet zone approximately 100mm which is not mentioned in as-built drawing. Factory engineer is required to update the as-built drawing with accurate on-site condition.

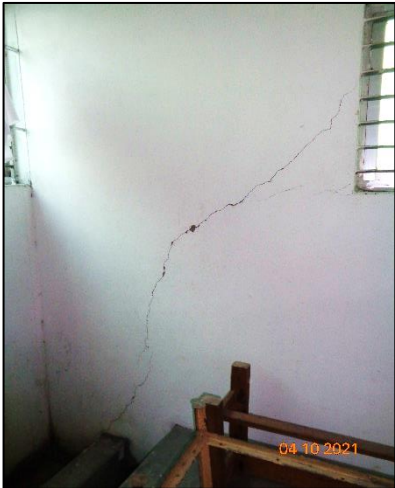
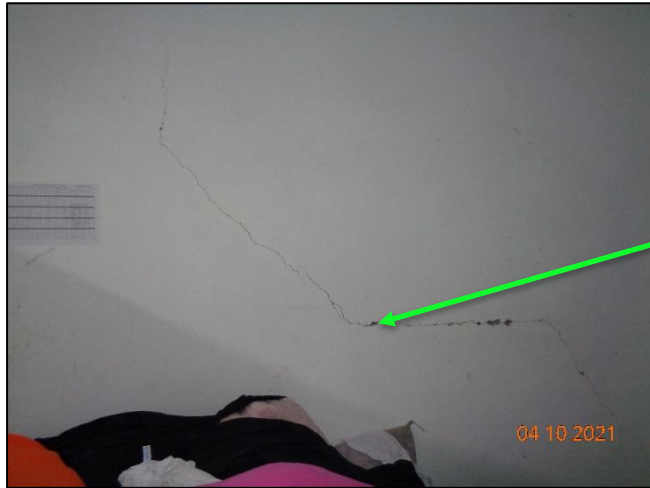
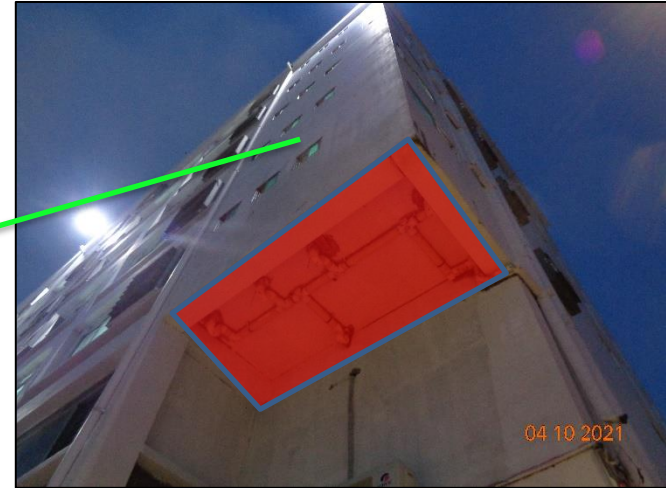
Cracks on periphery brick wall

Cantilever part

Severe cracks were found on periphery brick wall at south-west cantilever part of the building. Factory engineer is required to investigate the cause of crack and repair the crack as per recommendation from investigation report.

| Item No. | Observation | Recommended Action Plan | Recommended Timeline |
|---|---|---|---|
| 08 | Cracks in periphery brick wall (Main Building (Extension)) | Factory engineer is required to investigate the cause of crack and repair the crack as per recommendation from investigation report. | 6-weeks |

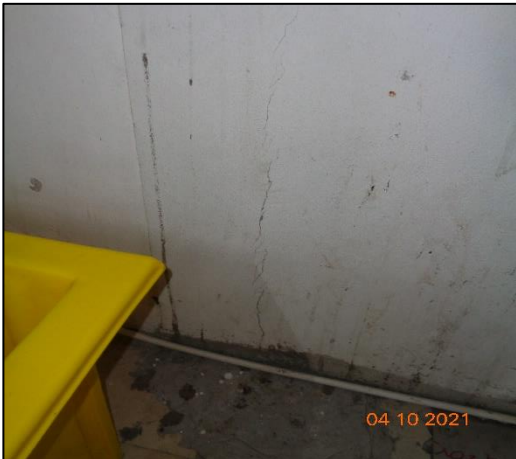
Cracks on internal brick wall

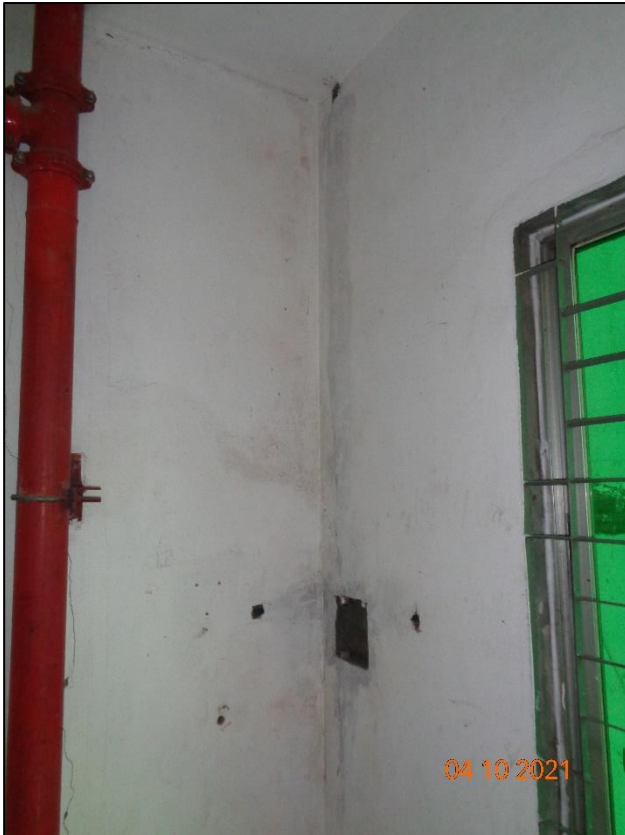
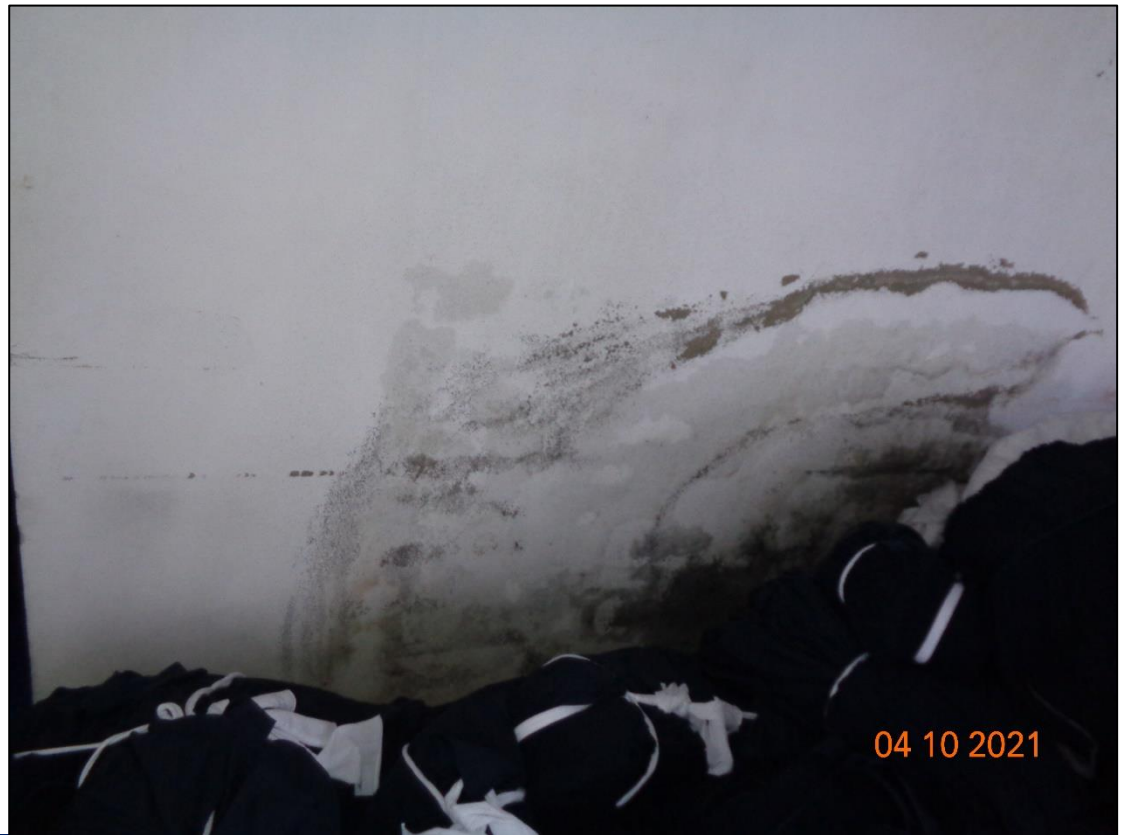
Dampness on brick wall

Due to water absorption, dampness was found on brick wall. Building engineer is required to take necessary measures to prevent dampness in brick wall.

| Item No. | Observation | Recommended Action Plan | Recommended Timeline |
|---|---|---|---|
| 10 | Dampness in brick wall (Main Building (Extension)) | Factory engineer is required to investigate the damp area to verify if any damaged occurred due to the presence of the moisture and repair accordingly. | 6-weeks |

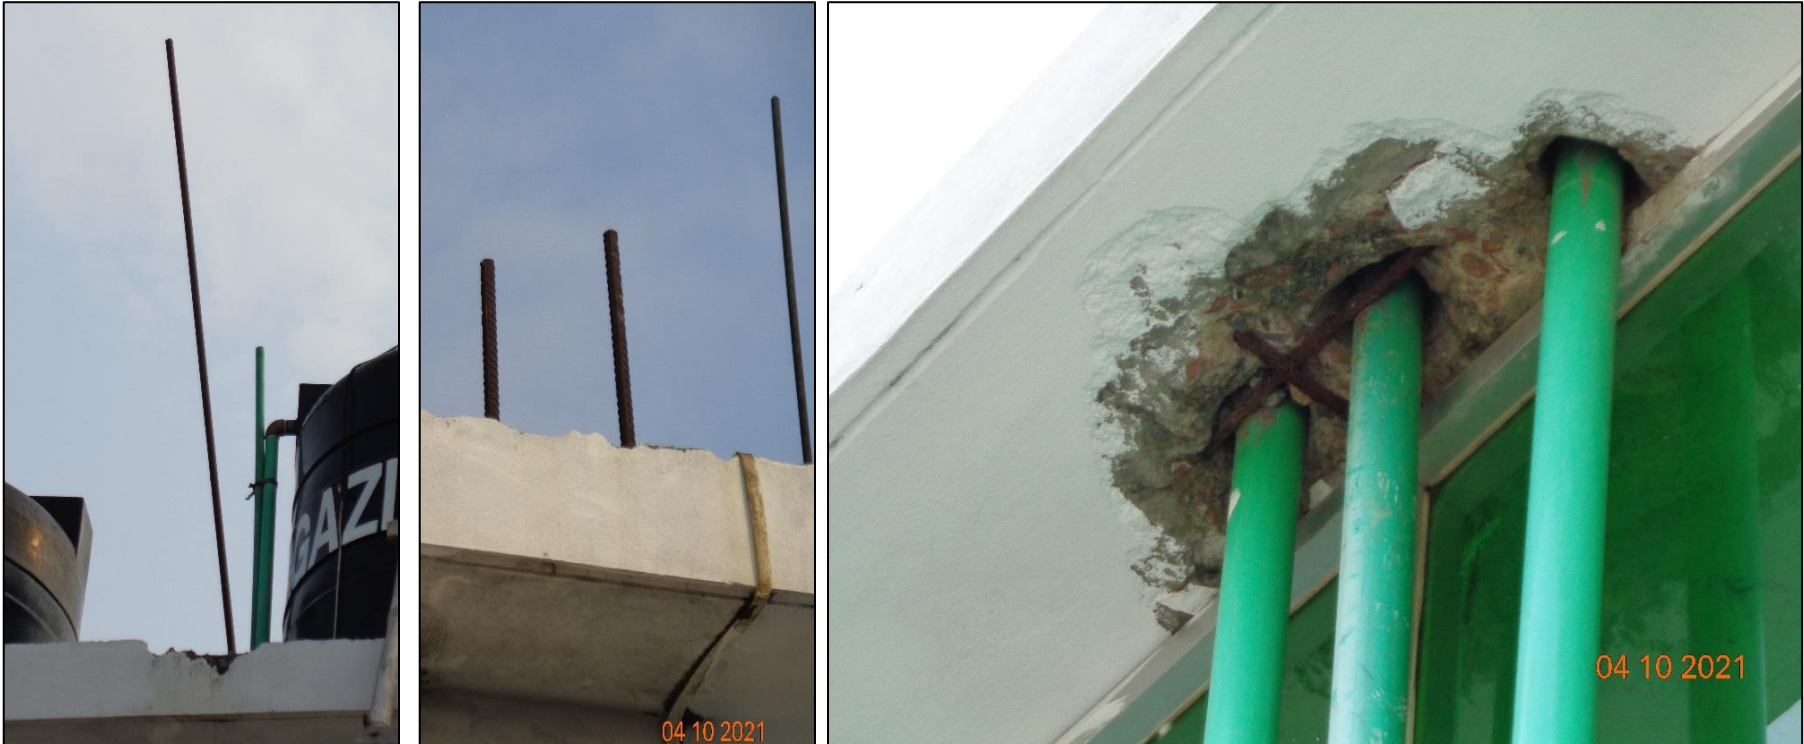
Exposed rebar at roof

Exposed reinforcement was found on roof. Factory engineer is required to take necessary measures to prevent the corrosion in exposed rebar.

| Item No. | Observation | Recommended Action Plan | Recommended Timeline |
|---|---|---|---|
| 11 | Exposed rebar at roof (Main Building (Extension)) | All exposed reinforcement is to be protected from corrosion which may cause degradation of the concrete. | 6-weeks |

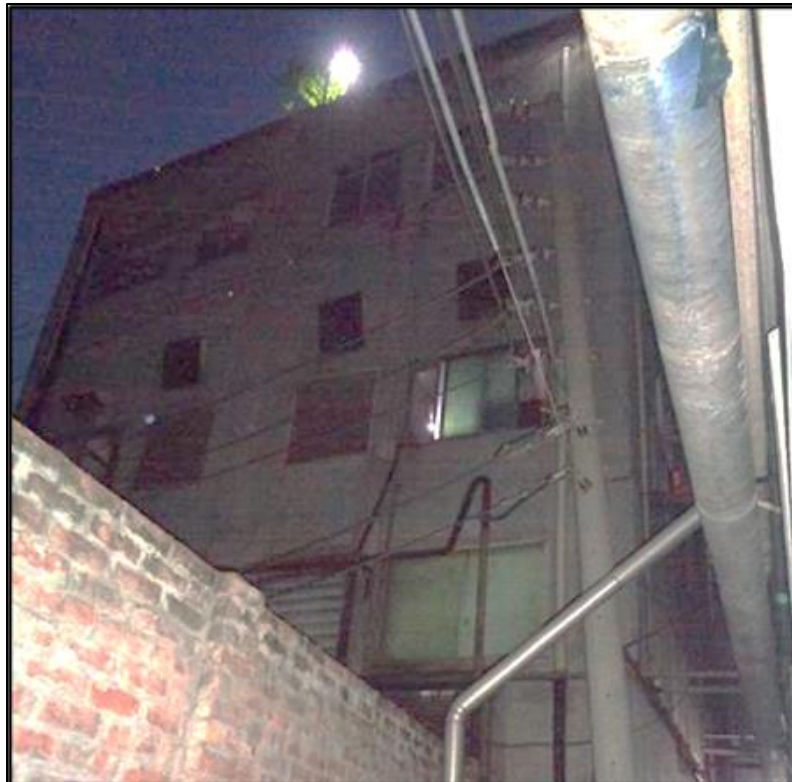
No design report for utility building

As per BNBC, every building or structure designed shall have its design documents prepared in accordance with the provision of Section 1.9.1. The design document shall include a design report, and a set of structural drawings, which shall be prepared in compliance with section 1.9.1.1 and section 1.9.1.2 as per BNBC (Part-6). Factory provided only as-built drawing for this structure, but no design report was available at the time of inspection.

Factory engineer is required to prepare design documents including design report, load plan following BNBC-2006 requirements.

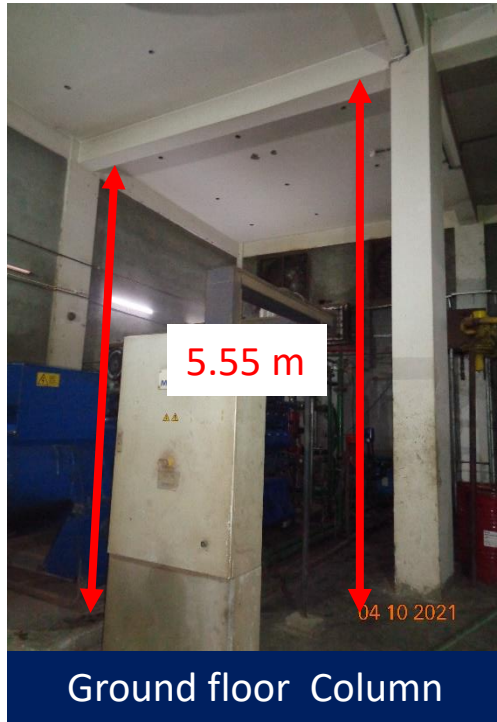
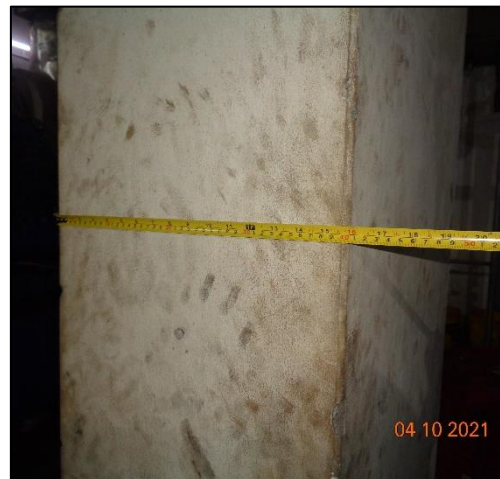
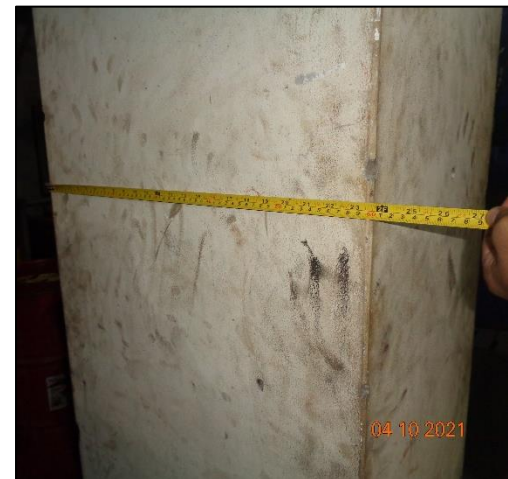
Size of the Column was measured 375X575mm

Ground floor columns are 5.55 m in length and 375X575 mm in size. The length/width=14.8 indicates that the columns are critical for slenderness effect.  
So, the factory engineer is required to check and address this issue in the design report.

| Item No. | Observation | Recommended Action Plan | Recommended Timeline |
|---|---|---|---|
| 14 | Column appears to be slender (Utility Building) | Building engineer is required to check the slenderness effect of the column. | 6-weeks |

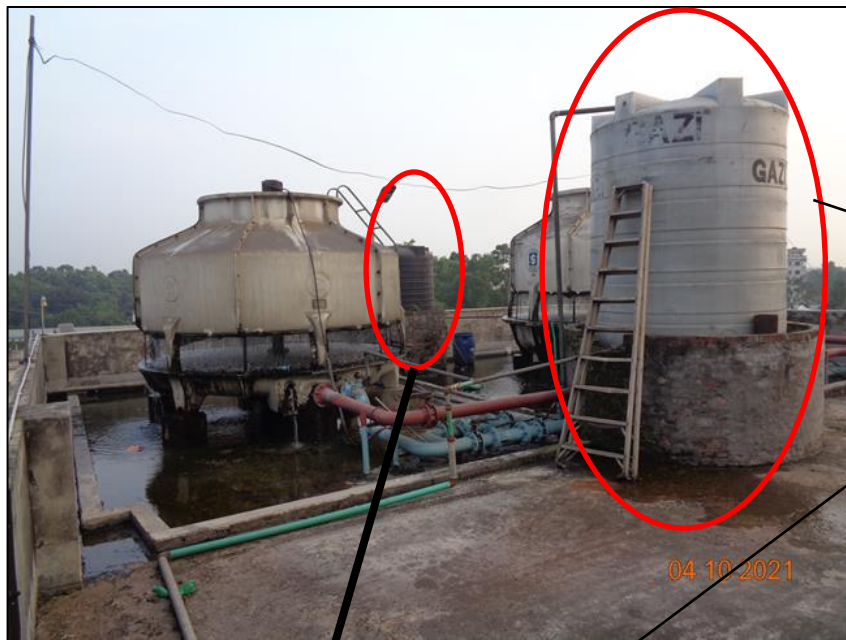
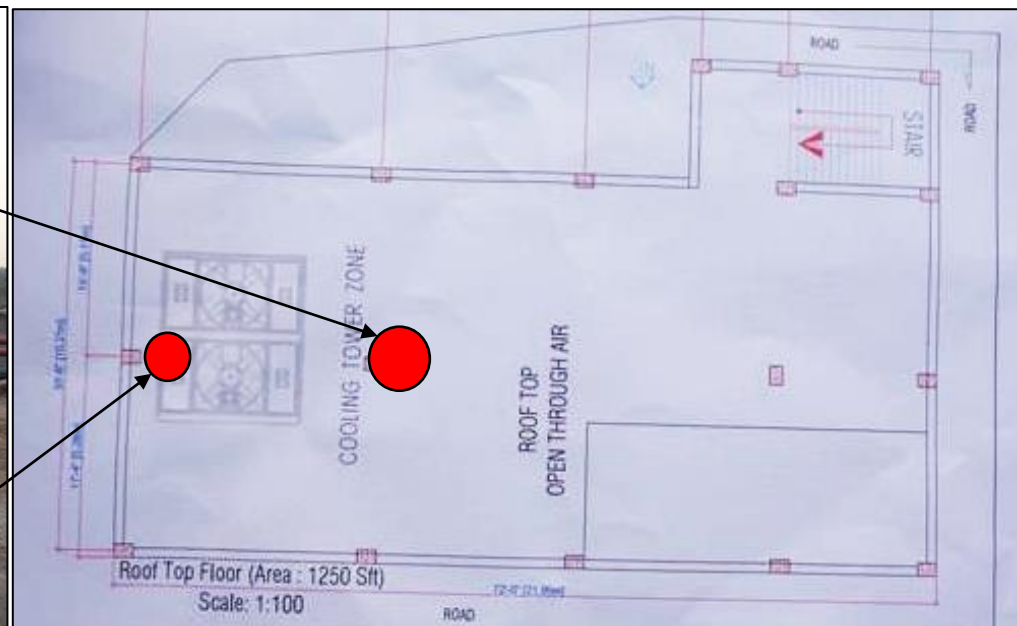
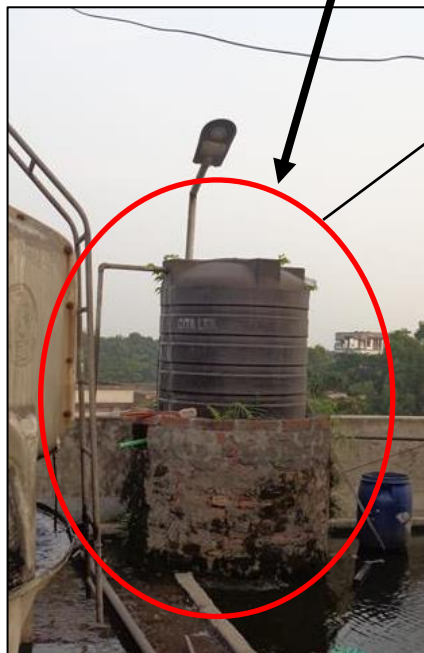
Roof Layout plan

Undocumented water tank was found at roof. One 5000 L and one 500 L water tank water was found roof with build up which has not been shown in drawing.  
Factory engineer is required to survey the whole structures and update the as-built drawings.

| Item No. | Observation | Recommended Action Plan | Recommended Timeline |
|---|---|---|---|
| 16 | Discrepancy in as-built drawing (Utility Building) | Factory engineer is required to update the as-built drawing as per onsite condition. | 6-weeks |

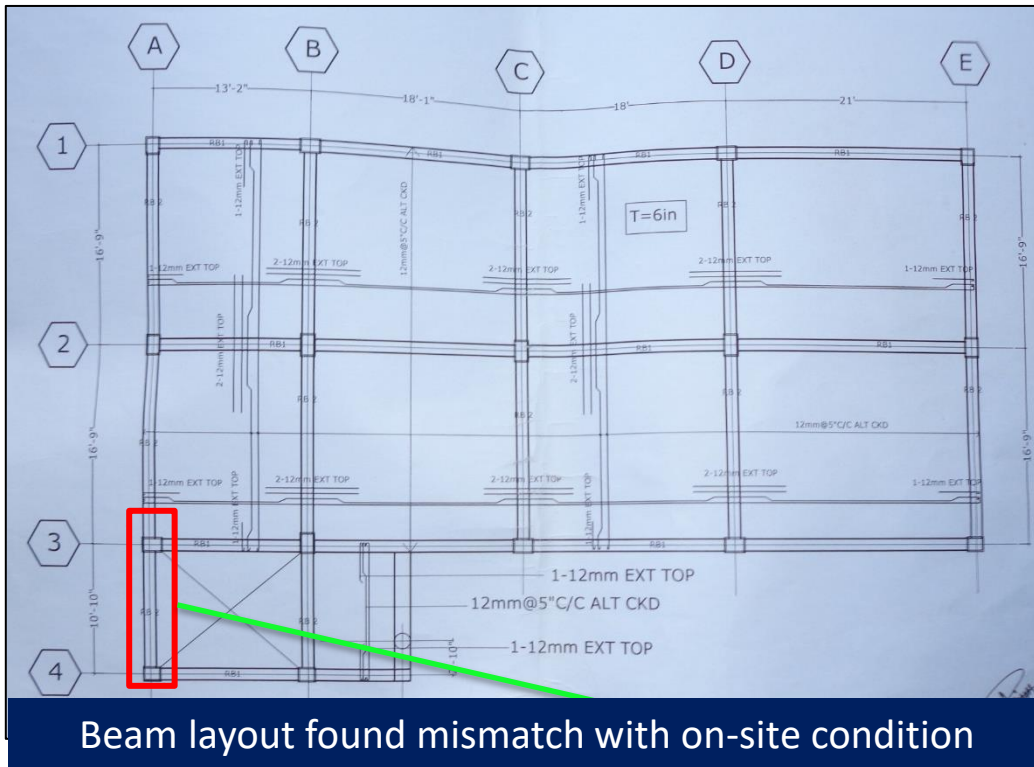
Beam was found at intermediate landing level instead of floor level. Factory engineer is required to update the structural drawing.

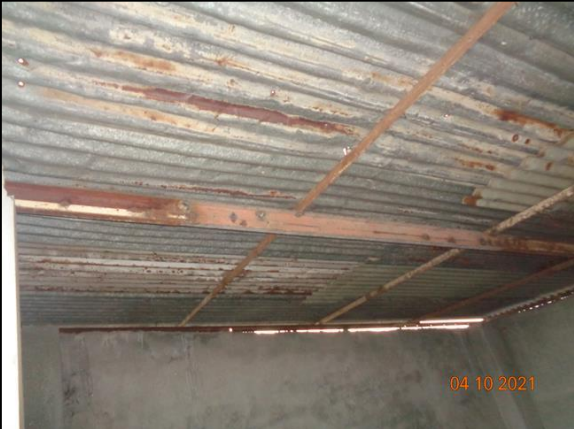
Light weight shed over the staircase

Light weight steel roof shed was found at staircase and roof top. The light-weight steel roof is made of steel angle section. There is no apparent load path to transfer the lateral loading. Poor connection details observed at joints. Building Engineer is required to check the lateral stability of the light-weight steel shed otherwise, replace the shed with engineered one.

| Item No. | Observation | Recommended Action Plan | Recommended Timeline |
|---|---|---|---|
| 17 | Roof shed appears to be non-engineered (Utility Building) | Building Engineer is required to check the lateral stability of the light-weight steel shed otherwise, replace the shed with any engineered structure. | 6-weeks |

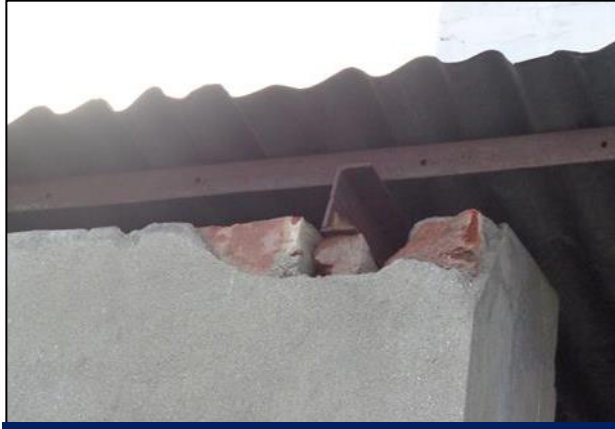
Connection seems to be inadequate for the light weight shed of staircase

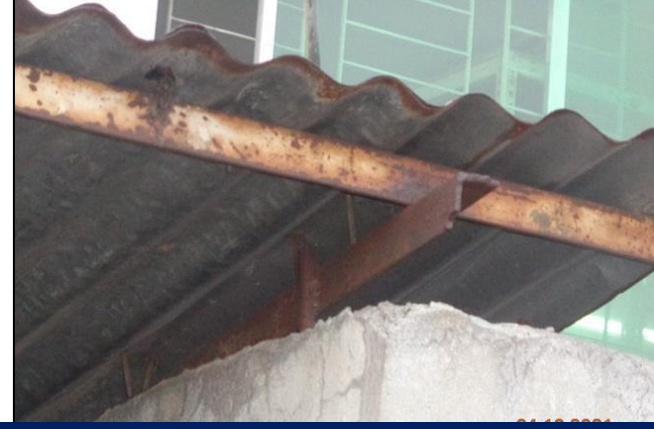
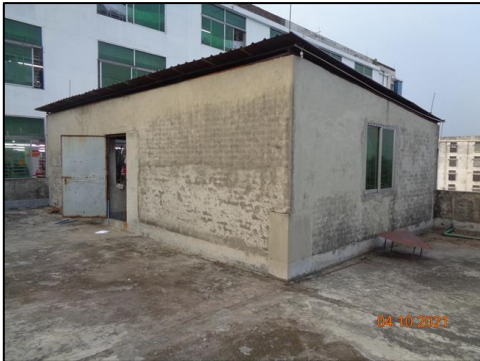
Light weight roof shed supported by brick wall

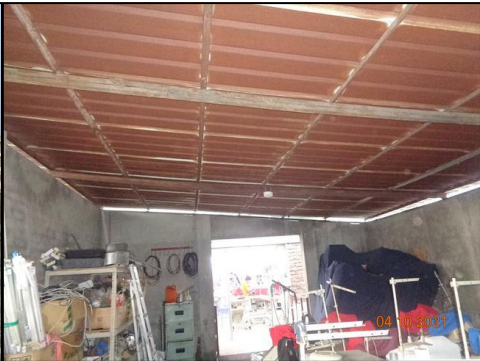
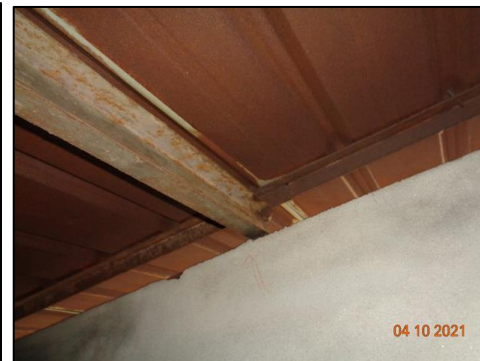
Connection seems to be inadequate for roof shed

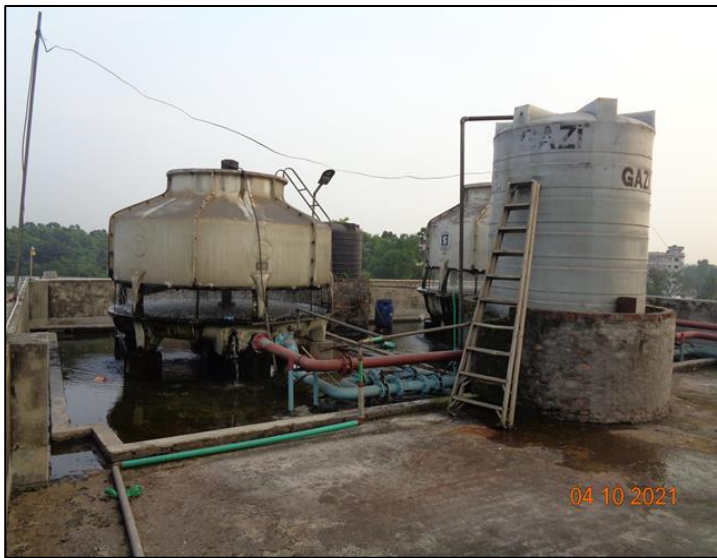
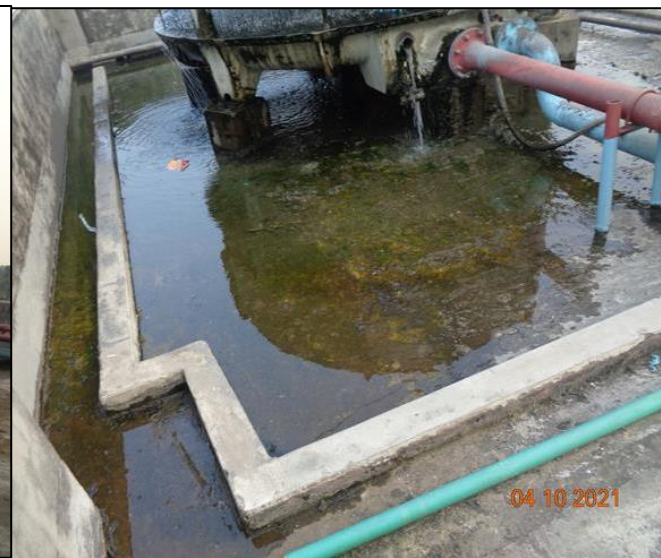
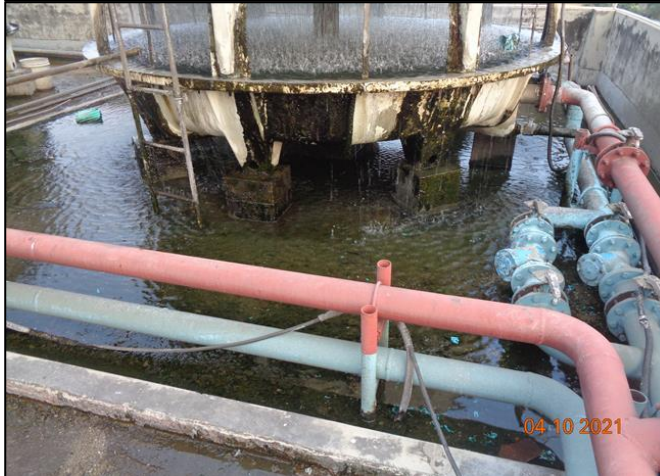
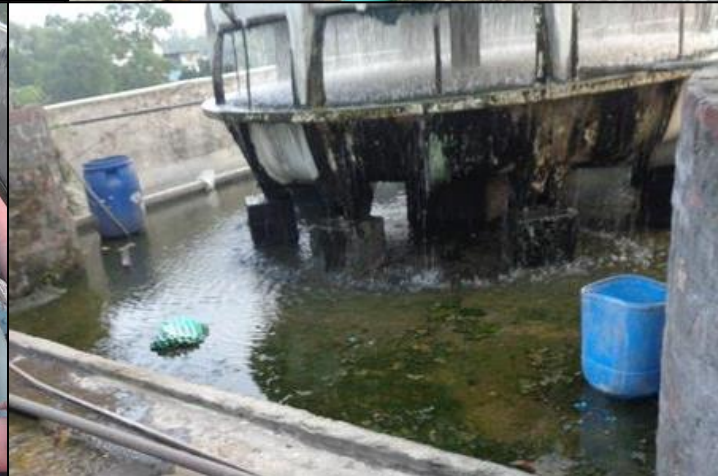
Water ponding at roof floor

Water ponding was found at beneath of water-cooling tower due to spalling of water. Due to lack of proper water drainage system and adequate sloping, water can not be drained out. The factory engineer is required to develop proper drainage system with adequate sloping on the mentioned area.

| Item No. | Observation | Recommended Action Plan | Recommended Timeline |
|---|---|---|---|
| 19 | Water ponding at roof (Utility Building) | The factory engineer to develop proper drainage system with adequate sloping to resist water ponding on roof. | 6-weeks |
