EXCOM Fashions Ltd. (relocated)

Nimertek, Rajfulbaria, Savar, Dhaka
(23.803371, 90.265160)

7th November 2021

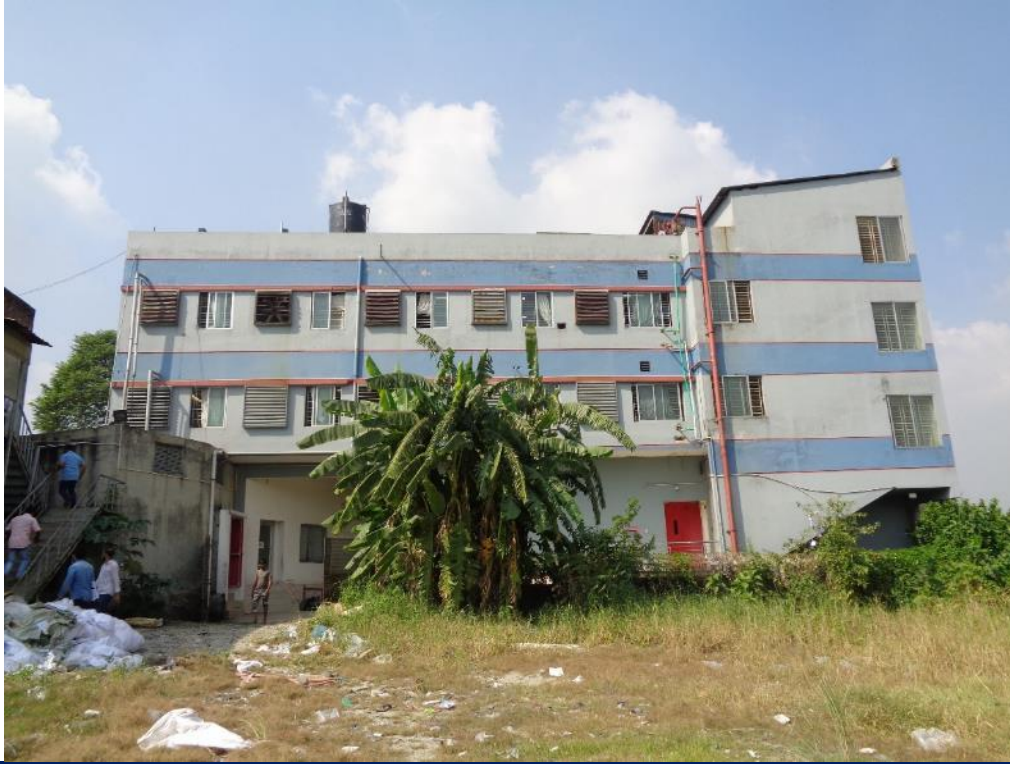
East view

Design Report needs to be prepared

As per BNBC, every building or structure designed shall have its design documents prepared in accordance with the provision of Section 1.9.1. The design document shall include a design report, and a set of structural drawings, which shall be prepared in compliance with section 1.9.1.1 and section 1.9.1.2 as per BNBC. At the time of inspection, only as-built drawing was available, but no design report was available which is required to be prepared in compliance with section 1.9.1.1 (part-6, BNBC).

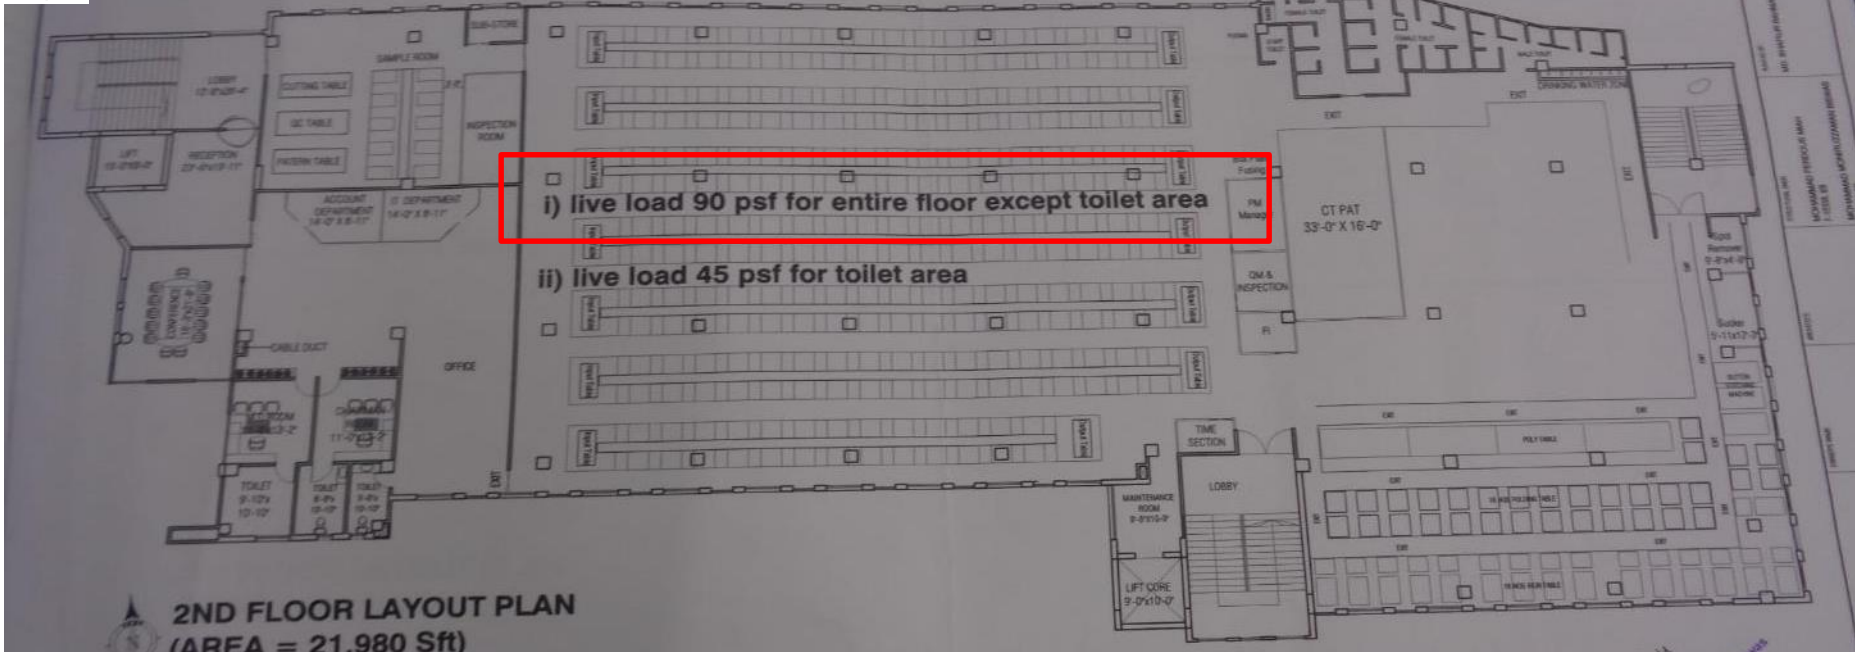
Live load plan- 2nd floor 4.28 kPa (90 psf)

Prepared load plan to be revised

Live load on typical floor is considered as 4.28 kPa in prepared load plan. As per BNBC- Part 6, live load for light storage areas is required to be considered minimum 6 kPa. However, the factory engineer is required to revise the load plan as per BNBC requirement and check the design accordingly.

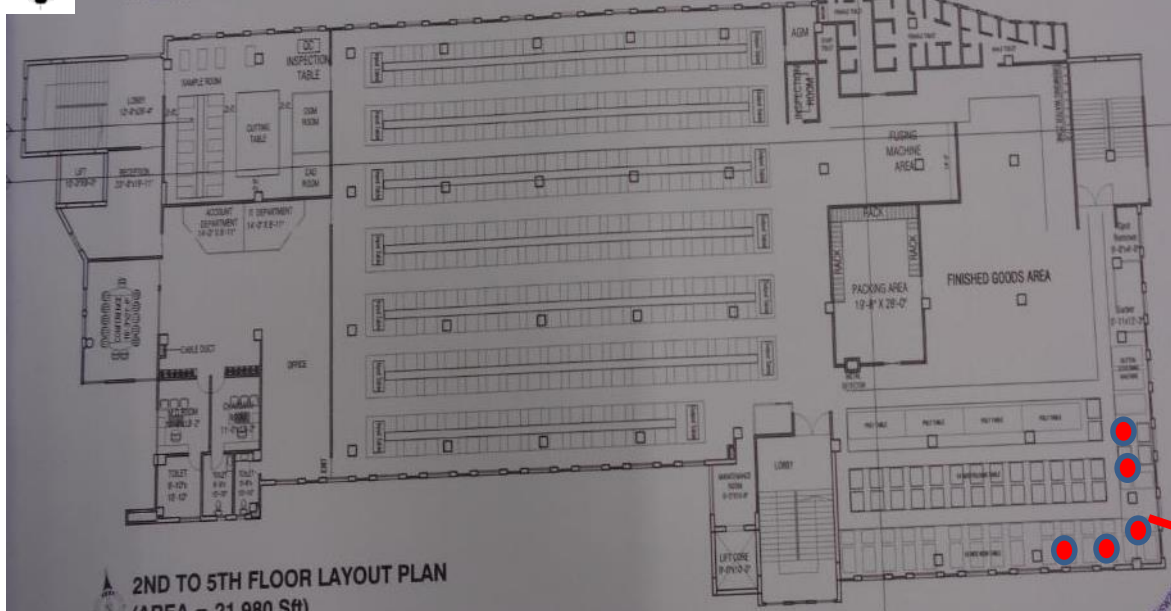
Roof layout

Five plastic water tank having capacity of 2000 litre each found on roof slab which were not shown in roof layout. Factory engineer is required to update the as-built drawing as well as check the capacity of roof beam-slab considering the point load.

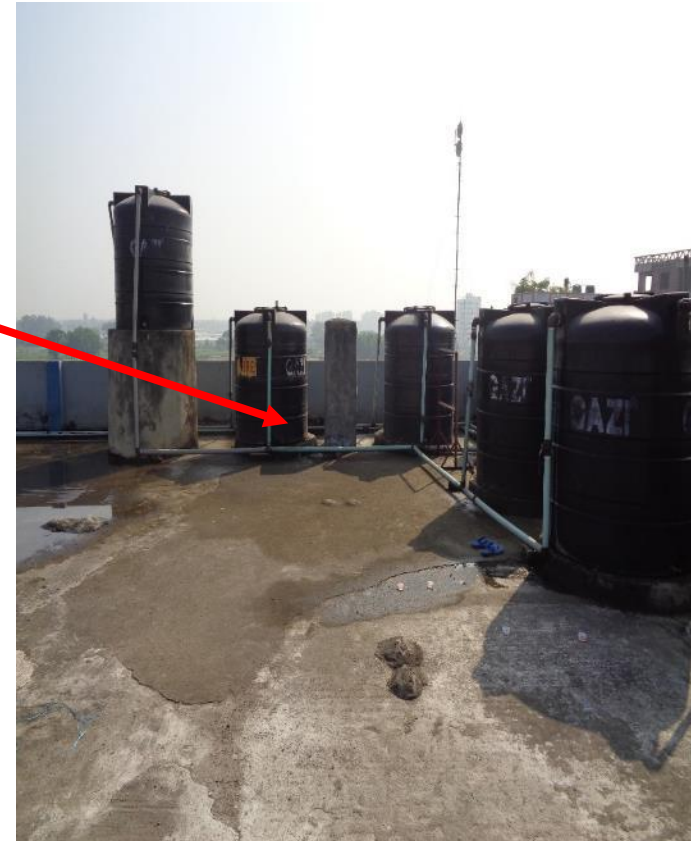
Plastic water tank (2000 liter each)

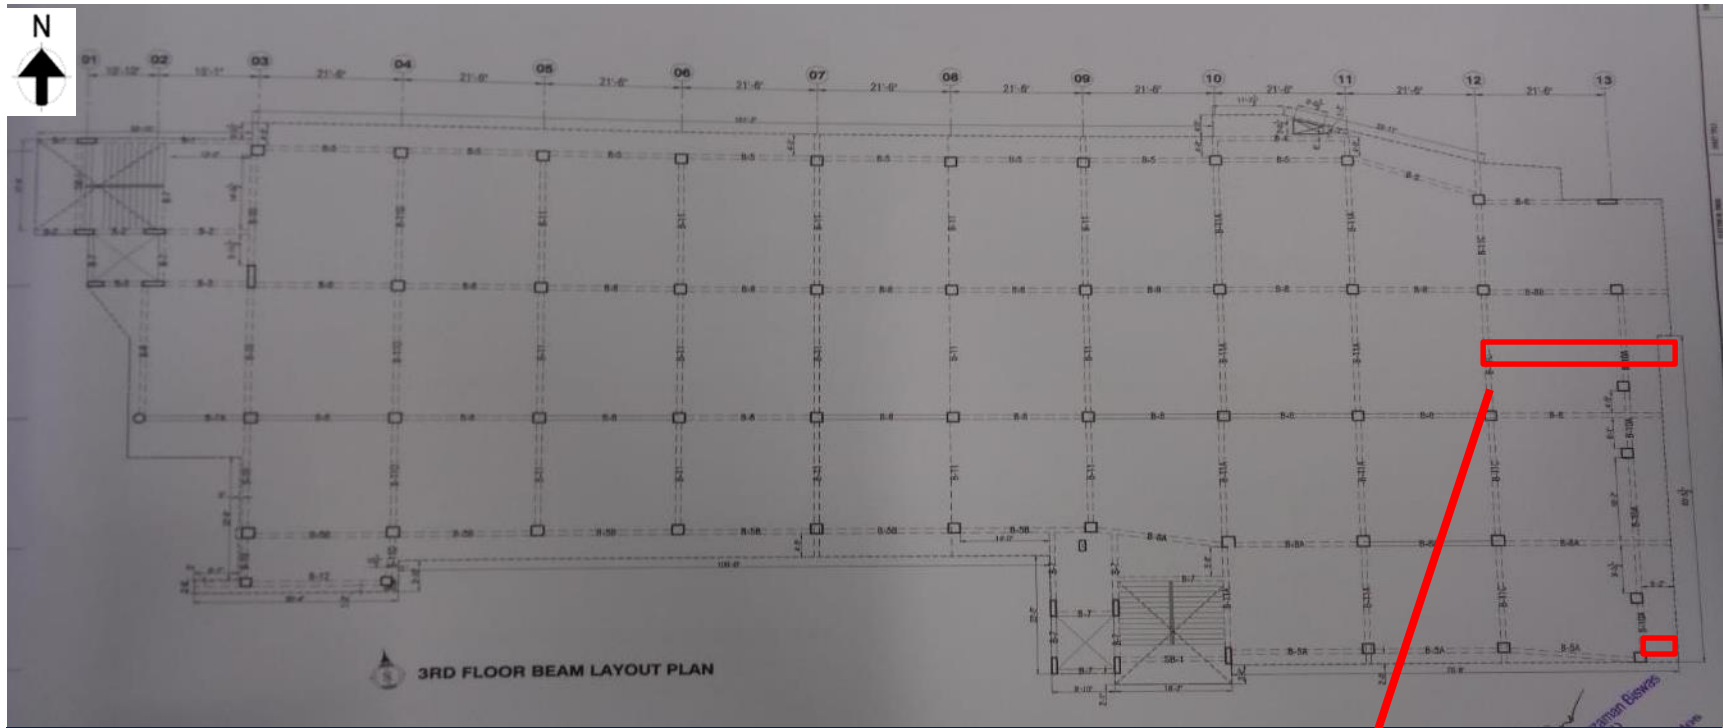
Third floor (Existing roof) beam layout

Highlighted beams were found onsite but not shown in drawing. Factory engineer is required to update the as-built drawing.

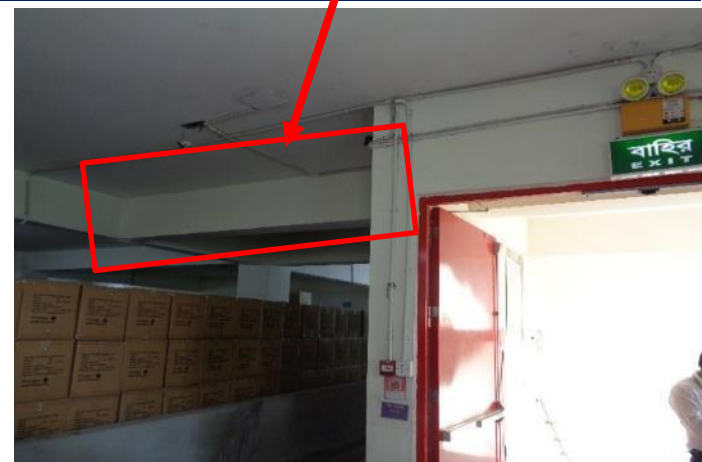
Beam not shown in drawing

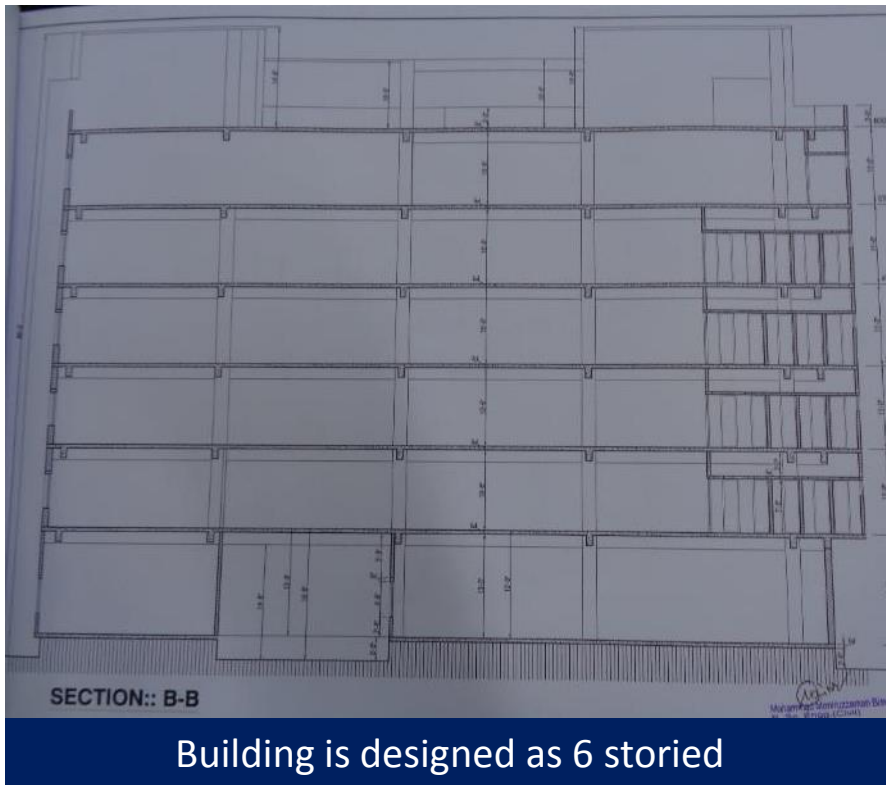
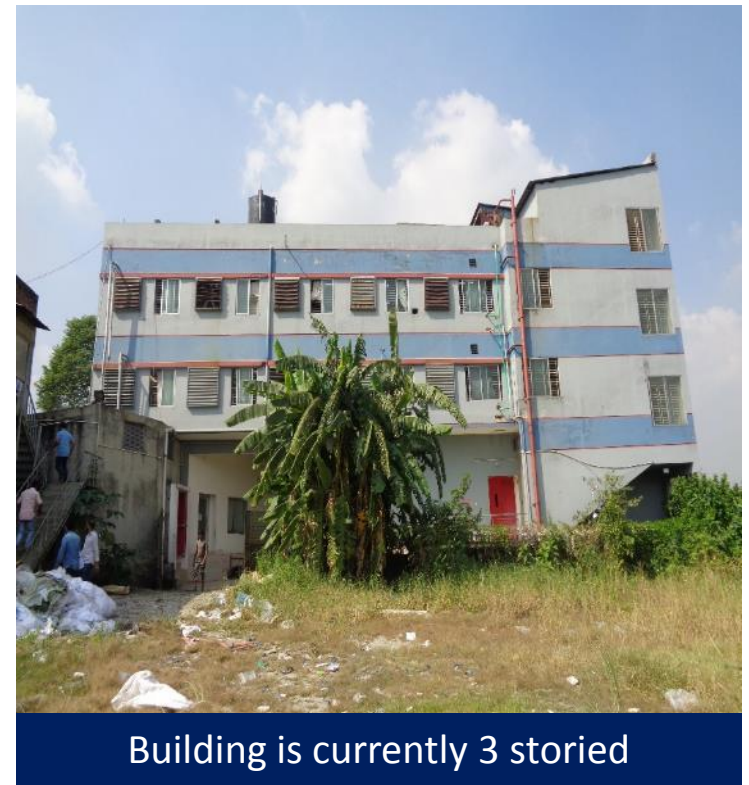
Possible vertical extension

The building has permit drawing for 6 storied and factory is intended to conduct vertical extension in future. However, the building is currently existed as three storied.

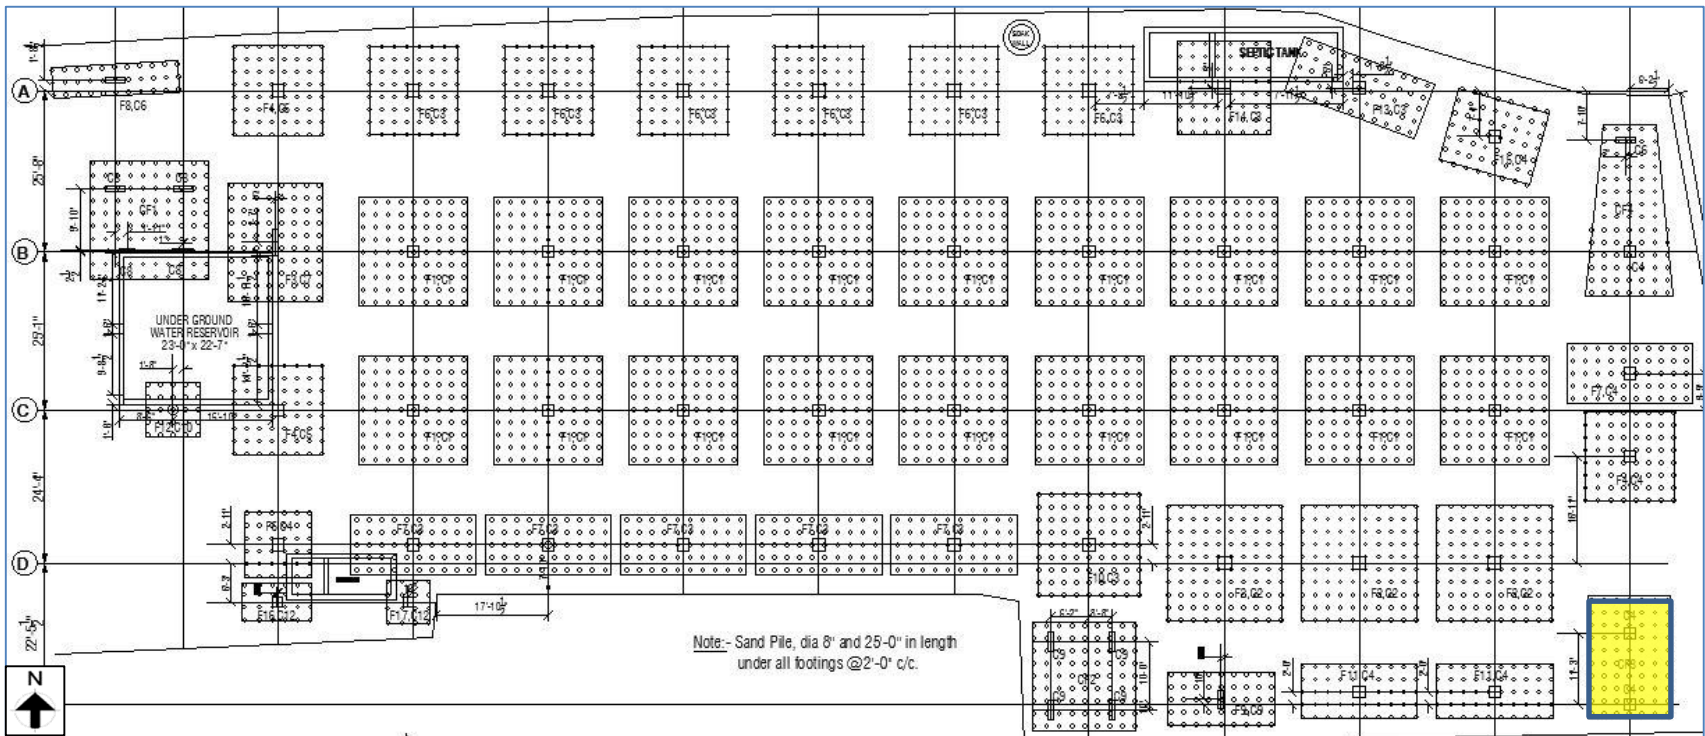
Stressed column/foundation in layout

Cursory calculation indicates the stress in highlighted column & foundation in layout will exceed normal design limit for above of 4 storied. Factory engineer is required to review, design of column and foundation stress in-case of conducting any vertical extension above 4 storied. Also, take 4-100 mm diameter concrete cylinder core from lower tier of the building to evaluate concrete strength of the existing column.

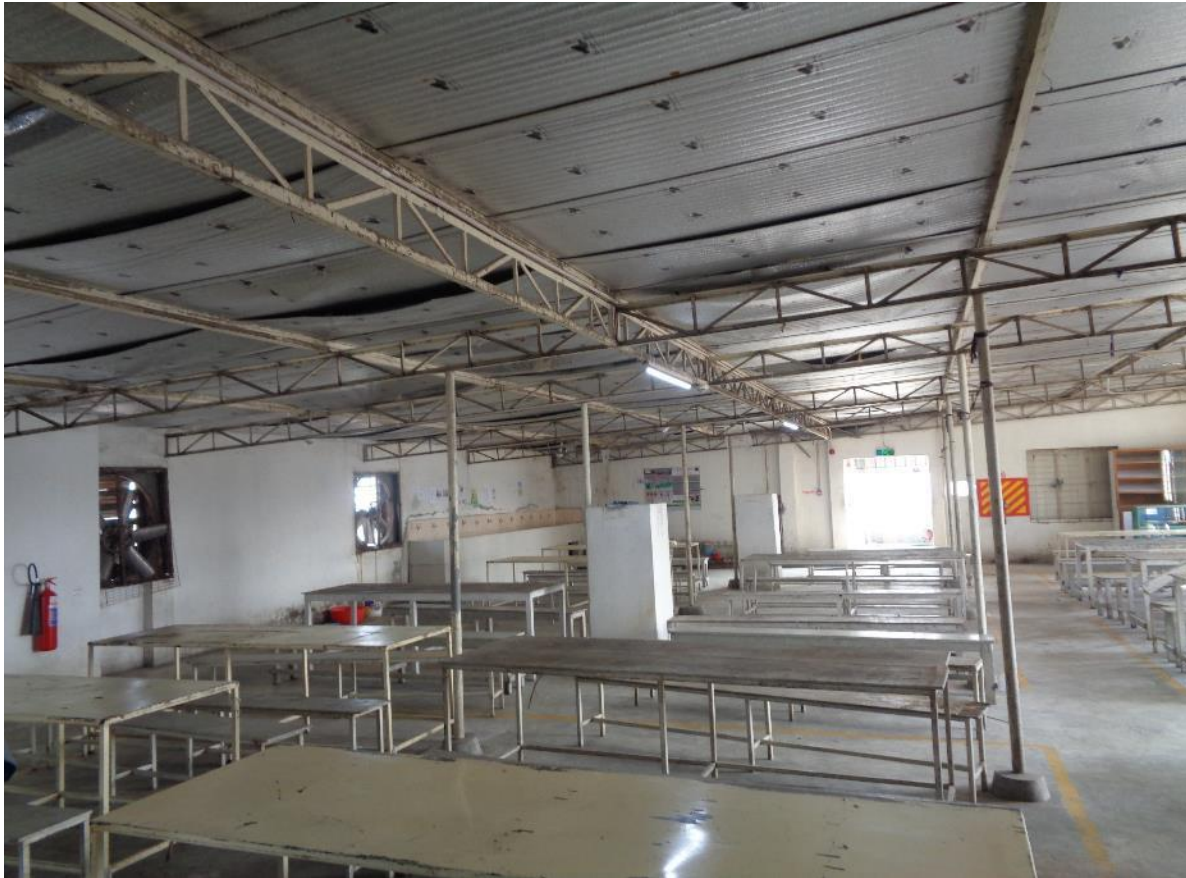
No framing (along periphery)/bracing system provided

Truss framing is provided along long direction at mid portion, but no compression member provided (along periphery). Also, roof bracing is not provided for roof. Factory engineer is required to check the lateral stability of the shed.

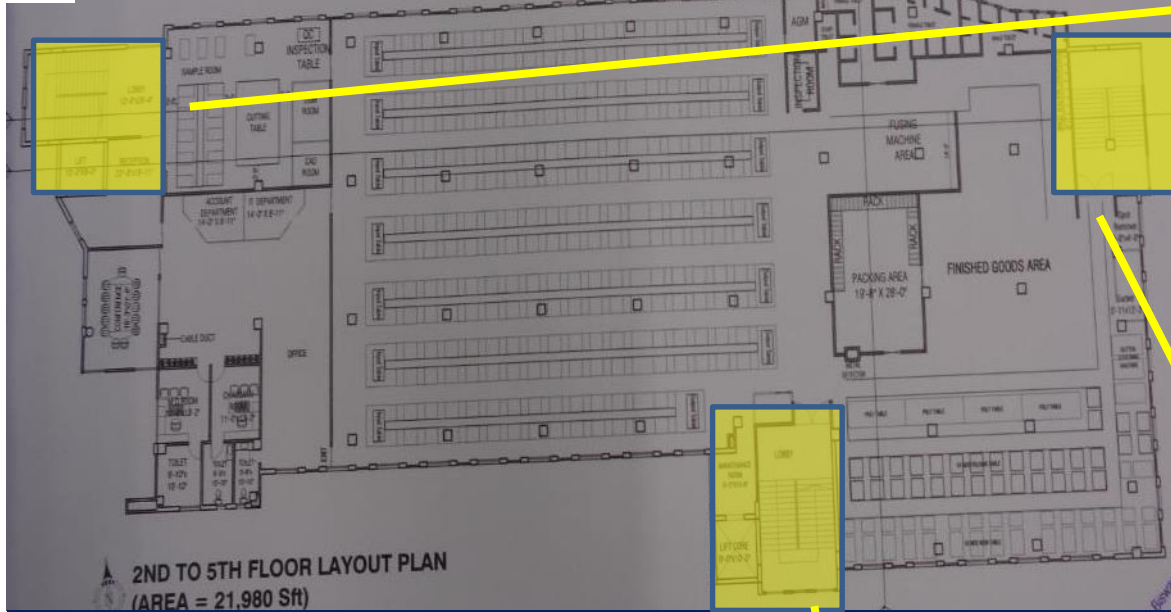
Staircase/lift core location

Apparently non engineered shed over staircase & lift room

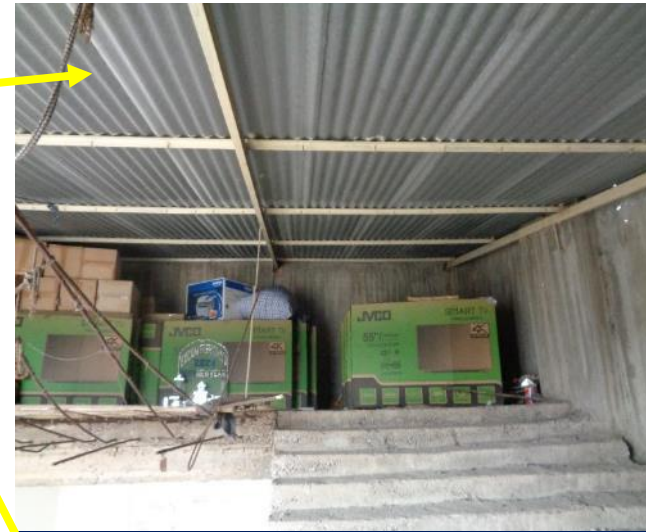
No apparent load path with poor connection

No apparent load path with poor connection in all sheds over staircase and lift room. Factory engineer is required to check the connections against uplift forces or replace with engineered structure.

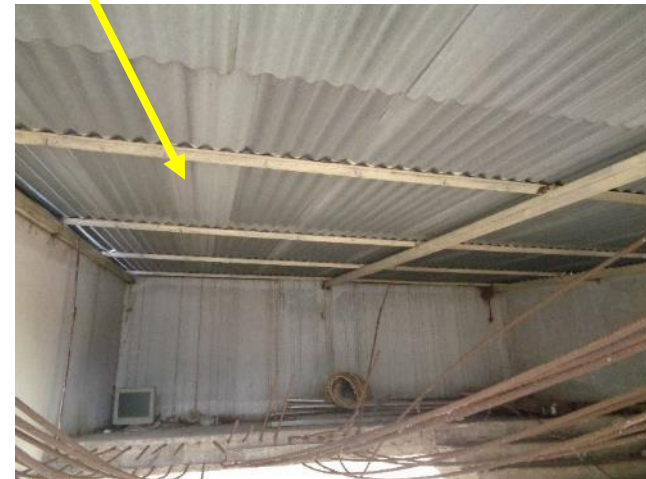
No apparent load path with poor connection

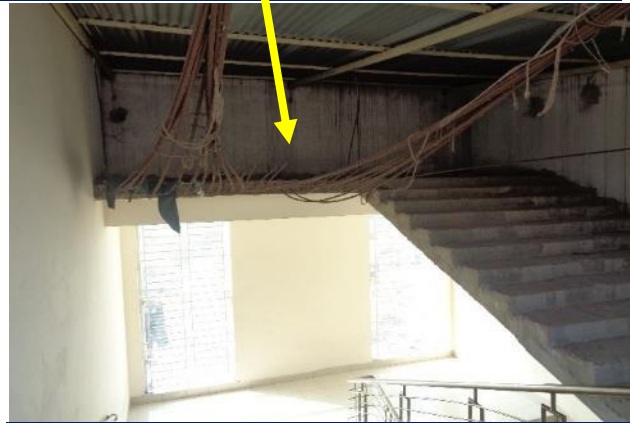
No apparent load path with poor connection

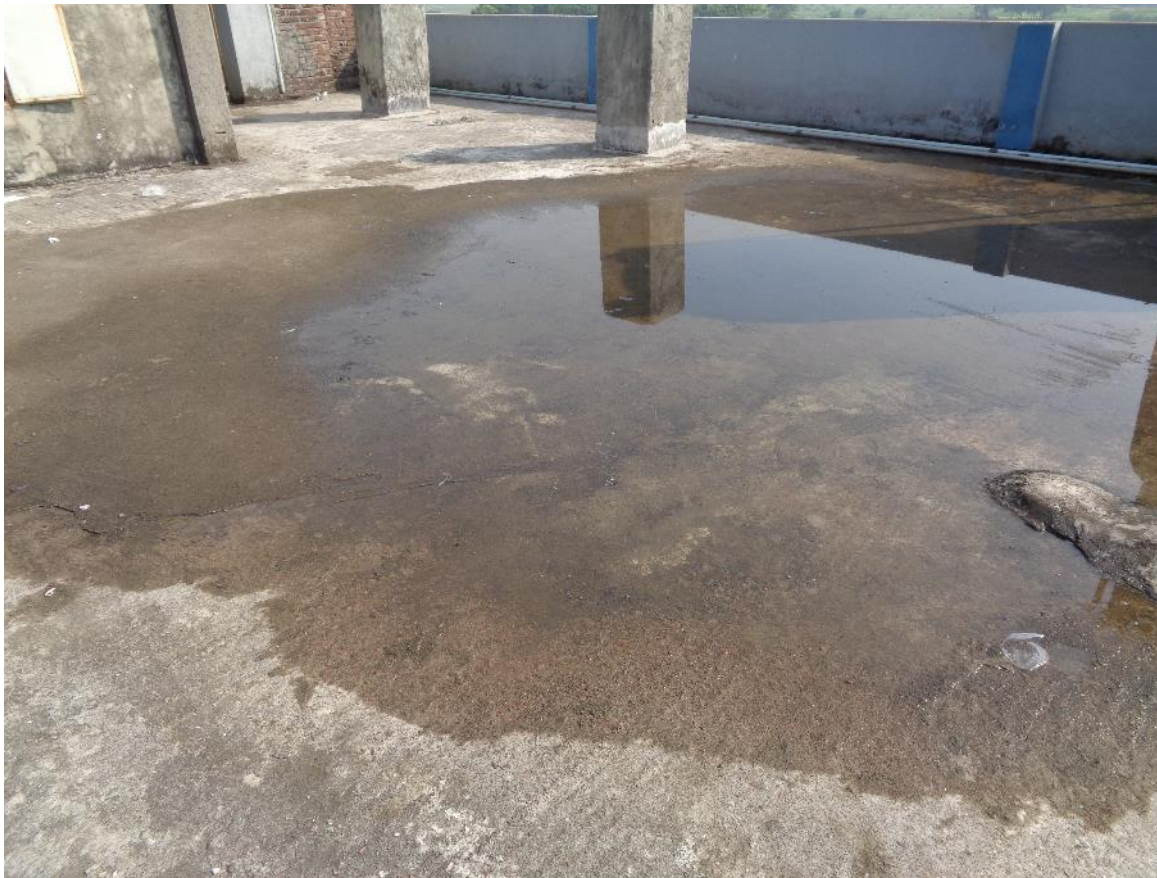
Water ponding on roof slab due to poor drainage system

Water ponding on roof slab due to poor drainage system. Aggregate of slab casting was observed as brick chips. Factory is required to improve drainage system and water proofing on roof slab.

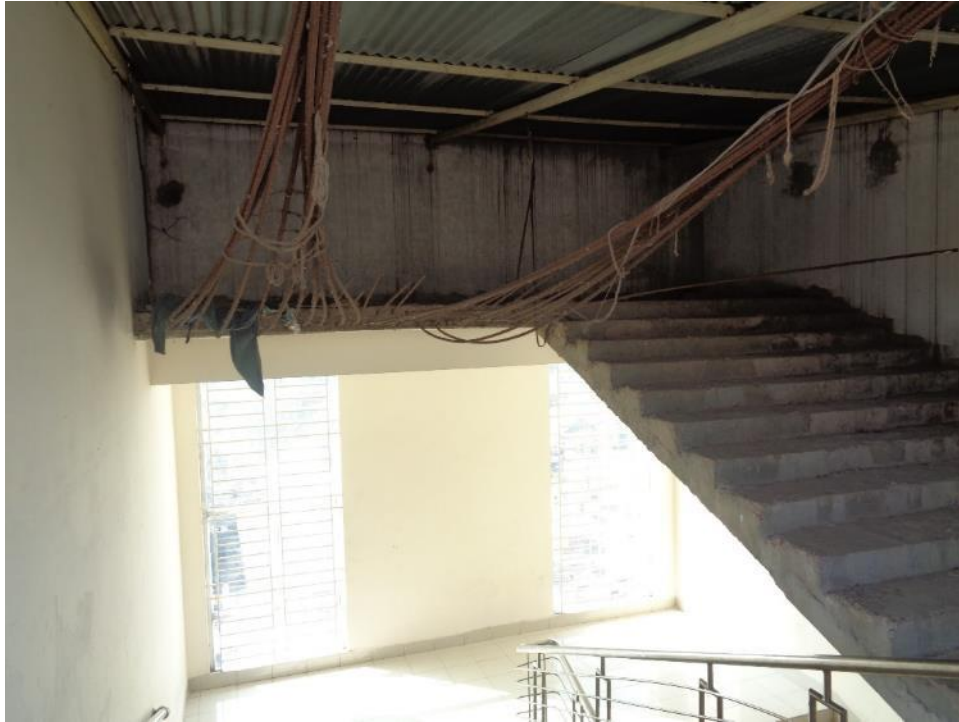
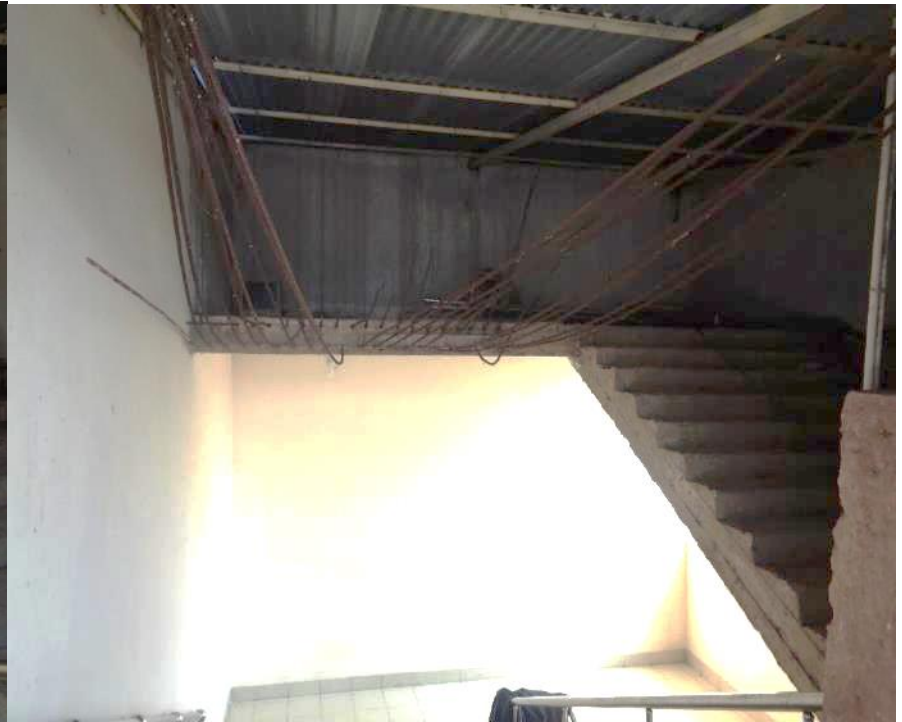
Exposed reinforcement left at Staircase

Exposed reinforcement is left at staircase which was prone to corrosion. Factory is required to provide rust proof paint on exposed reinforcement to protect from corrosion.

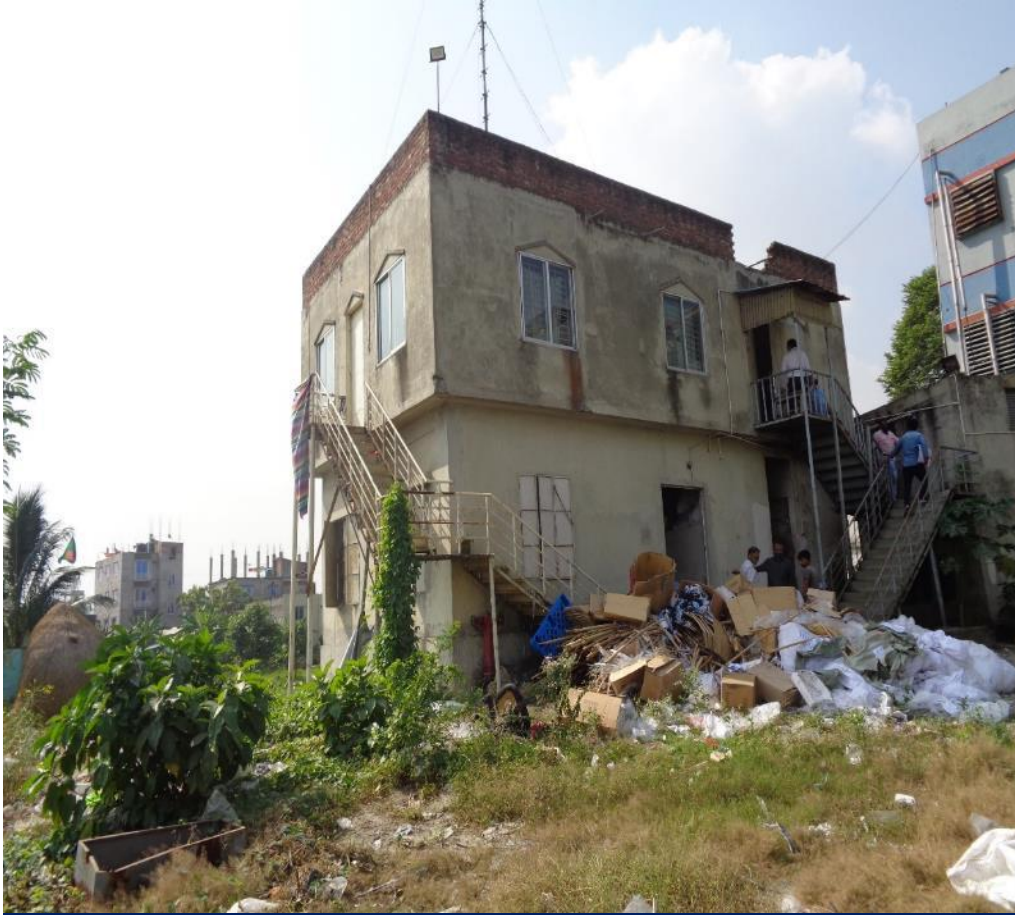
North-East view

Design Report needs to be prepared

As per BNBC, every building or structure designed shall have its design documents prepared in accordance with the provision of Section 1.9.1. The design document shall include a design report, and a set of structural drawings, which shall be prepared in compliance with section 1.9.1.1 and section 1.9.1.2 as per BNBC. At the time of inspection, only as-built drawing was available, but no design report was available which is required to be prepared in compliance with section 1.9.1.1 (part-6, BNBC).

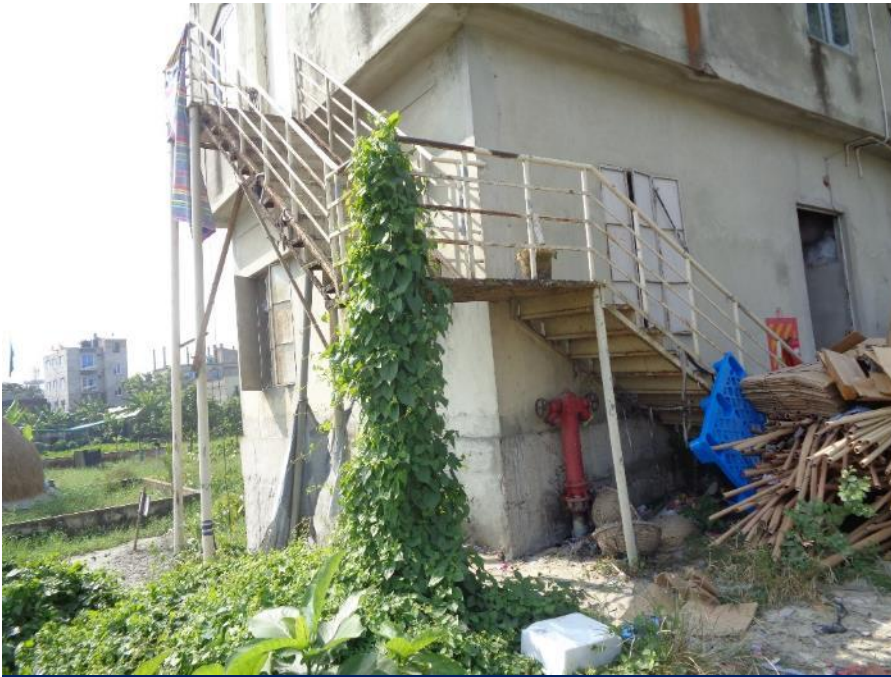
Steel stair-1

Two non engineered steel stairs were found with no obvious stability system, poor connection and apparently undersized members. Factory engineer is required to check the adequacy of those steel stairs or replace with engineered structures.

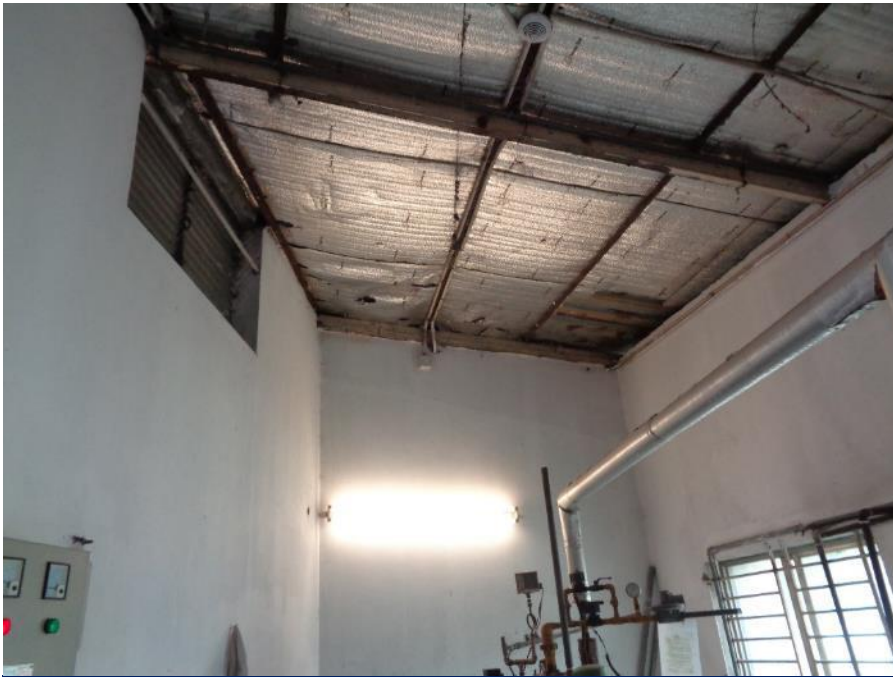
Boiler

Both sheds were appeared to be non engineered with no obvious stability system, poor connection and apparently undersized members. Factory engineer is required to check the adequacy of those sheds or replace with engineered structures.

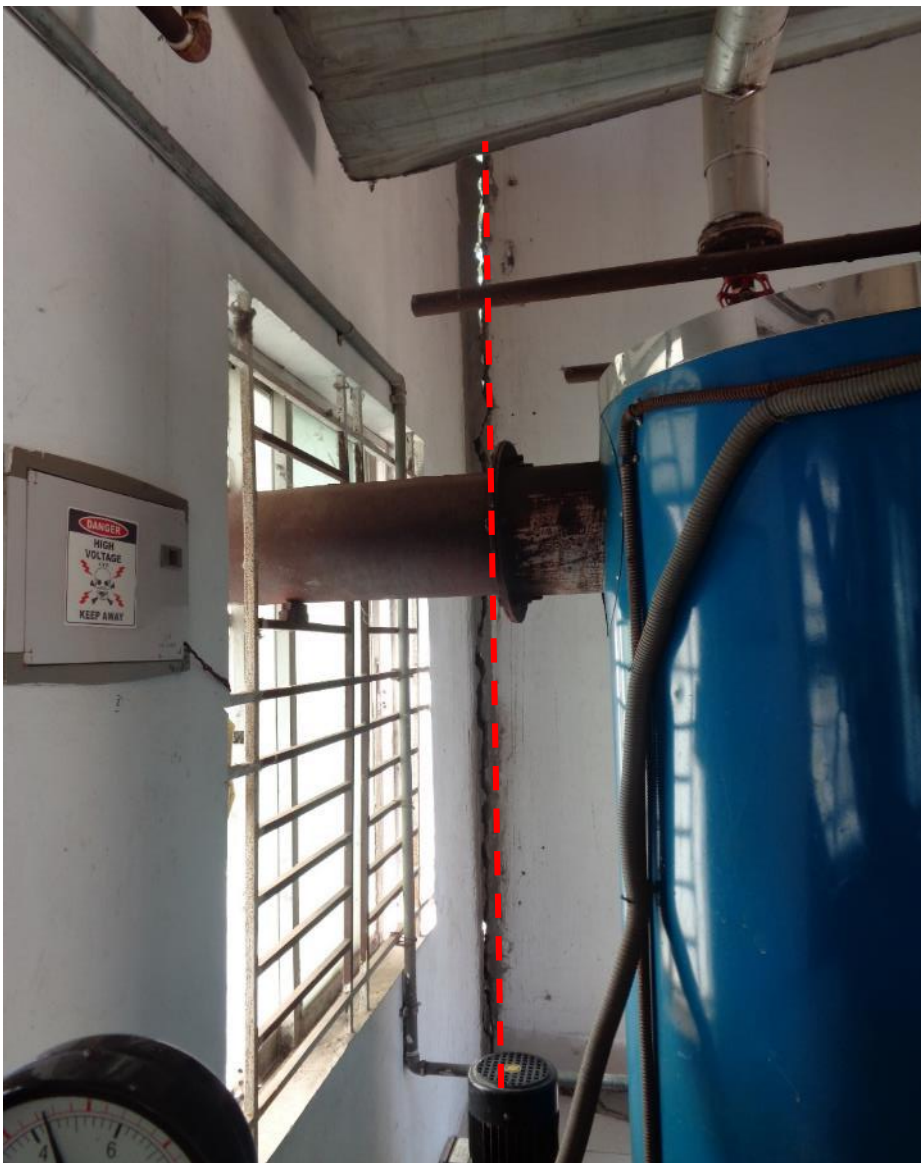
Brick wall drifted (apparently) from original position

A 250 mm thick and 3.05 m high brick wall was appeared to be out of plumb which may have been drifted vertically due to foundation settlement or any lateral movement. Factory engineer is required to check the plumb of wall and investigate the reason for the vertical displacement. Also, implement remediation work according to the investigation report.

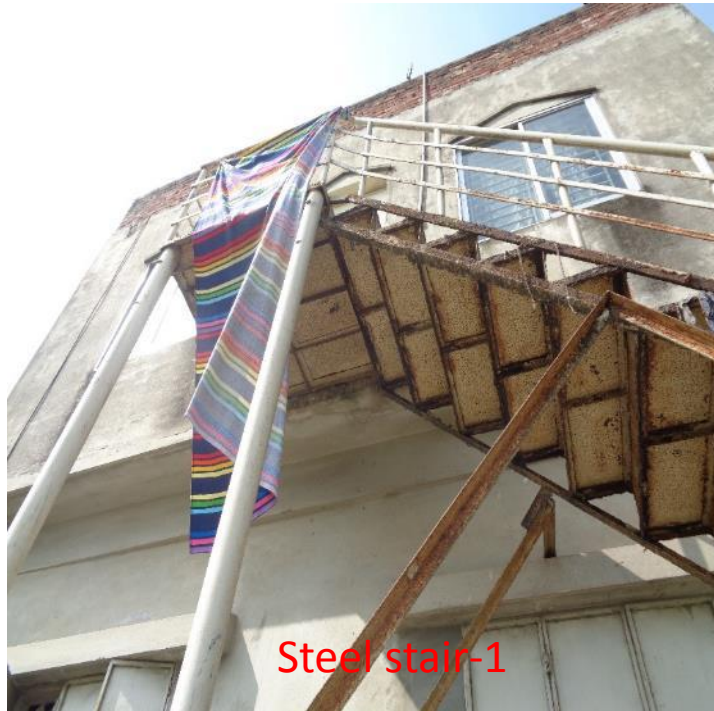
Steel stair-1

Severe corrosion in steel members

Severe corrosion was observed on steel members at steel stairs and Boiler shed. Factory is required to replace the damaged steel members and provide rust proof paint on all steel members to protect from corrosion.
