# Muazuddin Textile Ltd. (Sheds)

16 November 2021

# Observations

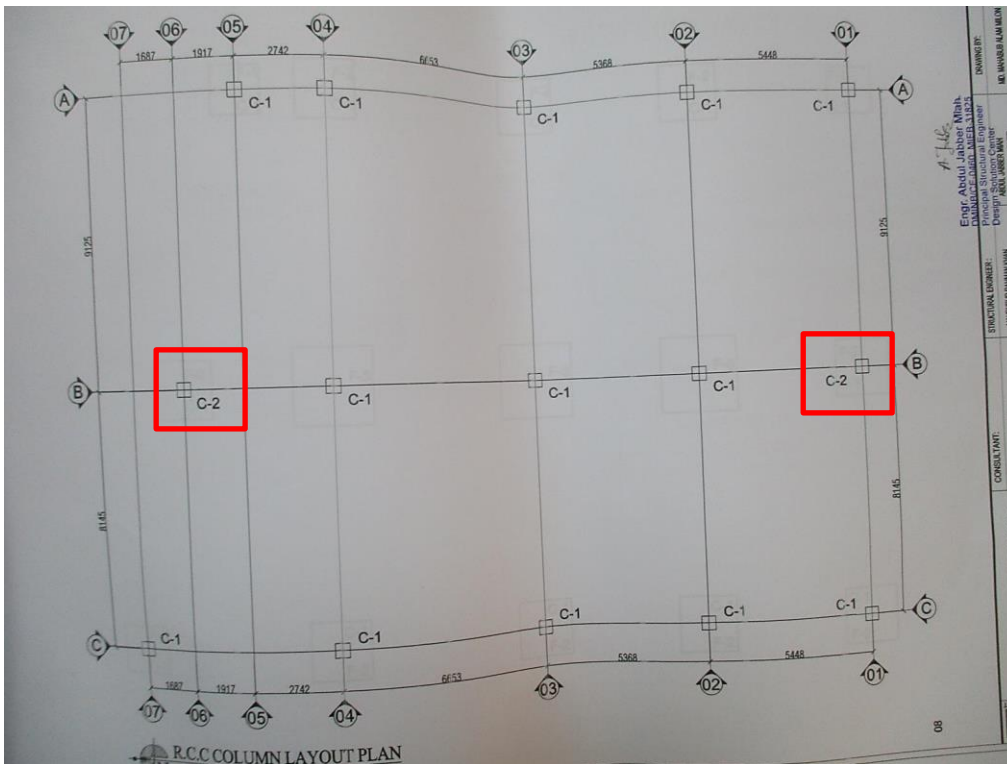
RC Column layout plan

C2 type columns are shown in RC column layout plan and in the column schedule. During inspection, all columns were found C1 type. Though all columns are shown as C1 in construction drawing. And RC slab extension was observed at the eave of the shed which was not mentioned in the drawing. Building engineer to survey the structure and prepare accurate as-built drawings accordingly.

Item No.	Observation	Recommended Action Plan	Recommended Timeline
01	Discrepancy in as-built drawings. (New Knitting Shed, Shed-9)	The building engineer is required to survey the structural components and produce accurate as-built structural details.	6-weeks
02	Lack of lateral stability system. (New Knitting Shed, Shed-9)	Building engineer is required to check the lateral stability of the structure and suggest proper remedial actions accordingly	6-weeks
03	Lack of lateral stability system. (New Knitting Shed, Shed-9)	Carry out remedial works suggested by the engineer.	6-months
04	DEA report needs to be reviewed. (New Knitting Shed, Shed-9)	Building engineer is required to revise the DEA report & retrofitting scheme based on accurate as-built drawings, in-situ material strength and applicable building code.	6-months

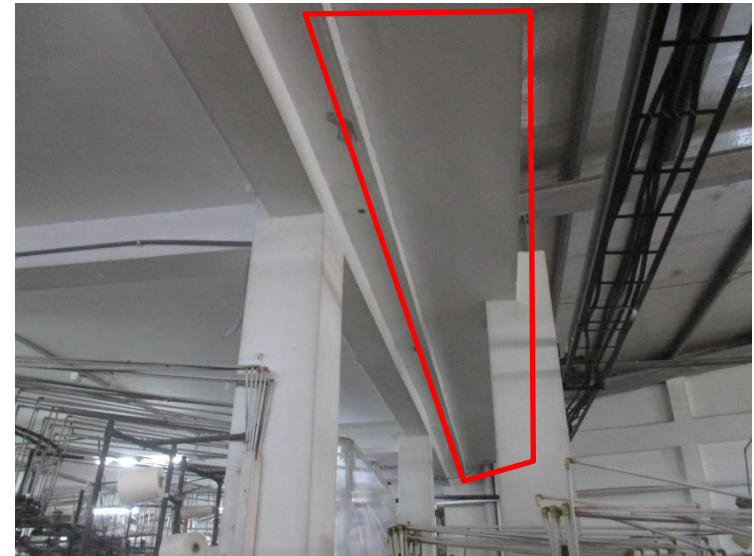
RC slab extension for roof drainage

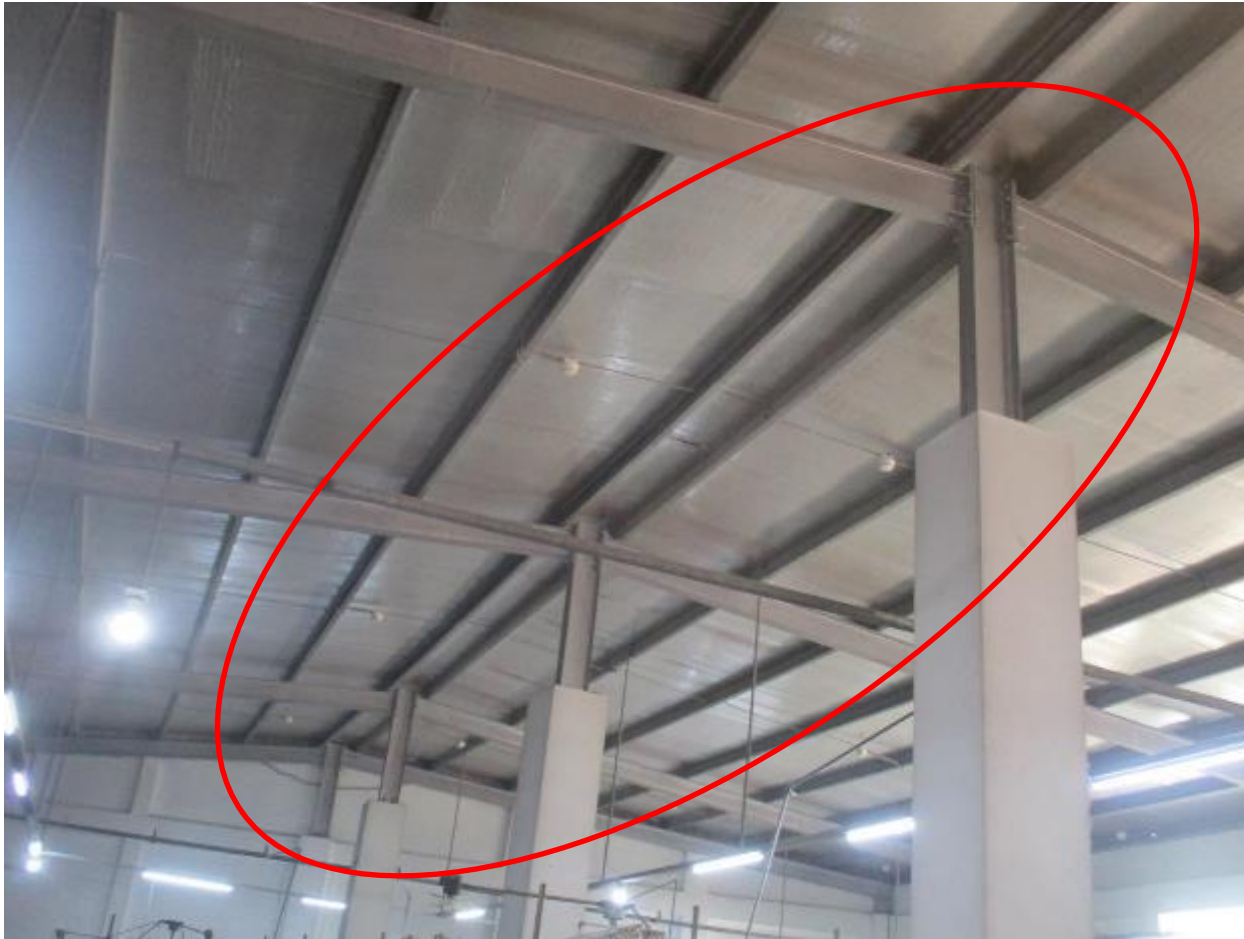
Absence of roof bracing & lateral load transfer media along ridge

Lack of lateral stability system observed at the roof of the shed. Building engineer is required to check the lateral stability of the structure and suggest proper remedial actions accordingly.

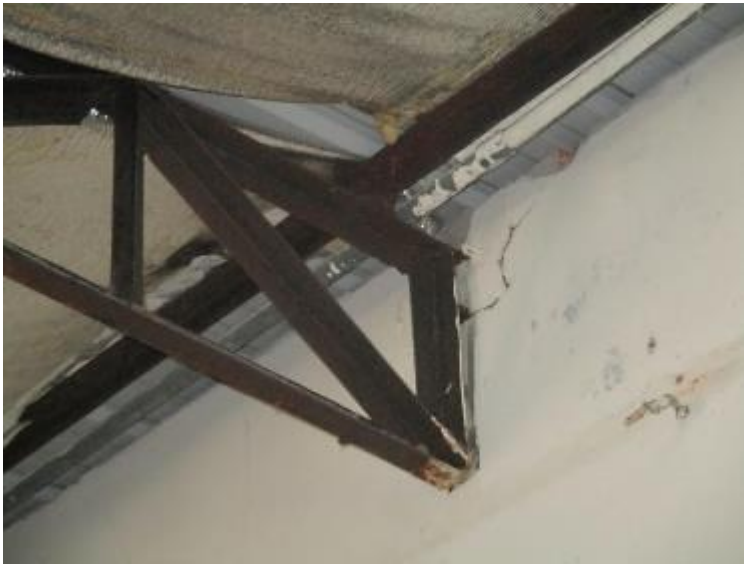
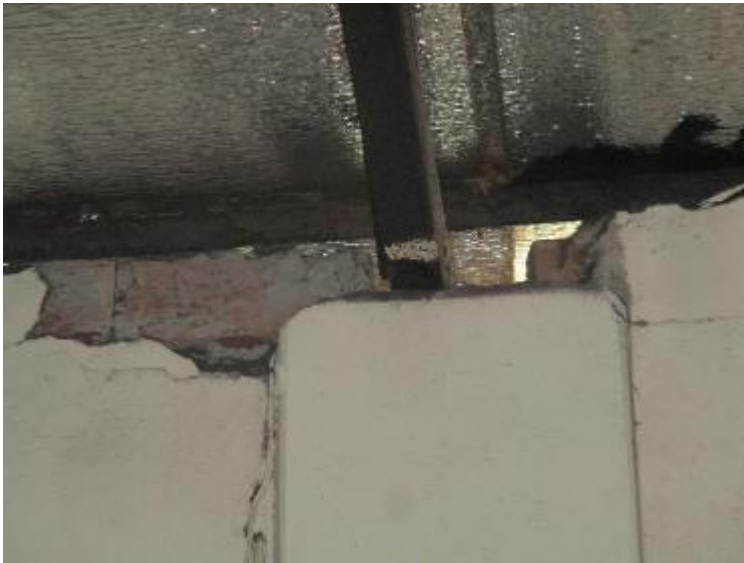
Poor and non-engineered connection

Poor connections, inadequate members and multiple & irregular roof framing systems were observed on-site. Therefore, the roof system seems to be non-engineered.

Item No.	Observation	Recommended Action Plan	Recommended Timeline
05	Discrepancy in as-built drawings. (New Knitting Shed, Shed-9)	Carry out remedial works suggested by the engineer.	6-weeks
06	Apparently non-engineered structure. (Tumble Shed)	Building engineer to survey the structure, check the roof system, connections, member adequacy and suggest required actions.	6-weeks
07	Apparently non-engineered structure. (Tumble Shed)	Implement the actions suggested by the engineer.	6-months

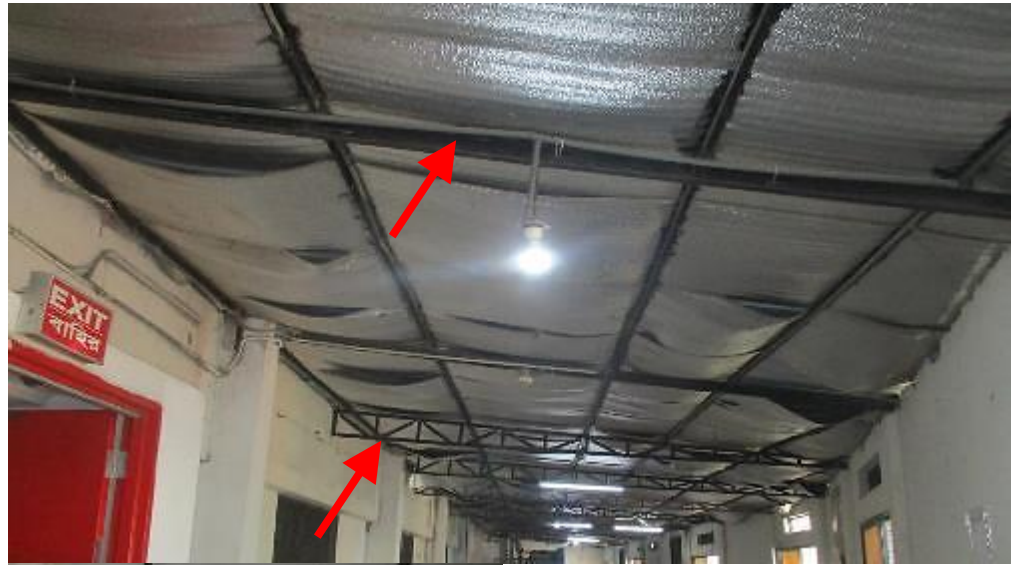
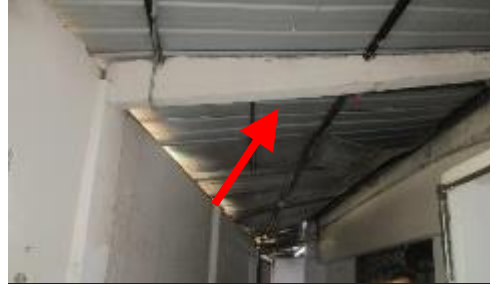
Multiple roof systems

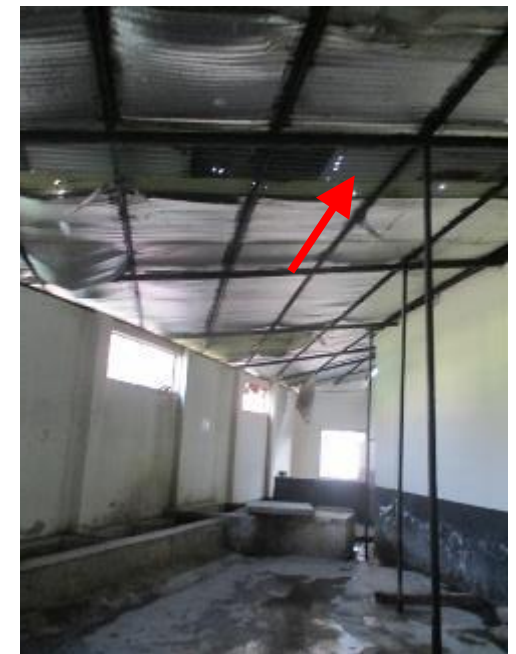
Inadequate members
