# B2B Excellence Ltd. (Extension Buildings)

Purbapara Mirzapur, 8 No. Mirzapur Mouza, Mirzapur, Gazipur Sador, Gazipur  
(24.08869, 90.35672)  
15<sup>th</sup> November 2021

# Observations

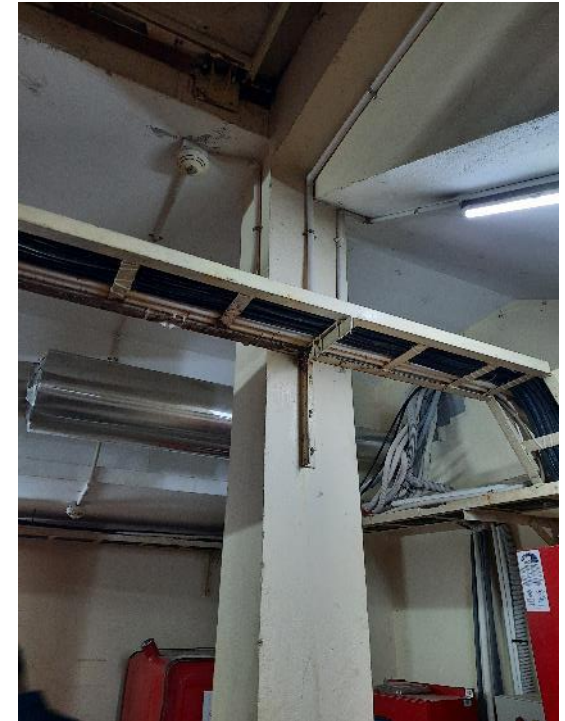
Two additional column found on the basement floor but not shown in the drawing. Building engineer is required to update the as-built drawings

| Item No. | Observation | Recommended Action Plan | Recommended Timeline |
|---|---|---|---|
| 01 | Inconsistency in as-built drawing & engineering assessment report. (2-Storied RCC Building) | Building engineer is required to update the as-built drawings. | 6-weeks |

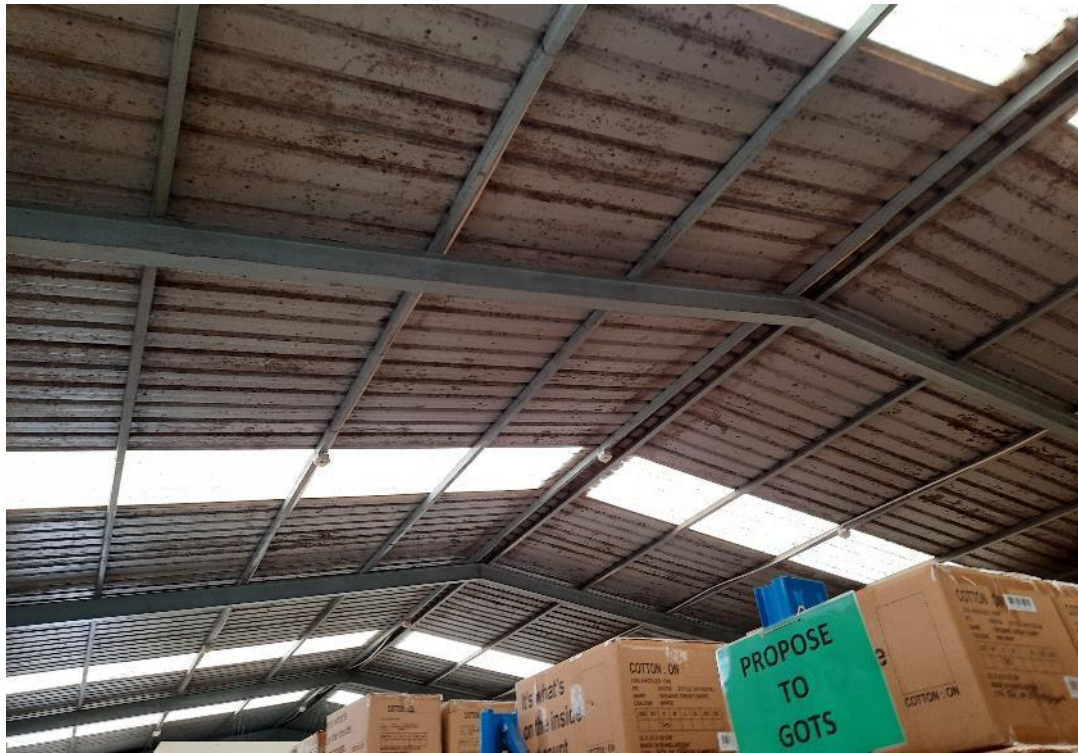
**Apparently lack of lateral stability system &  
inadequate member size**

No compression strut provided at ridge position in the long direction. No roof bracings provided along the short direction. Apparently lack of lateral stability observed. The building engineer is required to check the lateral stability system of the shed.

| Item No. | Observation | Recommended Action Plan | Recommended Timeline |
|---|---|---|---|
| 05 | Apparently lack of lateral stability system & inadequate member size (CNG Vehicle & Finished Goods Shed) | The building engineer is required to check the lateral stability system of the shed. | 6-weeks |

| Item No. | Observation | Recommended Action Plan | Recommended Timeline |
|---|---|---|---|
| 06 | Apparently lack of lateral stability system & inadequate member size (CNG Vehicle & Finished Goods Shed) | Carryout remedial works where necessary. | 6-months |

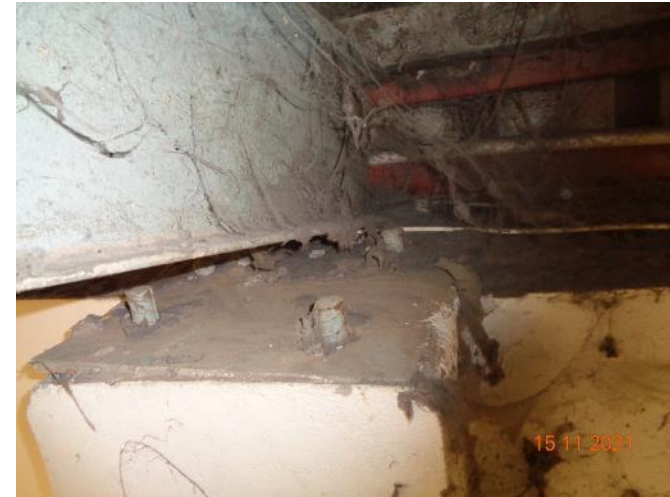
Poor connection details

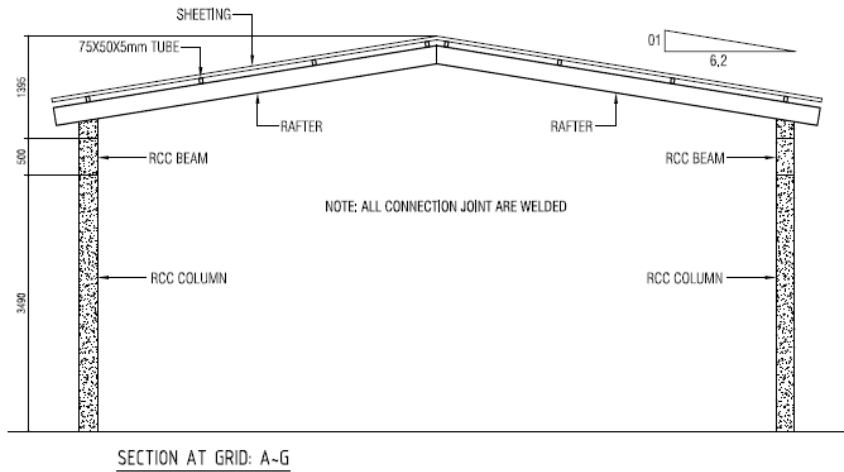
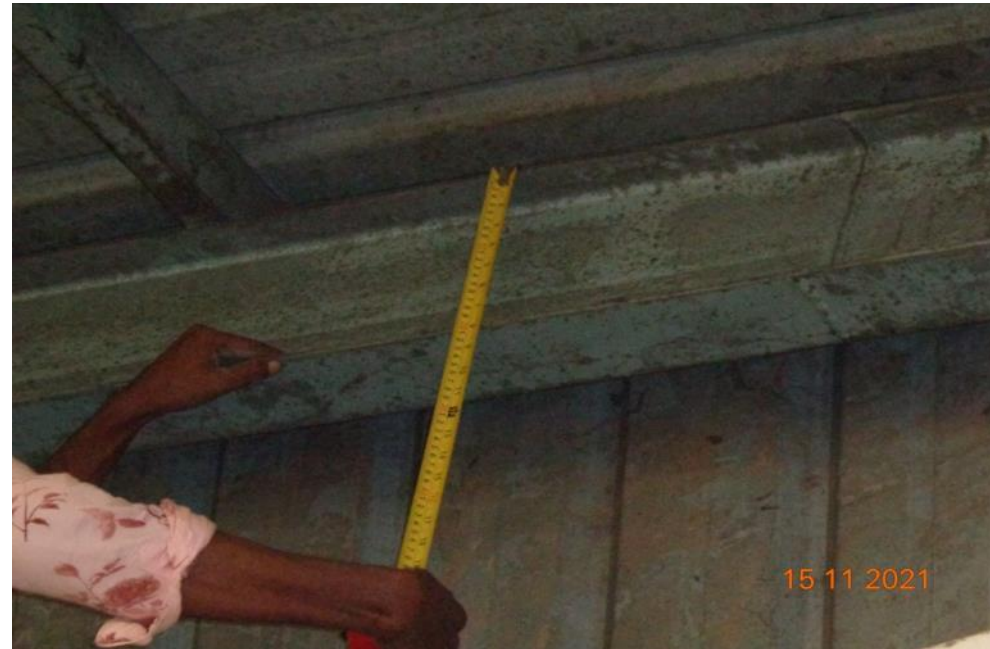
Rafter depth shown 250 mm on as-built drawing, but depth measured 200 mm onsite. Building engineer is required to update the as-built drawings.

| Item No. | Observation | Recommended Action Plan | Recommended Timeline |
|---|---|---|---|
| 07 | Inconsistency in as-built drawing. (CNG Vehicle & Finished Goods Shed) | Building engineer is required to update the as-built drawings. | 6-weeks |

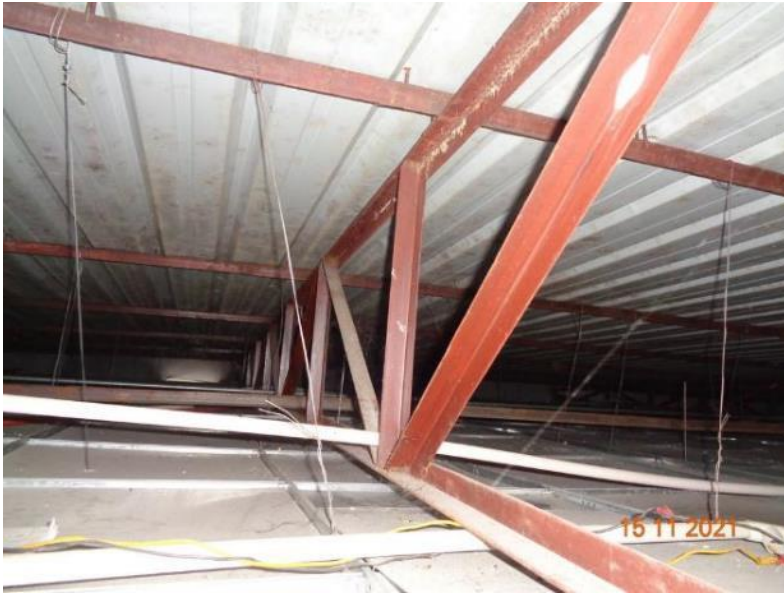
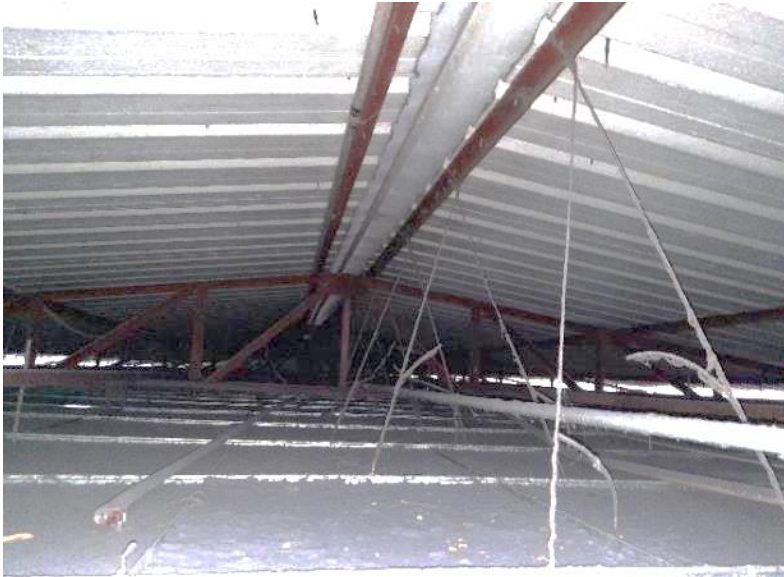
No roof bracing

No roof bracing provided to integrated the trusses. only truss action in the short direction. Load transfer media in long direction is missing. Also, poor connections are observed. The building engineer is required to check the lateral stability system of the structure and suggest proper remedial measures.

| Item No. | Observation | Recommended Action Plan | Recommended Timeline |
|---|---|---|---|
| 08 | Apparently lack of lateral stability system & inadequate member size. (Cutting Shed) | The building engineer is required to check the lateral stability system of the shed. | 6-weeks |
| 09 | Apparently lack of lateral stability system & inadequate member size. (Cutting Shed) | Carryout remedial works where necessary. | 6-months |

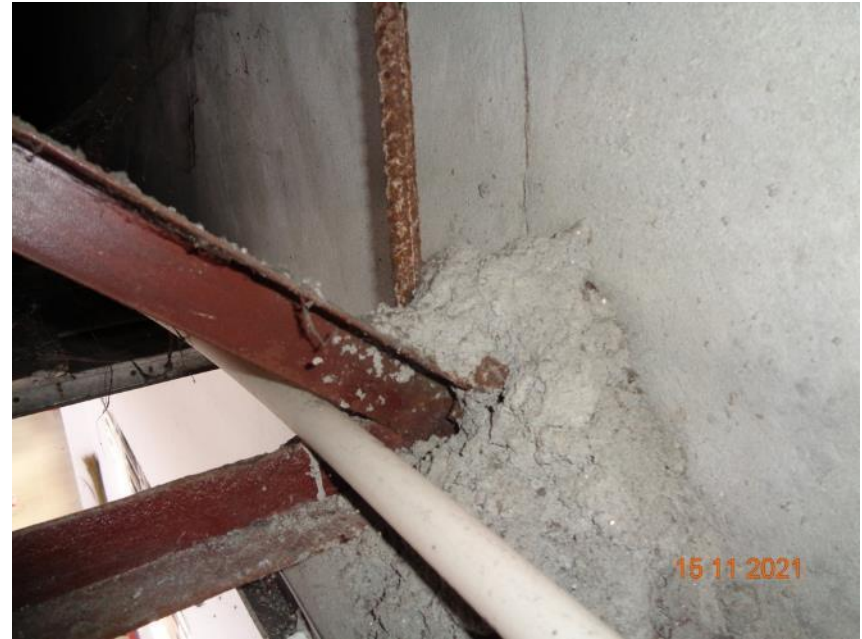
Poor connection

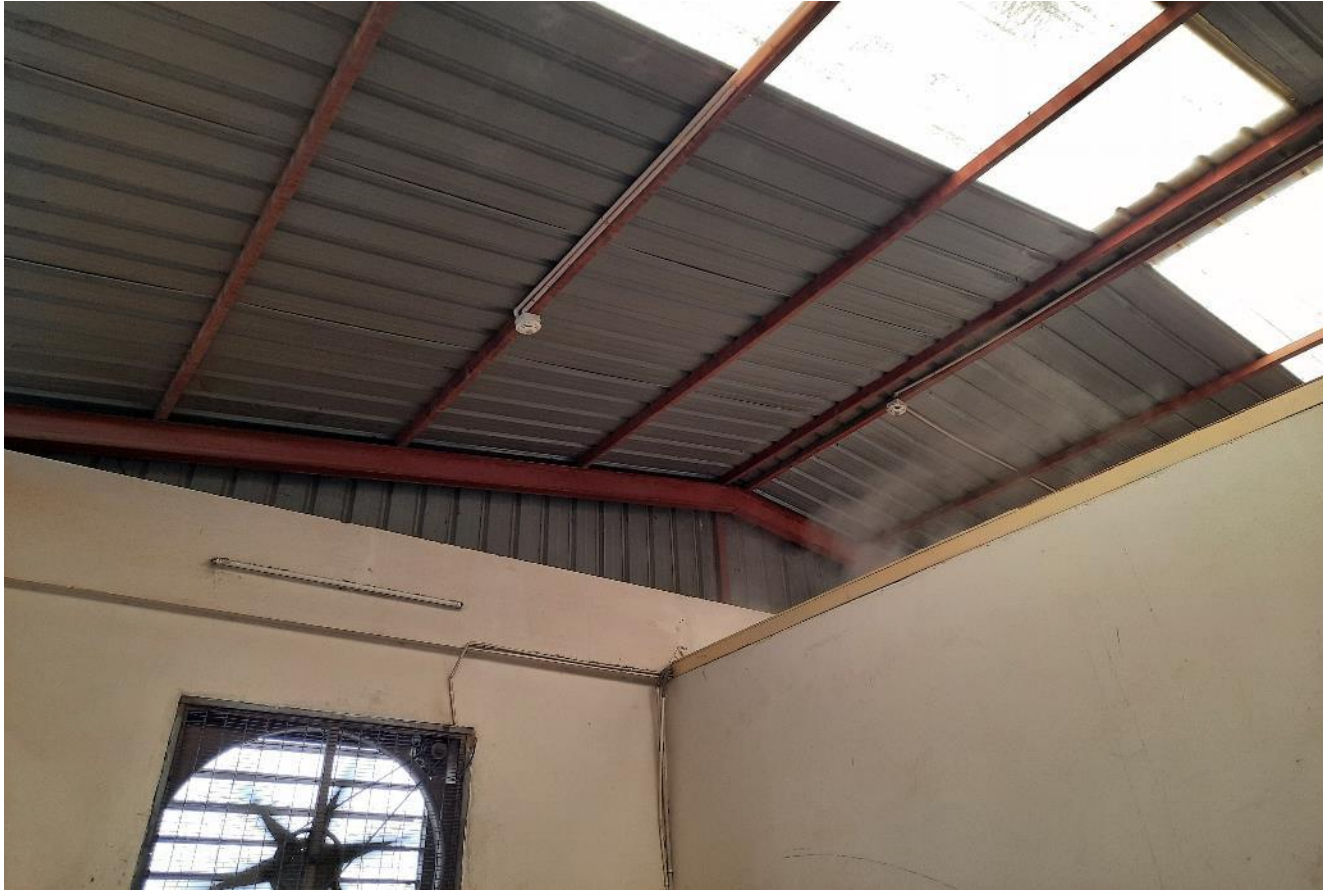
**Apparently lack of lateral stability system &  
Inadequate RC members**

No compression strut was at ridge position provided in the long direction.  
No roof bracings provided along the short direction. Apparently lack of lateral stability observed.  
The building engineer is required to check the lateral stability system of the shed.

| Item No. | Observation | Recommended Action Plan | Recommended Timeline |
|---|---|---|---|
| 10 | Apparently lack of lateral stability system & Inadequate RC members. (Compressor & Boiler) | The building engineer is required to check the lateral stability system of the shed. | 6-weeks |

| Item No. | Observation | Recommended Action Plan | Recommended Timeline |
|---|---|---|---|
| 11 | Apparently lack of lateral stability system & Inadequate RC members. (Compressor & Boiler) | Carryout remedial works where necessary. | 6-months |

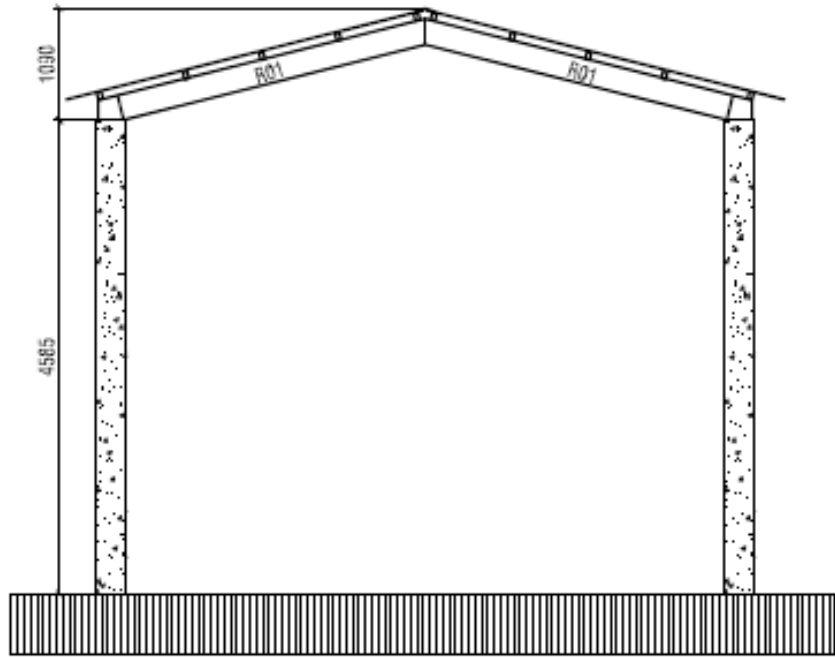
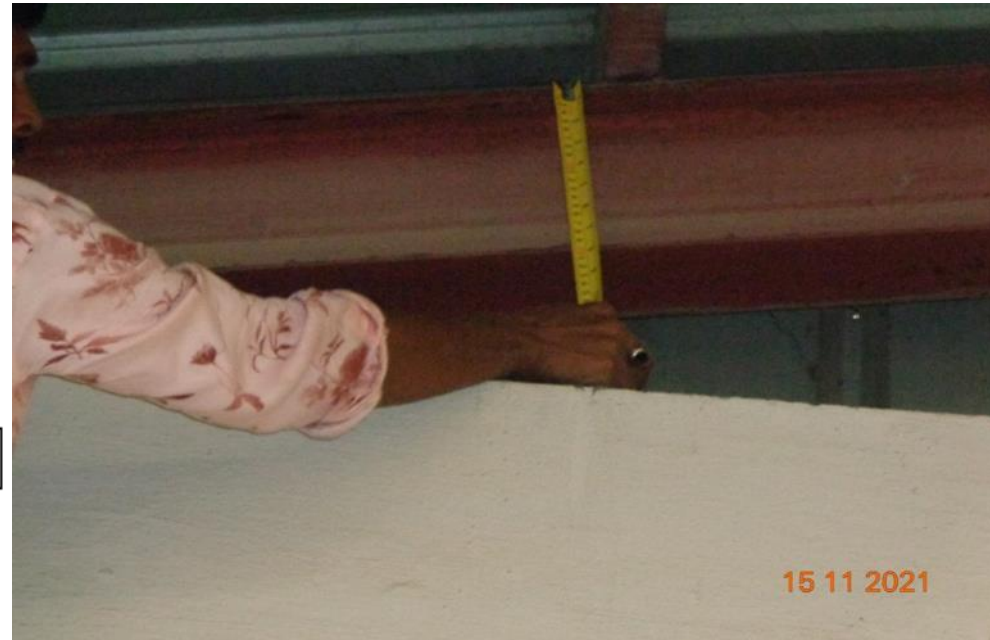
Rafter depth shown 250 mm on as-built drawing, but depth measured 200 mm onsite. Building engineer is required to update the as-built drawings.

| Item No. | Observation | Recommended Action Plan | Recommended Timeline |
|---|---|---|---|
| 12 | Inconsistency in as-built drawing. (Compressor & Boiler) | Building engineer is required to update the as-built drawings. | 6-weeks |

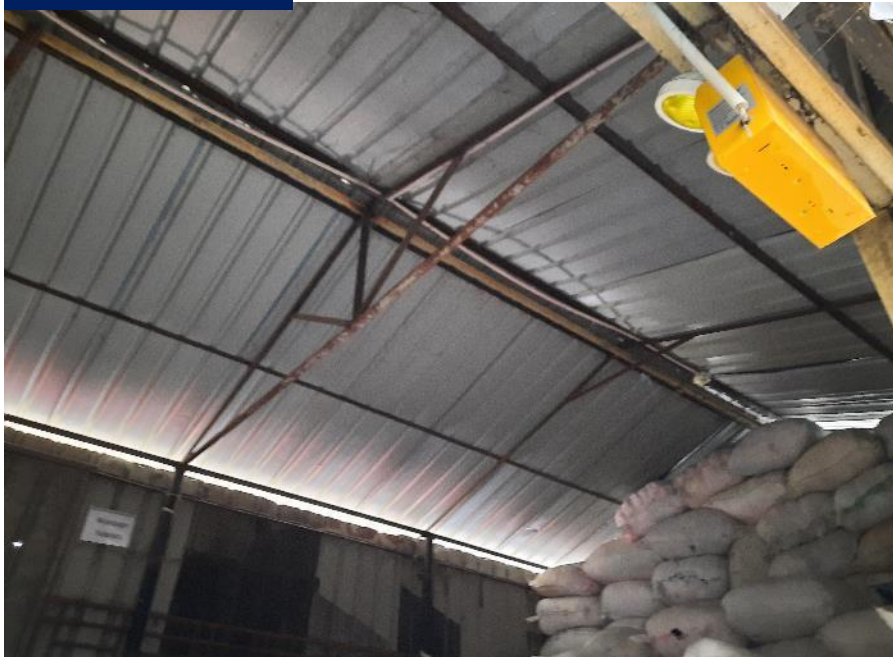
Wastage Shed

Inadequate member size, lack of lateral stability system and poor connection details observed. Building engineer is required to replace the structure.

| Item No. | Observation | Recommended Action Plan | Recommended Timeline |
|---|---|---|---|
| 13 | Non-engineered shed. (Kitchen & Wastage Shed) | Building Engineer to prepare design report as per BNBC (part-6; Article 1.9.1) by reviewing design, loads and capacity of structural members. | 6-weeks |

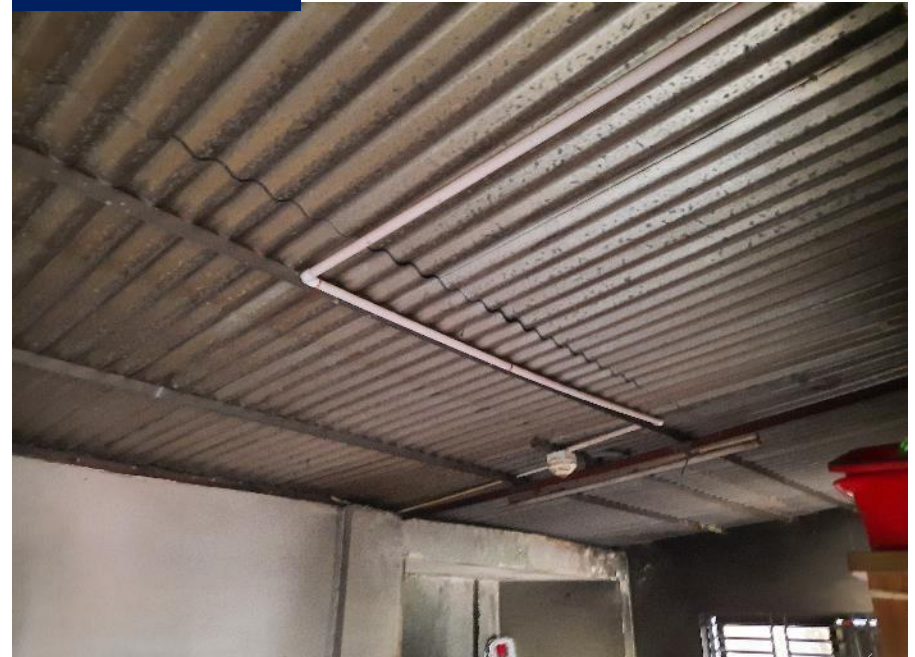
Kitchen Shed

Inadequate member size, lack of lateral stability system and poor connection details observed. Building engineer is required to replace the structure.
