# Liberty Knitwear Co. Ltd. (9501)

Ramarbagh, Kutubpur, Fatullah, Narayangani, Bangladesh

27.MARCH.2014

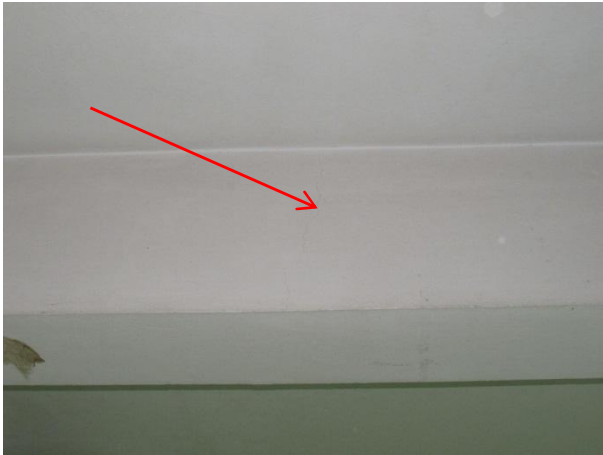
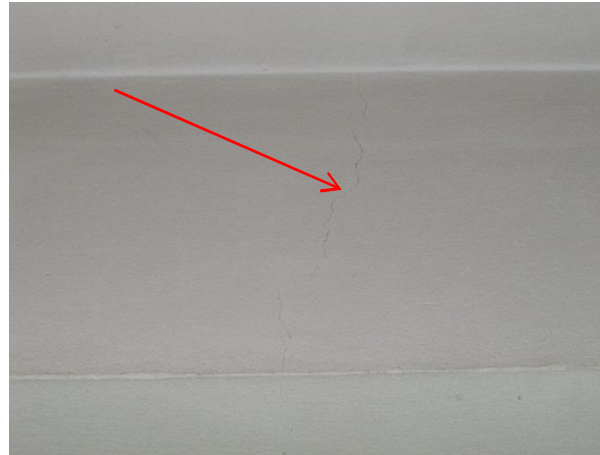
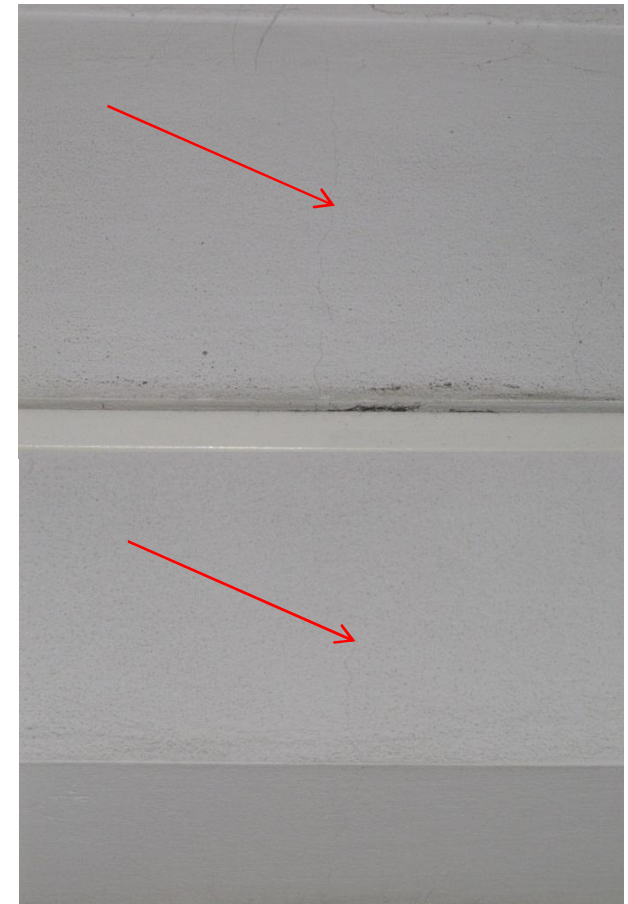
The cause of cracks occurred on long span beam as shown on 4th floor plan seems to be from uncontrolled heavy load.

Cracks appeared along slab soffit and beam, capacity check is required prior to repairing.

- Request the detail engineering assessment of factory to be carried out and a suitable method of repair is to be established.
- Simply plastering over is not allowed.

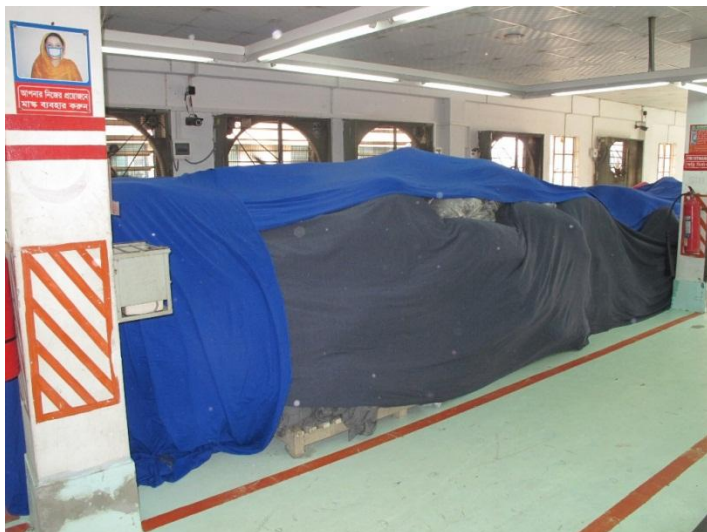
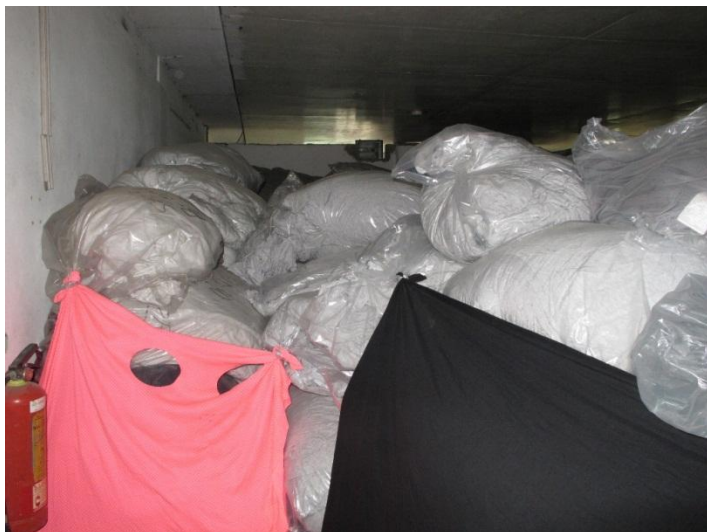
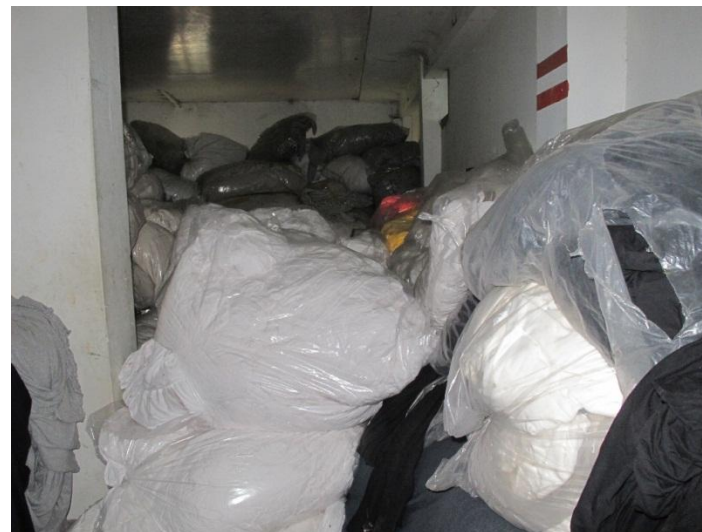
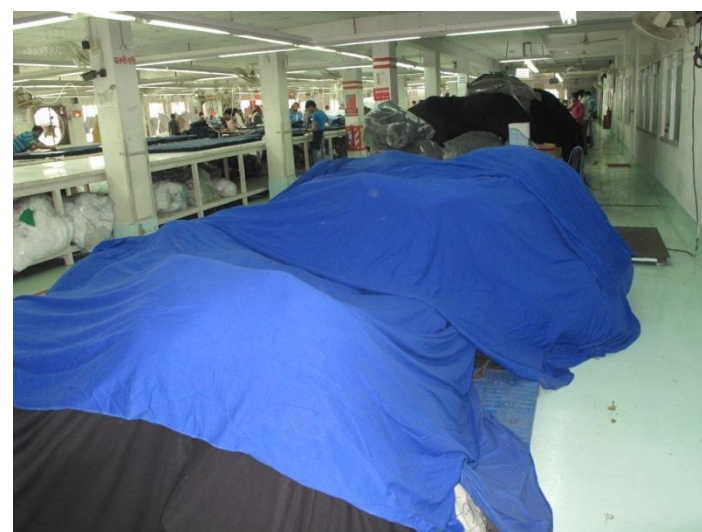
Uncontrolled heavy storage on 4<sup>th</sup> floor. Reduce stacking height of storage to ensure total load does not exceed 3.0kPa.

- Reduce stacking height of fabric rolls to ensure total load does not exceed 3.0kPa.

- Adopt some sort of signage/staff guidance to ensure that the maximum weight of storage is not exceeded.
- Produce an allowable loading plan for each level.

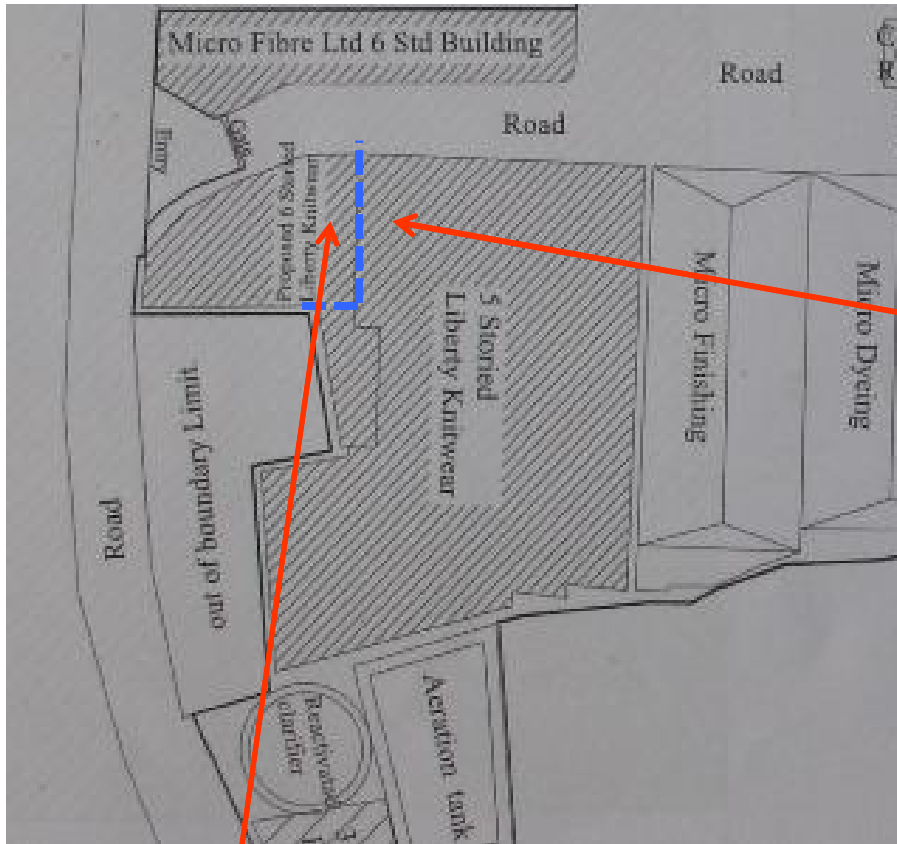
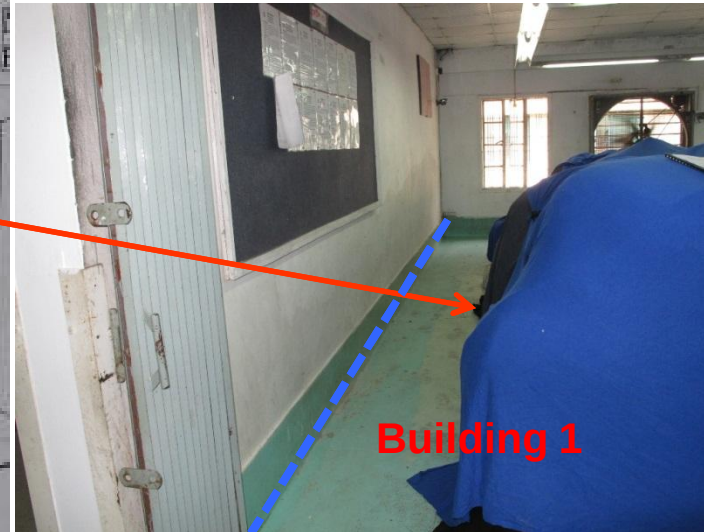
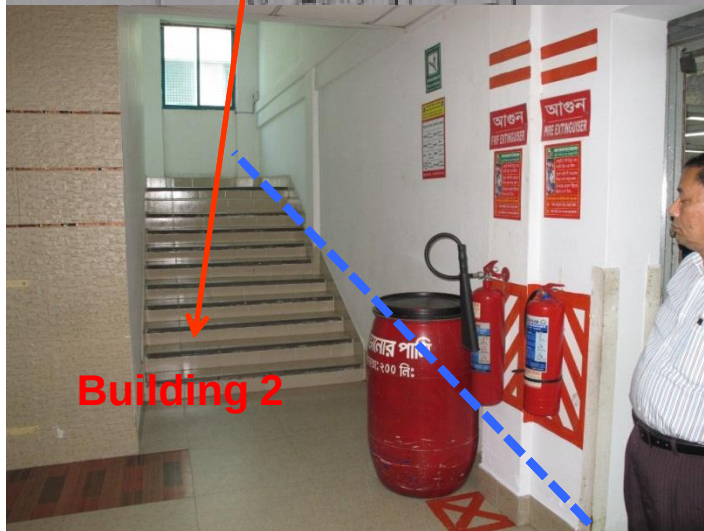
No movement joint properly established  
to separate Building 1 and Building 2

----- Movement joint to be established properly

No movement joint established properly to separate building 1 and 2. Building assessment including column and foundation capacity checks are required.

- Construct a freely moveable and unrestricted movement joint between the two buildings at each level.

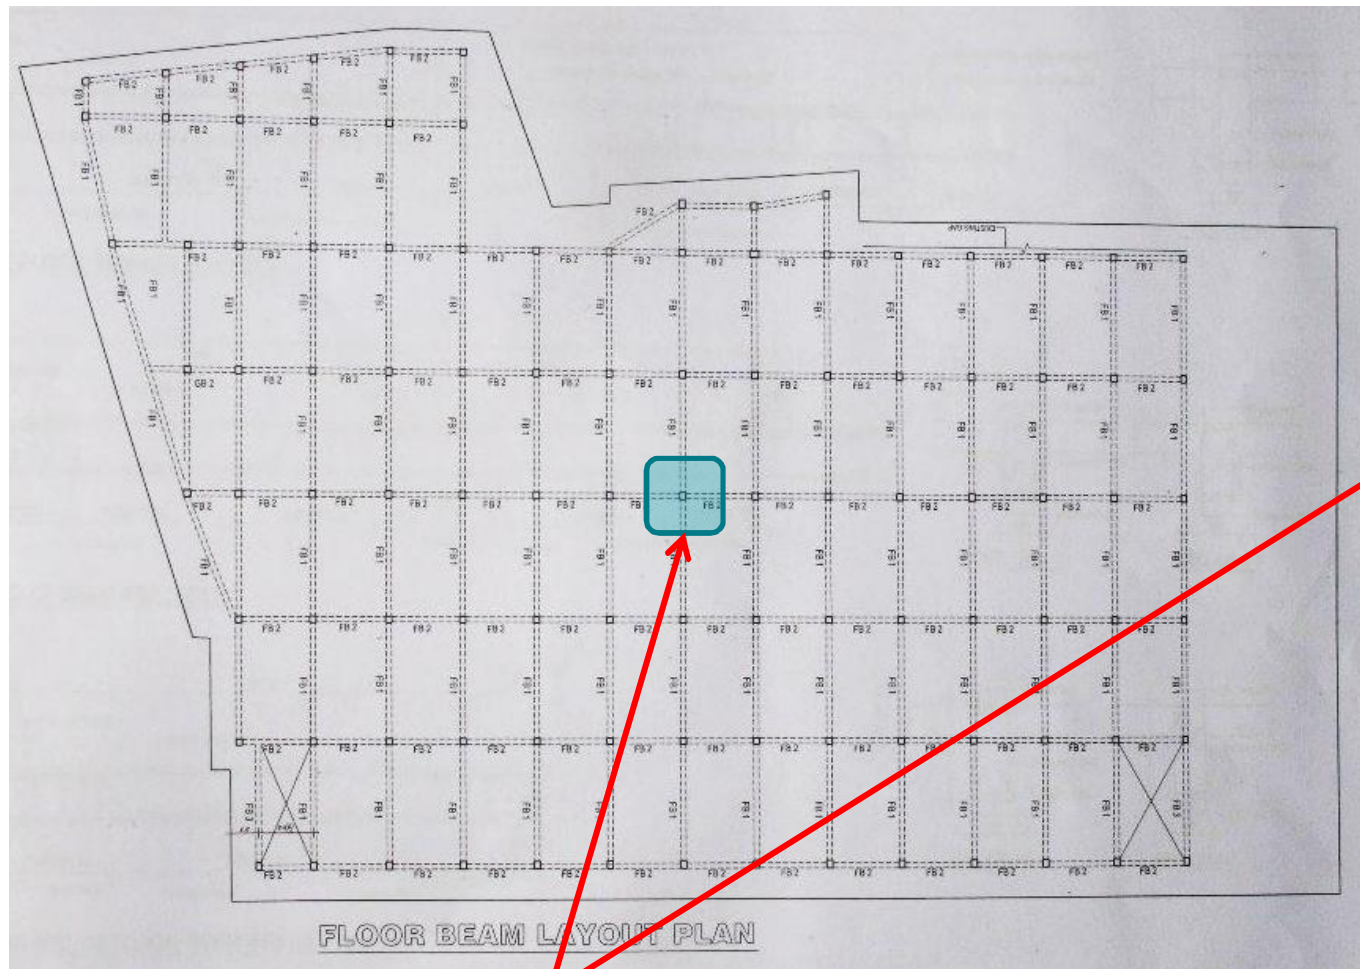
**Load rundown** at the key concrete column; it is found that the column stress is within the range of FoS between 1.50 and 1.86 which is a '**YELLOW**' rating.

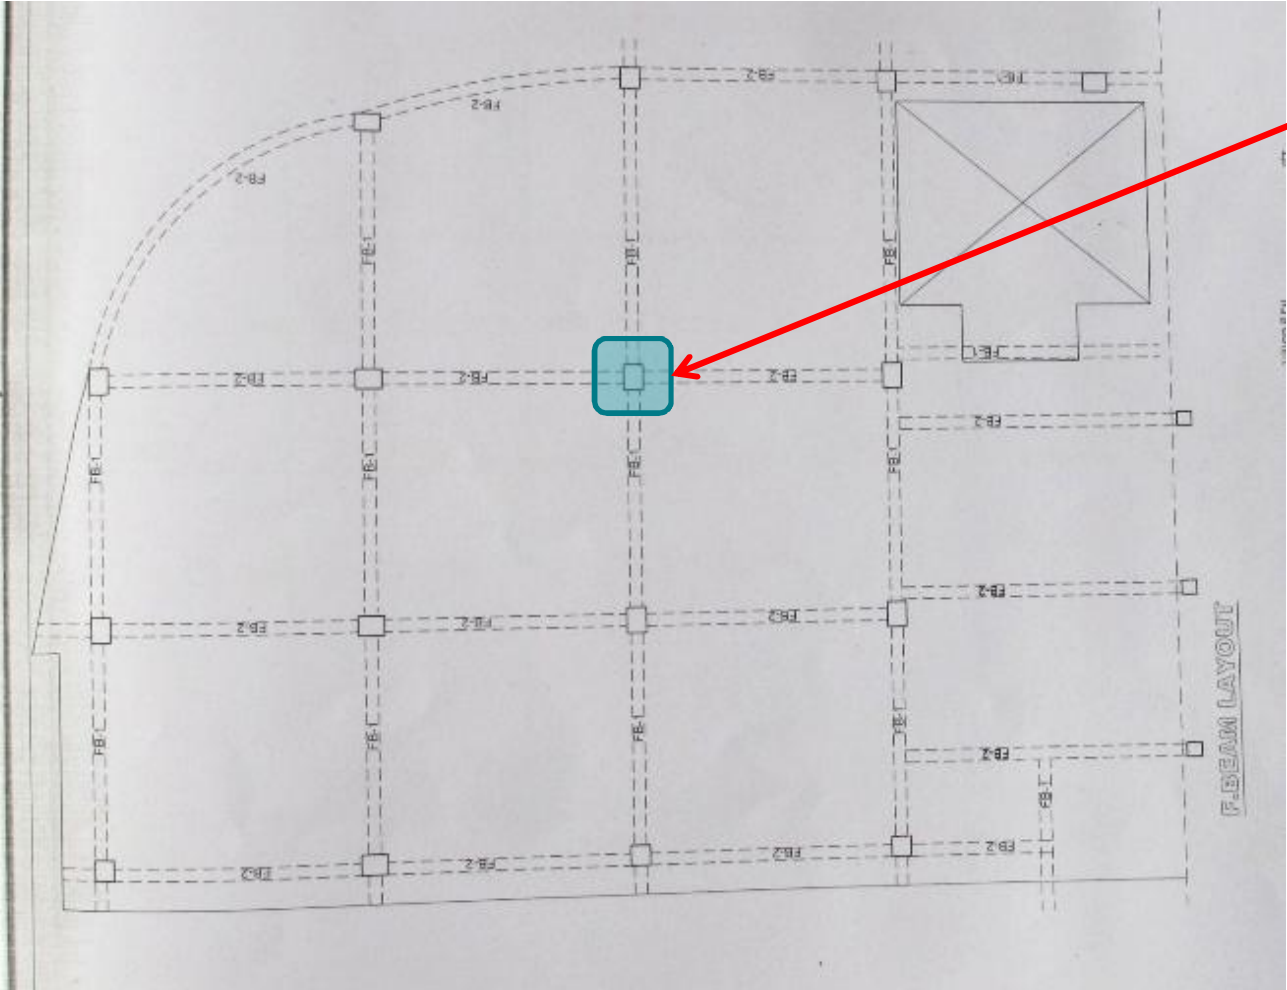
Load rundown at the key concrete column; it is found that the column stress has FoS greater than 1.86 which is a 'GREEN' rating.

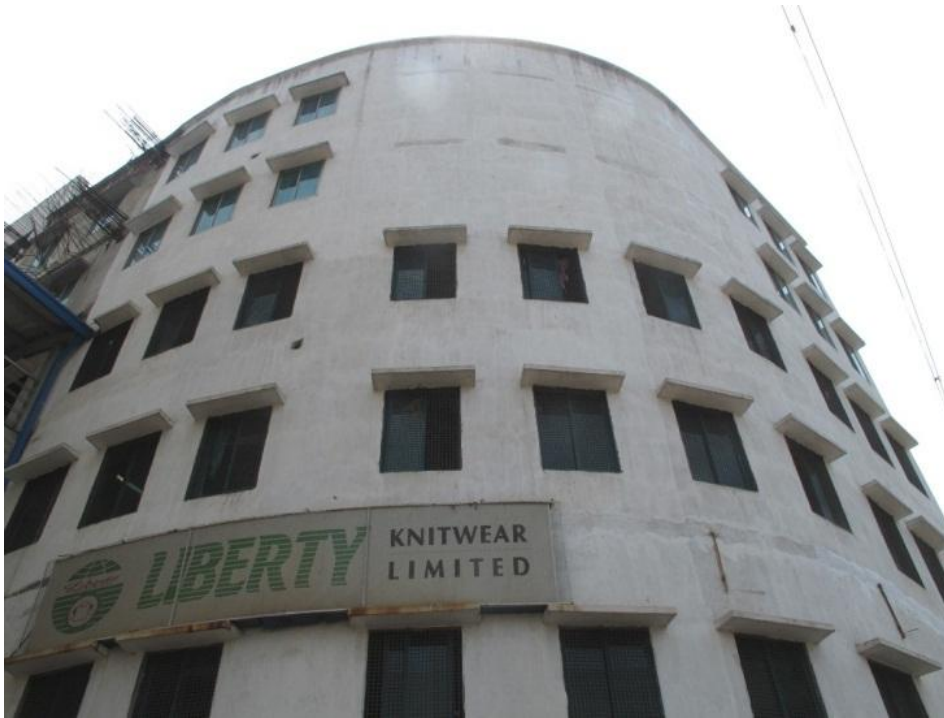
Concerns on the stability system for lateral loading and seismic loading. Façade brickwork with little capacity; lack of moment capacity in connection between columns and beams.

A further Detail Engineering Assessment is required to assess whether such a system can resist lateral loads from wind & earthquakes

- A Detail Engineering Assessment to be carried out, in particular stability and foundation aspects to be investigated in detail.
