# GM Apparels Ltd.

280/2, Meher Nagar, Dobadia, Uttar Khan, Dhaka - 1230

22<sup>nd</sup> November 2021

# Observations

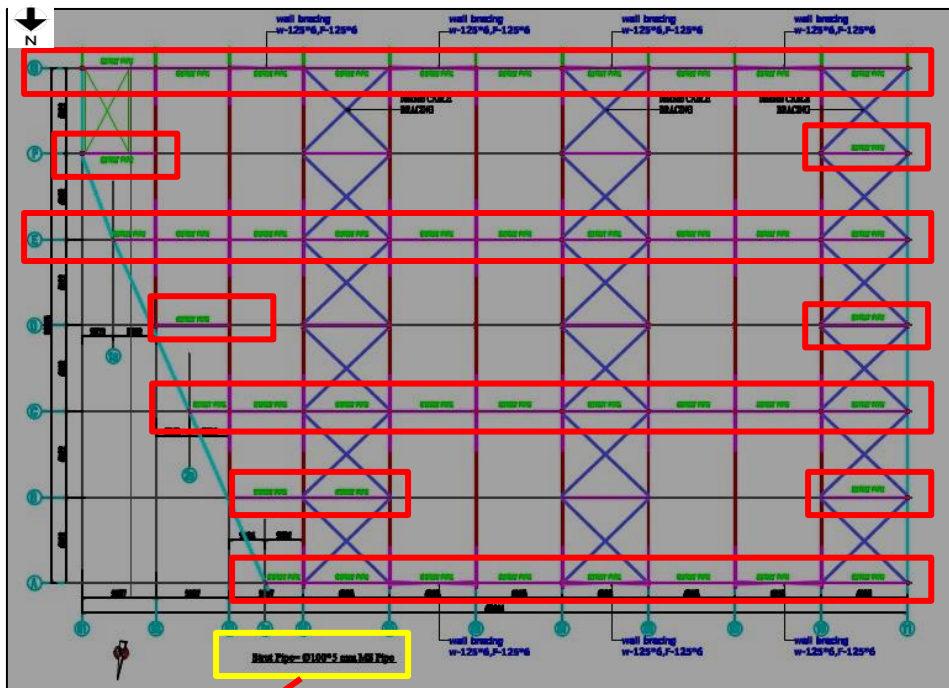
Strut Pipe was found missing at Marked location.

Strut pipe- 100 mm diameter and thickness 5 mm mentioned in the drawing

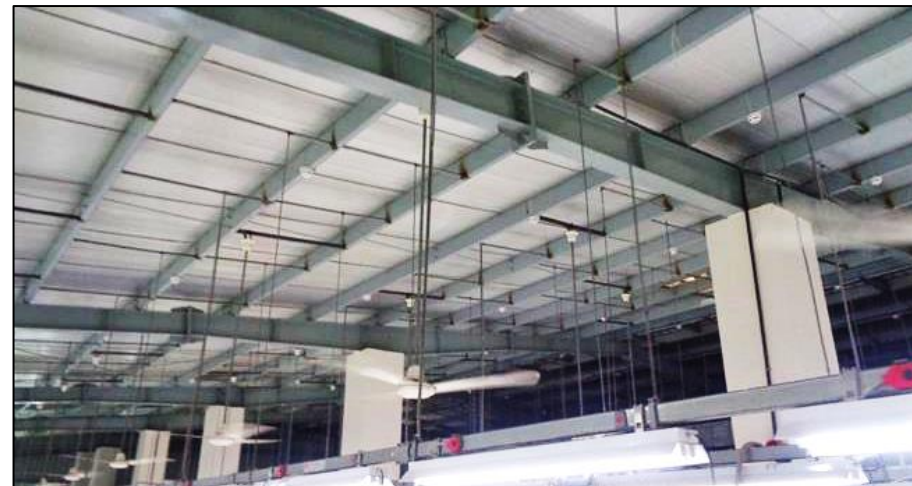
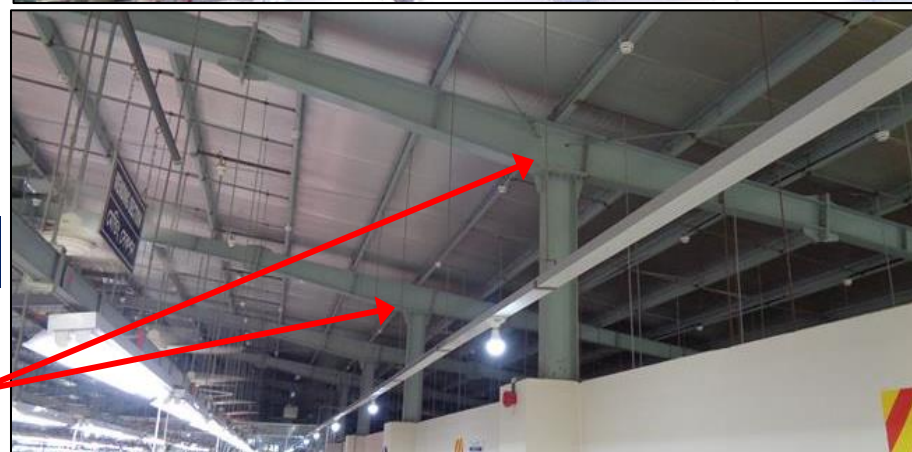
Strut bracing missing

Strut pipe was not found at site as per drawing

Lateral load transfer media (compression strut) along the ridge, eave and other positions are missing that have been shown in as-built drawing. Building engineer to check the lateral load path and review the stability of the structure accordingly.

| Item No. | Observation | Recommended Action Plan | Recommended Timeline |
|---|---|---|---|
| 01 | Lateral stability system | Building Engineer is required to confirm the lateral load path & verify the lateral stability of the steel shed. | 6-weeks |
| 02 | Lateral stability system | Implement the remediation if required. | 6-months |

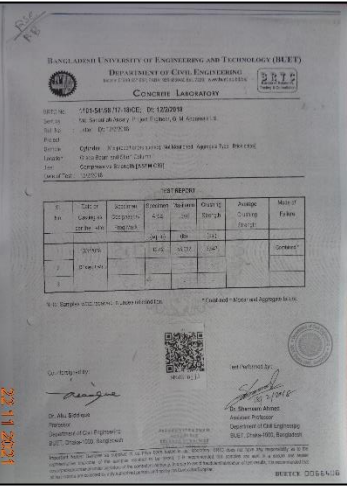
NOTE :  
CONCRETE STRENGTH,  $f'_c = 3,000$  Psi  
CONCRETE MIX = 1:1.5:3 (With Brick Chips)  
STEEL ( $f_y$ ) = 6,0000 psi (60 grade)

Concrete strength has been considered 20.7 MPa but only one set of cylinder test report was available. Factory engineer is required to verify in-situ concrete and rebar strength and revise the design report accordingly.

Factory engineer is required to revise the design documents including material strength, floor loading and foundation capacity as per BNBC requirements.

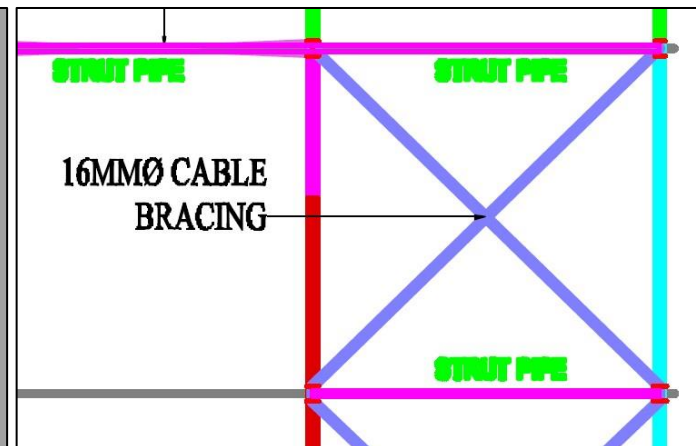
Cable Bracing of diameter 16 mm

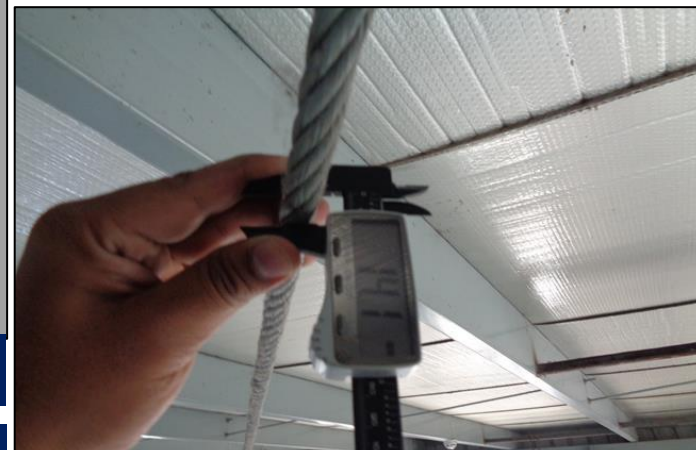
Diameter of cable bracing was found 14 mm at site

In as-built drawing diameter of cable bracing has been shown in 16mm. But at site condition, the bracing diameter was found as 14 mm diameter.

Factory engineer is required to survey the whole structure and develop accurate as-built drawing.

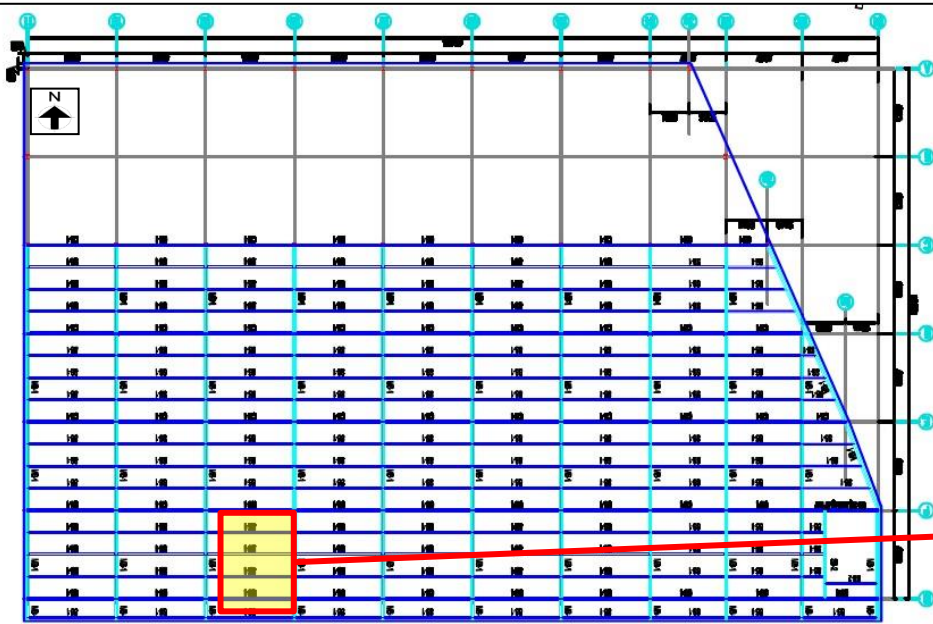
1<sup>st</sup> floor beam Layout plan

In as-built drawing of 1<sup>st</sup> floor beam layout plan (marked location), beam and sub-beam has been shown. But in floor layout plan and actual site condition, stair was found at the marked location. Factory engineer is required to survey the whole structure and develop accurate as-built drawing.

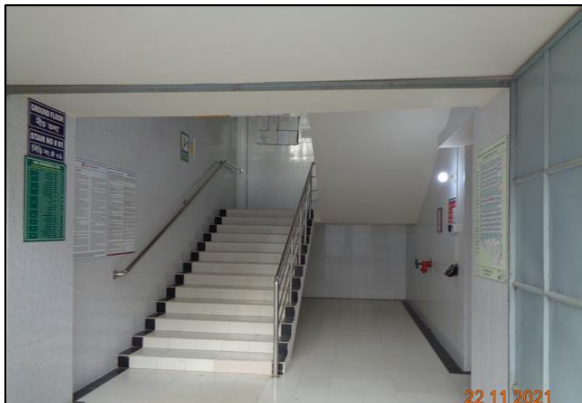
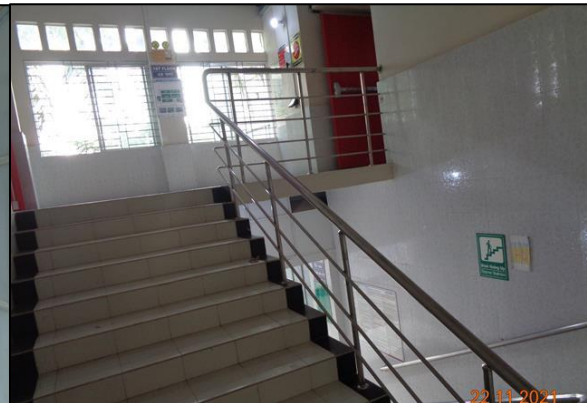
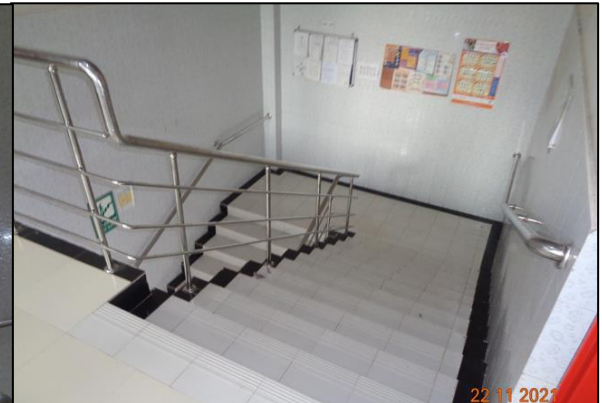
Stair was found at marked location

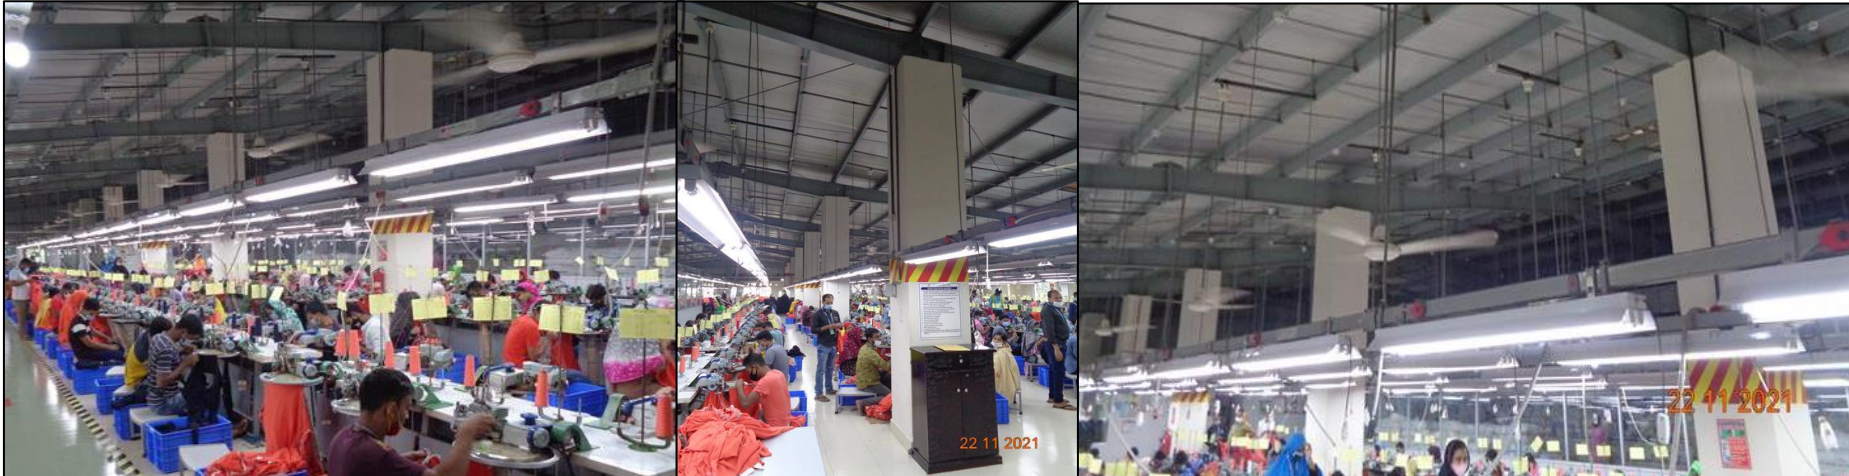
Steel Column are enclosed by brick masonry -1<sup>st</sup> Floor

Steel Column are enclosed by the Brick masonry. The size of the steel column could not be verified.  
Factory engineer is required take necessary measures to verify the steel column size.

| Item No. | Observation | Recommended Action Plan | Recommended Timeline |
|---|---|---|---|
| 06 | Column size needs to be verified | Factory engineer is required take necessary measures to verify the steel column size. | 6-weeks |

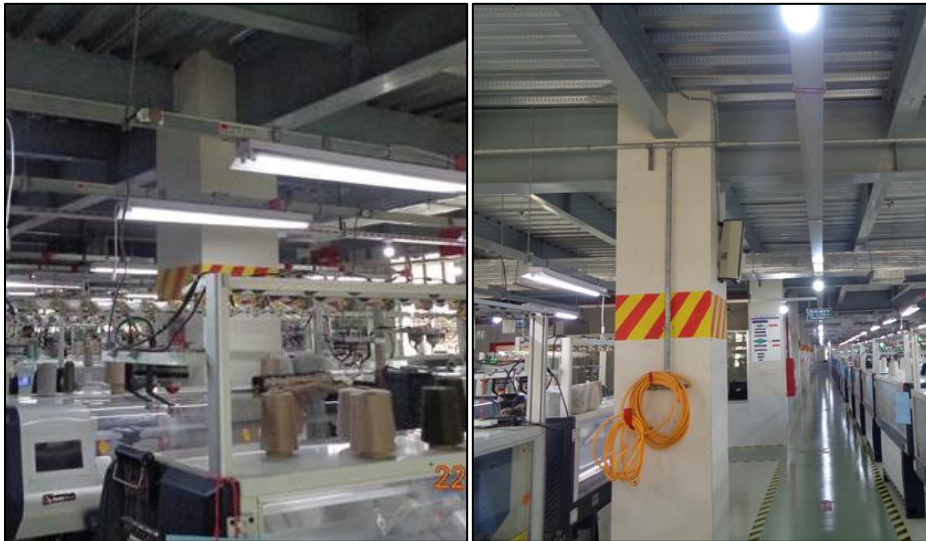
Steel Column are enclosed by brick masonry –  
Ground Floor

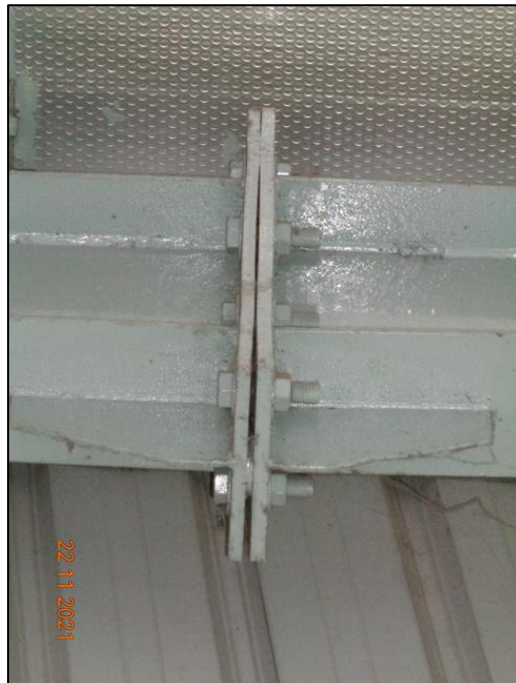
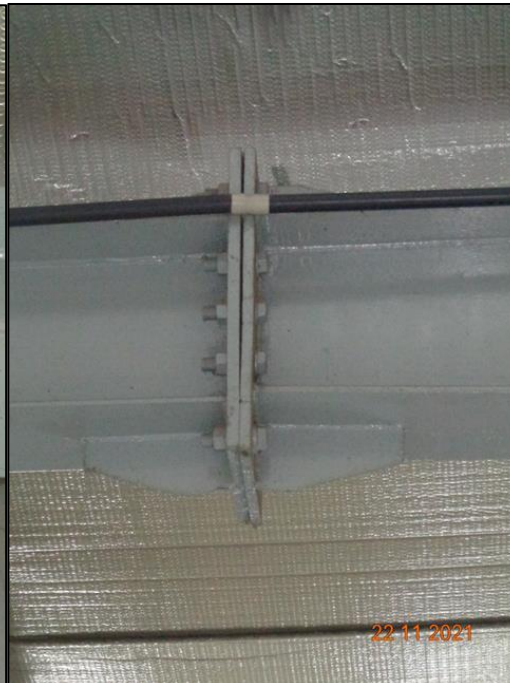
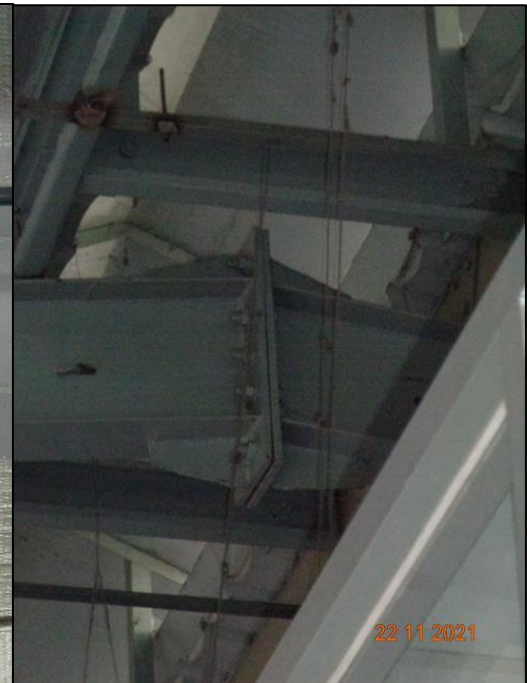
Rafter – Rafter connection

Significant gaps was found several location of the structure. Factory engineer is required to identify the location and carry out suitable remedial works.

| Item No. | Observation | Recommended Action Plan | Recommended Timeline |
|---|---|---|---|
| 07 | Connection gap at several locations | Identify the locations and carryout suitable repair works where necessary. | 6-weeks |

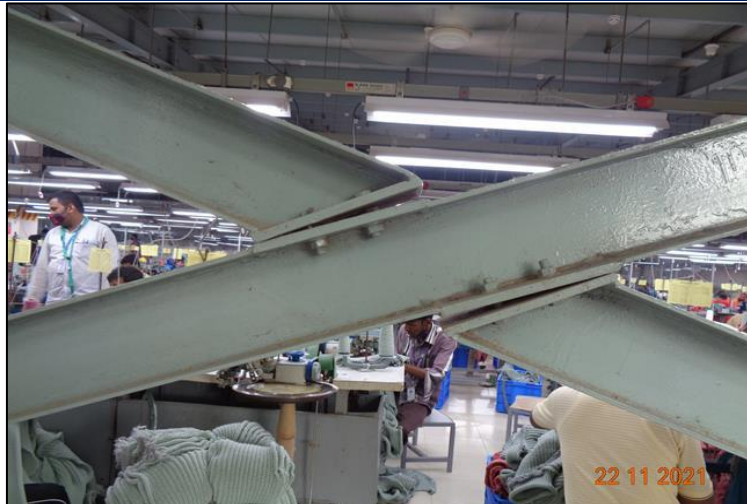
Vertical bracing connection

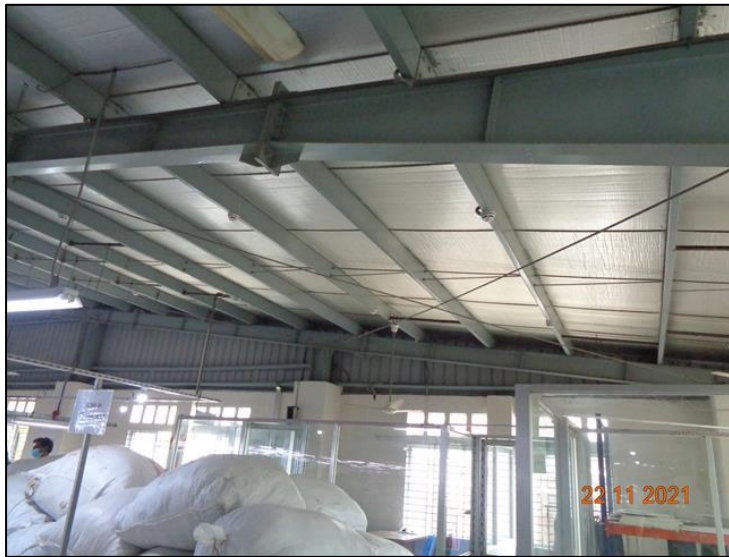
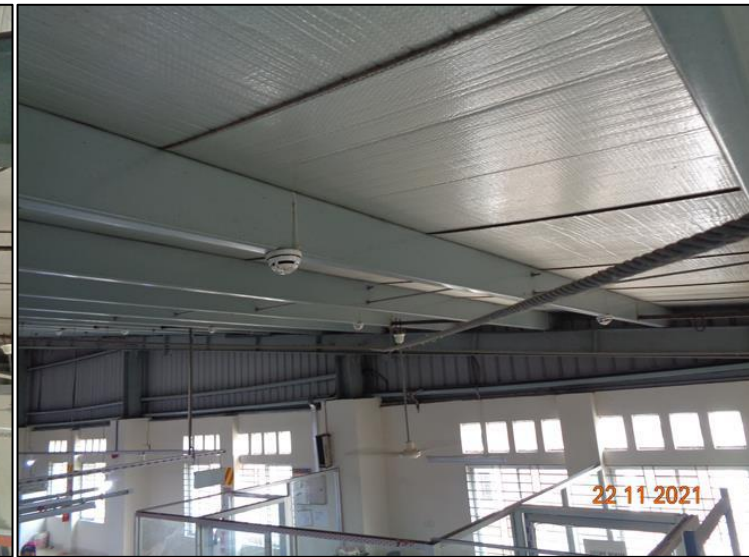
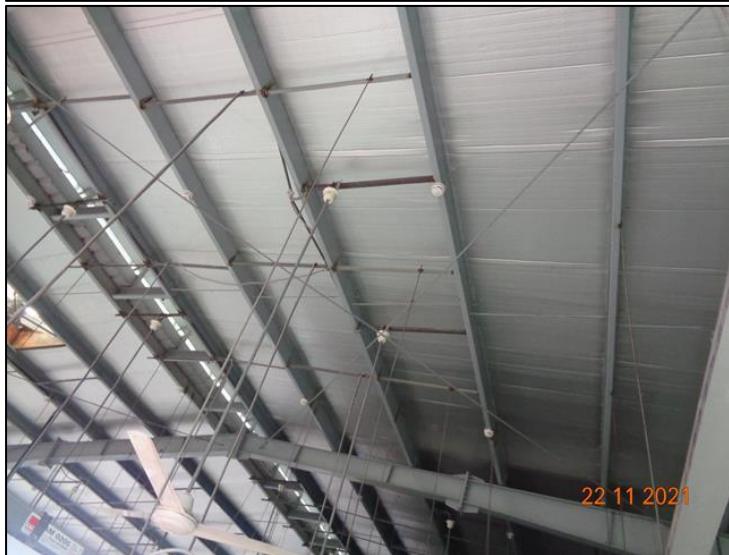
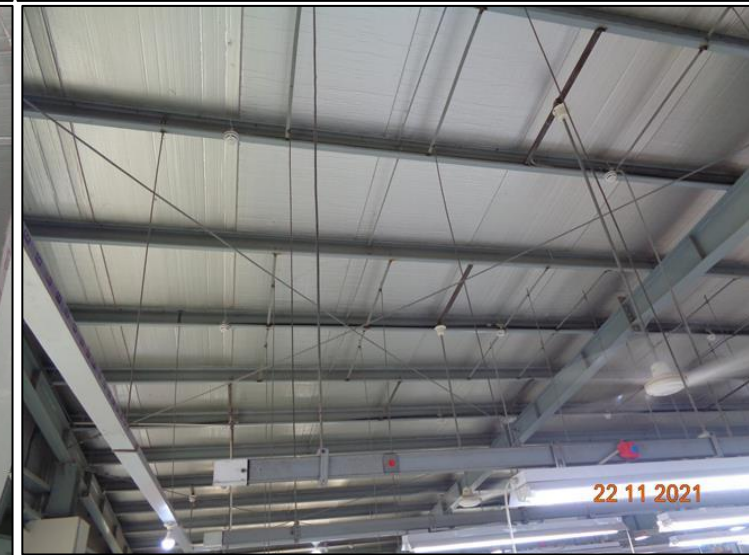
Loose cable bracing observed at roof. Factory is required to take necessary measures to tighten the roof bracings.

| Item No. | Observation | Recommended Action Plan | Recommended Timeline |
|---|---|---|---|
| 08 | Loose cable bracing at roof | Keep tighten the roof bracings. | 6-weeks |

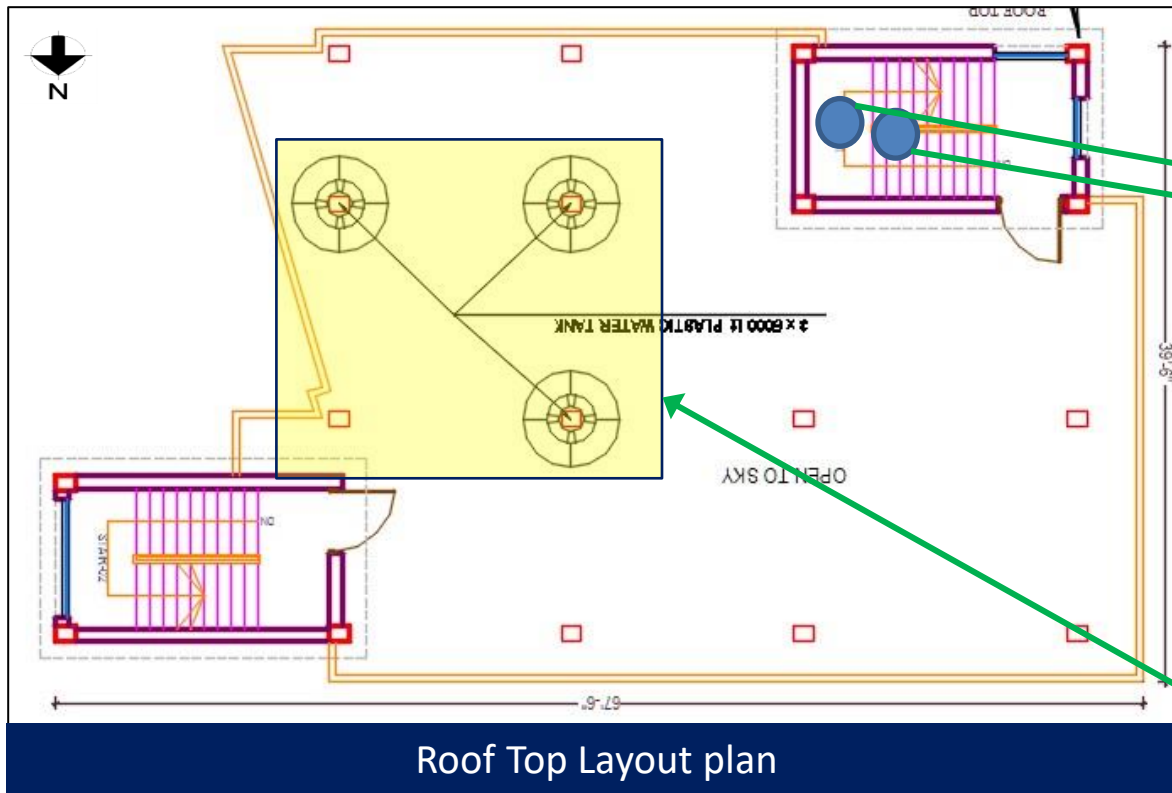
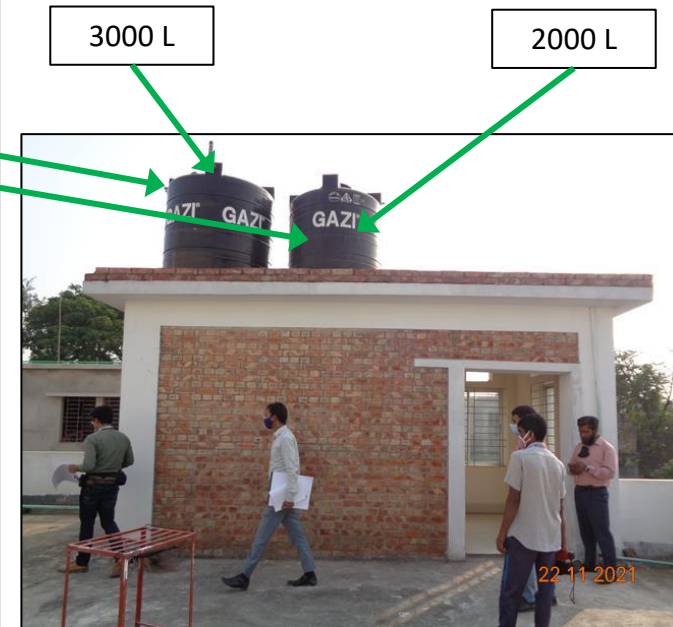
These three water was not found at roof

In as built drawing three number of water tank has been shown at roof which was not found at site. Additionally, two number water tank was found at staircase roof top. Factory engineer is required to survey the whole structure and develop accurate as-built drawing in compliance with section 1.9.1.2 as per BNBC.

| Item No. | Observation | Recommended Action Plan | Recommended Timeline |
|---|---|---|---|
| 09 | Discrepancy in as-built drawing | Building Engineer to survey the structure and prepare accurate as-built (architectural & structural) drawings in compliance with section 1.9.1.2, part-6 of BNBC. | 6-weeks |
