P.A Knit Composite (Extension)

Jamirdia, Habir Bari, Valuka, Mymensingh-2240

12th, 25th October & 29th November 2021

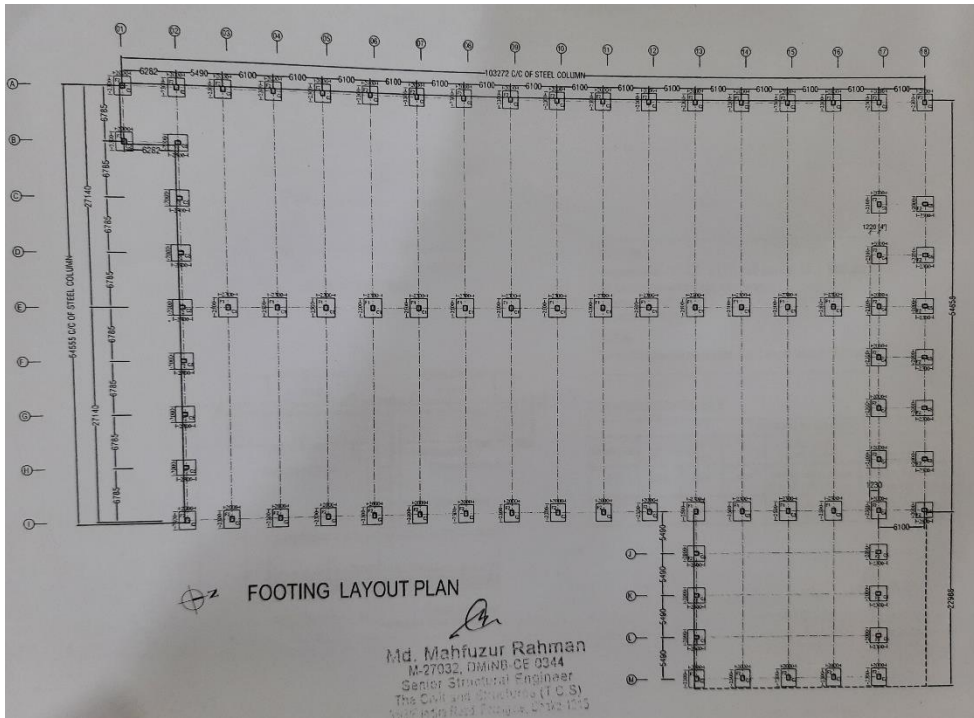
FOOTING SCHEDULE

Stress in foundation exceeds normal design limit

This building was constructed between May 2014 and October 2015. Soil test report was not available for the structure.

Cursory calculation indicates that footings are stressed above normal design limit considering 3 kPa floor live load (mezzanine) and minimum allowable bearing capacity 2 ksf (BNBC Ch-3, Table -6.3.5). The building engineer is required to review design, load, column & footing stress.

| Item No. | Observation | Recommended Action Plan | Recommended Timeline |
|---|---|--|---|
| 01 | Stress in foundation exceeds normal design limits (Building-1: Dyeing Shed 2) | As part of Detail Engineering Assessment (DEA) Building engineer is required to review design, load & footing stress. | 6-weeks |
| 02 | Stress in foundation exceeds normal design limits (Building-1: Dyeing Shed 2) | Prepare soil investigation report for the structure. | 6-weeks |
| 03 | Stress in foundation exceeds normal design limits (Building-1: Dyeing Shed 2) | Produce and actively manage a set of floor loading plan within the factory building considering foundation, column and floor capacity. | 6-weeks |

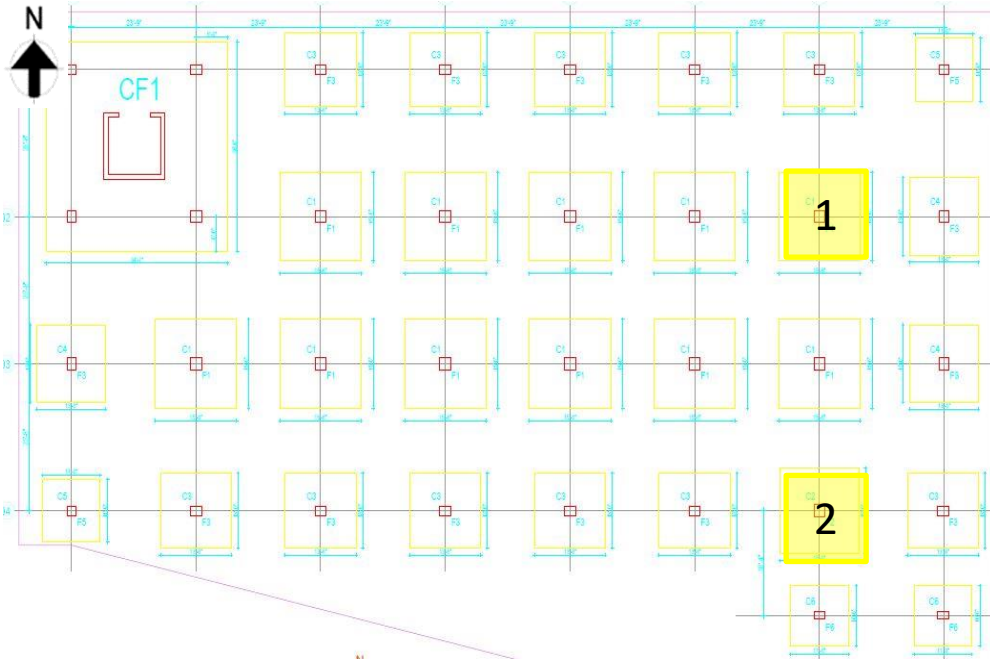
Stressed column/foundation layout

Stress in column and foundation exceeds normal design limit

Cursory calculation indicates that stress exceeds the normal design limit for both columns & foundations in marked location-1 and only for column at marked location-2 considering the floor live load (7 kPa for first & second floor, 4 kPa for typical floors as per load plan), minimum concrete strength based on aggregate type and allowable soil bearing capacity 20 T/m². Building engineer is required to review the design, loads and column/foundation stresses based on in-situ concrete strength.

| Item No. | Observation | Recommended Action Plan | Recommended Timeline |
|---|--|--|---|
| 25 | Stress in column and foundation exceeds normal design limit (Building-5: Printing Building) | Building engineer is required to review the design, load, column and foundation stresses based on in-situ concrete strength. | 6-weeks |

| Item No. | Observation | Recommended Action Plan | Recommended Timeline |
|---|--|--|---|
| 26 | Stress in column and foundation exceeds normal design limit (Building-5: Printing Building) | Verify in-situ concrete strength by taking minimum 4 concrete cores (100mm diameter) from lower tier of the buildings. | 6-weeks |

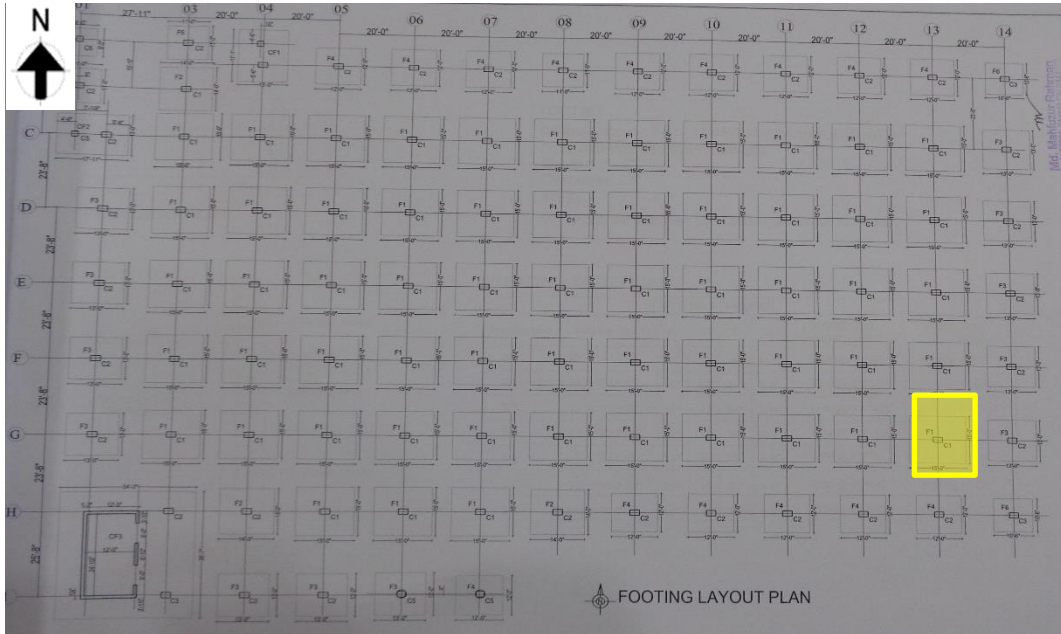
Stressed column/foundation layout

Cursory calculation indicates that stress in column and foundation exceeds the normal design limit at the marked location considering the floor live load 6 kPa for typical floors (mentioned on slab layout), minimum concrete strength based on aggregate type and allowable soil bearing capacity 14 T/m². Building engineer is required to review the design, loads and column/foundation stresses based on in-situ concrete strength.

| Item No. | Observation | Recommended Action Plan | Recommended Timeline |
|---|---|--|---|
| 31 | Stress in column and foundation exceeds normal design limit (Building-7: Garments Building-2) | Building engineer is required to review the design, load, column and foundation stresses based on in-situ concrete strength. | 6-weeks |
| 32 | Stress in column and foundation exceeds normal design limit (Building-7: Garments Building-2) | Verify in-situ concrete strength by taking minimum 4 concrete cores (100mm diameter) from lower tier of the buildings. | 6-weeks |

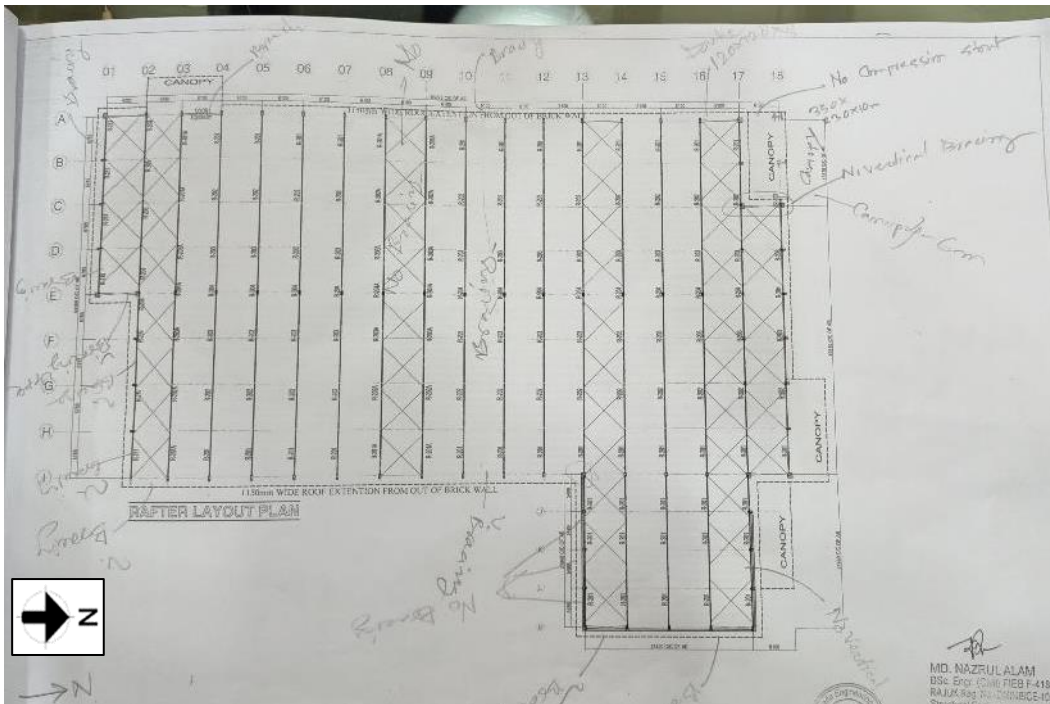
Bracing Layout

Lack of lateral stability

lateral load transfer media observed discontinued in roof. Also, bracing system are found mismatch with bracing layout. As part of Engineering Assessment (EA) building engineer is required to check the stability system of the Building and design the size & position of necessary compression element accordingly.

| Item No. | Observation | Recommended Action Plan | Recommended Timeline |
|---|---|--|---|
| 06 | Lack of lateral stability (Building-1: Dyeing Shed 2) | As part of Engineering Assessment (EA) building engineer is required to check the stability system of the Building and design the size & position of necessary compression elements accordingly. | 6-weeks |
| 07 | Lack of lateral stability (Building-1: Dyeing Shed 2) | Implement remedial actions where necessary. | 6-months |

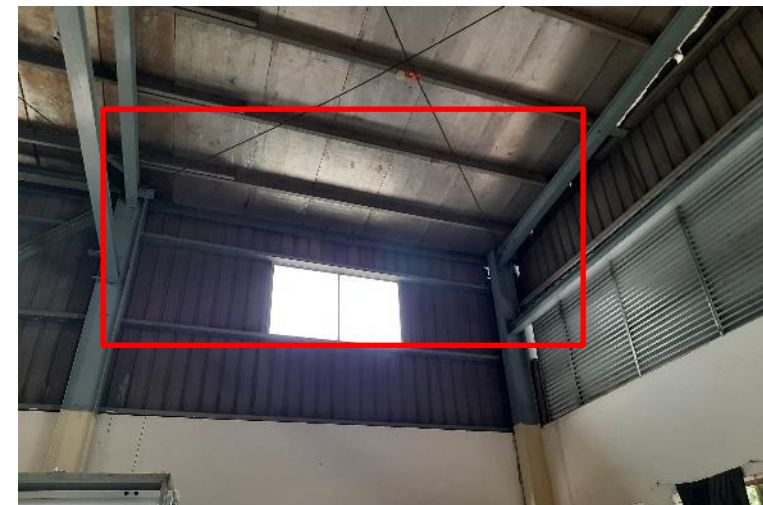
No compression member at grid 17~18

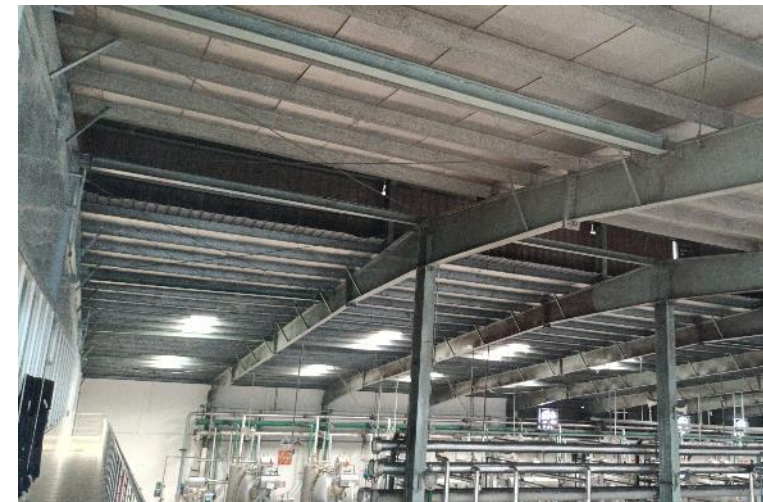
Bracings are found mismatch with layout

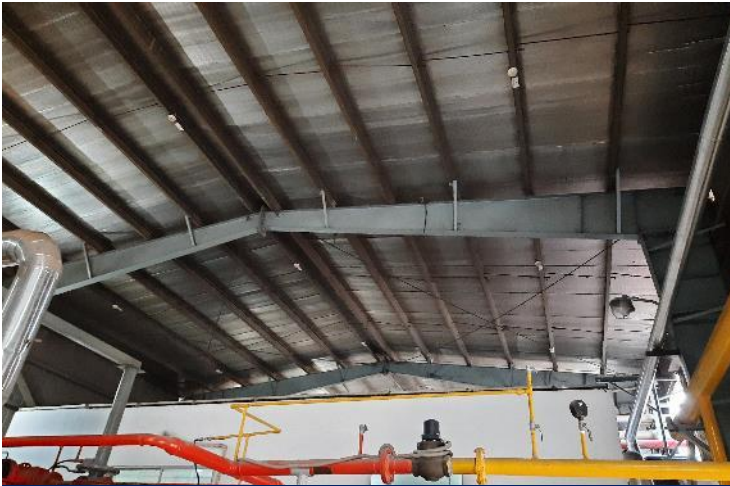
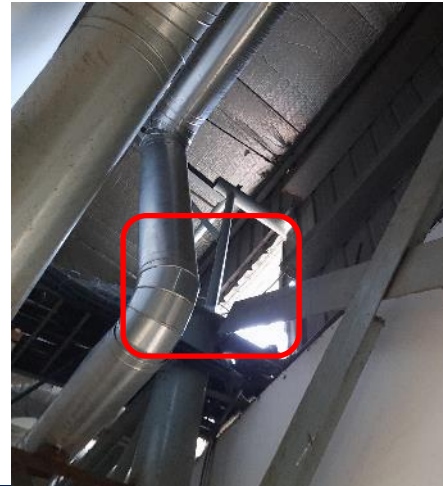
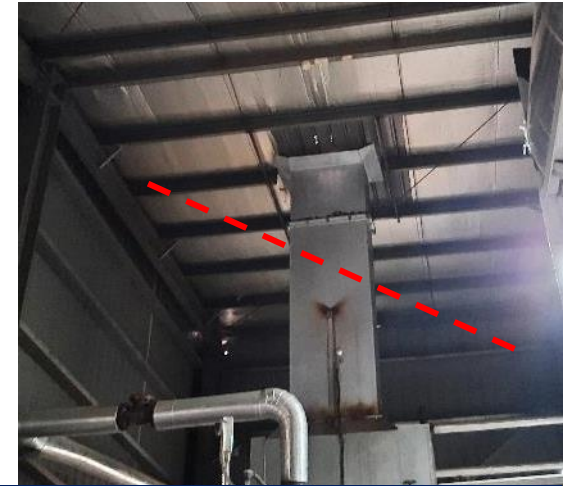
No compression strut, Vertical bracing discontinued and missing roof cable bracing one side

lateral load transfer media observed discontinued. Also, bracing system has no compression member. As part of Engineering Assessment (EA) building engineer is required to check the stability system of the Building and design the size & position of necessary compression element accordingly.

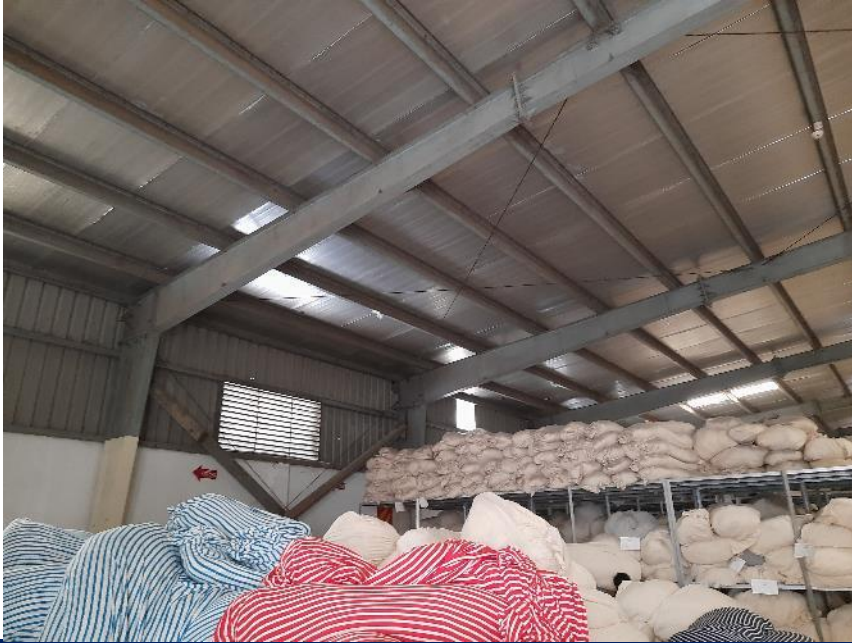
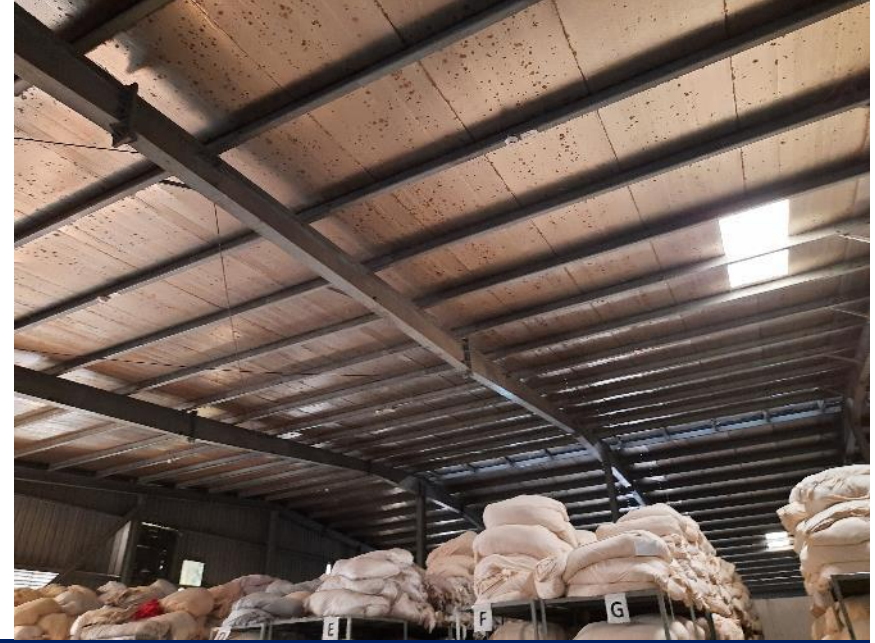
No compression strut/ lateral load transfer media at the roof level

No lateral load transfer media observed in roof. Also, bracing system has no compression member. As part of Engineering Assessment (EA) building engineer is required to check the stability system of the Building and design the size & position of necessary compression element accordingly.

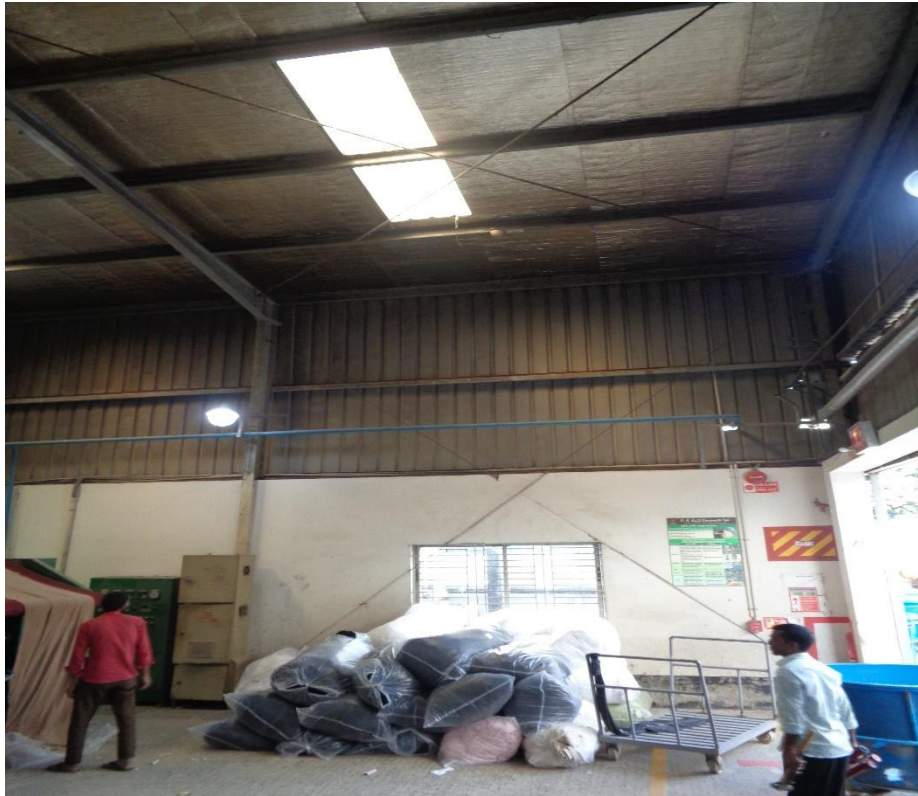
Wall/roof bracing provided at only one bay

No load transfer media is provided from frame to frame along long direction. In addition, wall/roof bracing is provided only at one bay but not provided at rest of the bays. Therefore, lateral stability system along long direction is incomplete. Building engineer is required to check the lateral stability of the shed against the lateral loading.

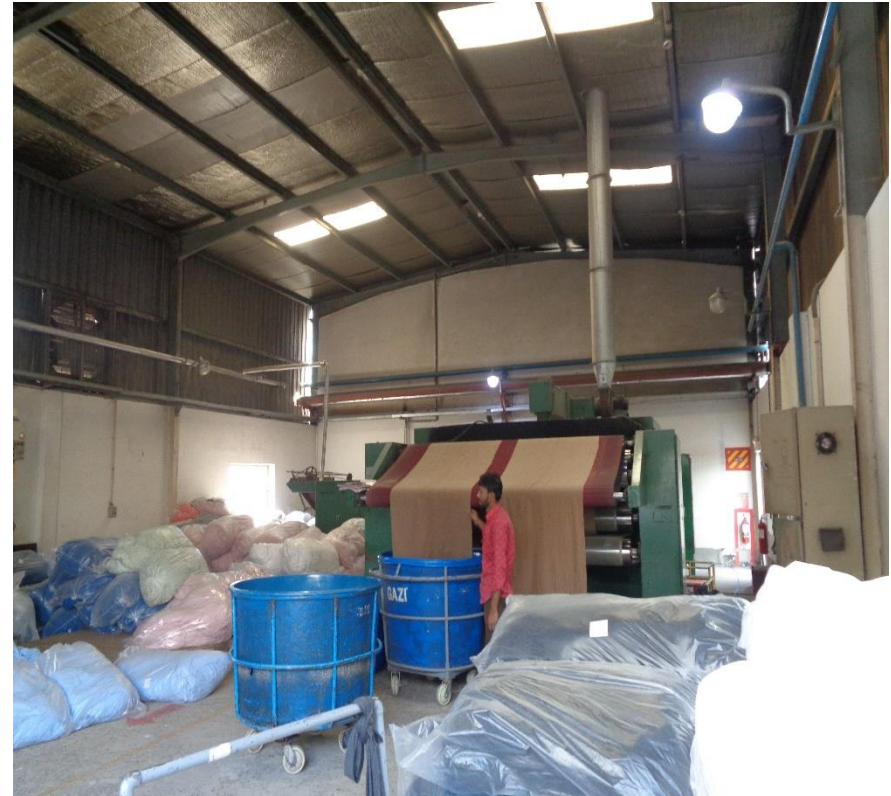
No load transfer media provided; wall/roof bracing not provided at rest of the bays

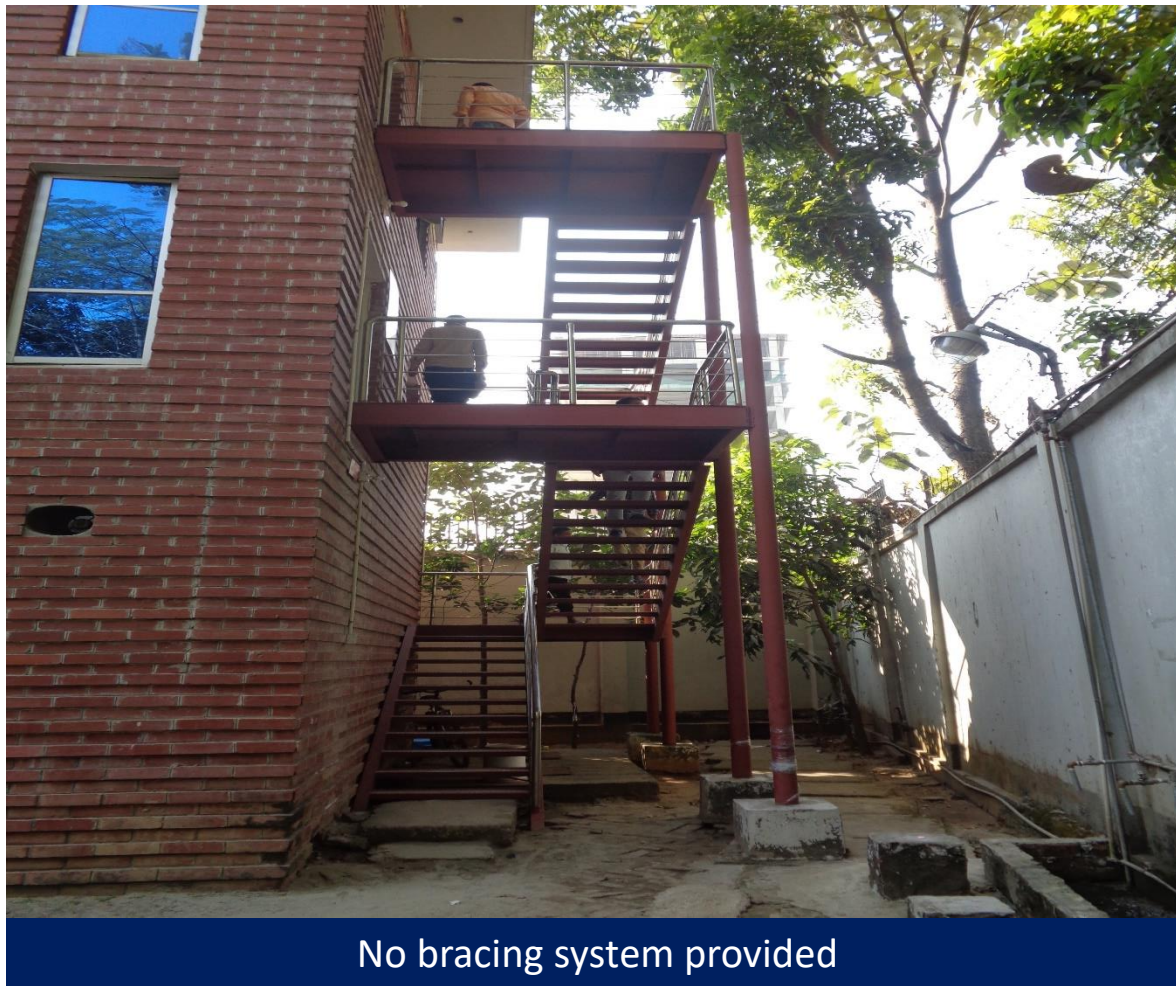
No bracing system provided

External steel stair was found at north side of the Building. The stair structurally connected with this building and no bracing system is provided for the steel stair to withstand the lateral load. Building engineer is required to check the lateral stability of the steel stair and building against the lateral loading.

| Item No. | Observation | Recommended Action Plan | Recommended Timeline |
|---|---|--|---|
| 19 | Lack of lateral stability of external steel stair (Building-3: Security Building) | Implement any remediation work if required. | 6-months |

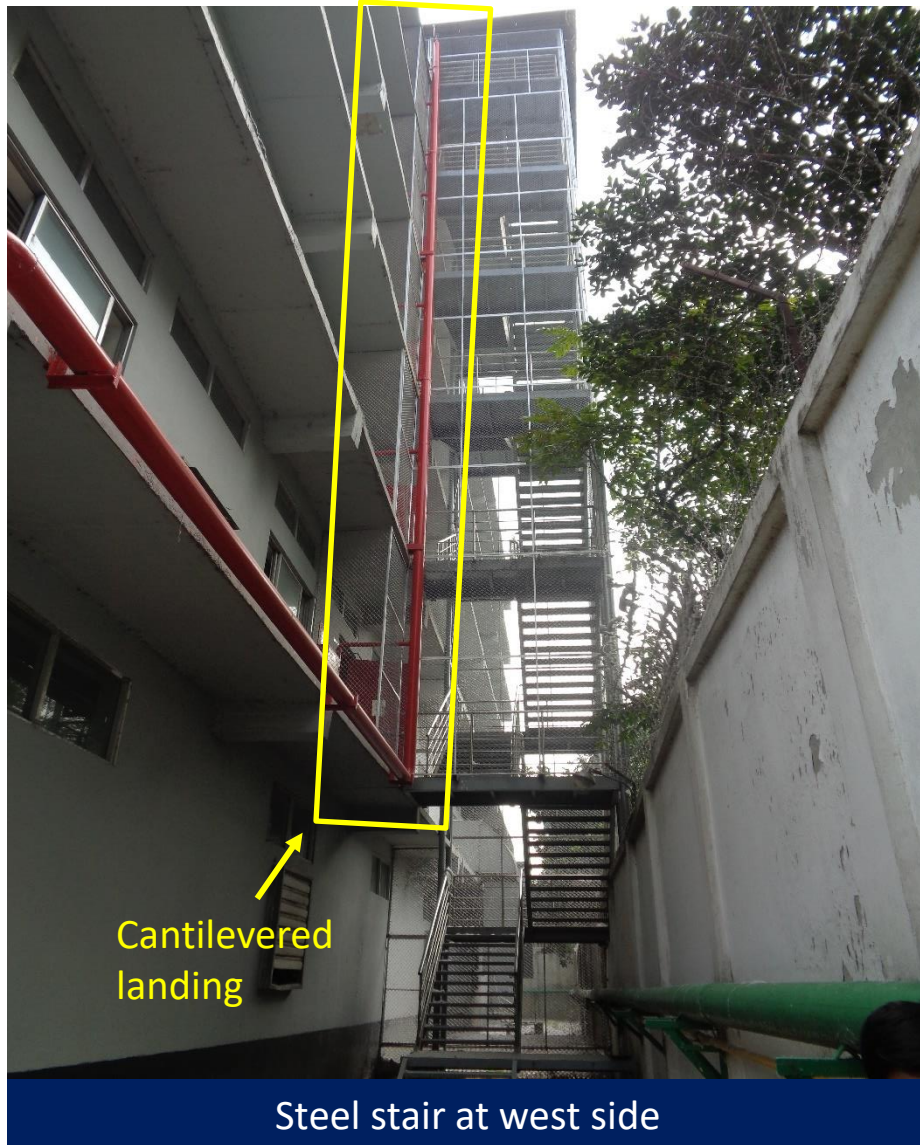
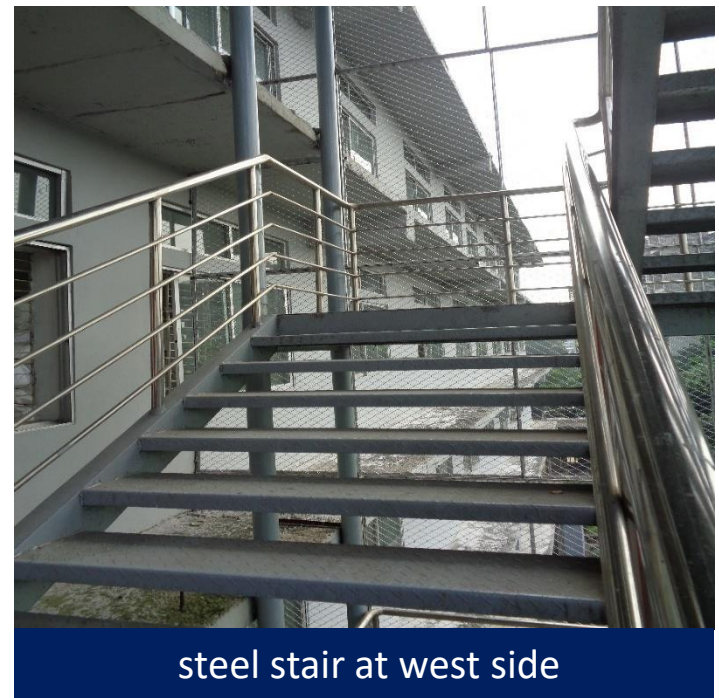
An undocumented steel stair was found at west side of Building-8 which was not shown in drawing. The landing of the stair is cantilevered at one side and bracing is not provided in any floor to withstand the lateral load therefore lateral stability system of this stair is apparently incomplete. Building engineer is required to check the stability of this steel stair for lateral and vertical loadings.

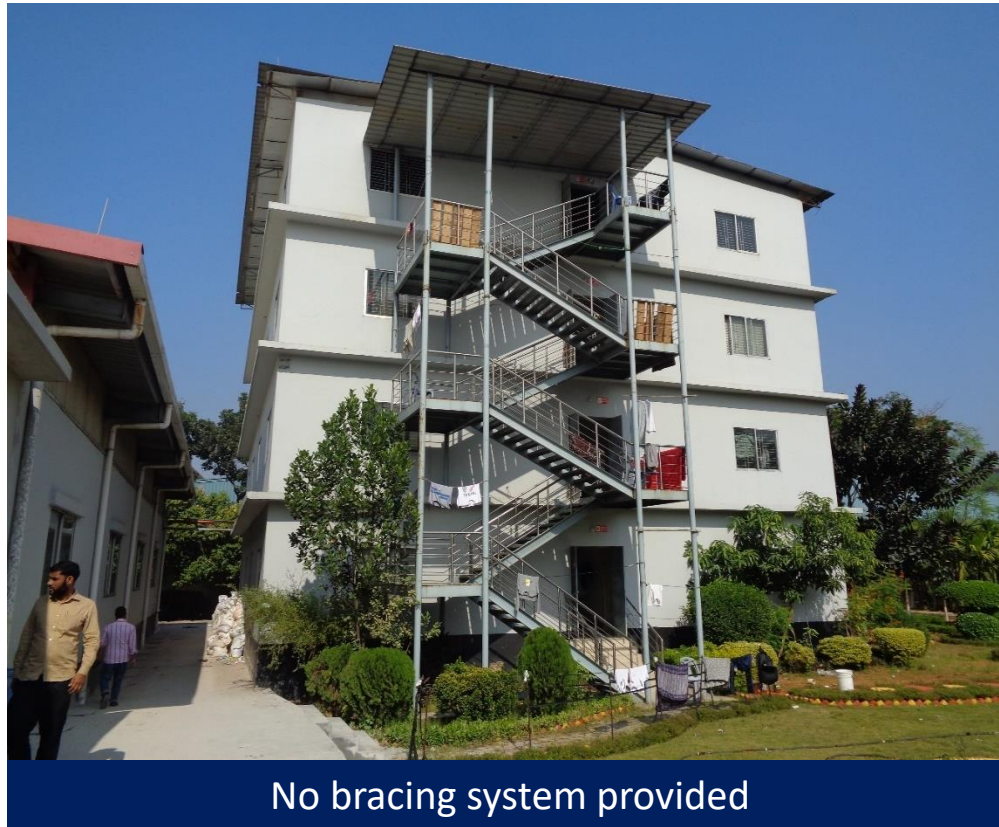
External steel stair was found at south side of the Building. No bracing system is provided for the steel stair to withstand the lateral load therefore there is no obvious lateral stability system. Building engineer is required to check the stability of this steel stair for lateral and vertical loadings.

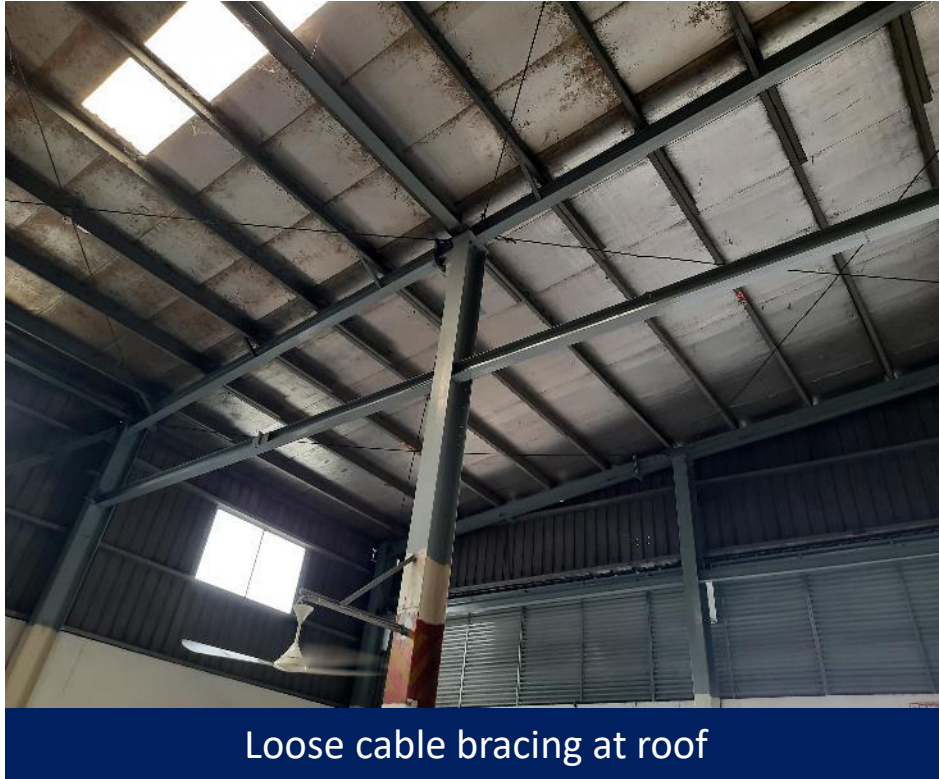
Loose cable bracing at roof

Some of the horizontal cable bracings were found loose. The factory is required to tight the bracings for transferring the lateral loads properly.

| Item No. | Observation | Recommended Action Plan | Recommended Timeline |
|---|---|--|---|
| 09 | Loose cable bracing (Building-1: Dyeing Shed 2) | The building engineer to check the bracing and tighten it properly. | 6-weeks |

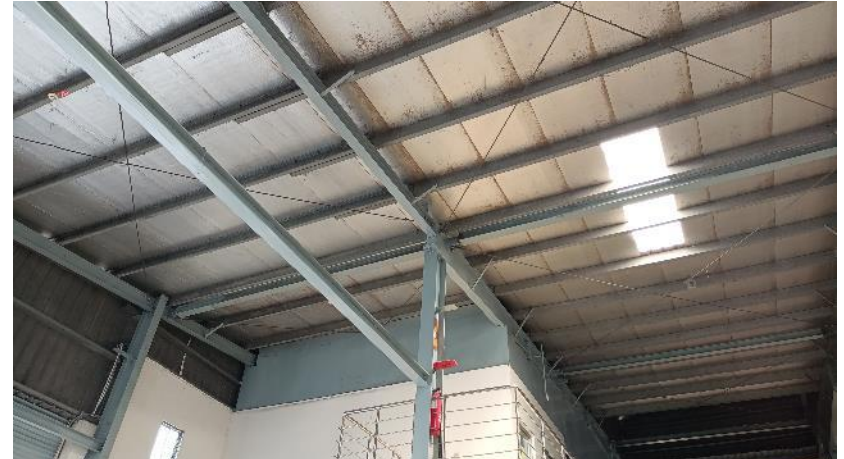
Loose cable bracing

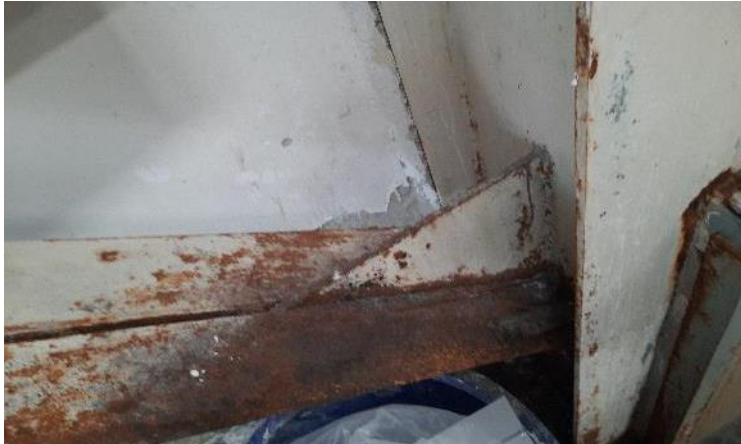
Corrosion in steel member was observed in several locations. The building engineer to suggest proper remedial measure accordingly.

Corrosion in Bracing

| Item No. | Observation | Recommended Action Plan | Recommended Timeline |
|---|---|--|---|
| 10 | Corrosion in steel member (Building-1: Dyeing Shed 2) | The building engineer to investigate the reason of corrosion and suggest proper remedial measure accordingly. | 6-weeks |

| Item No. | Observation | Recommended Action Plan | Recommended Timeline |
|---|--|--|---|
| 11 | Corrosion in steel member (Building-1: Dyeing Shed 2) | Repair the corroded steel members and take necessary measures to prevent further corrosion as per engineer's suggestion. | 6-months |

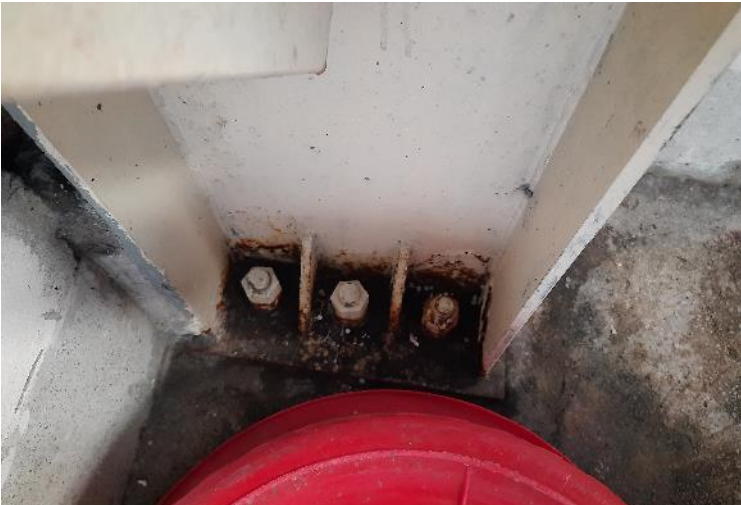
Corrosion in Base Plate

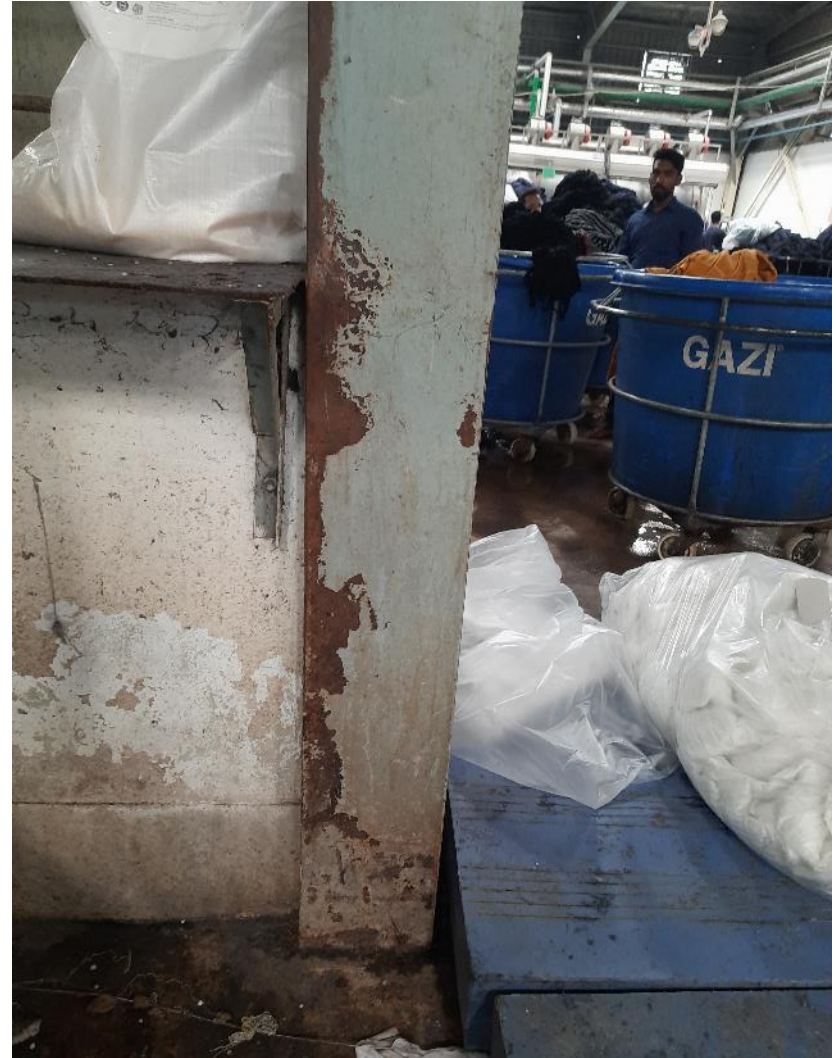
Corrosion in column

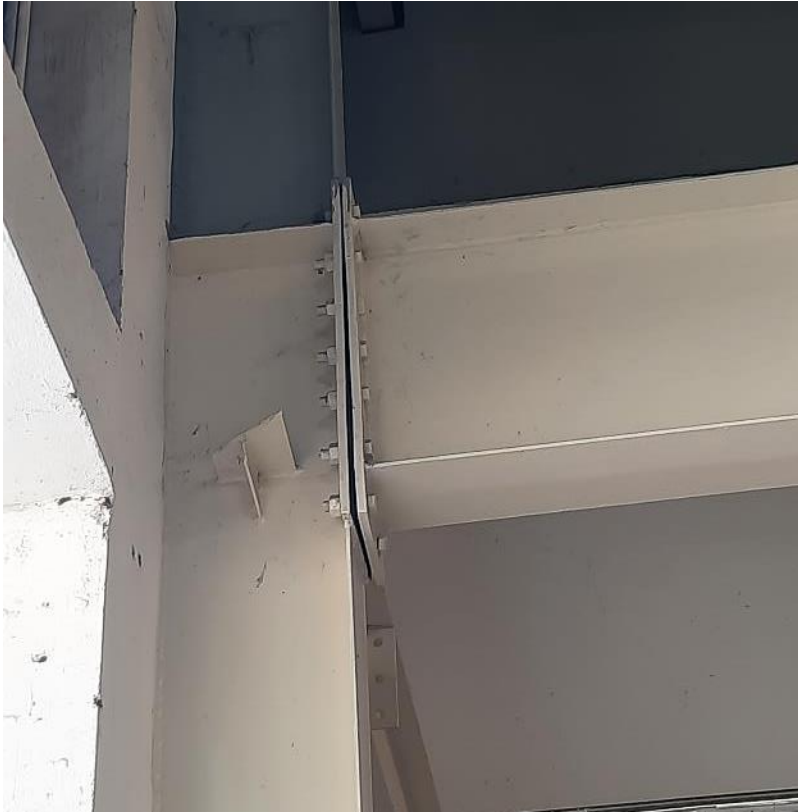
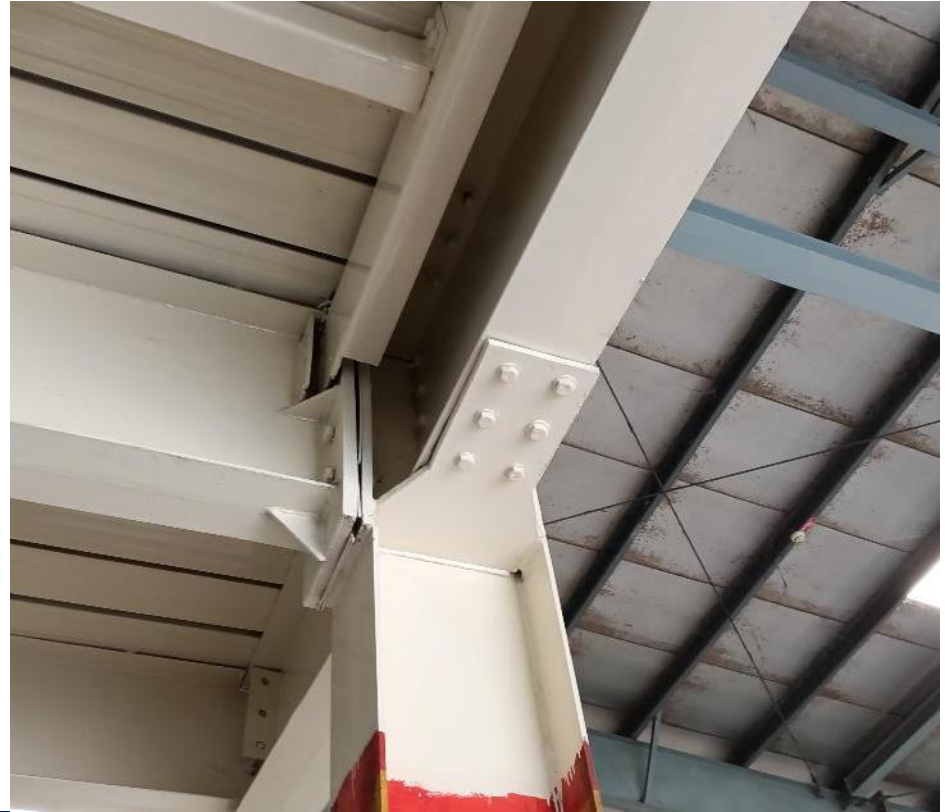
Gap observed in Beam- Column connection

Significant gaps observed at column-beam joint at several locations. Building engineer is required to carry out suitable remedial works.

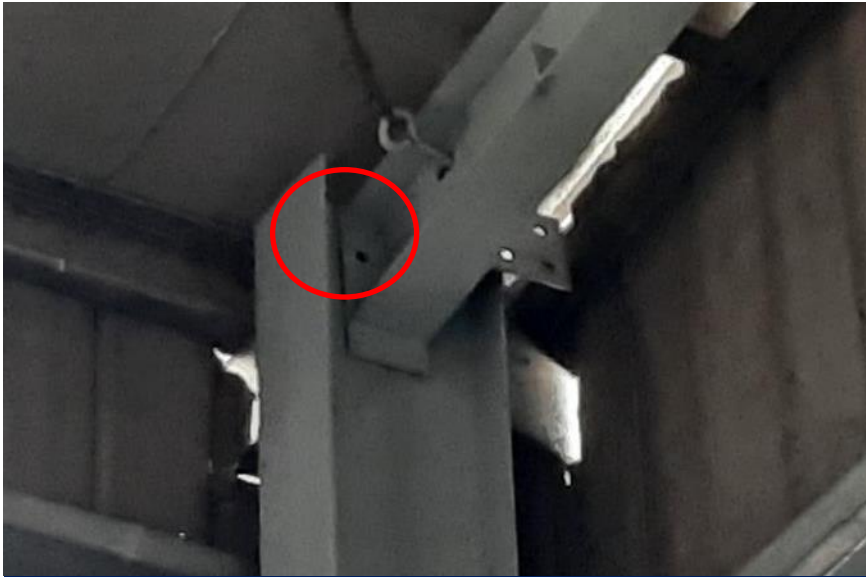
Bolt missing

Bolt missing in several connection joint.
Building engineer is required to identify the all locations and install missing bolt accordingly.

| Item No. | Observation | Recommended Action Plan | Recommended Timeline |
|---|--|--|---|
| 12 | Bolt missing in steel connection (Building-1: Dyeing Shed 2) | Building engineer is required to identify the all locations and install missing bolt accordingly. | 6-weeks |

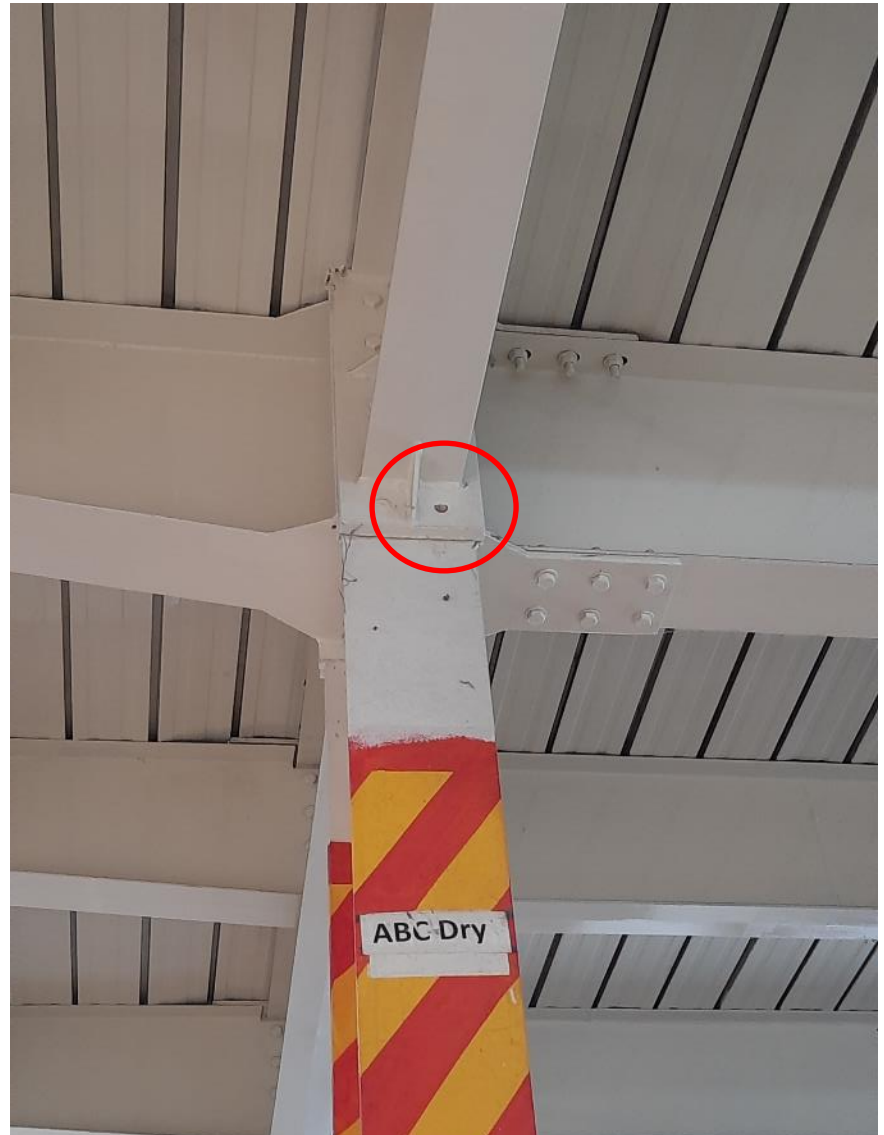
Bolt missing

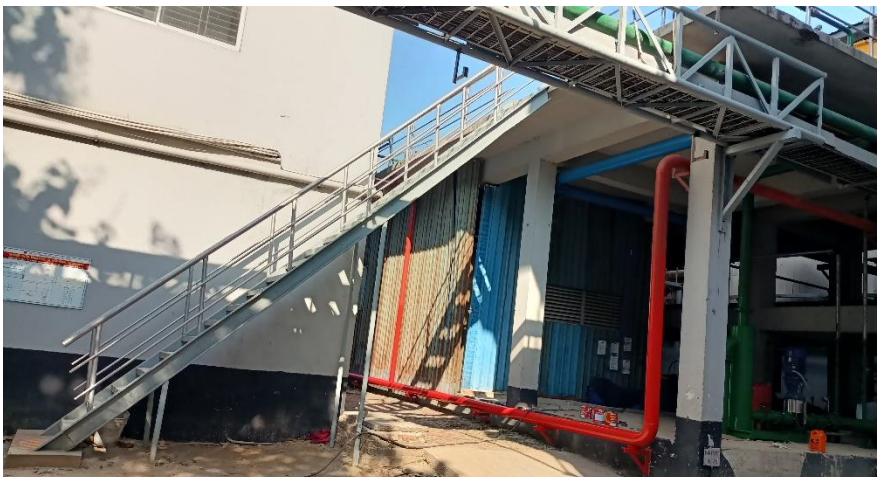
Building engineer is required to carry out the member adequacy & stability and implement remediation where required.

Apparently inadequate steel member size and no stability system provided.

| Item No. | Observation | Recommended Action Plan | Recommended Timeline |
|---|--|--|---|
| 23 | Apparently inadequate connection of steel stair (Building-4: Cooling Tower) | Building engineer is required to carry out stress & stability check of the steel stair. | 6-weeks |
| 24 | Apparently inadequate connection of steel stair (Building-4: Cooling Tower) | Implement remediation work where necessary. | 6-months |

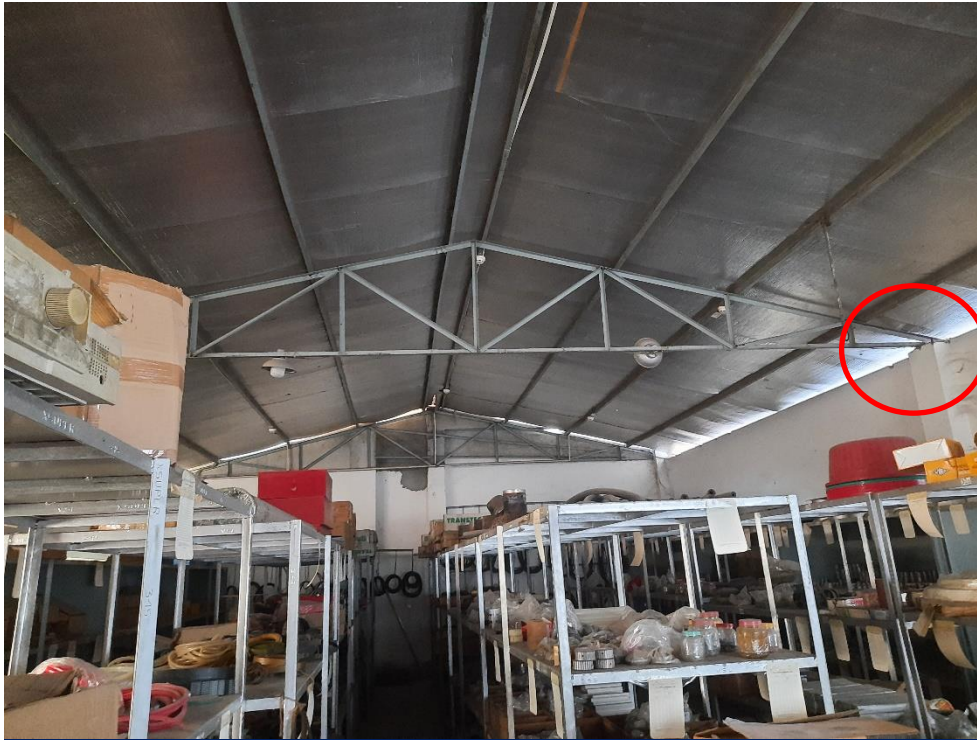
Connection of Truss-column

Connection at truss-column-base plate was appeared to be non engineered. Building engineer is required to check the connection for the up-lift pressure of wind.

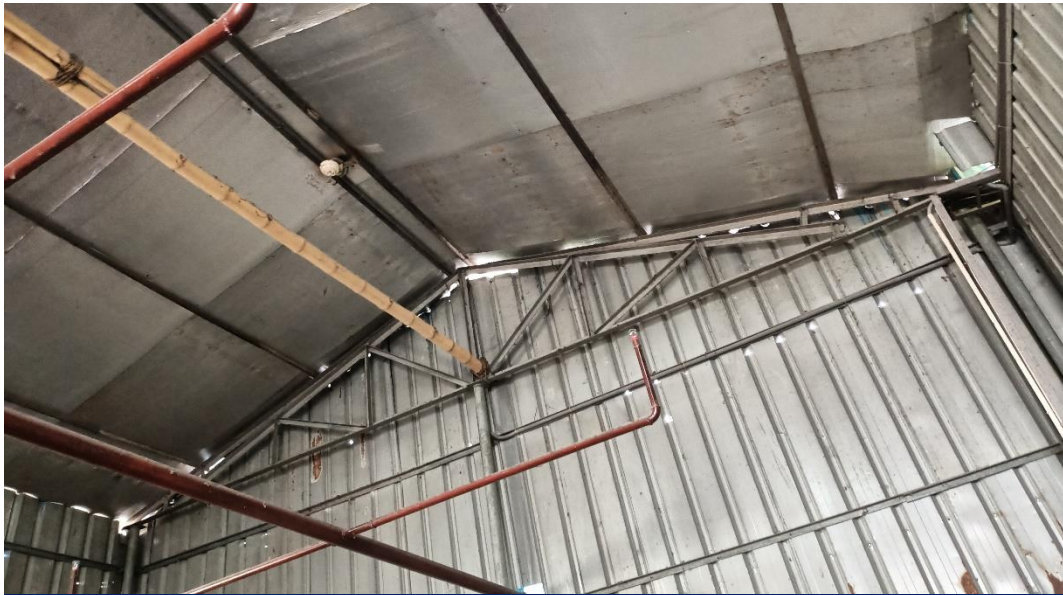
Connection of Truss-column

Connections at truss-column and Column-base plate were appeared to be non engineered. Building engineer is required to check the connection for the up-lift pressure of wind load.

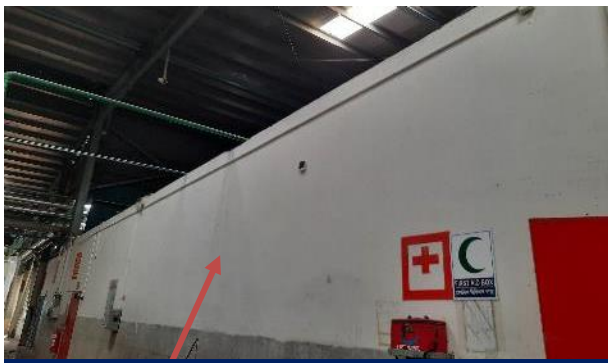
Separated RC chemical Store

No structural drawings details were found for the mezzanine floor. Undocumented extension was observed at Northwest corner. Also, connection details were not available in the provided drawings. Moreover, a separate single storied chemical building was found inside the shed.

| Item No. | Observation | Recommended Action Plan | Recommended Timeline |
|---|---|--|---|
| 08 | Lack of information and inconsistencies in as-built drawing (Building-1: Dyeing Shed 2) | The building engineer to survey the structure and prepare as-built structural drawings with clear connection details. | 6-weeks |

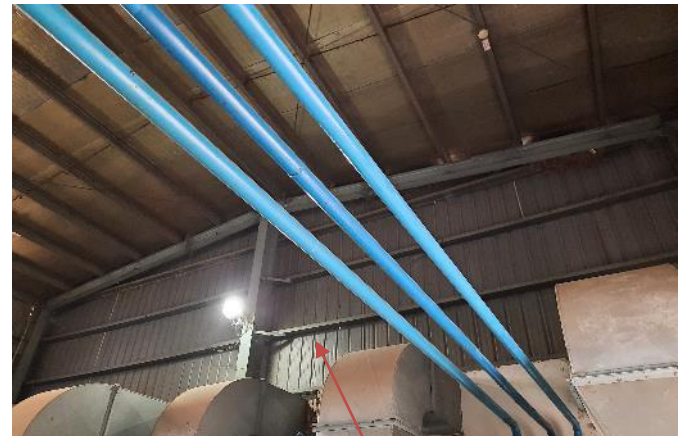
Section of Grid 9

Architectural of the shed were not found. Also, connection details and sectional details of Grid 9 were not available in provided drawings.

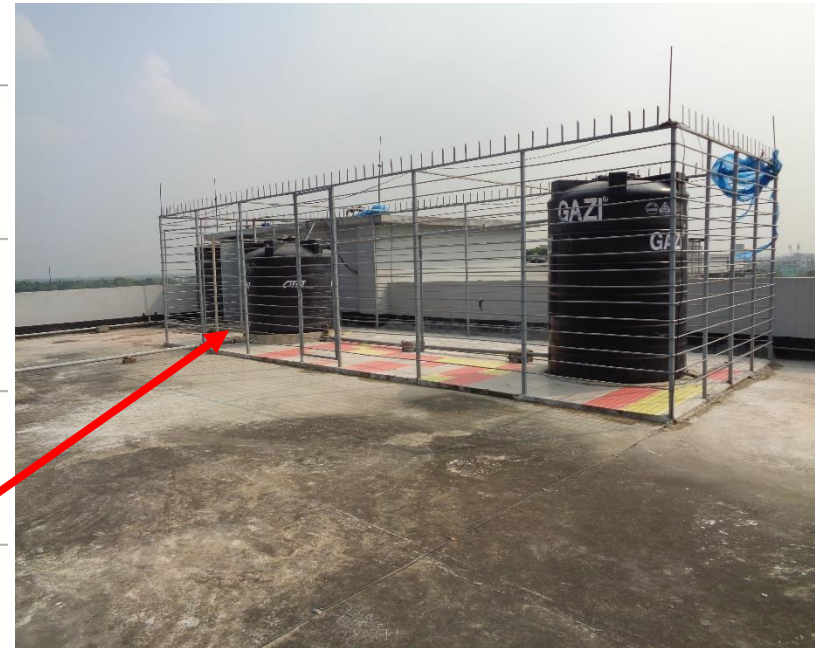
Plastic water tank (5000 liter each)

Two plastic water tank having capacity of 5000 litre each found on roof slab which were not shown in roof layout. Building engineer is required to update the as-built drawing as well as check the capacity of roof beam-slab considering the point load.
