P.A Knit Composite (Extension)

Jamirdia, Habir Bari, Valuka, Mymensingh-2240

12th, 25th October & 29th November 2021

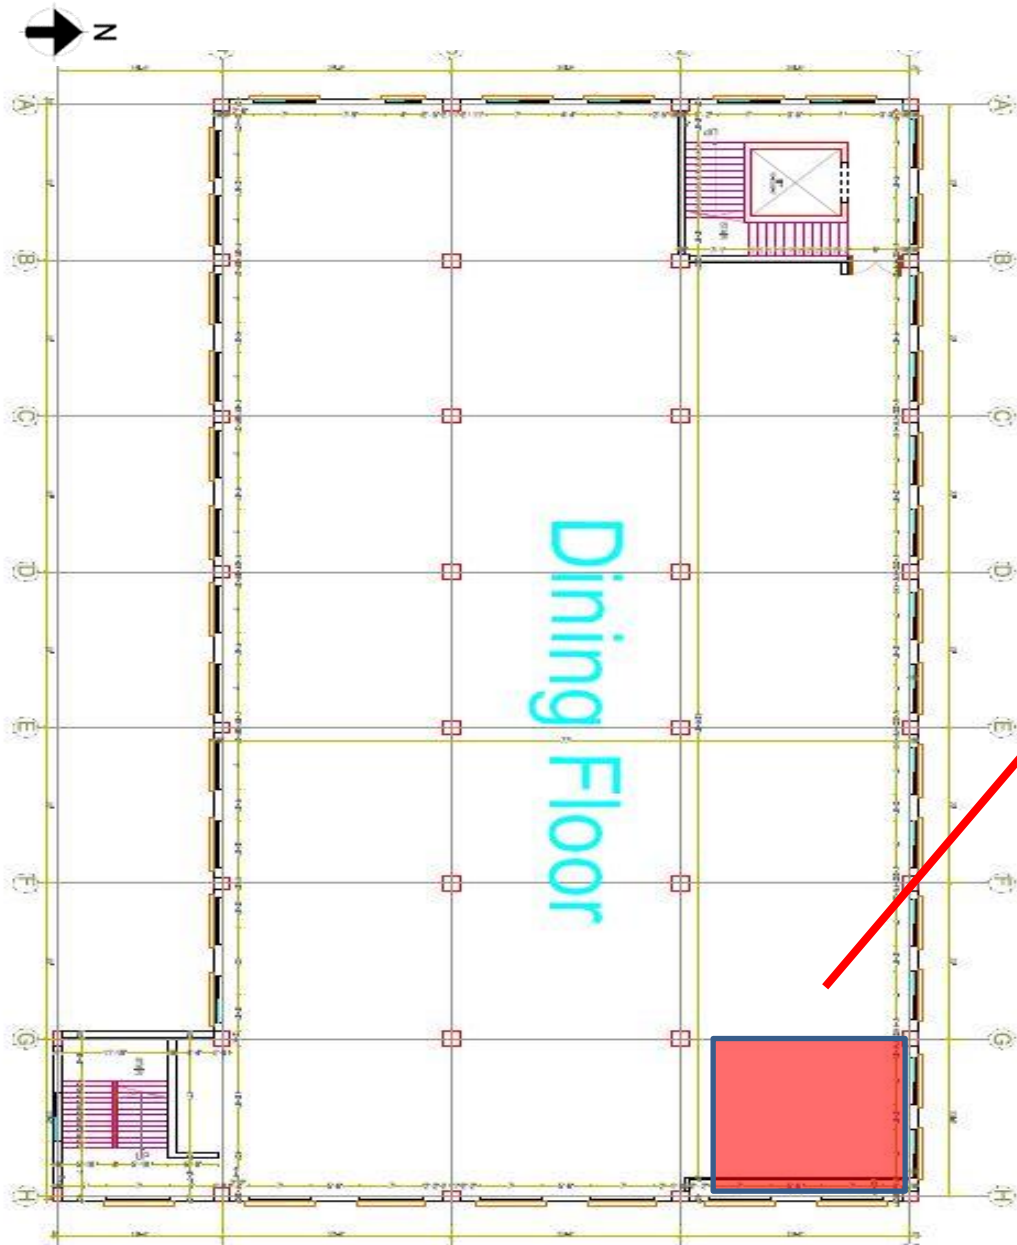
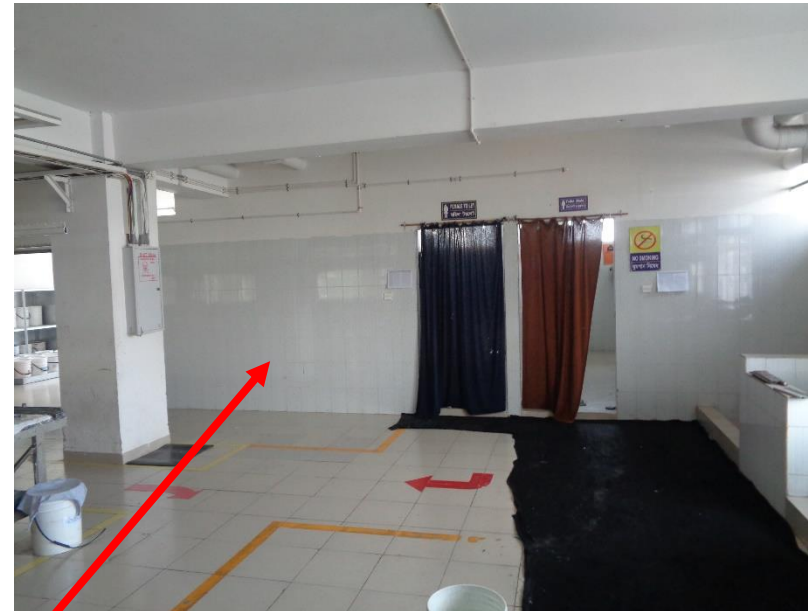
Third floor layout

Toilet area not shown in drawing

Undocumented toilet area found at third floor which was not shown in as-built drawing. Building engineer is required to update the as-built drawing.

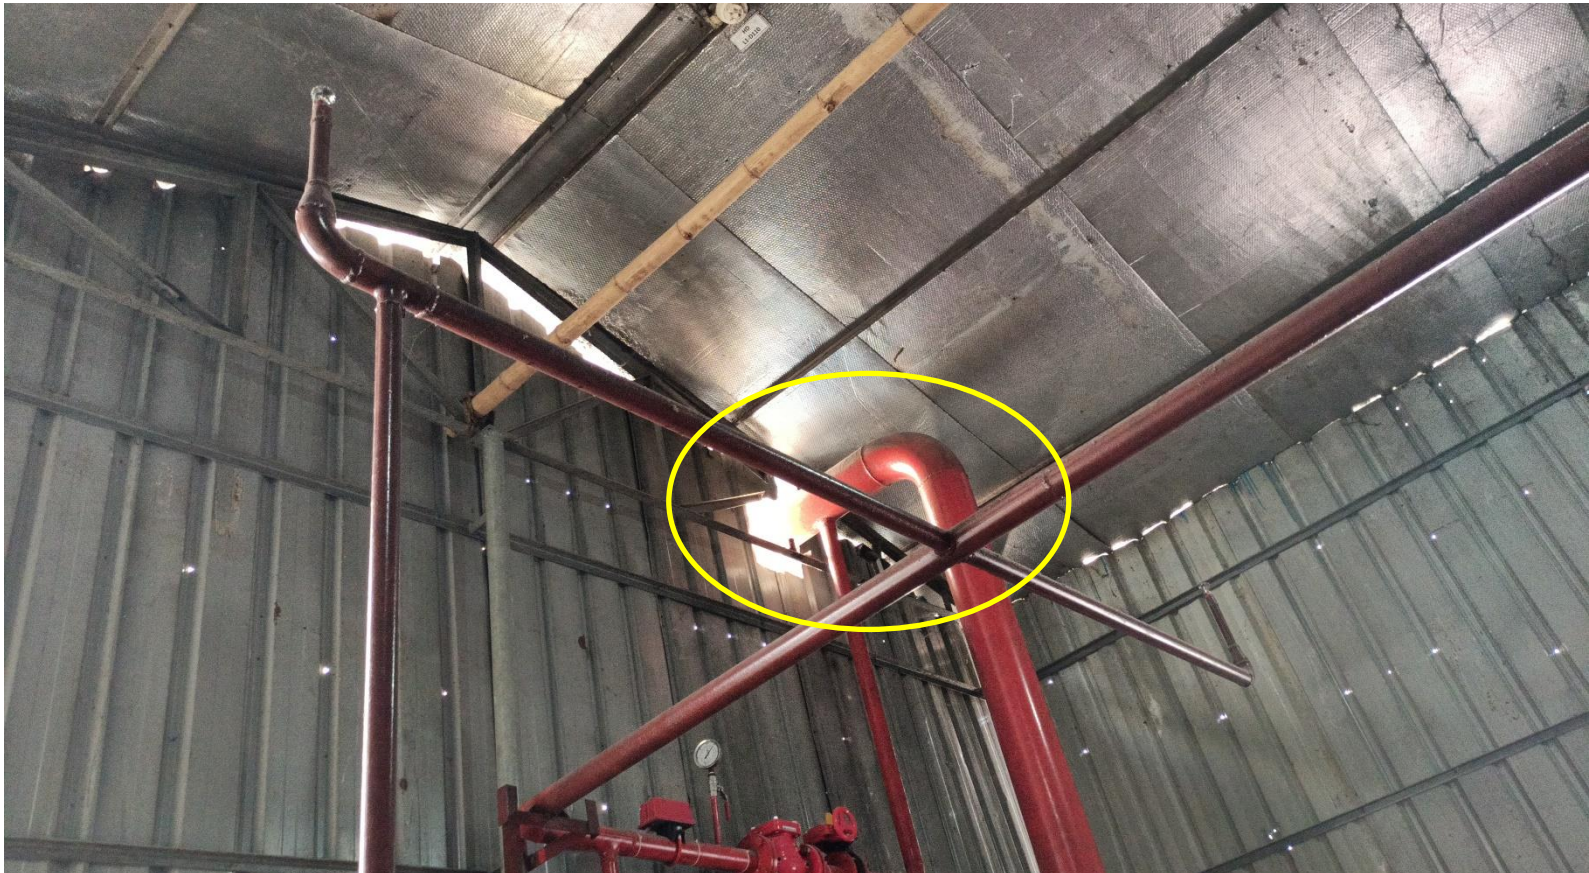
Discontinuous truss member

Diagonal truss member has been cut down due to fire hydrant discharge pipe. Building engineer is required to repair the truss frame with suitable method.

| Item No. | Observation | Recommended Action Plan | Recommended Timeline |
|---|---|--|---|
| 57 | Discontinuous truss member (Building-17: Fire Pump House) | Building engineer is required to repair the truss frame with suitable method. | 6-weeks |

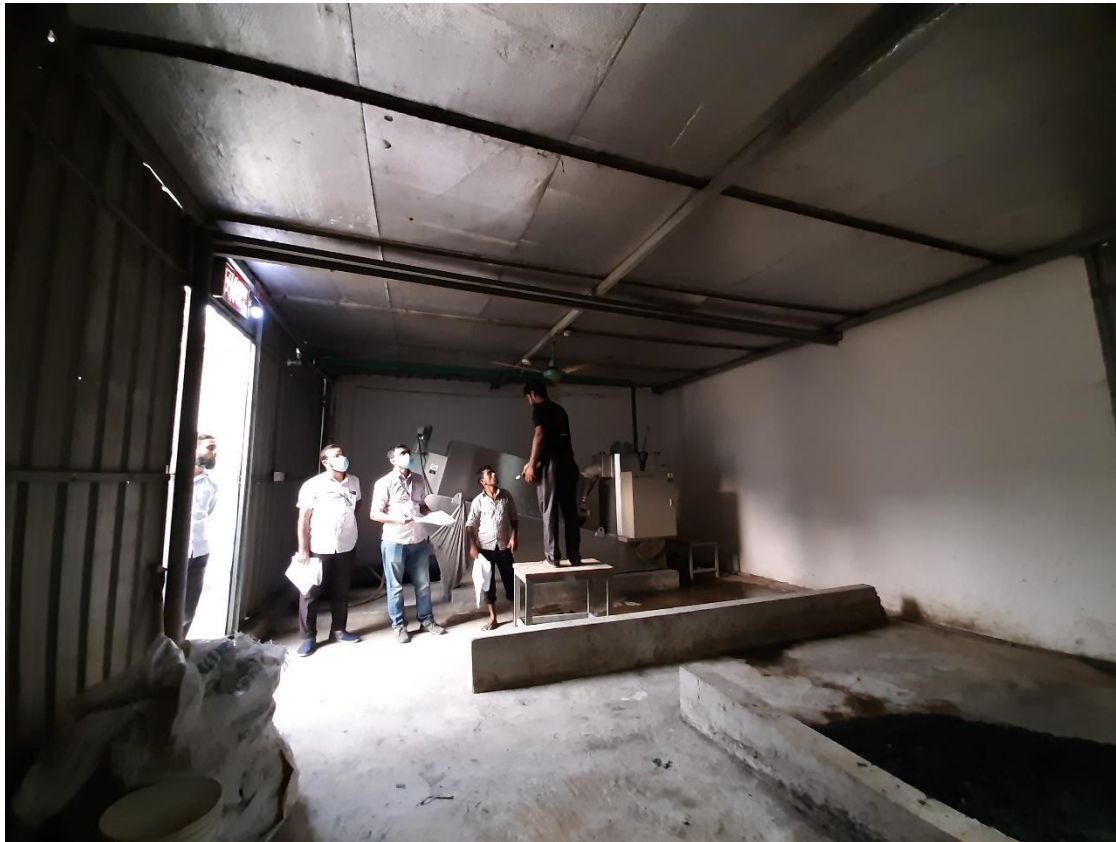
No clear load path and poor connection

This structure is apparently non engineered. Factory is required to ensure that the lateral load path is proper and connections for uplift force is adequate; otherwise replace the shed with engineered structure.

| Item No. | Observation | Recommended Action Plan | Recommended Timeline |
|---|---|--|---|
| 60 | Apparently non engineered shed (Building-18,19) | Building engineer is required to ensure that the lateral load path is proper, and connections are adequate for uplift force; otherwise replace the shed with engineered structure. | 6-weeks |

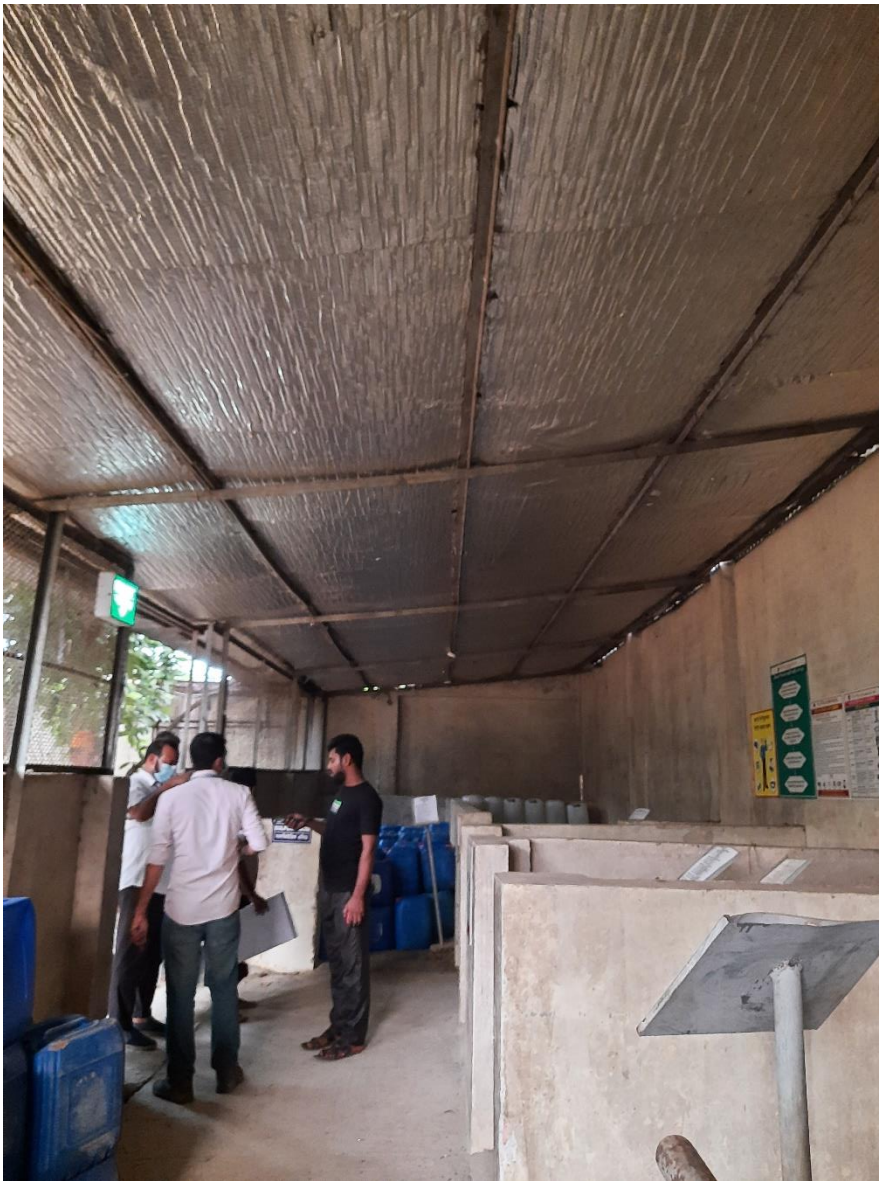
No clear load path with poor connection

This structure is apparently non engineered. Factory is required to ensure that the lateral load path is proper and connections for uplift force is adequate; otherwise replace the shed with engineered structure.

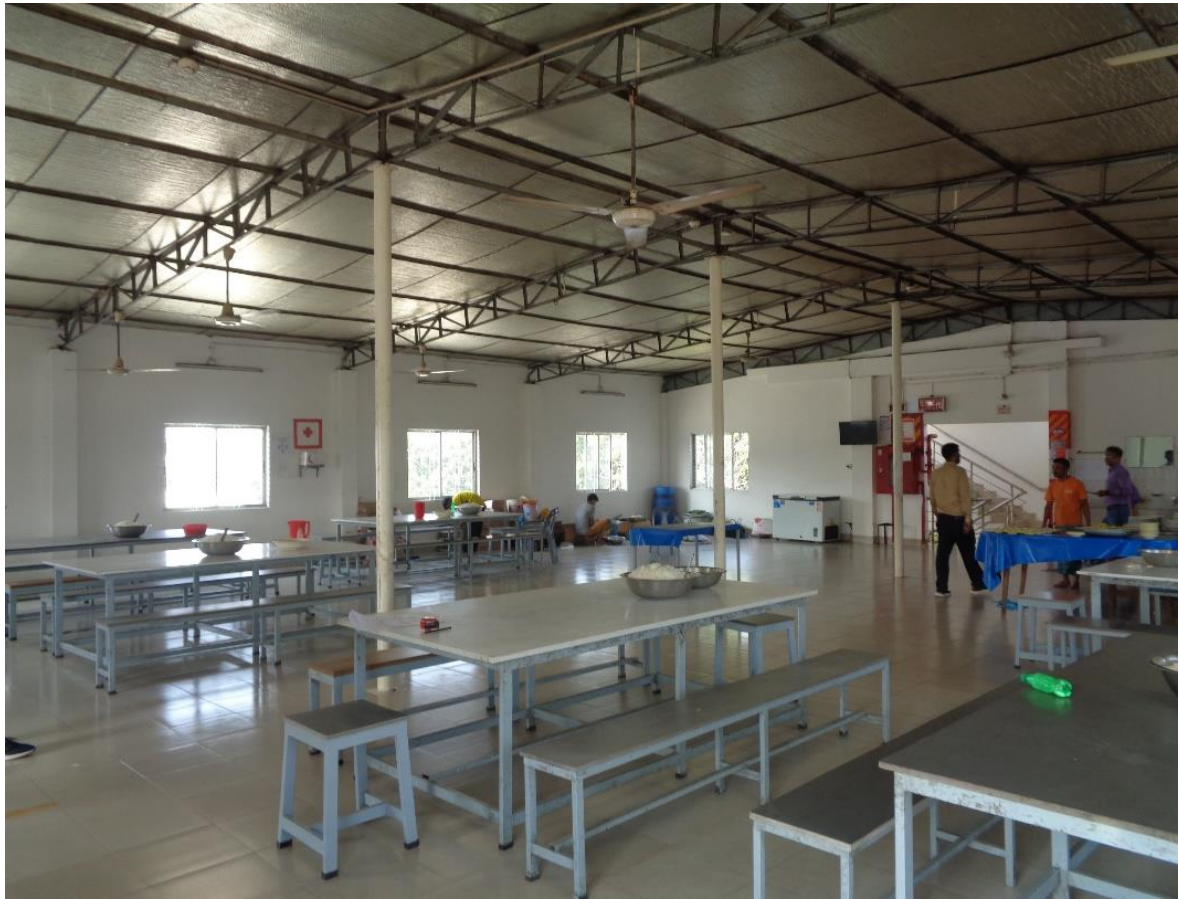
No bracing system/load transfer media provided

No load transfer media provided from frame to frame along long direction. In addition, no roof bracing system is provided therefore there is no obvious lateral stability for this shed. Building engineer is required to check the lateral stability of the shed against the lateral loadings.
