# Mars Stitch Ltd (10053)

1E, Nayem Uddin Mullah Road, Ayuchpara, 1712, Tongi, Gazipur

15.APRIL.2014

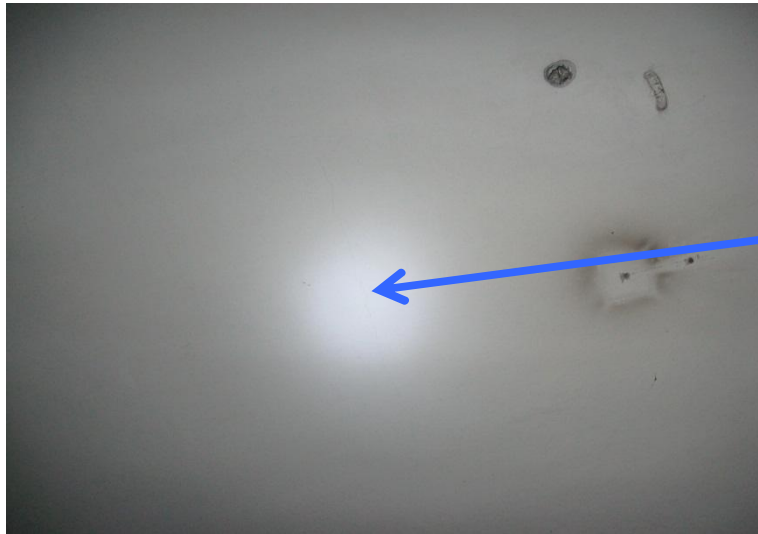
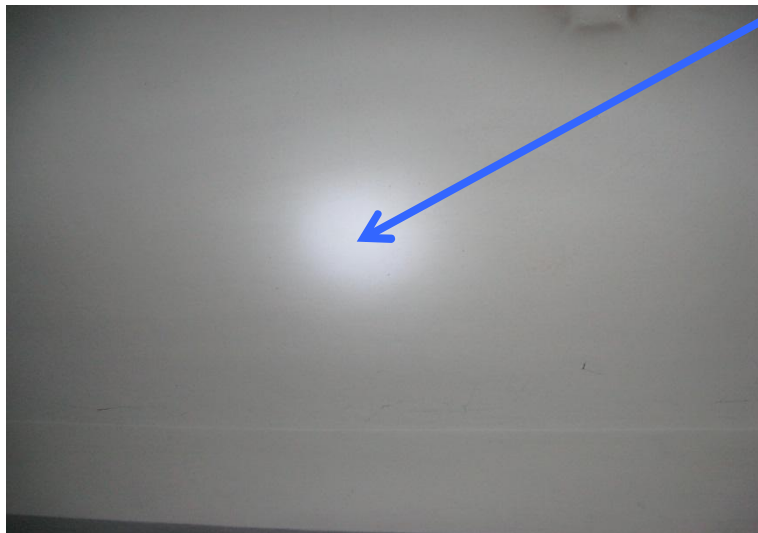
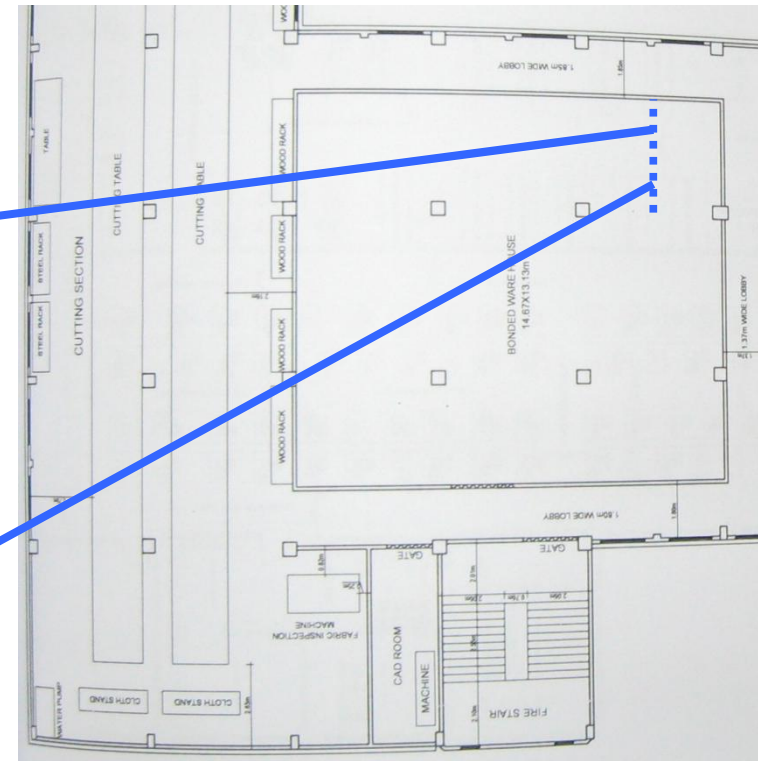
## 1<sup>st</sup> Priority 2 Concern

There are cracks in the middle of 2<sup>nd</sup> floor slabs' soffit in area (E-F/5-6). It also appears that some form of repair has been attempted to cracks on the surface of floor slab above.

- Carry out a Detailed Engineering Assessment of this area .
- The distress found is recommended to be repaired with suitable proper methods. Repair by re-plastering is not suitable.

- Set up and maintain a Loading Plan. Establish a quality control system to ensure that the loading plan is correctly followed so that problems do not arise in the future.

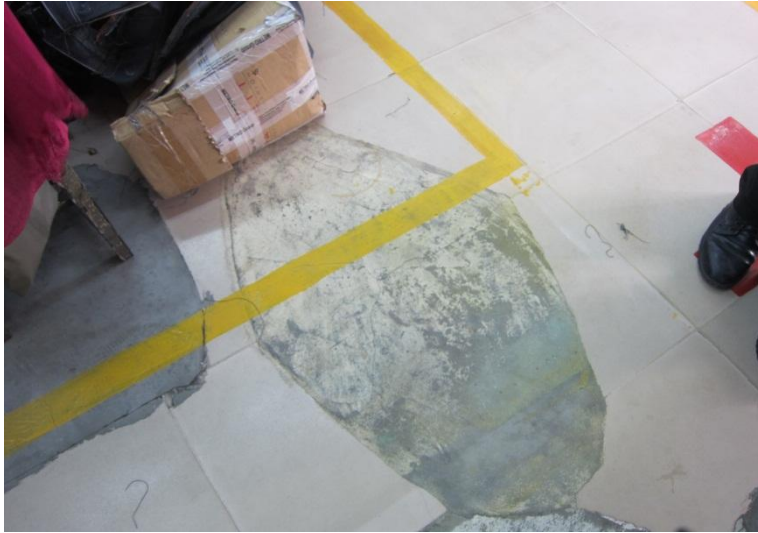
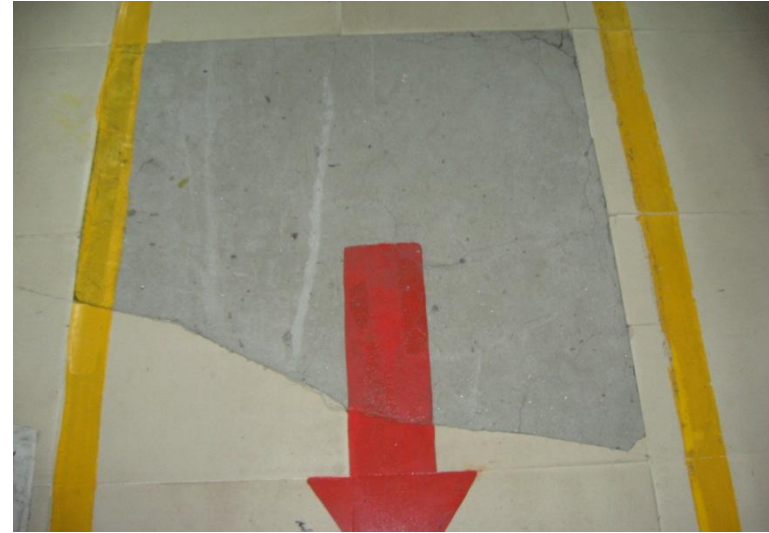
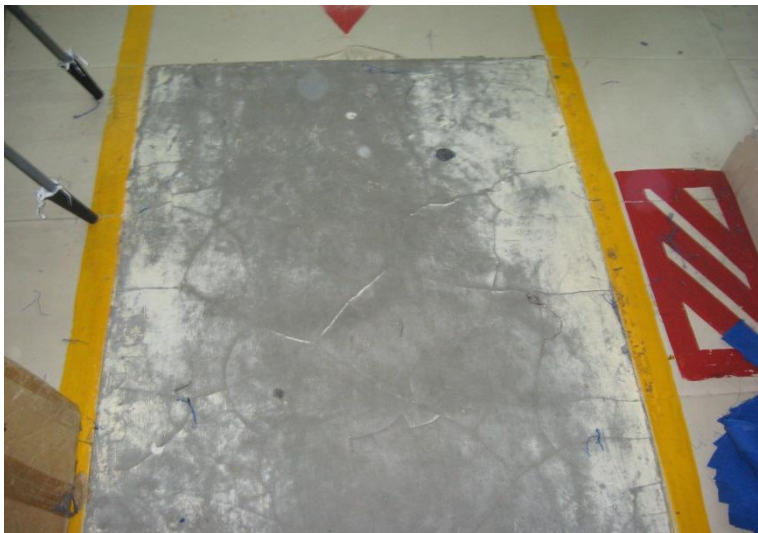
## Additional Comment

There are signs of crack repairs on the surface of floor slab above, where some finishes have been removed.

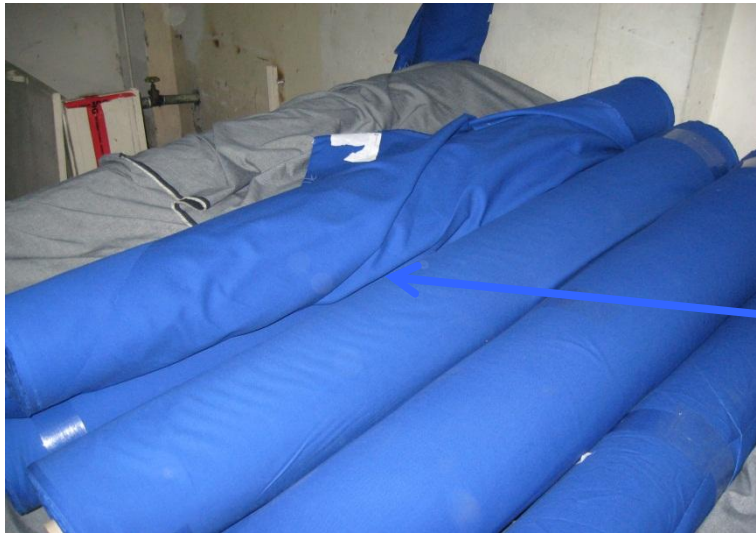
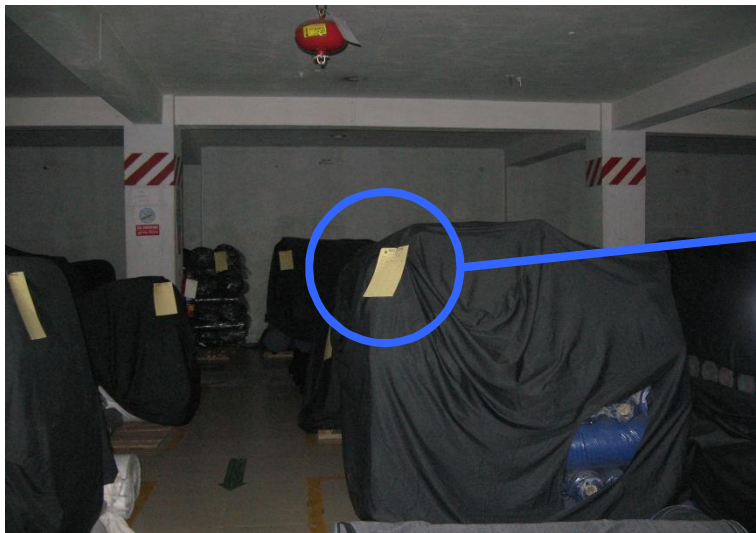
## 2<sup>nd</sup> Priority 2 Concern

There is uncontrolled heavy storage loads on the 1<sup>st</sup> floor in the warehouse. The actual live load under this load is believed to be approx. 8.75kPa (assumed 50 Kg per roll, 35 rolls per stack, 0.5 stack per sq.m.)

- Reduce stacking height to ensure total load does not exceed 3kPa.
- Adopt some sort of signage/staff guidance to ensure that the maximum weight of storage is not exceeded.

- Maintain standards of quality control to ensure that storage procedures are correctly followed and the Loading Plan is followed.

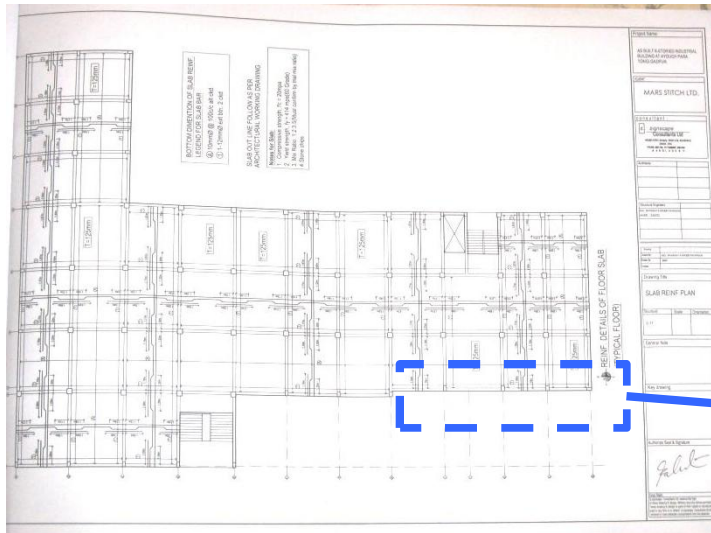
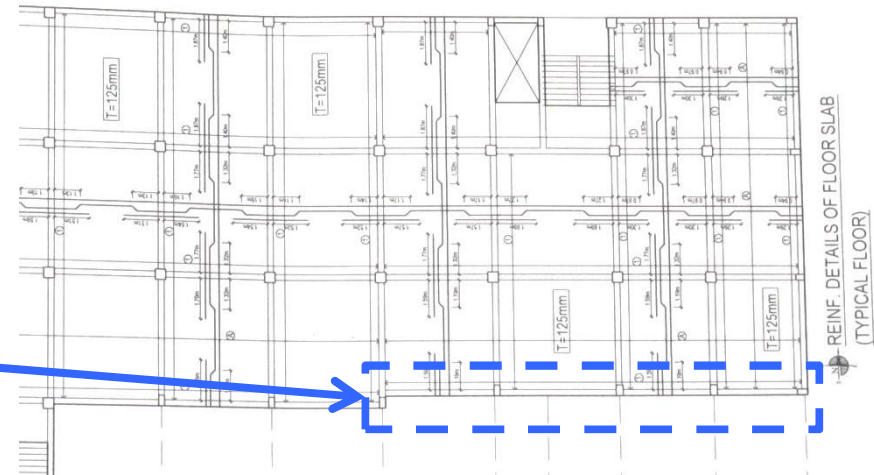
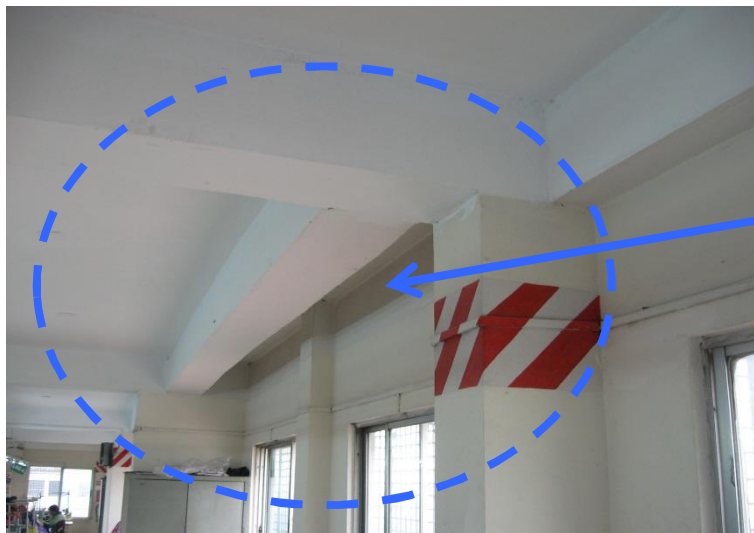
### 3<sup>rd</sup> Priority 2 Concern

There are cantilevered slabs in area (H-M/2-3) that do not appear on the structural drawings.

- Factory Engineer to review design, loads and columns stresses in area identified above.
- Verify in-situ concrete strengths either by cores or existing cylinder strength data for. Cores through the suspect slabs.

- Produce and actively manage a loading plan for all floor plates within the factory giving consideration to floor and column capacities.

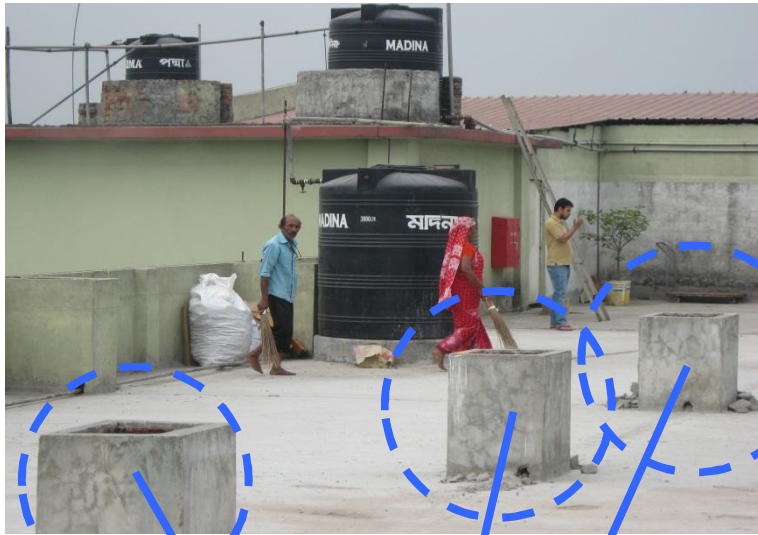
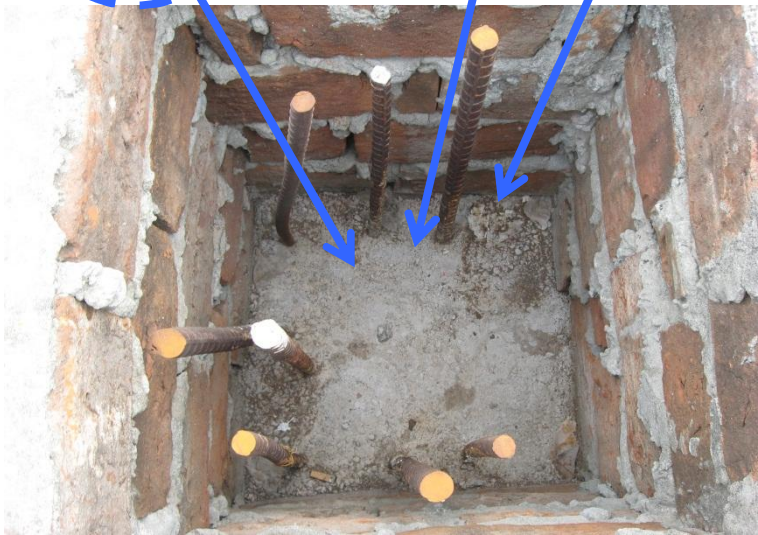
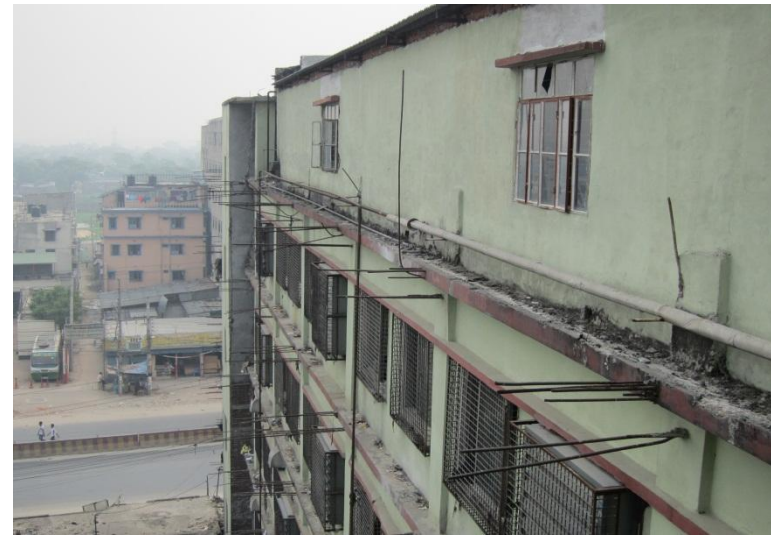
## 1<sup>st</sup> Priority 3 Concern

Reinforcement left exposed. It is unclear if rust proof paint is applied.

- Engineer to inspect the reinforcement where corrosion has occurred.
- For both durability and serviceability, rust proof paint is recommended.

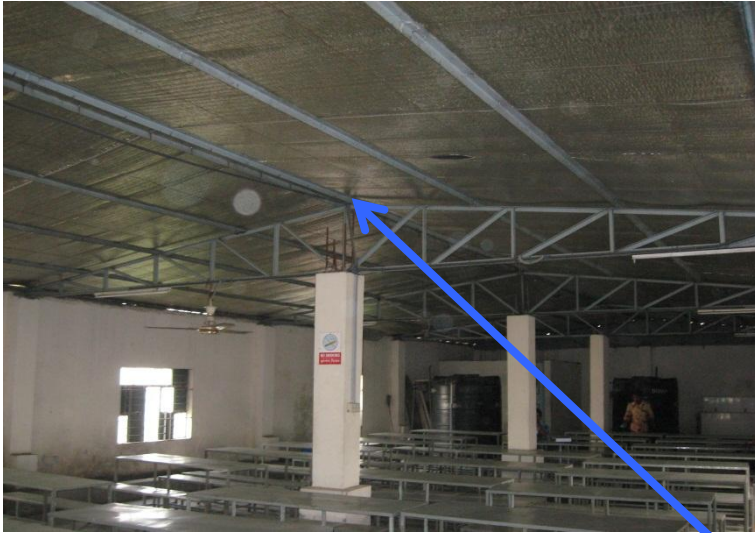
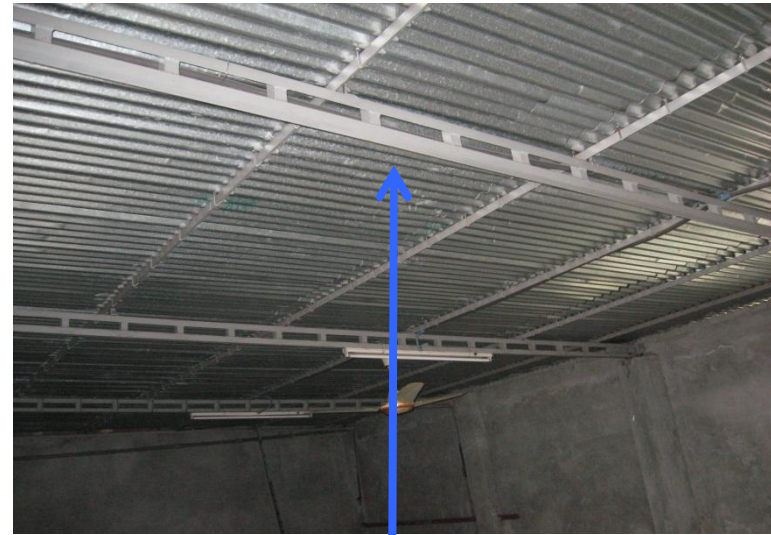
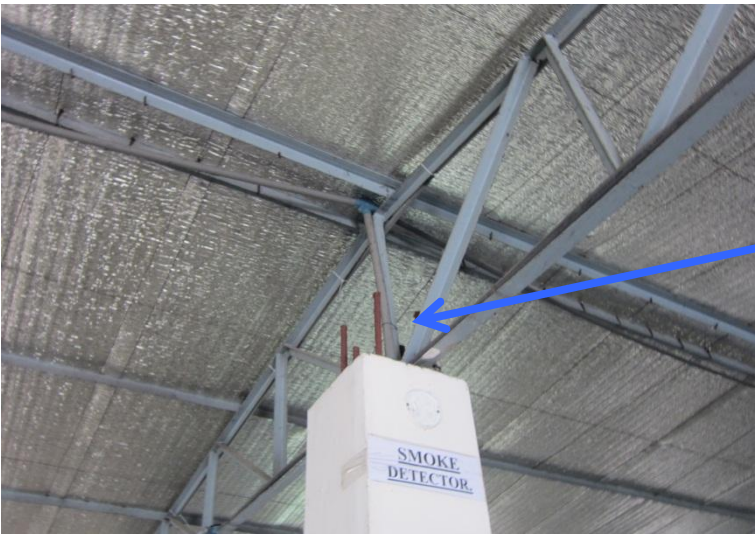
2<sup>nd</sup> Priority 3 Concern

Structural steel elements in all areas.  
It is unclear if fire proofing material is  
applied or required.

- Fireproofing material for structural steel element is recommended based on BNBC regulations.
- Maintain standard of quality control.

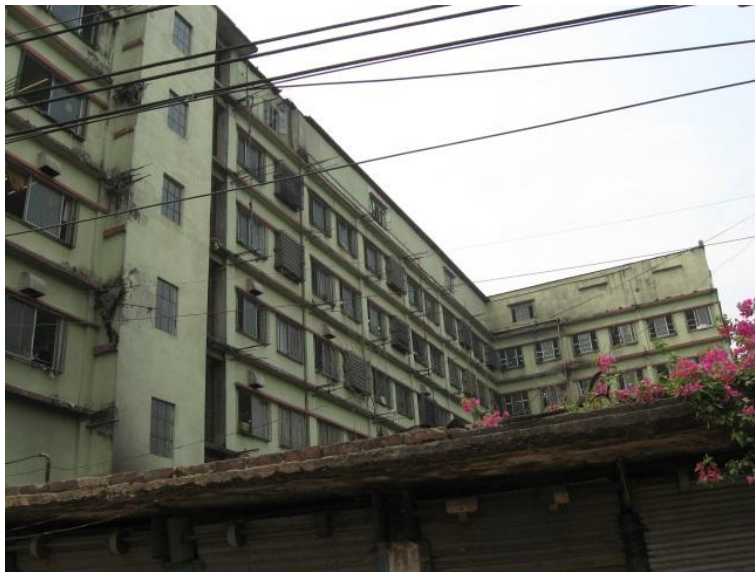
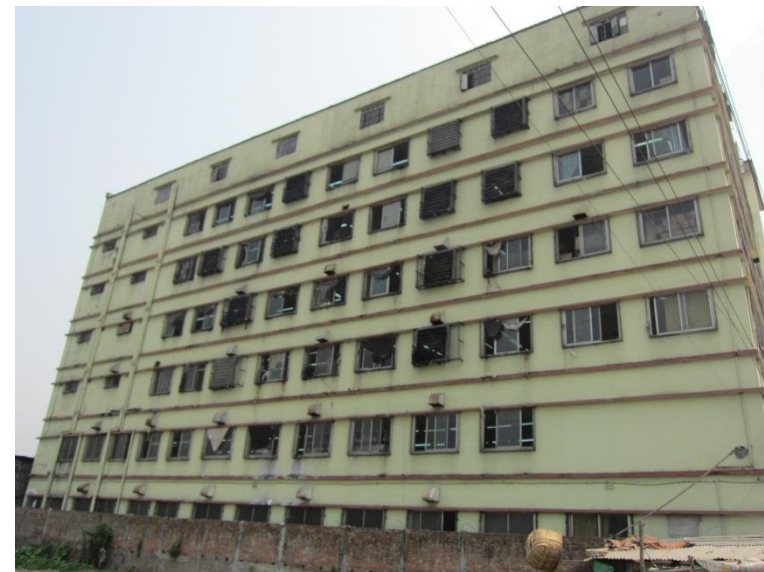
## Overall stability system / moment frame capacity

Concerns on the stability system for lateral loading and seismic loading. Façade brickwork walls lack of moment capacity in their connections between columns and beams.

We require that these items be investigated as part of a Detailed Engineering Assessment.

- The Detailed Engineering Assessment of the overall building is to be carried out and in particular, stability and foundation aspects should be investigated in detail.

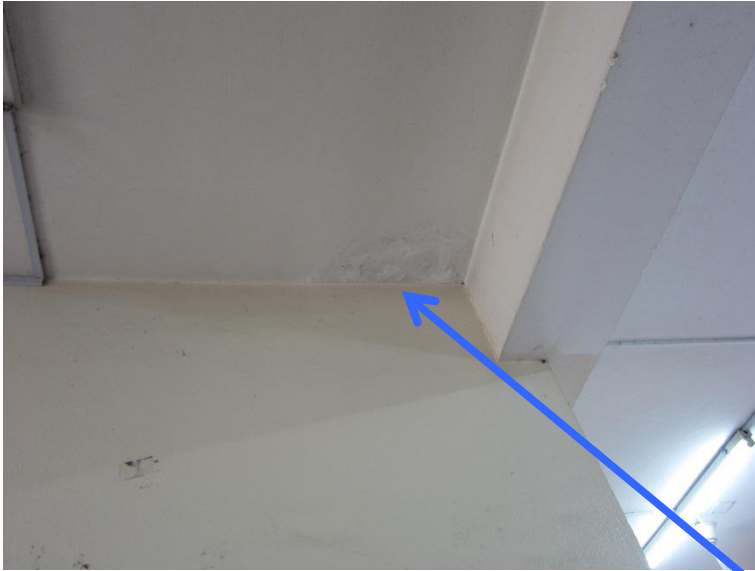
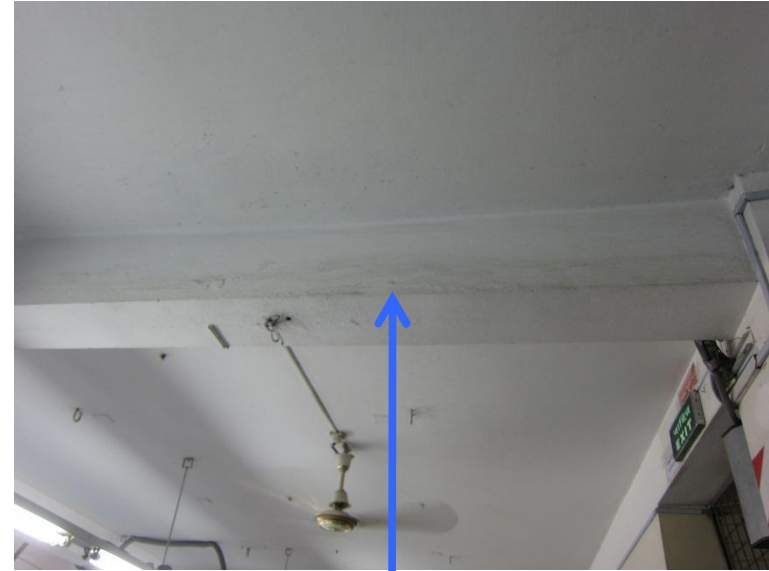
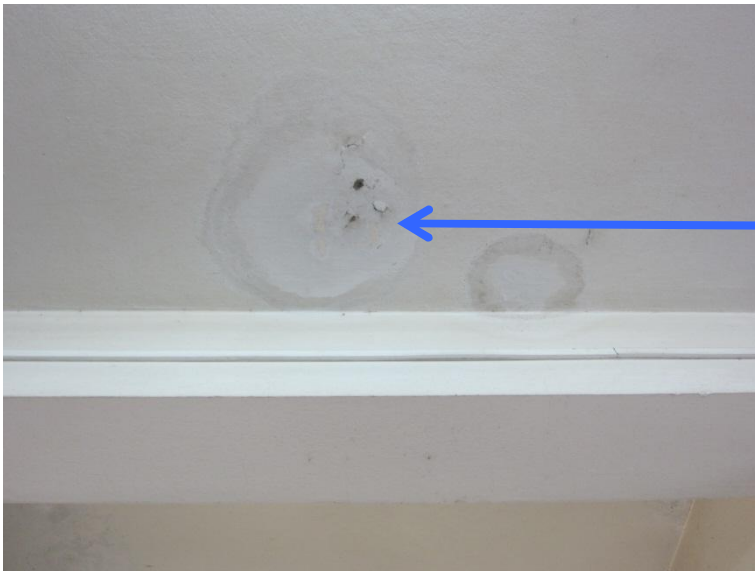
## Water ingress

Water ingress found on structural elements. In some areas mould could be seen. This may lead to further deterioration and spalling of concrete in the future.

- For both serviceability and durability, it's recommended to repair the distresses found with suitable methods.
- Install a waterproofing system to the roof above.

- A Structural Engineer is to inspect the water damaged structural elements and propose a suitable repair method.
- For both durability and serviceability, waterproofing on the roof slab is recommended. The roof slab drainage system should also be improved.

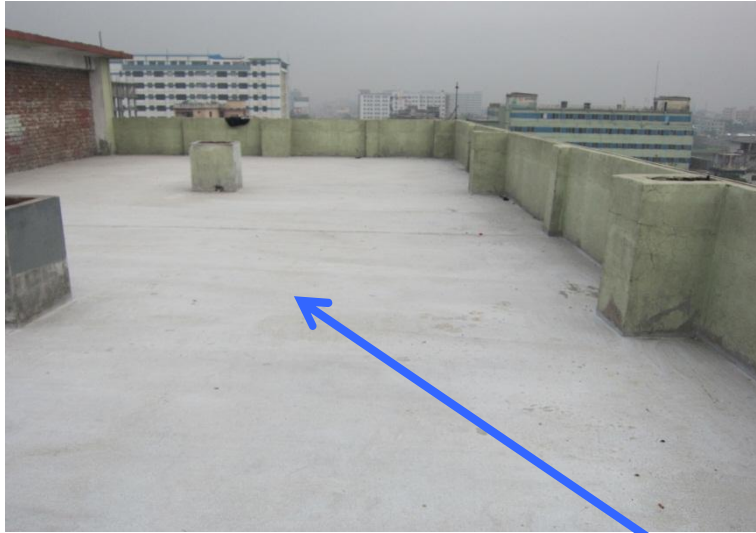
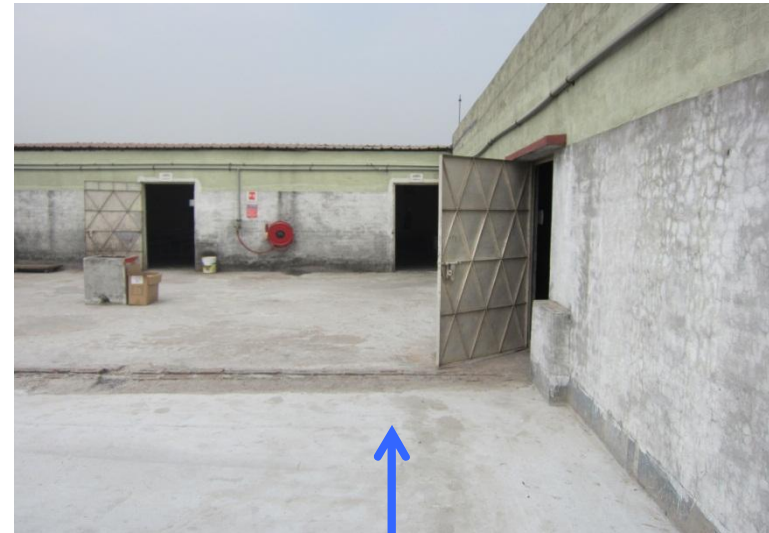
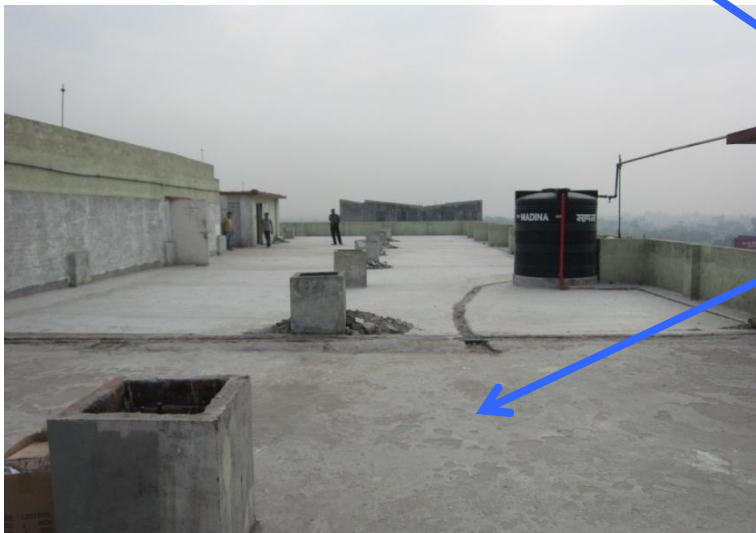
A waterproofing layer is recommended on the provided structural drawing, in its “General Notes”. However, no waterproofing material was seen on site.

- Ensure that an appropriate layer of waterproofing is included on the final roof slab.
