Tusuka Apparels Ltd. (Relocation)

40/5, Hazrat Shahjalal Road, Rajnagar, Sataish, Tongi, Gazipur.

20th December 2021

1. **Building 2** is a 4-storied (G+3) reinforced concrete building.

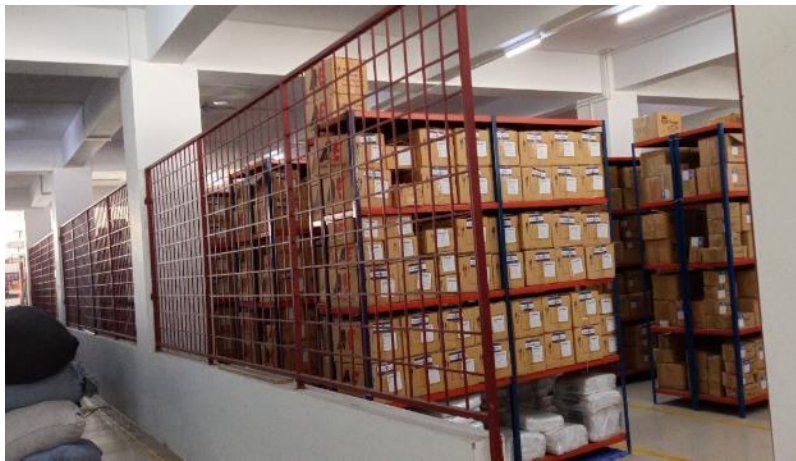
**Prepared design report not fully comply with
BNBC**

As per BNBC, the minimum floor live load for light storage is 6 kN/m² (125 psf). The storage in this building is designed for 4 kN/m² live loads. The building engineer is required to revise the storage live load limit based on BNBC requirement.

| Item No. | Observation | Recommended Action Plan | Recommended Timeline |
|---|--|--|---|
| 01 | Prepared design report not comply with BNBC. | The building engineer to check the occupancies and update the floor live loading plan for the building based on BNBC loading requirements, capacity of building floor, column & foundations. | 6-weeks |
| 02 | Prepared design report not comply with BNBC. | Revise the design report as per updated load plan. | 6-weeks |
| 03 | Prepared design report not comply with BNBC. | Implement the floor loading plan (posting load plan, providing signage and maintaining loadings). | 6-months |

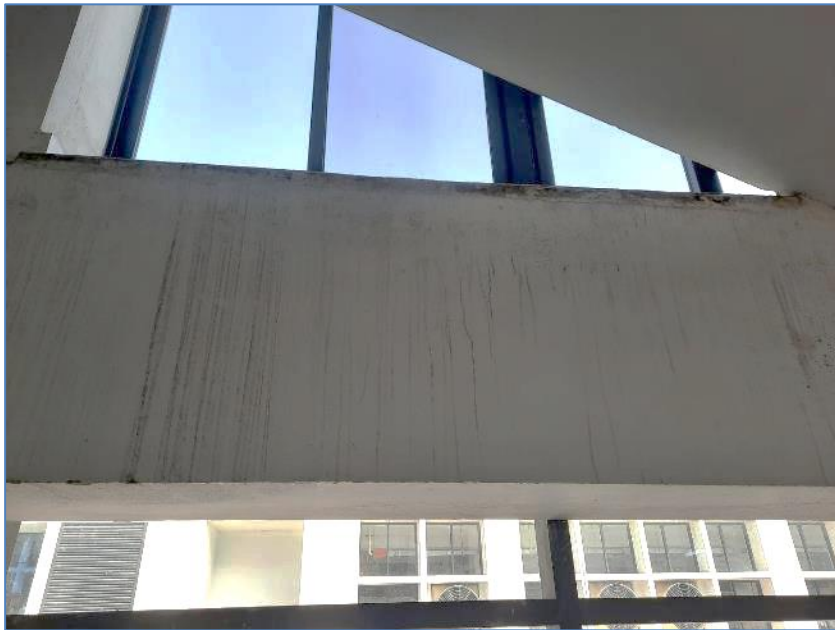
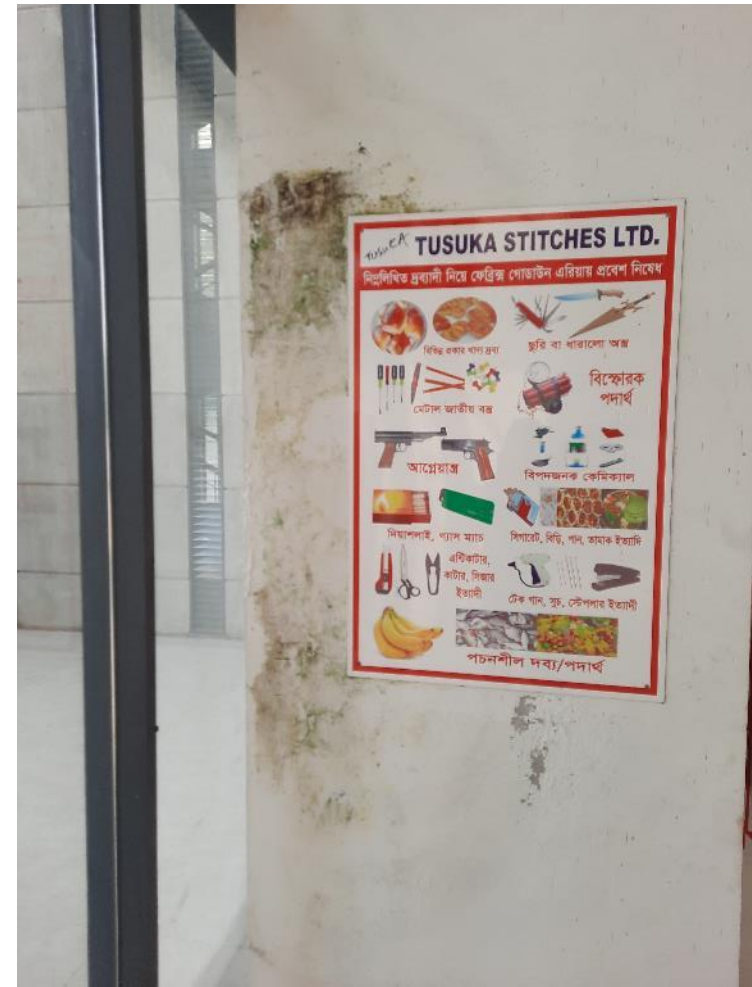
Signage of dampness observed in the building. Building engineer is required to identify the reason of the dampness and suggest suitable repair works.

| Item No. | Observation | Recommended Action Plan | Recommended Timeline |
|---|--|--|---|
| 04 | Signage of dampness. | Building engineer is required to identify the reason of the dampness and suggest suitable repair works. | 6-weeks |

| Item No. | Observation | Recommended Action Plan | Recommended Timeline |
|---|---|--|---|
| 05 | Signage of dampness. | Carryout repair works where necessary. | 6-weeks |

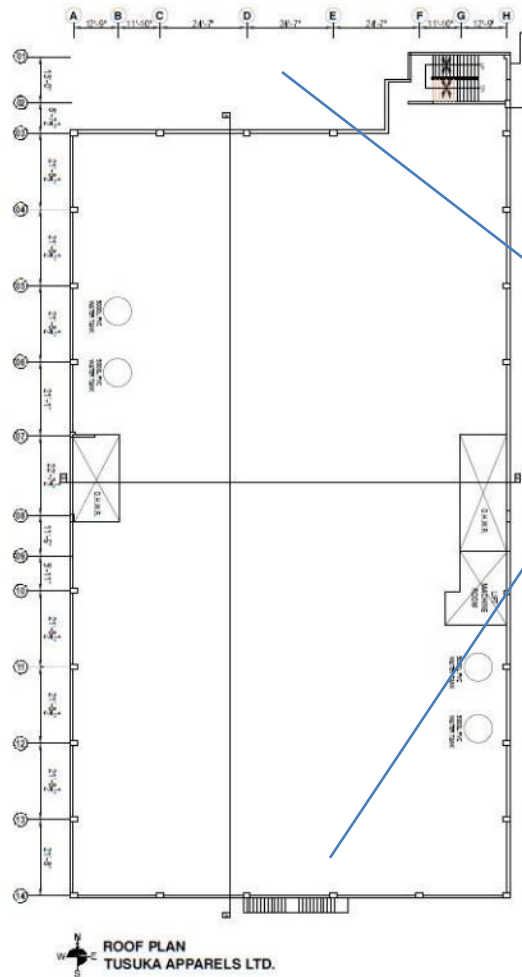
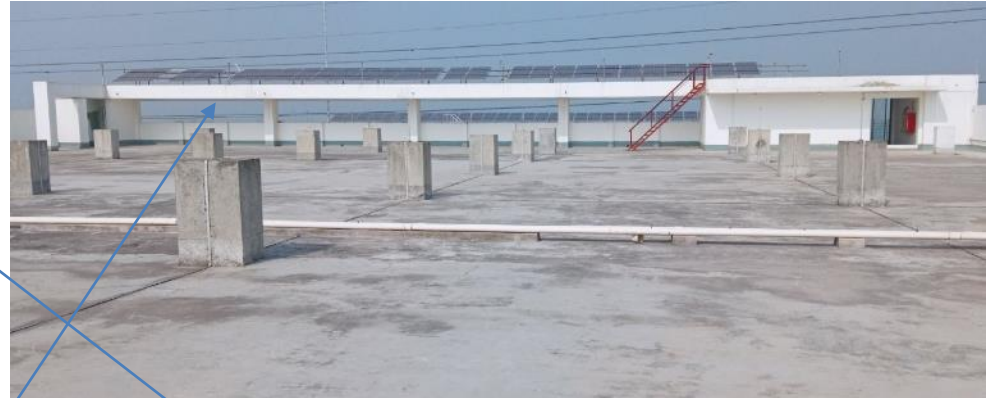
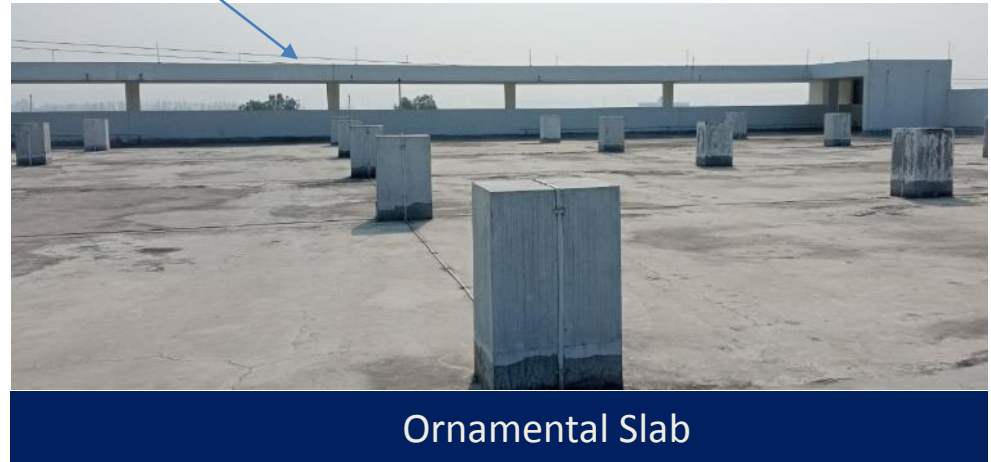
Lack of as-built drawing of roof

No as-built drawings were available onsite for the roof. Building engineer is required to produce a as-built drawings.

| Item No. | Observation | Recommended Action Plan | Recommended Timeline |
|---|---|--|---|
| 06 | Lack of as-built drawing of roof. | Building engineer is required to produce as-built drawings of the roof. | 6-weeks |

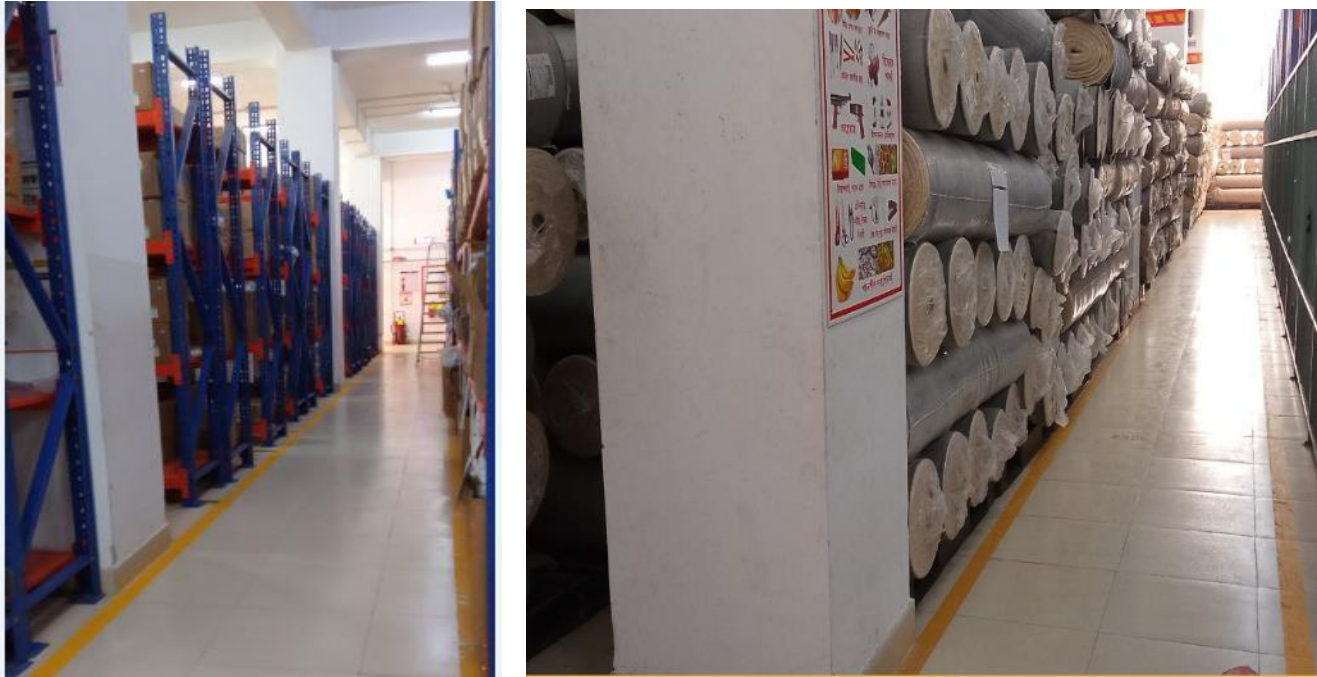
Column susceptible to trolley impact

Some of the columns were found adjacent of driveway of trolley movement. These column are susceptible to trolley impact. The factory engineer is required to take necessary measures to prevent the trolley impact by providing the barrier around the columns.

| Item No. | Observation | Recommended Action Plan | Recommended Timeline |
|---|---|--|---|
| 03 | Column susceptible to trolley impact. | The factory engineer is required to provide proper barrier around the columns to protect from possible trolley impact. | 6-weeks |
