# AR-TEX COMPOSITE LTD.

Bholail, Kashipur, Fatullah, Narayanganj

21 December 2021

# Observations

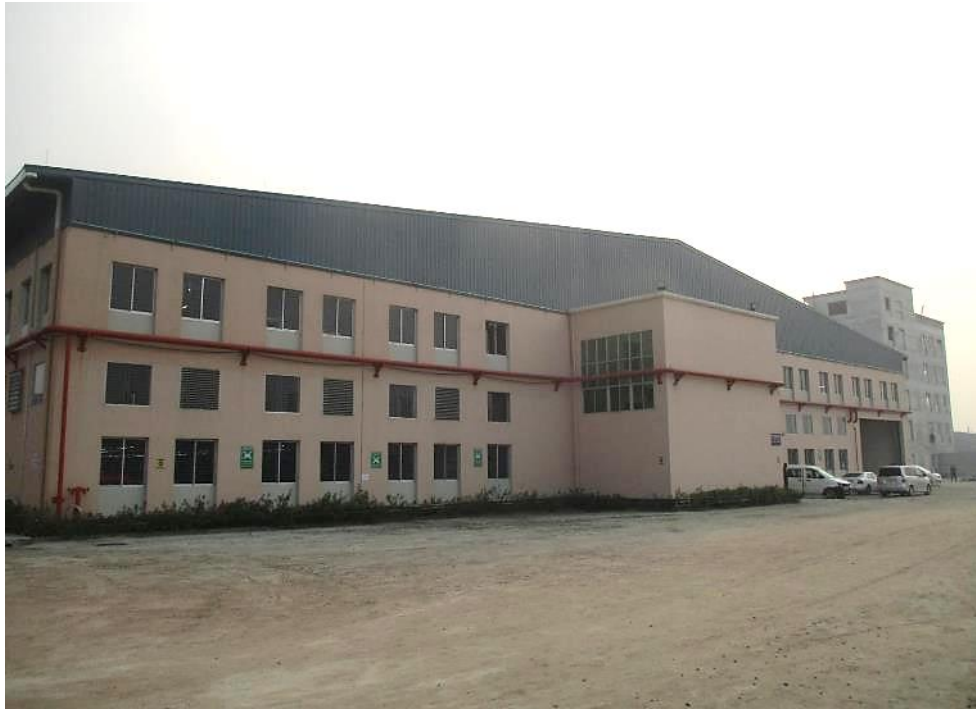
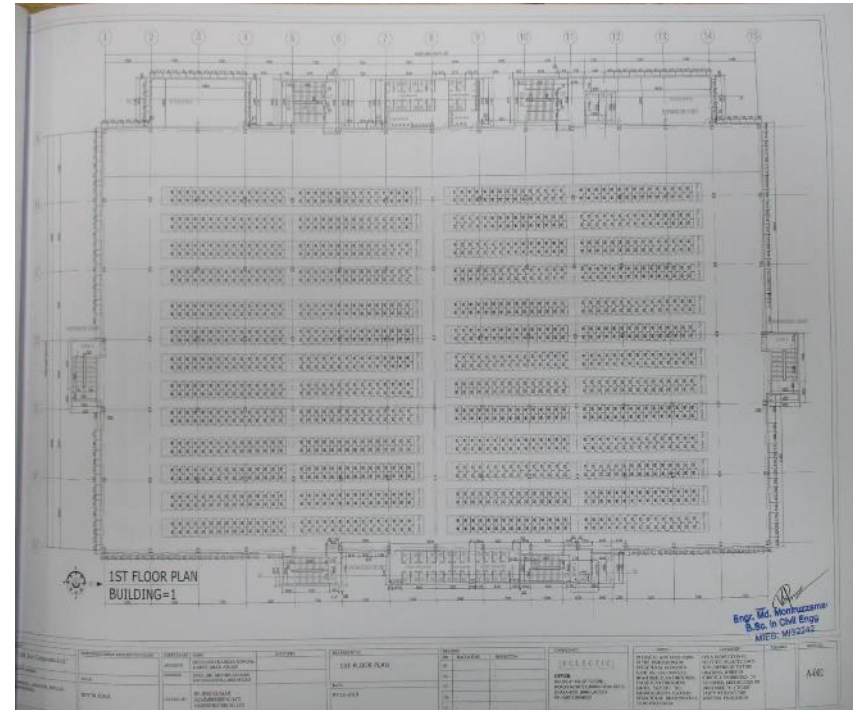
Building-1 (Steel Building)

**Design report to be prepared**

Only Architectural & structural drawings were available for Building-1. As per BNBC, every building designed shall have its design documents prepared in accordance with the provision of Section 1.9.1. The design document shall include a design report, and a set of structural drawings, which shall be prepared in compliance with section 1.9.1.1 and section 1.9.1.2 as per BNBC. However, the factory is required to prepare a design report in compliance of BNBC.

| Item No. | Observation | Recommended Action Plan | Recommended Timeline |
|---|---|---|---|
| 01 | Design report to be prepared. (Building-1) | The factory engineer is required to prepare the design report in compliance of BNBC 1.9.1. | 6-weeks |
| 02 | Design report to be prepared. (Building-1) | Implement the remedial works where required. | 6-months |

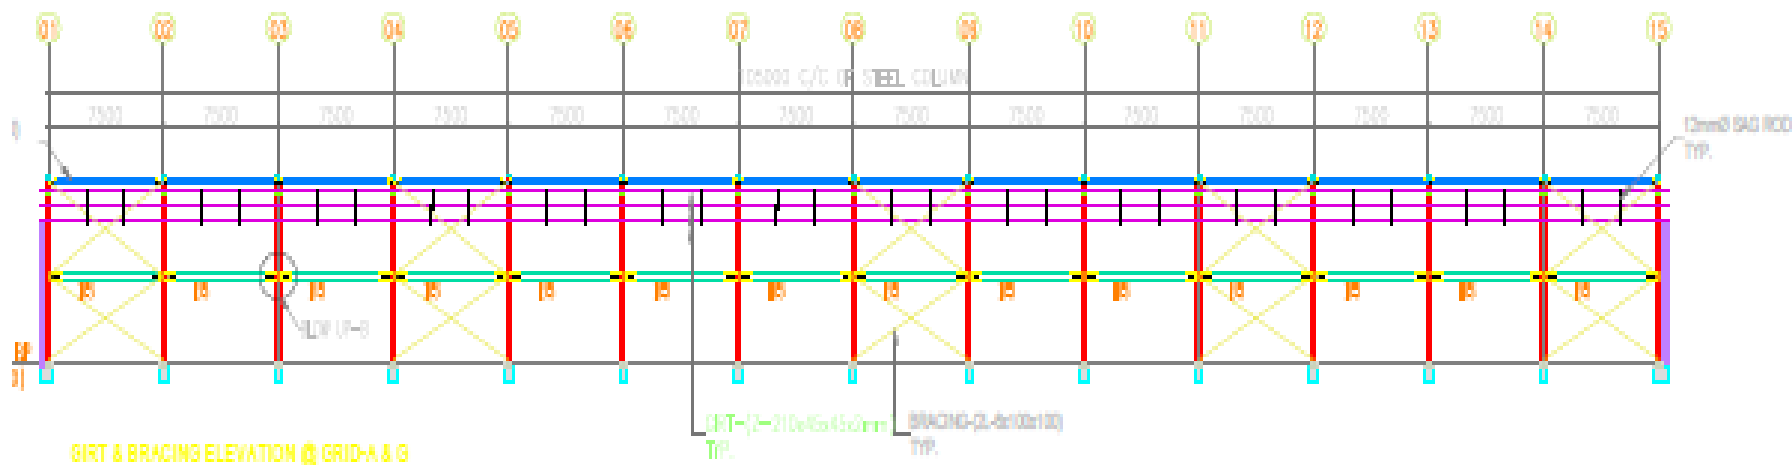
## **Absence of vertical bracings**

Vertical bracing layout shown in the provided drawing, but no vertical bracing observed on-site. Building engineer to check the bracing requirement and suggest remedial actions accordingly.

| Item No. | Observation | Recommended Action Plan | Recommended Timeline |
|---|---|---|---|
| 03 | Absence of vertical bracing. (Building-1) | The factory engineer is required to check the stability requirements and suggest the remedial actions. | 6-weeks |
| 04 | Absence of vertical bracing. (Building-1) | Carry out remedial works if necessary. | 6-months |

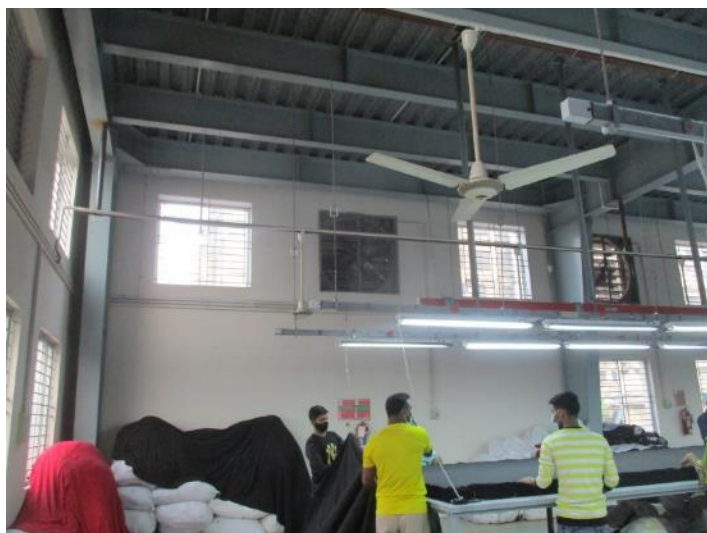
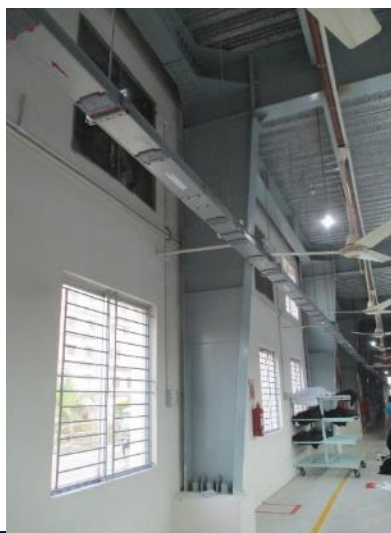
No vertical bracing at wall

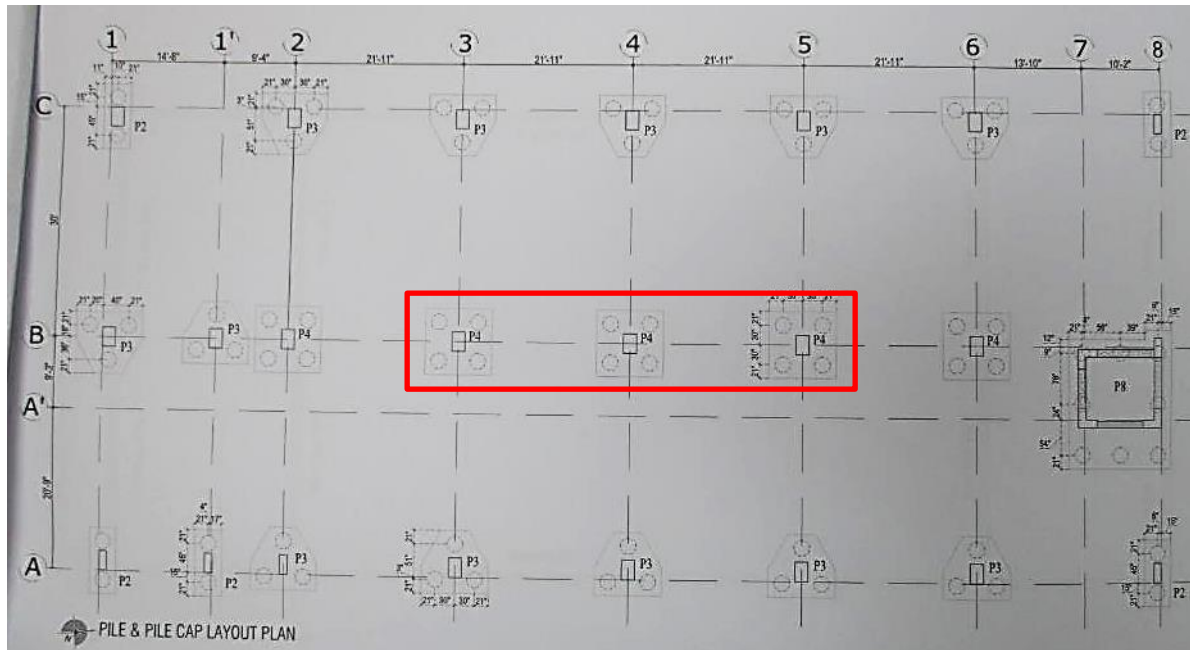
Pile foundation layout and schedule

**Foundation stress exceeds above normal design limit**

Cursory calculation indicates that foundations are stressed above normal design limit considering typical floor live load 3 kPa, loads from UGWR approximate 18 kPa, ultimate single pile capacity from soil test report (3x70 ton= 2055 kN) and minimum concrete strength (16.3 MPa). The building engineer is required to check the design, loads, foundation stresses for the marked foundations based on in-situ material strength and suggest necessary remedial actions accordingly.

| Item No. | Observation | Recommended Action Plan | Recommended Timeline |
|---|---|---|---|
| 05 | Foundation stress exceeds above normal design limit. (Building-2) | As part of DEA, building engineer is required to check the design, loads, foundation stresses for the foundations based on in-situ material strength. | 6-weeks |

| Item No. | Observation | Recommended Action Plan | Recommended Timeline |
|---|---|---|---|
| 06 | Foundation stress exceeds above normal design limit. (Building-2) | Produce and actively manage floor loading plan in compliance with BNBC. | 6-weeks |
| 07 | Foundation stress exceeds above normal design limit. (Building-2) | Carry out remedial works where required. | 6-months |
| 08 | Foundation stress exceeds above normal design limit. (Building-2) | Implement final loading plan. | 6-months |

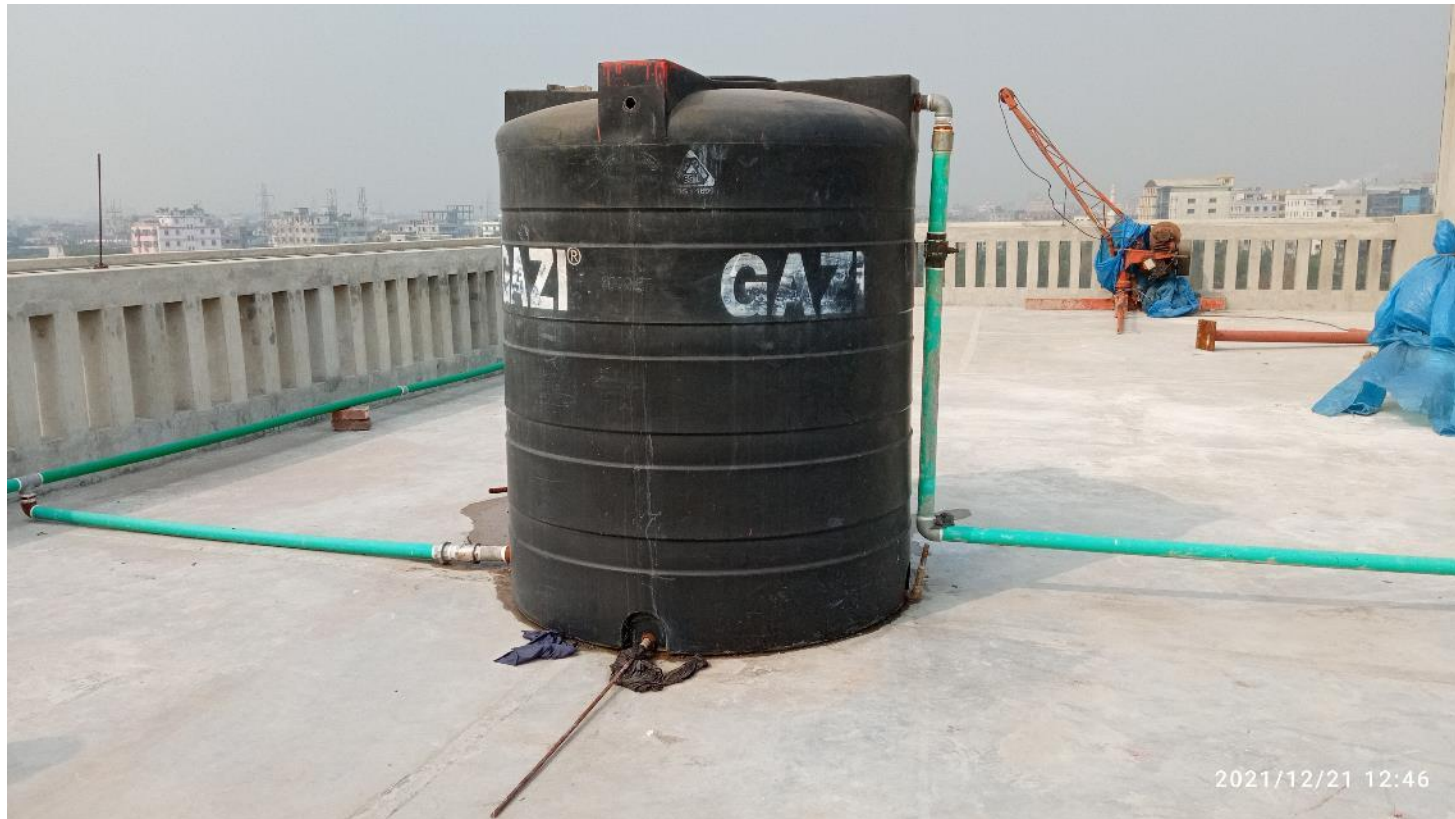
# **Undocumented water tank on roof**

Undocumented water tank was observed on the roof. The building engineer is required to incorporate it in as-built drawings.

| Item No. | Observation | Recommended Action Plan | Recommended Timeline |
|---|---|---|---|
| 09 | Undocumented water tank on roof. (Building-2) | Building engineer is required to survey the structure incorporate water tank location in as-built drawings. | 6-months |

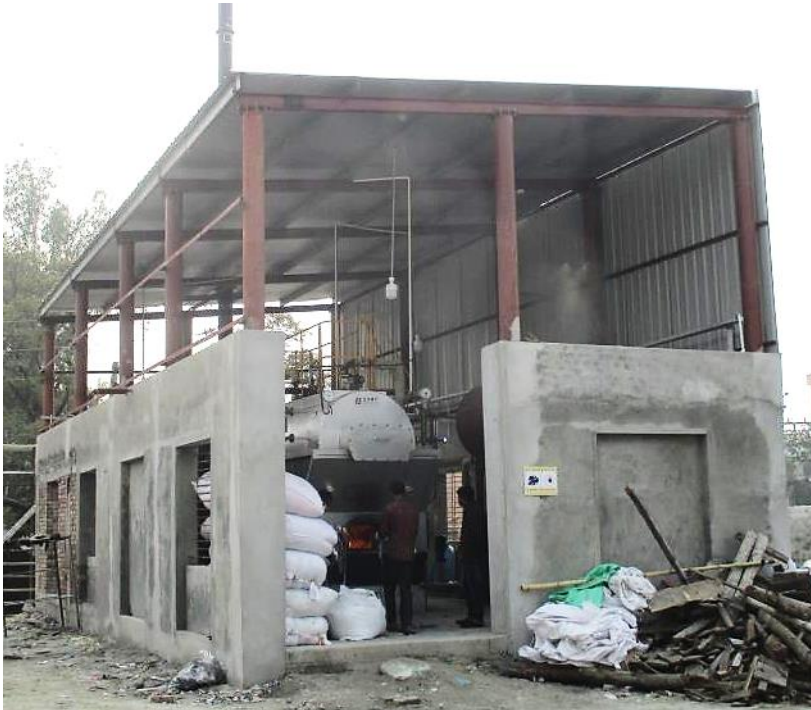
Steel framing without bracings

Lack of lateral stability system observed at the roof of the shed. Building engineer is required to check the lateral stability of the structure and suggest proper remedial actions accordingly.

| Item No. | Observation | Recommended Action Plan | Recommended Timeline |
|---|---|---|---|
| 10 | Lack of lateral stability system. (Building-3) | Building engineer is required to check the lateral stability of the structure and suggest proper remedial actions accordingly. | 6-weeks |
| 11 | Lack of lateral stability system. (Building-3) | Carry out remedial works suggested by the engineer. | 6-months |

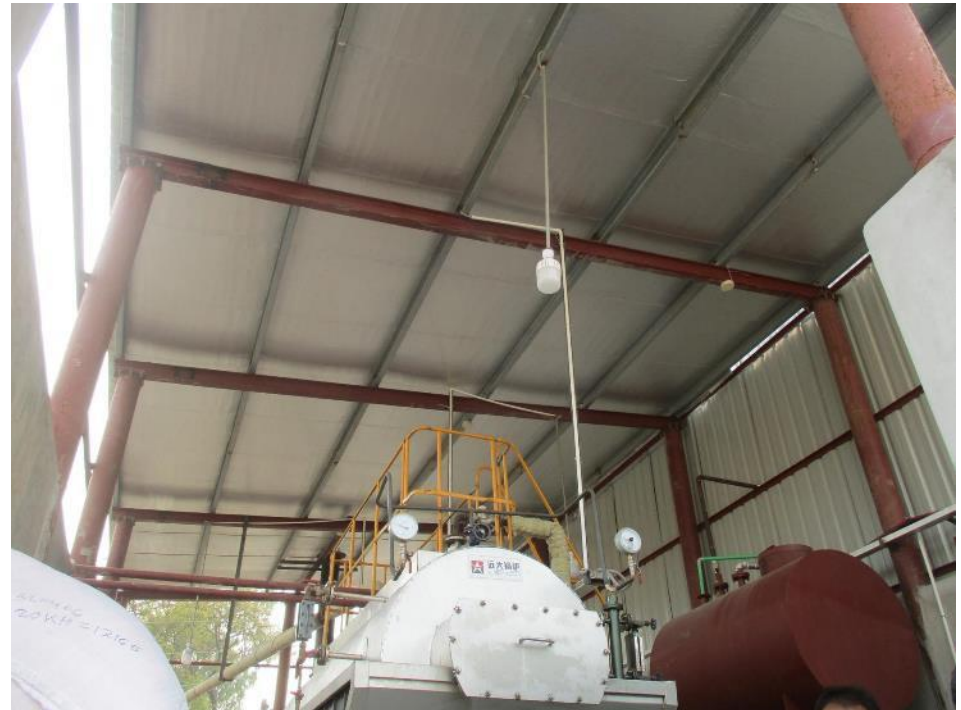
No obvious lateral load transfer media
