# Tusuka Processing Ltd. (Unit-02)

420/1, Konabari, Neelnagar, Gazipur  
(24.012817, 90.325573)

21<sup>st</sup> November 2021

# Executive Summary

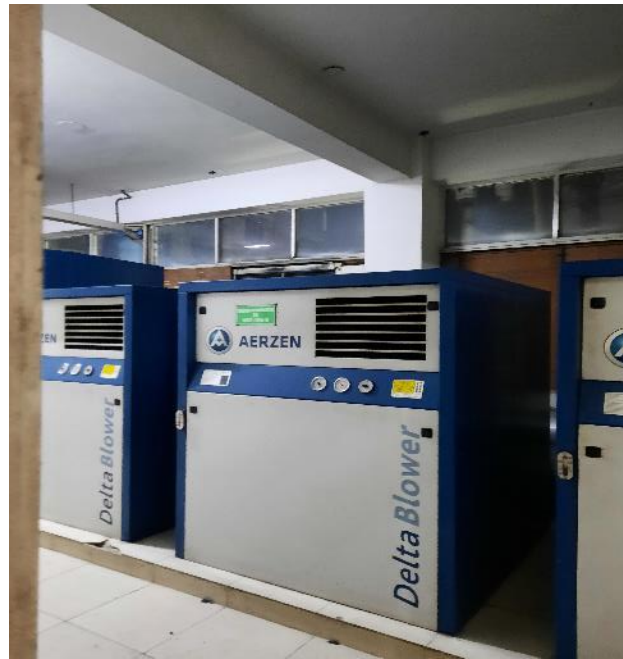
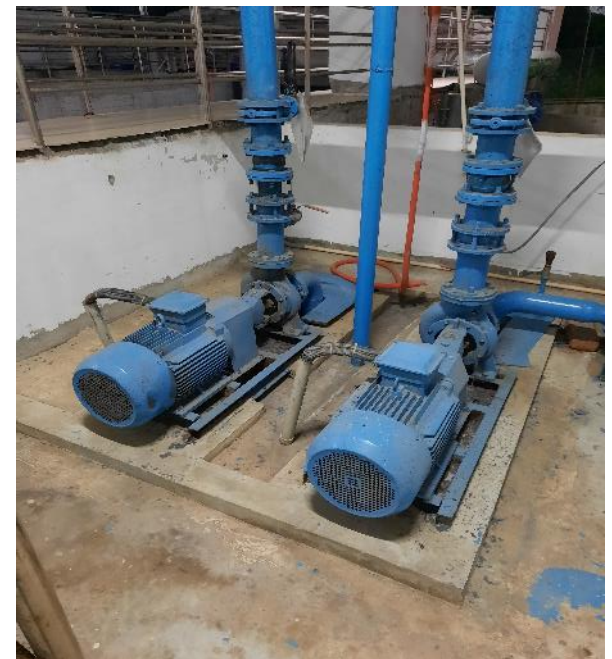
Source of vibration

Significant vibration was felt on the ground floor due to operation of machineries. Building engineer is required to investigate the long-term effect of the vibration and suggest proper remediation.

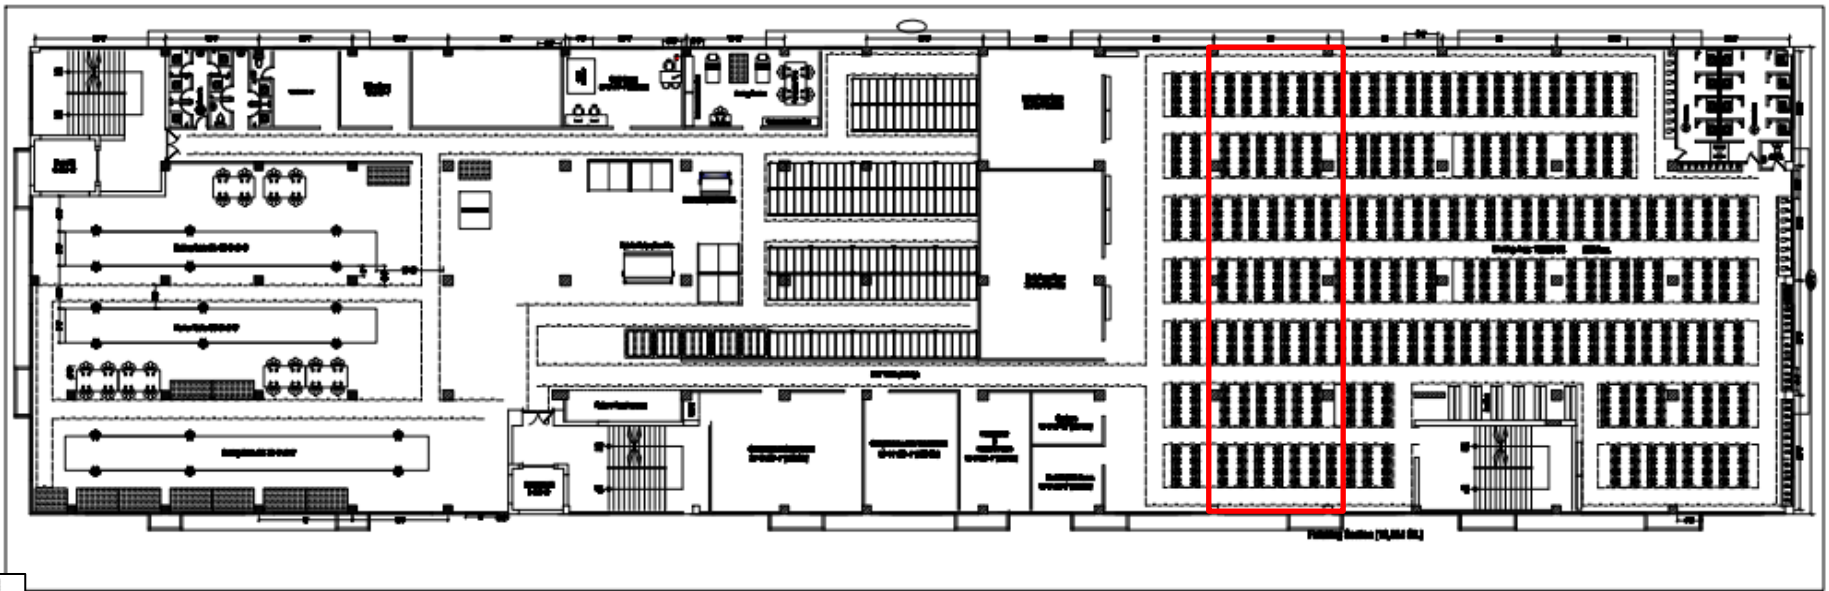
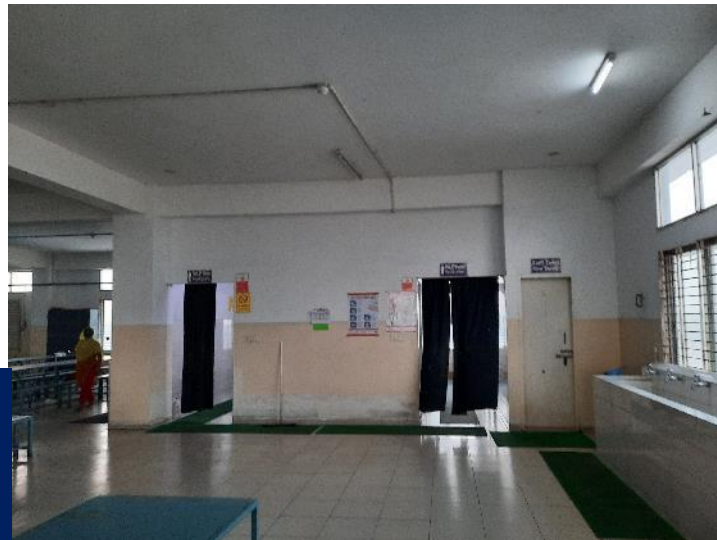
Floor layout plan (4<sup>th</sup> floor)

There are some changes in the floor layout plan. The marked bay is not using for the dining purpose.

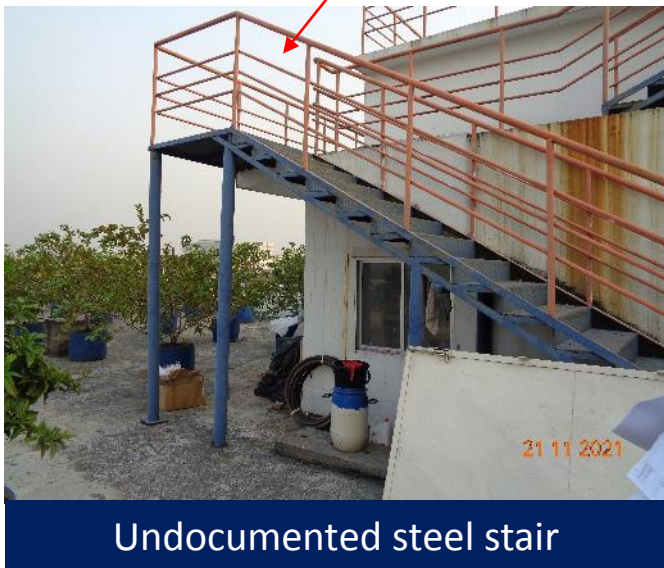
Undocumented steel stair

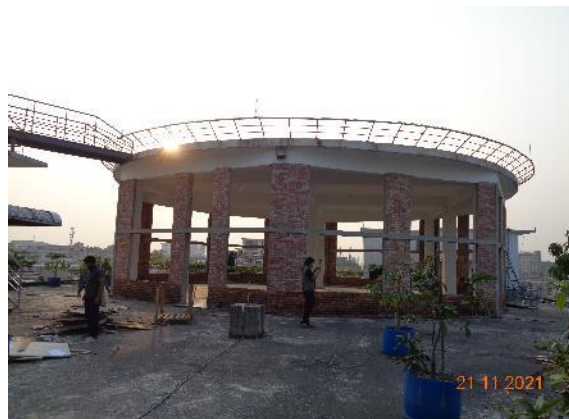
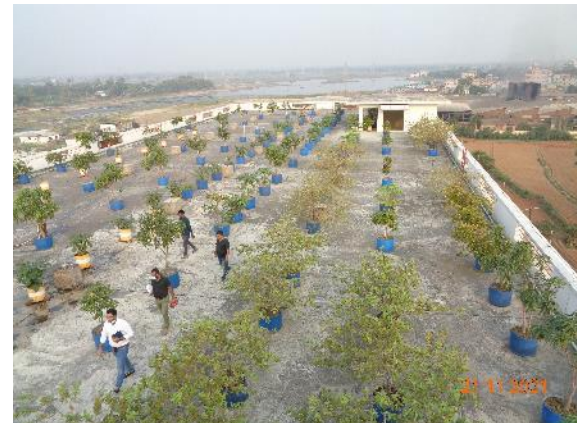
Roof and helipad load plan not produced. Gardening also not include in the roof layout plan.

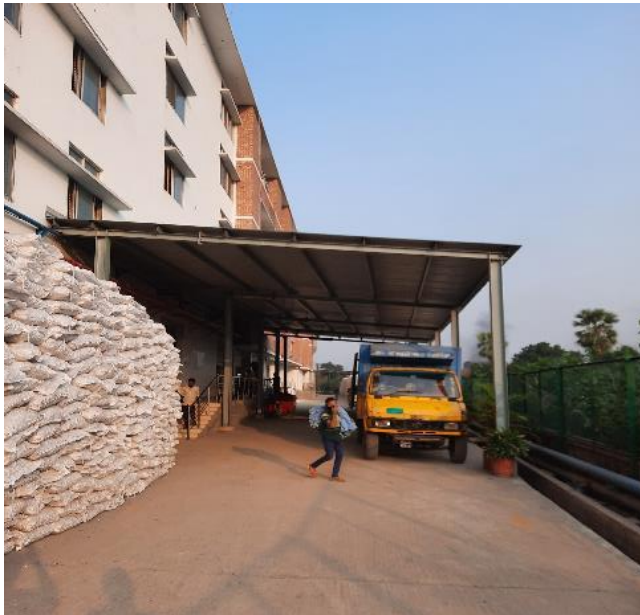
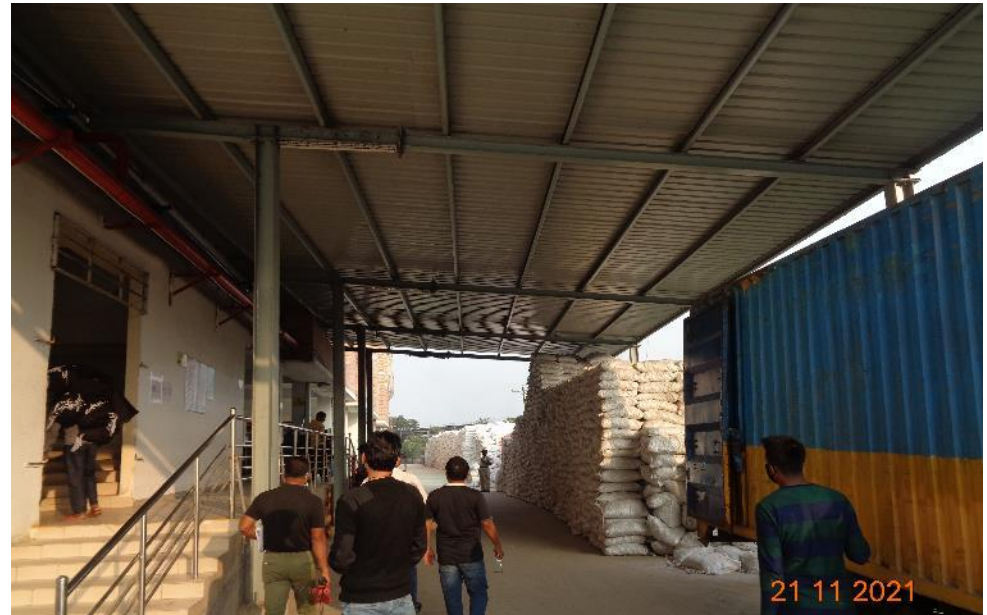
Undocumented loading unloading porch

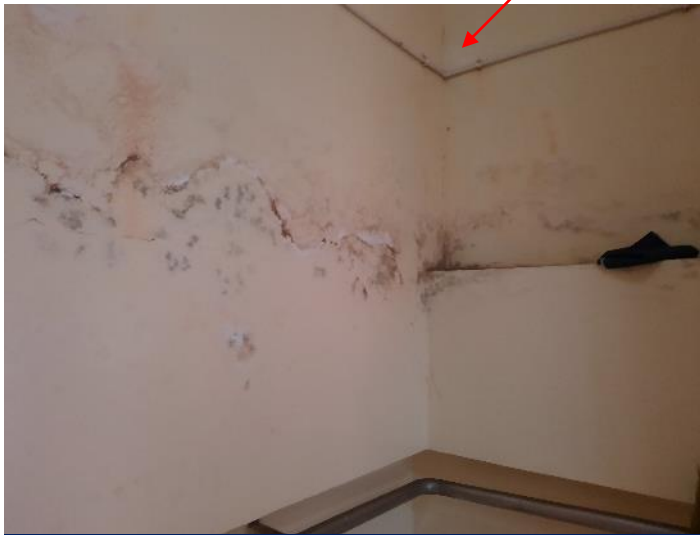
Dampness on 4<sup>th</sup> floor staircase

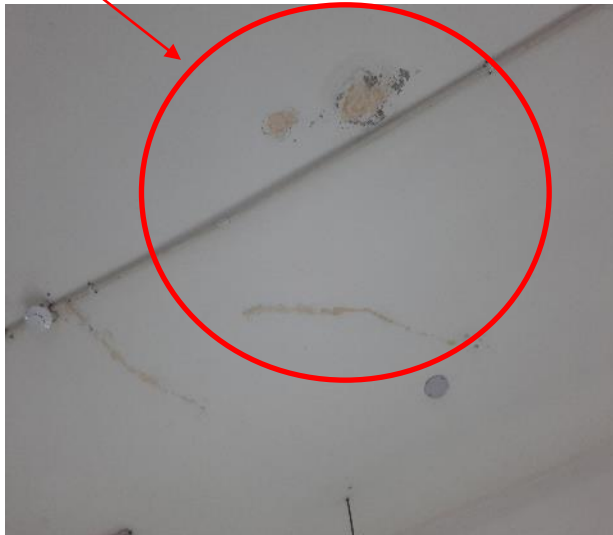
Dampness on 1<sup>st</sup> floor roof

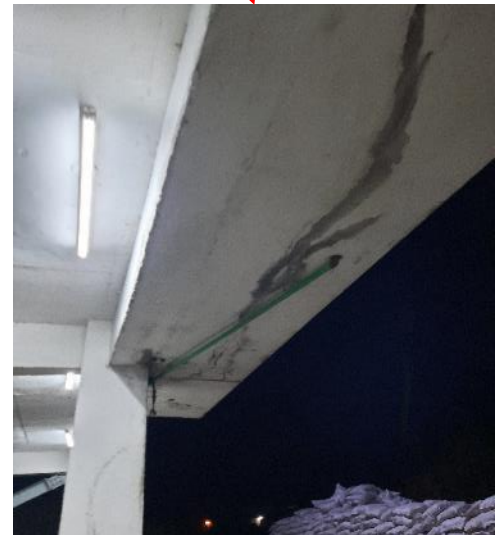
Dampness on ground floor

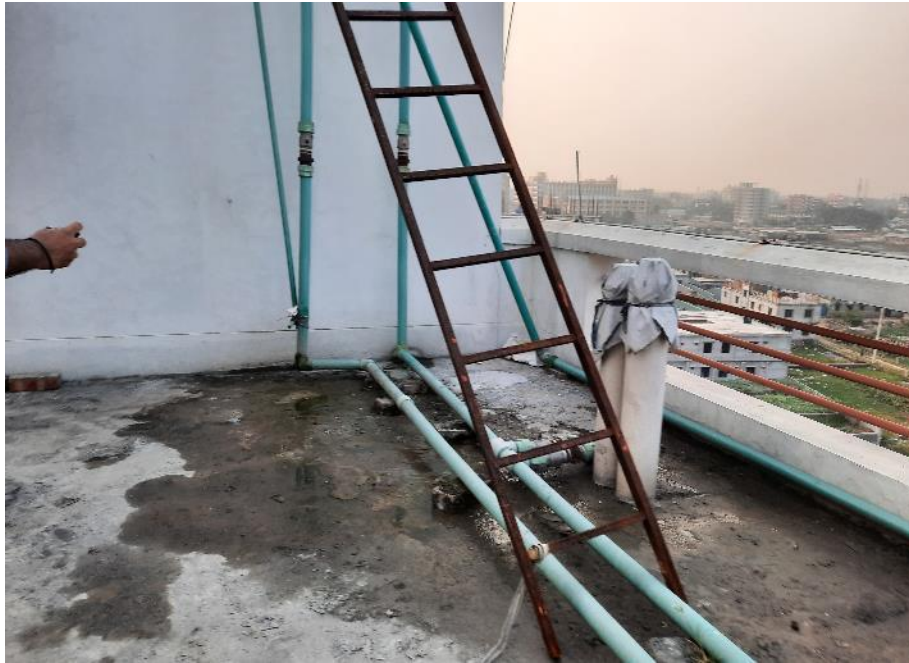
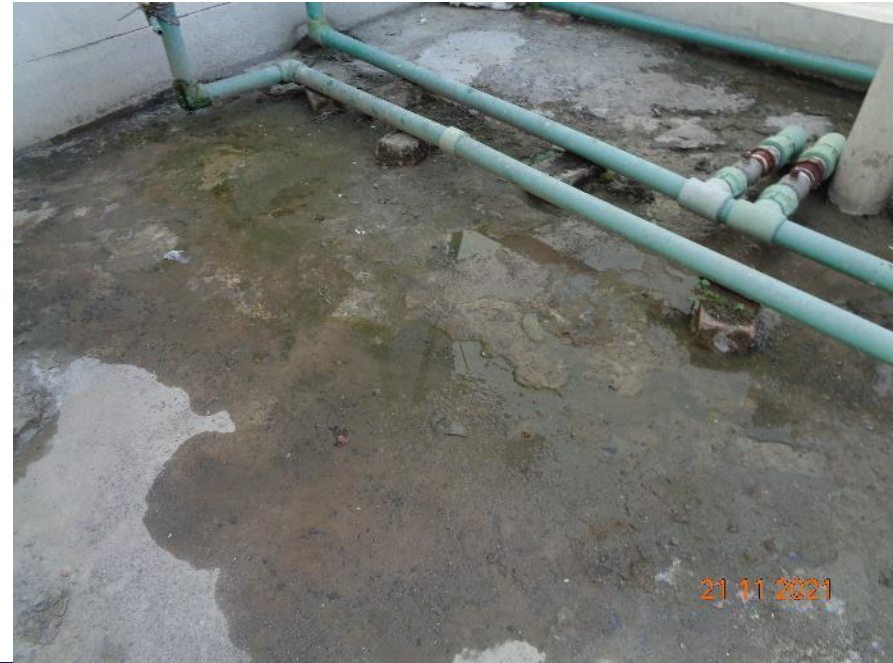
Stagnant of water observed on roof. Building engineer is required to improve the roof drainage system.

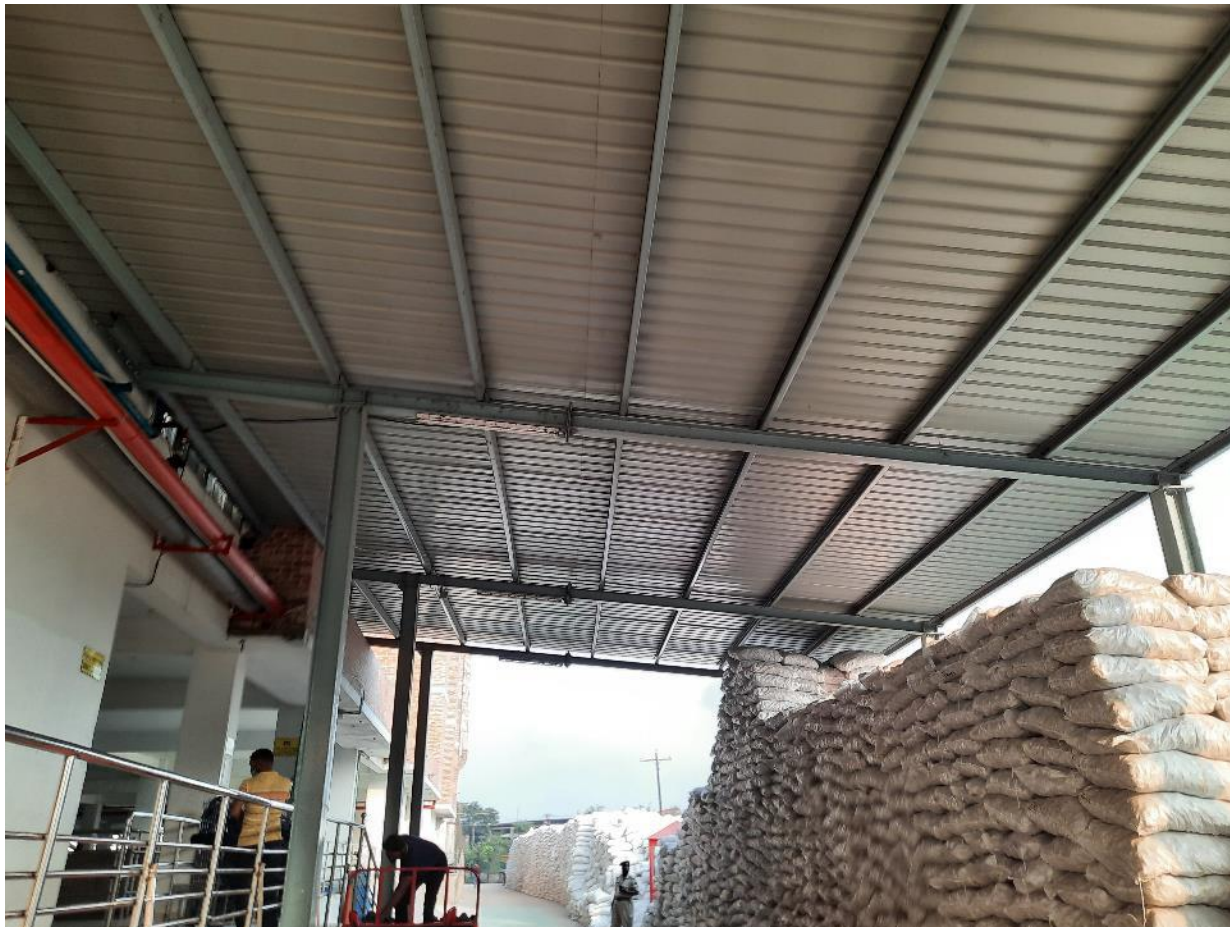
Absence of load transfer media observed in the long direction. Building engineer is required to check the lateral stability of the porch.

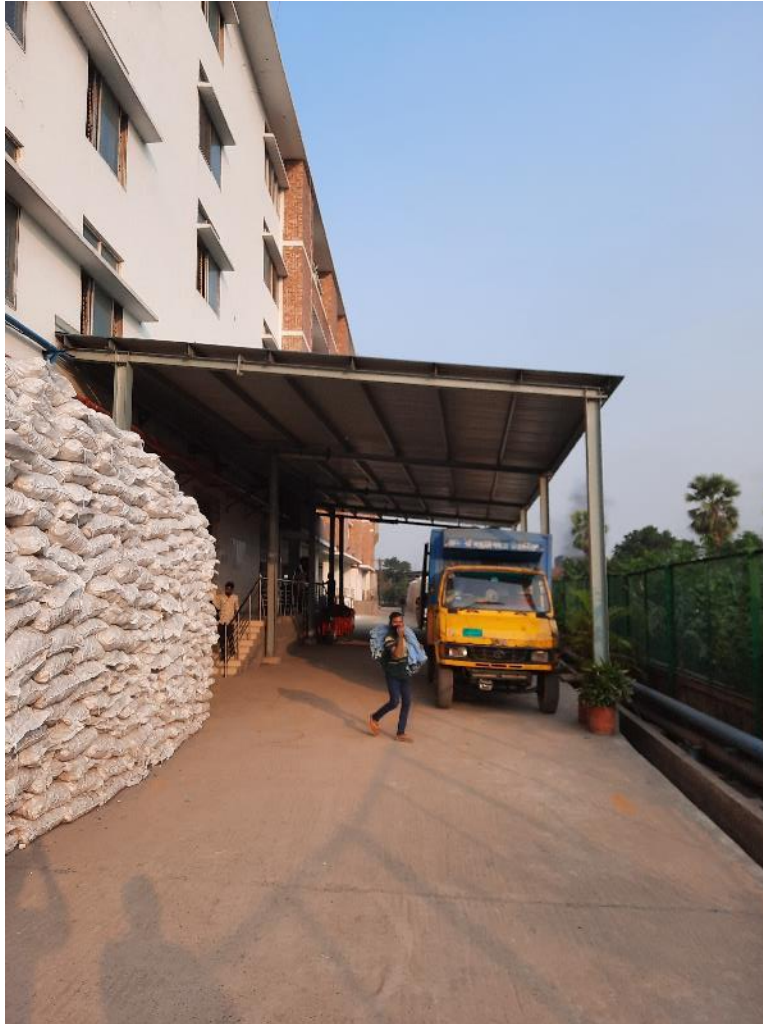
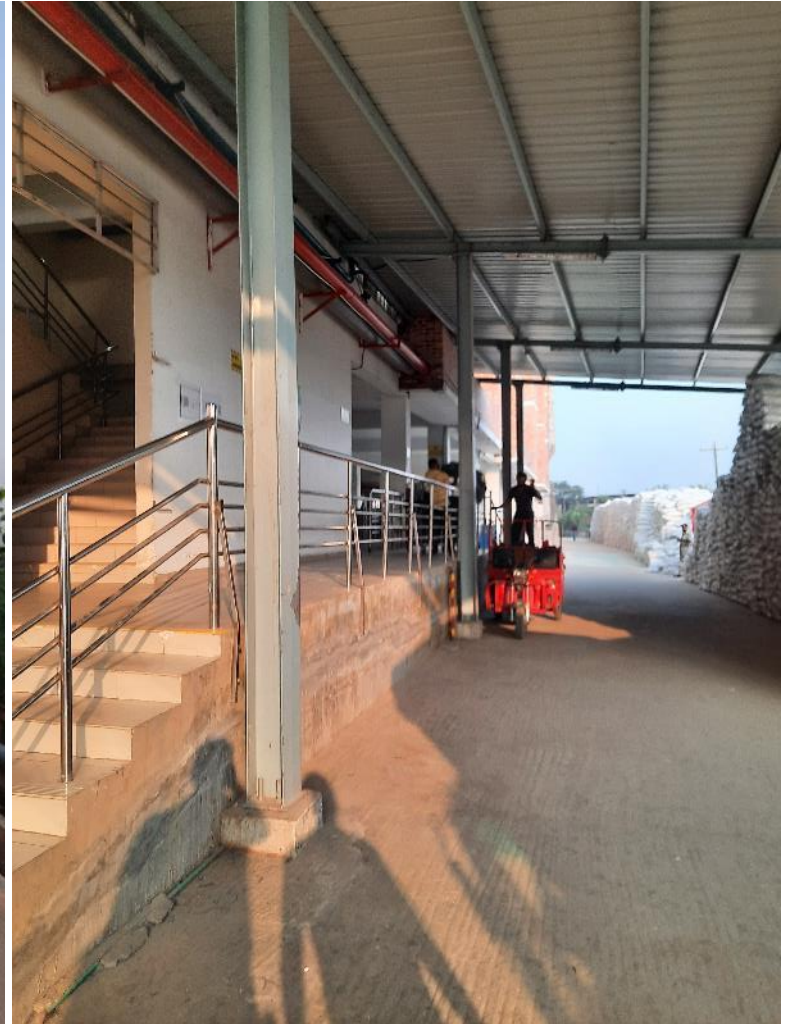
Columns are susceptible to have vehicle impact loading. Building engineer is required to provide vehicle impact protection around the column.

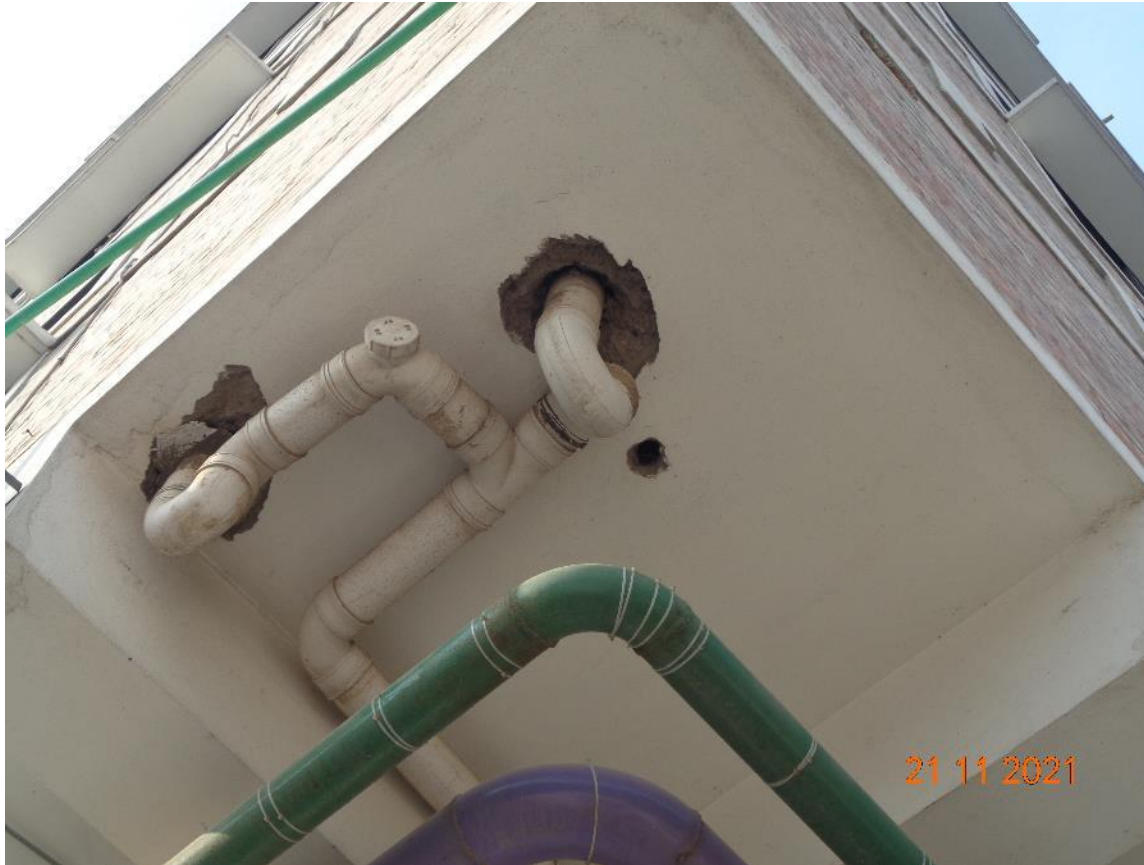
Service hole through the slab and loose concrete around the hole observed. Building engineer is required to remove the loose concrete to avoid falling hazard and check slab rebar are not compromised due to the hole.

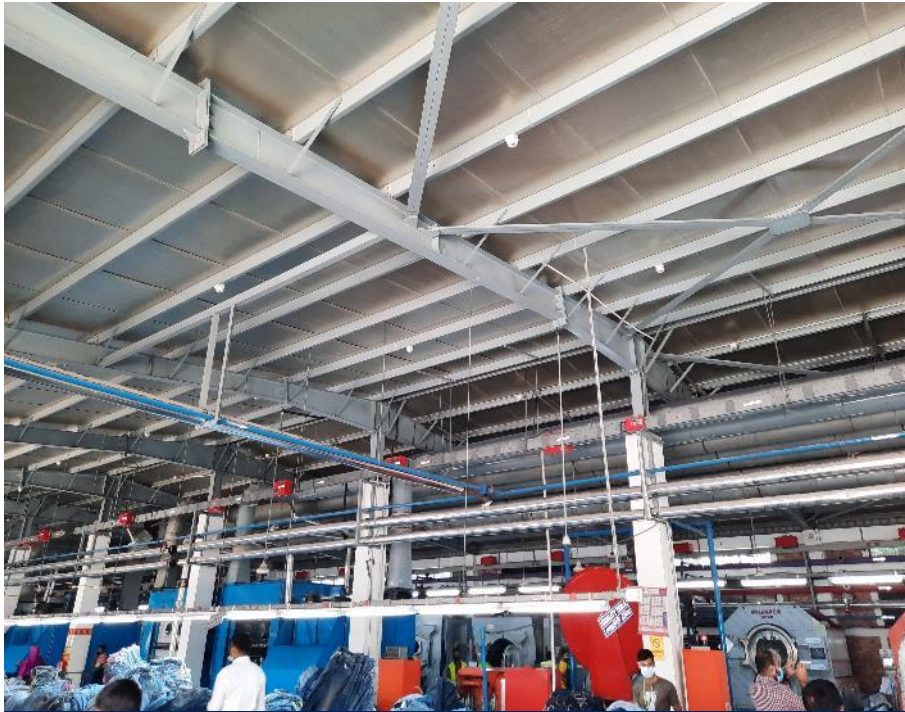
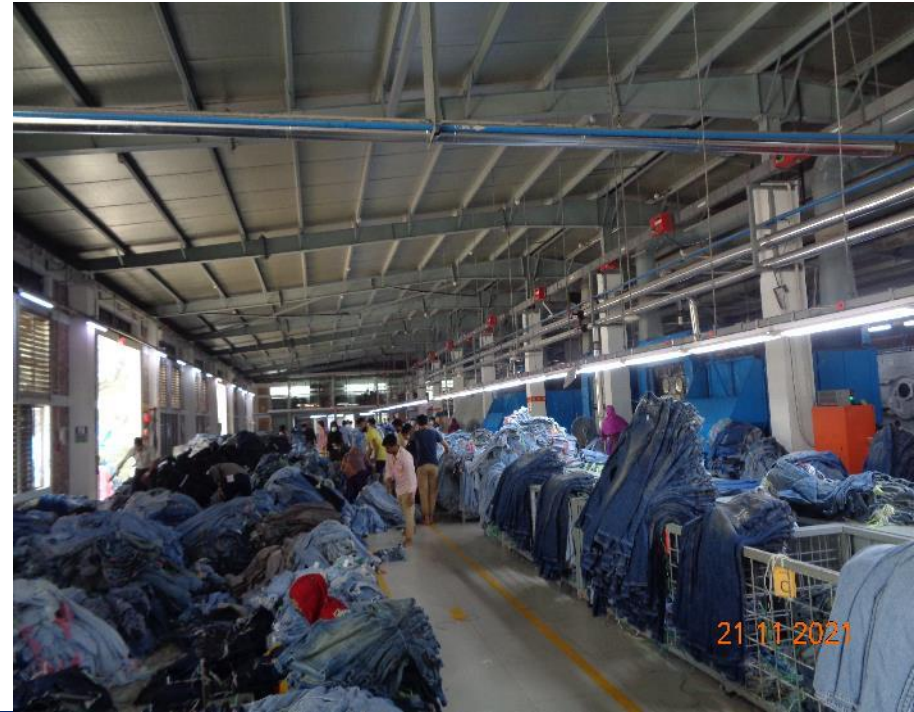
Compression strut/tie beams are not provided in the ridge position along long direction. Building engineer is required to check the lateral stability of the shed.

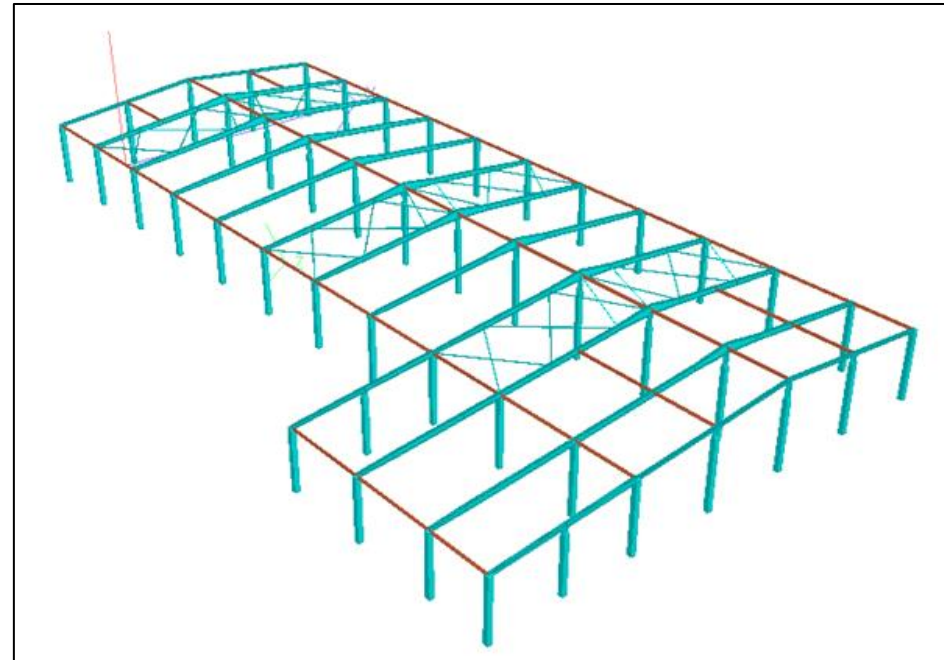
In design report, adequacy check for RC member not addressed, serviceability checks not addressed as per BNBC, detail calculation of assigned loads & connection not addressed. Building engineer is required to prepare the design report addressing all highlighted issue and compliance with BNBC 1.9.1

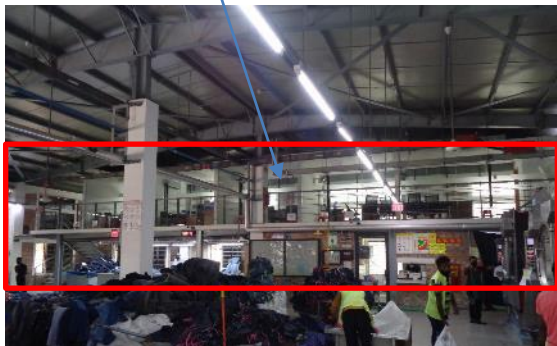
South Mezzanine

Structurally connected Mezzanine floor at north and south not shown in the as-built architectural and structural drawing.

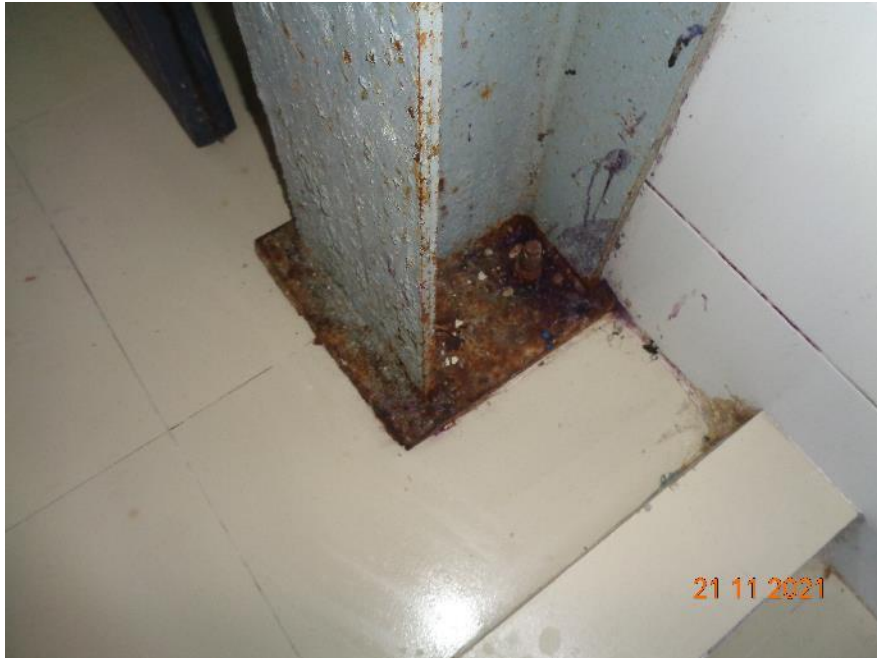
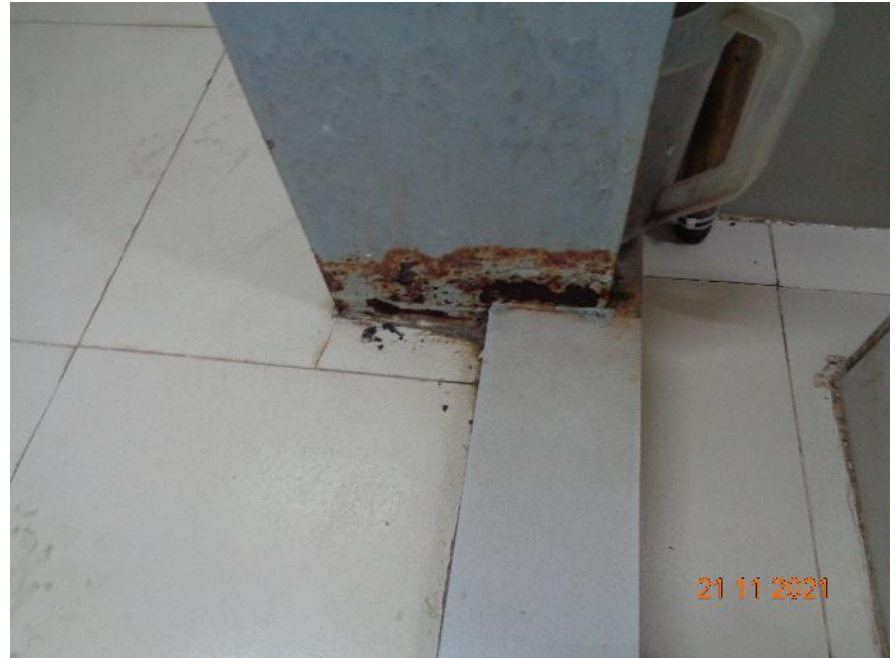
Corrosion observed on the steel member. The factory is required remove the rust and provide corrosion proofing coating on the steel member.

Item No.	Observation	Recommended Action Plan	Recommended Timeline
17	Inconsistency in the as-built drawing. (Building 3)	Building engineer is required to survey the structure and prepare accurate as-built drawings.	6-weeks
18	Corrosion on steel member. (Building 3)	The factory is required remove the rust and provide corrosion proofing coating on the steel member.	6-weeks
