# Knitex Dresses Ltd.

Sultan Market, Sharodagonj, Kashimpur, Gazipur

05 December 2021

# Observations

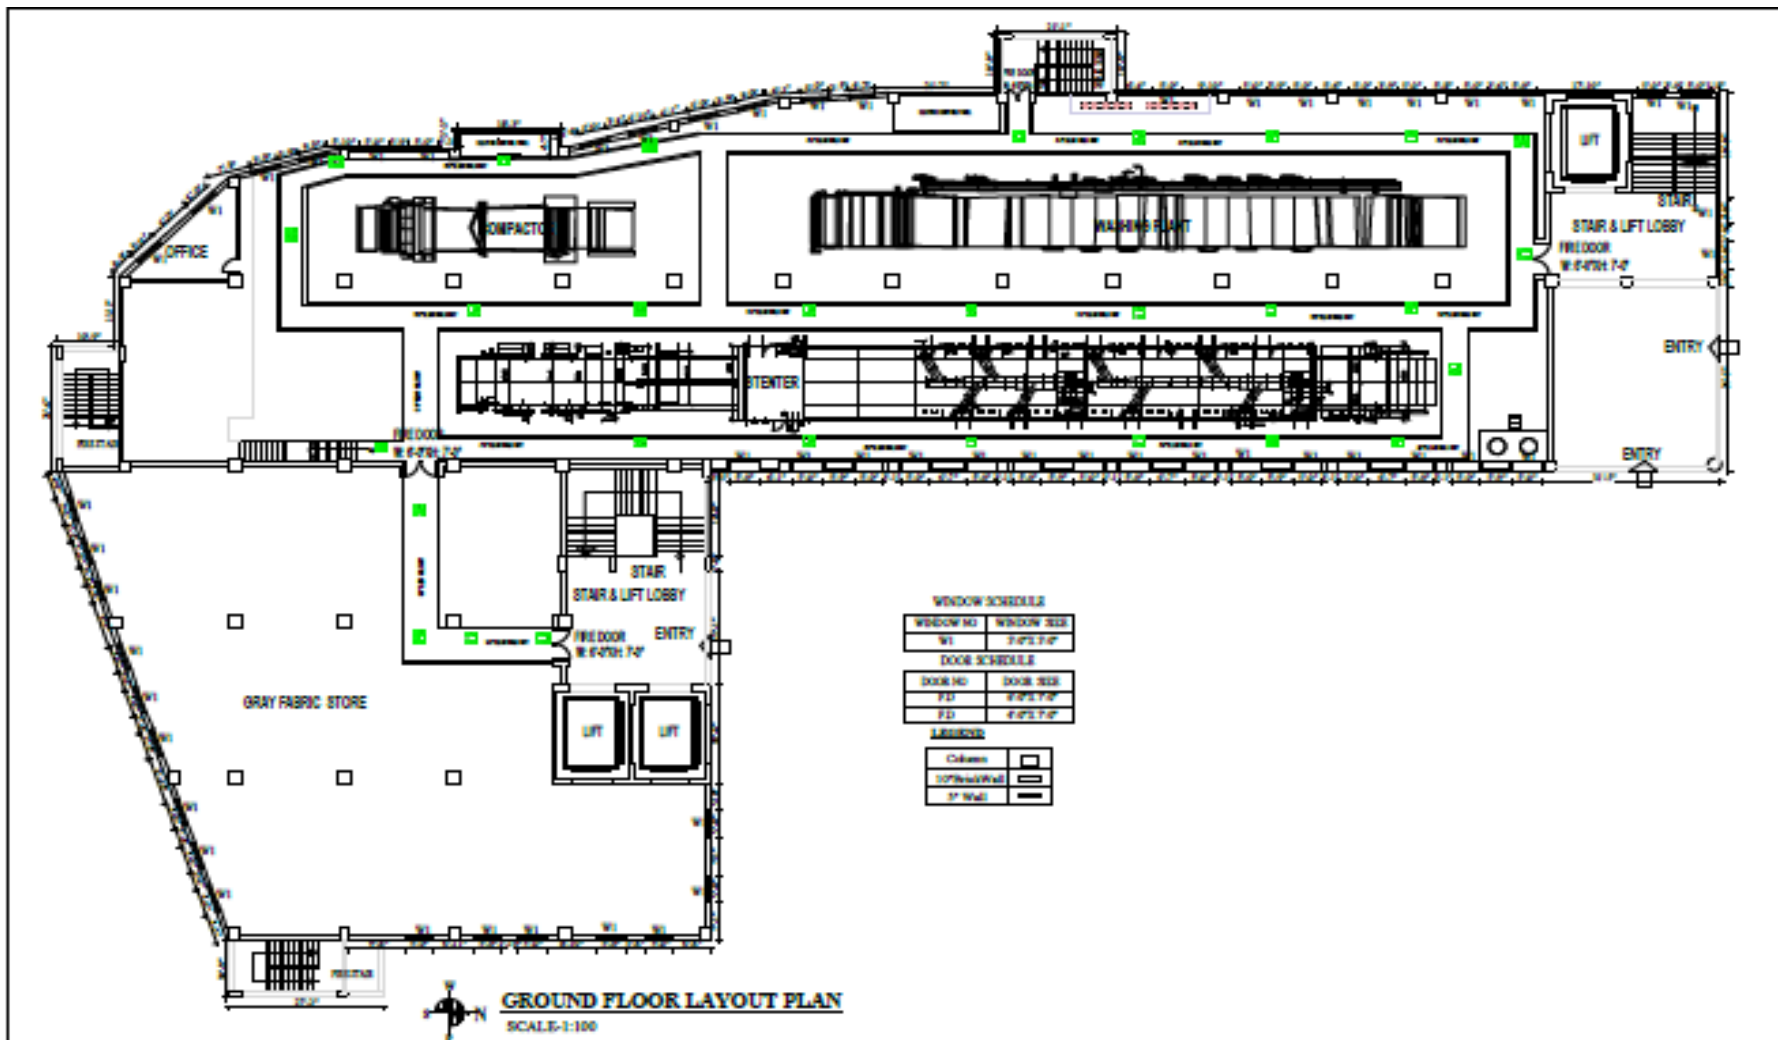
**Irregularities check not included in the DEA report**

The building is irregular in shape. Irregularity of re-entrant corner & torsional irregularities have not been checked in the provided DEA report. Building engineer is required to check all type of irregularities & incorporate it in the software-based FEA model & DEA report.

Item 01: Irregularities check not included in the DEA report.

| Item No. | Observation | Recommended Action Plan | Recommended Timeline |
|---|---|---|---|
| 01 | Irregularities check not included in the DEA report. (Building-1) | Building engineer is required to check all type of irregularities & incorporate in the software-based FEA model & DEA report. | 6-weeks |
| 02 | Irregularities check not included in the DEA report. (Building-1) | Implement remedial works where required. | 6-weeks |

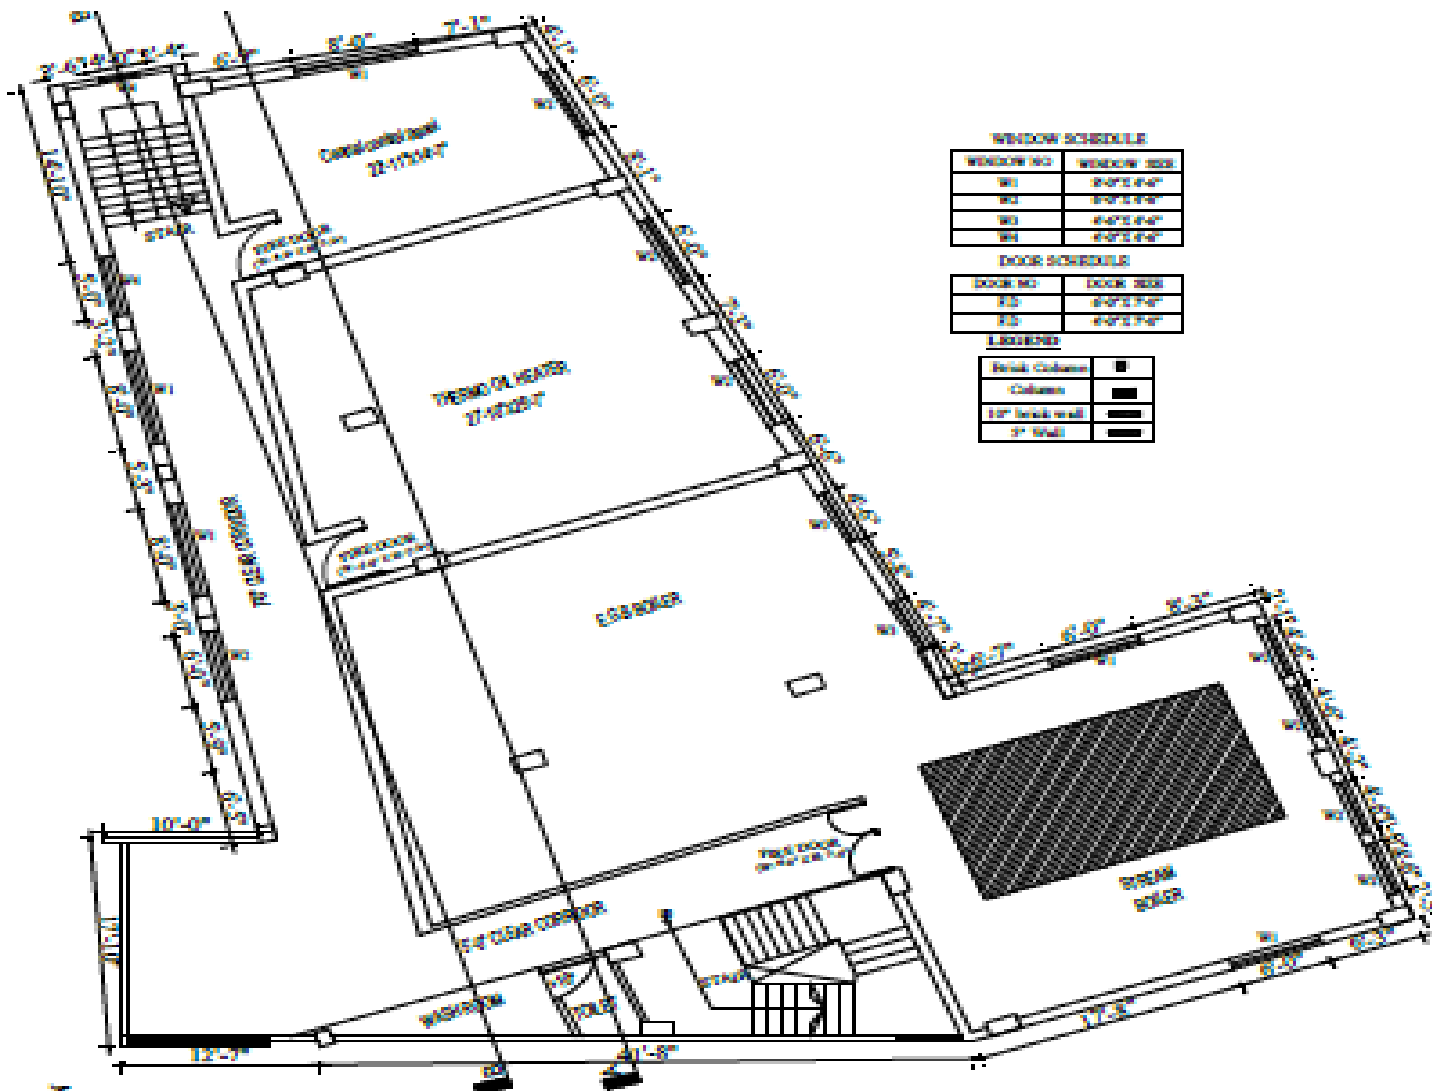
**Torsional irregularity check not included in  
the DEA report**

As per building plan, it has an irregular shape which induced torsion into the structure. Building engineer is required to check all type of irregularities & incorporate it in the software-based FEA model & DEA report.

Item 02: Torsional irregularity check not included in the DEA report.

| Item No. | Observation | Recommended Action Plan | Recommended Timeline |
|---|---|---|---|
| 03 | Torsional irregularity check not included in the DEA report. (Building-2) | Building engineer is required to check all type of irregularities & incorporate in the software-based FEA model & DEA report. | 6-months |
| 04 | Torsional irregularity check not included in the DEA report. (Building-2) | Implement remedial works where required. | 6-months |

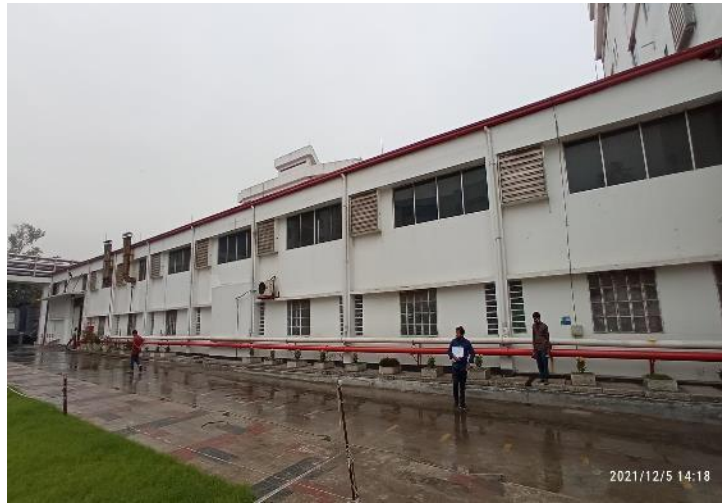
No column schedule was available for building-3 main part

Column schedule of main part was not available in drawings, mismatch was observed in column size of mezzanine floor & rafter size of main part. The building engineer is required to survey the structure and produce accurate as-built drawings.

| Item No. | Observation | Recommended Action Plan | Recommended Timeline |
|---|---|---|---|
| 07 | Discrepancies between drawings & as-built condition. (Building-3) | The building engineer is required to survey the structure and produce accurate as-built drawings. | 6-weeks |

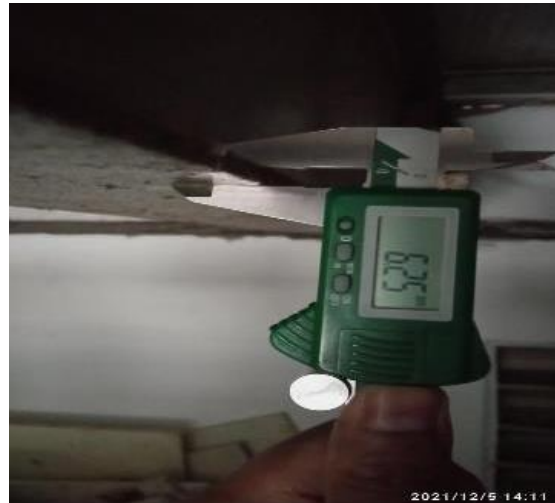
Flange thickness found 6 mm instead of 8 mm

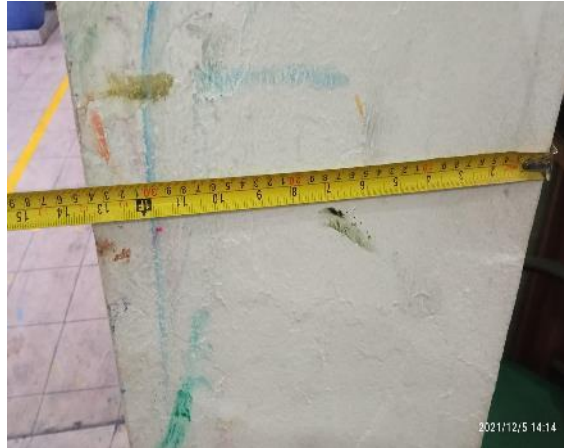
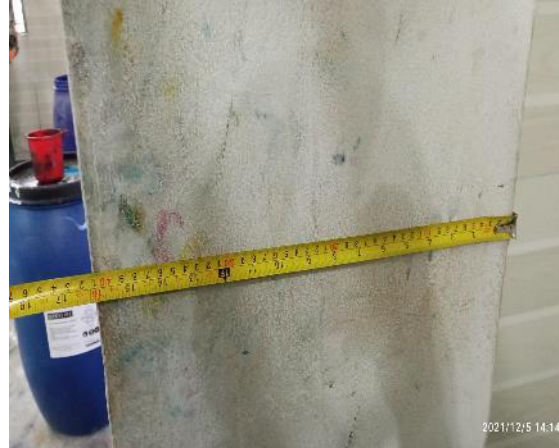
Mismatch in column size of mezzanine floor, Column size found (340 x 400) mm instead of (350 x 350) mm

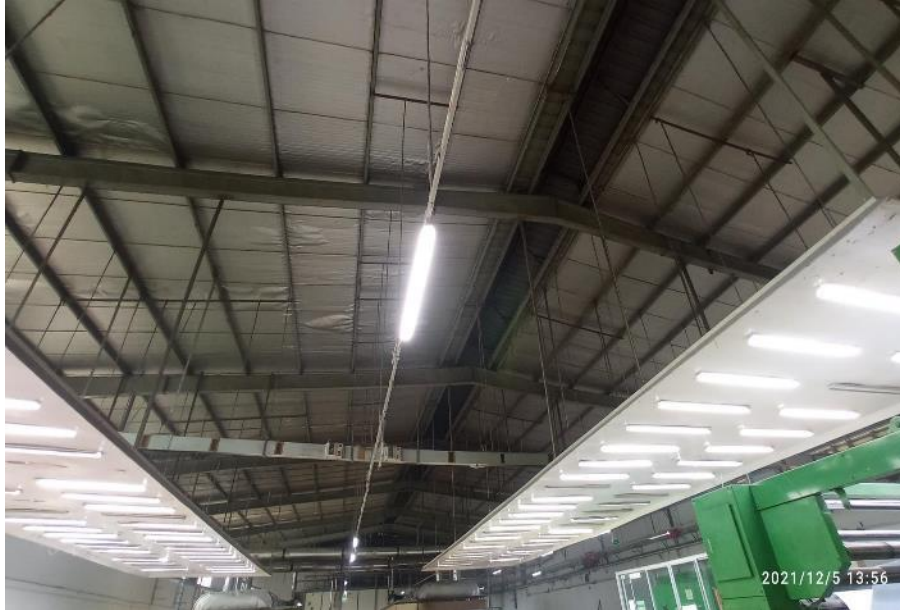
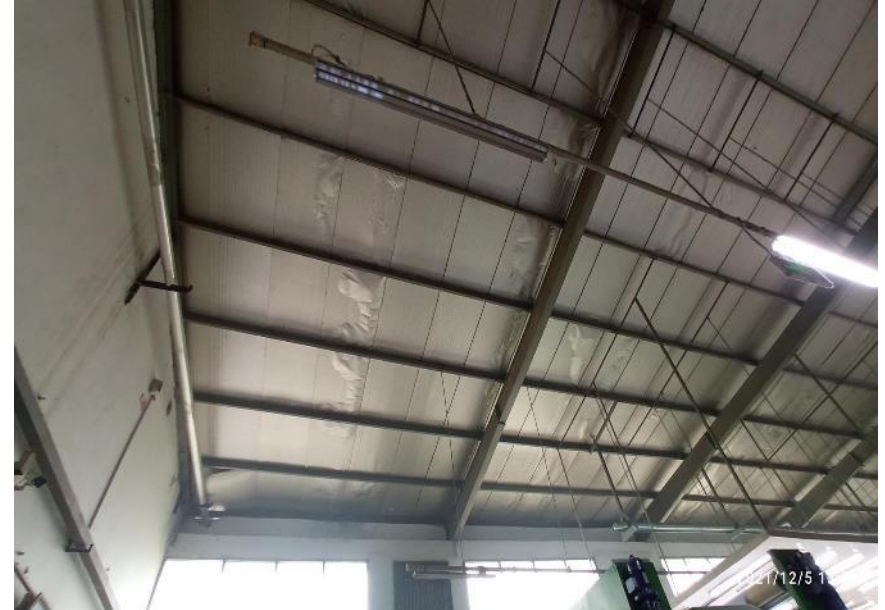
## **Lack of lateral stability system**

Absence of roof bracing & lateral load transfer media along ridge

Lack of lateral stability system observed at the roof of the shed. Building engineer is required to check the lateral stability of the structure and suggest proper remedial actions accordingly.

| Item No. | Observation | Recommended Action Plan | Recommended Timeline |
|---|---|---|---|
| 08 | Lack of lateral stability system. (Building-3) | Building engineer is required to check the lateral stability of the structure and suggest proper remedial actions accordingly | 6-weeks |
| 09 | Lack of lateral stability system. (Building-3) | Carry out remedial works suggested by the engineer. | 6-months |

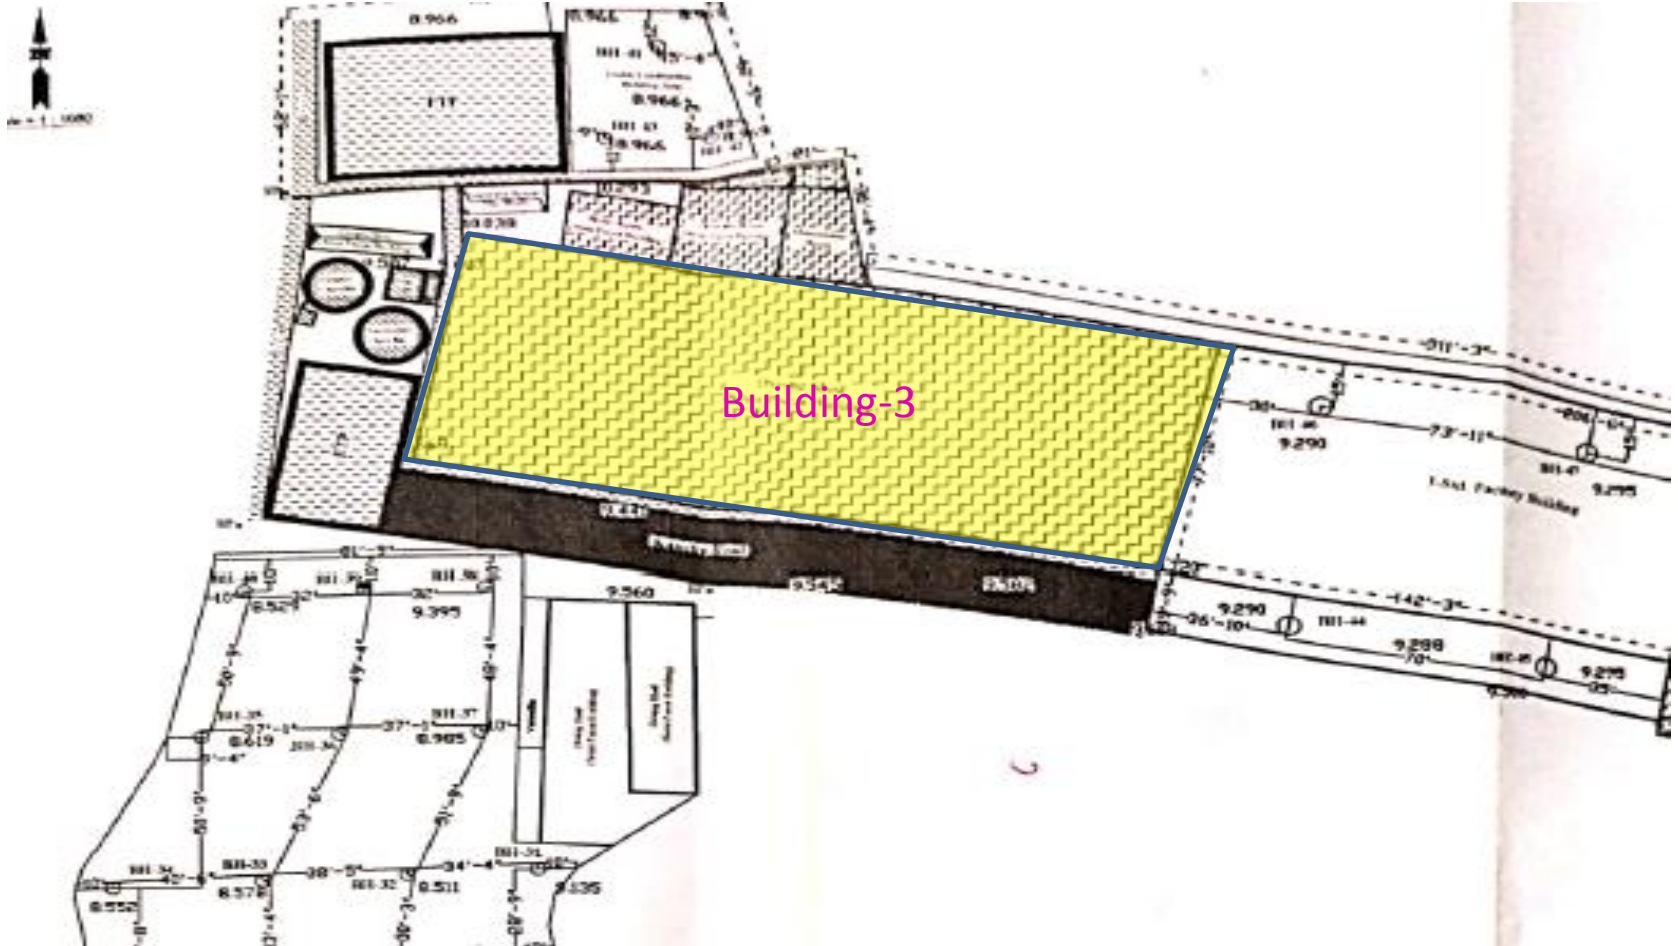
**Bore hole did not covered the building plan**

Locations of bore hole in the building area are missing in the soil test report.

Conduct geotechnical investigation to close vicinity of the structure, determine actual soil bearing capacity and check the foundation adequacy accordingly.

| Item No. | Observation | Recommended Action Plan | Recommended Timeline |
|---|---|---|---|
| 10 | Bore hole did not covered the building plan. (Building-3) | Conduct geotechnical investigation to close vicinity of the structure, determine actual soil bearing capacity and check the foundation adequacy. | 6-months |

| Item No. | Observation | Recommended Action Plan | Recommended Timeline |
|---|---|---|---|
| 11 | Bore hole did not covered the building plan. (Building-3) | Implement remedial works if required. | 6-weeks |

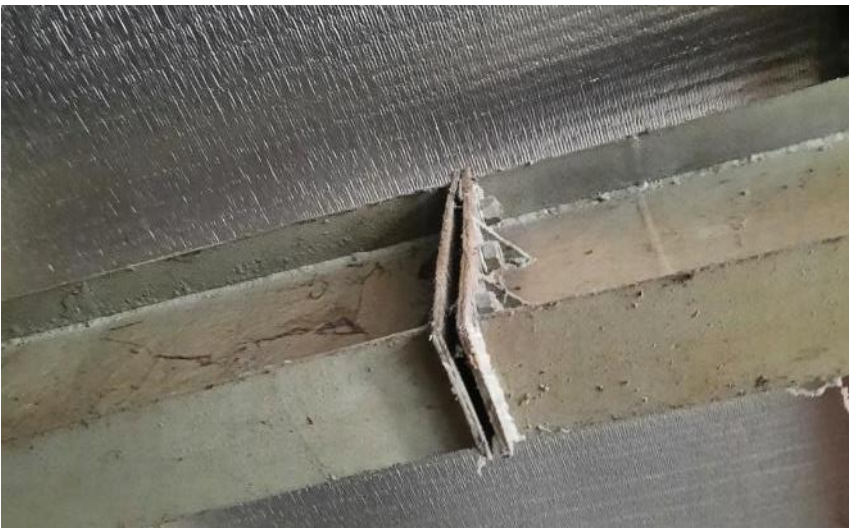
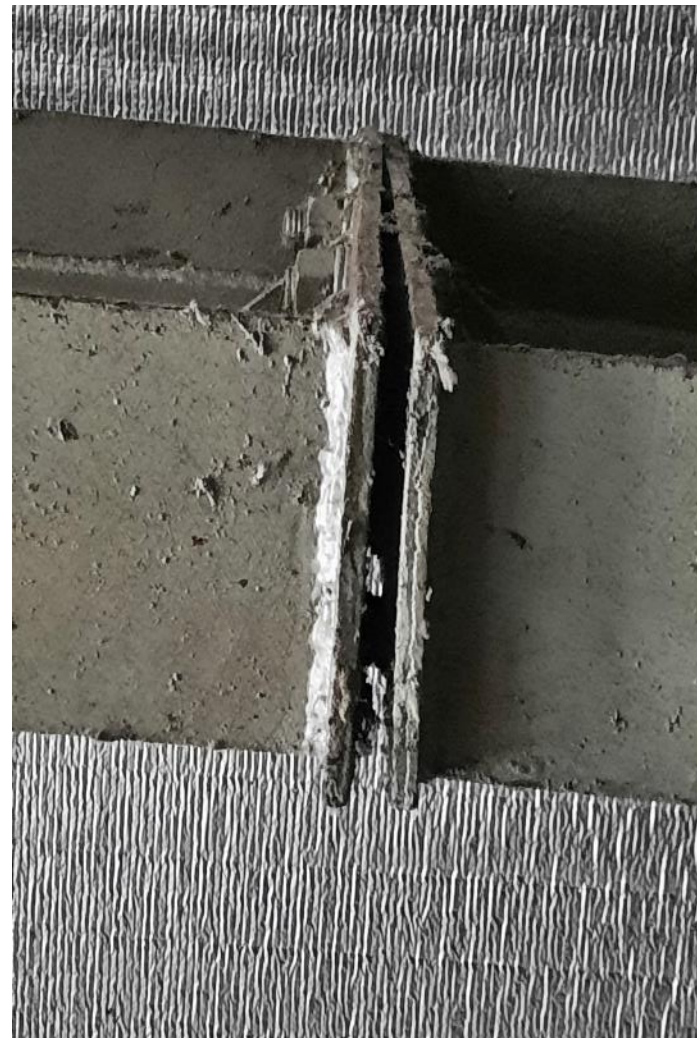
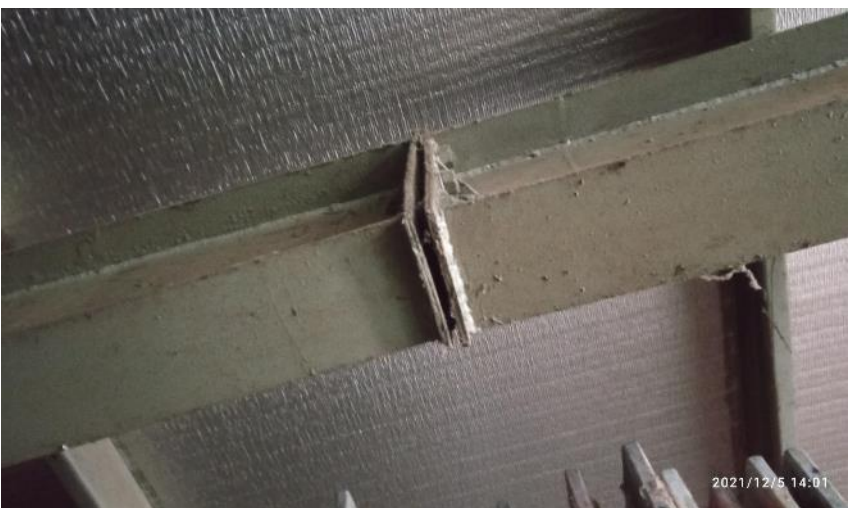
# Gap between connection plates

Connection gap at rafter joints

The building engineer is required to fill the connection gaps of all joints.

| Item No. | Observation | Recommended Action Plan | Recommended Timeline |
|---|---|---|---|
| 12 | Gap between connection plates. (Building-3) | The building engineer is required to fill the connection gaps for all joints. | 6-weeks |

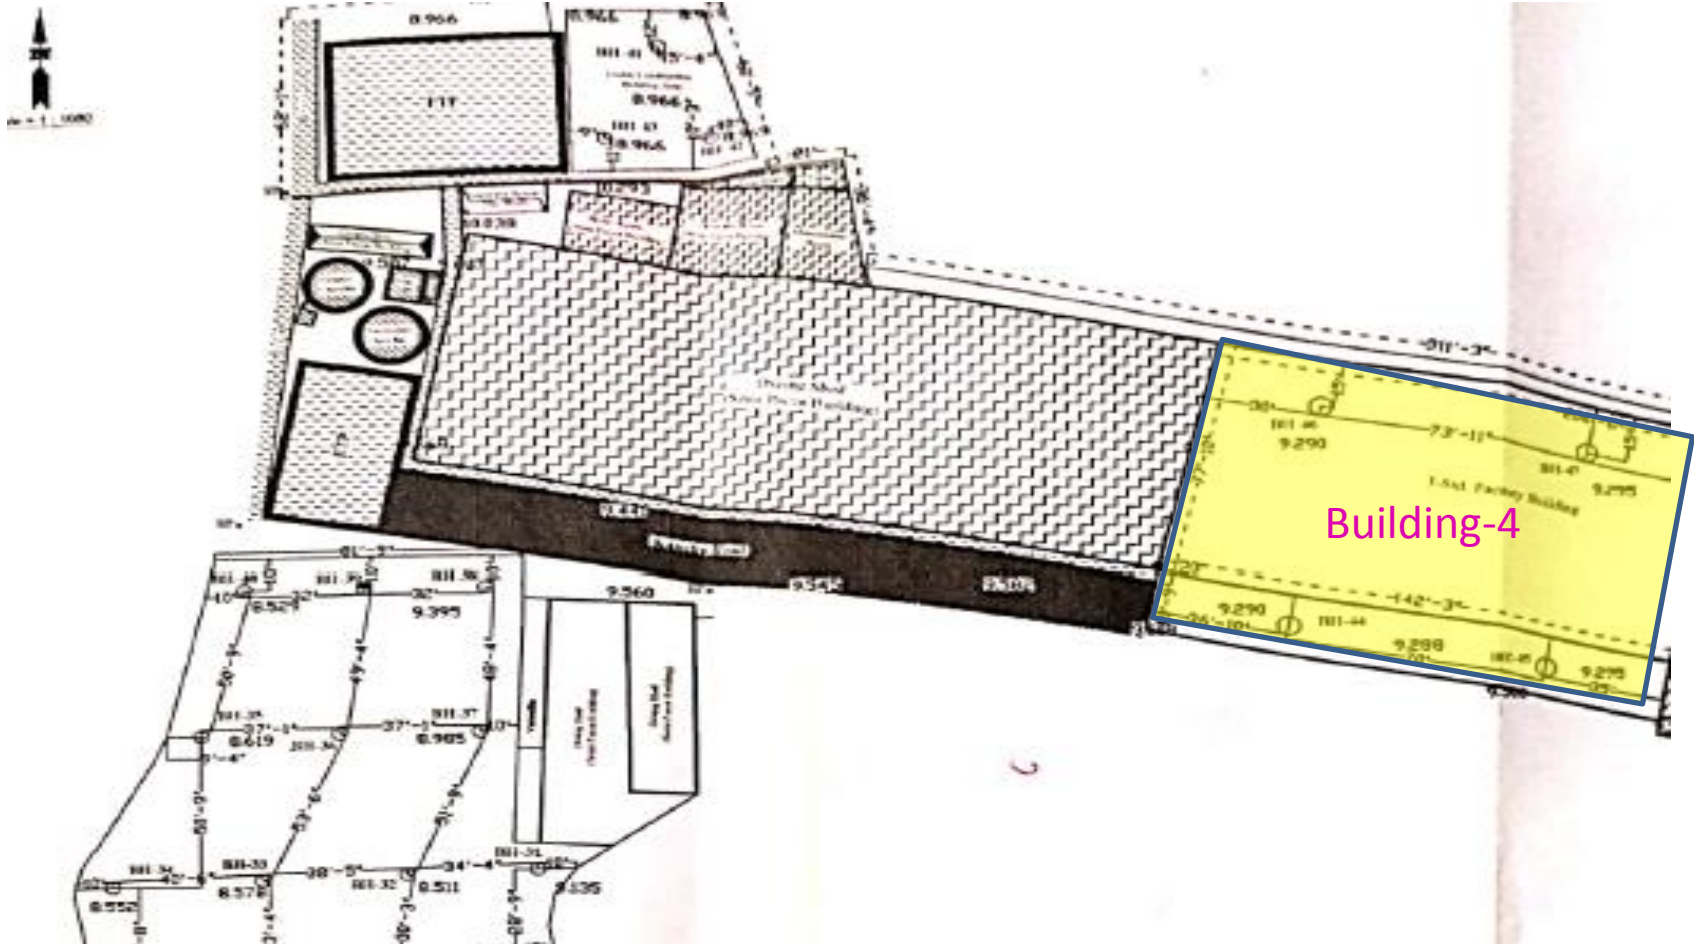
# **Bearing capacity consideration in foundation design**

Only 4 bore hole available near the building. In DEA report, bearing capacity of all 45-bore hole has been considered in foundation calculation. Bearing capacity must be considered as per bore hole close to the building plan.

| Item No. | Observation | Recommended Action Plan | Recommended Timeline |
|---|---|---|---|
| 13 | Bearing capacity consideration in foundation design. (Buuilding-4) | Building engineer is required to consider bearing capacity of soil according to the bore hole close to/cover the building plan. | 6-weeks |
| 14 | Bearing capacity consideration in foundation design. (Buuilding-4) | Implement the remedial actions if required. | 6-months |

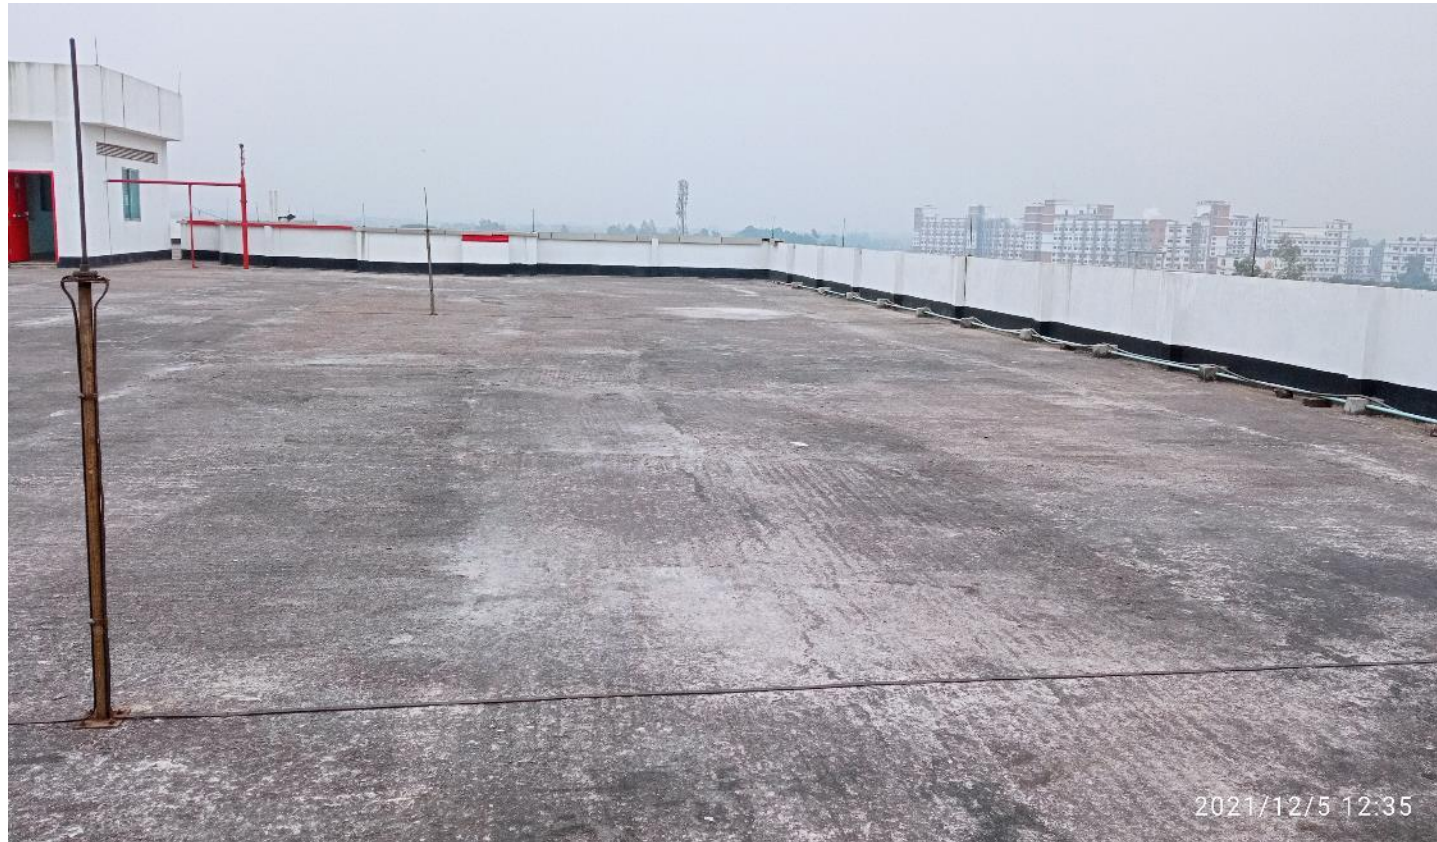
# **Water proofing at roof**

No Water proofing layer has been provided on roof

Develop proper drainage system on the roof with adequate slope and apply water proofing layer on the roof to resist water ingress into the slab.

| Item No. | Observation | Recommended Action Plan | Recommended Timeline |
|---|---|---|---|
| 15 | Water proofing at roof (Building-4) | Develop proper drainage system on the roof with adequate slope and apply water proofing layer on the roof to resist water ingress into the slab. | 6-months |

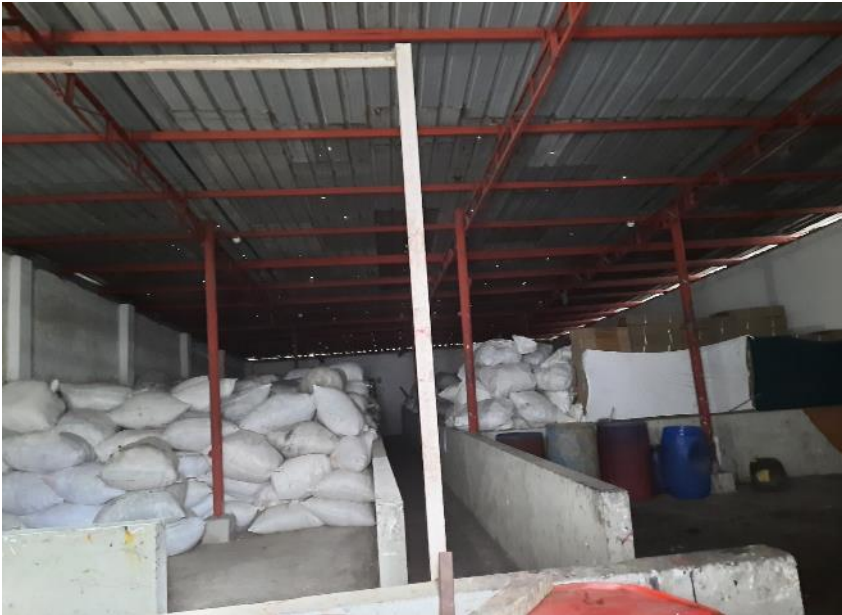
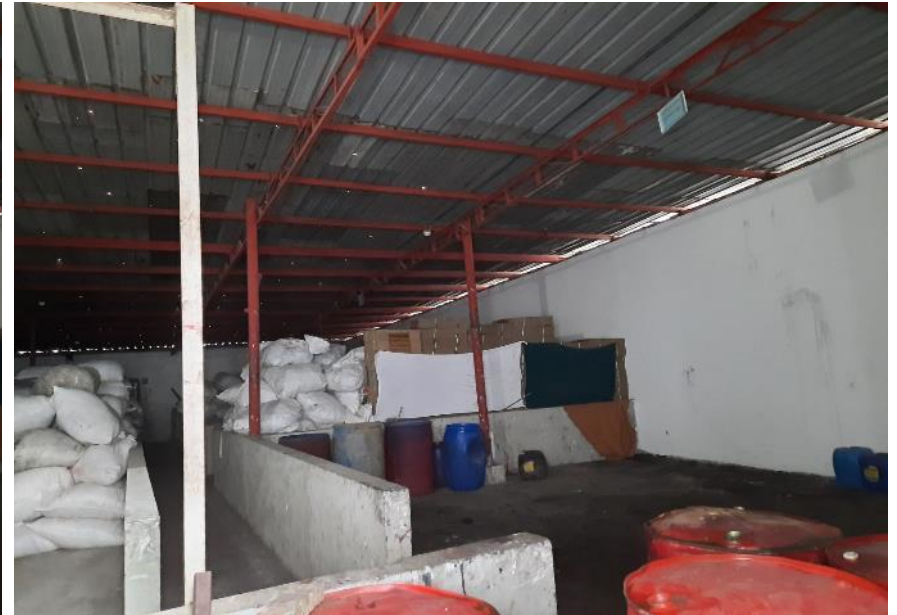
**Apparently non engineering shed**

Poor connections, inadequate members were observed on-site. Therefore, the roof system seems to be non-engineered.

| Item No. | Observation | Recommended Action Plan | Recommended Timeline |
|---|---|---|---|
| 16 | Apparently non-engineering shed (Building-6) | Building engineer to survey the structure, check the roof system, connections, member adequacy and suggest required actions. | 6-weeks |
| 17 | Apparently non-engineering shed (Building-6) | Implement the actions suggested by the engineer. | 6-months |
