# **FIRE SAFETY INSPECTION REPORT**

## **DEBONAIR LIMITED UNIT-2**

**PLOT # 356, SHORIFPUR, OZARPARA, NATIONAL  
UNIVERSITY, JOYDEBPUR**

May 25, 2014

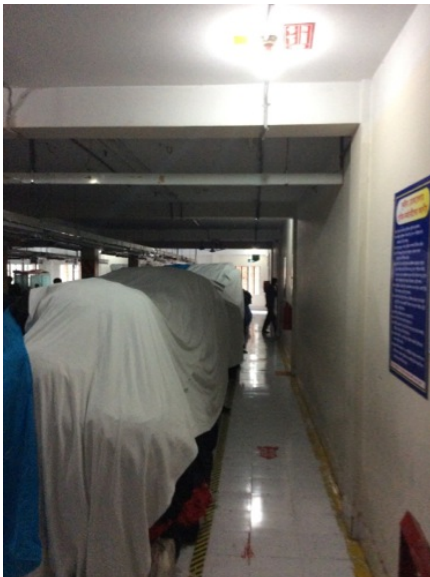
| No. | Category | Finding | Recommendation | Remediation Timeframe |
|---|---|---|---|---|
| F-1 | Fire Rated Construction | Storage rooms and process storage areas on most floors used for combustible storage are not separated by fire-rated construction. | <p>Provide dedicated storage rooms separated by minimum 1-hr fire-rated construction.</p> <p>Where separate storage rooms are not feasible, provide defined storage areas and limit the storage arrangement as follows:</p> <ul style="list-style-type: none"> <li>- Maximum height of 2.4m and maximum area of 23m<sup>2</sup></li> <li>- If sprinkler protected: maximum height of 3.66m and maximum area of 93m<sup>2</sup></li> </ul> <p>Separate areas of unenclosed combustible storage by a minimum clear distance of 3m.</p> | Within 3 months |

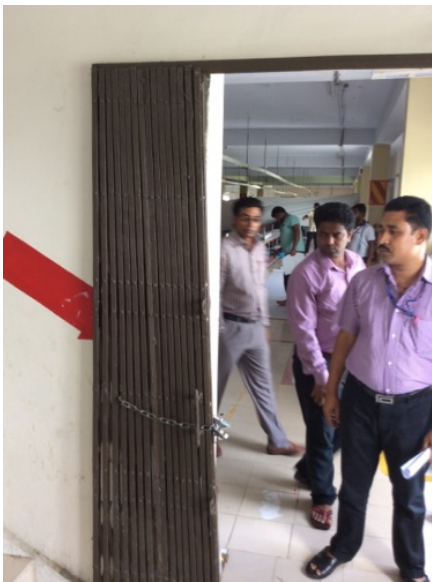
| F-2 | Fire Rated Construction | The exit stairs are not separated from work areas on each floor by fire-rated construction. | <p>Provide minimum 1.5-hr fire rated doors and seal all unprotected openings to separate the exit stairs from work areas and other building spaces on all floor levels. Ensure that the fire doors are self-closing and positive latching and that they are provided with fire exit (panic) hardware where serving production floors.</p> <p>If fire doors are required to be held open for functional reasons, provide automatic-closing devices tied to the fire alarm system.</p> | Within 3 months |

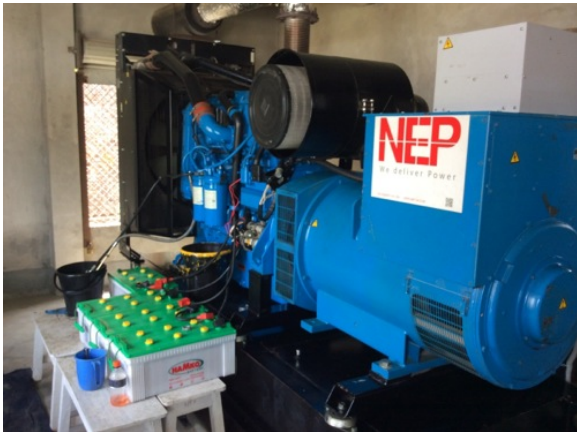
| F-3 | Fire Rated Construction | The generator and transformer rooms are not separated by fire-rated construction. | Separate the generator and transformer rooms by a minimum 2-hr fire-rated construction. Seal and/or protected all openings to maintain the required fire separations | Within 3 months |

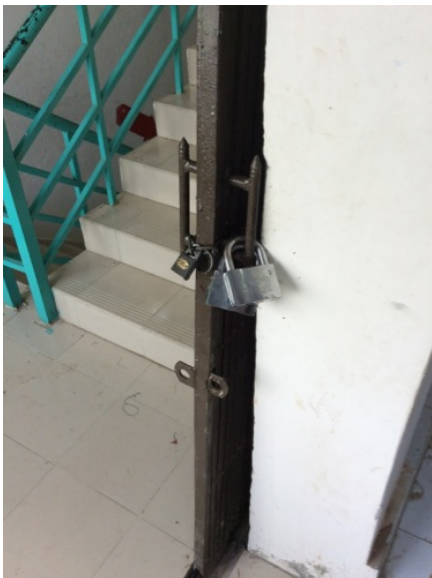
| F-4 | Egress | Egress gates with locking features are provided at exit stairs throughout the building. | Remove locking features from all egress gates.<br><br>If locks are required for security reasons, utilize special door locking features complying with NFPA 101. | Immediate |

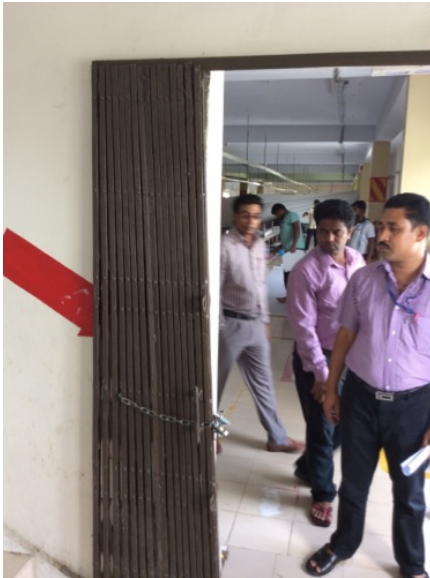
| F-5 | Egress | Collapsible gates are provided throughout both stairwells at each floor. | Replace all gates along the means of egress with side-hinged, swinging egress doors. | Within 1 month |

If locks are required for security reasons, utilize special door locking features complying with NFPA 101.

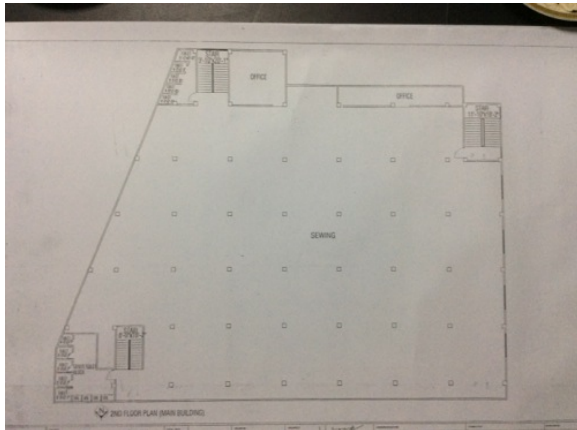
| F-6 | Egress | Exit capacity (484) is not adequate for the occupant load (550) on floor 2 | Immediately reduce occupant load to not more than available exit capacity.<br><br>If possible provide additional exits to increase exit capacity. | Within 3 months |

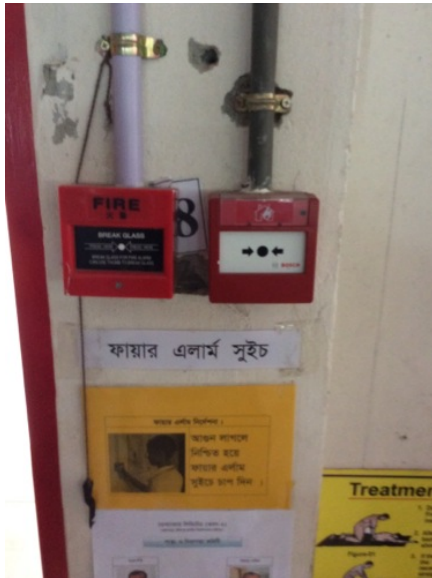
| F-8 | Fire Protection | Inspection, testing, and maintenance for the fire alarm system it was not in accordance with NFPA 72. | Inspect, test and maintain the fire alarm system, and keep written records on-site, in accordance with NFPA 72. | Within 3 months |

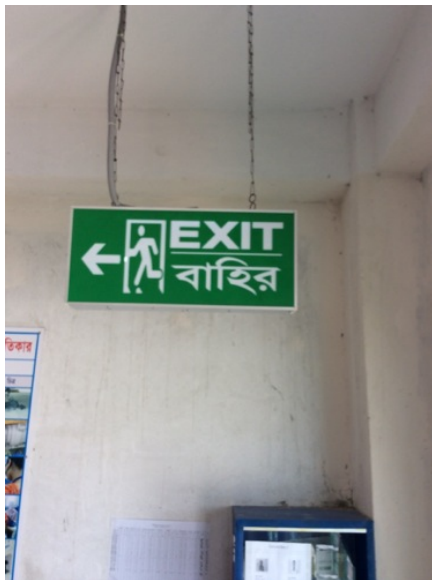
| F-9 | Egress Lighting | Exit signage throughout factory not illuminated (burned out, broken, etc.). | Regularly inspect all exit signage and replace/install lights as needed to illuminate signs. | Within 1 month |

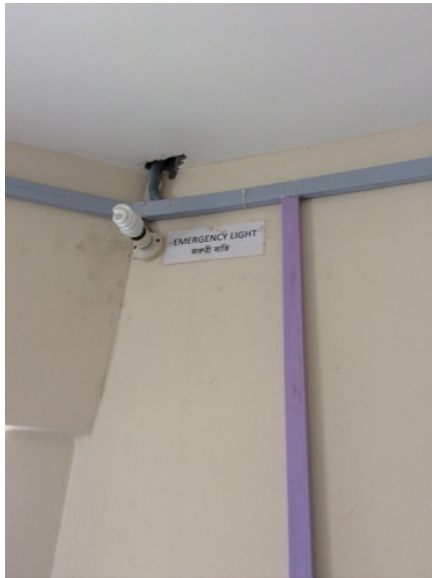
| F-10 | Egress Lighting | At least one emergency light did not function in test mode (burned out, broken, etc.). | Regularly test the emergency lighting system on each floor and replace/repair lights as needed. | Within 1 month |

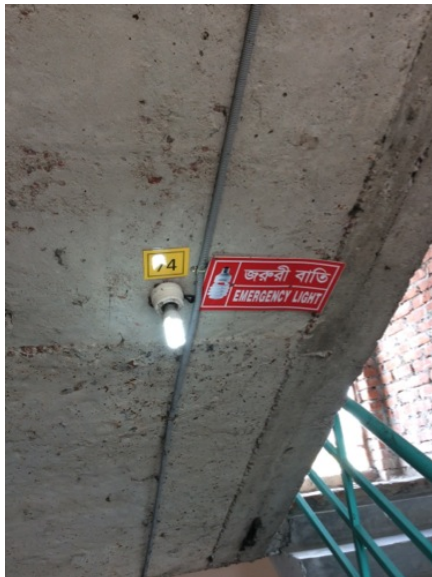
| F-11 | Egress Lighting | Inspection, testing, and maintenance records for the emergency lighting system were not available. | Inspect, test and maintain the emergency lighting system in accordance with The ACCORD standard. Keep written records on-site. | Within 3 months |
