Revision: Issue 1  
Date: 25.01.2022

# Saiham Knit Composite Ltd. (Extension Area)

Saiham Nagar, Noyapara, Madhabpur, Hobigonj  
(24.18375, 91.35222)

2<sup>nd</sup> June & 26<sup>th</sup> August 2021

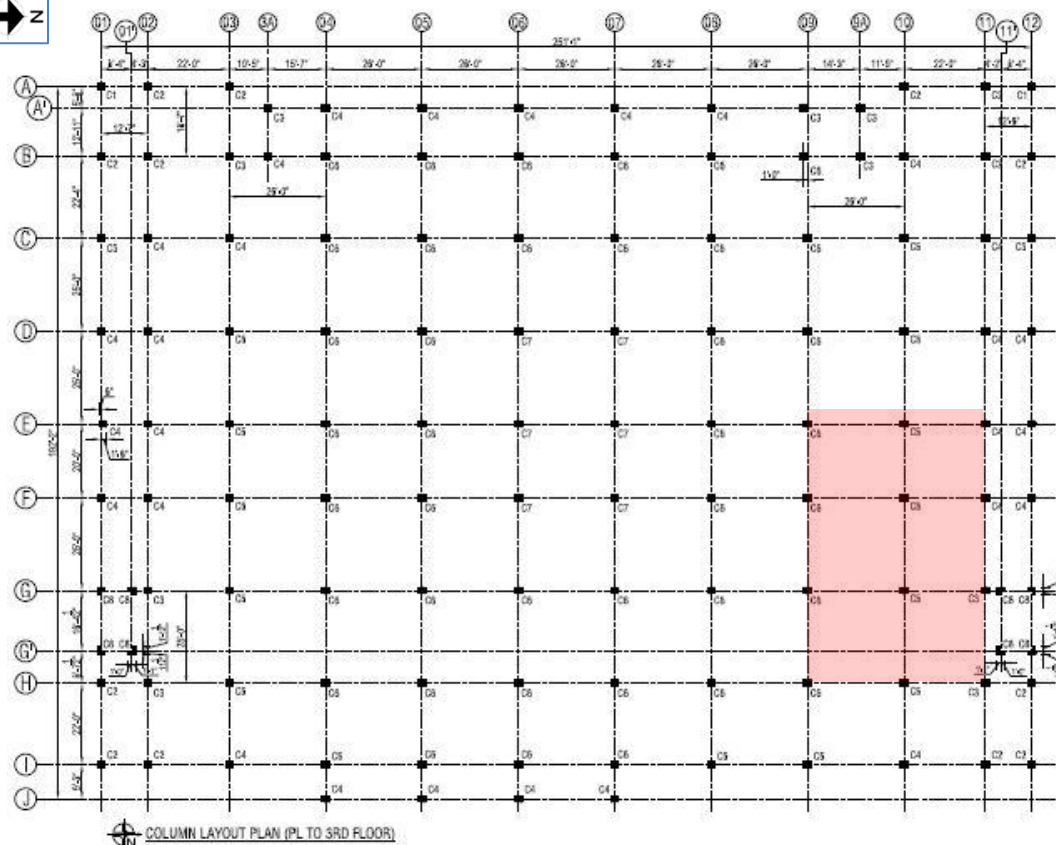
Column Layout

**Column to be stressed above normal design  
limit**

Cursory calculation indicates that the columns at marked area are stressed above normal design limit considering prepared live load plan and equivalent concrete strength from concrete core test value. Building engineer is required to review design, load & column stress in the area identified above.

| Item No. | Observation | Recommended Action Plan | Recommended Timeline |
|---|---|---|---|
| 01 | Column to be stressed above normal design limit. (Building 1-Special Building) | Building engineer to review design, loads and columns stresses in area identified above. | 6-weeks |
| 03 | Column to be stressed above normal design limit. (Building 1-Special Building) | Produce and actively manage a loading plan for all floor plates within the factory Building considering floor, column and foundation capacity. | 6-weeks |

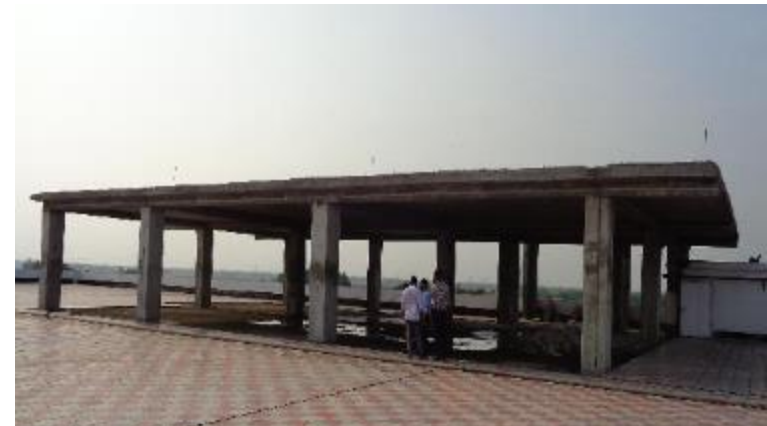
Additional roof extension

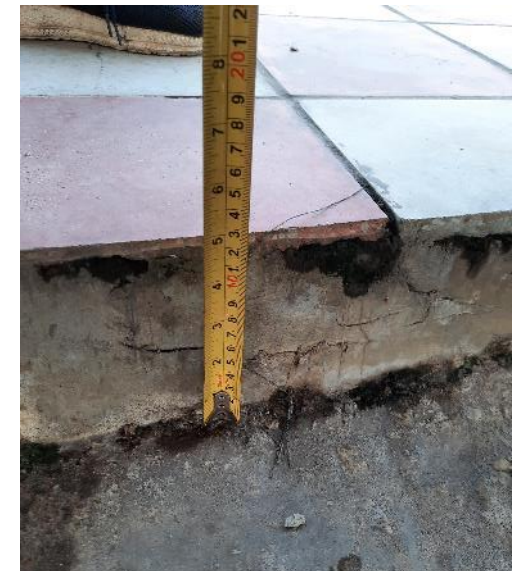
125 mm additional floor finishes

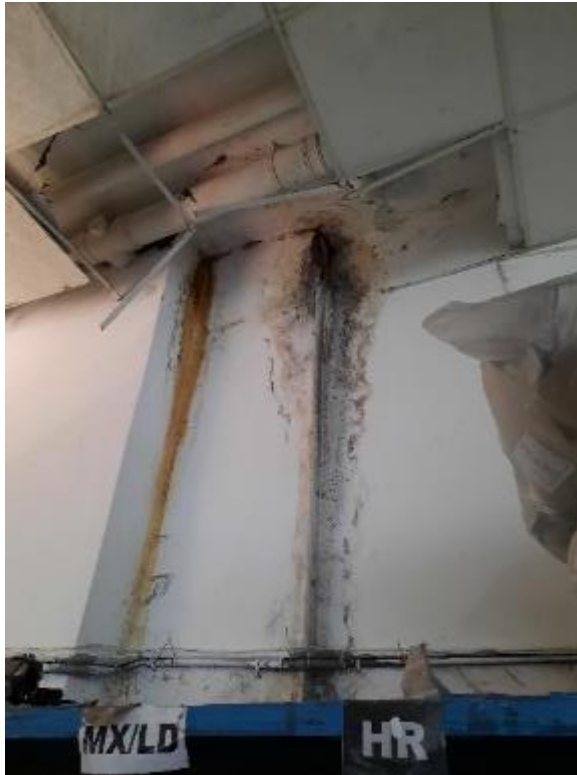
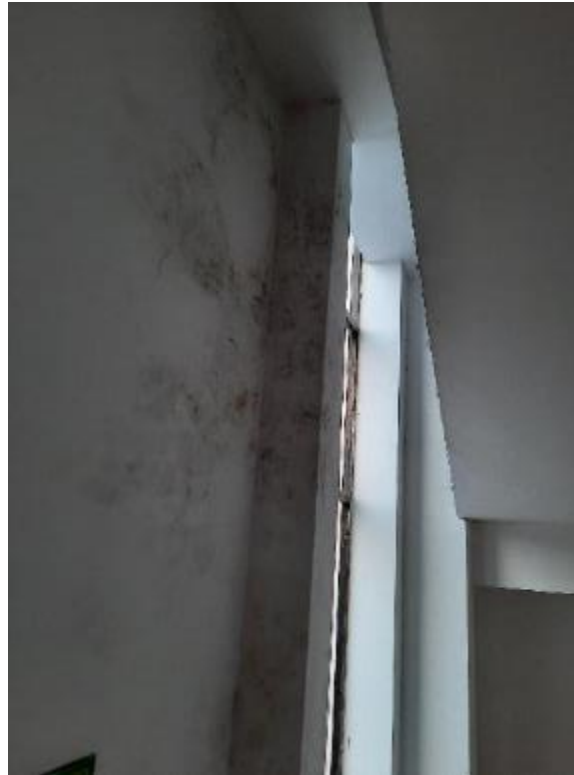
**Dampness throughout the building**

Dampness was observed through the building. Building engineer is required to investigate the reason of dampness and suggest remedial actions.

| Item No. | Observation | Recommended Action Plan | Recommended Timeline |
|---|---|---|---|
| 06 | Dampness throughout the building. (Building 1-Special Building) | Building engineer is required to investigate the reason of dampness and suggest proper remedial actions. | 6-weeks |
| 08 | Dampness throughout the building. (Building 1-Special Building) | Carryout remedial works as per investigate report. | 6-months |

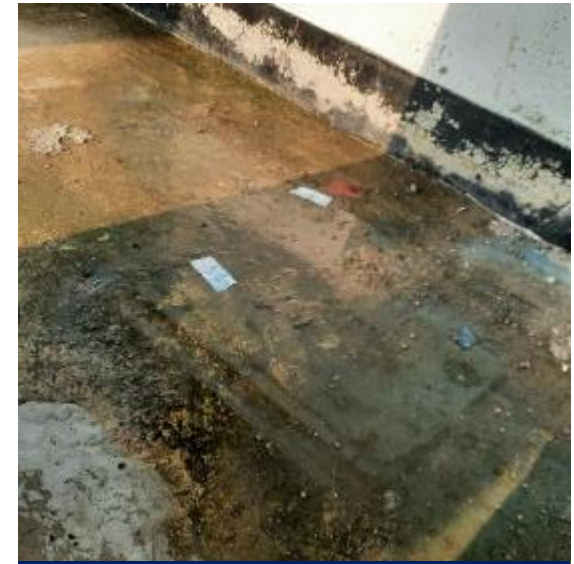
Stagnant water at roof

| Item No. | Observation | Recommended Action Plan | Recommended Timeline |
|---|---|---|---|
| 07 | Dampness throughout the building. (Building 1-Special Building) | Complete the finishing works on the roof. | 6-weeks |

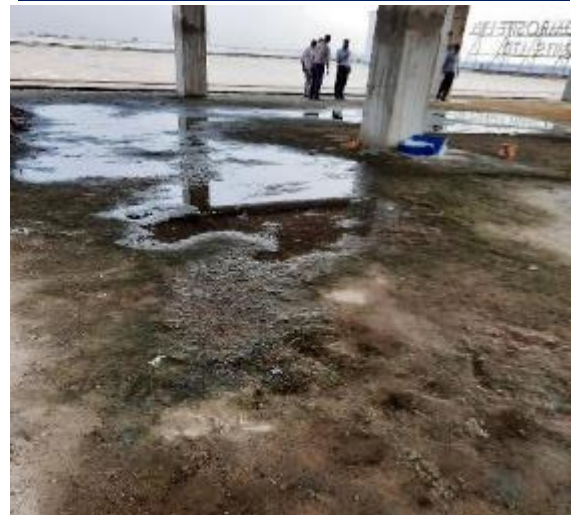
Incomplete finishing works at roof

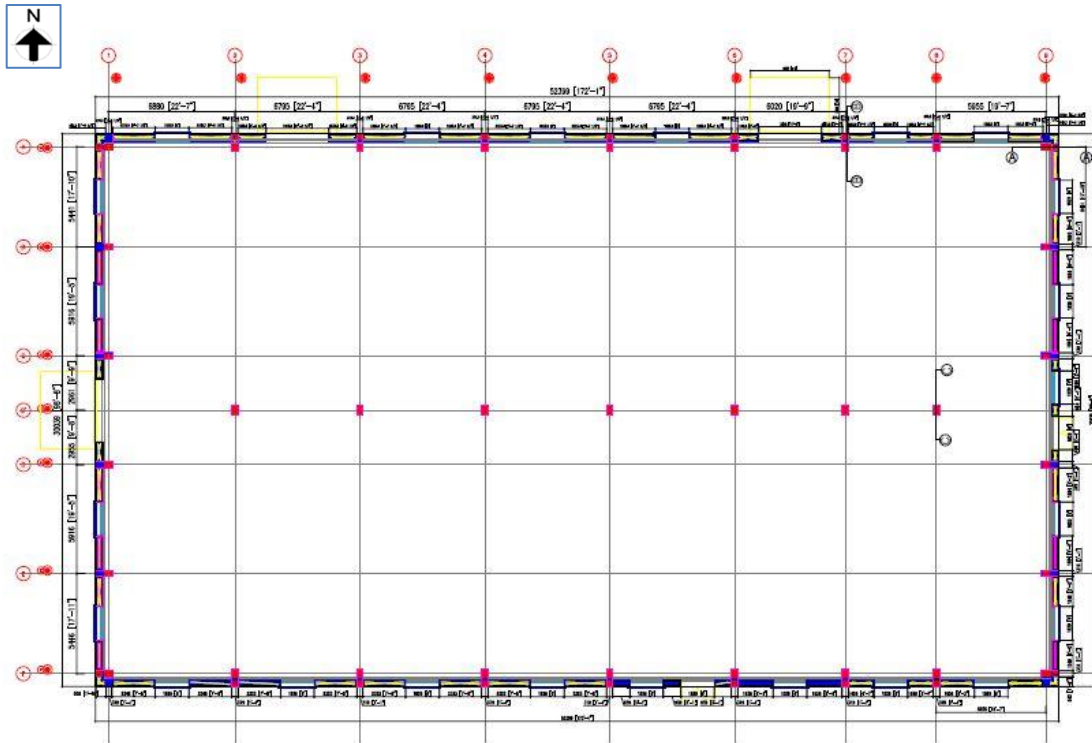
Floor Layout Plan

# **Laterally unsupported long columns**

The 14.5 m long columns are not laterally supported along its weaker direction. Compression strut/tie beams are not provided in the intermediate position of these long columns. Building engineer is required to check the lateral stability of the shed.

| Item No. | Observation | Recommended Action Plan | Recommended Timeline |
|---|---|---|---|
| 09 | Laterally unsupported long columns. (Building 2-Central Warehouse-1) | Carry out Engineering Assessment (EA) to check the lateral stability of the shed. | 6-weeks |
| 10 | Laterally unsupported long columns. (Building 2-Central Warehouse-1) | Implement remedial works as per EA. | 6-months |

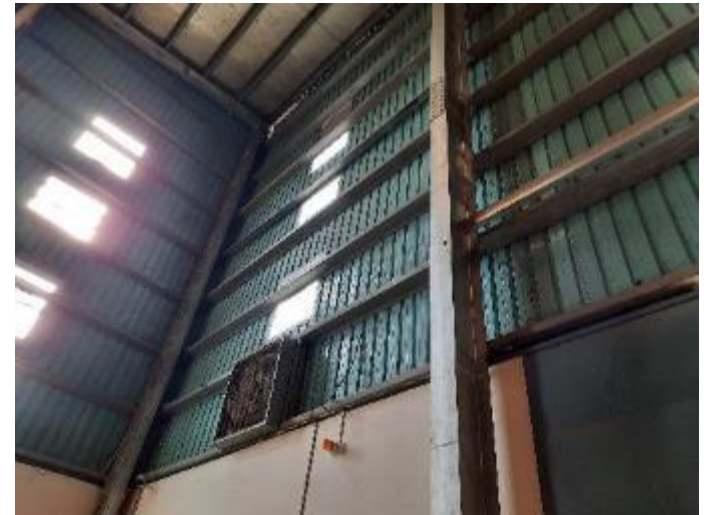
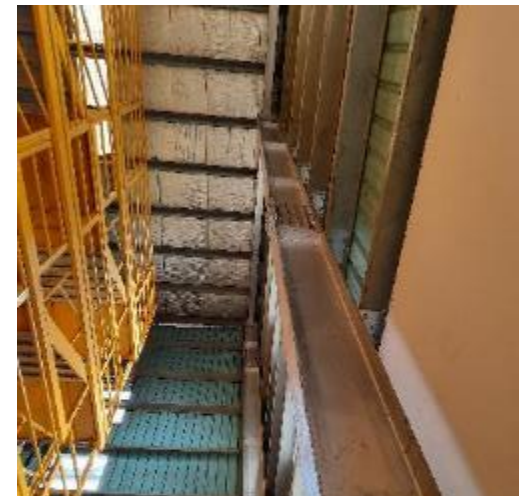
Compression strut/tie beams not provided in the long direction

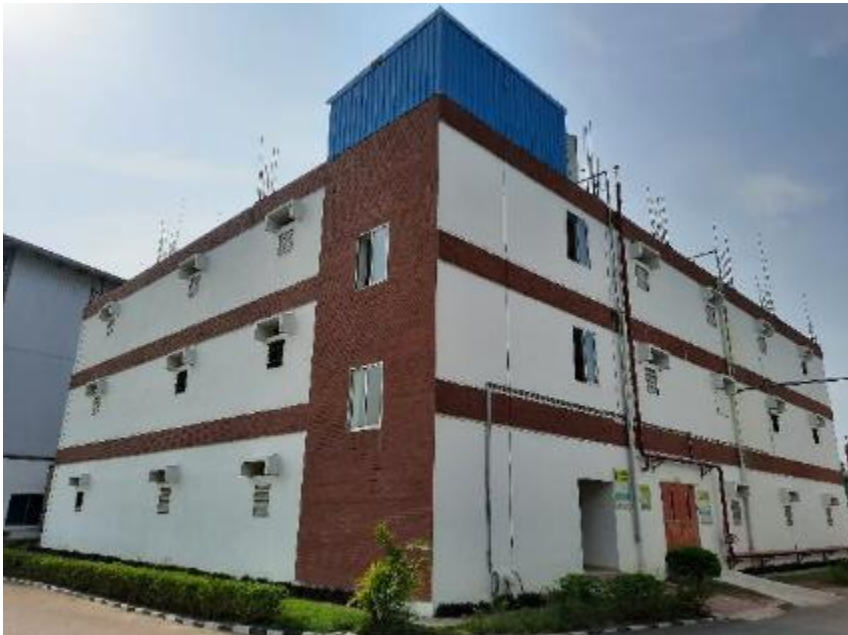
As permit drawings are for 3-Storey factory building, column & foundation capacity has been checked for existing condition (3-Storey). Factory has a plan to extend the building vertically up to 4-Storey.

Existing 3 storey building

| Item No. | Observation | Recommended Action Plan | Recommended Timeline |
|---|---|---|---|
| 11 | Vertical extension to be carried out. (Building 3 -Chemical Bonded Warehouse) | For any vertical extension, a Detail Engineering Assessment (DEA) considering BNBC provision to be completed before commencement further construction. | 6-weeks |

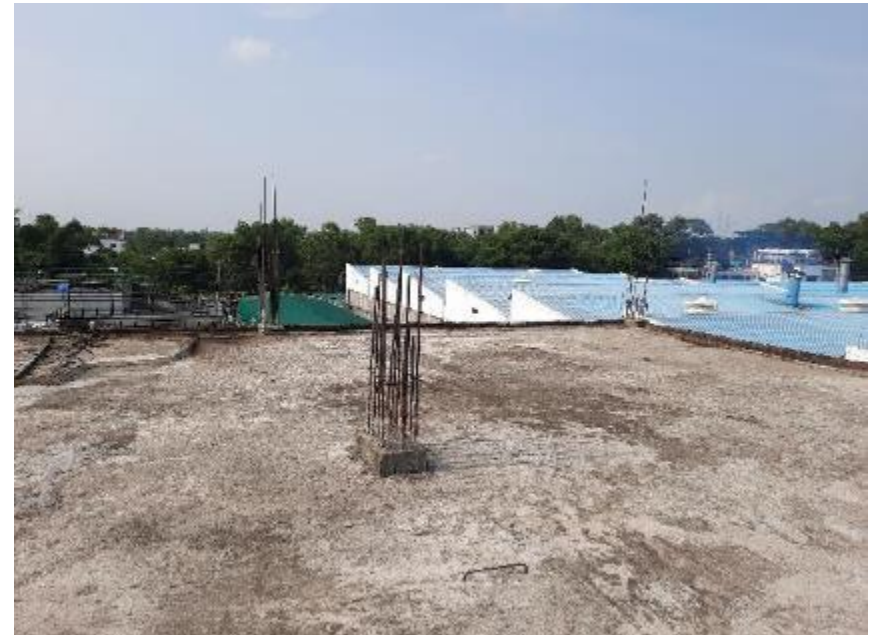
Exposed rebar indicated further construction

For any vertical extension, columns & foundation will have higher stresses. A Detail Engineering Assessment (DEA) considering BNBC provision to be completed before further construction.

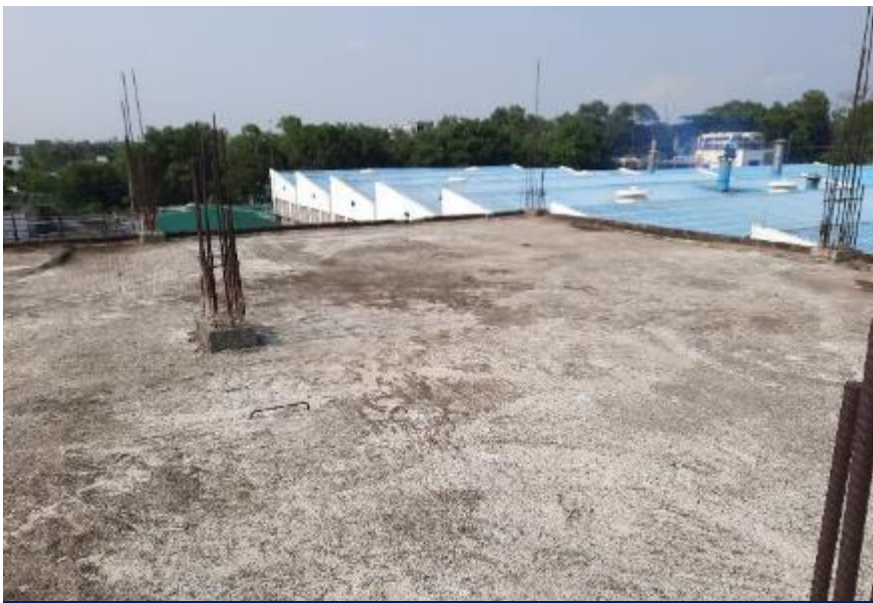
No parapet on roof

| Item No. | Observation | Recommended Action Plan | Recommended Timeline |
|---|---|---|---|
| 13 | Falling Hazard & Exposed Rebar at Roof. (Building 3-Chemical Bonded Warehouse) | Install parapet & guardrails to prevent falling hazard. | 6-weeks |

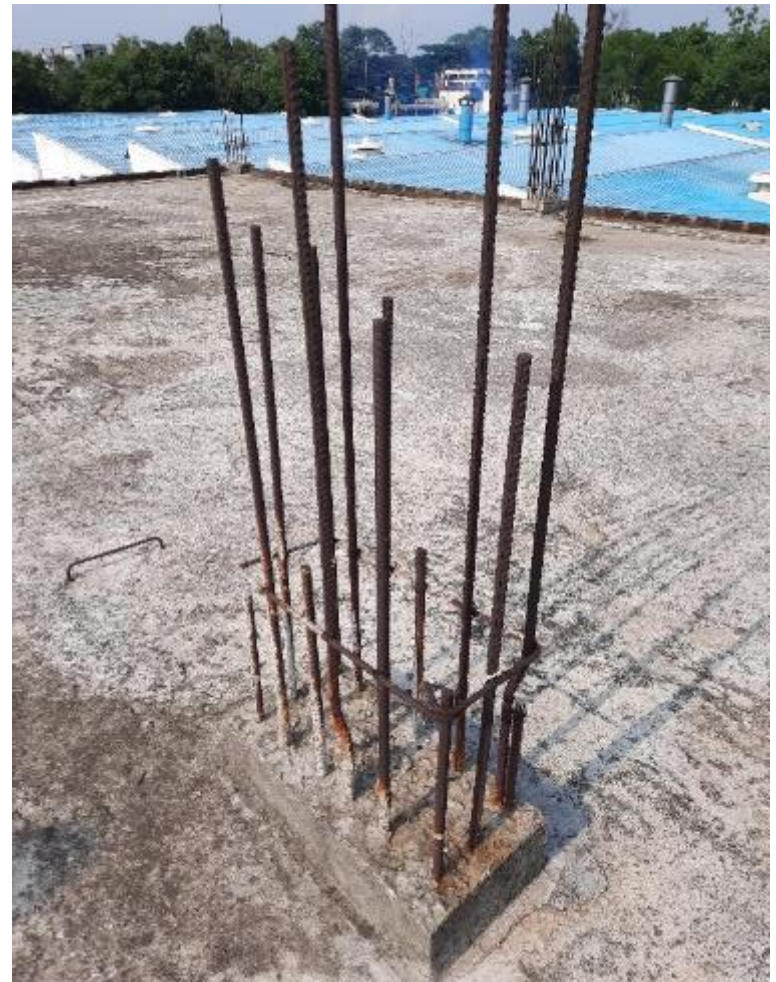
Exposed rebar prone to be corroded

| Item No. | Observation | Recommended Action Plan | Recommended Timeline |
|---|---|---|---|
| 14 | Falling Hazard & Exposed Rebar at Roof. (Building 3-Chemical Bonded Warehouse) | Building engineer is required to provide rust proofing paint on the exposed rebar. | 6-weeks |

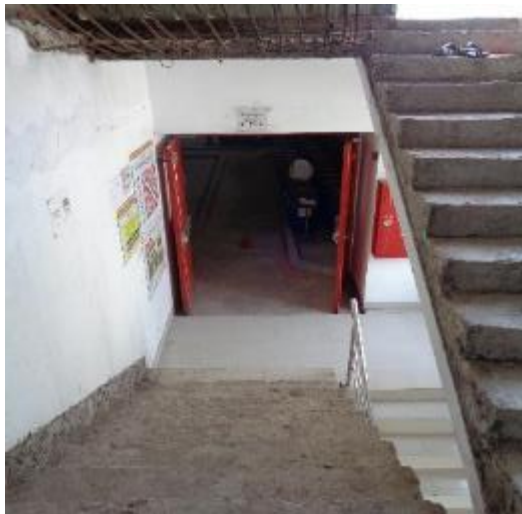
No guardrails around the stair

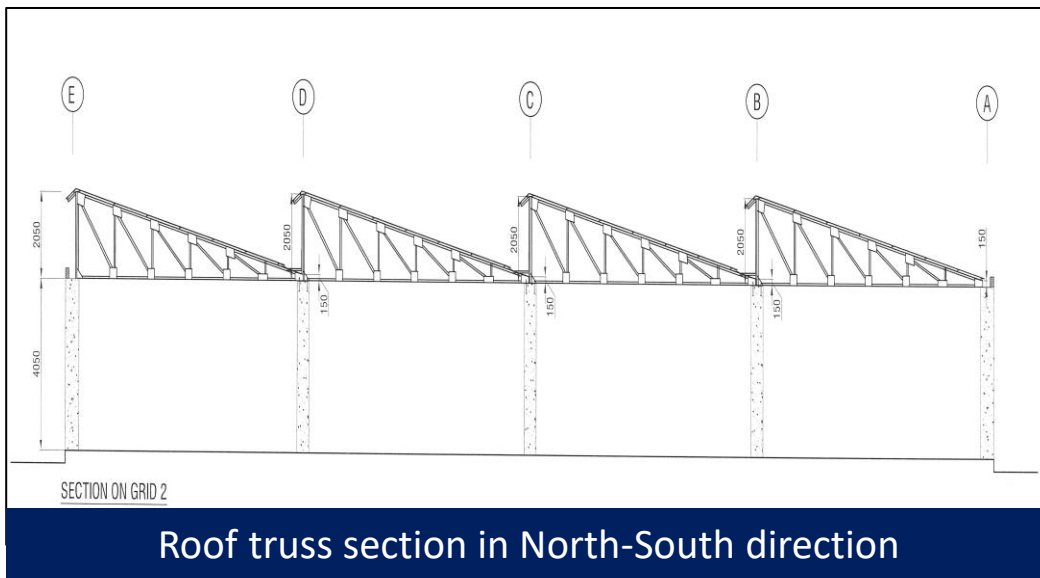
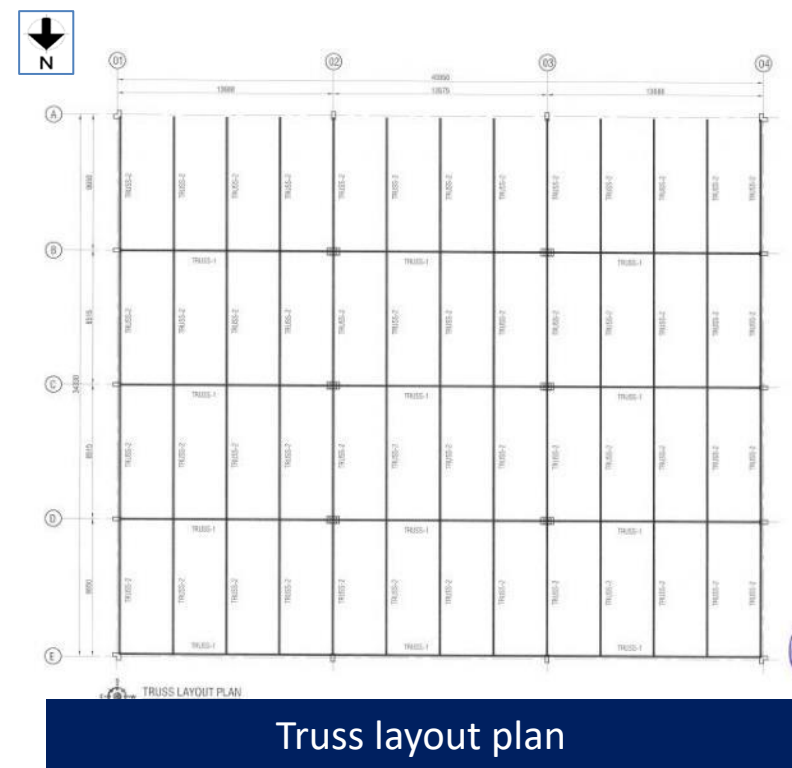
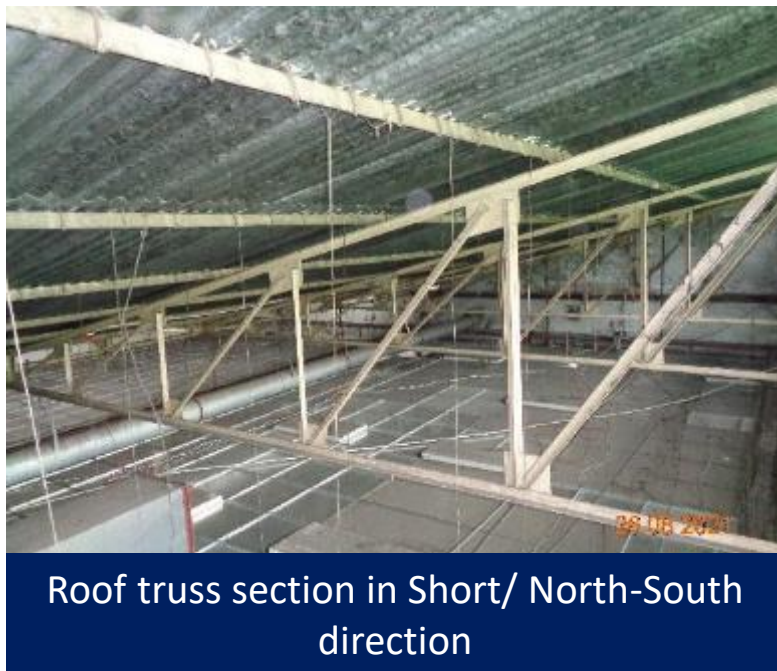
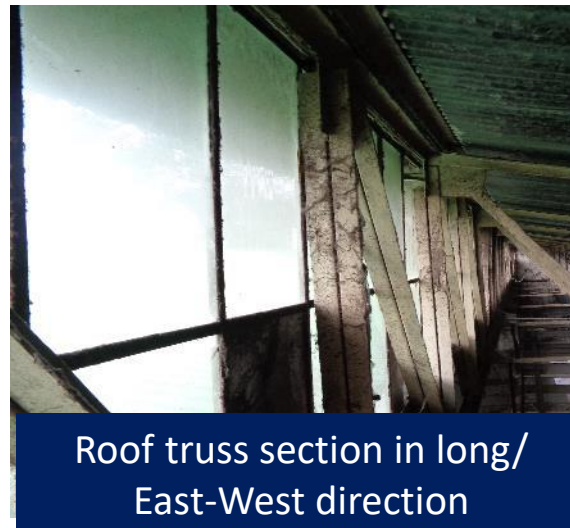
**Roof bracing missing to integrated the truss**

No roof bracing provided to integrated the truss. The building engineer is required to check the requirement of the roof bracing.

| Item No. | Observation | Recommended Action Plan | Recommended Timeline |
|---|---|---|---|
| 17 | Roof bracing missing to integrated the truss. (Building 5 -Printing Shed) | Building engineer is required to check the requirement of the roof bracing for lateral stability. | 6-weeks |
| 18 | Roof bracing missing to integrated the truss. (Building 5 -Printing Shed) | Carryout remedial works where necessary. | 6-months |

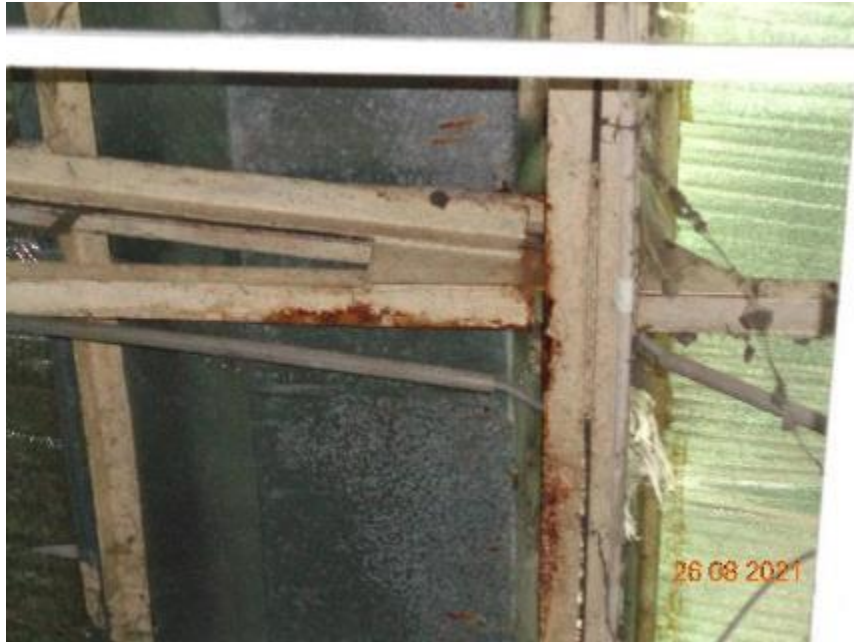
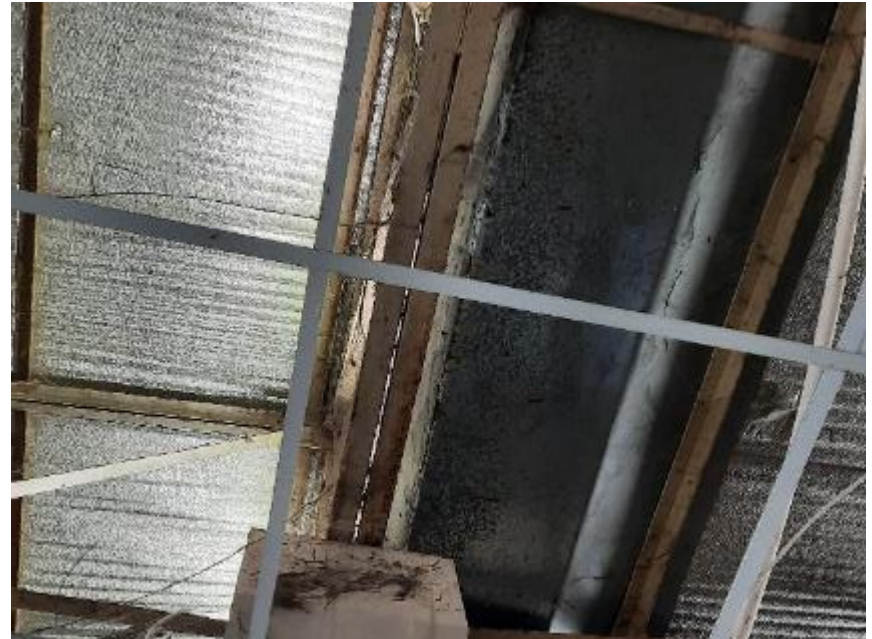
## **Corrosion on steel member**

Corrosion observed on the steel member. Building engineer is required provide rust proofing on the steel member.

| Item No. | Observation | Recommended Action Plan | Recommended Timeline |
|---|---|---|---|
| 19 | Corrosion on steel member. (Building 5- Printing Shed) | Provide anti rust paint to the corrosion prone steel. | 6-weeks |

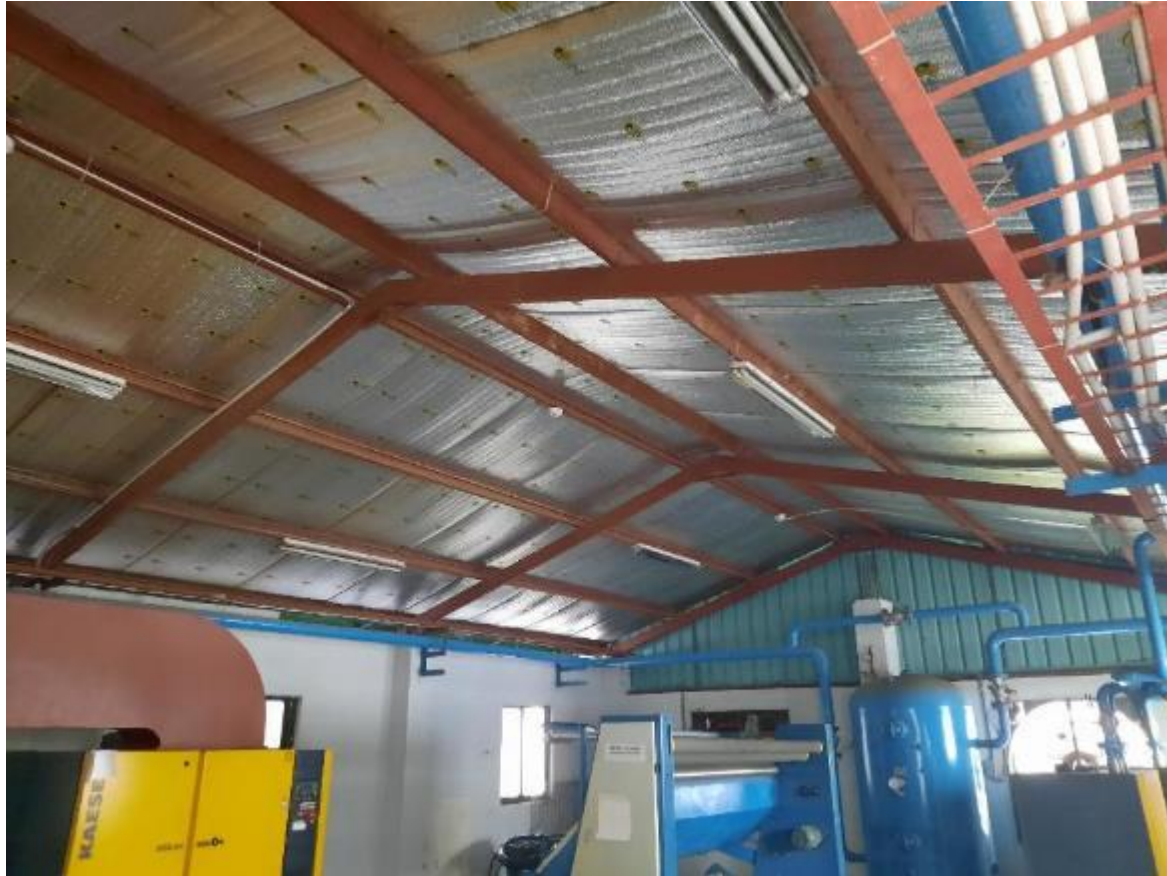
**Apparently lack of lateral stability system**

No bracings and compression members are provided in the roof level. The building engineer is required to check the lateral stability system of the shed.

| Item No. | Observation | Recommended Action Plan | Recommended Timeline |
|---|---|---|---|
| 20 | Apparently lack of lateral stability system. (Building 6:Utility Building-Part B) | Building engineer is required to check the lateral stability of the shed. | 6-weeks |

| Item No. | Observation | Recommended Action Plan | Recommended Timeline |

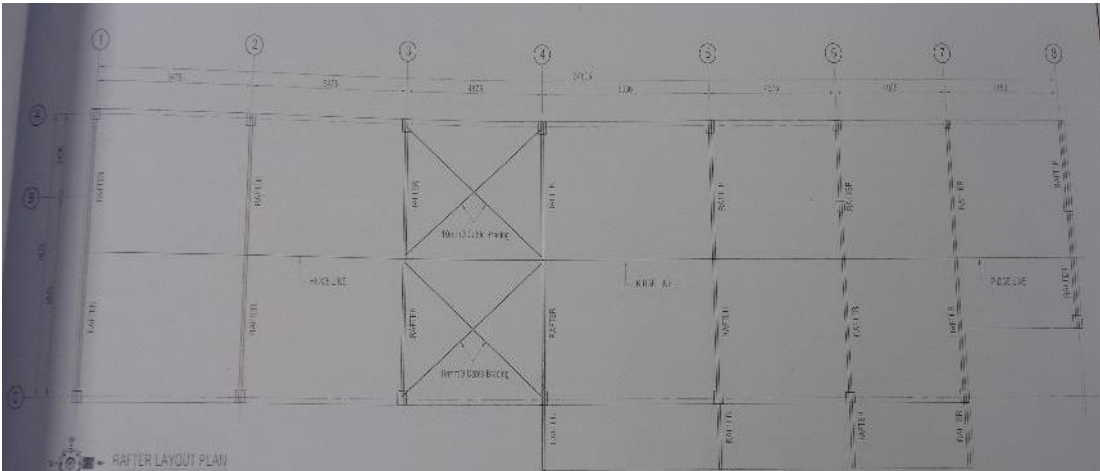
Roof bracing layout plan

Roof bracing  
only in one bay

No vertical bracings / tie beam / compression struts were provided in the long direction. Only roof bracings provided in one bay along the short direction, lateral stability along the long direction is appeared to be incomplete. The building engineer is required to check the lateral stability system of the shed.

| Item No. | Observation | Recommended Action Plan | Recommended Timeline |
|---|---|---|---|
| 22 | Apparently lack of lateral stability system. (Building 7 -Washing Shed) | Building engineer is required to check the lateral stability of the shed. | 6-weeks |
| 23 | Apparently lack of lateral stability system. (Building 7 -Washing Shed) | Carryout remedial works where necessary. | 6-months |

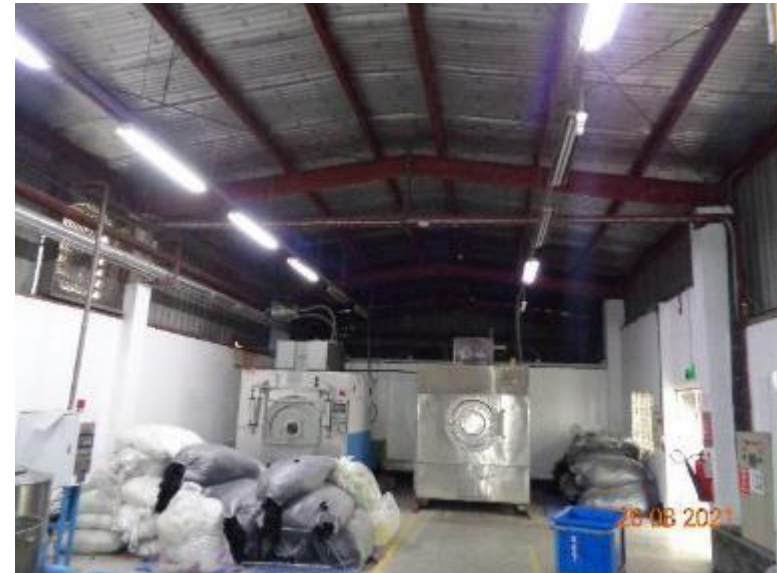
Absence of load transfer media in long direction

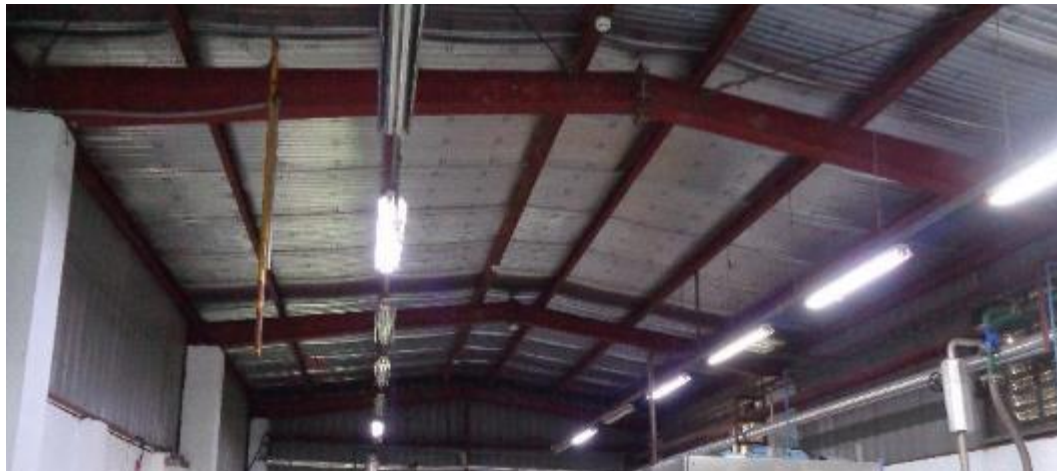
Roof bracing only in one bay

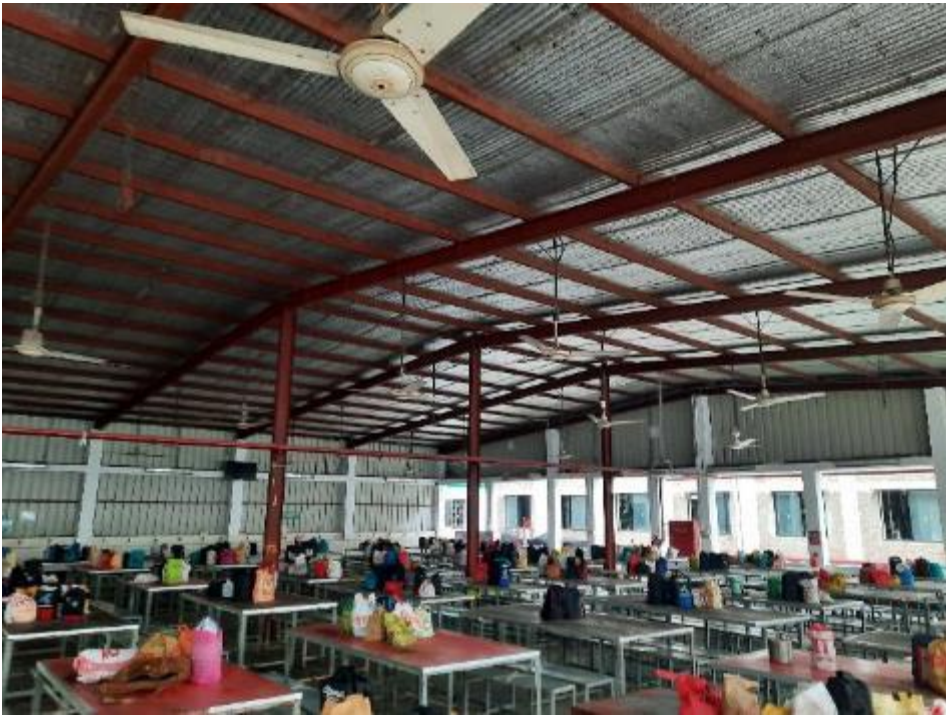
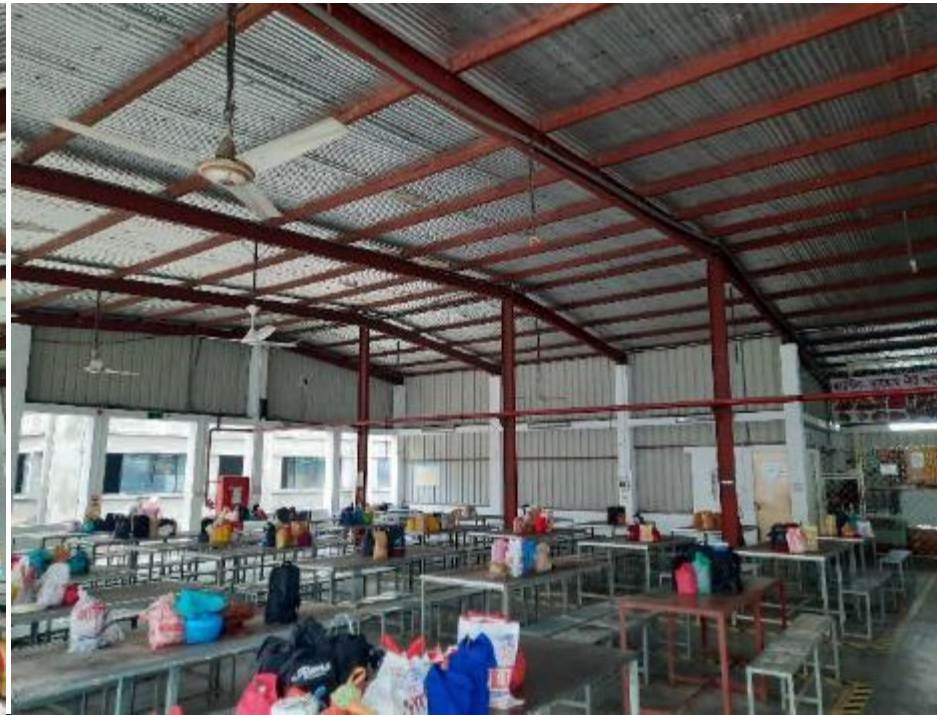
No vertical bracings, compression struts were provided in the long direction. No roof bracings provided along the short direction. Apparently lack of lateral stability observed.  
The building engineer is required to check the lateral stability system of the shed.

| Item No. | Observation | Recommended Action Plan | Recommended Timeline |
|---|---|---|---|
| 24 | Apparently lack of lateral stability system. (Building 8: Canteen 1) | Building engineer is required to check the lateral stability of the shed. | 6-weeks |
| 25 | Apparently lack of lateral stability system. (Building 8: Canteen 1) | Building engineer is required to check the connection capacity against uplift forces. | 6-weeks |

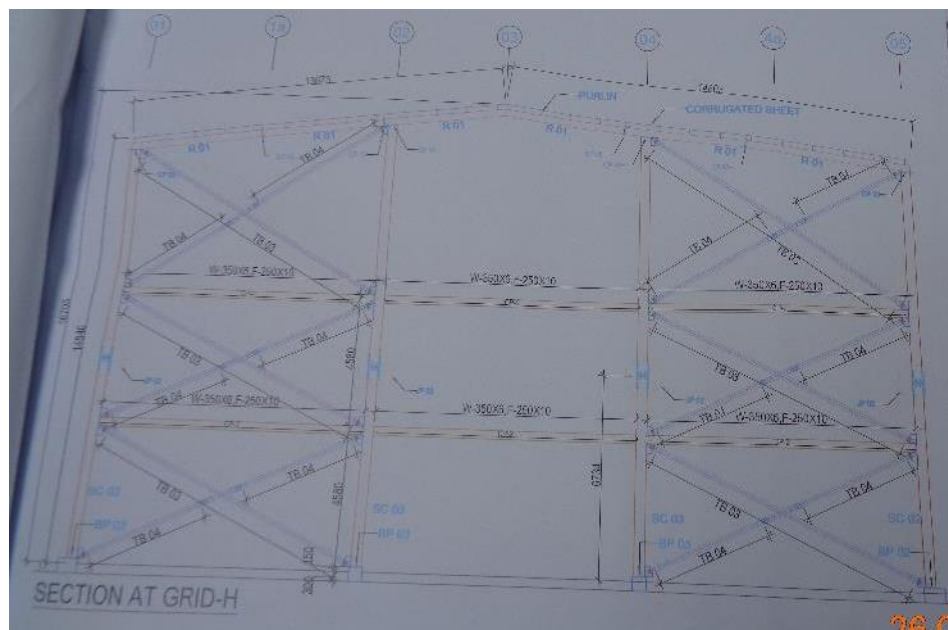
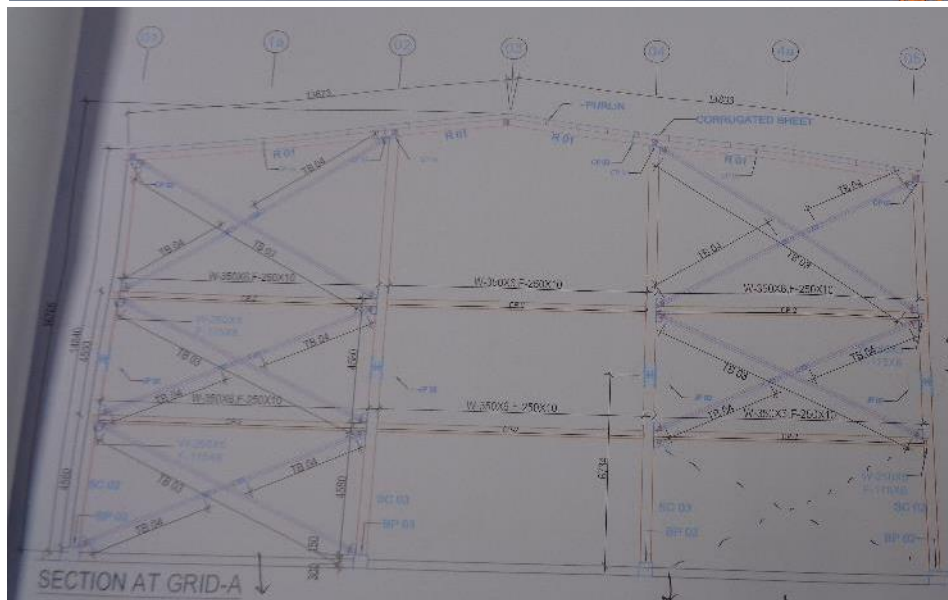
Bracing System as per drawing

On site bracing placement not matched with the drawing.

| Item No. | Observation | Recommended Action Plan | Recommended Timeline |
|---|---|---|---|
| 31 | Bracing System not matched with the drawing. (Building 12 - Central Warehouse-2) | Building engineer is required to update the as-built structural drawings and check the adequacy of existing bracing system for lateral stability. | 6-weeks |

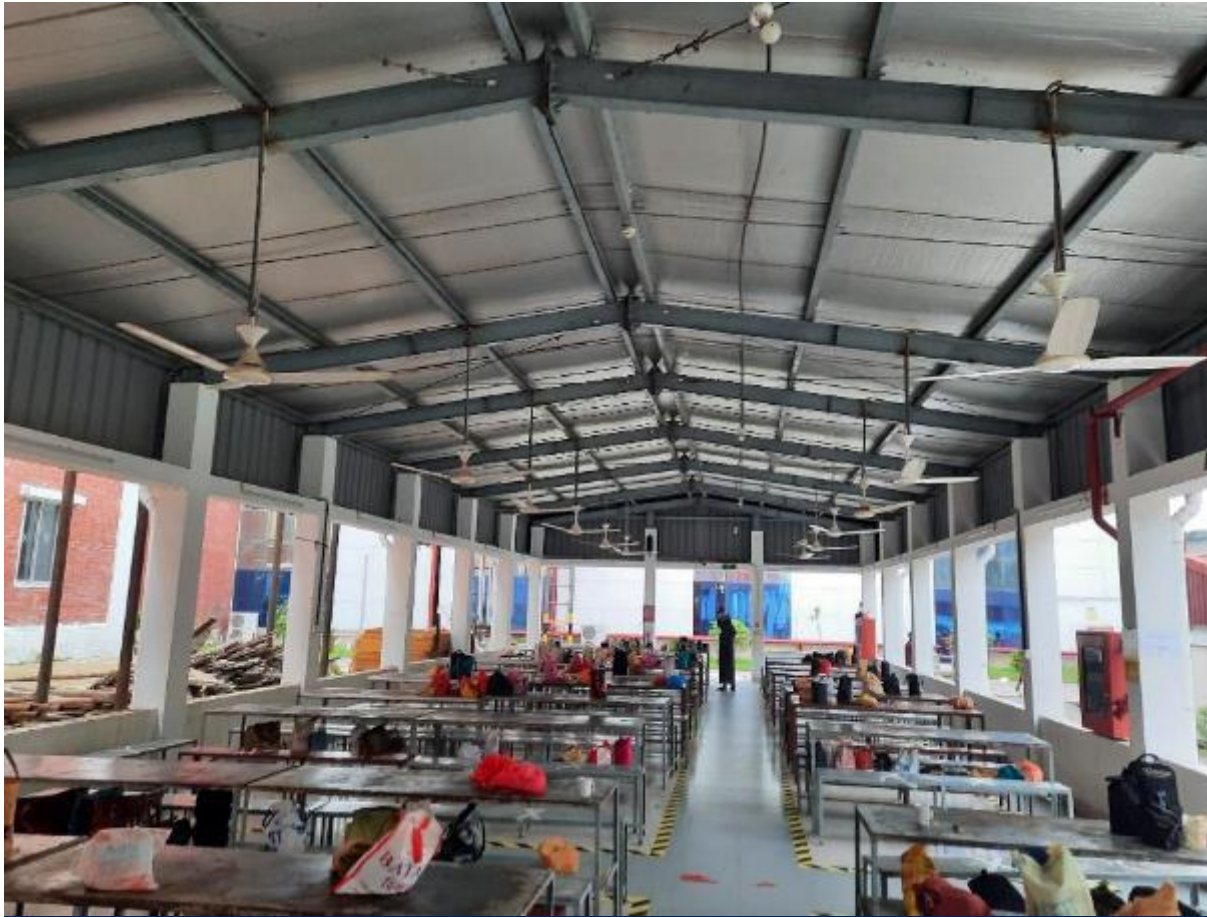
**Apparently lack of lateral stability system**

Only roof bracings provided along the short direction, lateral stability along the long direction is appeared to be incomplete. The building engineer is required to check the lateral stability system of the shed.

| Item No. | Observation | Recommended Action Plan | Recommended Timeline |
|---|---|---|---|
| 33 | Apparently lack of lateral stability system. (Building 13 -Canteen 02) | Building engineer is required to check the lateral stability of the shed. | 6-weeks |
| 34 | Apparently lack of lateral stability system. (Building 13 -Canteen 02) | Carryout remedial works where necessary. | 6-months |
